# **SCHEDULE OF CONDITION**

**ST. PATRICK'S WELL  
TRINITY COLLEGE  
NASSAU STREET  
DUBLIN 2**

**RAILWAY PROCUREMENT AGENCY  
PARKGATE BUSINESS CENTRE  
PARKGATE STREET  
DUBLIN 8**

*Date: November 2009*

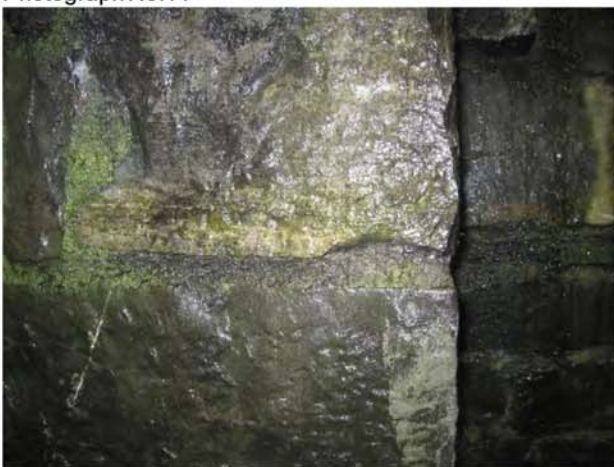
Photograph No.13

1.1.9			Small section of pointing missing on bottom horizontal joint at right hand corner of pier (10mm x 110mm in width).
1.1.10			Missing section of vertical pointing on left hand face of right hand pier (40mm in width).

10.           Right hand section of stone wall over concrete.
11.           Mid section of wall.
12.           Left hand section of the above wall.
13.           Missing pointing, front right hand corner of pier at high level.

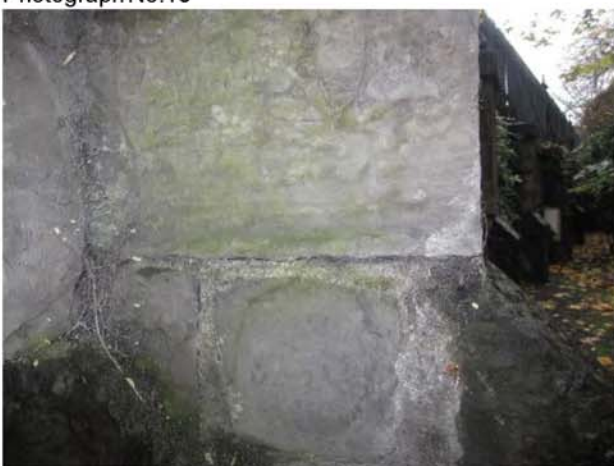
Photograph No.15

1.1.1			Light horizontal crack on right hand pier at juncture with splayed section mid way up on pier. Crack width 6.5mm.
1.1.2			No evidence of cracking to concrete section of wall but vertical joints from formwork visible.

14.           Ditto at low level.
15.           Cracking to horizontal joint at left hand face of pier.
16.           Missing pointing to left hand face of pier at low level.

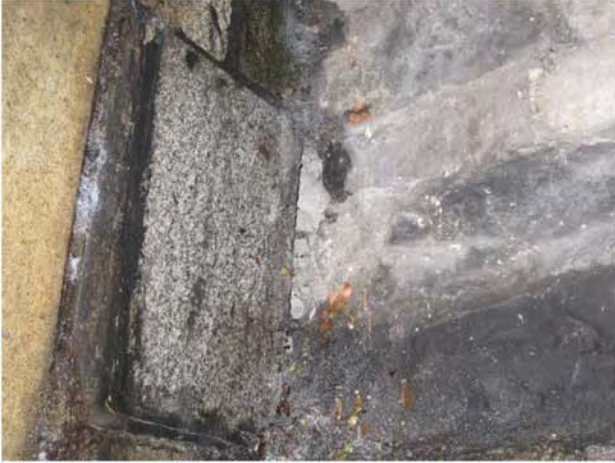
Photograph No.17

1.1.5			Metal gate at entrance to well corroded and generally stiff to open and close with wire mesh on gate damaged around perimeter.
1.1.6			Large gap at juncture between stonework and granite pier at top left side of entrance to well measuring 40mm in width x 230mm in length.

17.           Large gap at juncture between stone work and granite pier at top left side of entrance to well.

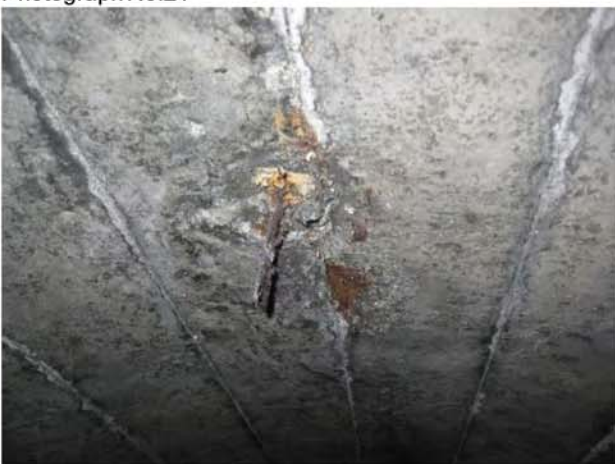
Photograph No.23

2.1.1			Small exposed section of reinforcement to top of arch at mid section of entrance and spalled section of concrete in this general area.
2.1.2			Light crack on top section of arch to front of entrance over gate and white damp staining evident in crack.

- 23. Exposed section of reinforcement to top of arch.
- 24. Light cracking to front section of arch over gate.

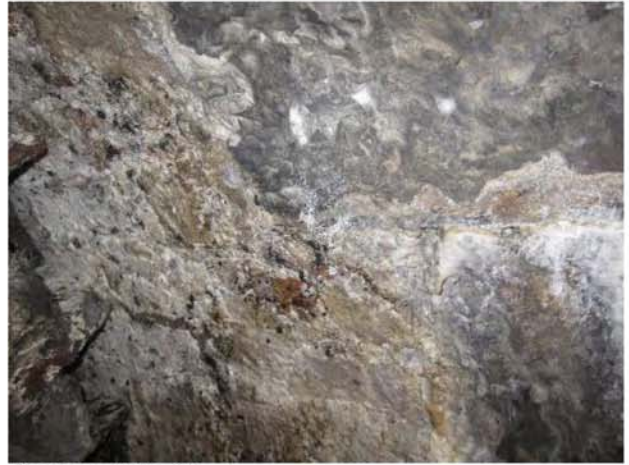
Photograph No.34

2.2.12			Light cracking evident on rear wall at juncture with left side of brick head.
2.2.13			Considerable surface spalling on brickwork to left side of the arch head generally over entrance to well.

- 32. Ditto towards top.
- 33. Ditto to left hand side.
- 34. Spalling to brickwork at top section of front of brick arch.
- 35. Cracking to front of brick arch right hand side (overhead).

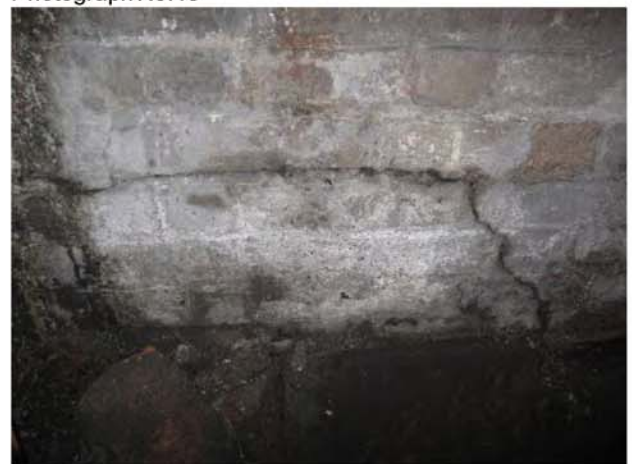
Photograph No.48

2.2.8			The above horizontal crack steps upwards to centre of arch overhead and extends also to rear wall.
2.2.9			Horizontal crack evident in brickwork joint at low level towards rear of right hand wall stepping down to floor level (stepped section on bottom of crack is 2mm and horizontal section measures 2.5mm). Cracking extending 750mm from rear wall.

- 44. Ditto rear section.
- 45. Cracking on top section of brick arch overhead (front section).
- 46. Ditto mid section.
- 47. Ditto to rear.
- 48. Horizontal and stepped crack at low level to rear of right hand brick wall.

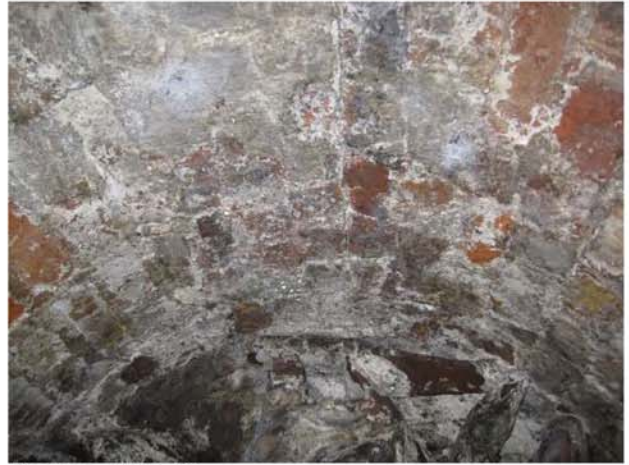
Photograph No.50

2.2.10			Separation crack evident at juncture between right hand wall and rear brick wall at low level (approximately 10mm).
2.2.11			General light cracking evident through brickwork joints on arch overhead to rear of this area and a lot of water ingress evident through this section of brickwork.

49. Vertical crack at juncture between right hand wall and rear wall (low level).
50. Light cracking and spalled brickwork on top section of arch towards rear.
51. Ditto mid section.
52. Ditto front section.
53. General surface spalling to brickwork over head of entrance to well.
54. Stepped cracking at a height of approximately 1.6m on left hand wall above step.
55. Horizontal crack on rear wall.
56. Vertical crack to left side of rear wall at entrance to well (high level).
57. Ditto at low level.
58. Cracking at bottom left side of entrance to well.
59. Cracking underfoot at mouth of well.
60. Overview of rear brick wall at right side of well entrance.

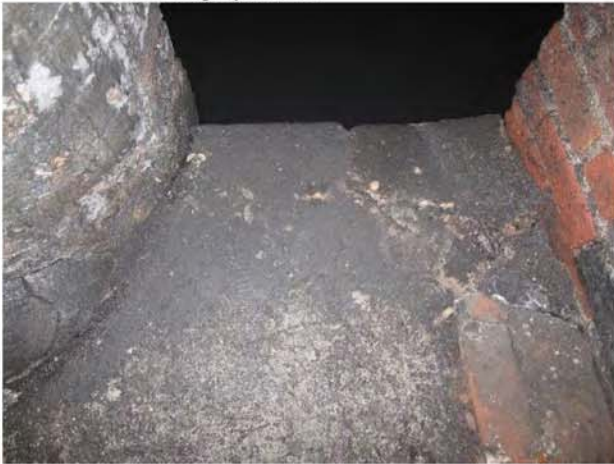
Photograph No.59

2.3.7			Stone surface underfoot badly cracked and loose at mouth of well. This section of stone can be moved by hand and ground sloping downwards in this area.

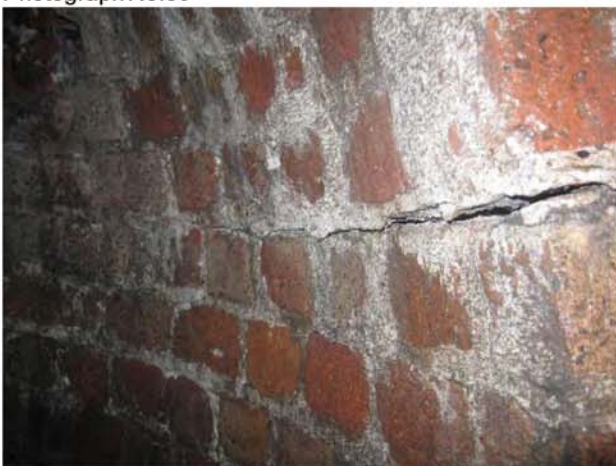
Photograph No.71

2.4.3			Horizontal crack on rear wall at entrance to well extends across the brickwork joint to right hand side directly over the well by 400mm and veers off to hairline crack.

61. Overview of rear brick wall over well.
62. Ditto to right hand section.
63. Ditto to left hand side.
64. Ditto to top section.
65. Overview of stonework beneath bricks to rear section of well.
66. Ditto to right hand side.
67. Ditto to left hand side.
68. Left hand section of well where stepped cracking is evident (photograph at low level).
69. Ditto mid section.
70. Ditto top section of this area.
71. Horizontal crack extending across brickwork to right hand side of entrance at mouth of well.

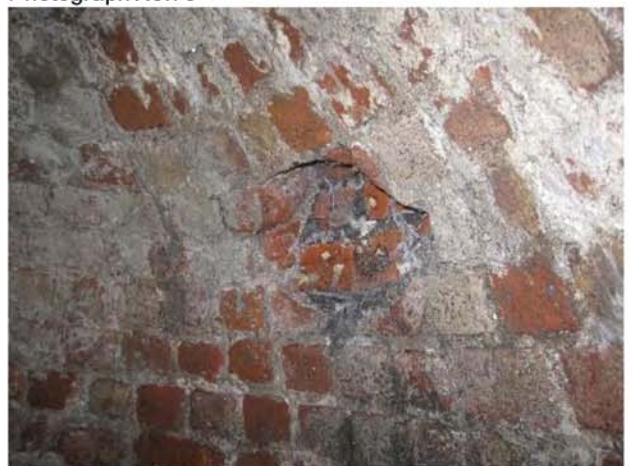
Photograph No.72

2.4.4			Section of brickwork missing towards top of brick vault over right hand side of well.
2.4.5			Stepped cracking evident to left hand side of well extending approximately from top of vault to level of stonework beneath.

- 72. Missing section of brickwork to top right hand side of well.
- 73. Crack through brickwork joints on overhead at entrance to mount of well.
- 74. Main horizontal crack on rear wall (left hand side).
- 75. Ditto to right side of wall.
- 76. Vertical crack to right hand side of well entrance.

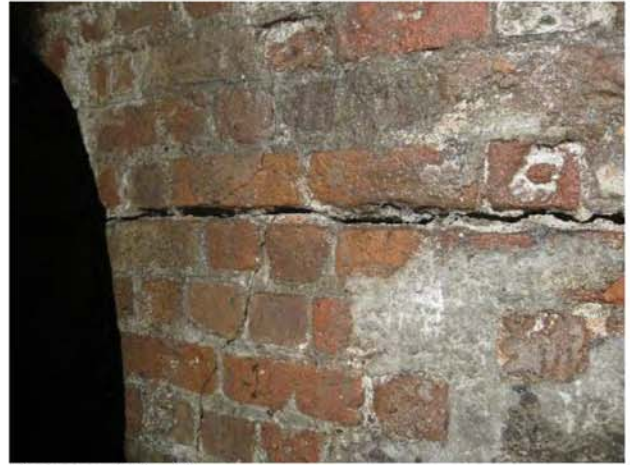
Photograph No.74

2.3.2			Considerable horizontal crack mid way up on wall extending fully from left to right hand side (crack measures 22mm at side of entrance to well, 7mm towards centre of wall and 18mm in right hand corner).

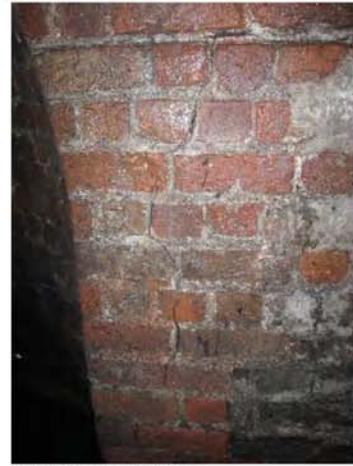
Photograph No.76

2.3.5			Deteriorated mortar pointing to brick joints at ground level to right hand side of well entrance.
2.3.6			Light vertical crack to right hand side of entrance to well extending from bottom of arch to horizontal crack across rear wall.

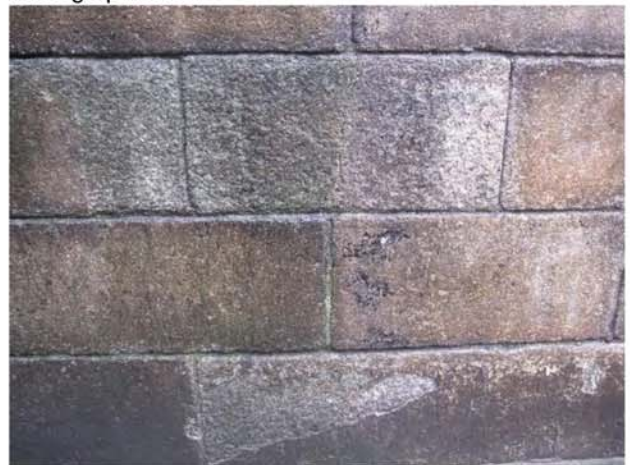
Photograph No.86

1.2.2			Light crack extending through stonework at left hand section of wall in line with pier on opposite side of wall.
1.2.3			Some small missing sections of mortar pointing, particularly on horizontal joints mainly towards left side of wall.

- 77. Overview of front wall from footpath.
- 78. Overview of large pier to right hand side of the above wall.
- 79. Close up to left hand section of wall.
- 80. Ditto to mid section.
- 81. Ditto to right hand side towards pier.
- 82. Close up of bottom section of large pier.
- 83. Ditto towards mid section.
- 84. Ditto on top of pier.
- 85. Overview of right hand face of large pier.
- 86. Close up of cracking extending through stonework.
- 87. Damage to capping at centre of wall.

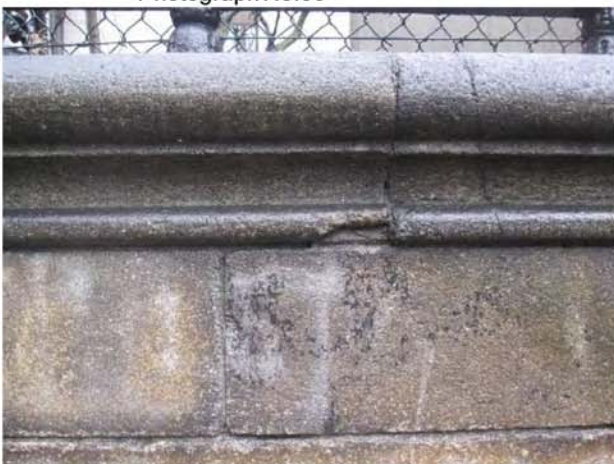
Photograph No.87

1.2.1			Chipped section to bottom of capping and light cracking through capping to left hand side of wall. Light cracking to pointing on capping in line with left hand pier.
