## TII268 OPEN RESEARCH CALL

# LOT 6: LIFESPAN OF STEEL SAFETY BARRIERS

### FACTUAL REPORT

MGT0613RP0002  
P02  
15 October 2024

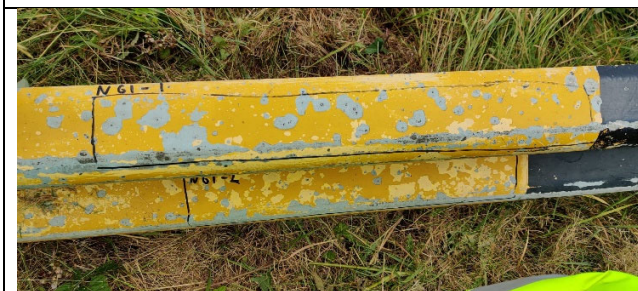
Figure 9: Testing site on N4 (N61 near Athlone)

- i. The first system, and the one with the lowest measured zinc coating thickness, was at test site N4 (N61 near Athlone) (non-motorway, rural, 25+) which had a 12µm coating. This equates to an estimated remaining lifespan of approx. 6 years (assuming a 2µm/year corrosion rate). While not an immediate concern, this system should be programmed for replacement in any upcoming replacement programmes for this area. It should be noted that while this particular barrier was included in the 25+ category, it is likely considerably older than that and possibly 40-to-50 years old. It is very much an outlier and not representative of other 25 year plus barriers.

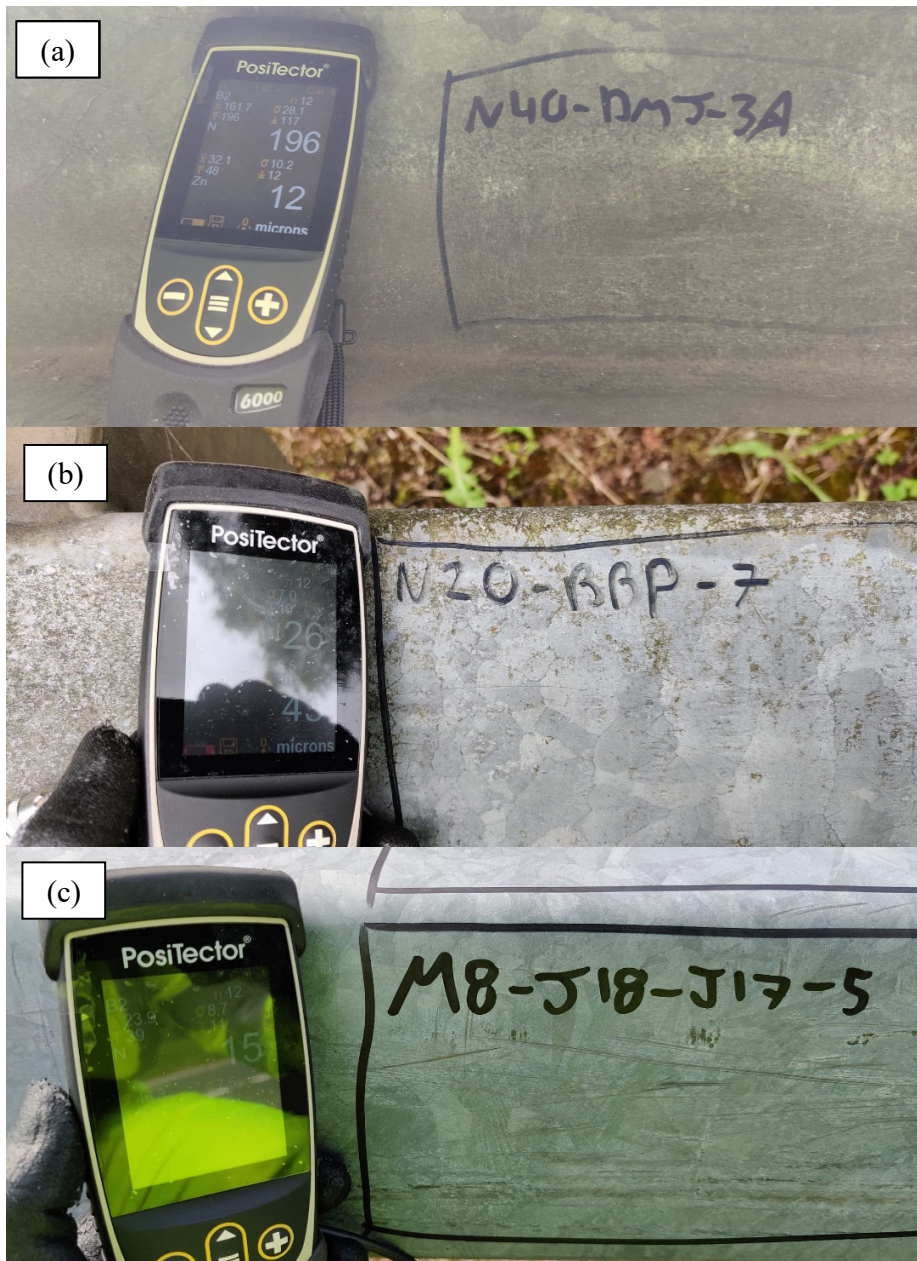
Figure 24: Three locations with relatively thin zinc coating. (a) N40 Douglas / Mahon Junction, (b) N20 Blackpool By-Pass & (c) M8 J18-to-J17 with noticeable impact damage (i.e. gouges and scratches).

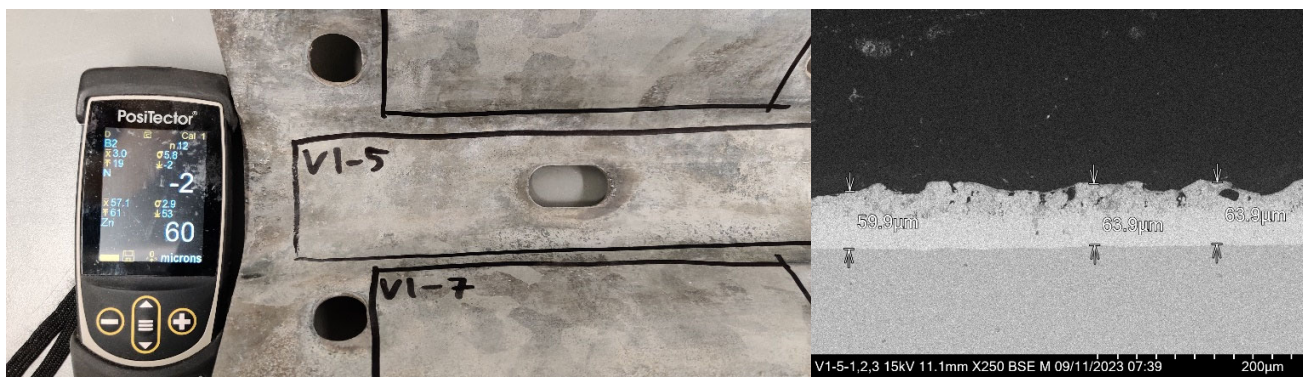
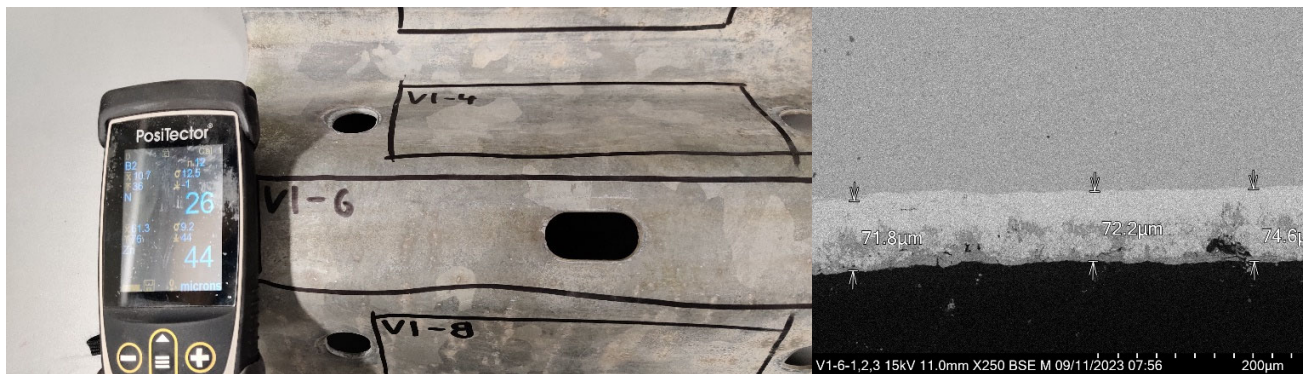
The crash barrier taken from the N03 did not display the typical galvanised zinc coating surface pattern that was observed on other barriers (see Figure 15, Figure 19, Figure 21 & Figure 23). In general, it appeared ‘worn’, with very slight signs of rust, even after cleaning to remove any surface contamination. Figure 13 & Figure 14 show two such areas with a photograph on the left and SEM cross-section on the right. Despite the worn appearance, there was still approximately 60um of zinc coating remaining on the Front (Figure 13) and 70um on the Back (Figure 14).

**Figure 13:** Photograph of front area of N03-CN-0042 (V1-5) (left) and correspond SEM image (right). Galvanised zinc coating has been measured at 12 points using the Positector and 9 points via SEM.

**Figure 14:** Photograph of back area of N03-CN-0042 (V1-6) (left) and correspond SEM image (right). Galvanised zinc coating has been measured at 12 points using the Positector and 9 points via SEM.

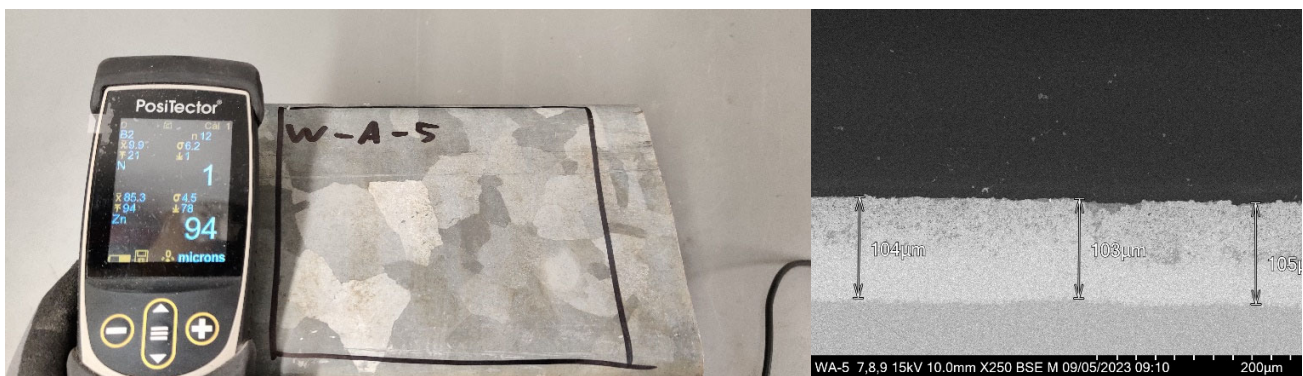
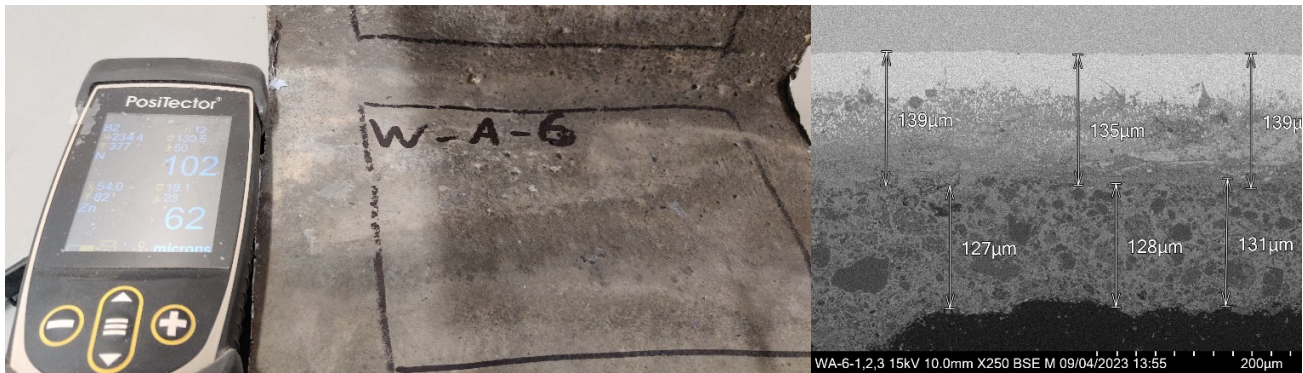
- iii. The third barrier system was at N55 Athlone (non-motorway, urban, 20-25), and is an OBB system. The exterior surface of the OBB was in satisfactory condition from a visual inspection and had over 100µm of zinc coating remaining. However, the inside of the OBB beam (i.e. the surface facing away from the traffic) exhibited a layer of an unknown coating. Further EDX analysis revealed this layer contained the elements Calcium and Silicon, and resembled concrete. While the concrete did have a negative effect on the appearance of the galvanised layer, there was sufficient zinc remaining to protect the steel.

Figure 15: Photograph of front area of N55-ATH (WA-5) (left) and correspond SEM image (right). Galvanised zinc coating has been measured at 12 points using the Positector and 9 points via SEM.

Figure 16: Photograph of front area of N55-ATH (WA-6) (left) and correspond SEM image (right). Galvanised zinc coating has been measured at 12 points using the Positector and 9 points via SEM.

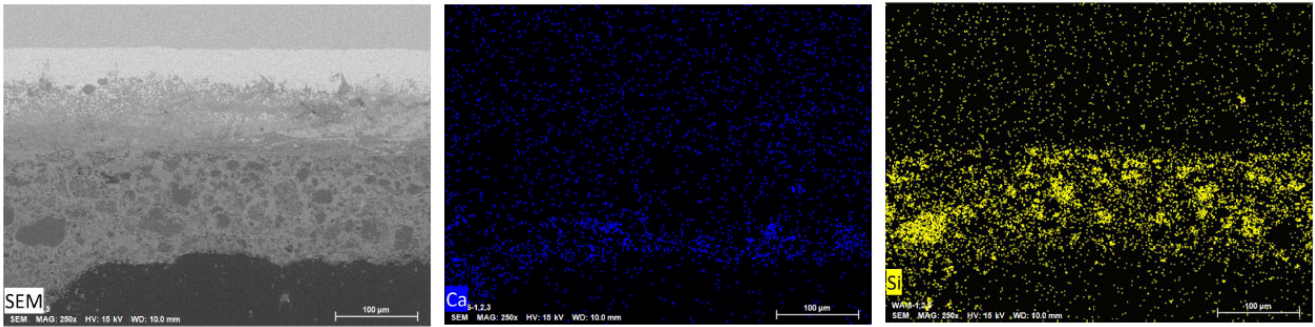
**Figure 17:** Further EDX analysis of the SEM cross-section from **Figure 16** (right). In this Figure, the SEM image is on the left with Calcium elemental map in the centre and Silicon map on the right.

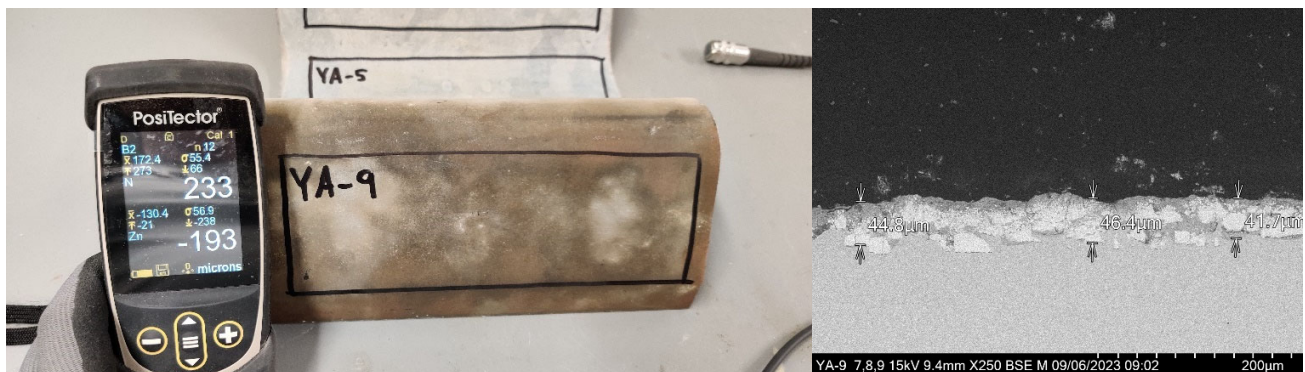
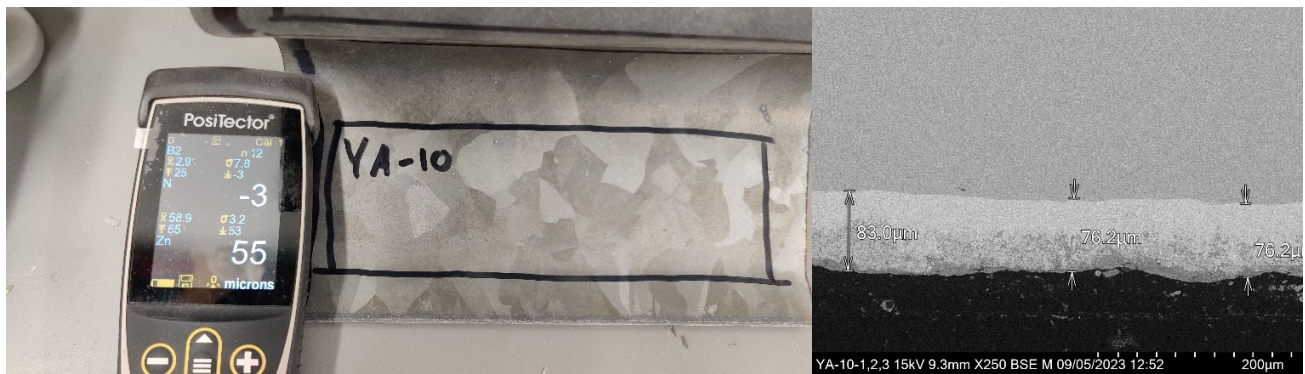
- ii. The second barrier, N59-GY-SB09A (non-motorway, coastal, 20-25), had an acceptable zinc coating thickness as measured via the Positector Probe (min 35µm). However, there were signs of potential chemical staining at the bottom of the barrier. SEM analysis showed a non-homogeneous / non-continuous zinc layer. Therefore, barriers showing this feature could be monitored as part of any upcoming replacement programmes for this area.

Figure 20: Photograph of front area of N59-GY-SB09A (YA-9) (left) and correspond SEM image (right). Galvanised zinc coating has been measured at three points.

Figure 21: Photograph of front area of N59-GY-SB09A (YA-10) (left) and correspond SEM image (right). Galvanised zinc coating has been measured at three points.
