Subject: Leinster Bridges Non Routine Maintenance No.4 - AA Screening

Dysart South Bridge (KK-N78-004.00)

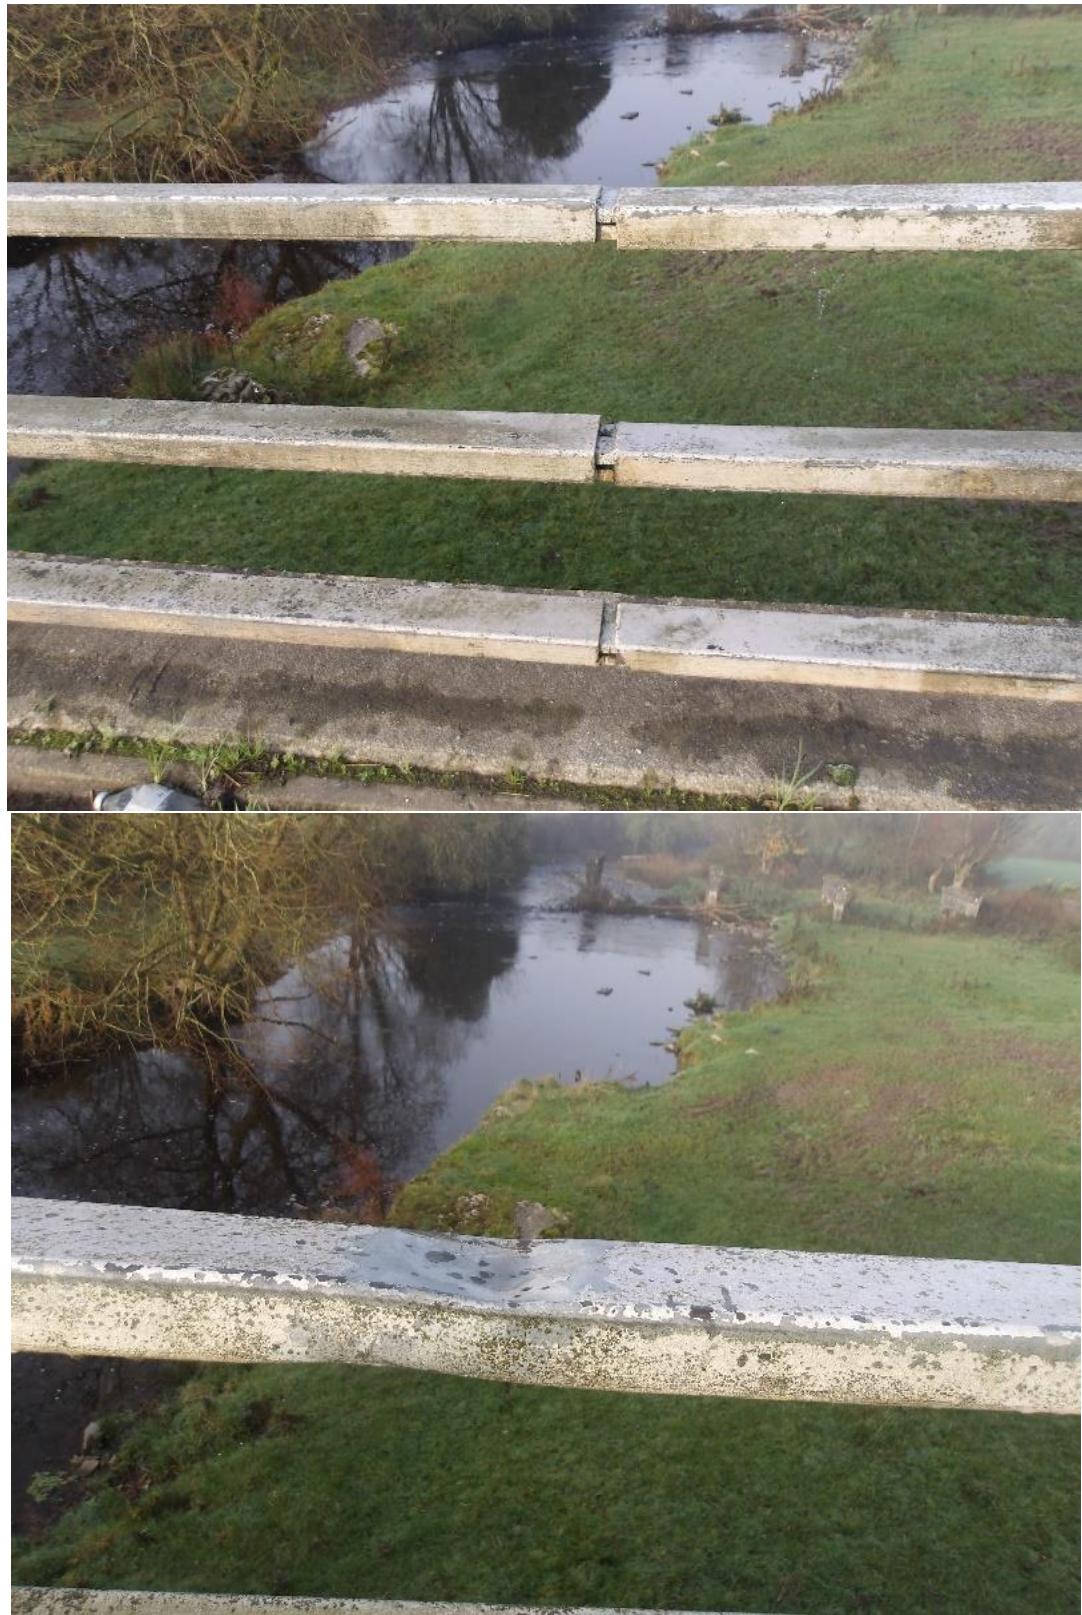
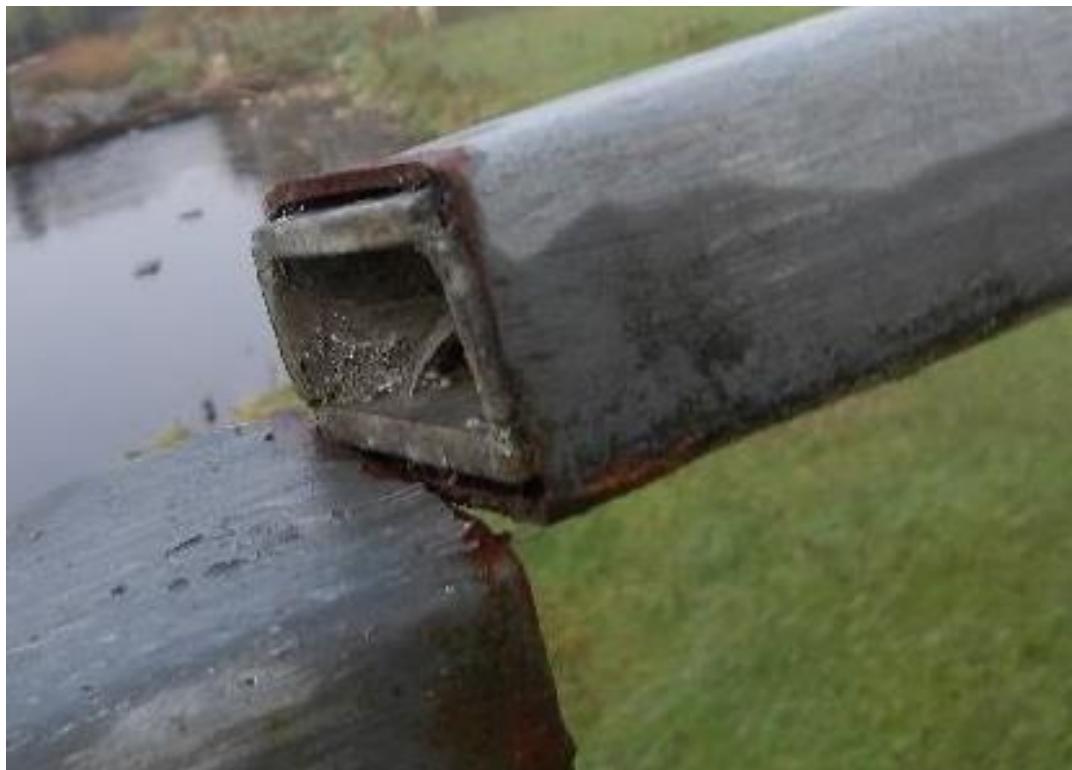
Dysart Bridge (KK-N78-004.00)

Description of the works: Remove the existing damaged top rail from the break point back to the existing expansion joint to both locations (approximately 6.7m in length (each)). Fabricate new length of rail to the same type, size and colour as the existing rail to the west of the break. Welding of the old and new sections together and replicating the existing movement set up at the existing expansion joint at both locations. Existing post connections to be adjusted or refabricated to suit the new railing piece, at both locations. Works to be completed during normal daytime hours. The projected duration of the proposed works is two 2 days.
