From: [O'Malley Vincent](#)
To: [Phelan Sarah-Jane](#)
Cc: [Nea Christian](#)
Subject: RE: Re. Mullnaveagh Bridge [DL-N14-011.00]
Date: Wednesday 18 November 2020 11:23:25

Re. Mullnaveagh Bridge [DL-N14-011.00]

Mullnaveagh Bridge [DL-N14-011.00] is a single arch masonry bridge (see Figure 1) located on the N14 which crosses the Swilly Burn [EPA River segment - 01_1852] to the southeast of Raphoe, Co. Donegal (circled in red in Figure 2, below). To the east the Swilly Burn discharges to the River Foyle ca. 6.6km downstream of the bridge.

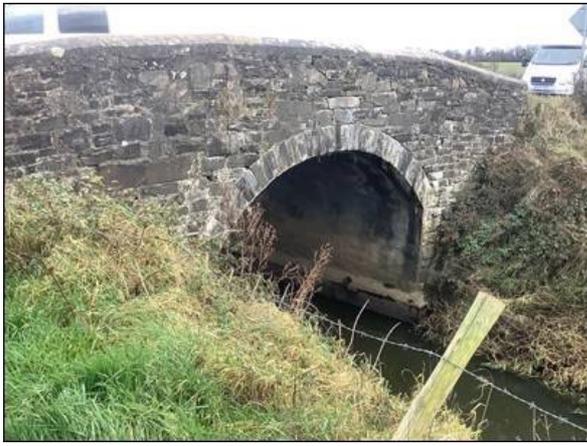
Figure 1. Mullaveagh Bride.

It is proposed under Reactive Maintenance to fully rebuild the south end section of the east wingwall and to partially rebuild the north end section of the west wingwall at DL-N14-011.00 Mullaveagh Bridge as the stone masonry was found to be in a poor condition following a recent visual inspection at the bridge.

The damage to the south end of the east parapet wall comprises masonry joint separation and horizontal displacement (outward by up to 30mm) of the end section of the parapet wall extending some 600mm below adjoining carriageway level and over a horizontal distance of 2m from the end of the wall where the concrete coping also shows displaced cracking at this point. The displaced wall has resulted in some loose masonry to the roadside face of the displaced section as well as separation between the adjoining carriageway surfacing and the wall. Joint separation to the wall (riverside) visible below the displaced section does not extend down into the base section of the wall. Loss of pointing was noted to the base section of exposed masonry immediately above embankment level. Refer also attached photos.

Localised stepped masonry joint separation to the riverside face of the west parapet wall at the north end was noted where the concrete coping has displaced horizontally by up to 20mm outwards extending over a distance of 2m from the end of the wall. Some localised damage (uplifted section) was noted to the edge of carriageway surfacing at the end of the wall where separation of up to 20mm was also noted between the carriageway surfacing and the wall.

- The existing stone masonry wall to be temporarily back propped off a suitably prepared temporary area on the embankment; this will be done prior to excavation and construction of a mass concrete support backing in the carriageway 2400mm long x 1700mm wide x 2400mm dee. This will be placed immediately adjacent to and fronting the end of the wall prior to taking down and rebuilding the wall itself. The back propping is to remain in place until such time as the concrete backing in the carriageway has fully cured. As a further precautionary measure the soffit of the arch under the bridge will also be propped utilising temporary timber trusses until the concrete backing wall has fully cured.

- Erect temporary access scaffolding, lined on top with a 1000 gauge visqueen type material, on the prepared embankment area behind the wall and take down using hand tools the existing defective stone masonry wall and in-situ concrete coping with any sound masonry salvaged and with any defective masonry removed and disposed of off-site. All debris arising from the construction works to be removed and disposed of off-site

- The wall will be reconstructed, from below existing embankment ground level on blinding concrete starting at a level to match the base of the concrete backing wall; work will be done with hand tools utilising lime mortars, existing sound masonry and locally sourced replacement masonry to match existing as required, all to tie on with the existing wingwall. Proprietary wall ties will secure the reconstructed masonry facings to the constructed concrete support backing.

- The end section of defective stone masonry wall and concrete coping is to be deconstructed to stable material at or just below existing carriageway level using hand tools with any sound masonry salvaged and with any defective masonry removed and disposed off site. All debris arising from the construction works to be removed and disposed of off-site.

- The wall will be reconstructed with hand tools utilising lime mortars, existing sound masonry and locally sourced replacement masonry to match existing as required, all to tie on with the existing wingwall. The extent of reconstruction of the wall will extend up to a horizontal distance of 2m from the end of the wall
