## Re. Lurgy Bridge (DL-N56-059.00) - Reactive Maintenance

We are requesting a Determination for a Reactive Maintenance Proposal to remediate the damage that has occurred to a steel post and rail east (downstream) parapet and northeast wingwall following vehicle impact at DL-N59-059.00 (Lurgy Bridge), refer also attached photos.

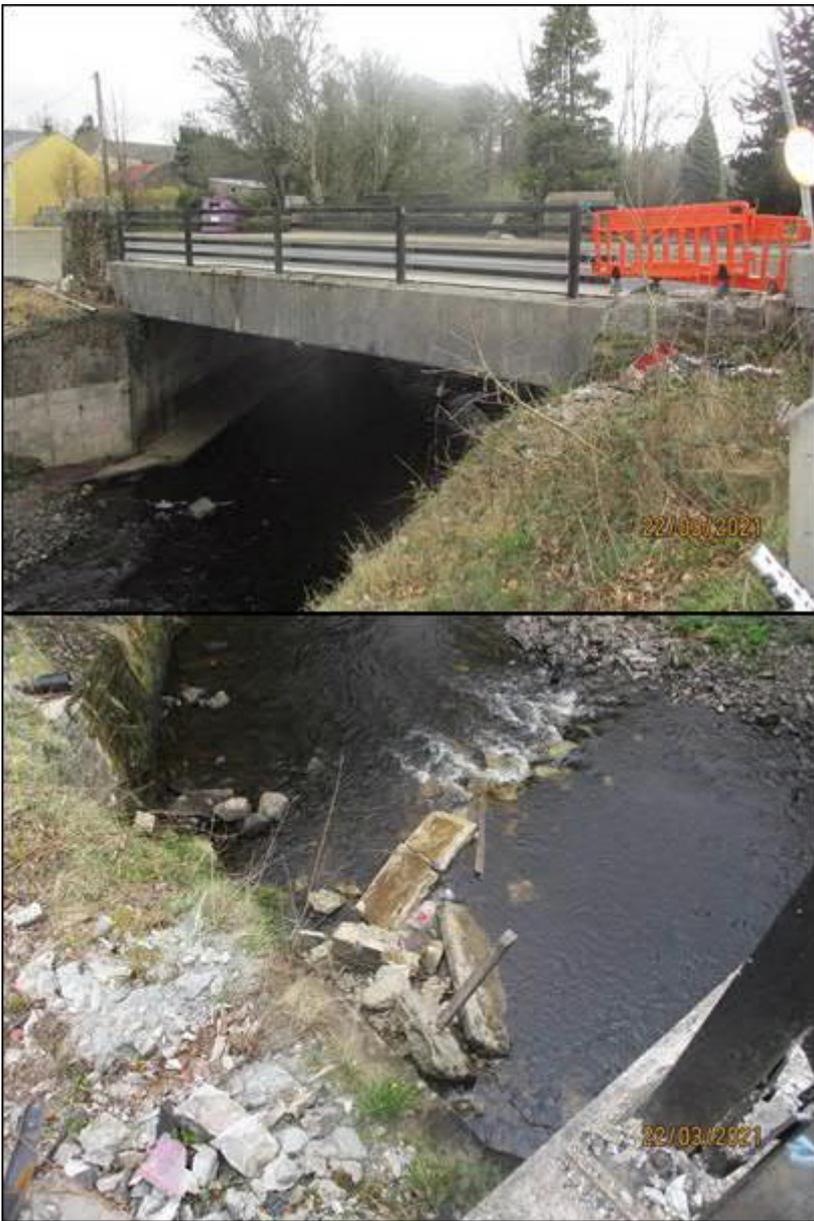
Plate 1 Works Area (left) and bridge debris in the river (right).

The northeast wingwall built in stone masonry complete with concrete steeple capping has been demolished to full height from approximately 150mm above adjoining footway level with the resultant debris lying largely in the watercourse below. The wingwall measures 2000m in length, 550mm wide and 1.23m high to underside of steeple

As can be seen on the accompanying photos, the works area is restricted to the road / bridge deck. While some regrouting is required this is restricted to 2 no. base plates of replaced parapet uprights. The wall to be replastered is over the riverbank rather than the river (see plate below).

- Remove 8m<sup>2</sup> of resultant masonry and concrete debris from watercourse, include also for other miscellaneous timber and other steel post/concrete.
