## Re. SO-N04-006.00 (Owenmore River Bridge) - Reactive Maintenance

We are requesting a Determination for a Reactive Maintenance Proposal to remediate the damage that has occurred to the south end of an aluminium post and rail east parapet, a section of the adjoining south east approach VRS (vehicle restraint system) and localised damage to south bridge expansion joint across southbound carriageway, following vehicle impact at SO-N04-006.00 (Owenmore River Bridge). Owenmore River Bridge is a three span structure, just north of Collooney, Co. Sligo, with the south span, closest to the damage, carrying the N4 across a local road.

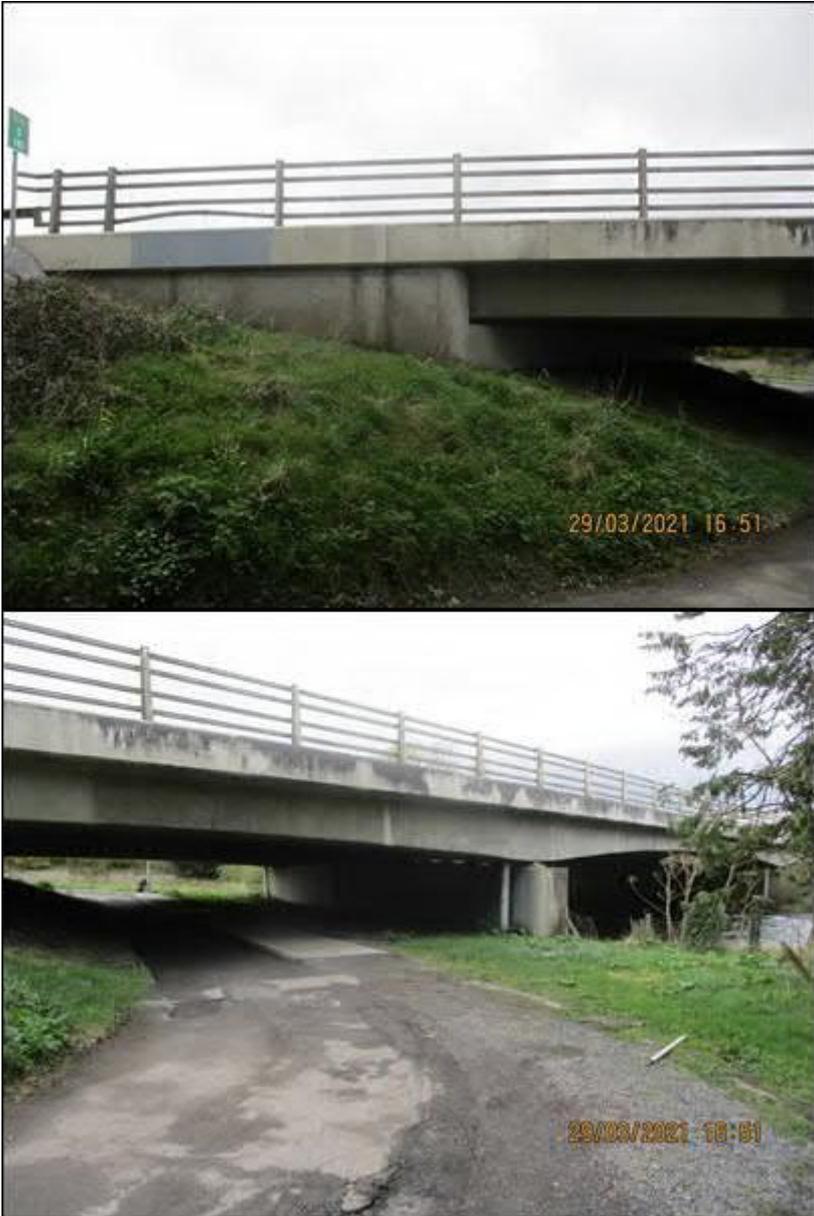
However, the works are to be undertaken on a span which is not over water, but over the embankment and adjoining local road which separates the works area from the river by ca. 30m. The works areas as can be seen on Plate 1 is above a grassy embankment which is not of ecological value (refer also to the accompanying photos). There are no records of invasive species from this location. Otter have been recorded from the Unshin in this area, but as shown below the works are well back from the river edge and should not disturb otter use of the River Unshin. There are no instream works and not emissions to the river predicted.

Plate 1 Location of works area (left) and adjoining road (right).

- Replace bottom damaged parapet rails complete with rail joint (overall length 5.45m)
- Replace next to bottom damaged parapet rails complete with rail joint (overall length 5.45m)
- Replace next to bottom angle mesh rails complete with rail joint (overall length 5.45m)
- Replace 4 No. damaged galvanised infill mesh panels (overall area 7.6m<sup>2</sup>)
- Reinstate transition plate connecting end of parapet and approach VRS
- Reinstate VRS posts, rails and connections (overall length 7.2m).
- Replace damaged nosing joint material to bridge expansion joint (overall length 4.5m). Method of repair to proprietary nosing in accordance with manufacturer's specification, new material to be compatible with existing nosing material.
- Remove minor plastic/glass from top of concrete parapet plinth and adjoining footway (0.5m<sup>2</sup>).
