LUAS BROOMBRIDGE

Advance Archaeological Testing at Broadstone

Assessment Report

Date: June 2010

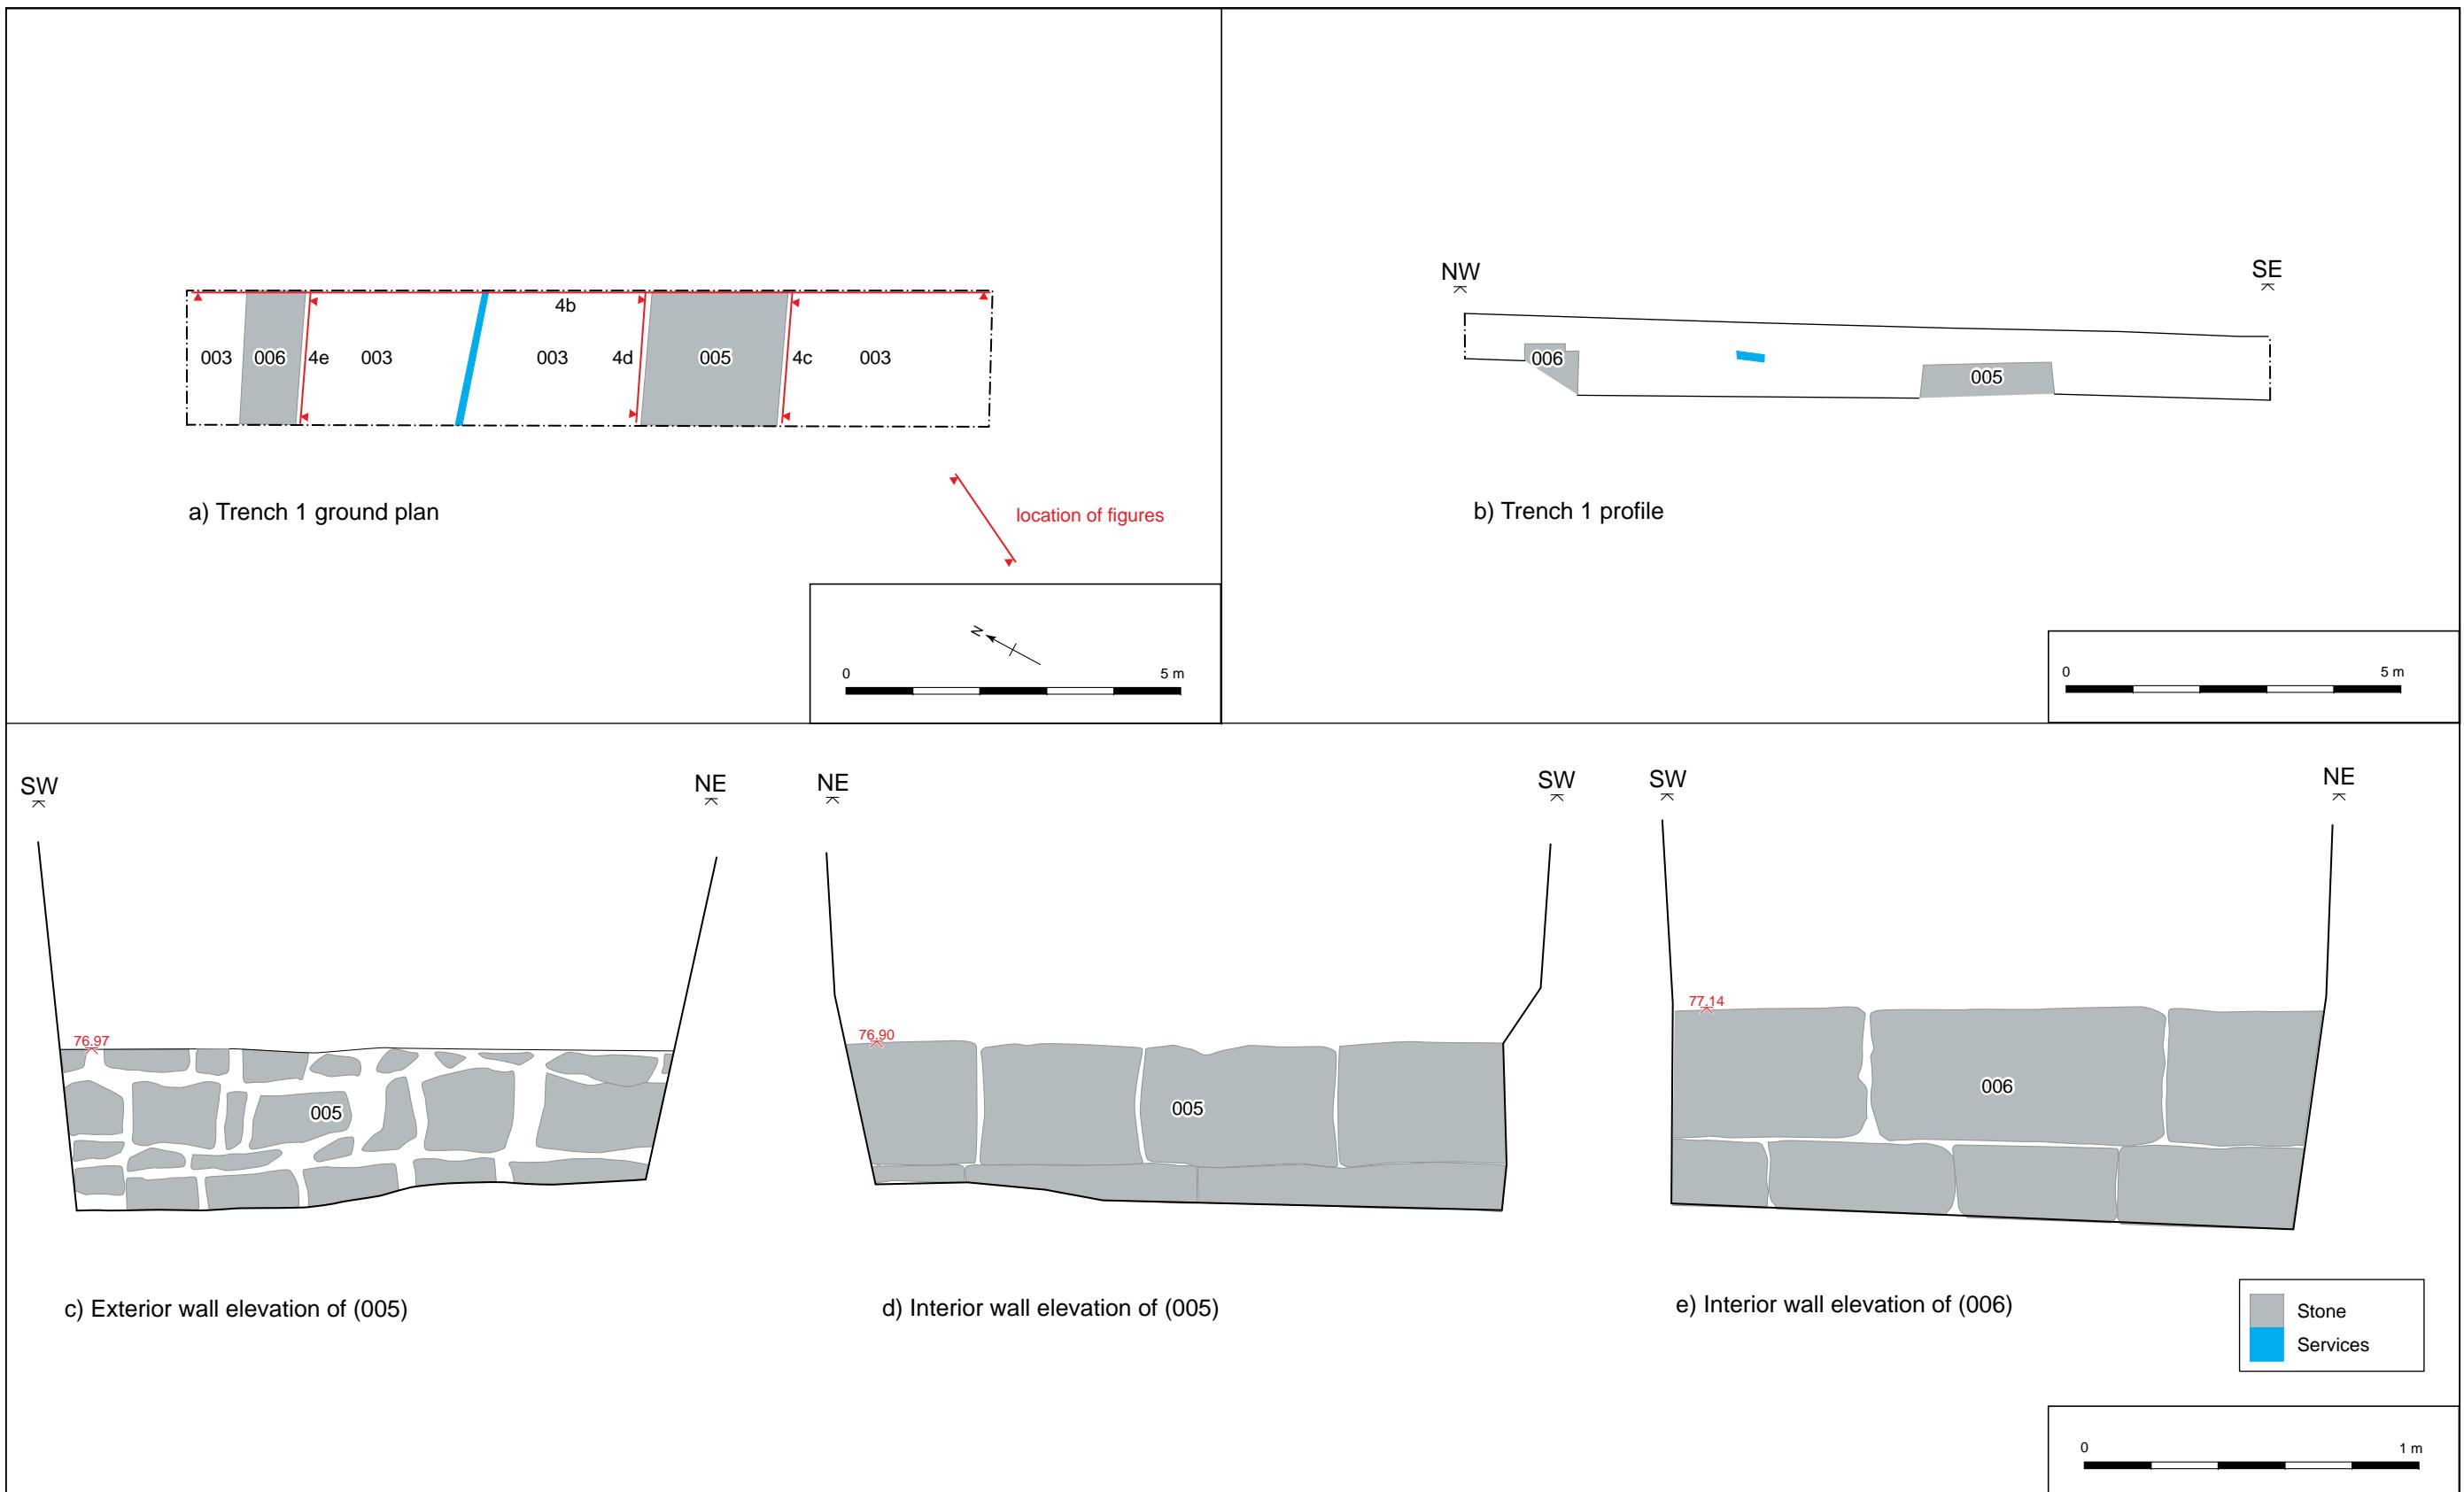
The exposed remains of both walls (005) and (006) located in Trench 1 were in extremely good condition with the upper part of the walls undisturbed. This strengthens historical documentary sources that indicated the canal branch and harbour were infilled rather than removed (Delaney 1992; Nolan 2001). To substantiate this even further was a deposit (003) that was identified in all three trenches. It overlay both walls in Trench 1, the possible slipway in Trench 2 and formed the main deposit in Trench 3. It possibly represented the main infill of the canal and harbour. Artefacts were recovered from deposits in Trench 1 and Trench 2. A total of 10 post medieval finds were recovered from the infill deposit (003) in Trench 1. A further two post medieval artefacts were recovered from a small deposit (010) identified in Trench 2.

Figure 4 - : RPA, Luas Line BXD 710: Broadstone, 10E90, a) Trench 1, ground plan, b) Trench 1, profile, c) Trench 1, exterior wall elevation of (005), d) Trench 1, interior wall elevation of (005), e) Trench 1, interior wall elevation of (006)

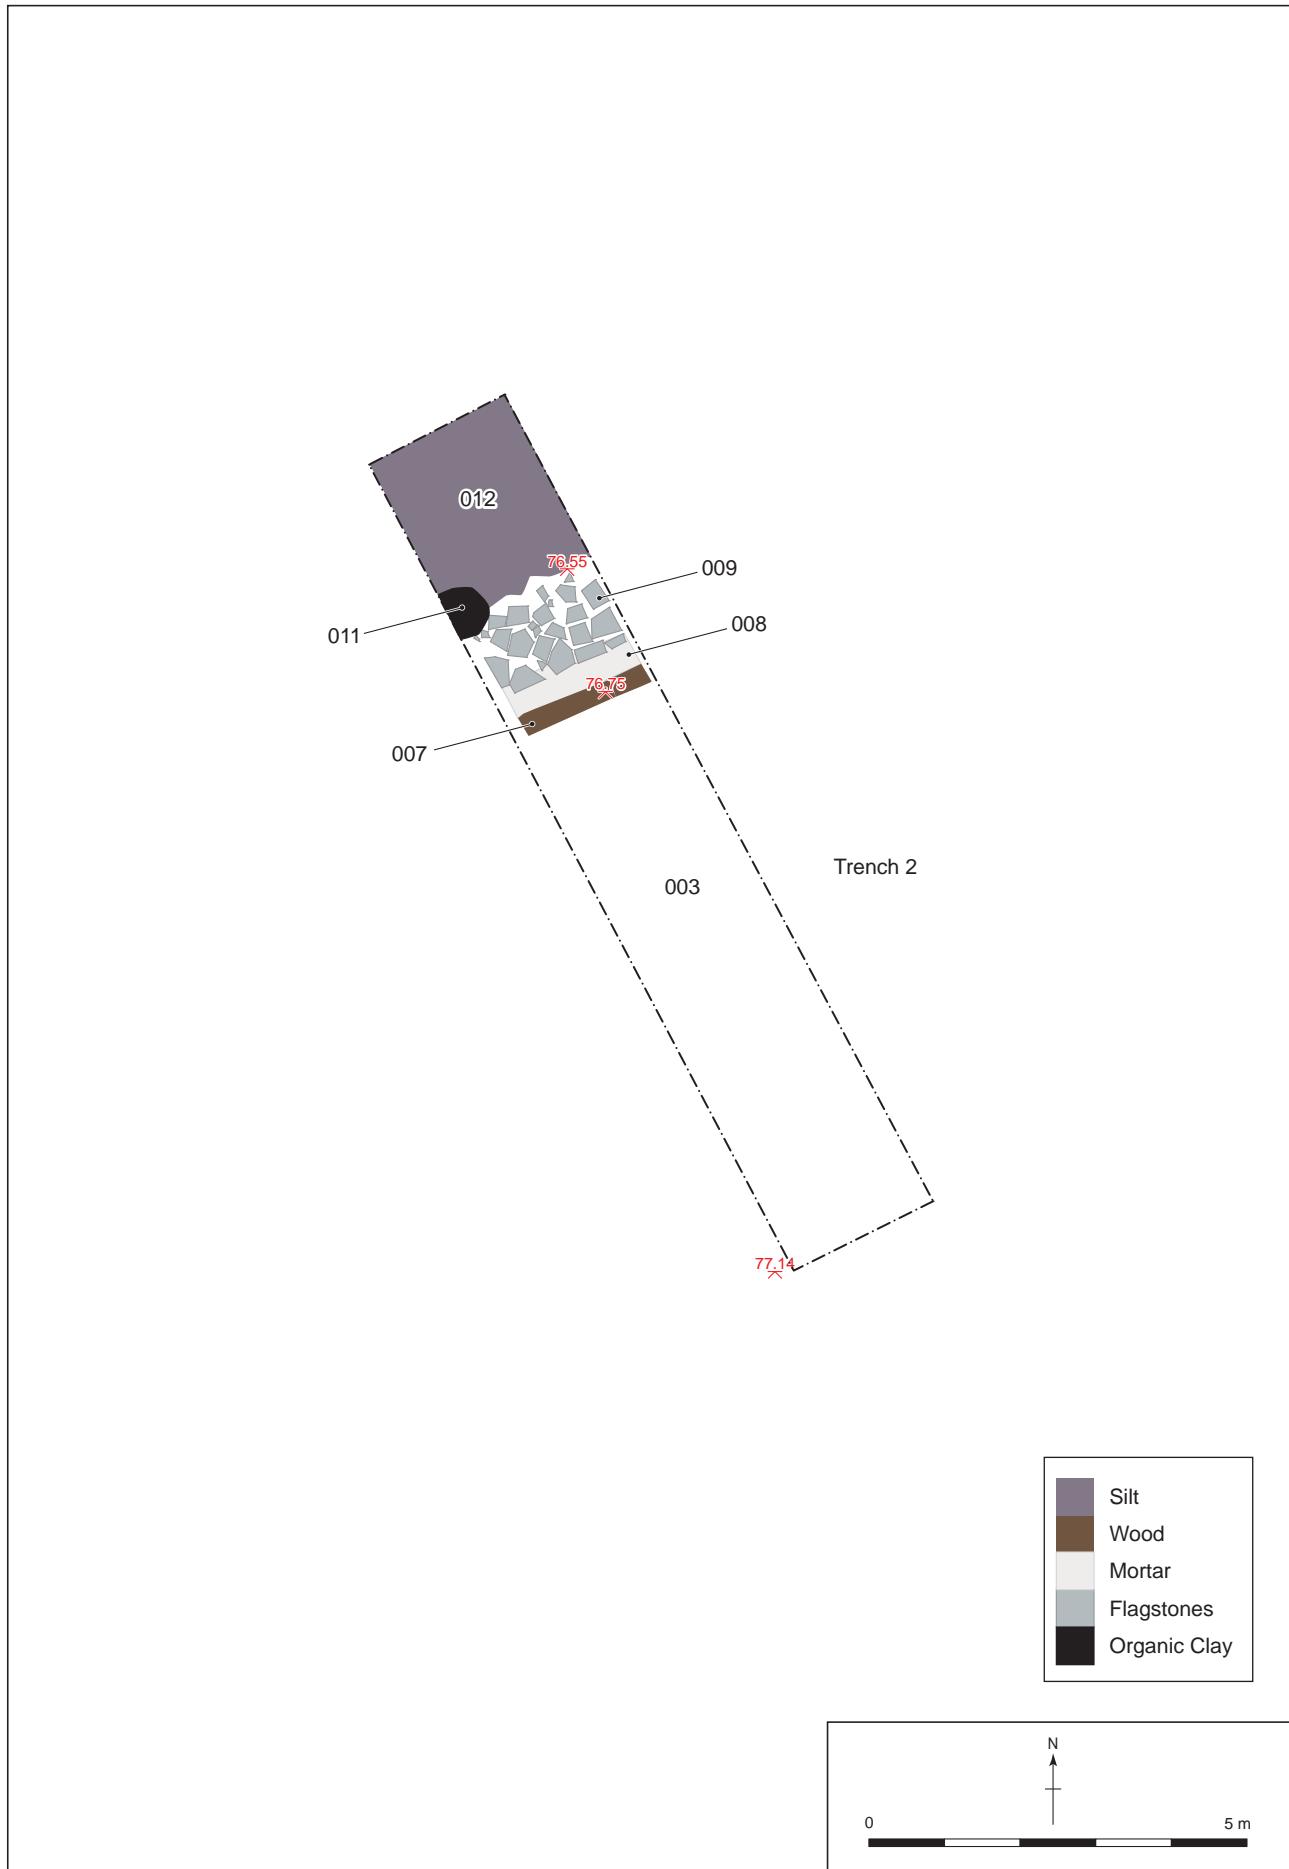
A possible slipway into the canal was identified in Trench 2. This is located in an area were a temporary crossing or floating wooden pontoon bridge crossed the canal. This floating bridge could be moved from one side of the canal to the other to allow boats in and out of the harbour. It was designed by J & R Mallet and provided access to the Broadstone terminus building and railway yard north of the canal and harbour

Figure 5 - : RPA, Luas Line BXD 710: Broadstone, 10E90, Trench 2 ground plan with detail of possible slipway

- The possible slipway remains in Test Trench 2 would not be suitable for preservation *in situ* given their fragile nature and it is recommended that these remains be fully exposed, recorded and excavated prior to construction commencing. As the extent of this feature is currently unknown it is recommended that the area for excavation extend at least from Test Trench 1 on the east side to where the edge of the proposed underpass narrows on the west side.

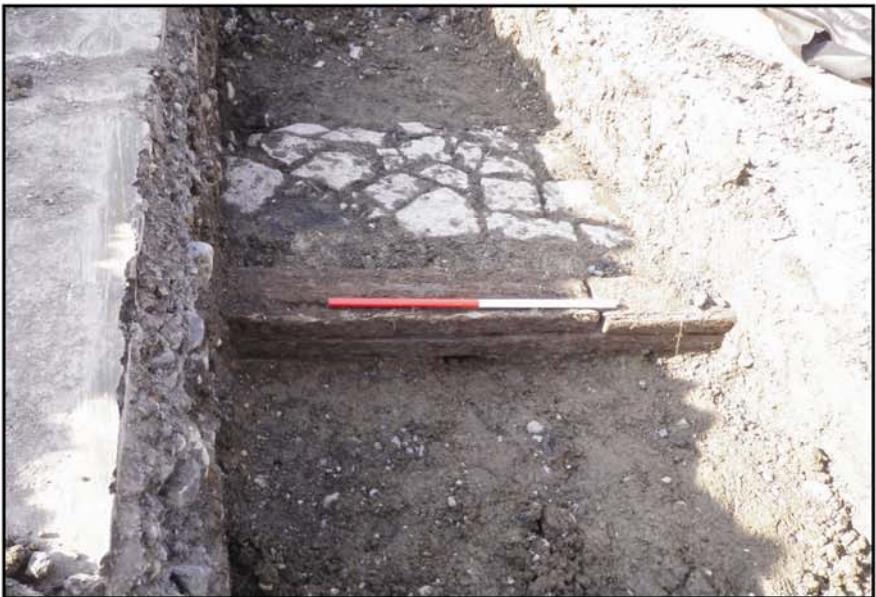
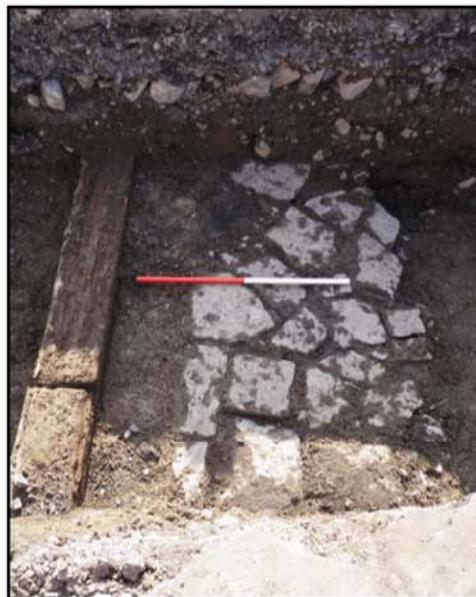
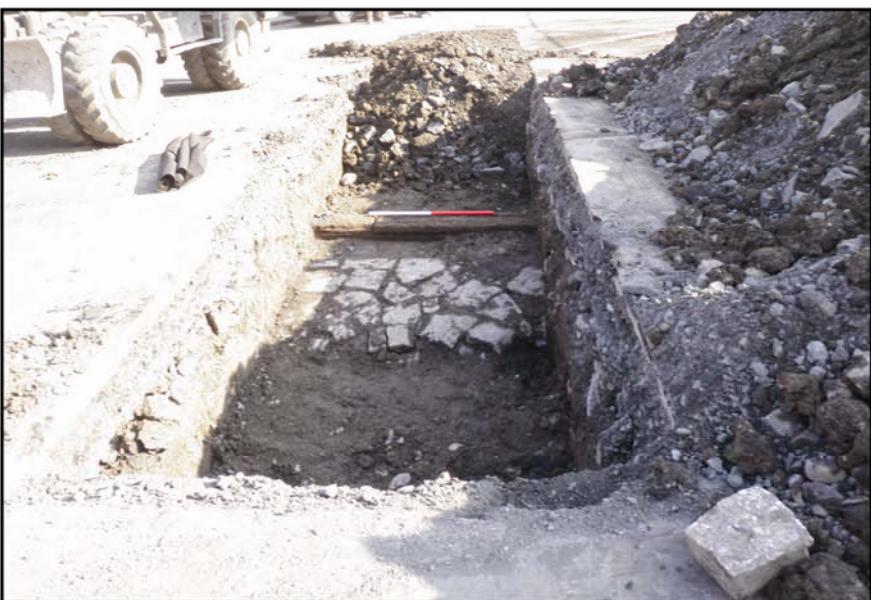
(Delaney 1992; Casey 2005). The condition of the possible slipway was not as stable as the walls encountered in Trench 1. The three wooden planks (007) were in relatively good condition but the lime mortar (008) was loose and crumbling. The flagstones (009) were set into firm brown grey clay (010) with the remains of lime mortar identified between the stones. Further random flagstones were scattered over a deposit (012) located to the north of this. These additional flagstones had clearly separated from the main stone slipway. This is possibly due to the high moisture content in this deposit (012).

Plate 9 - Mid-excavation of Trench 2, showing possible slipway, northeast facing

Plate 10 - Mid-excavation of Trench 2, showing possible slipway, southwest facing

Plate 11 - Mid-excavation of Trench 2, showing possible slipway, southeast facing

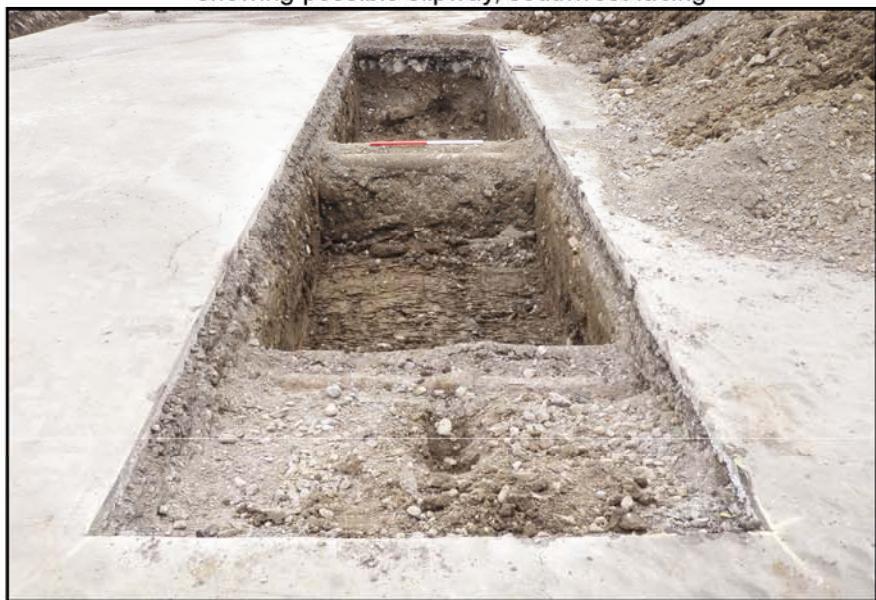
be fully excavated to the agreed 1.25m depth. This was due to one of these modern utilities traversing the trench at a slight angle, quite close to the trenches northern limit. Similar to Trenches 1 and 2 a modern hardcore layer (002) overlay this deposit and was completed by an upper layer of asphalt (001).

Plate 12 - Mid-excavation of Trench 3, showing modern utilities, southeast facing

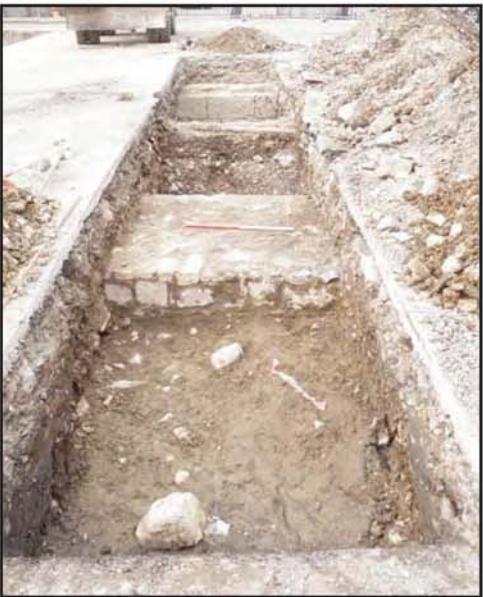
The first of two walls (005) was identified to the south of Trench 1 (Plate 1), orientated in a southwest/northeast direction across the width of the test trench. This wall did not appear to be disturbed; and the top of the wall was situated at a depth of 0.36m from the car park surface. The wall measured 1.90m wide and extended the width of the test trench (2m). The wall had a depth of 0.67m and clearly continued below the designated 1.25m depth cut off. Two separate wall faces were recorded. The northwest face or inner wall face was ashlar built and comprised of large fine cut, roughly hammer dressed square or rectangular blocks of limestone (Plate 2). The mortar between the stones was less than 3mm thick and possibly consisted of firm

Plate 1 - Mid-excavation of Trench 1, northwest facing

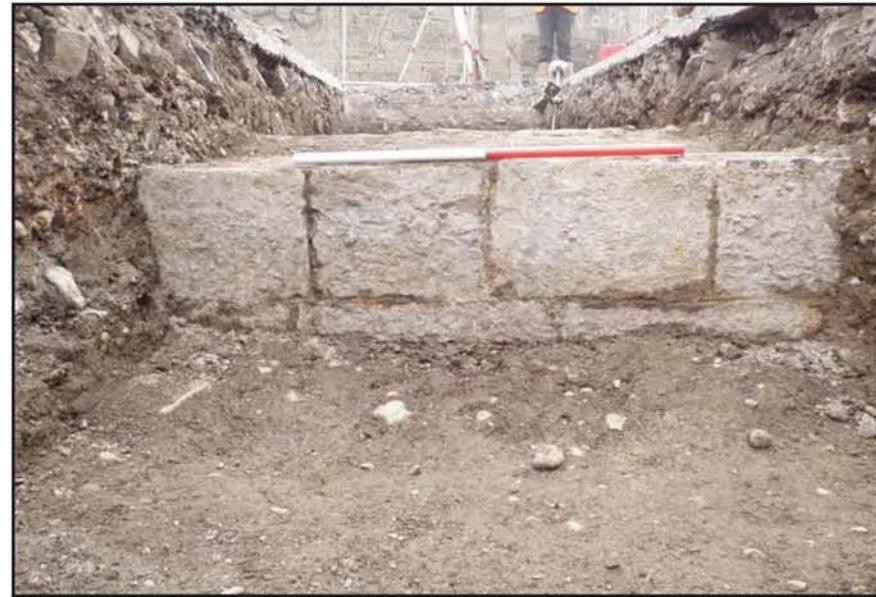
In general the section of the exposed wall (005) was extremely sturdy and in good condition. There was some evidence of possible salt crystallisation on a couple of limestone blocks located on the ashlar built southeast face of the wall. This was concentrated to a very small area and there was no evidence of it affecting the mortar. A thorough examination of the entire wall would determine if this threatened the walls overall integrity.

Plate 2 – Mid-excavation of Trench 1, ashlar wall (005), southeast facing

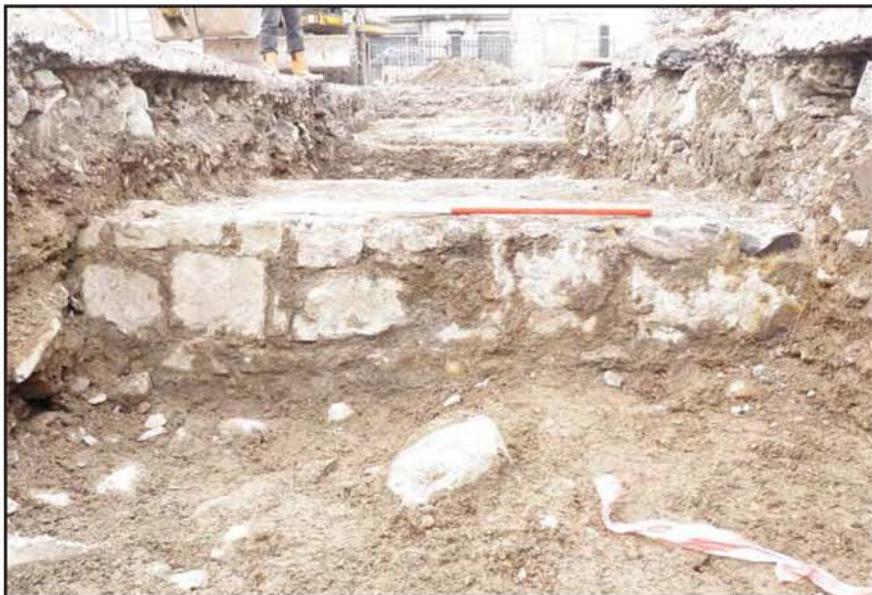
hydraulic lime mortar. The southeast face or possible outer wall face comprised of random rubble (Plate 3). Due to the shallow exposed depth of this wall it remained unclear if this wall was built to course. The limestone blocks were much smaller on this side and roughly square cut with small stones or pinnings inserted between some of the joints. The mortar on this side varied in thickness between the stones and again, the mortar appeared to consist of hydraulic lime mortar. Between both wall faces was a core fill that possibly comprised of small calp limestones. This core fill was identified from the top of the wall, here; the mortar was at its thickest, with small amounts of limestone showing through the mortar (Plate 4).

Plate 3 - Mid-excavation of Trench 1, random rubble wall (005), northwest facing

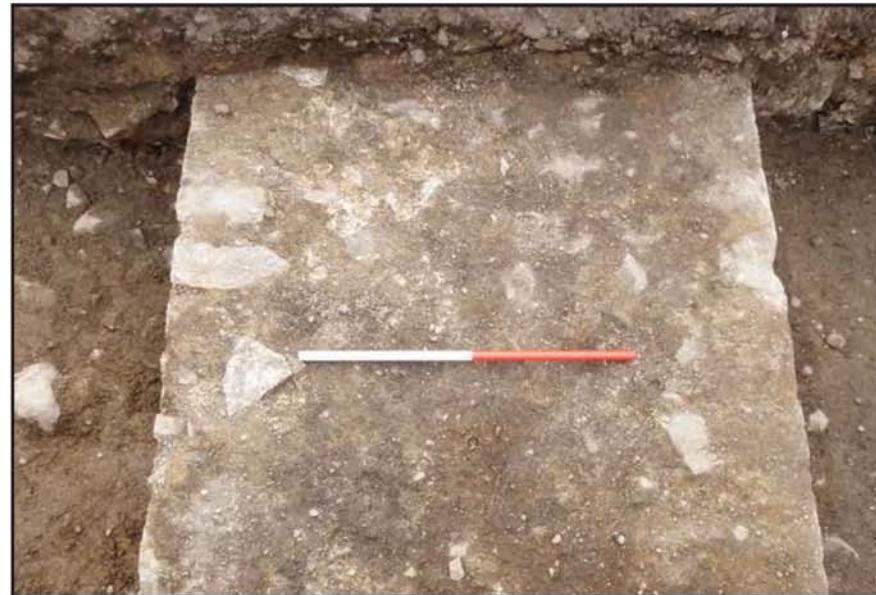
Plate 4 - Mid-excavation of Trench 1, wall (005), northeast facing

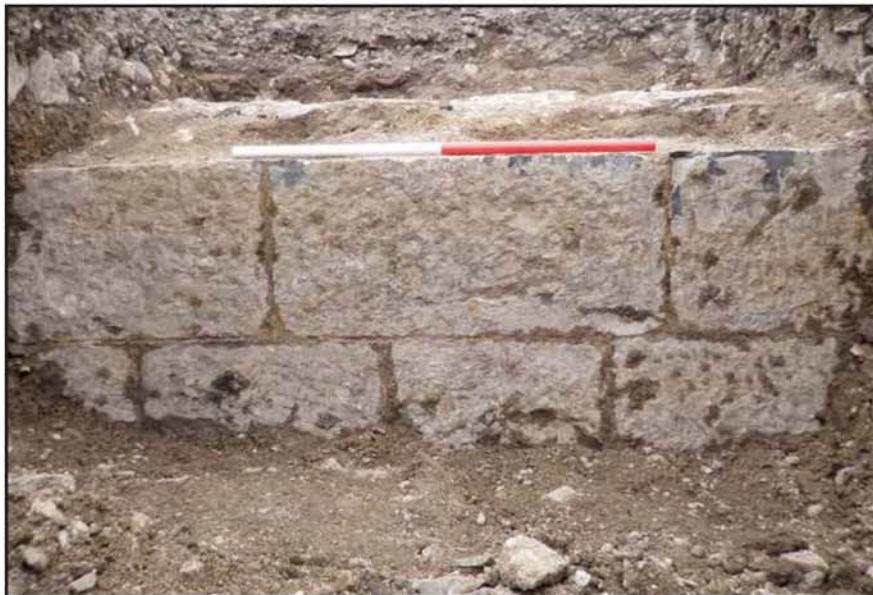
A second wall (006) was identified approximately 5.30m to the northwest within Test Trench 1 orientated along the same alignment as the first wall (005). This wall was not as thick as the first wall (005) wall, measuring 0.75m wide and extending the width of the trench (2m). The top of the wall was located at a depth of 0.61m from the modern car park surface and approximately 0.67m of the wall was exposed to a total trench depth of 1.25m. The wall, although not as thick, was structurally similar to the wider wall (005) to the south. The second wall (006) had a southeast facing wall or inner wall that was ashlar built and comprised of large fine cut, roughly hammer dressed or punch dressed rectangular blocks of limestone (Plate 5). The mortar between the stones was less than 3mm thick and consisted of possible hydraulic lime mortar. The ashlar wall was backed by a northwest facing wall that comprised of random rubble. This wall face rose above the ashlar wall face by about 0.10m (Plate 6). The limestone blocks on this random rubble wall were small and were mostly square-cut with angular stones or pinnings inserted between. The mortar on this side of the wall varied in thickness between the stones, and again, possibly comprised of hydraulic lime mortar.

Plate 5 – Trench 1, ashlar wall (006), northwest facing

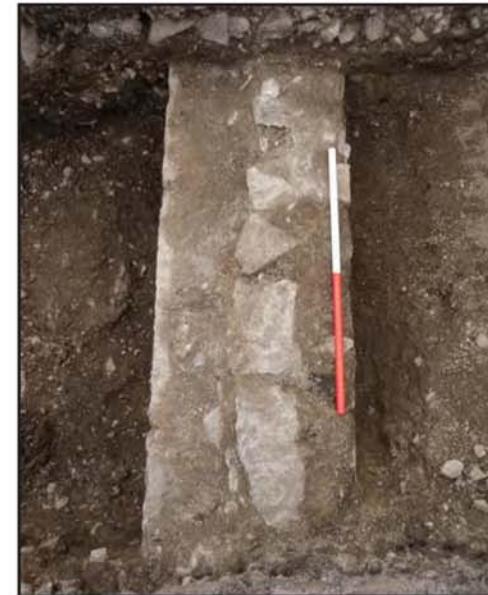
Plate 6 - Trench 1, wall (006), southwest facing
