Road Safety Inspections: An Overview

Jim Mc Elhinney Road Safety Inspection Engineer Western Region

May 2023

Comhairle Contae Ros Comáin Roscommon County Council

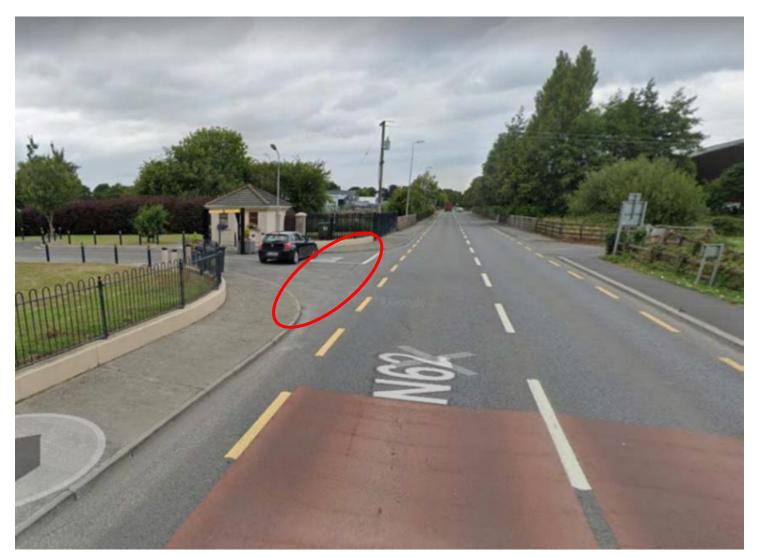
Before RSI Works

RSI Issue identified: dropped kerbs were not provided at the entrance.

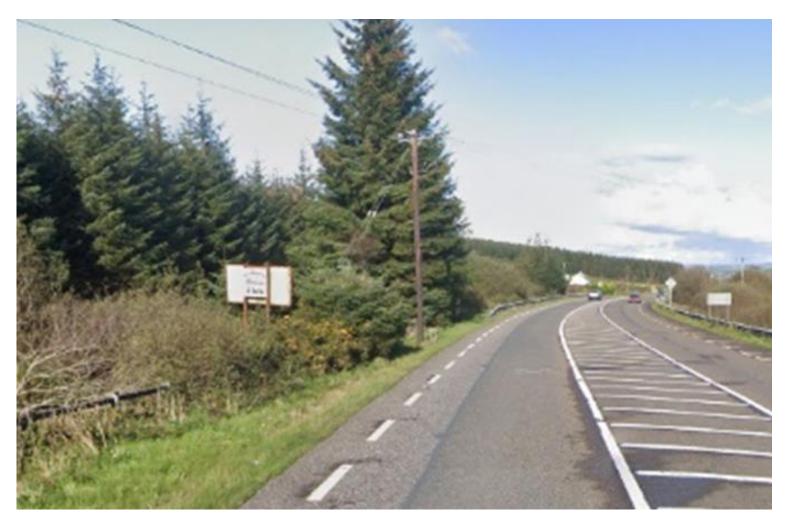
Before RSI Works

RSI issue identified:

ESB pole adjacent to carriageway.

Other hazards at location also: mature trees, concrete post and rail fence (route wide issue) & Ramped terminal end on the existing barrier.

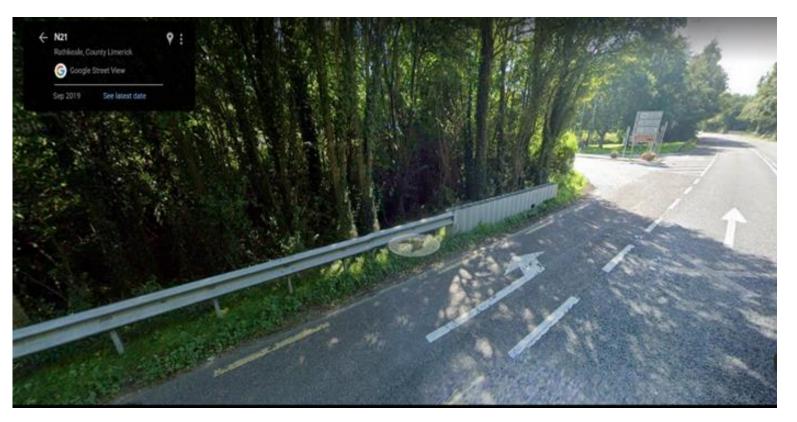
Before RSI Works

RSI issue identified:

Inadequate sight distance from junction.

Location of side road junction unclear to a driver on the mainline approach.
