## Motorway Maintenance and Renewals Contract (MMaRC)

Seán McDonnell, MCAAS Commission Manager, Technical Director, Atkins.

15<sup>th</sup> January 2021

# MMaRC Update

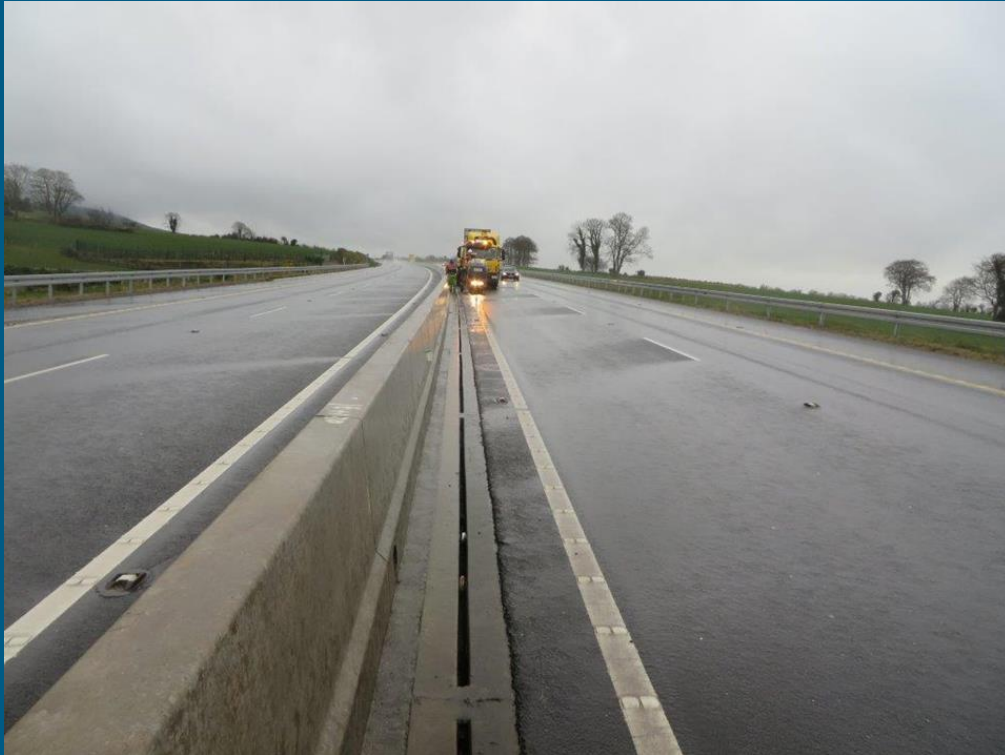
Before

Drainage Improvements - Vibro Line removal for drainage gaps.

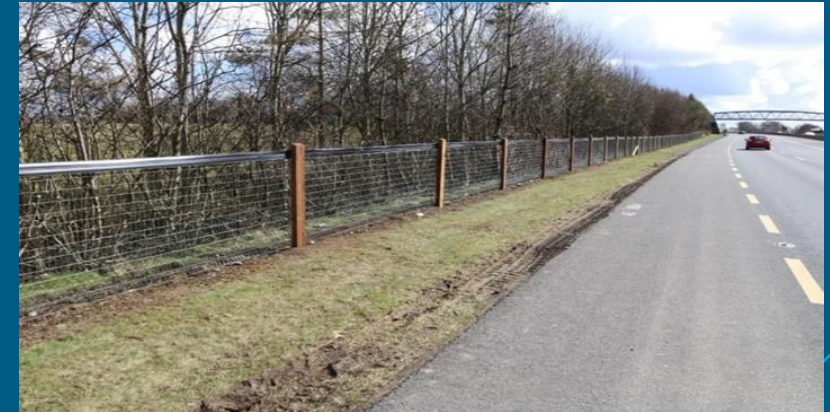
Repairs to Mesh fence following collision

- Collisions recorded to date with New Tensioned Wire Mesh.
- Fence has performed well in all instances.
- Repairs were simple to carryout;
  - Damaged and Broken Timber Posts are replaced;
  - Damaged section of mesh is cut out and replaced;
  - The mesh is re-joined with gripple joiners;
  - The mesh is re-tensioned with Straining Clamp and Mesh Pullers;
  - Damaged section of Plastic Rail is cut out and joined again using Joining Buckle Splicer;
  - Plastic Rail is re-tensioned again using existing Inline Tensioner;
  - Mesh is stapled to Intermediate posts and missing Hog Rings replaced.

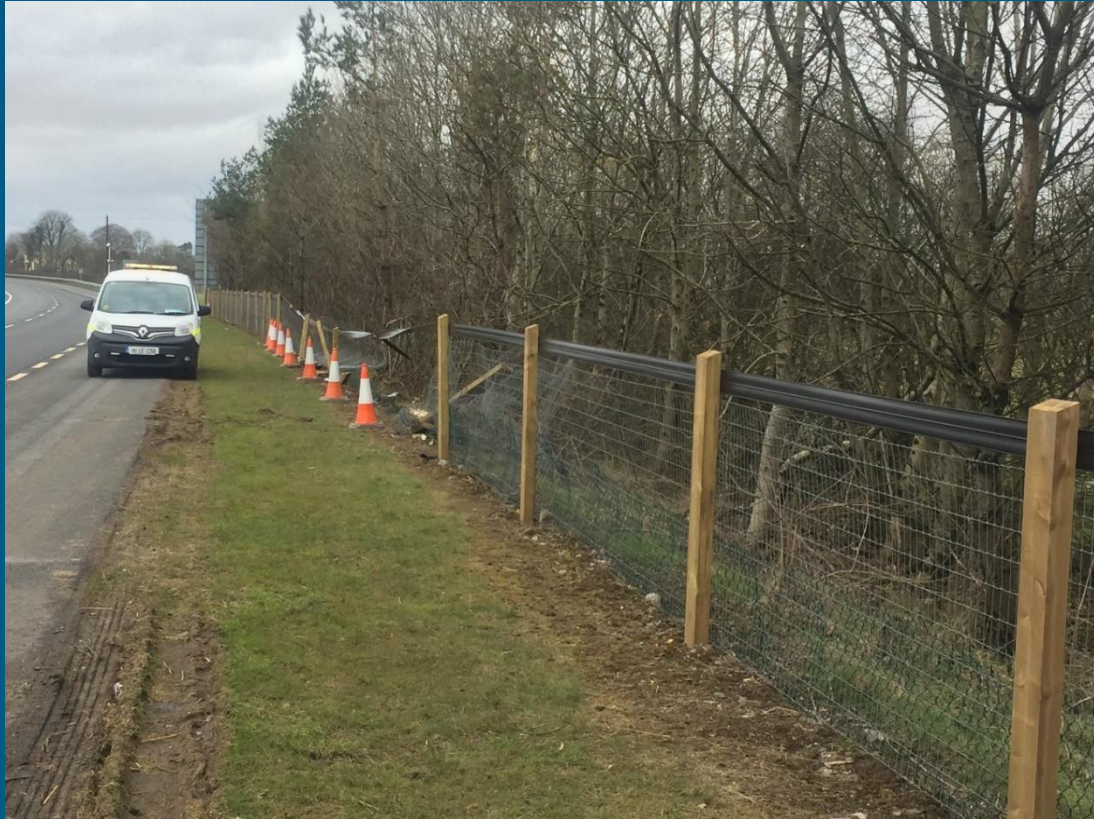
Following Collision

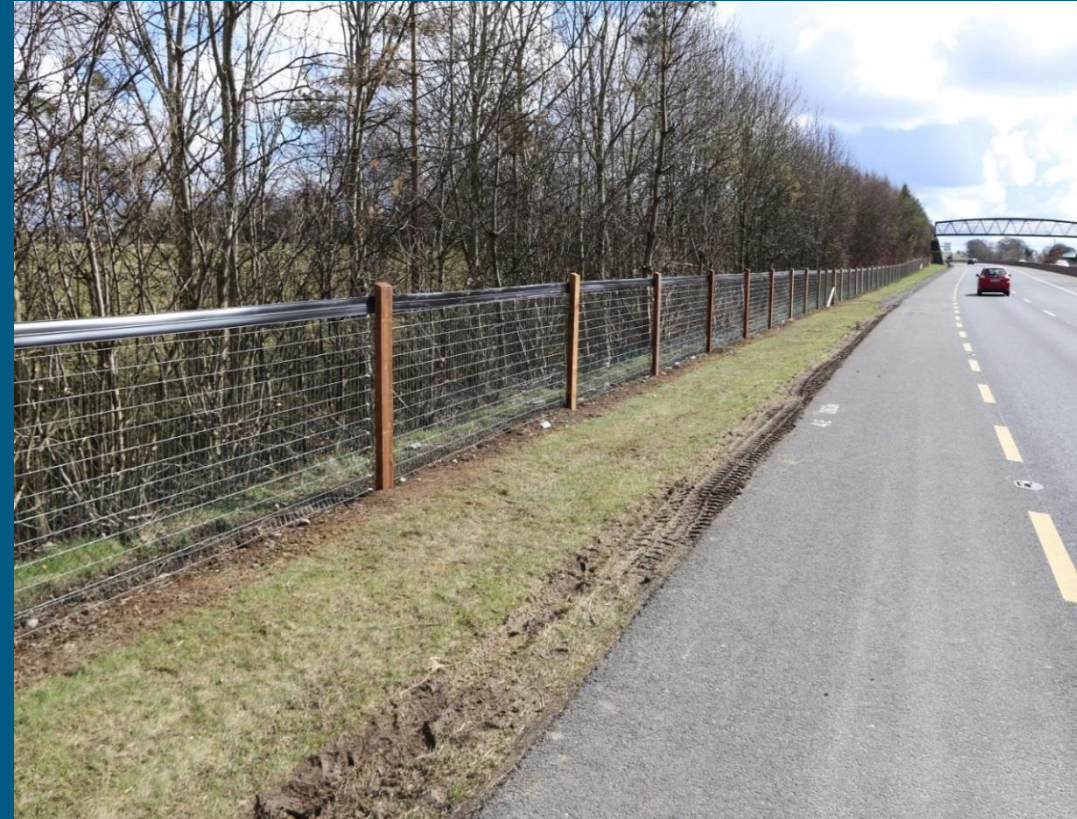
Following Repairs
