Our Ref: 5162555CO44

Re. Submission of Natura Impact Statement pursuant to the Minister for Tourism, Culture, Arts, Gaeltacht, Sport and Media pursuant to the requirements of Regulation 49(9)(c) of the European Communities (Birds and Natural Habitats) Regulations, 2011 (as amended)

TO270 – Munster Term Maintenance Contract No 3 – Munster Bridges Year 3.

Table 1 Review of Structures with respect to Otter.

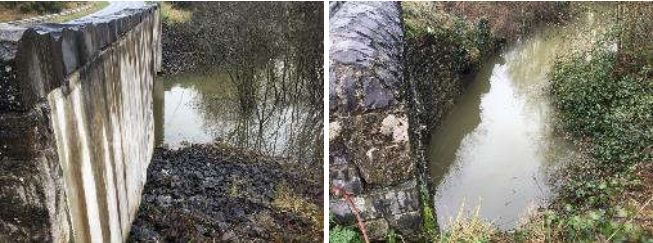
Bridge	Within	Field Surveys undertaken by an Ecologist in 2020	Photo (showing both upstream & downstream)	Information from bat survey
Carrig Bridge (CC-N72-027.00)	Blackwater River SAC	Bat survey 2020; FWPM survey 2020

<p>Otter spraints on rock at downstream face of the bridge.</p> <p>Site photographs reviewed in full – no signs of conditions suitable for an otter holt with ca. 10m of bridge.</p>
Ballynamona Bridge (CC-N73-005.00)	Blackwater River SAC	Not surveyed.

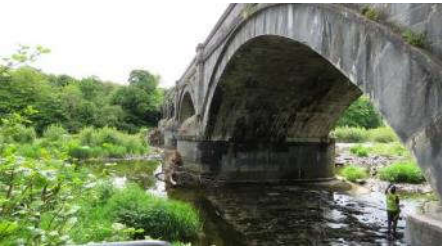
<p>River banks flanked by GA1; narrow fringe of trees. Farm complex close to upstream side. Suitable locations for holt in woodland upstream of the site. No signs of conditions suitable for an otter holt with ca. 10m of bridge.</p>
Listowel Bridge (KY-N69-017.00)	Lower River Shannon SAC	Bat survey 2020; FWPM survey 2020

<p>No signs of Otter noted in bat report.</p> <p>Extensive structure. Preconstruction survey is required to account for potential changes since preparation of the NIS.</p>

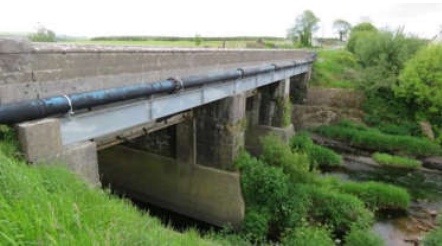
River Galey Bridge (KY-N69-020.00)	Lower River Shannon SAC	Bat survey 2020

<p>During the bat survey an otter trail was recorded on the southern side of the bridge.</p> <p>Preconstruction survey is required to account for potential changes since preparation of the NIS.</p>

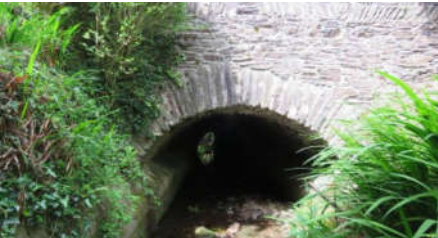
Bridge	Within	Field Surveys undertaken by an Ecologist in 2020	Photo (showing both upstream & downstream)	Information from bat survey
Kilnabrack Upper Bridge (KY-N70-019.00)	Castlemaine Harbour SAC	Bat survey 2020

<p>A low / bridge culvert.</p> <p>No information on Otter included in bat report.</p> <p>Preconstruction survey required.</p>
Assroe Bridge (KY-N70-056.00)	Kenmare River SAC ca. 200m d/s of bridge	Bat survey 2020

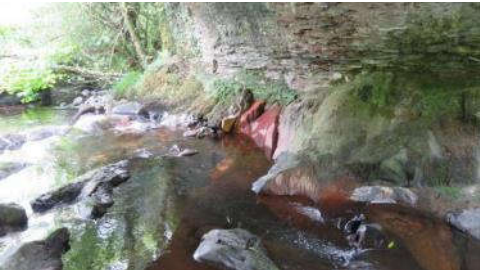
<p>A clump of otter hair was noted on a rock at the upstream face.</p> <p>A large area of woodland is located upstream of the bridge. A preconstruction survey is required to account for potential changes since preparation of the NIS & to check tree cover on upstream side of the bridge.</p>
The Red Bridge (KY-N86-014.00)	Tralee Bay & Magharees Peninsula, West To Cloghane SAC ca. 250m d/s of bridge	Bat survey 2020

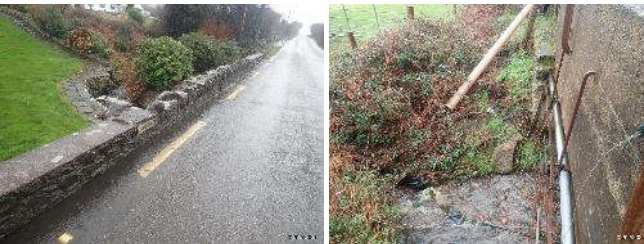
<p>No information on Otter included in bat report.</p> <p>Adjoined by a garden on roadside; farmland on other side. No suitable habitat for holting.</p>
