# Munster Term Maintenance Contract No 3

Blennerville Bridge Repairs - Natura Impact  
Statement

Transport Infrastructure Ireland

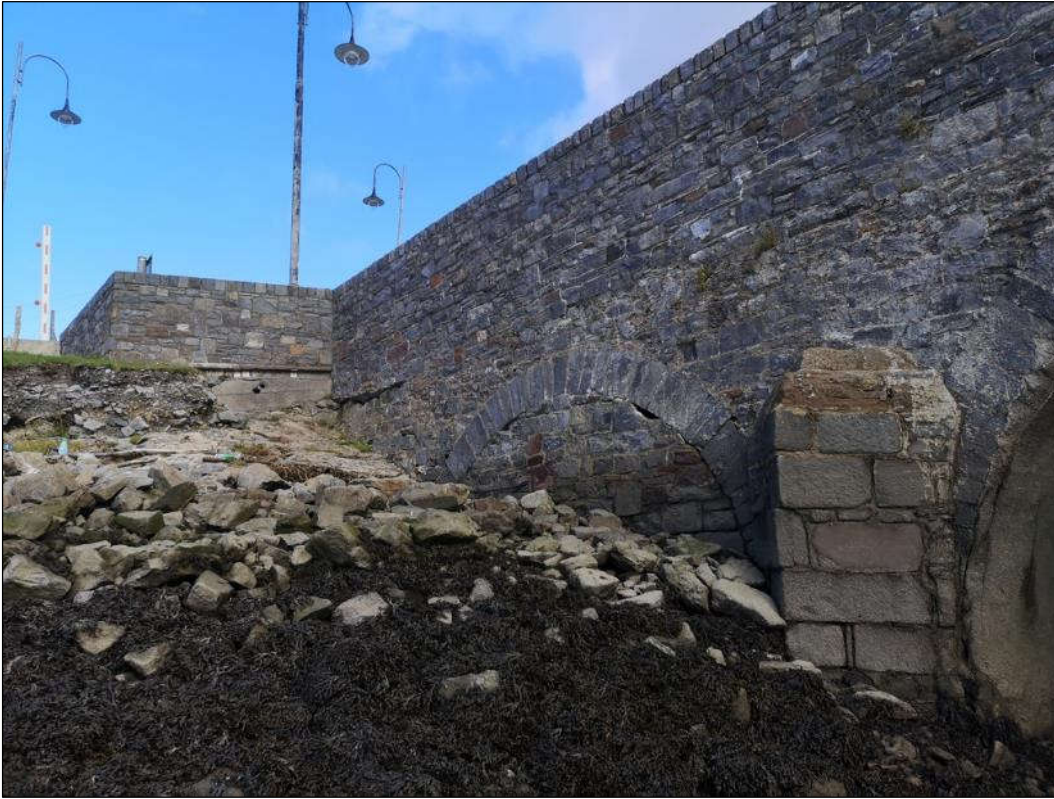
**Plate 1.5** View of the NW wing wall and infilled north span.

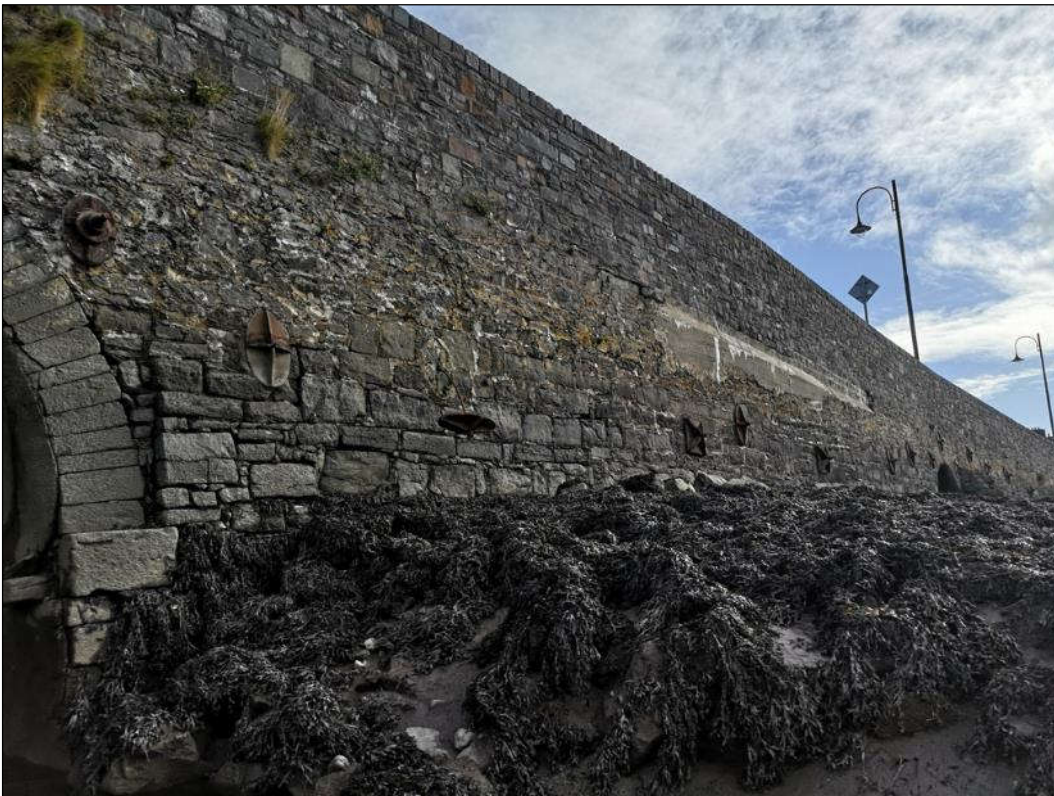
**Plate 1.6** View of the SW wing wall with detached parrass plate and previous concrete repair evident.

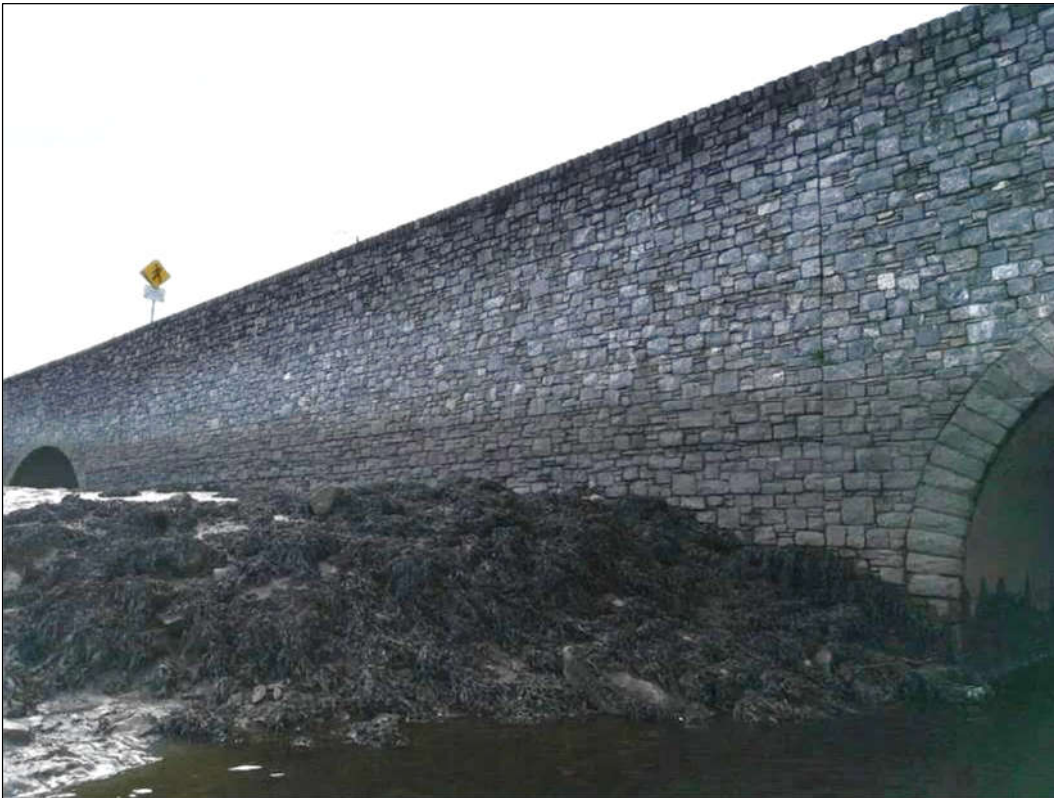
**Plate 1.7** View of the SE wing wall with high tide staining evident.

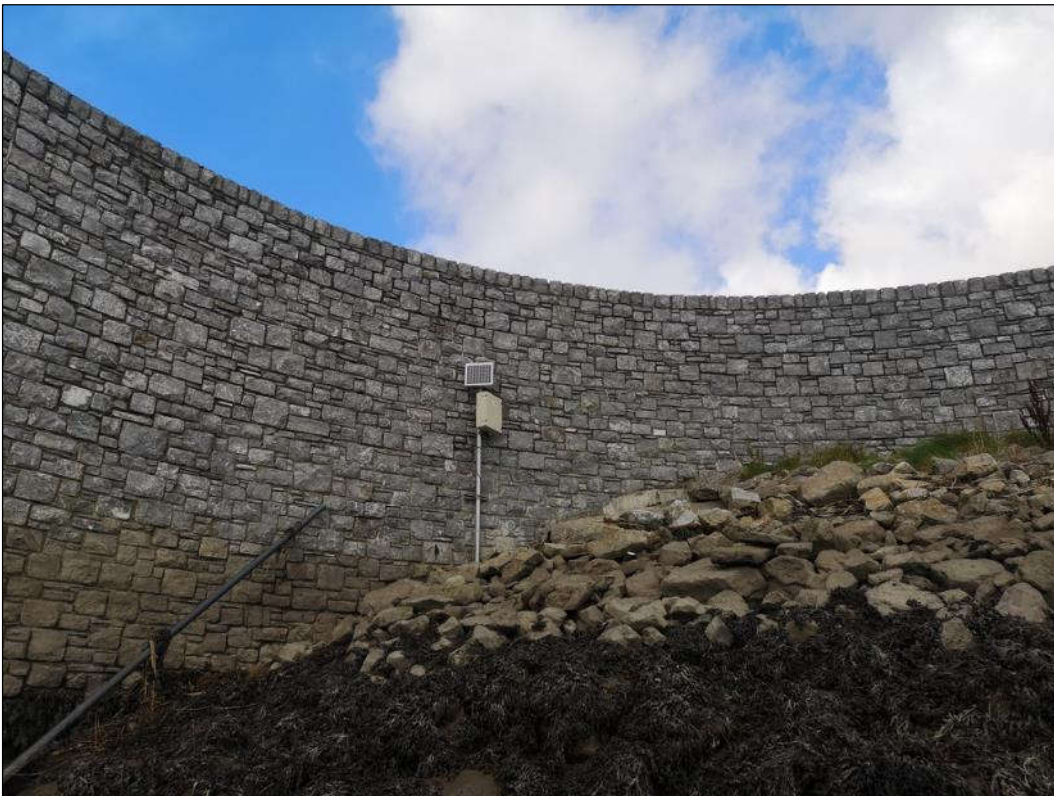
**Plate 1.8** View of the NE wing wall with high tide staining evident.

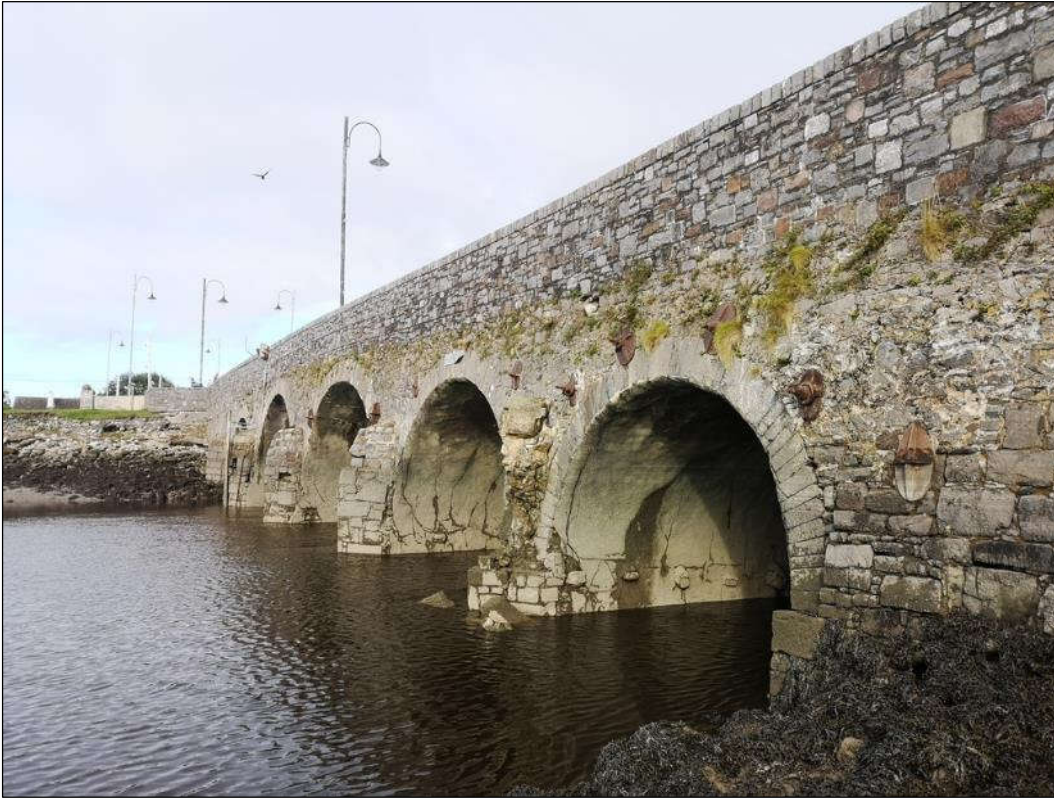
**Plate 1.9** View of the west spandrel wall with vegetation growth evident.

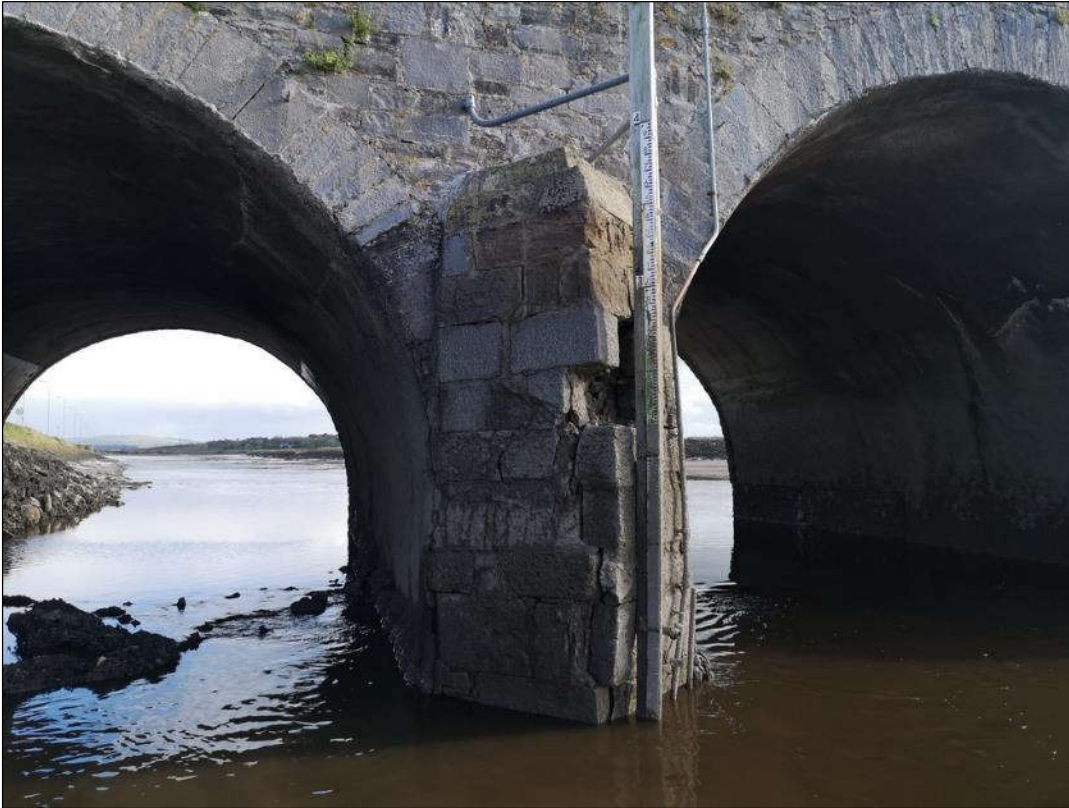
**Plate 1.11** View of the west cutwater of pier 1 with cracked and missing masonry evident.

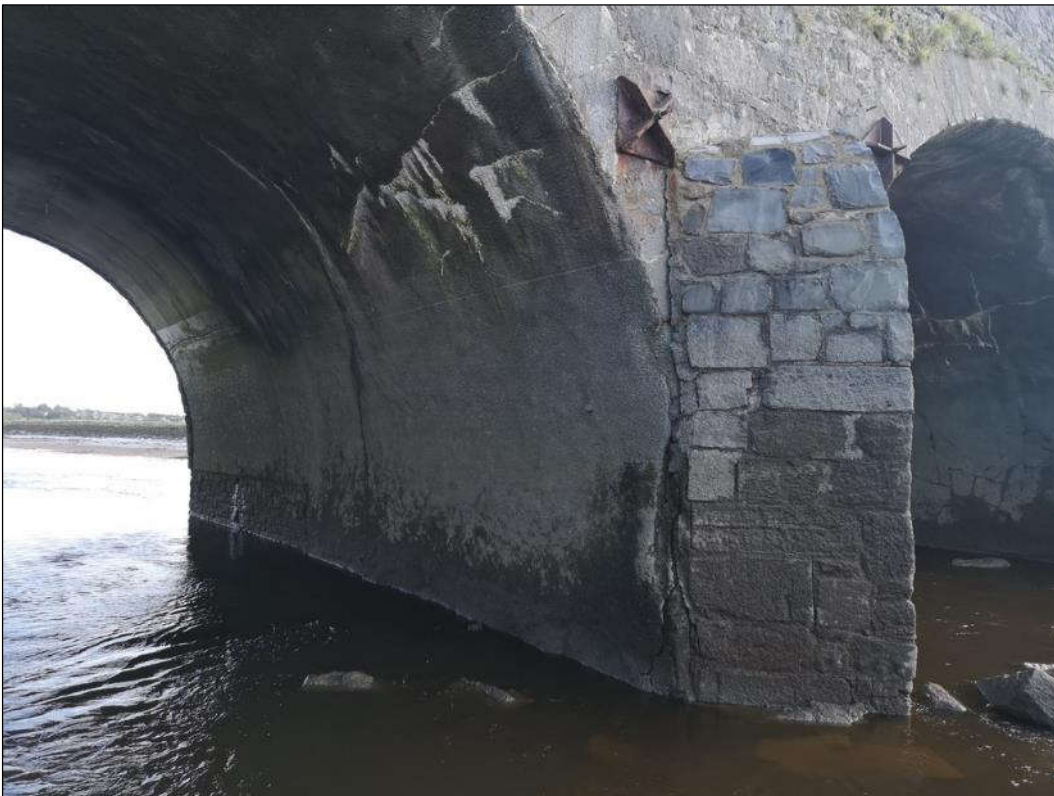
**Plate 1.12** View of the north face of pier 2 with 10mm wide vertical crack evident from quarter point of arch down to riverbed at middle of structure.

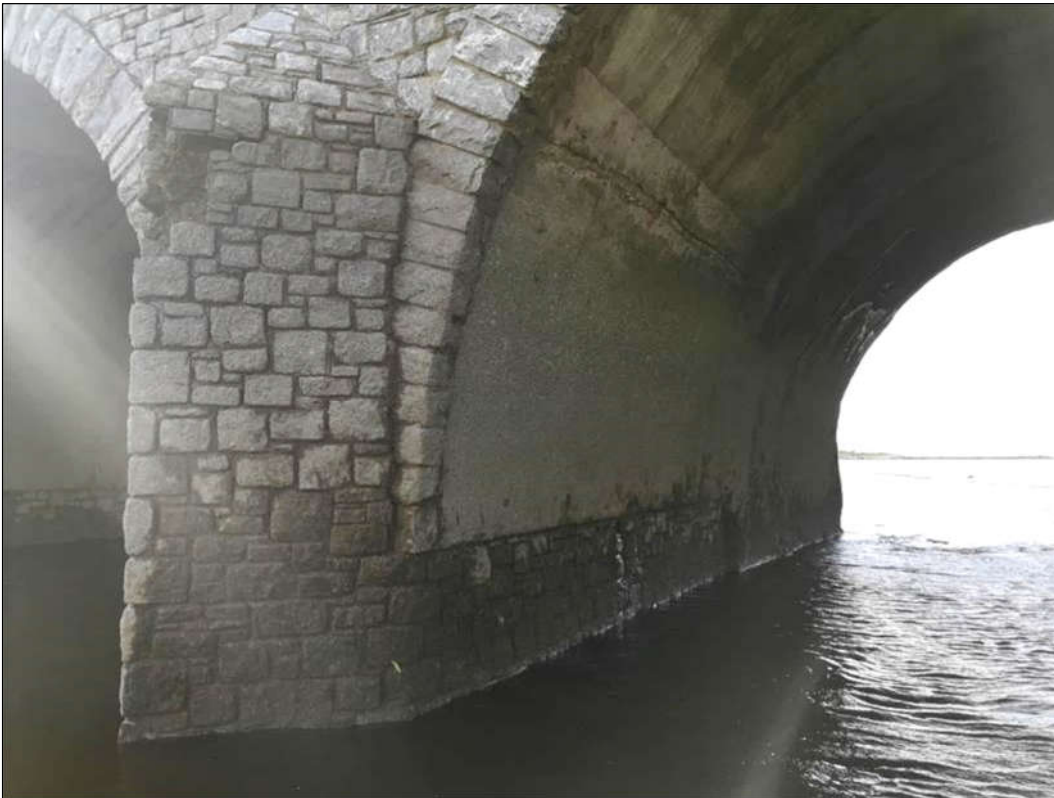
**Plate 1.13** Missing masonry to the east cutwater of pier 2.

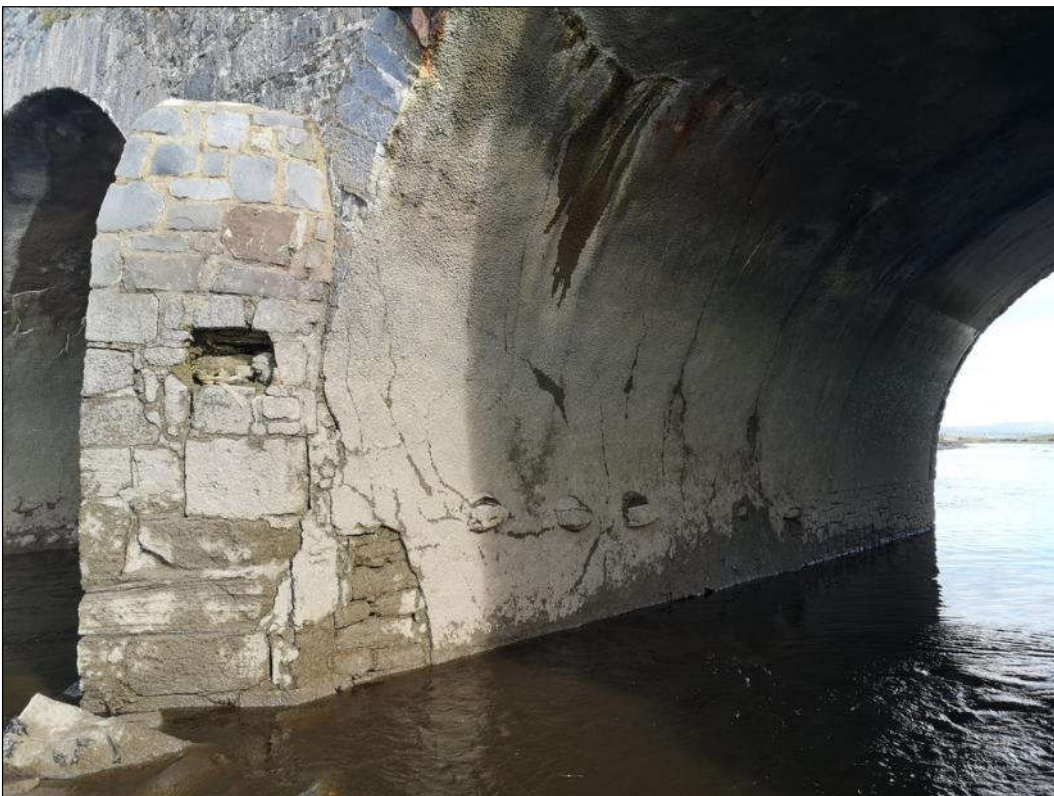
**Plate 1.14** Masonry loss and separation to the west cutwater of pier 2.

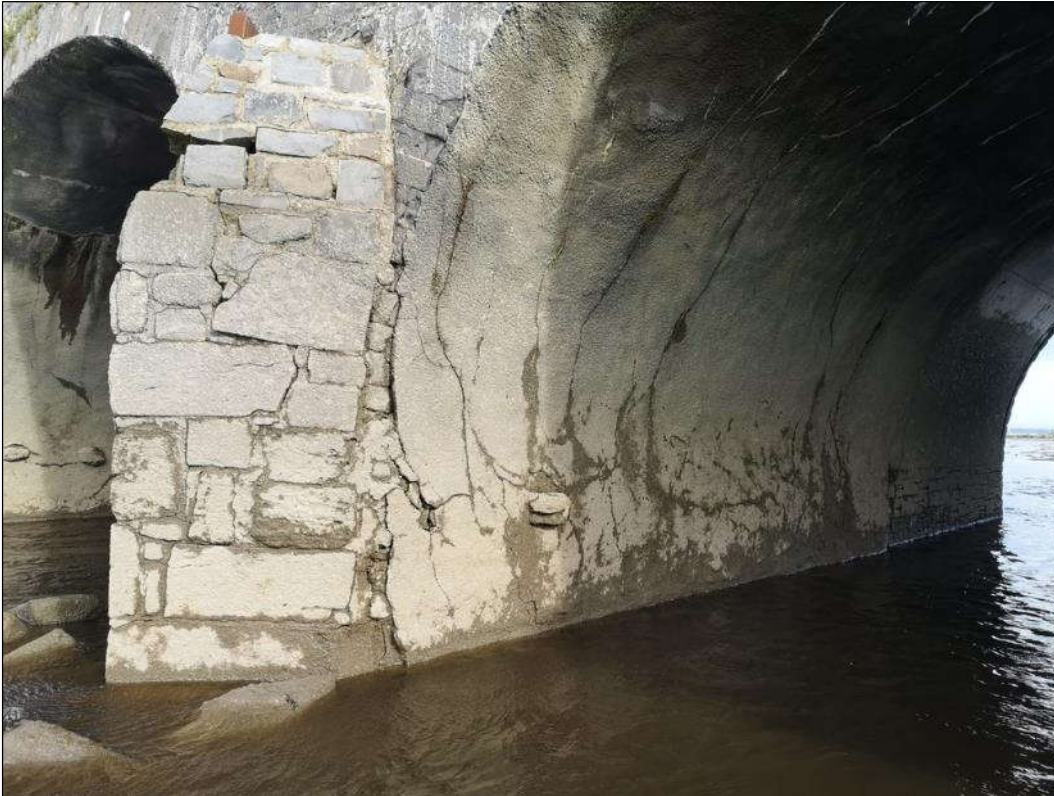
**Plate 1.15** View of the west cutwater of pier 3 with masonry loss evident and cracking to the gunnite layer on the south face.

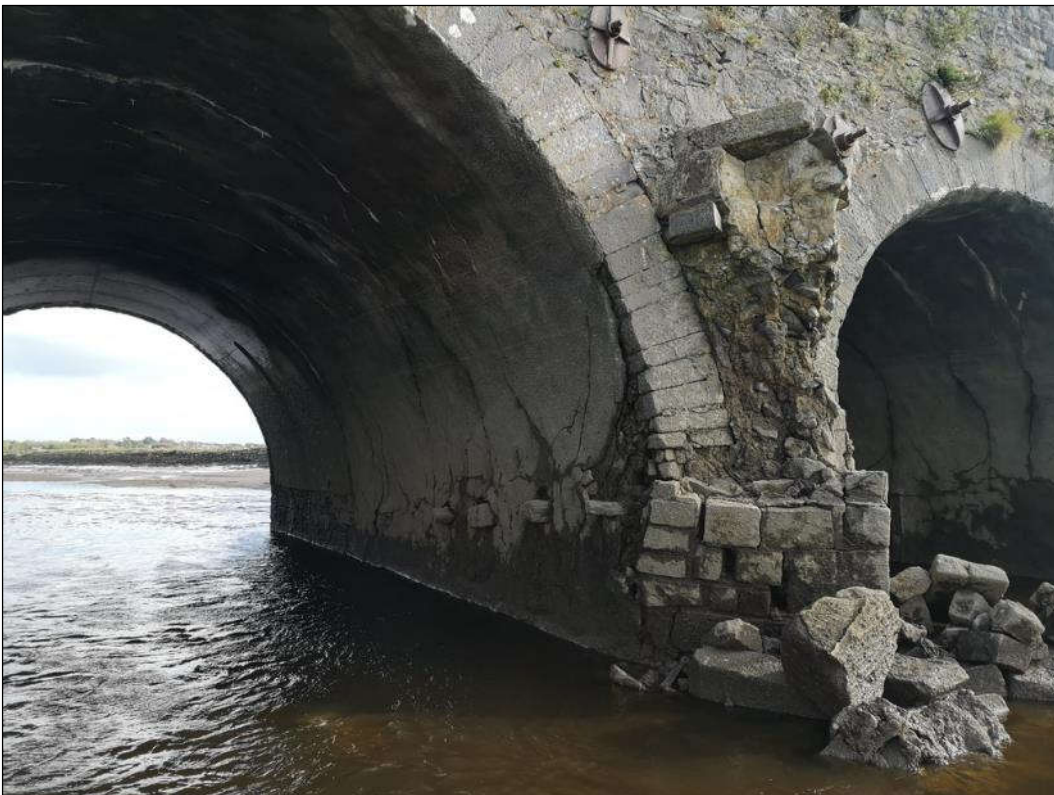
**Plate 1.16** Collapsed west cutwater of pier 4.

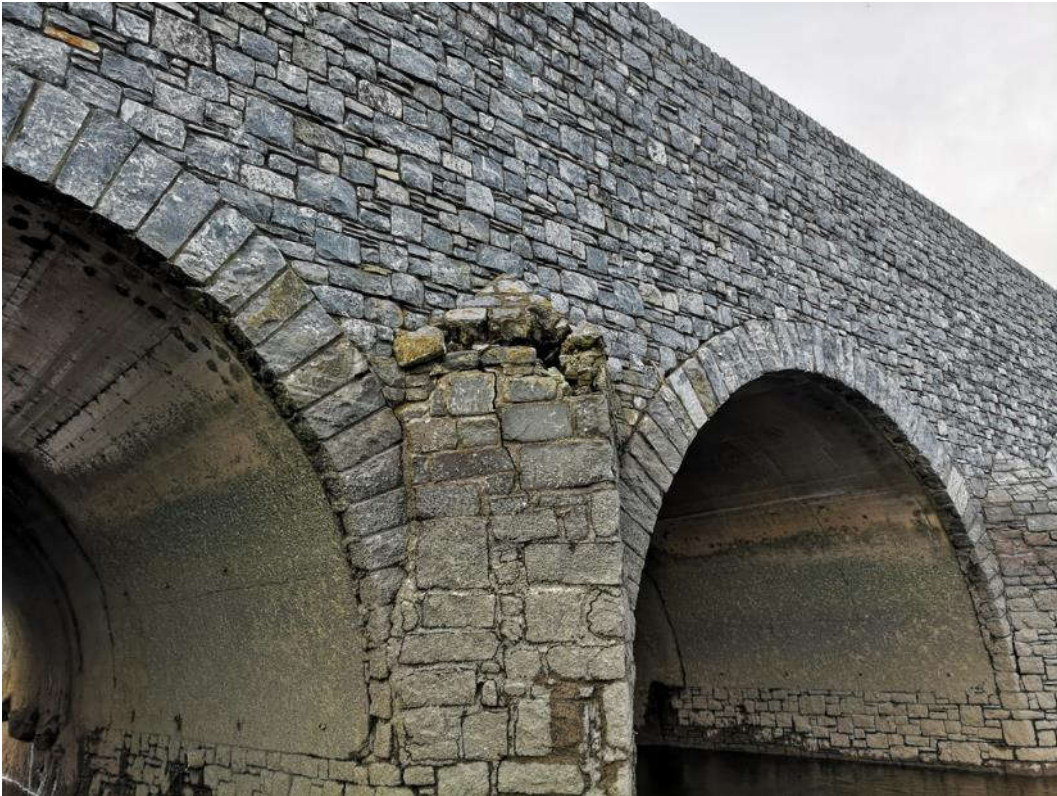
**Plate 1.17** Missing and cracked masonry to the east cutwater of pier 4.

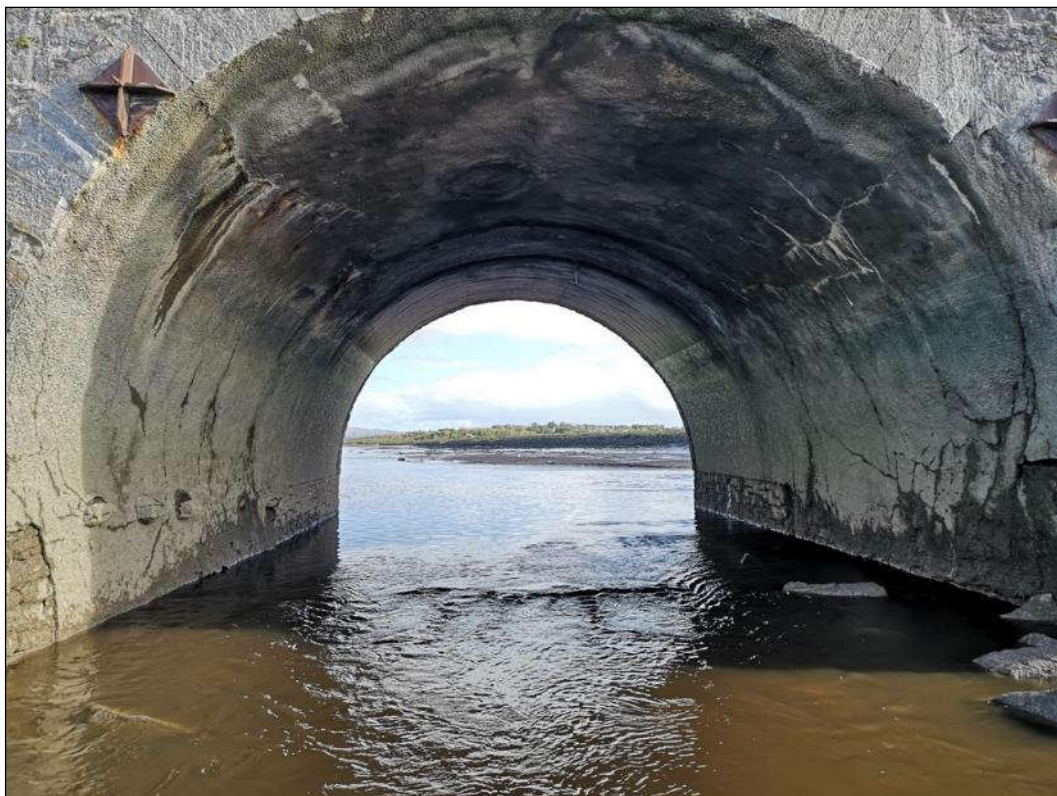
**Plate 1.18** View of arch barrel in span 3 with extensive cracking to the gunnite layer at both quarter points.

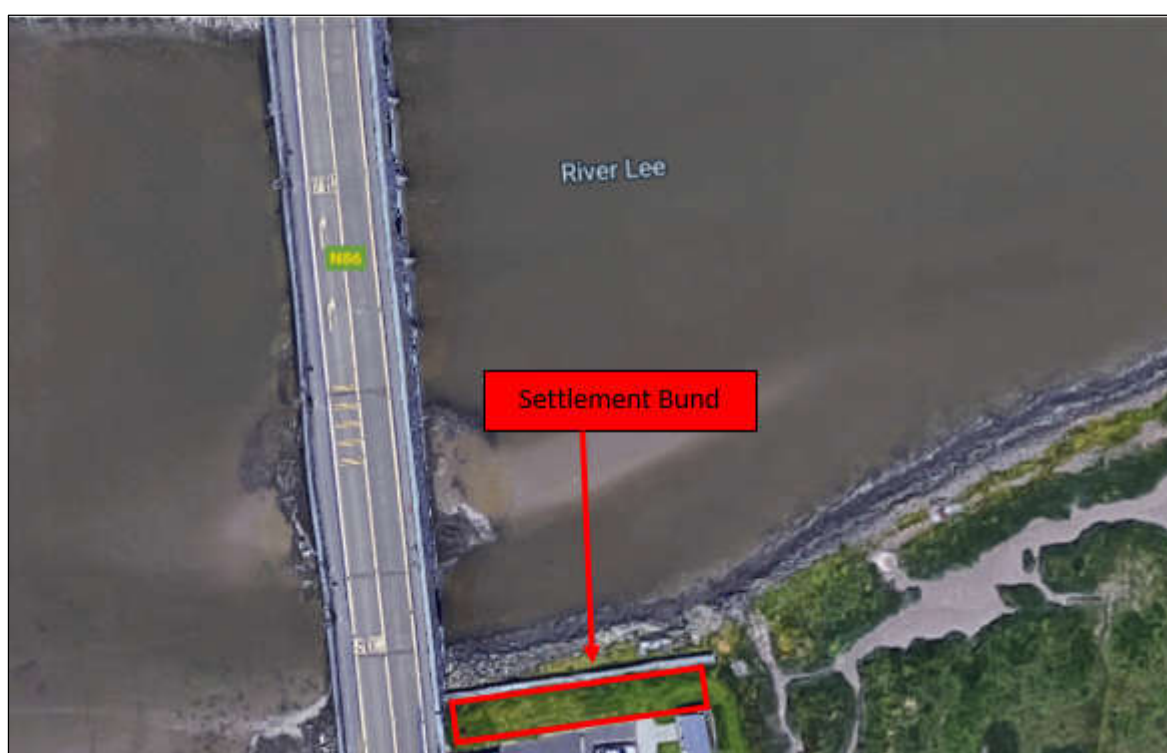
**Figure 1.6 Location of settlement bund for water management.**

- All works to be carried out at low tide.
- 4ft scaffold to be erected at each side of the cutwater to access the top of the cutwater.
- Scaffold will be founded on the reno mattress and the 1 T sand bags.
- Scaffold to be designed and TWDC<sup>1</sup> signed off before erection.
- All scaffold materials to be steam cleaned prior to being put in the water.
- Scaffold to be lowered from the bridge and erected in the area of works.
- At low tide the sandbag coffer dam will be pumped out with a 4 inch pump pumping to settlement bund to the SE side of the bridge. This area will be bunded off with sandbags allowing the pumped water to filter through the ground (see Figure 1.6).

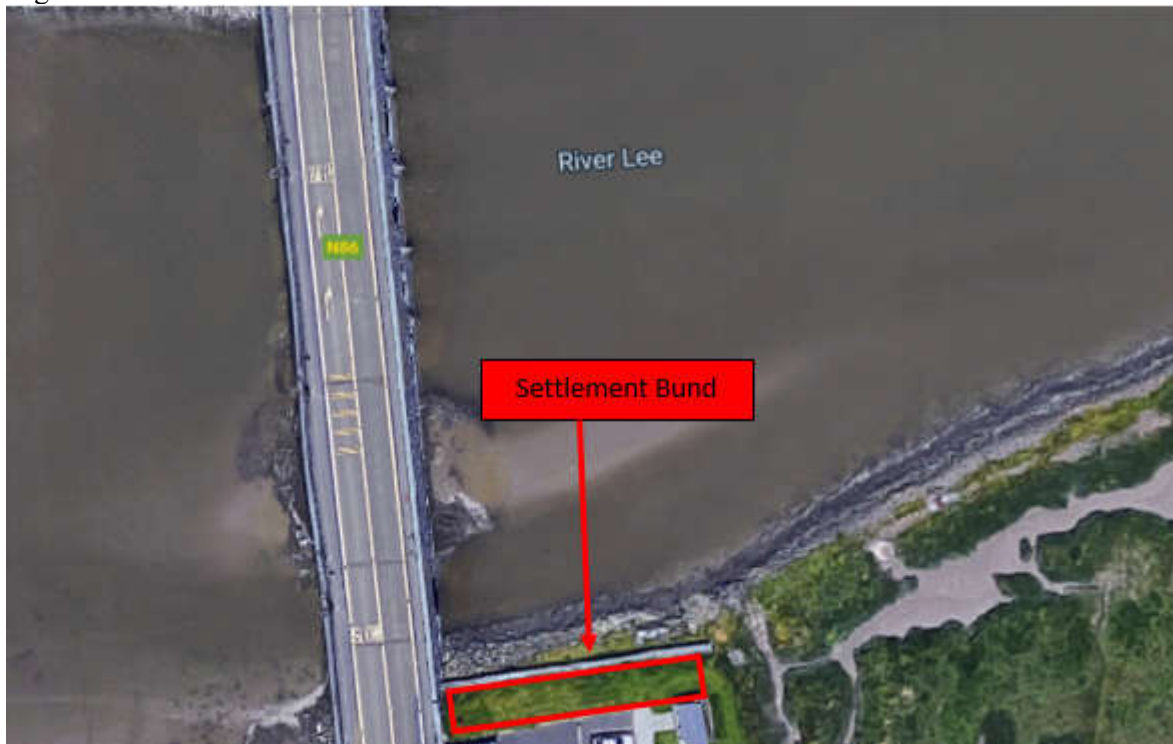
- All works to be carried out at low tide
- 4ft scaffold to be erected at each side of the cutwater to access the top of the cutwater
- Scaffold will be founded on the reno mattress and the 1 T sand bags.
- Scaffold to be designed and TWDC signed off before erection
- All scaffold materials to be steam cleaned prior to being put in the water
- Scaffold to be lowered from the bridge and erected in the area of works
- At low tide the sandbag coffer dam will be pumped out with a 4 inch pump pumping to settlement bund to the SE side of the bridge. This area will be bunded off with sandbags allowing the pumped water to filter through the ground.

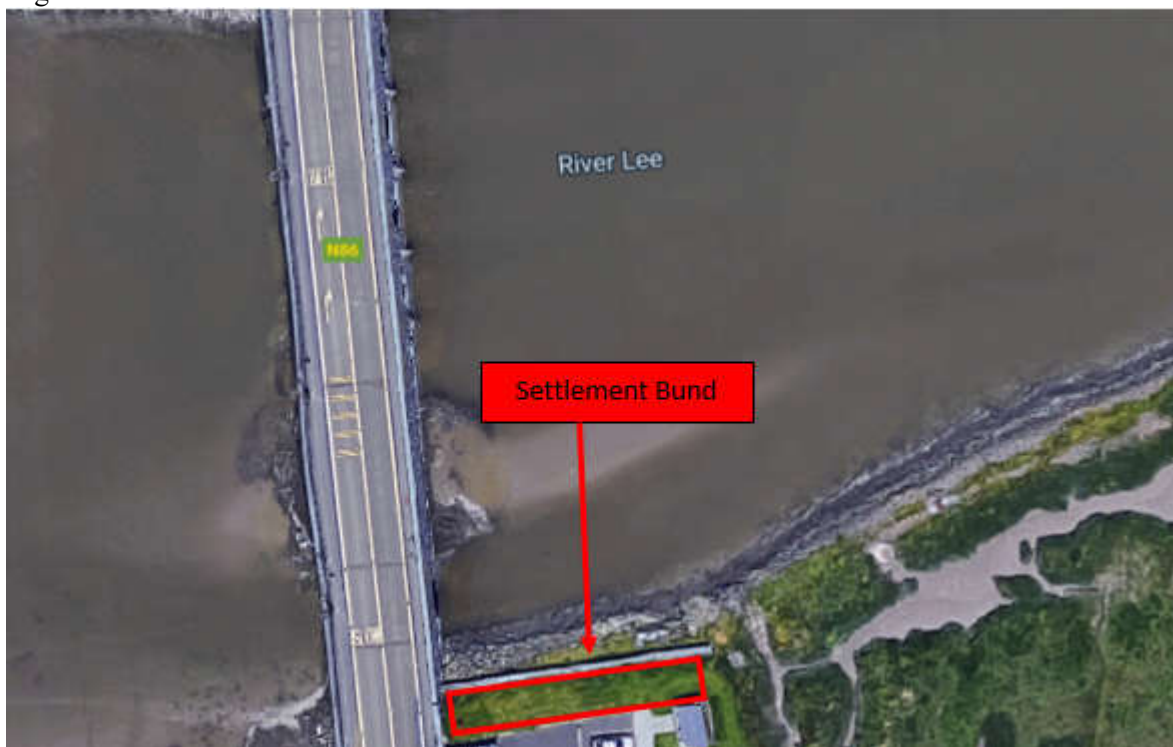
- All works to be carried out at low tide
- 4ft scaffold to be erected at each side of the cutwater to access the top of the cutwater
- Scaffold to be designed and TWDC signed off before erection
- All scaffold materials to be steam cleaned prior to being put in the water
- Scaffold to be lowered from the bridge and erected in the area of works
- At low tide the sandbag coffer dam will be pumped out with a 4 inch pump pumping to settlement bund to the SE side of the bridge. This area will be bunded off with sandbags allowing the pumped water to filter through the ground.
