## Appropriate Assessment Screening – Note TO270/01

Project:	5162555_TO 270 Munster Bridges		
Subject:	Reactive Maintenance - AA Screening No. TO270/04		
Author:	Paul O'Donoghue, Atkins Principal Ecologist	Atkins No.:	Appropriate Assessment Screening – Note TO270/04. Revision 1.0
Date of Query:	01/08/2019	Date Issued:	06/08/2019
Distribution:	Martin Jennings, PM Vincent Daly, RE, TO270 Vincent O'Malley Christian Nea	Representing:	Atkins Atkins TII TII

Bridge	Glenbeigh National School Bridge / Coolroe Bridge
Structure ID	KY-N70-021.00
County	Kerry
Location	On the N70, beside Glenbeigh National School (ING ref: 465130 589299).

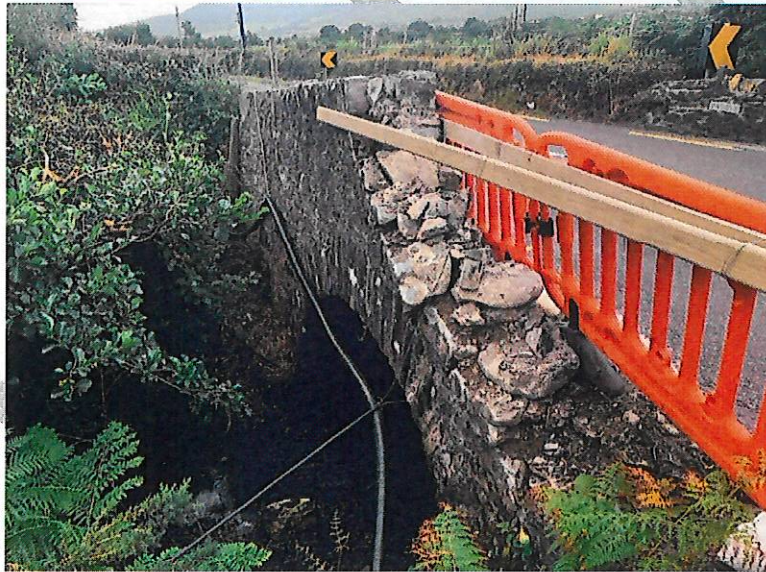
**Plate 1.** Damage to parapet wall on northern side of the N70.

Following a vehicle impact at KY-N70-021.00, masonry reconstruction measuring 2.9m long x 1.2m high x 0.42m deep is required. The repair will be on a like for like basis. At the area of the damage most stone is available for reuse however some imported stone may be required. Measured area of repair includes minor deformation to masonry still in place. Basic scaffold is required to complete the works which will be decked out with plywood. Any masonry in the watercourse will be recovered by hand. No concrete works are required. All repointing is to be done using NHL 5. Repairs will take approximately 2 days.

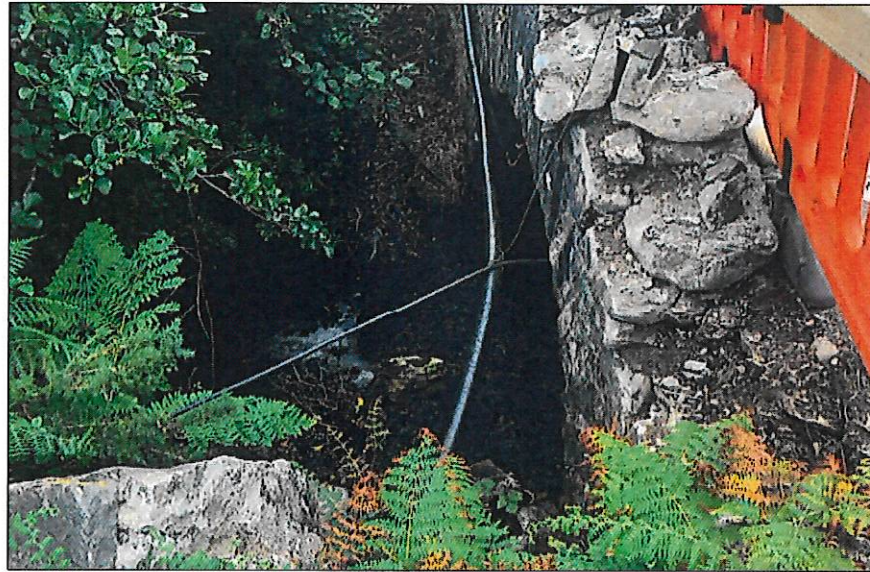
**Plate 2.** Damage to parapet wall on northern side of the N70.

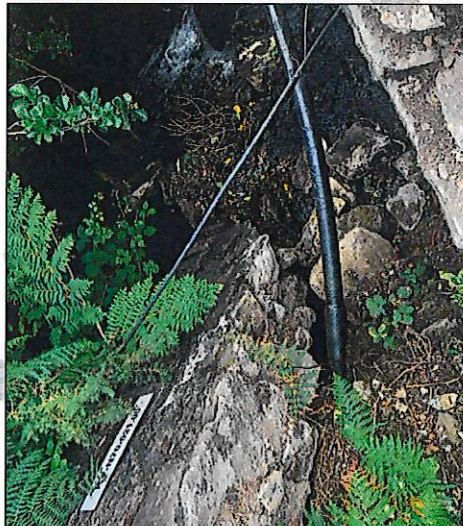
**Plate 3.** Debris having fallen into the stream / onto river bank – looking downstream (northwards).

Instream debris will be removed by hand, with no other instream works required. Loss of debris to the stream is likely to be minimal due to the working methods employed by use of scaffolding fitted with plywood that adjoins the bridge. The plywood that will adjoin the bridge will catch any potential debris or mortar droppings entering the watercourse.
