N7 Online Bus Stops Safety Review

Presenter: **Martin Deegan**
BEng (Hons) MSc CEng MIEI
Principal Engineer
traffico
ROAD SAFETY ENGINEERING

Friday 13 November 2020

To highlight the process and outcomes of the N7 On-Line Bus Stops Safety Review which was commissioned by TII to establish and document the usage of the existing on-line bus stops on the N7, establish their associated operational risks and then propose a suite of countermeasures to mitigate the risks identified.

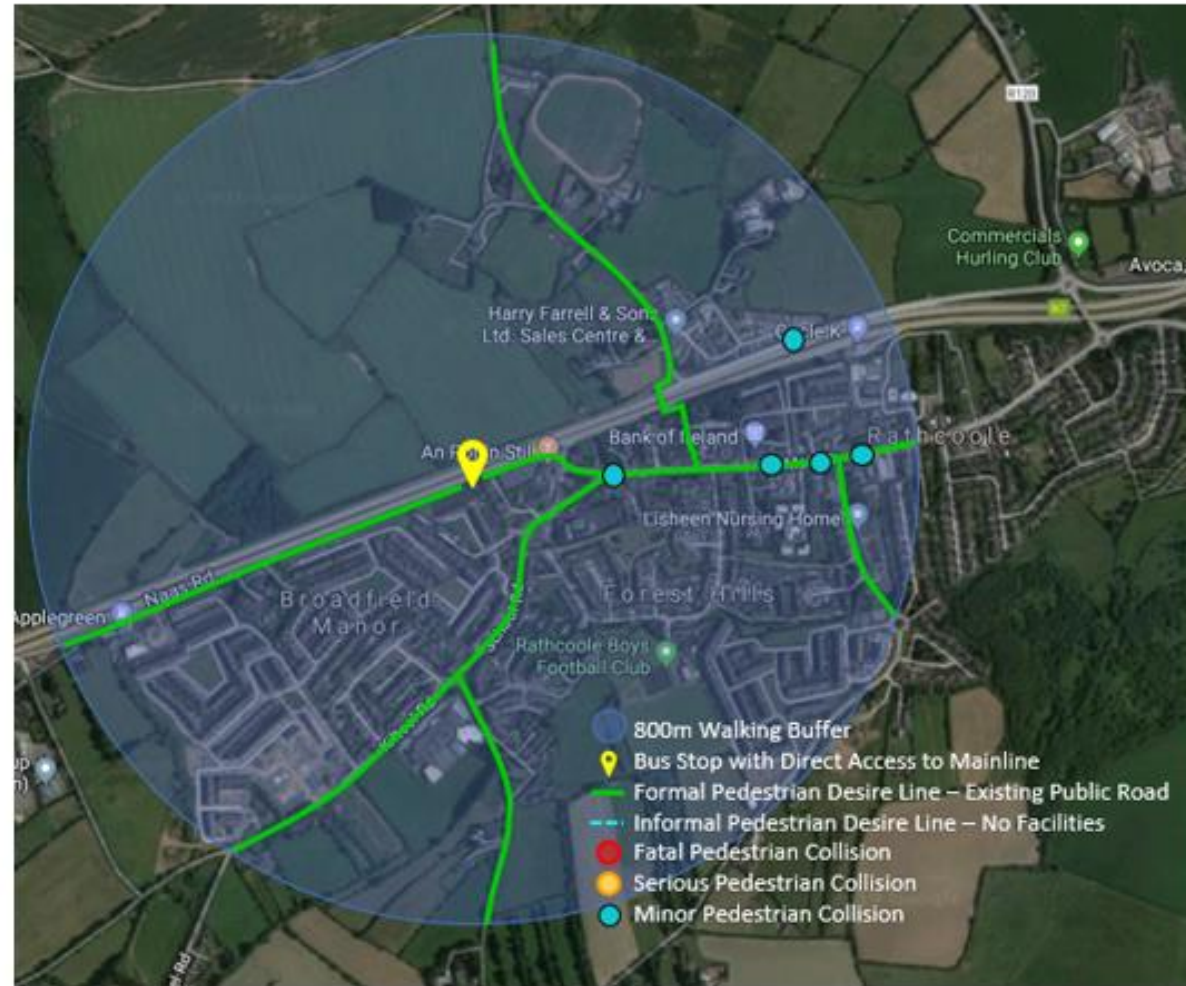
Figure 2-7 - Site 6 (Stop ID 133951) Outbound, Rathcoole

Pedestrian Access & Catchments – Site 6 (high use)

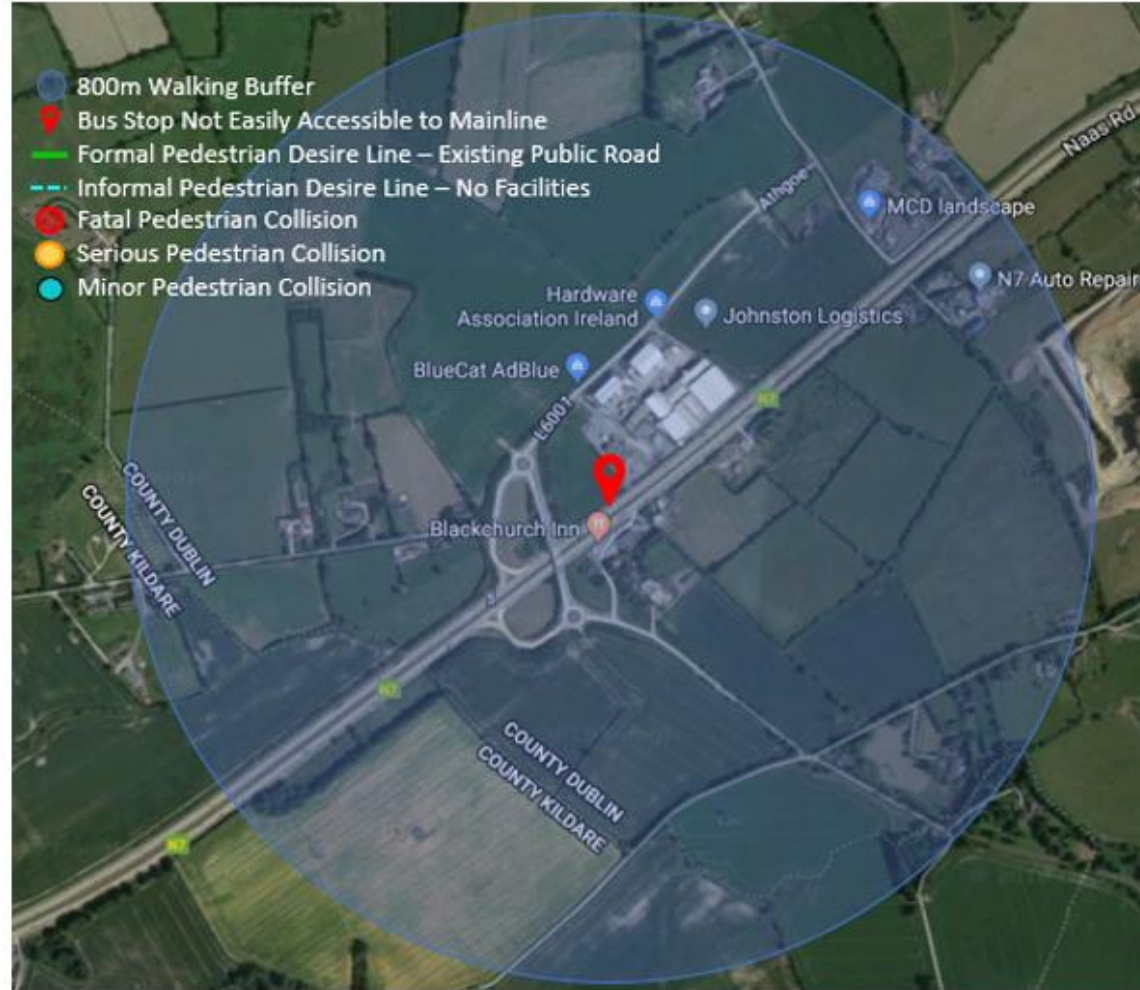
Figure 2-10 - Site 9 (Stop ID 136351) Inbound, Opposite Blackchurch Inn

Pedestrian Access & Catchments – Site 9 (low use)

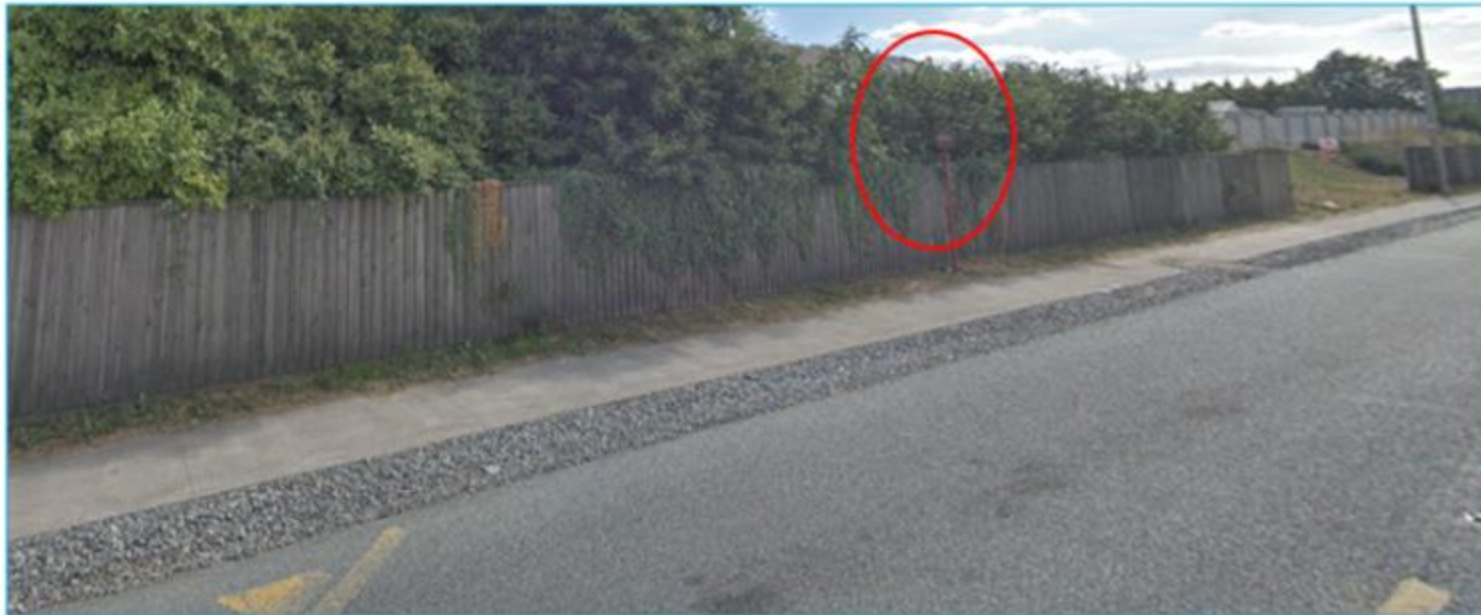
Figure 3-10 - Bus Stop location in hard shoulder at end of Rathcoole merge lane

A Bus Éireann marker post and sign were identified during the site visit. The marker post was located in the vicinity of Rathcoole and An Poitín Stil and is served by a narrow pedestrian footpath which runs beside the hard shoulder.

The bus stop is situated in the hard shoulder, just beyond the termination of an uphill merge lane which services the preceding Rathcoole compact junction. This places a stationary bus at high risk of rear end / shunt collisions.

There are no safety barrier or protective measures in place at this location.

No.	Stop ID	Stop Name	Usage Summary	Summary of Contributing Factors & Resultant Risks	Proposed Countermeasures
6	133951	Outbound, Rathcoole	Medium	The bus stop is served by a substandard footpath adjacent to the hard shoulder, just beyond the termination of an uphill merge lane. This places users at risk of conflict with high speed traffic and a stationary bus at high risk of rear end shunt collisions.	Removal of existing bus stop infrastructure and development of new protected off-line stop some 30m to the west, in an area of embankment between the edge of the hard shoulder and the rear gardens associated with dwelling houses on Windmill Close.
7	133721	Outbound, Keatings Park	None	No pedestrian facilities and the stop is located in the verge within the extents of a merge lane, placing a potential stationary bus at high risk of a rear end shunt collision. The verge indicates a history of unlawful HGV parking.	Extinguishment of bus stop operation.

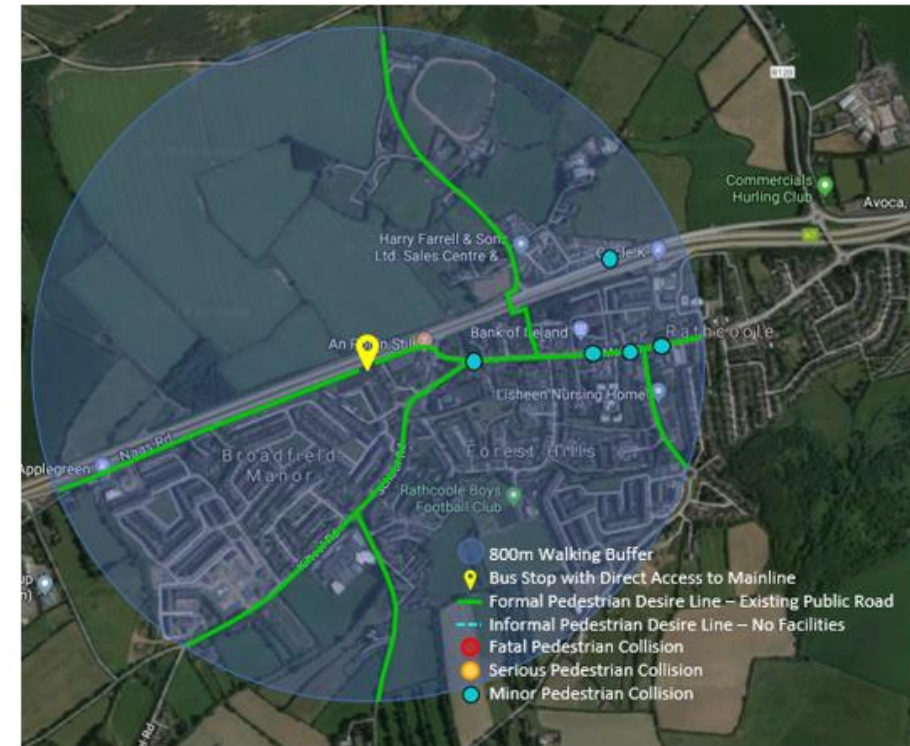
Figure 2-7 - Site 6 (Stop ID 133951) Outbound, Rathcoole

3.2.6. Site 6 – (Stop ID 133951) Outbound, Rathcoole

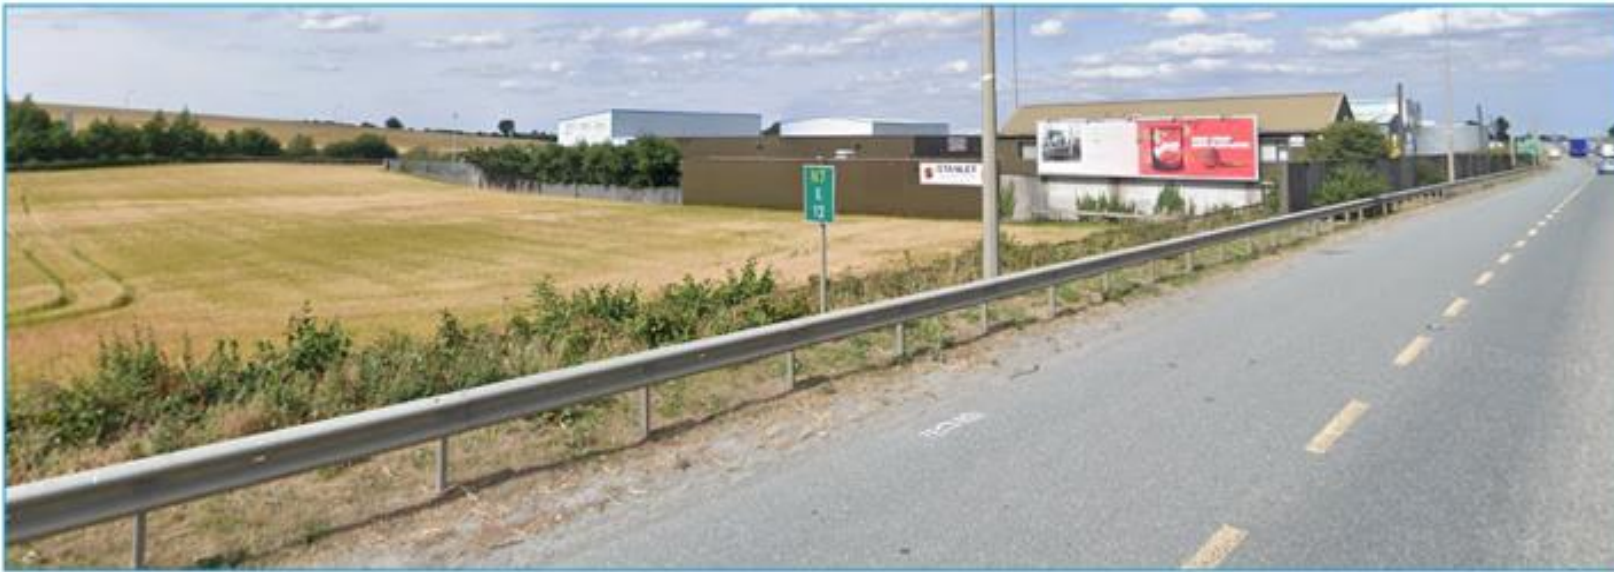
Figure 3-13 - Inaccessible Stop opposite Blackchurch Inn, in verge behind safety barrier

Bus stop infrastructure was not identified at this stop during the site visit, nor were pedestrian facilities or evidence of pedestrian walking routes in the verge. This is reflected within the AVL data considered which shows no user activity.

This site is highly inaccessible from a pedestrian perspective. It is positioned in the verge on a section of raised embankment behind a continuous safety barrier.

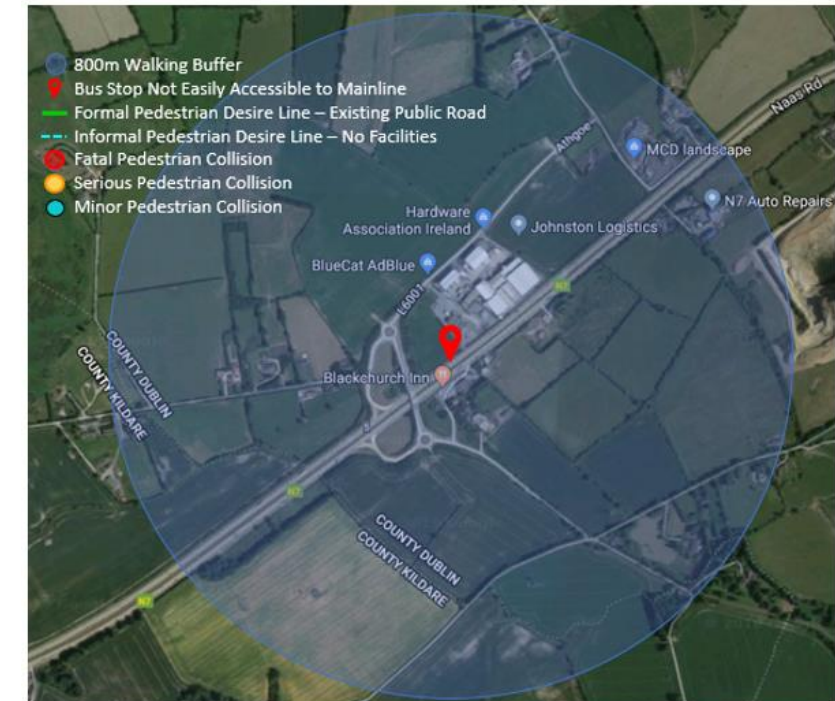
Figure 2-10 - Site 9 (Stop ID 136351) Inbound, Opposite Blackchurch Inn

3.2.9. Site 9 (Stop ID 136351) Inbound, Opposite Blackchurch Inn

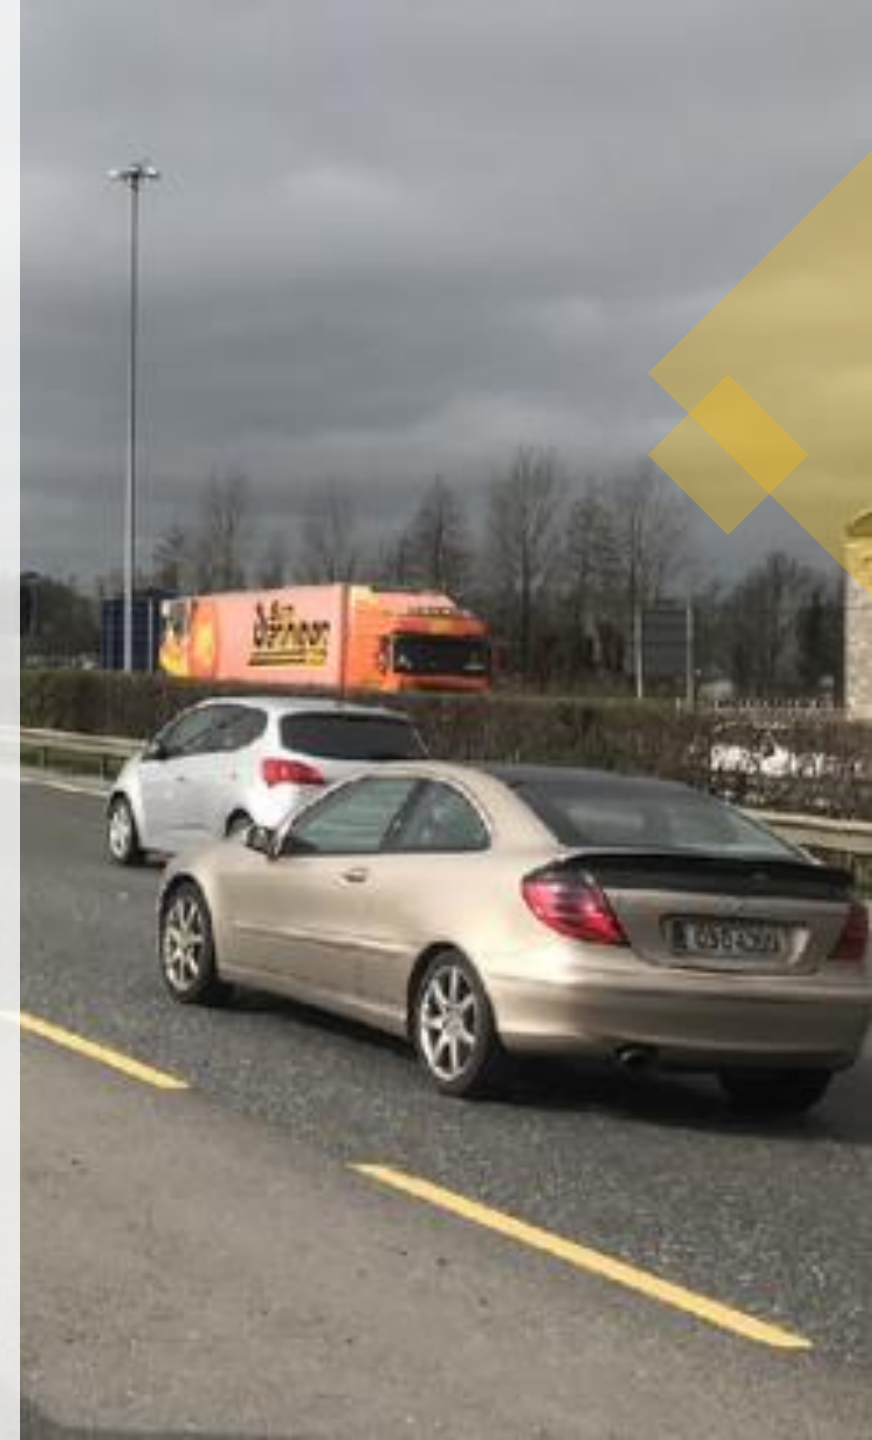
Problems and Risks Common to all N7 Online Bus Stops

1. Pedestrians being struck by an errant vehicle.
2. Buses which stop adjacent to the mainline cause distraction to other drivers and are at risk of being struck by errant vehicles.
3. Buses decelerating out of or accelerating into Lane 1 increase the risk of conflict with drivers on the mainline.
4. The presence of stationary buses, merging or diverging buses may result in sudden lane changing / conflicts.

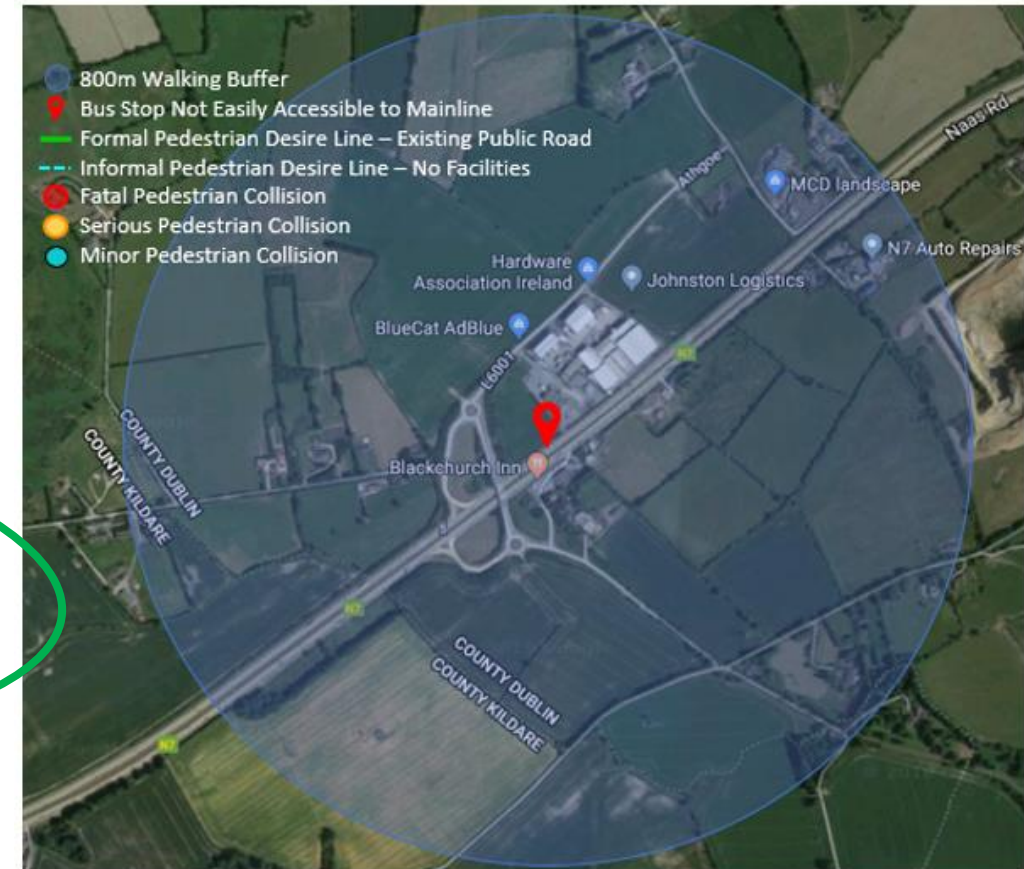
Figure 2-10 - Site 9 (Stop ID 136351) Inbound, Opposite Blackchurch Inn

8	133521	Outbound, Blackchurch Inn	Low	No pedestrian facilities and the stop is positioned within a short deceleration lane serving the Blackchurch Inn, immediately in advance of the left-in entry point to the site car park. This places a stationary bus at high risk of rear end shunt collisions.	Extinguishment of bus stop operation.
9	136351	Inbound, Opposite Blackchurch Inn	None	This inaccessible stop has no pedestrian facilities and is positioned in the verge on a section of raised embankment behind a continuous safety barrier.	Extinguishment of bus stop operation.
10	104301	Inbound, Rathcoole (Slip Rd)	Medium	This set-down stop is located at the beginning of diverge lane at the end of a fast-downhill section of the mainline carriageway, this places a stationary bus at high risk of rear end shunt collisions. Anecdotal evidence suggests buses have been known to stop on the mainline in the section of chevrons on the outside of the traffic delineators.	Removal of existing bus stop infrastructure and relocation of the stop circa 500m east to a new position in Lane 1, at the top of the diverge ramp where it splits into two lanes in advance of the northern junction roundabout.
