Current Developments With HOT ROLLED ASPHALT

Eddie Winterlich, Transport Infrastructure
Sean Cassidy, Quality Asphalt

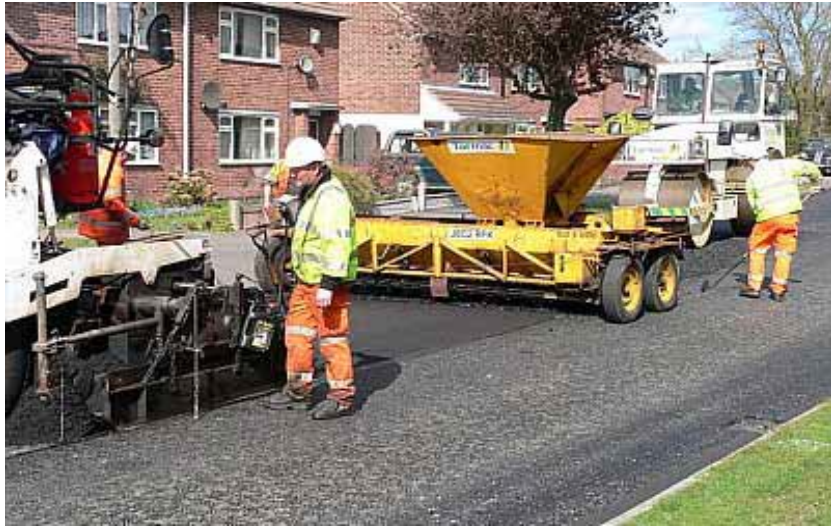
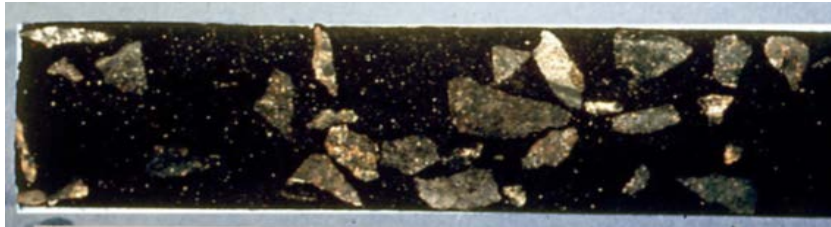
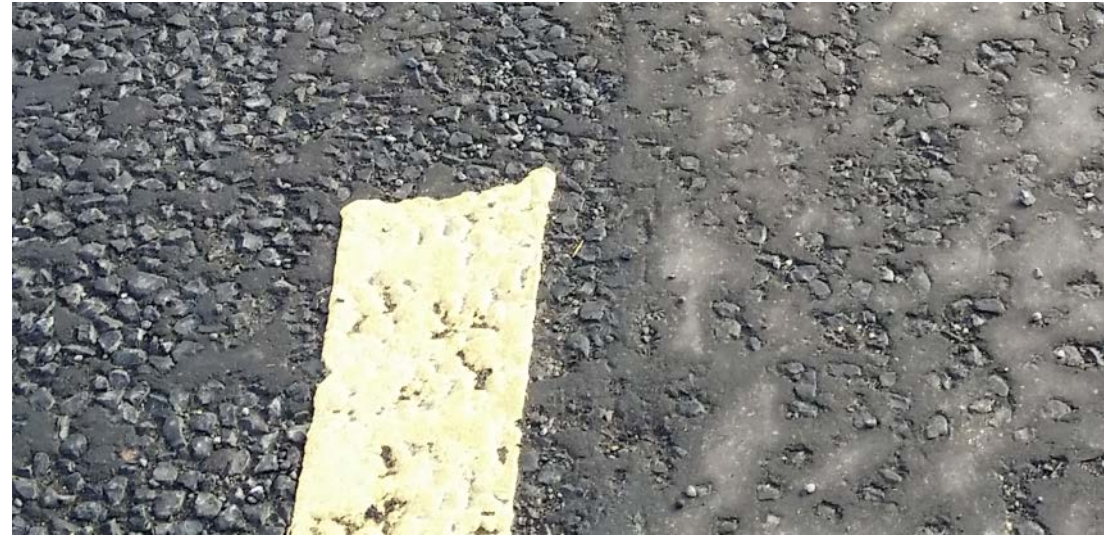
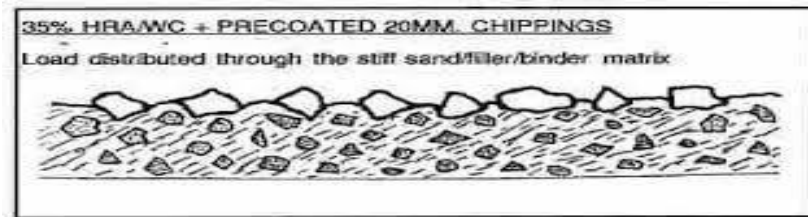
- Hot rolled asphalt is a very dense mixture containing a mortar of fine aggregate, filler, and bitumen. Coarse aggregate up to 35% is added to 'bulk out' the product.
- In addition Precoated Chippings are spread and rolled into the surface to give a **POSITIVE** Macro and Micro Texture necessary to provide friction for Skidding Resistance.

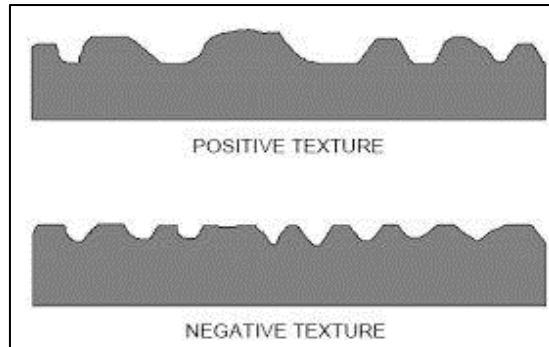
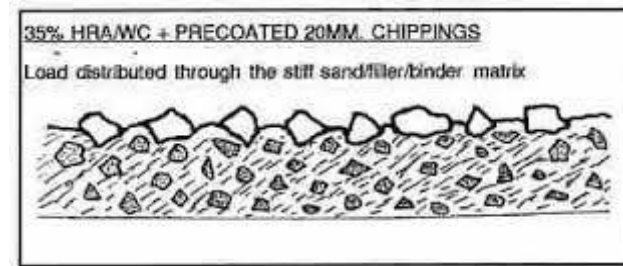
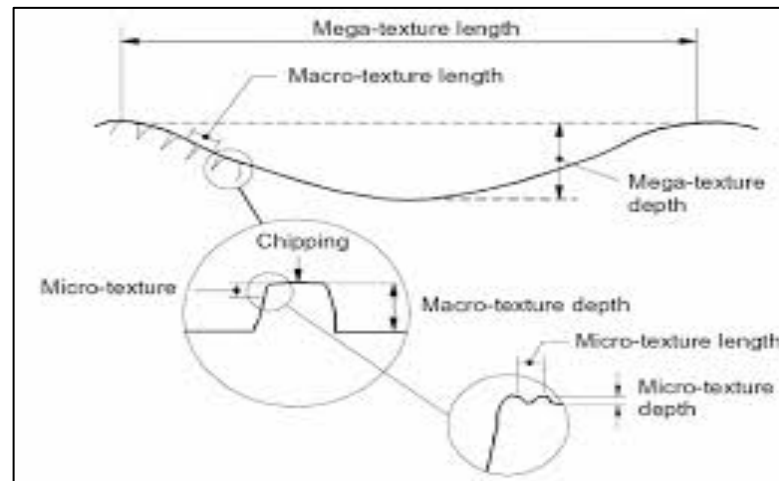
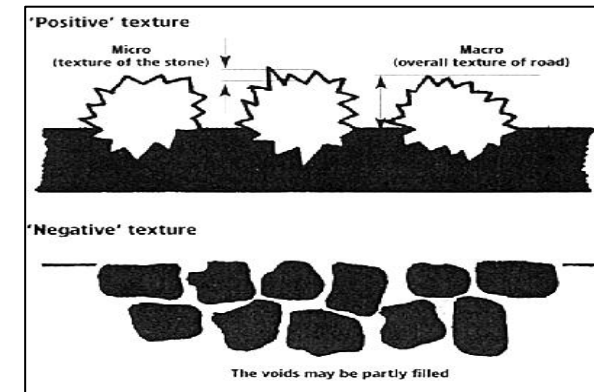
Positive / Negative Texture

- Cl 10.1.7.1 “the **contractor** shall ensure a uniform rate of spread so that they are rolled into the surface and they are **effectively held** to achieve the initial **positive** texture depth specified in Table 6

- Macro texture is required to assist with the dissipation of surface water and maintain tyre road contact preventing “*dynamic / viscous hydroplaning*”.

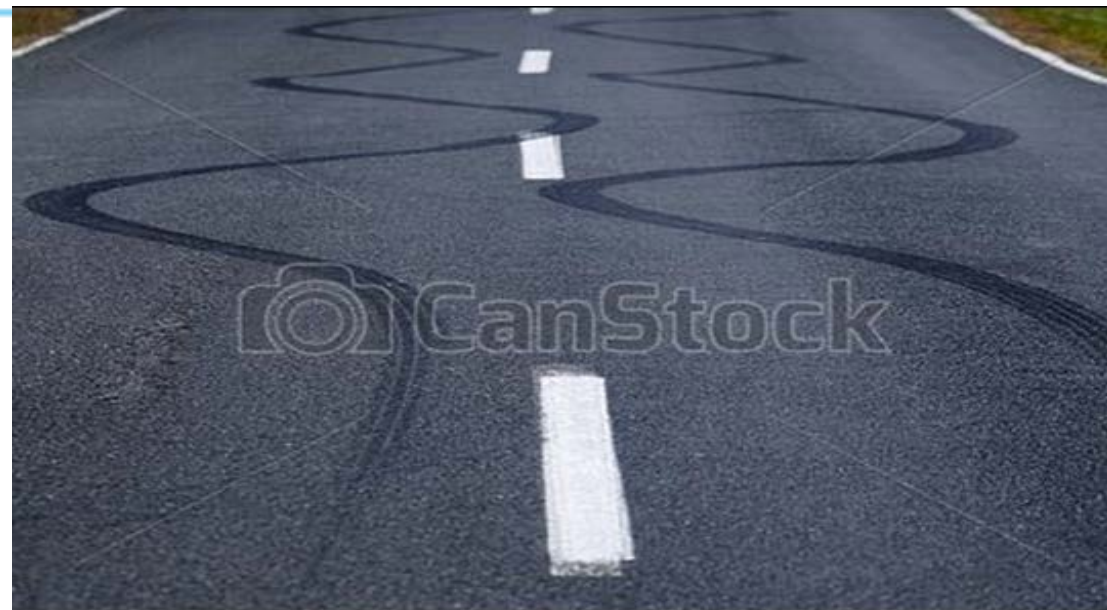
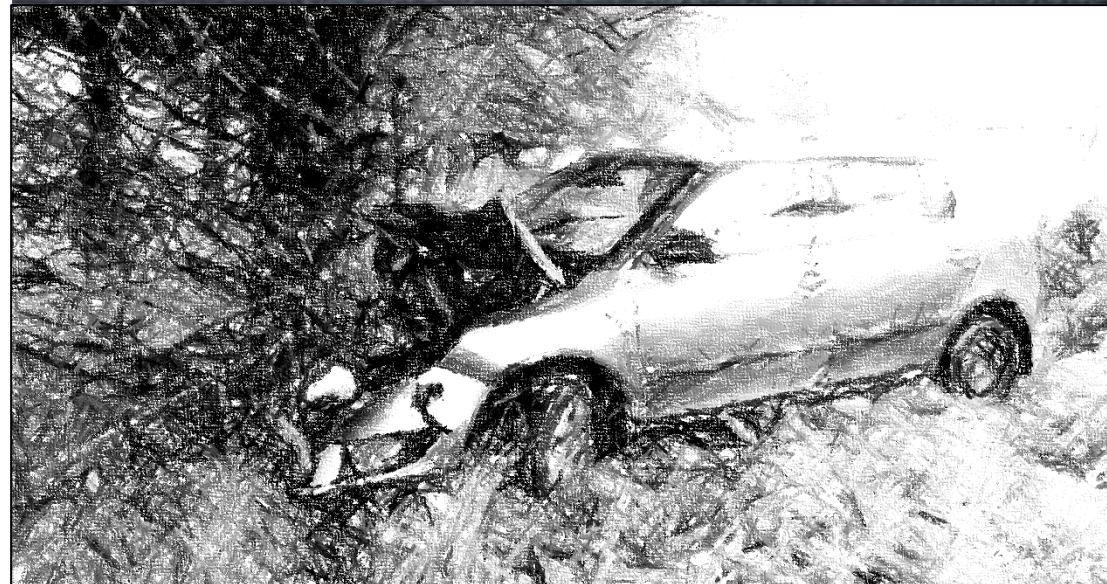
- The objective;
“broadly equalise the risk of skidding collisions across the national road network”
- Primarily an Asset Management policy it plays a major role in the Safety of the Network providing
 - Methodology for measuring the performance of the Network.
 - Methodology for assessing and prioritising remedial works at locations that are not performing as expected.

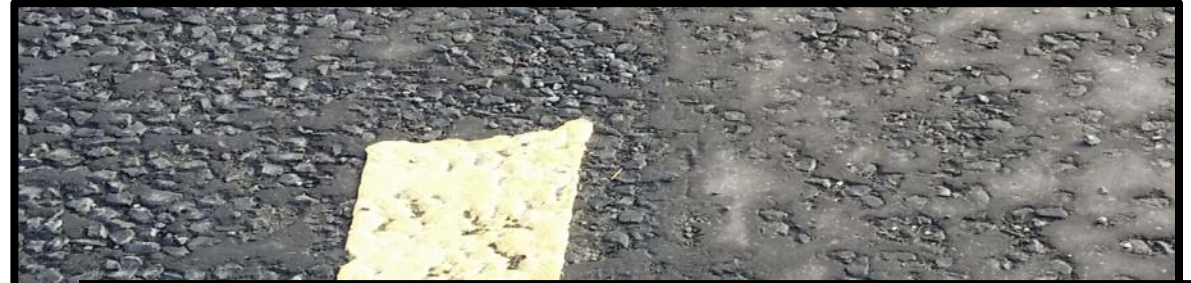
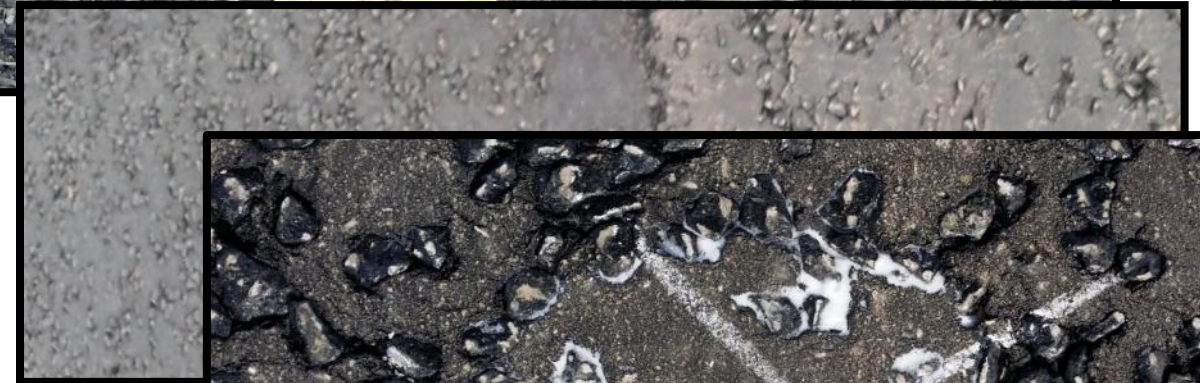
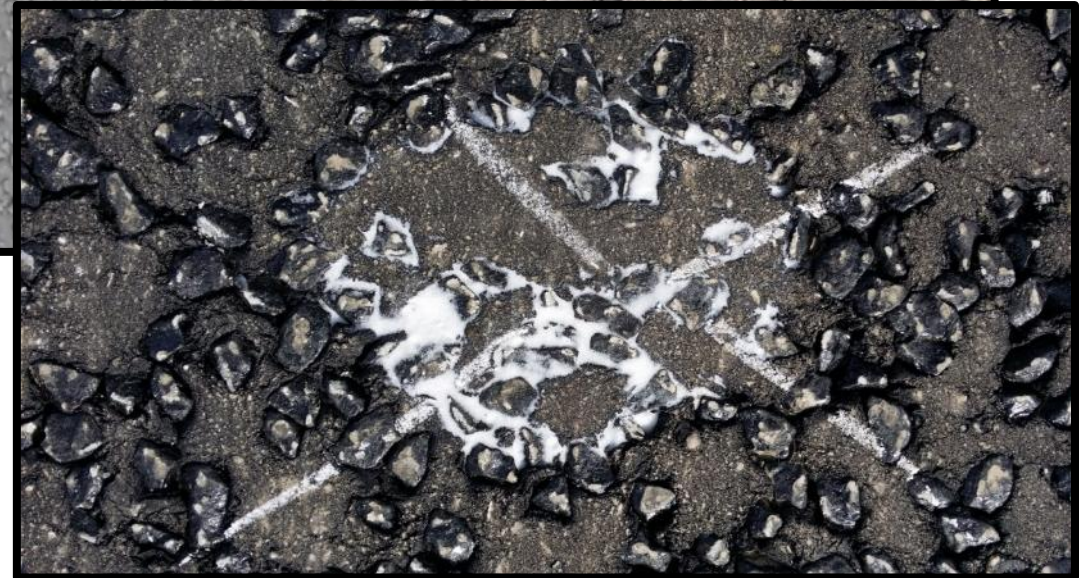
AM/PAV/06045 (HD28/11) Site Investigations

- The Network Survey reveals that HD28 Sites are becoming more frequent even on relatively new schemes where HRA has been installed as the Surface Course
 - Low and Variable PCC spread rates
 - Variable PCC quality – Size and Shape
 - PCC's pushed into the Surface leading to **NEGATIVE** texture and tyre/surface contact with the lower PSV of the mortar constituents

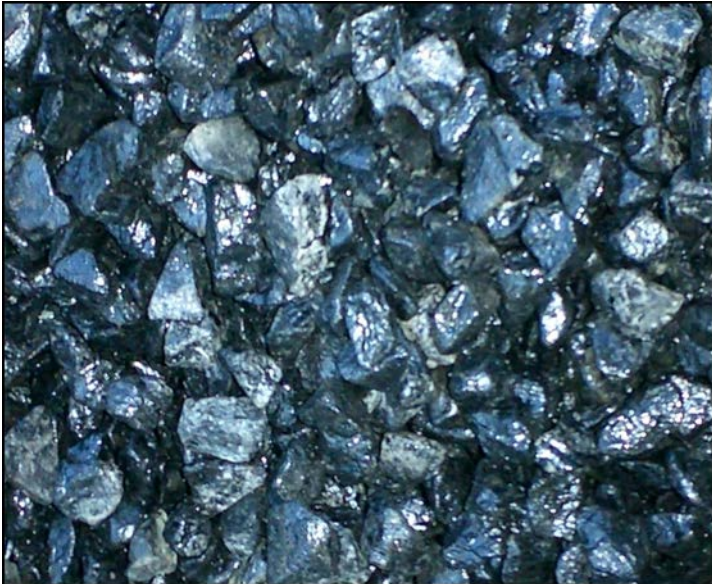
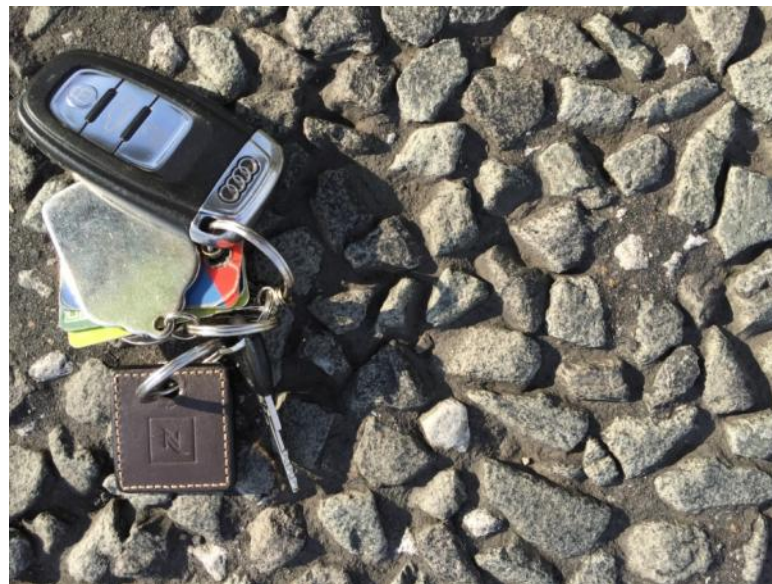
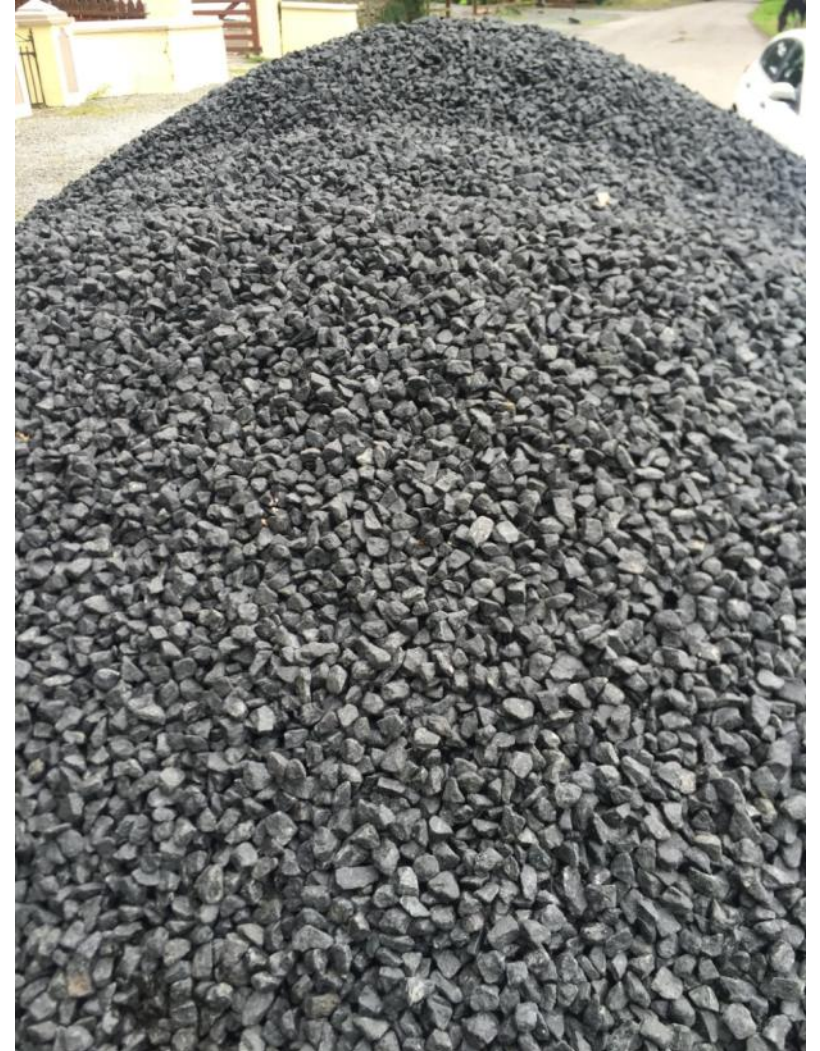
Pre Coated Chippings

- High Polished Stone Value aggregate
- Nominal size 20mm to 14mm
- Coated with ~ 1,5% bitumen

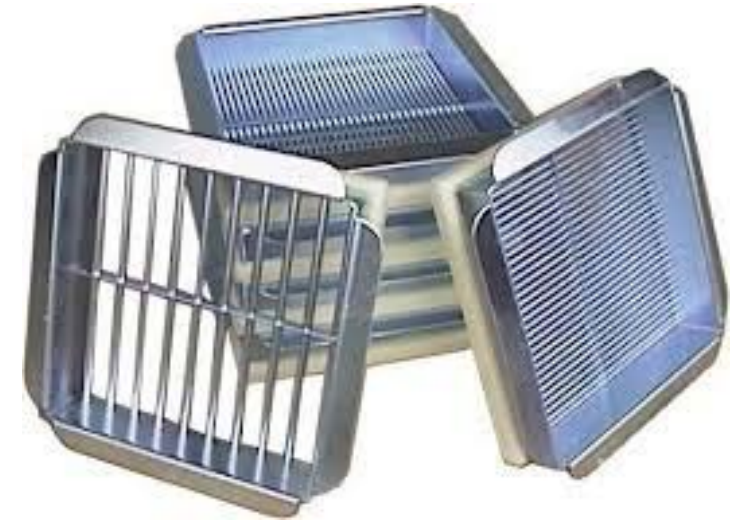
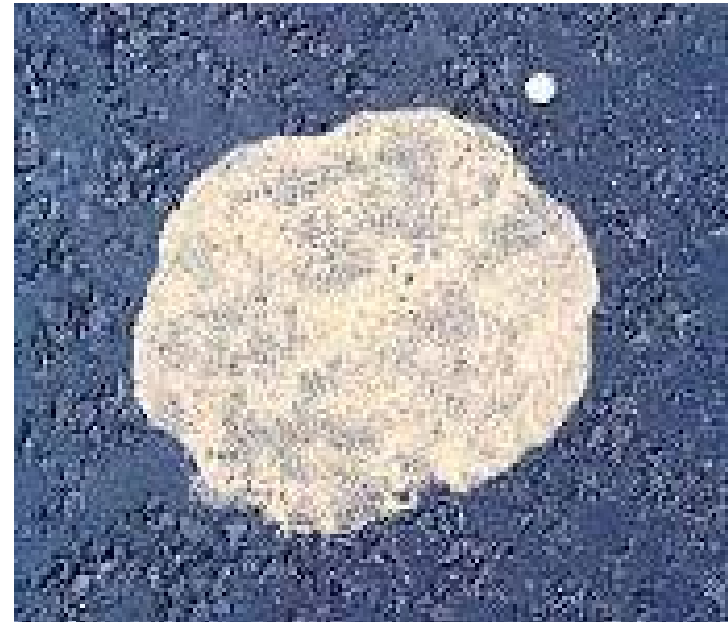
Testing

- Particle Size Distribution (PSD)
- Flakiness Index (FI)
- Macrotexture

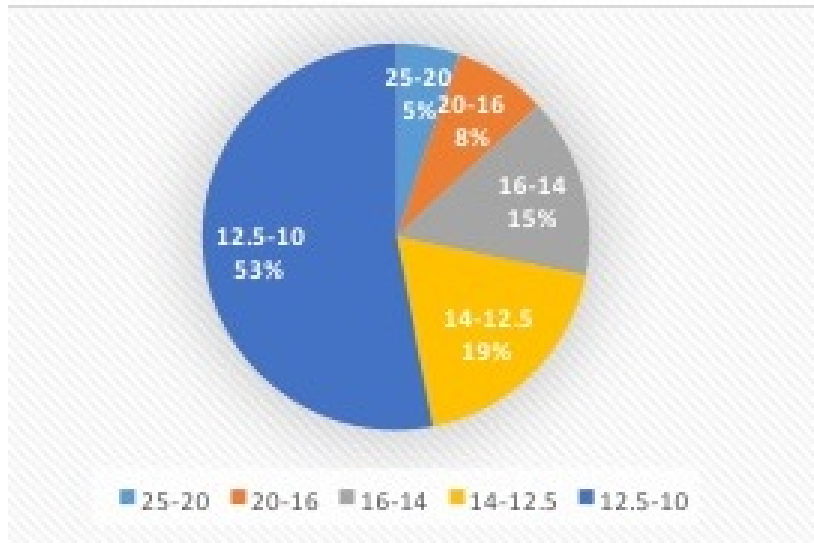
- Shape Index EN 933-4
- Similar to old BS 812 Elongation Index, assessing 'non cubical' particles
- Examples for three samples of Pre Coated Chippings:

Shape Index 15; Flakiness 6

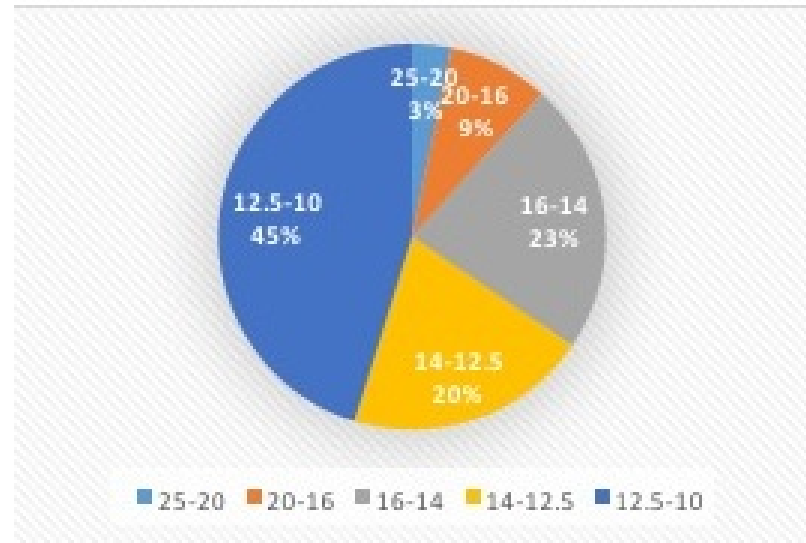
Shape Index 9; Flakiness 6

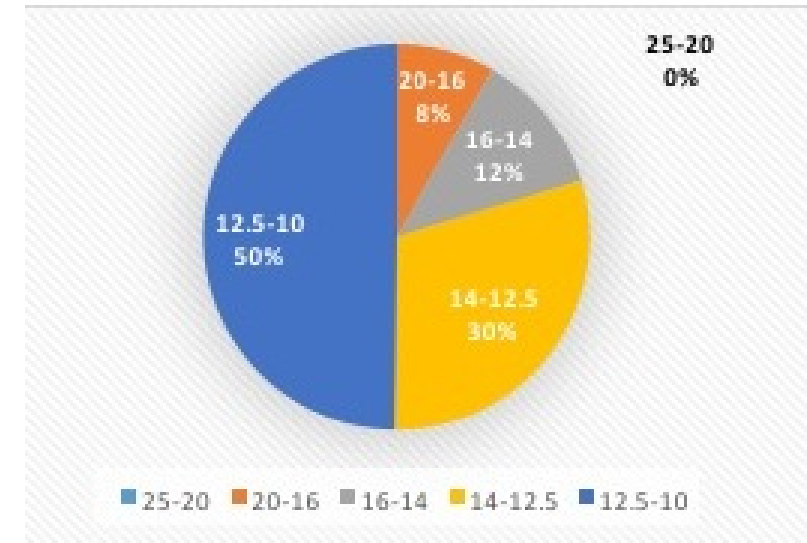
Shape Index 14; Flakiness 8

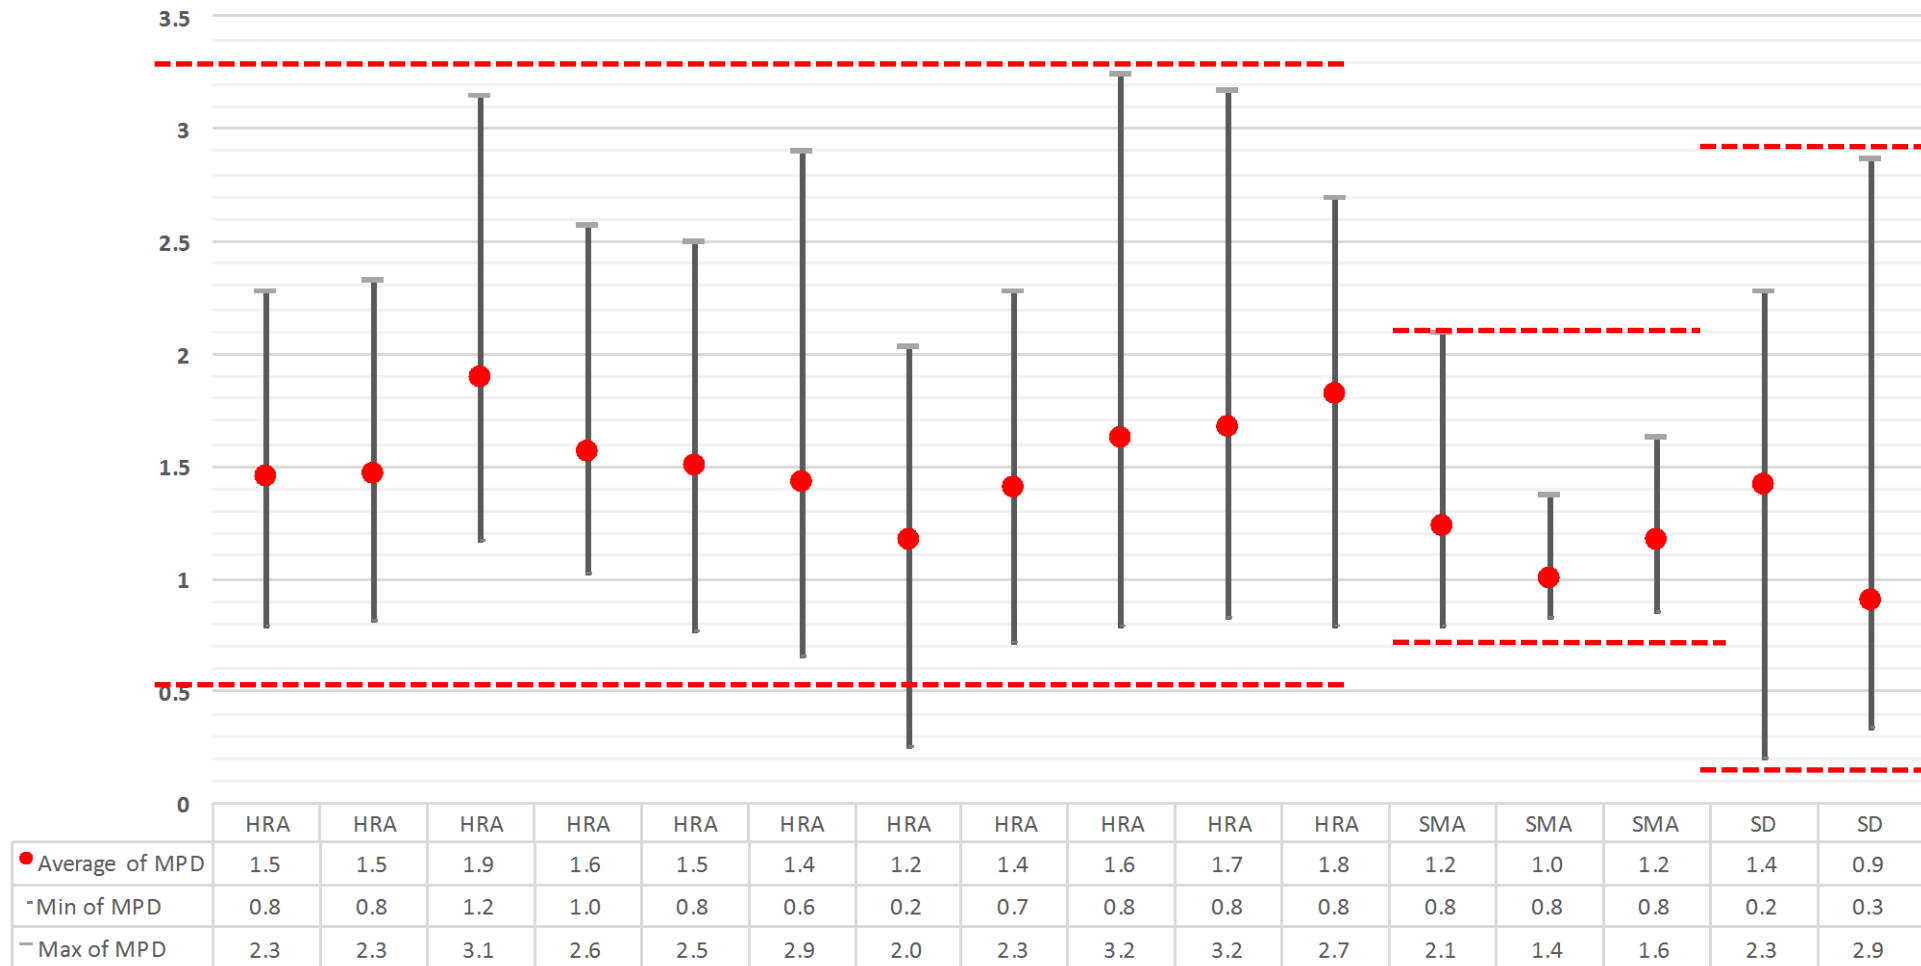
Science - Road Surface Profiler

Various Network Sites

Mean Profile Depth

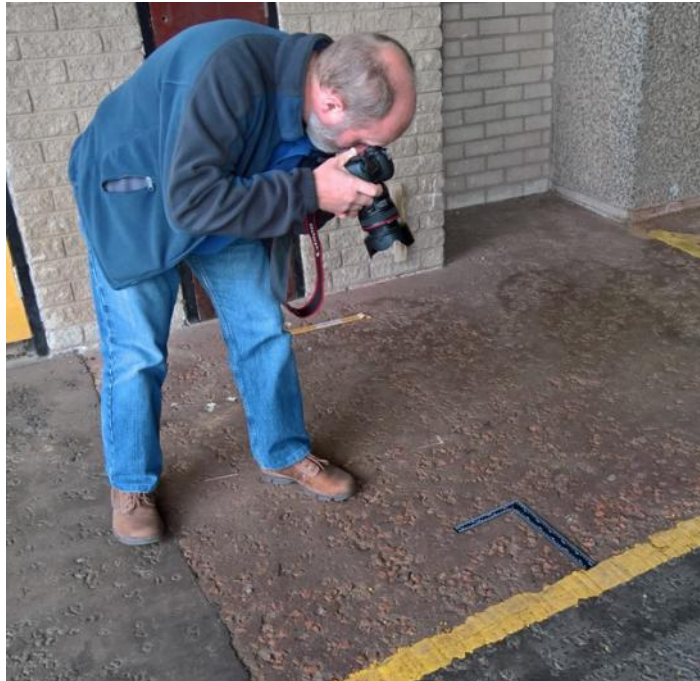
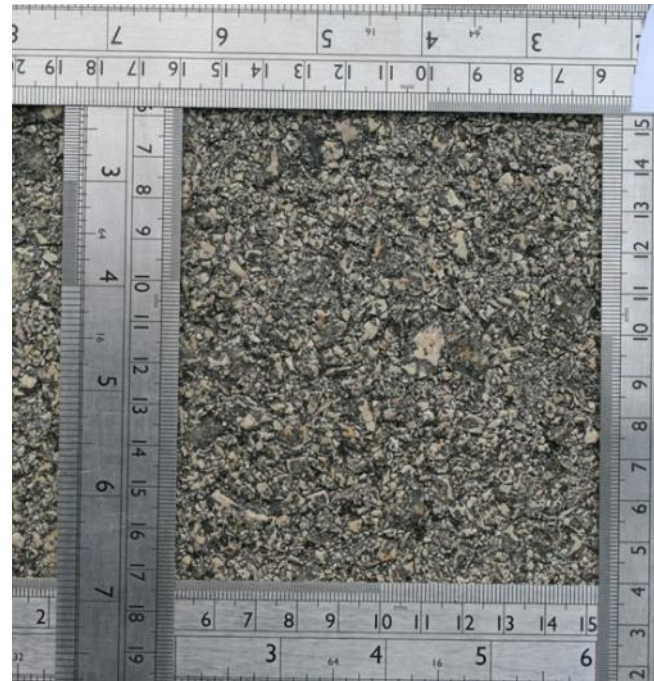
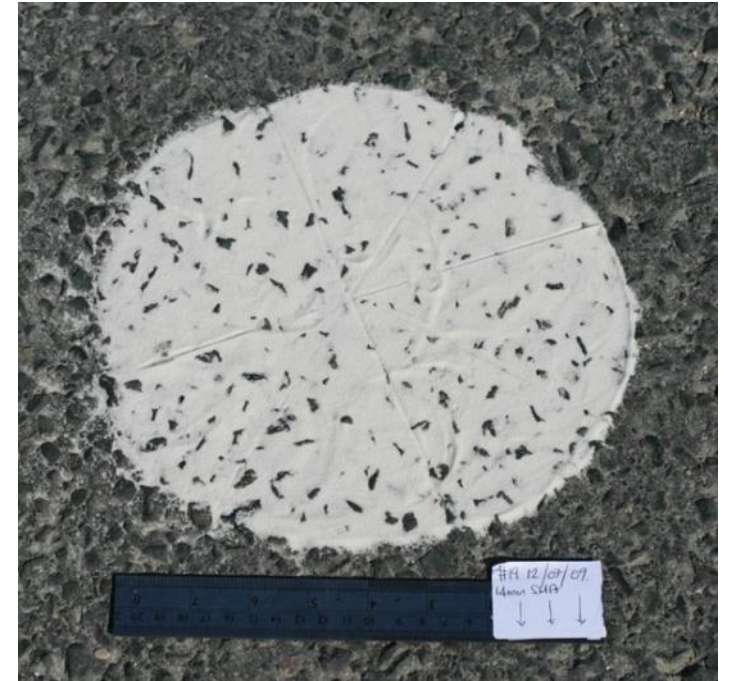
Science - Photography versus Sand?

- 2D and 3D models using photographs
- New ways of measuring giving new insight into texture related issues
- 'Off the shelf' software for modelling

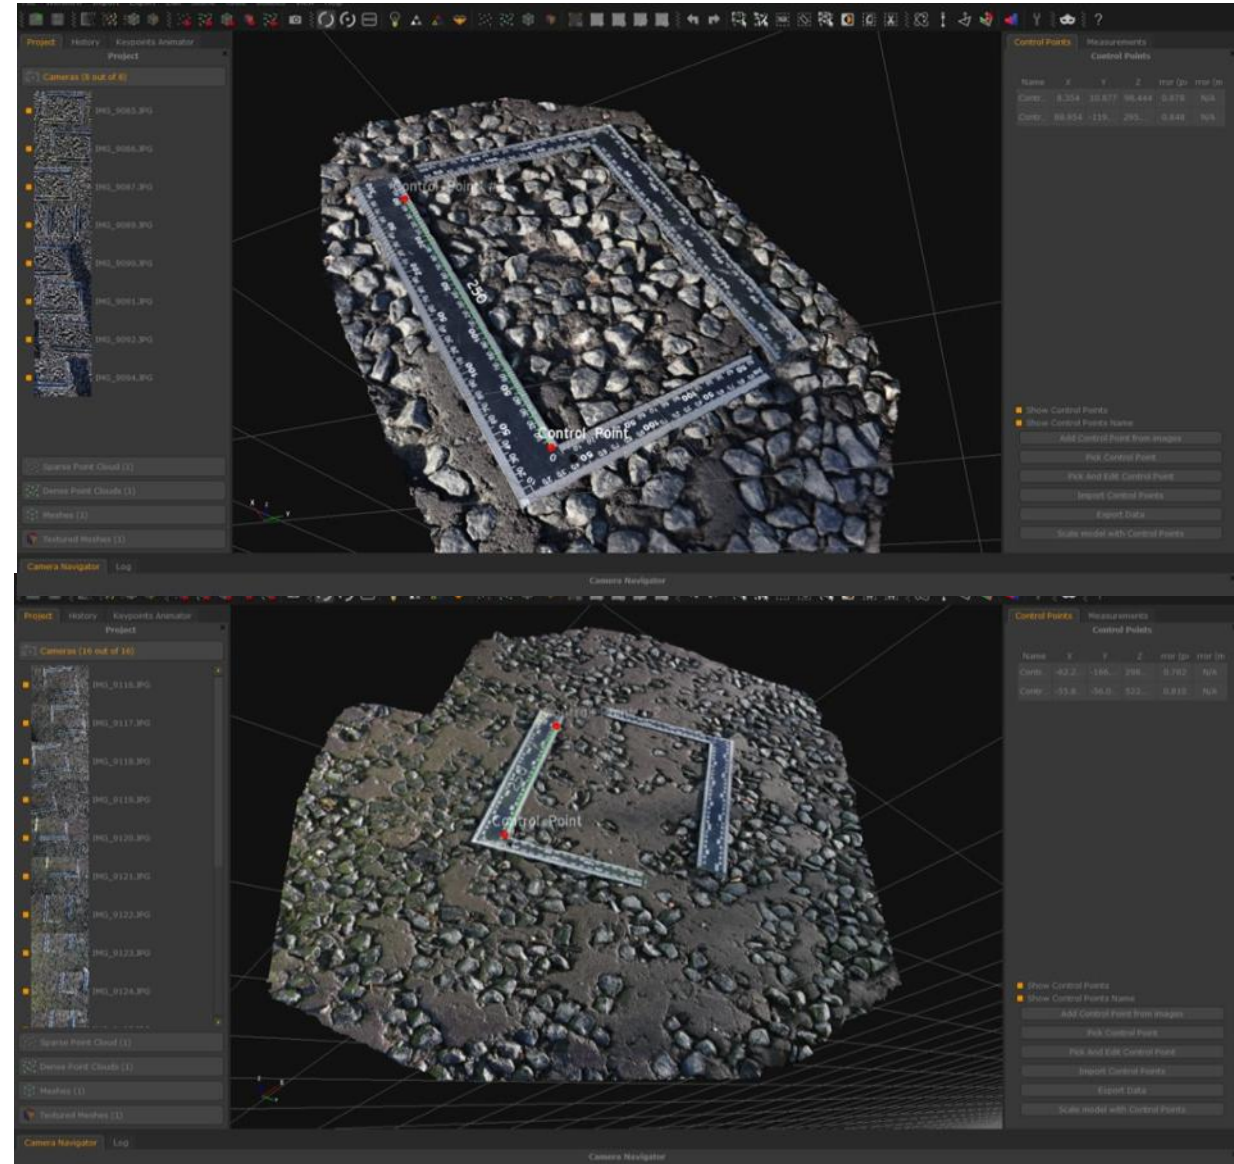
Science - 3D Photography & Modelling

- New HRA
- trafficked for a few weeks - 3D model showing chip loss

- Same site
- 3D model showing a lot of 'mastic'

Is this negative texture?

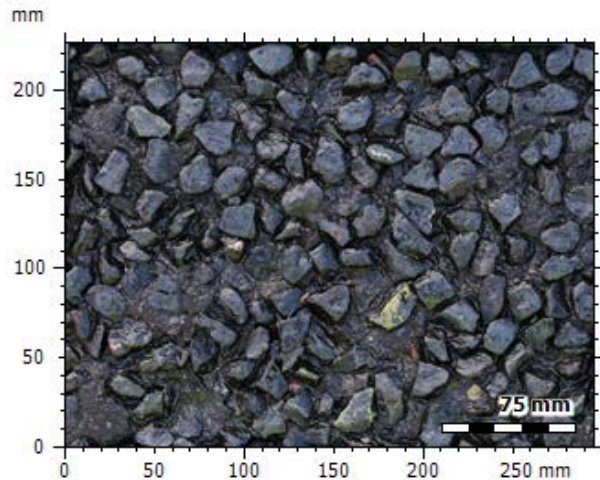
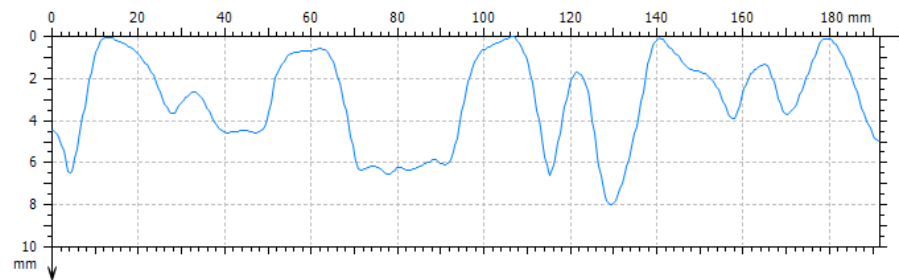
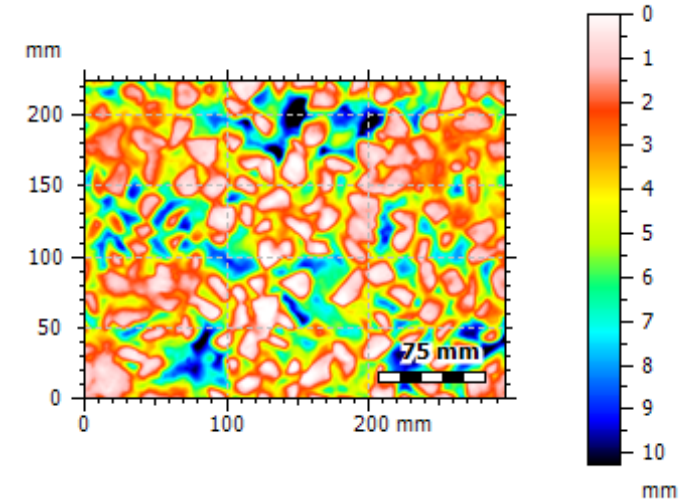
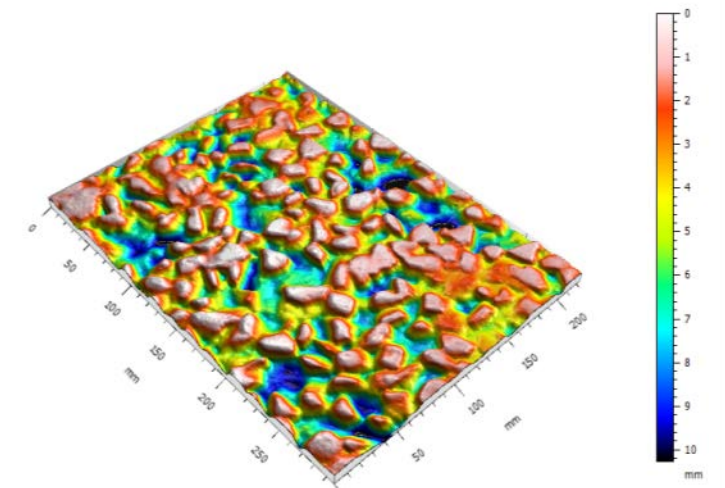
Science - 3D Photography & Modelling

- 3D model shows depth into the surface
- Positive texture obvious in 3D model
- Chips standing above level of mastic
- 2D section shows depth of texture

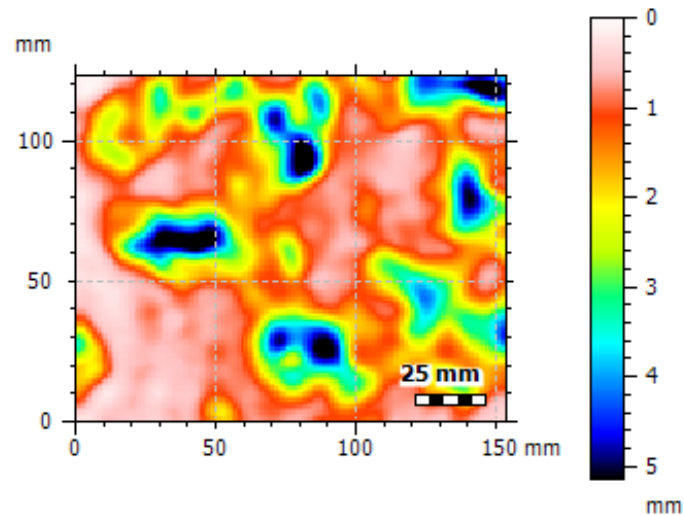
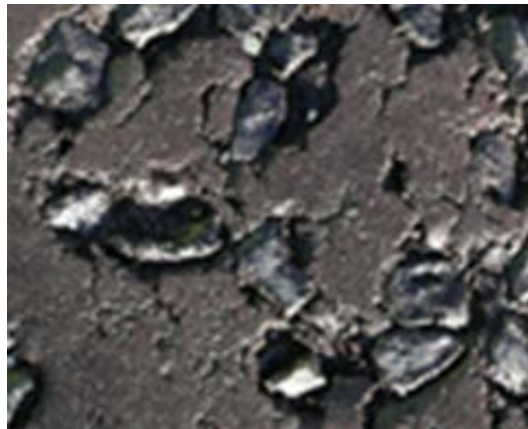
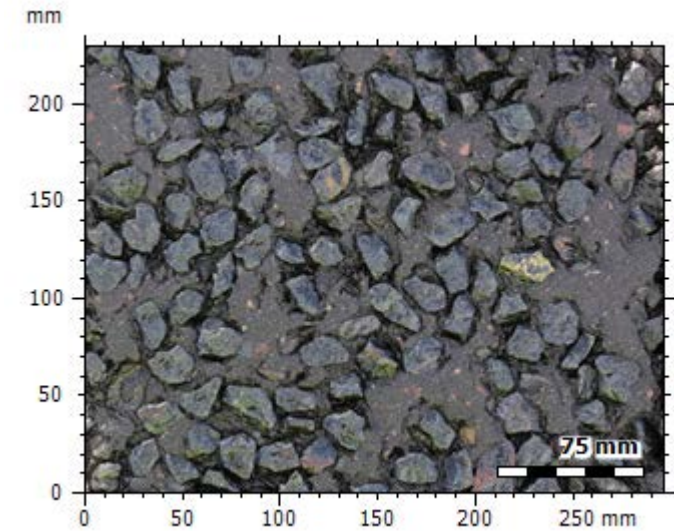
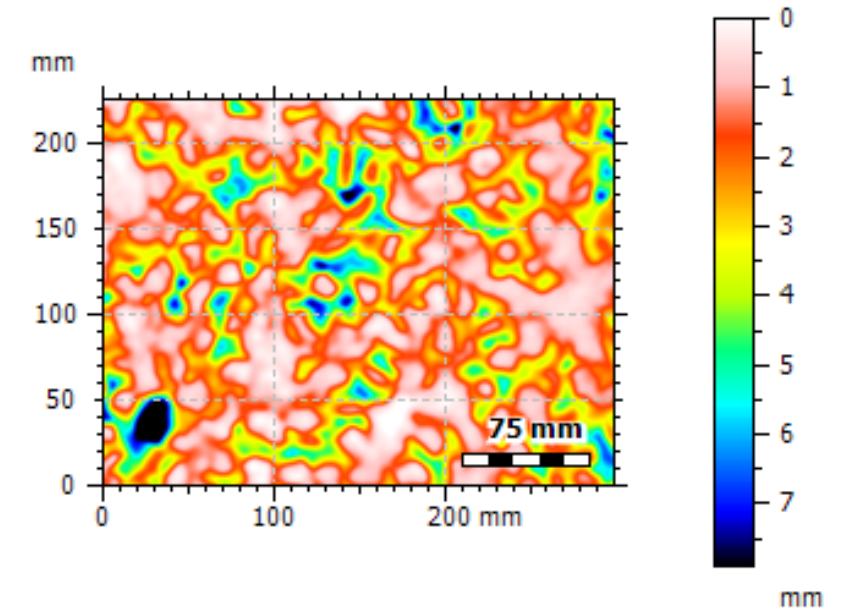
Science - 3D Photography & Modelling

- Chips pushed into the mastic
- Surface of mastic same height as chips
- Pockets of trapped water
- Blue coloured pockets of negative texture

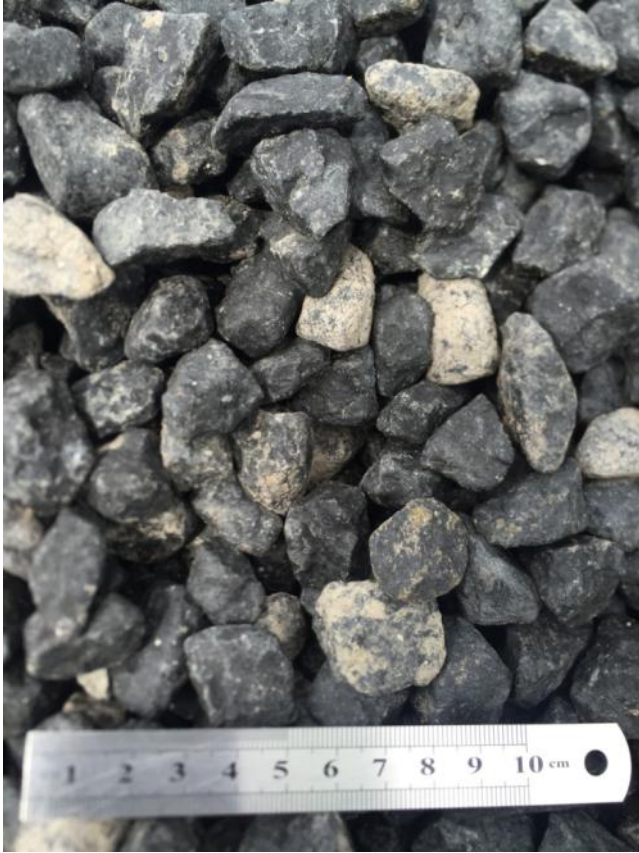
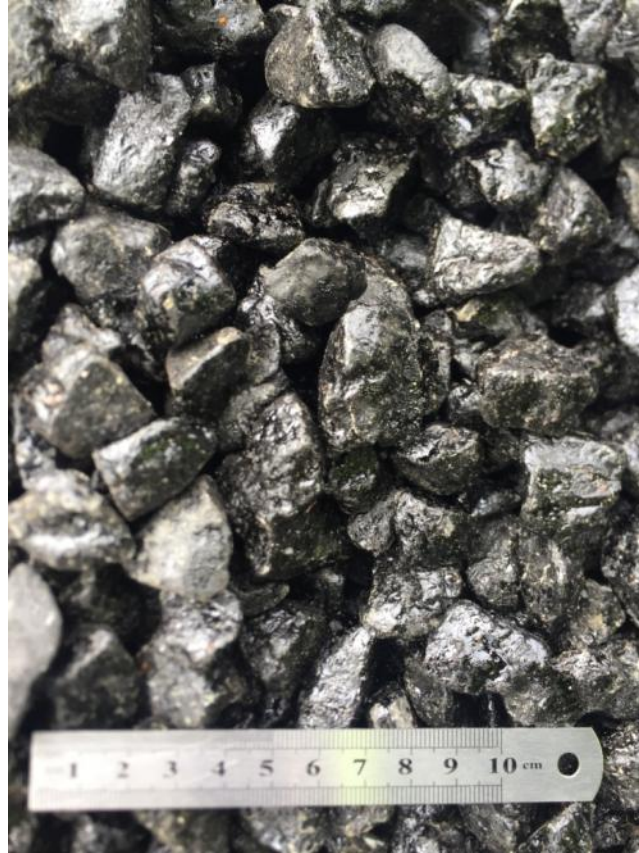
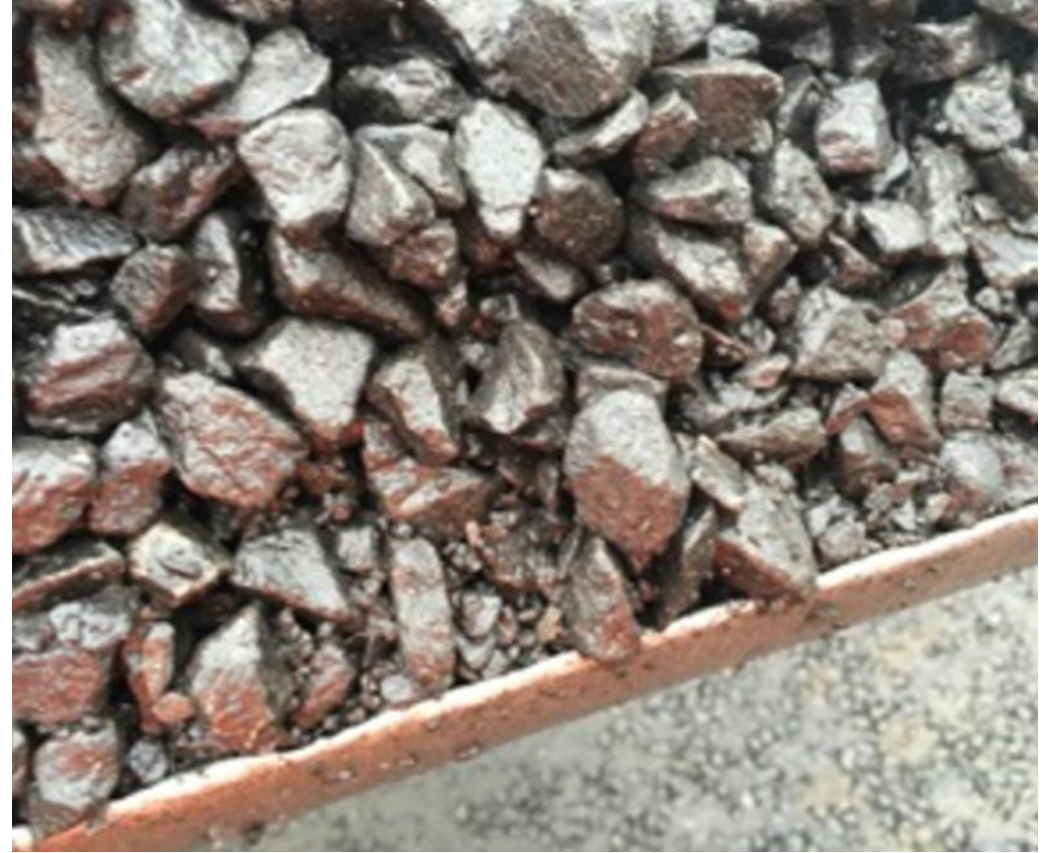
Condition of pre coated chippings

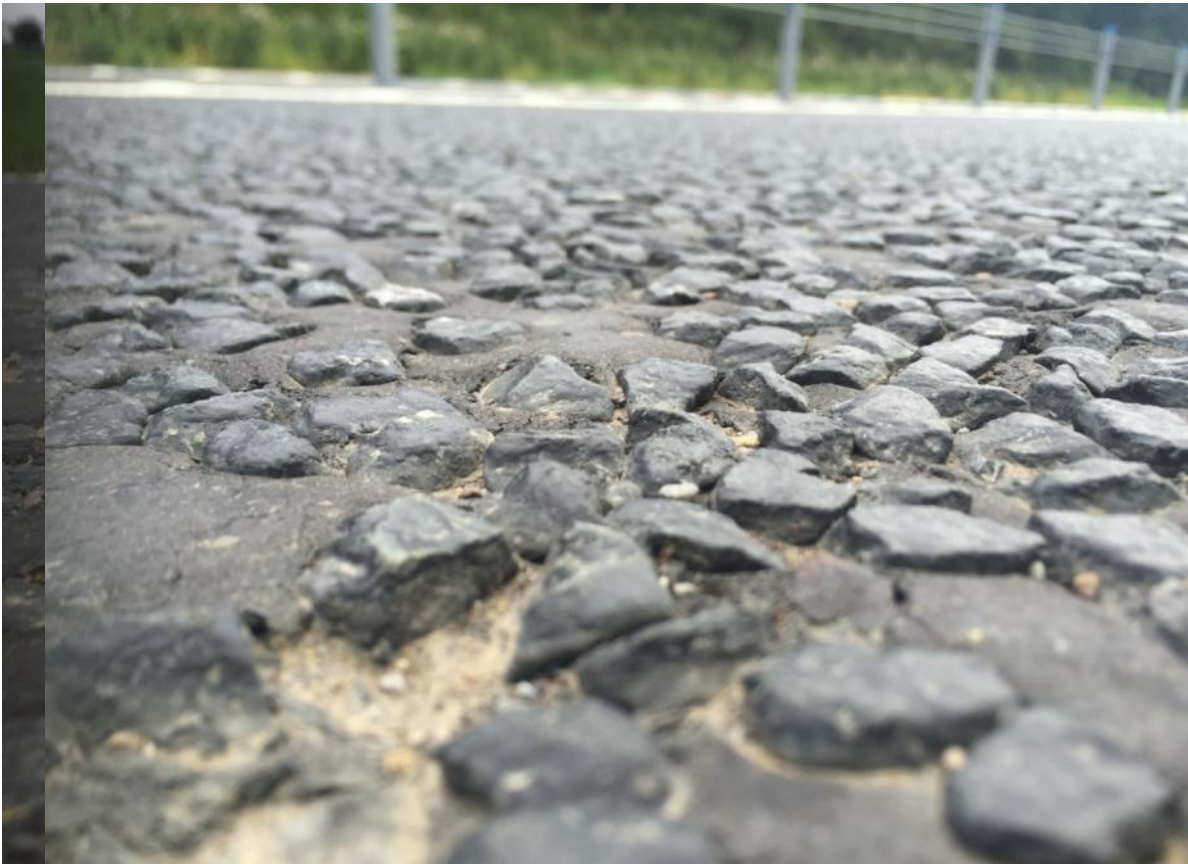
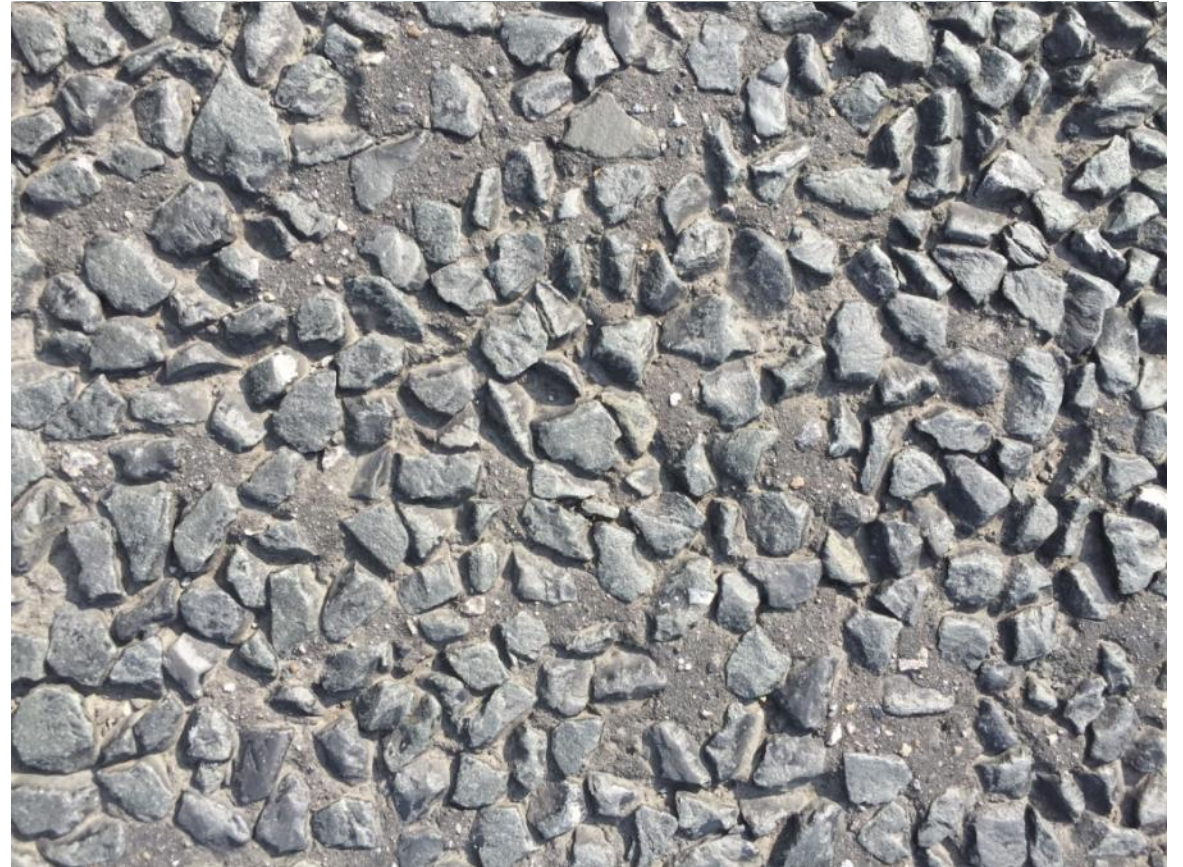
Experience of chipping teams - lost in recent times

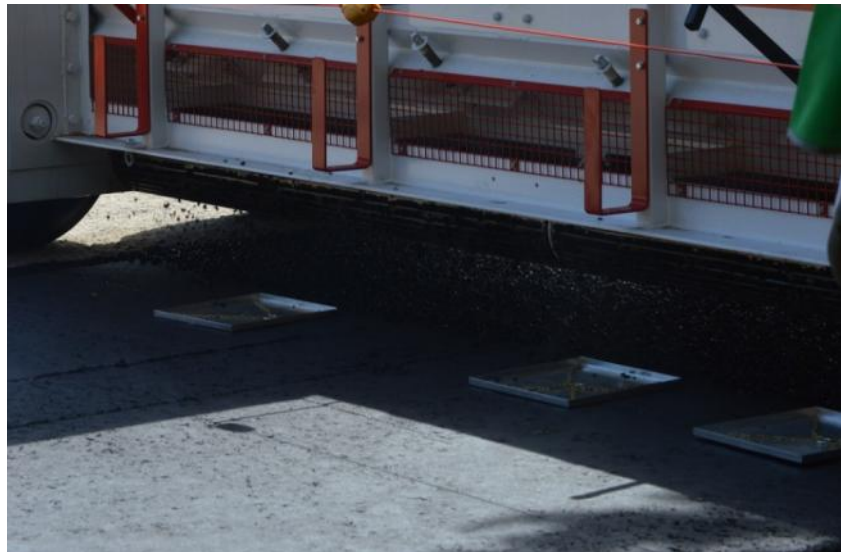
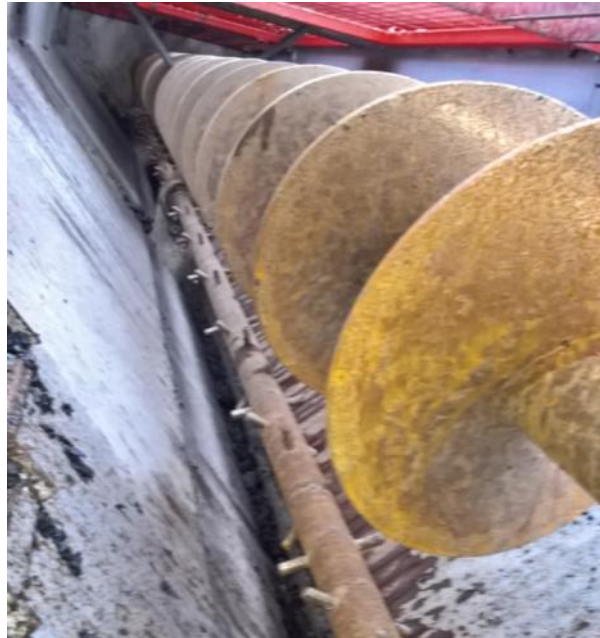
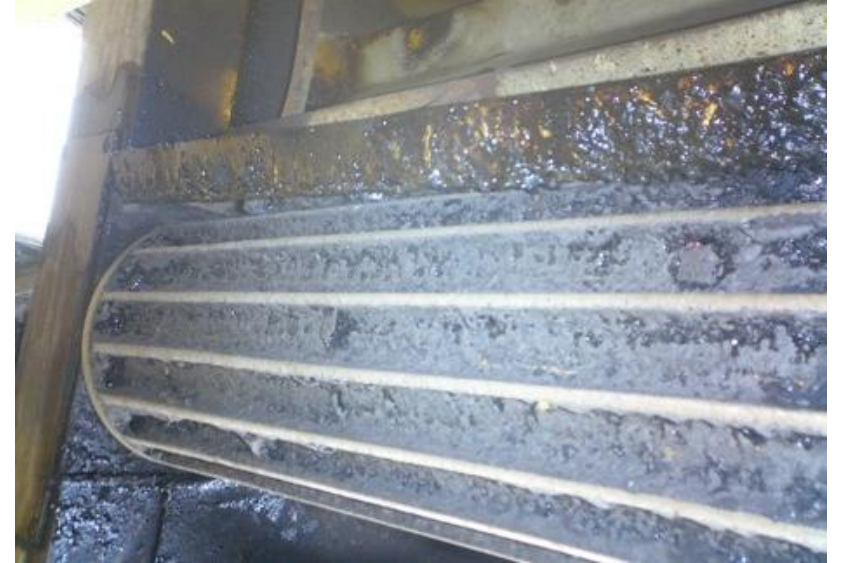
- Chip spreader maintenance
- Calibration & Evenness of rate of spread
