Current Developments With HOT ROLLED ASPHALT

Eddie Winterlich, Transport Infrastructure
Sean Cassidy, Quality Asphalt

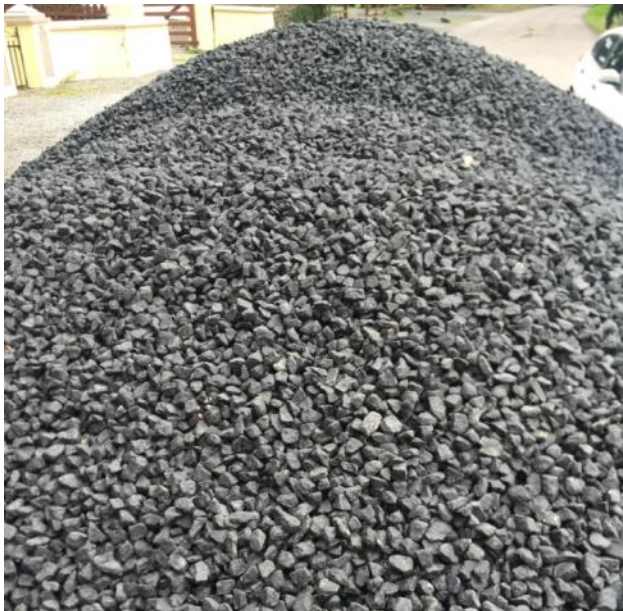
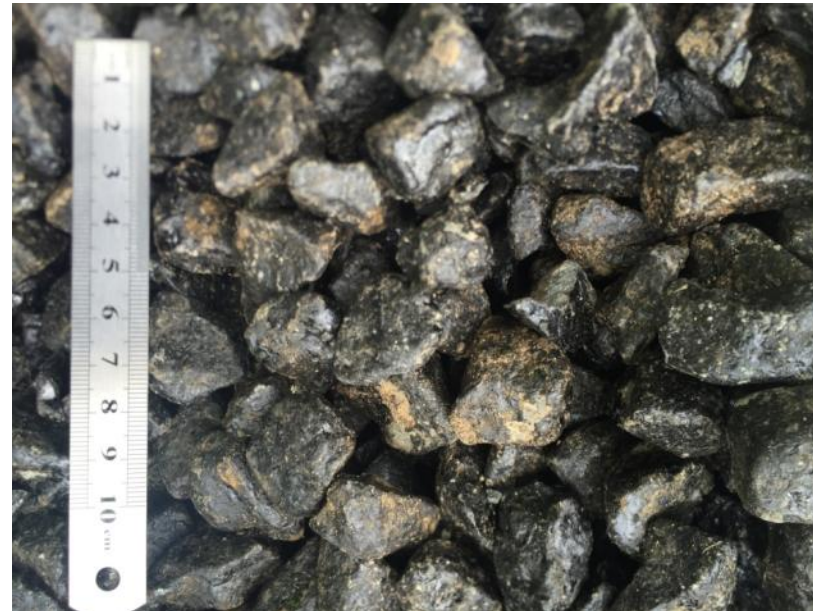
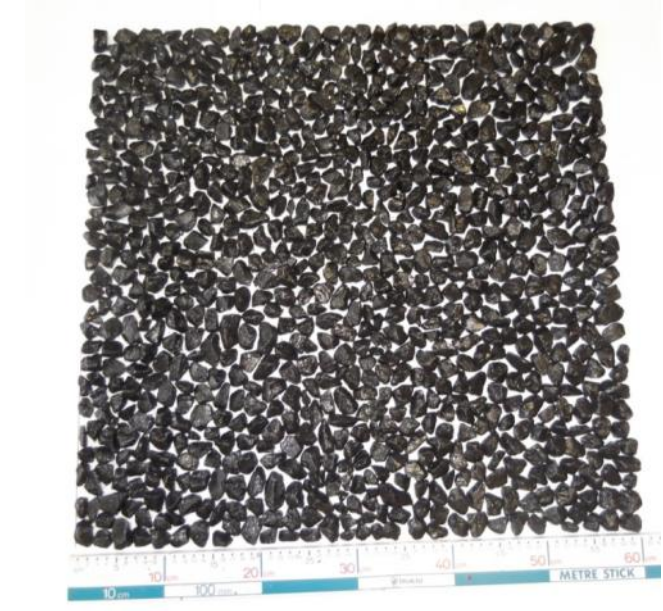
- Transport & Storage of chippings
- Cleanliness of stockpiles on site
- Trial strips with specific plant, mixtures and chippings
