ANALYSING DATA AT A LOCAL LEVEL

Fiona Bohane

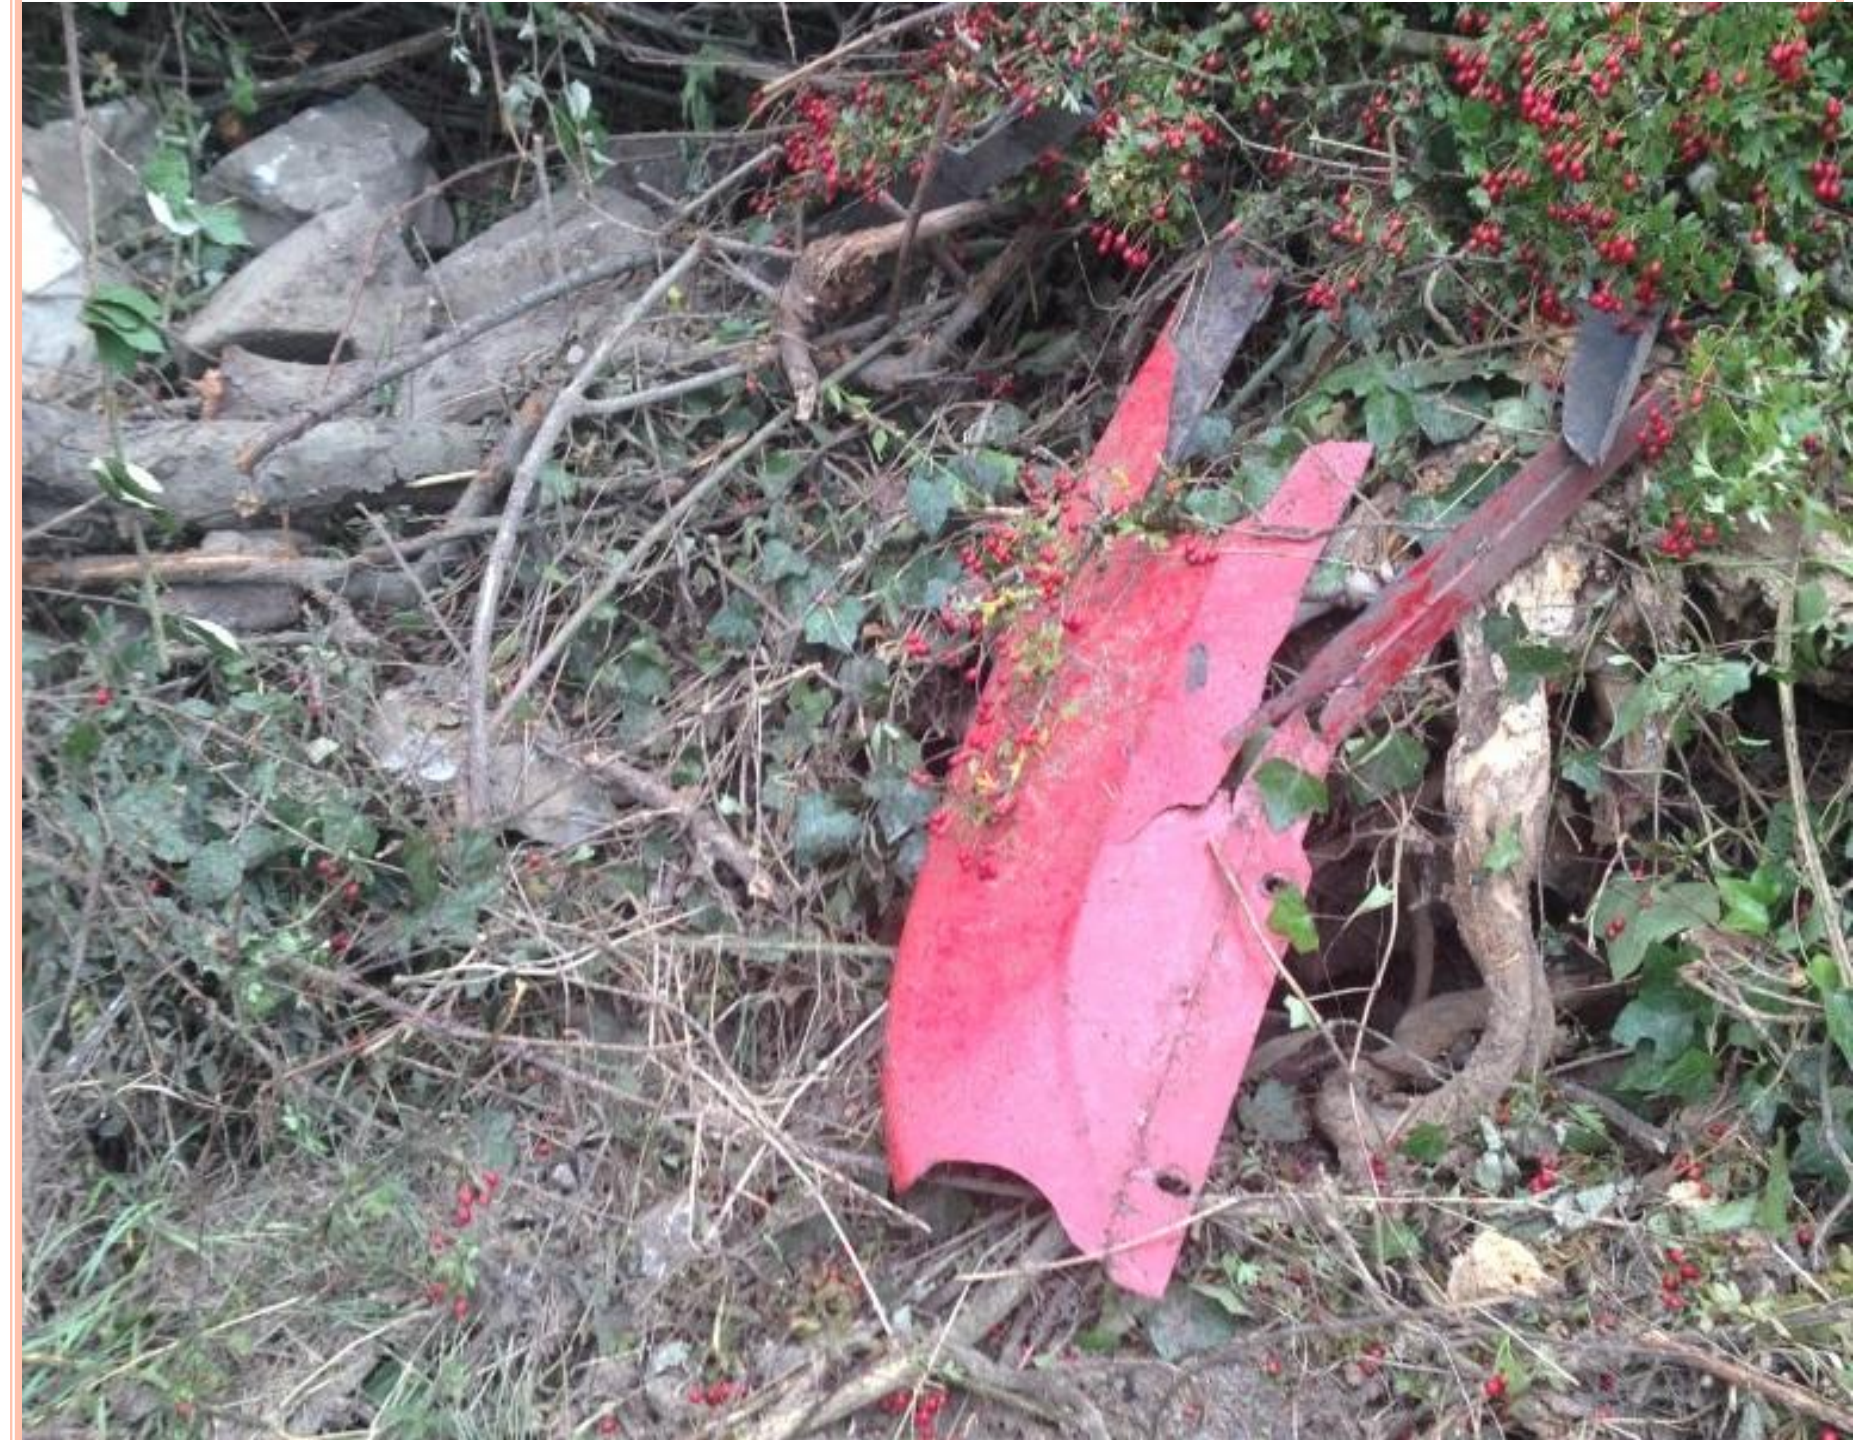
Barrier Repair

Worn surface

Vehicle debris

Kerb damage

- Evidence of collisions at the site.
- Information from locals.

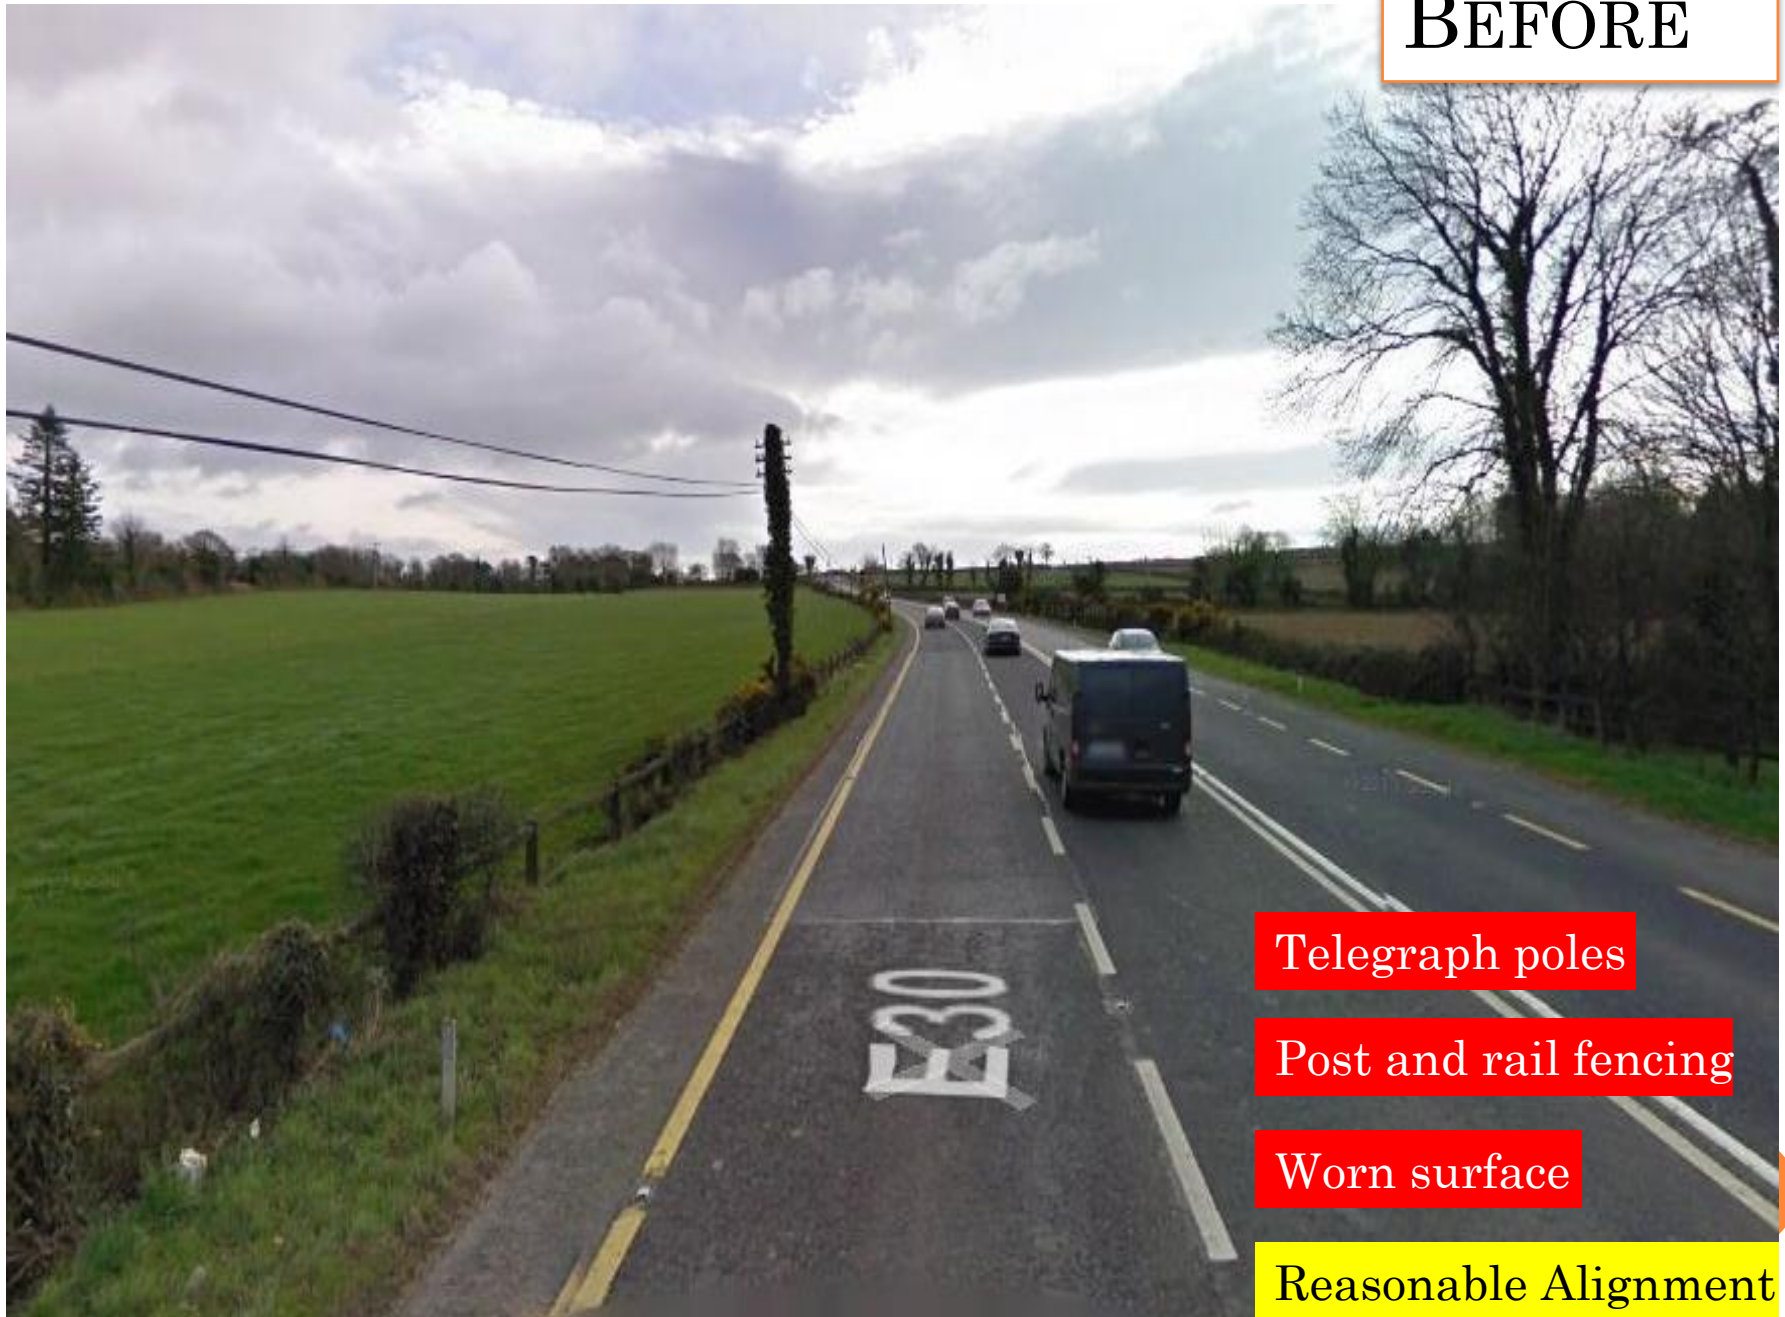
BEFORE

Telegraph poles

Post and rail fencing

Worn surface

Reasonable Alignment

- N25 Route
- 4km east of New Ross town, Wexford.
- Single carriageway with climbing lane.
- History of loss of control type collisions.
- Number of options considered including a full off line realignment. A “Management” option was decided on which consisted of overlay to improve super elevation, provide RTL, widening at certain sections to improve the horizontal geometry and removal of hazards in road side verge such as utility poles and concrete post and rail fencing.

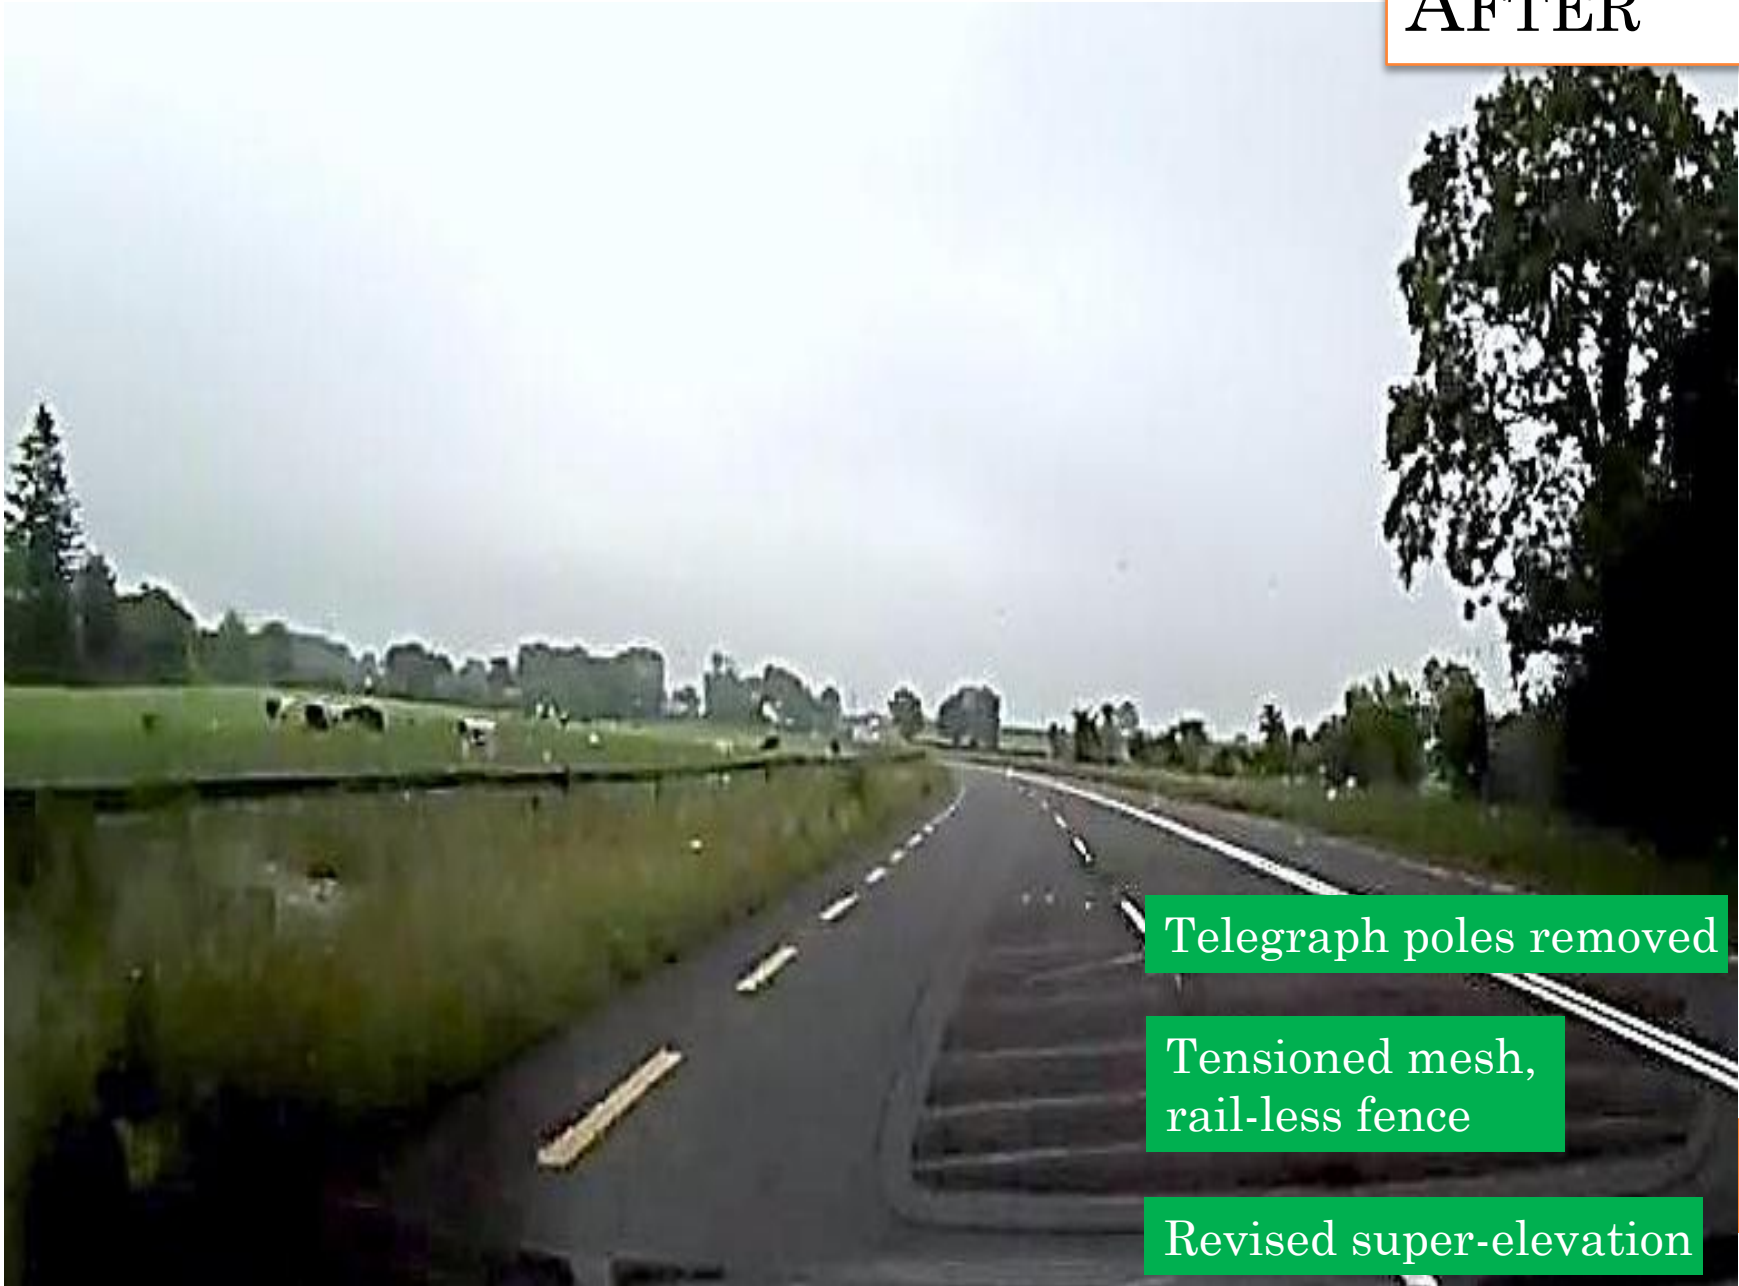
AFTER

Telegraph poles removed

Tensioned mesh,
rail-less fence

Revised super-elevation

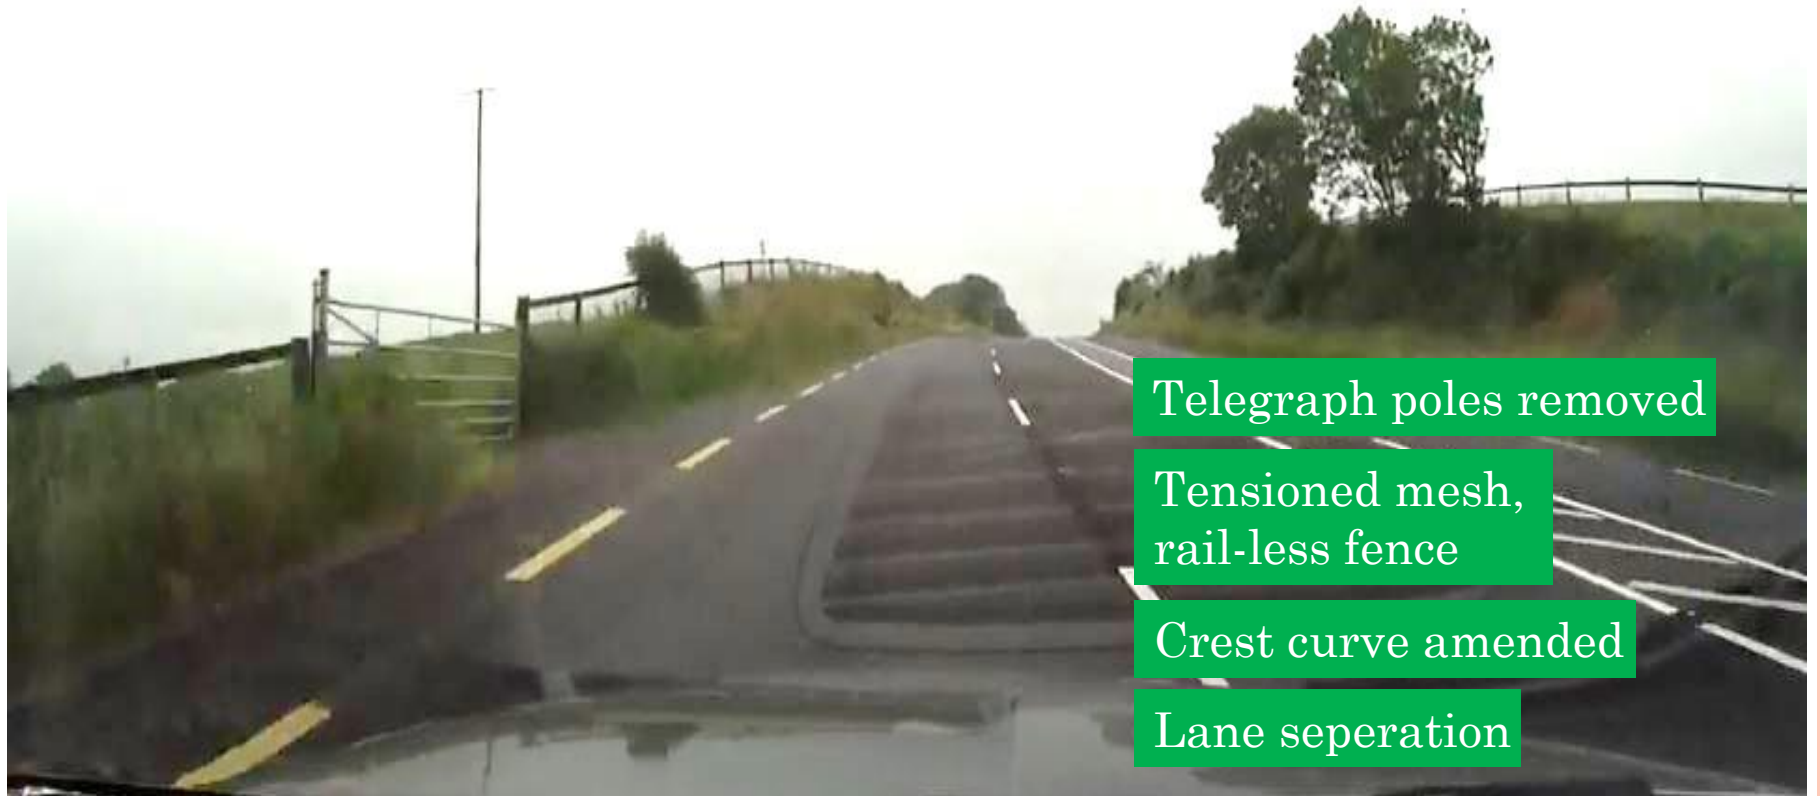
AFTER

Telegraph poles removed

Tensioned mesh,
rail-less fence

Crest curve amended

Lane separation
