**TII Road Safety Engineering
and Audit Conference**

N25 CARROLL'S CROSS

**RURAL TRAFFIC CALMING
SCHEME**

**Branko Erak, Executive Engineer
Waterford City & County Council**

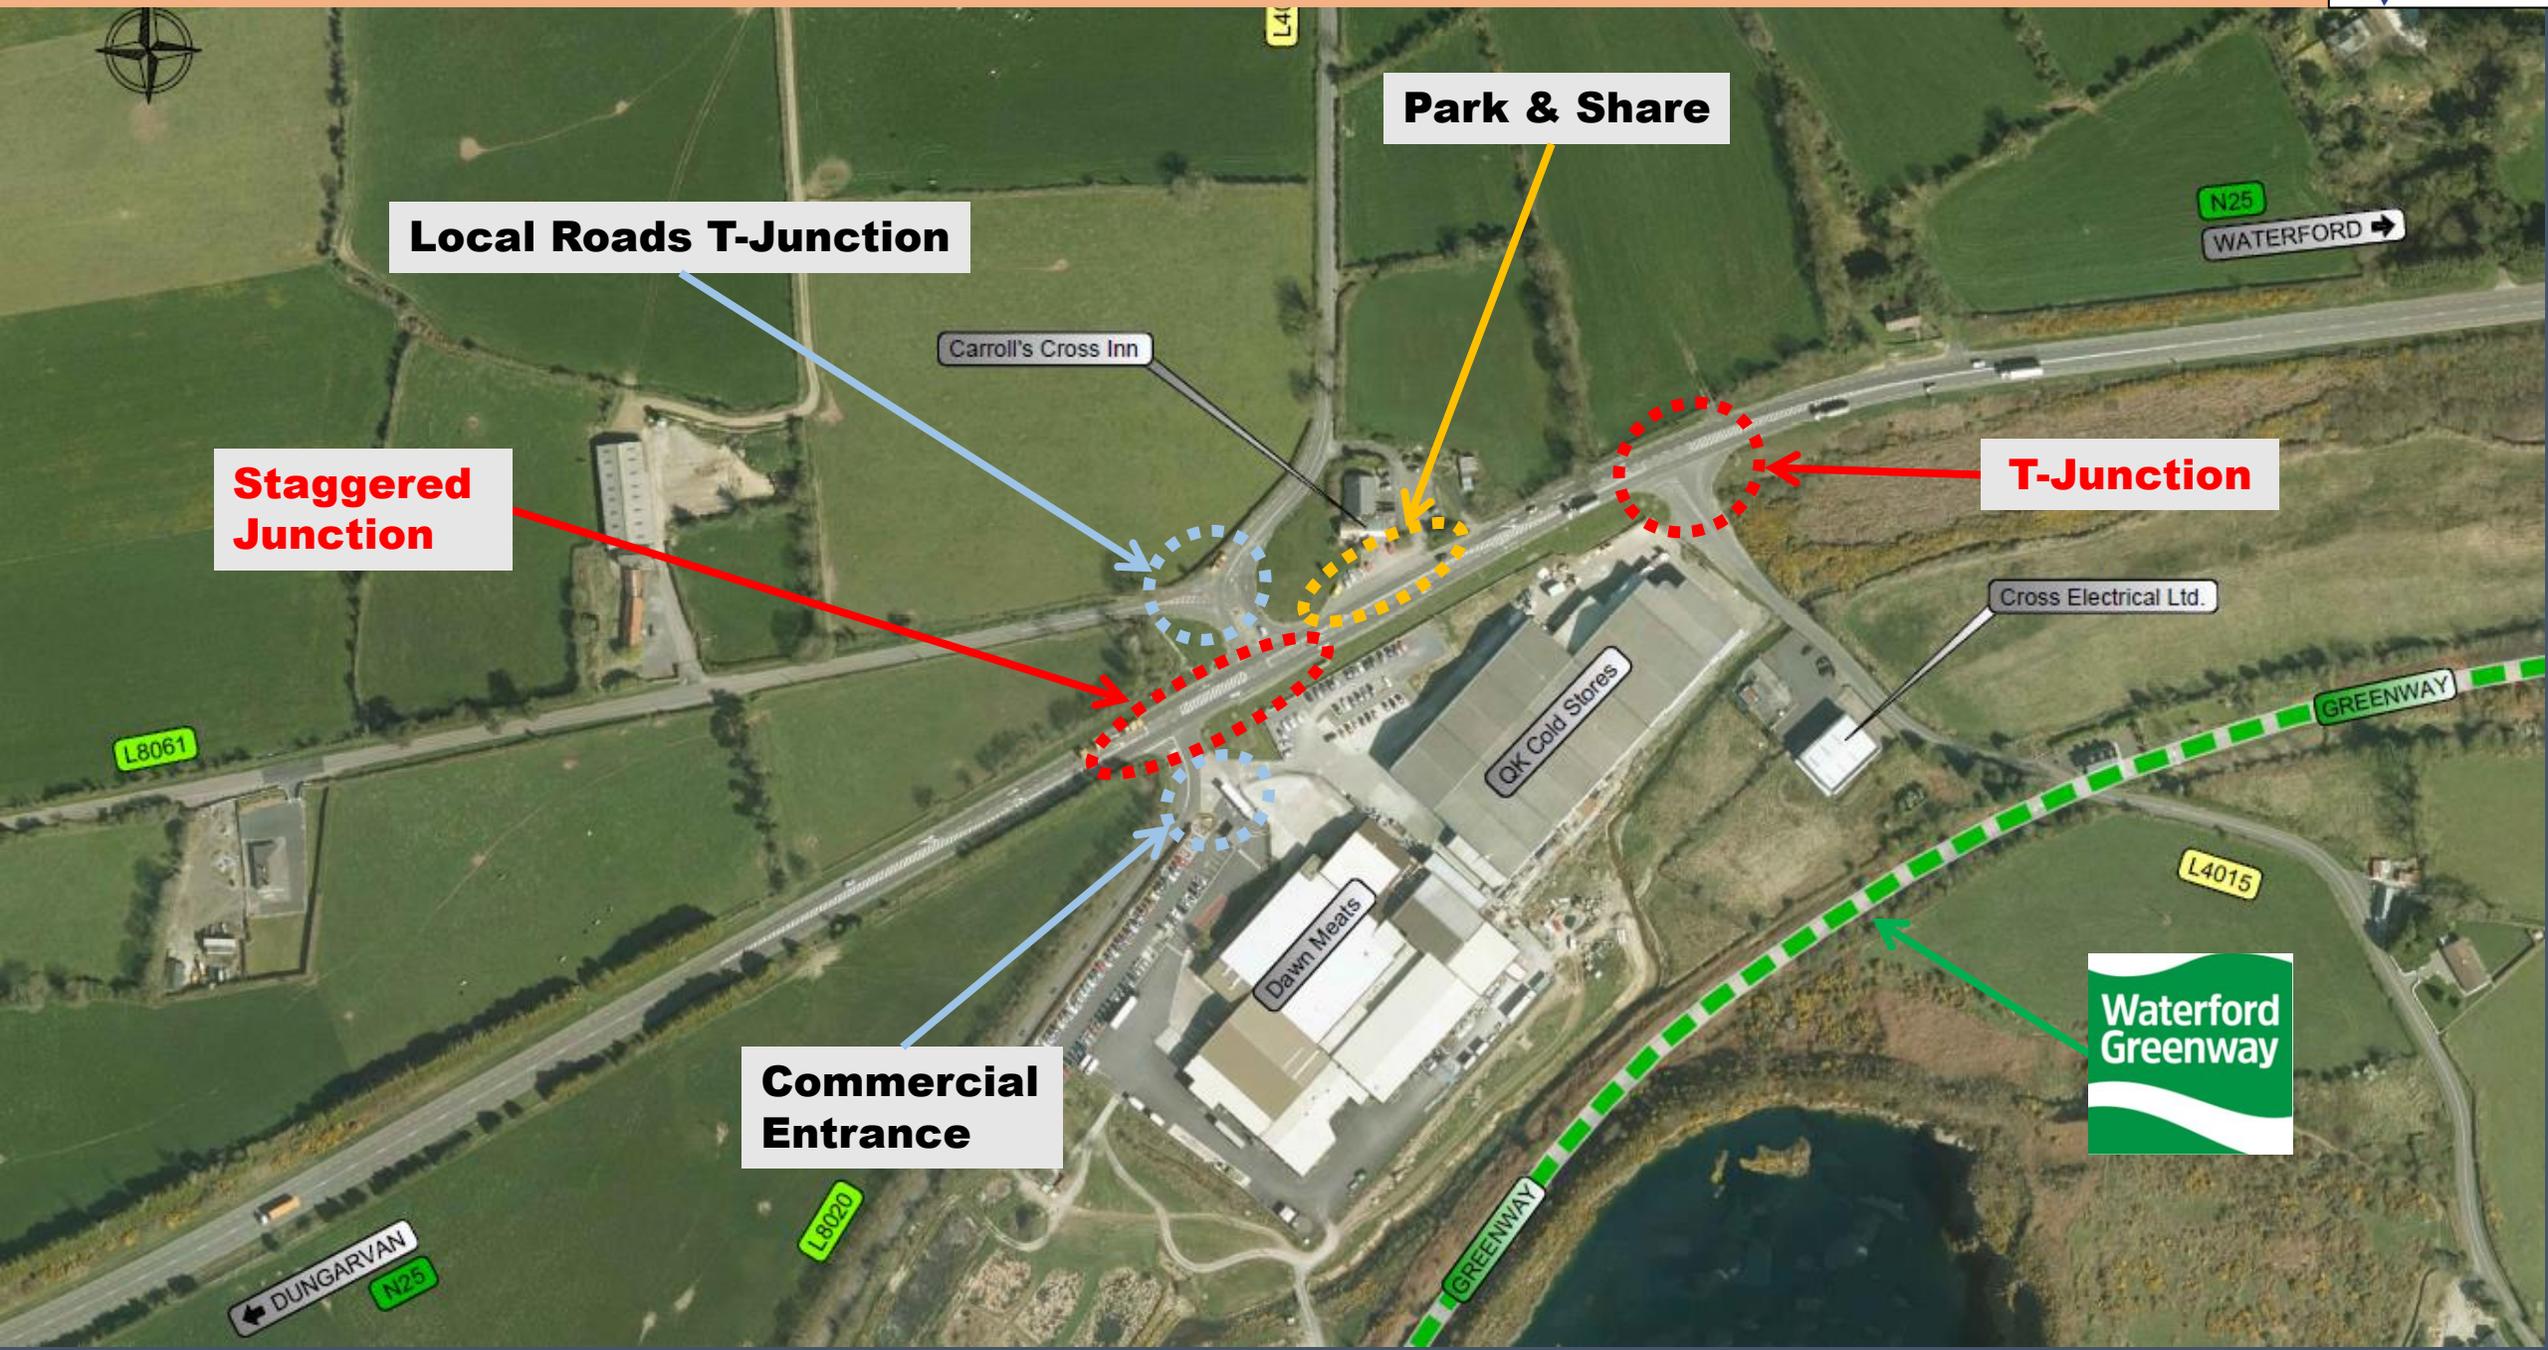
Introduction

Local Roads T-Junction

Park & Share

Staggered Junction

T-Junction

Commercial Entrance

L8061

L8020

L4015

N25

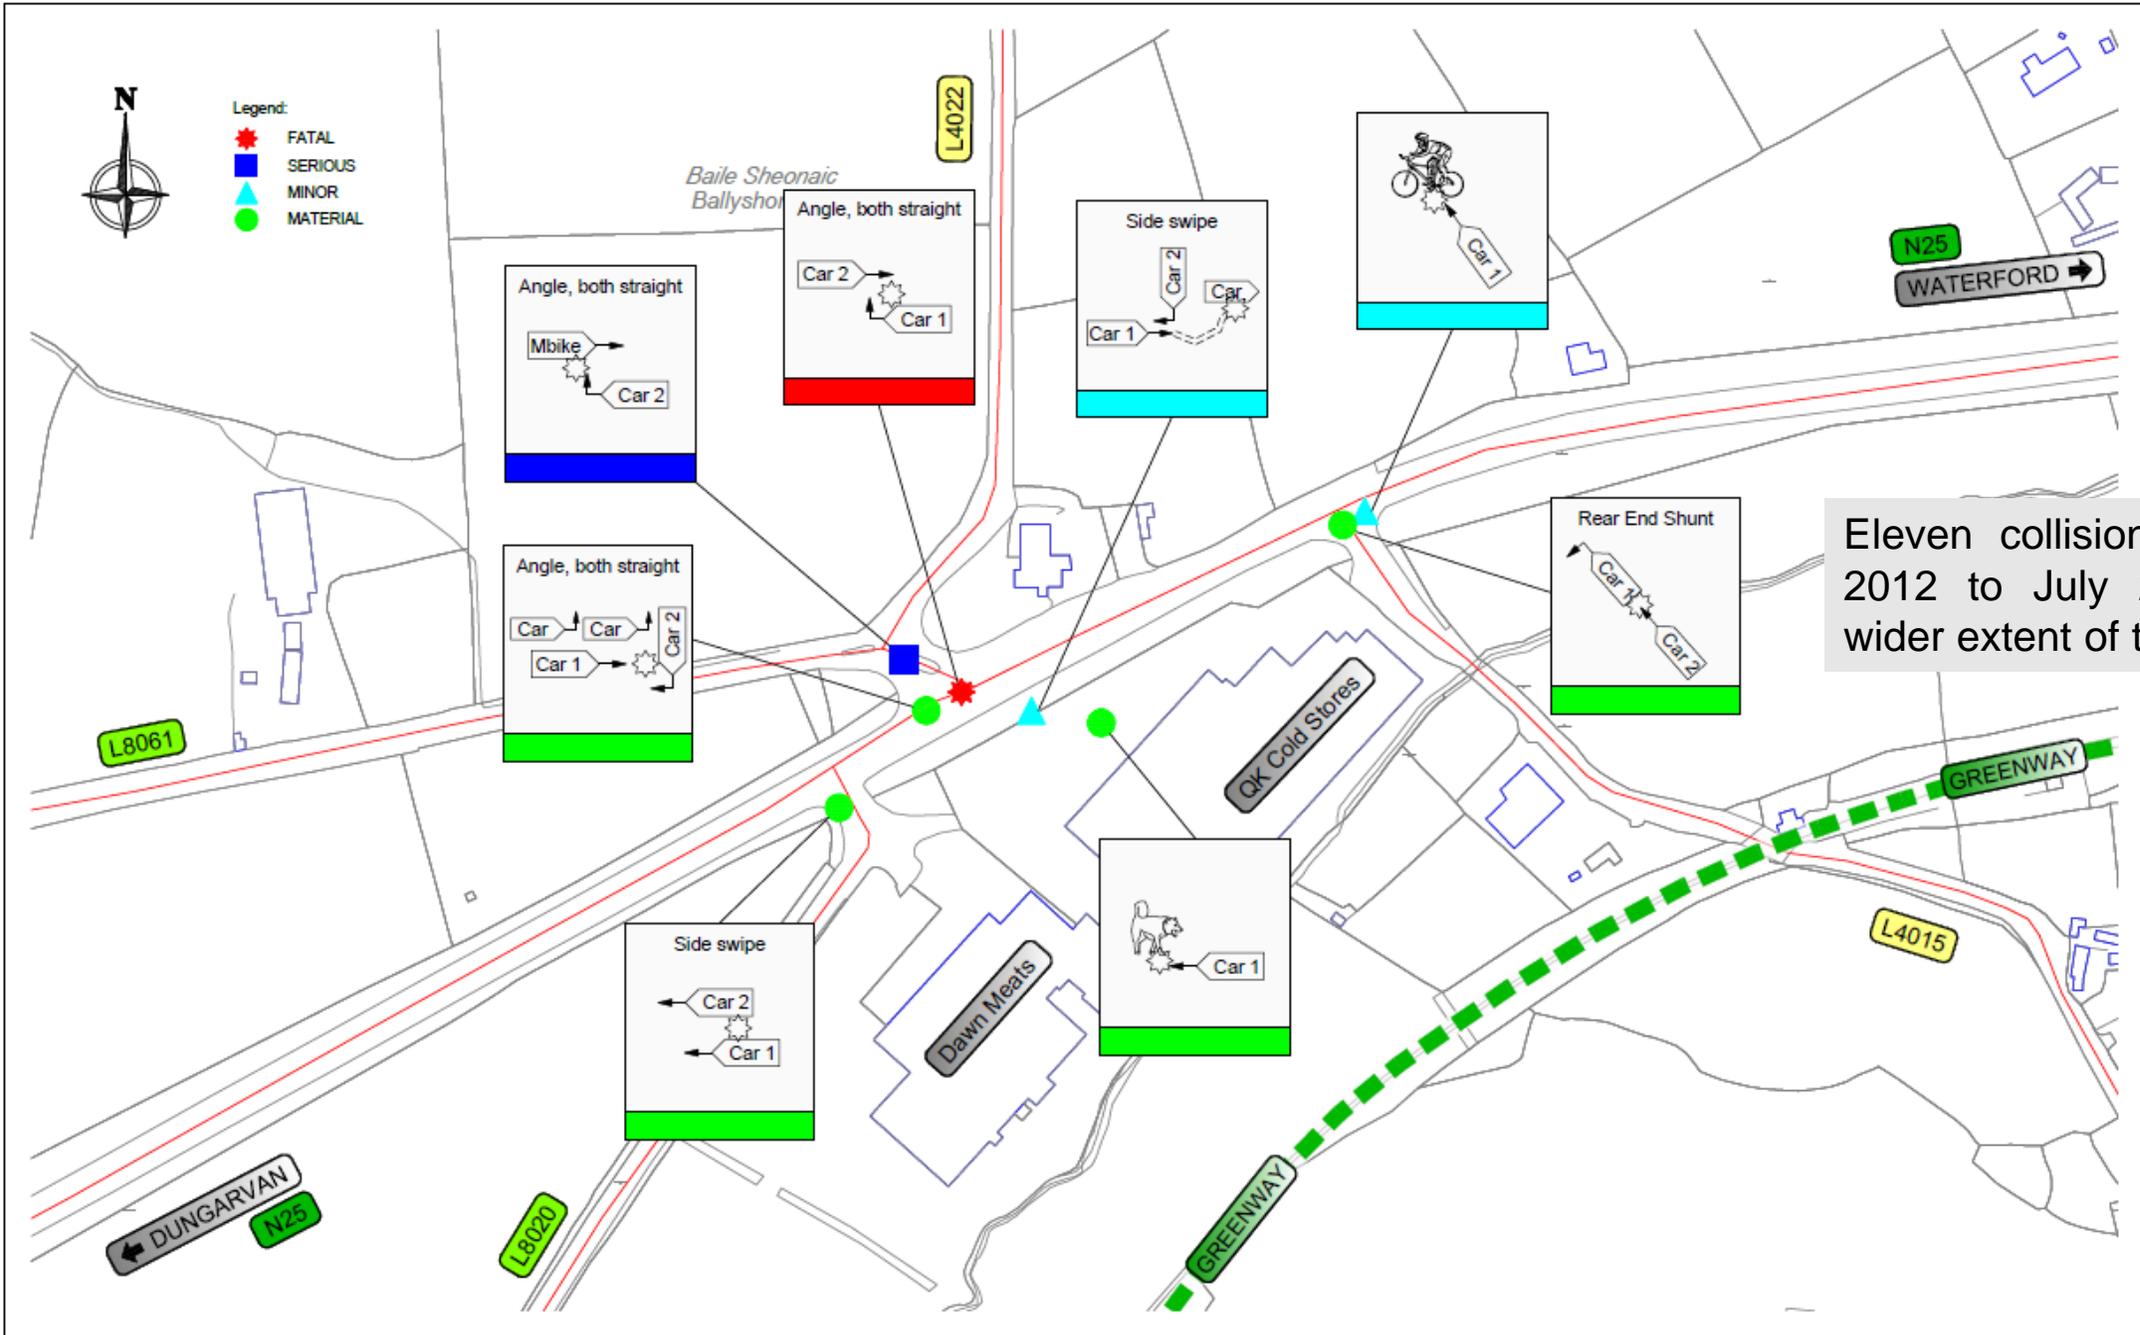
Introduction: Traffic Collisions (2012-2019)

Eleven collisions in the period 2012 to July 2019 within the wider extent of the site

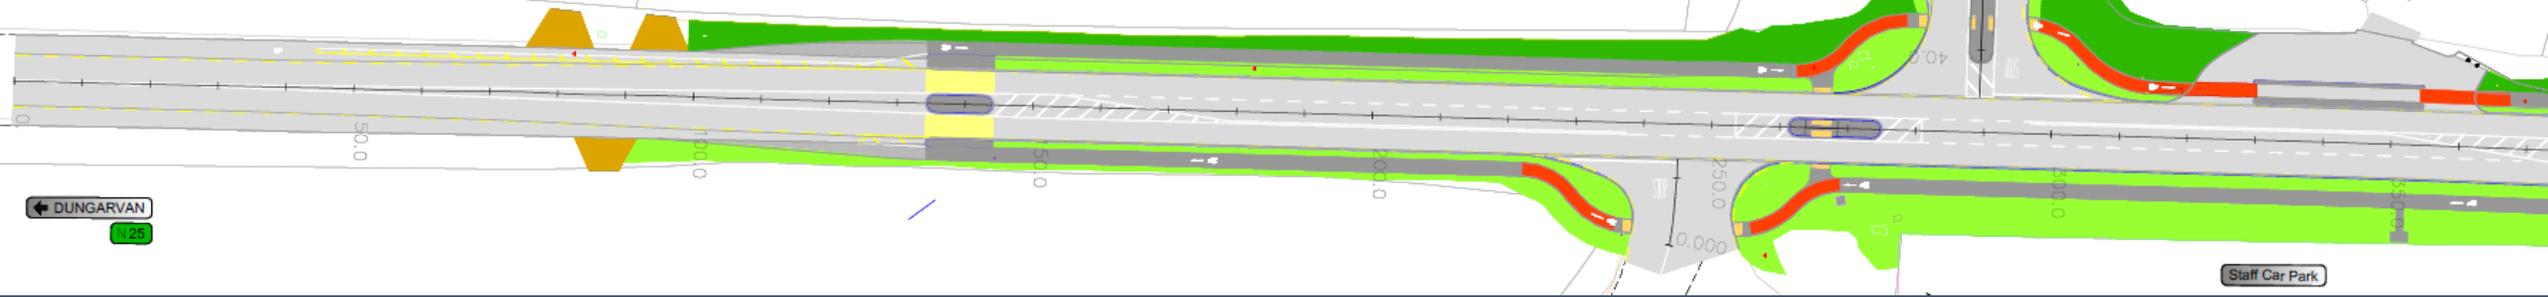
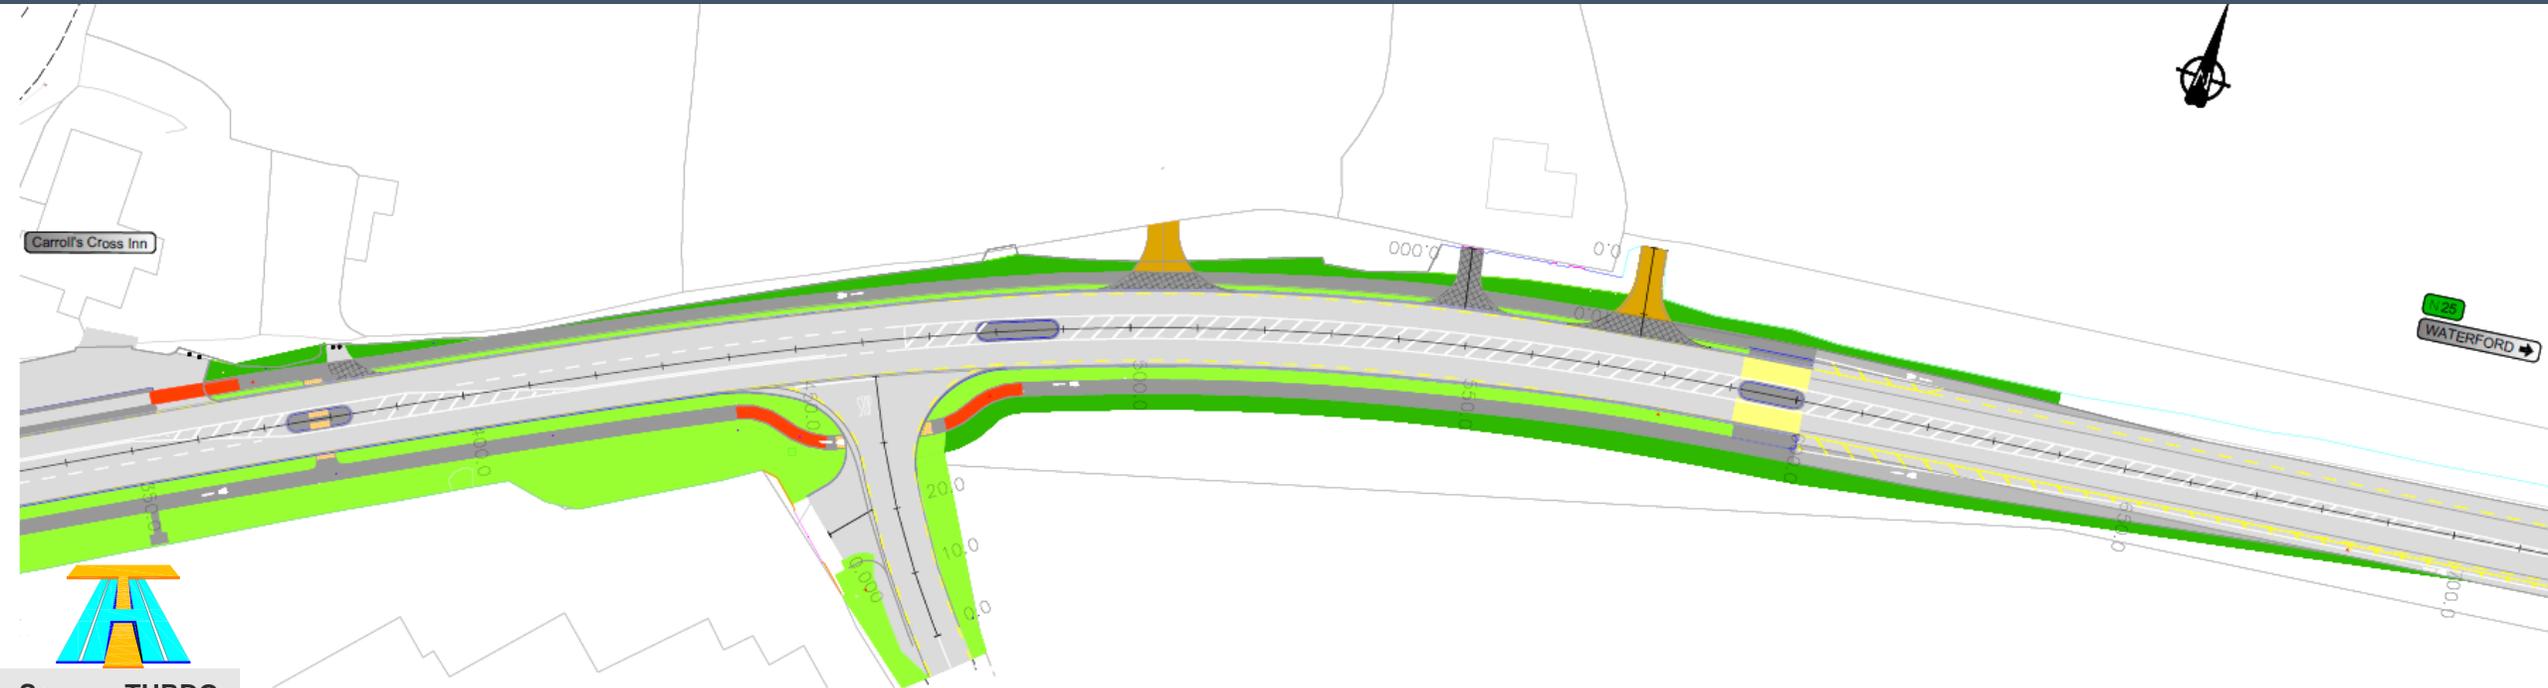
Design: Proposed Layout

Objectives:

- To reduce vehicular speed and improve the facilities for the vulnerable road users
- To create a safer environment along the existing section of N25 on approach to and through the junctions

Scheme Start

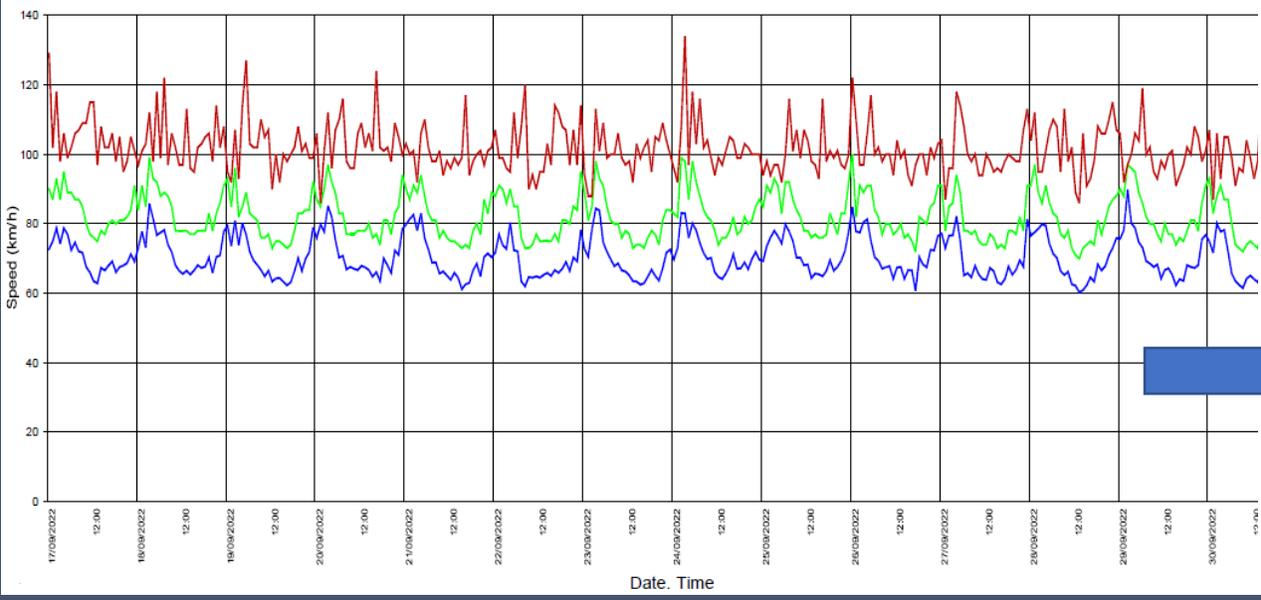
N25 Carroll's Cross - Location B Westbound direction, September 2022

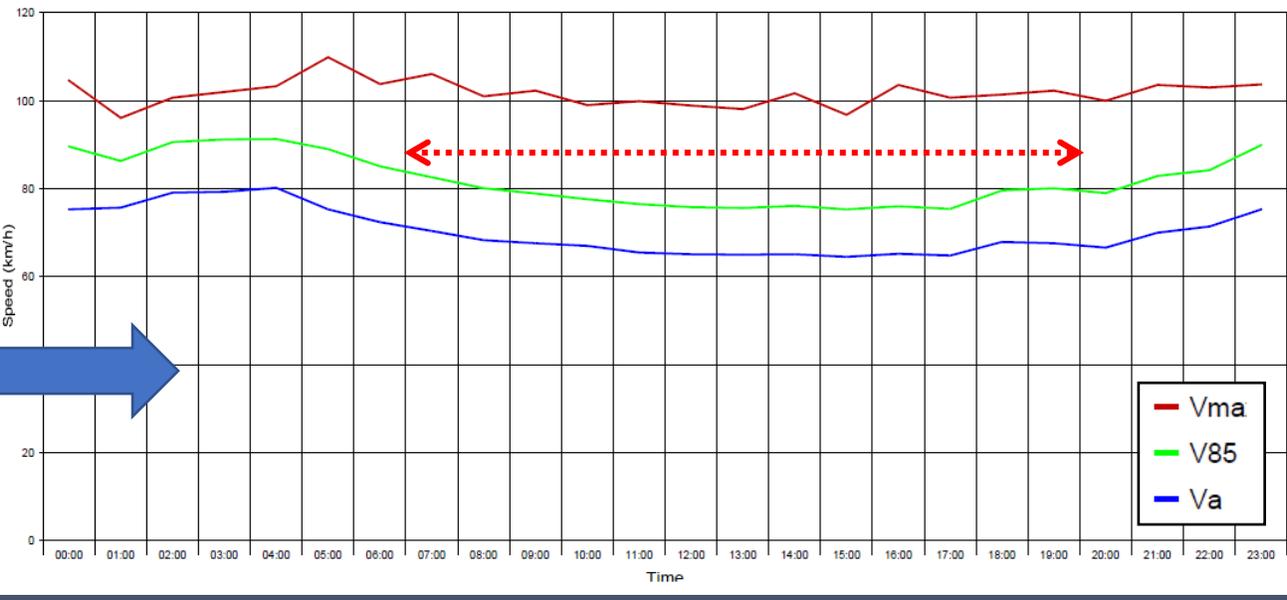
N25 Carroll's Cross - Location B Westbound direction, September 2022

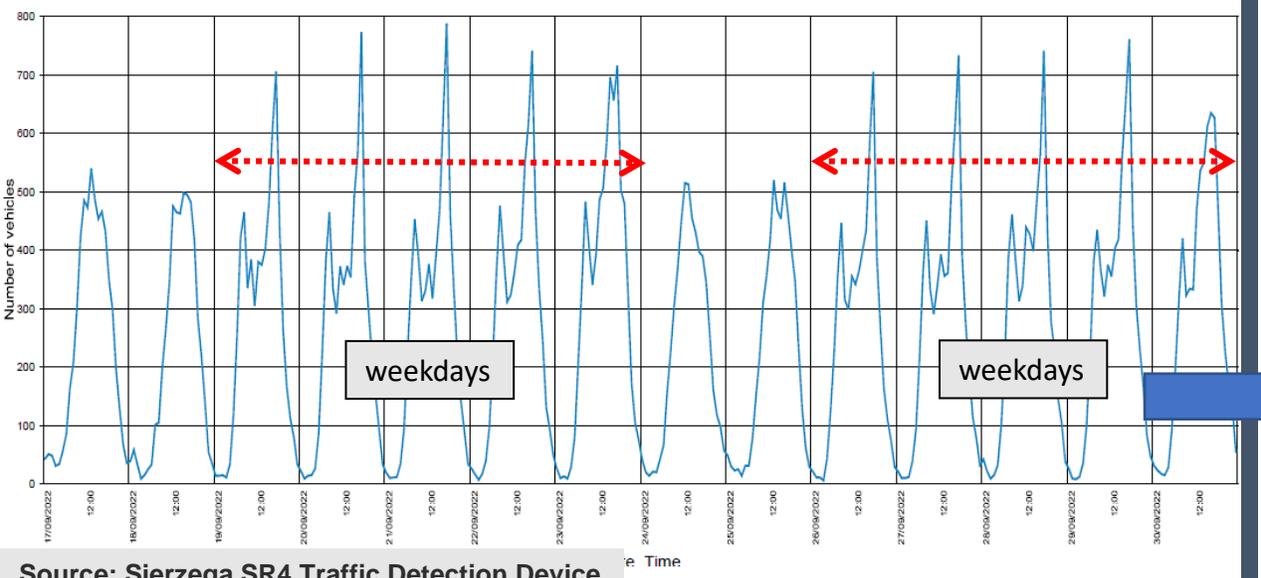
N25 Carroll's Cross - Location B Westbound direction, September 2022

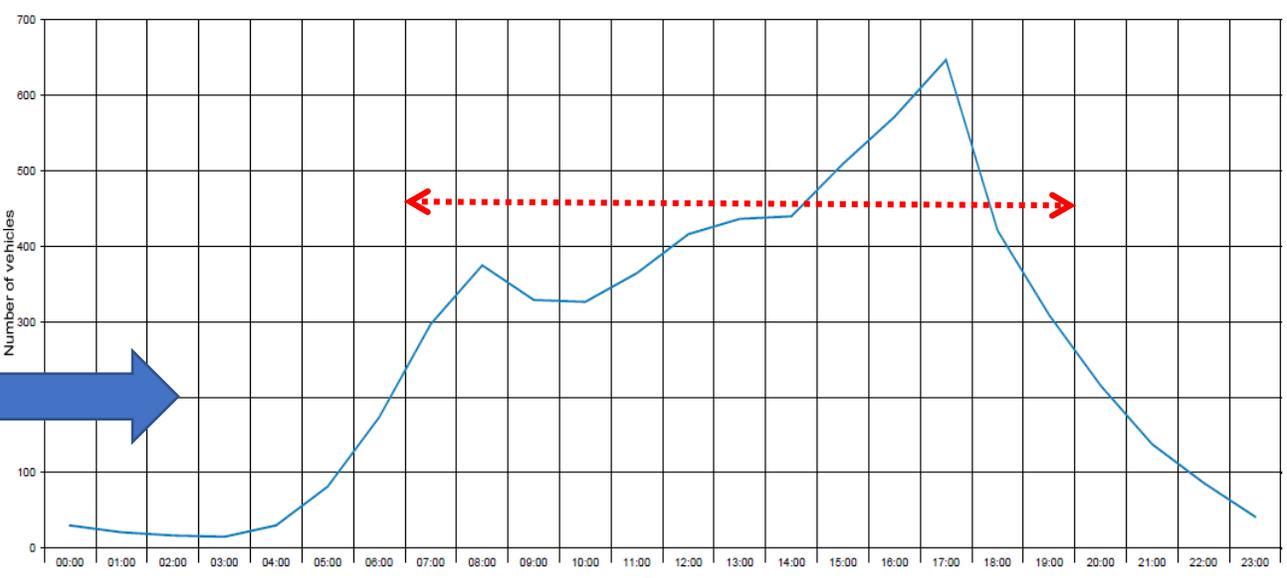
N25 Carroll's Cross - Location B Westbound direction, September 2022

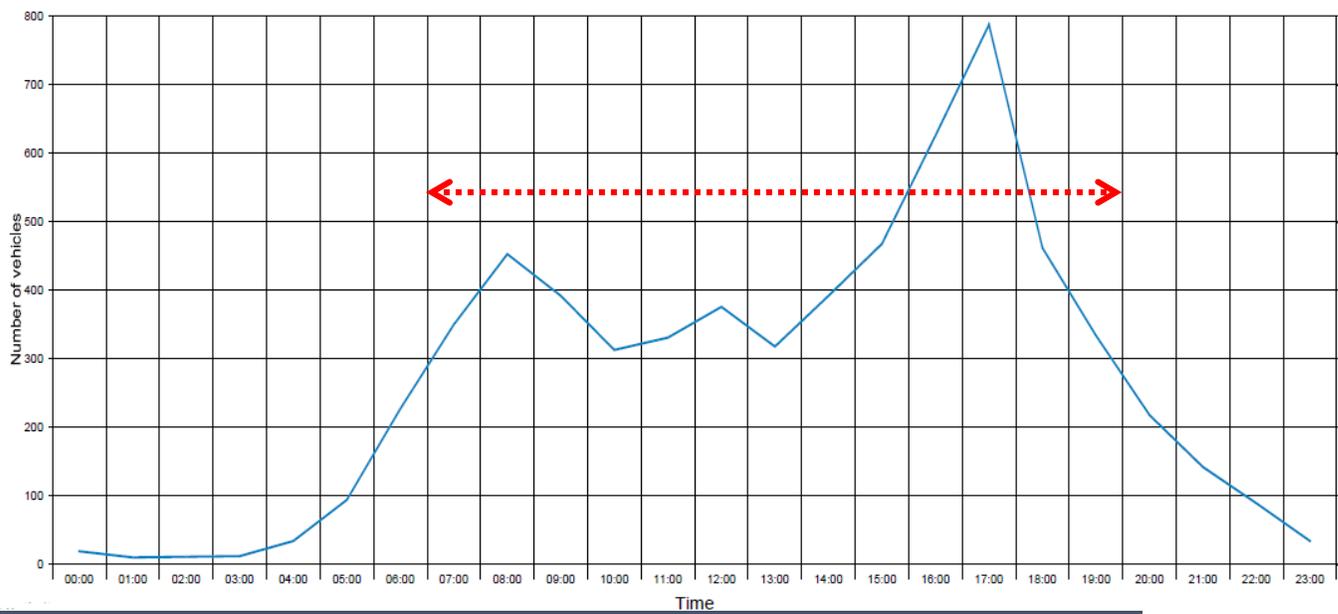
N25 Carroll's Cross - Location B Westbound direction, 21 September 2022

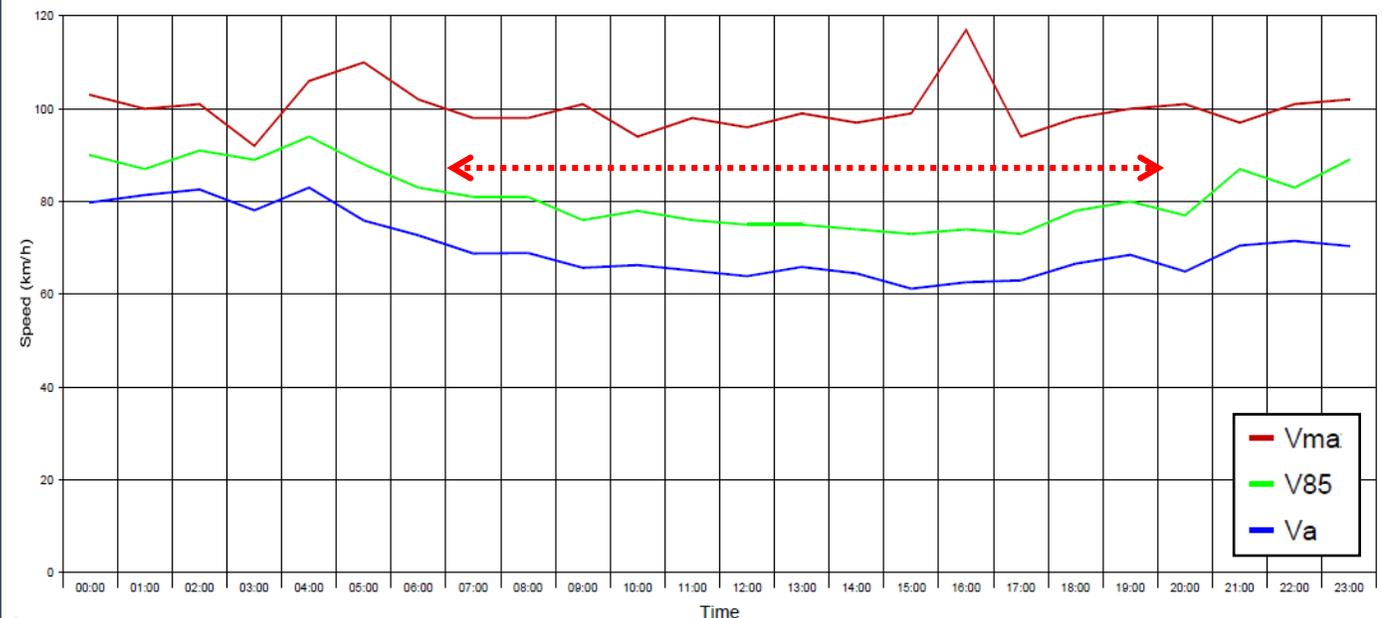
N25 Carroll's Cross - Location B Westbound direction, 21 September 2022

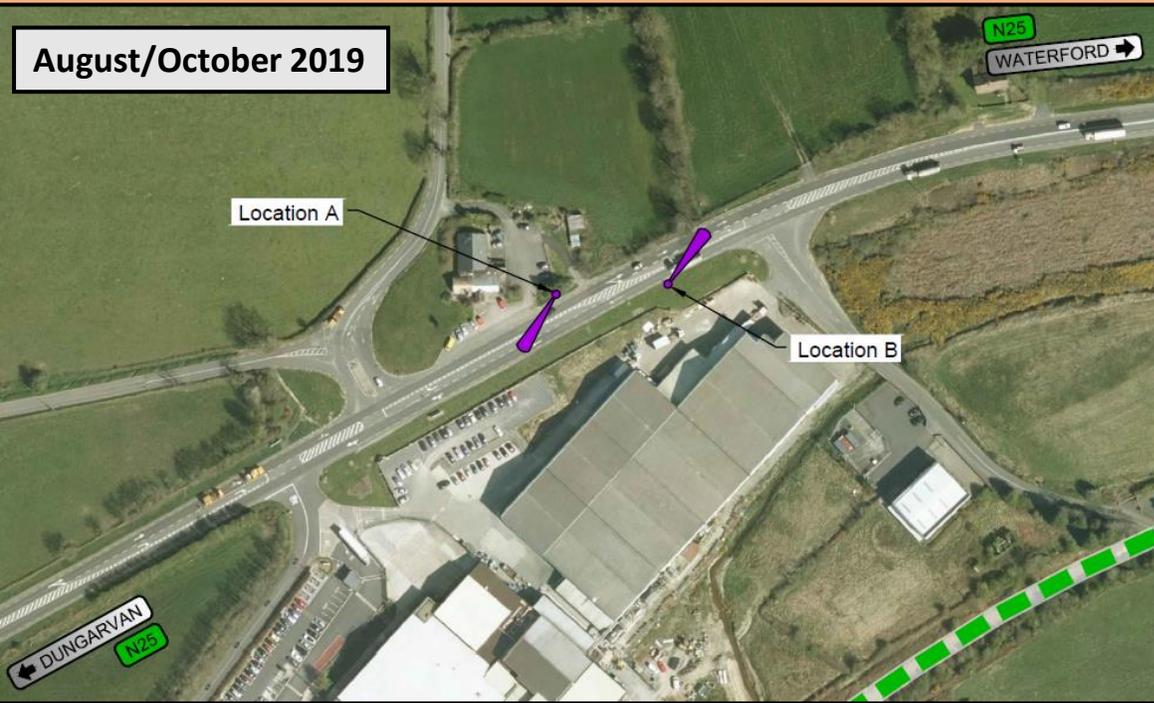
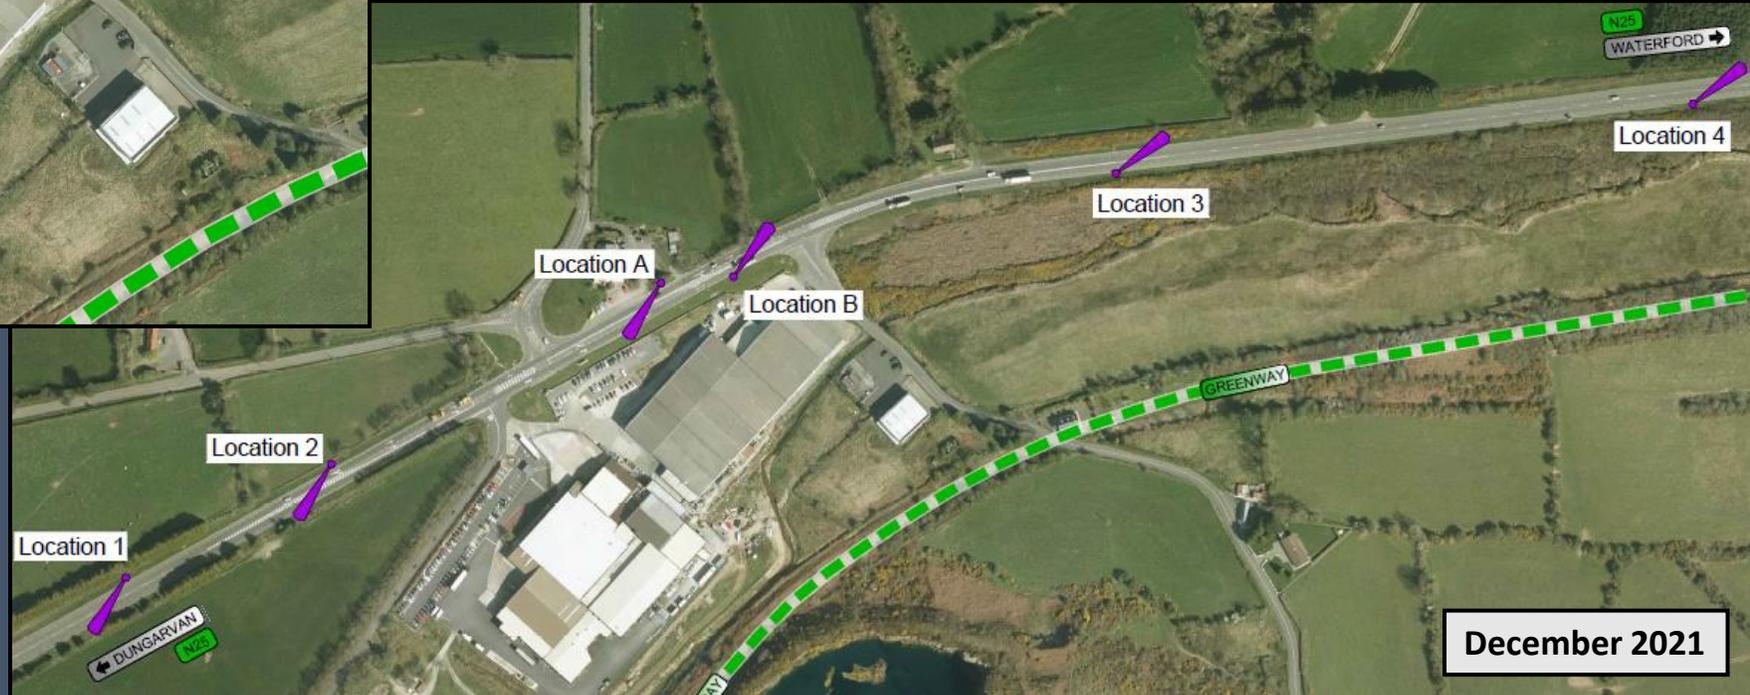
Traffic Speed Survey - BEFORE

December 2021

V85 (kph) Speed Survey - BEFORE						
Date	Location 1 (Eastbound)	Location 2 (Eastbound)	Location A (Eastbound)	Location B (Westbound)	Location 3 (Westbound)	Location 4 (Westbound)
August 2019	n/a	n/a	90	91	n/a	n/a
October 2019	n/a	n/a	92	85	n/a	n/a
December 2021	93	90	91	86	95	98
Average V85 (kph)	93	90	91	87	95	98

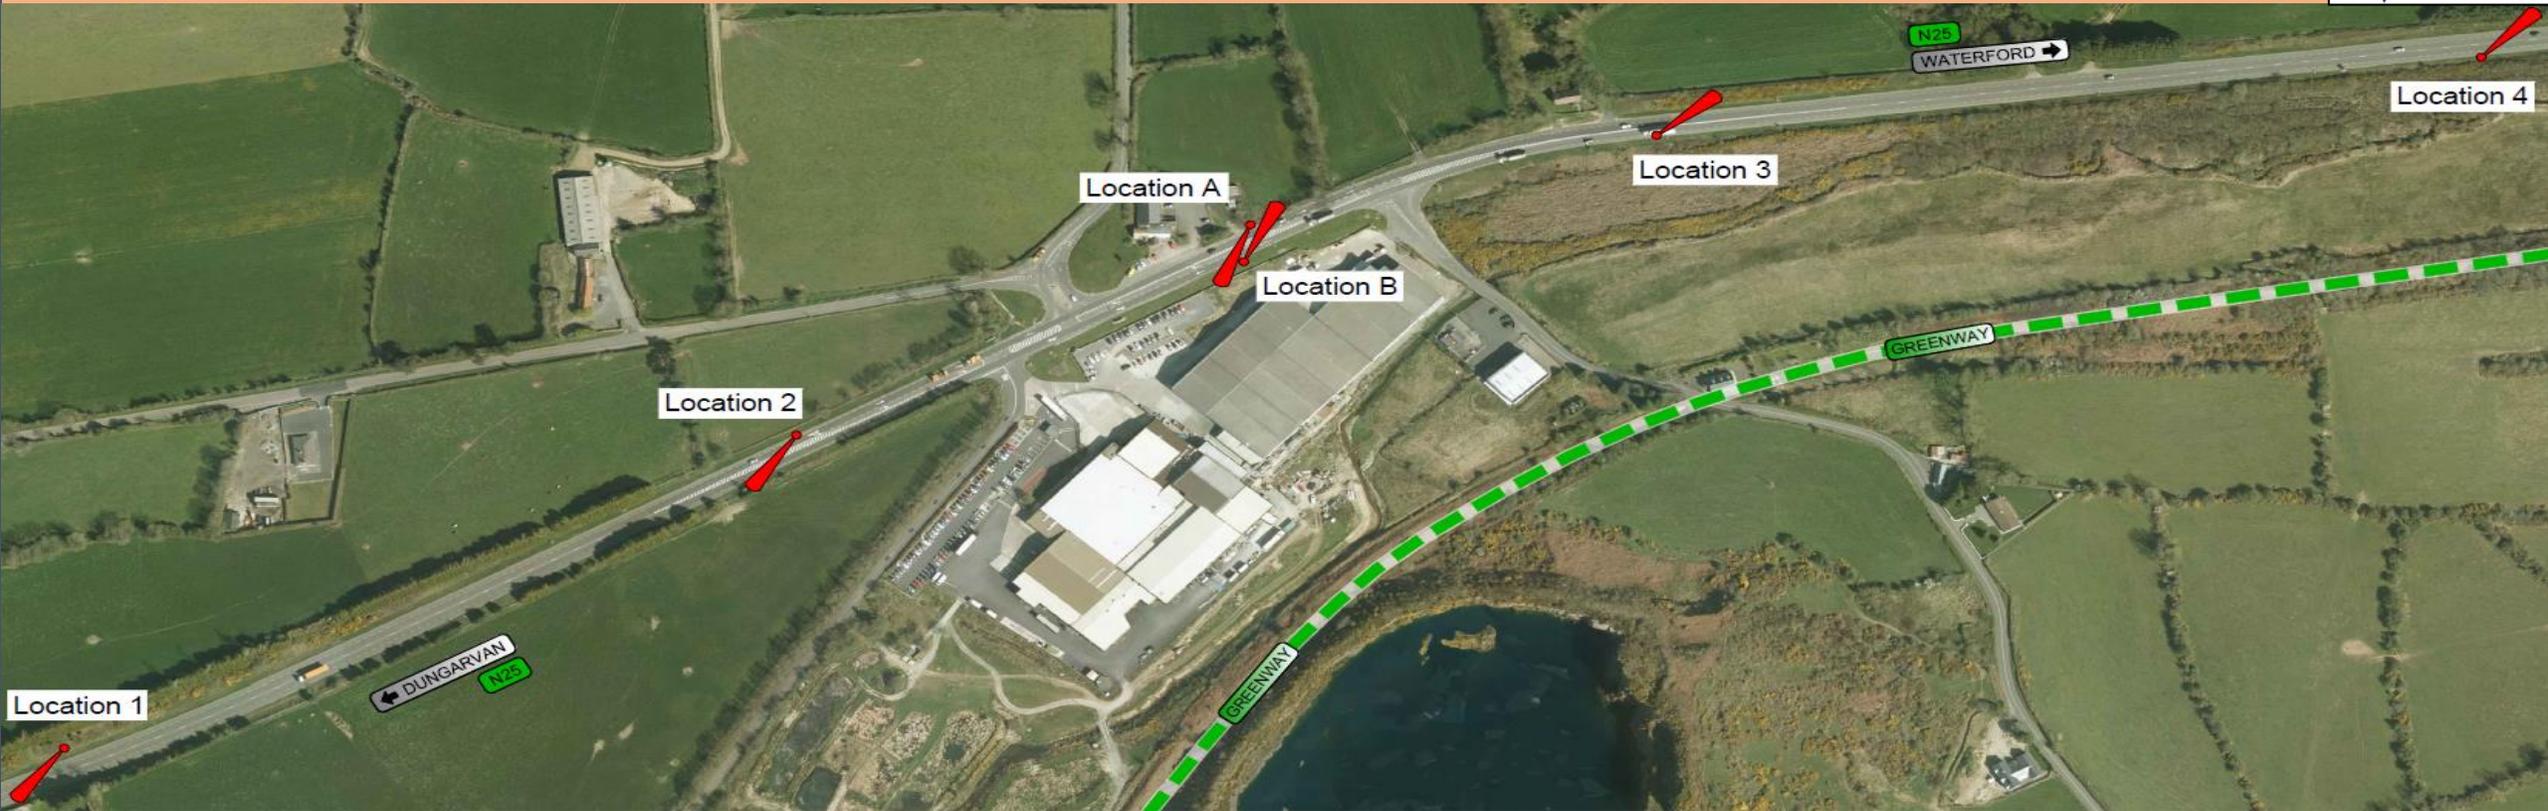
Traffic Speed Survey - AFTER

V85 (kph) Speed Survey - AFTER						
Date	Location 1 (Eastbound)	Location 2 (Eastbound)	Location A (Eastbound)	Location B (Westbound)	Location 3 (Westbound)	Location 4 (Westbound)
July 2022	95	88	76	78	83	94
August 2022	96	89	79	77	84	93
September 2022	101	87	78	78	86	93
October 2022	103	88	81	80	87	93
November 2022	102	87	81	79	86	92
December 2022	99	83	77	77	83	88
January 2023	103	88	78	78	86	92
March 2023	104	89	80	82	85	93
April 2023	105	89	81	79	86	93
Average V85 (kph)	101	88	79	79	85	92

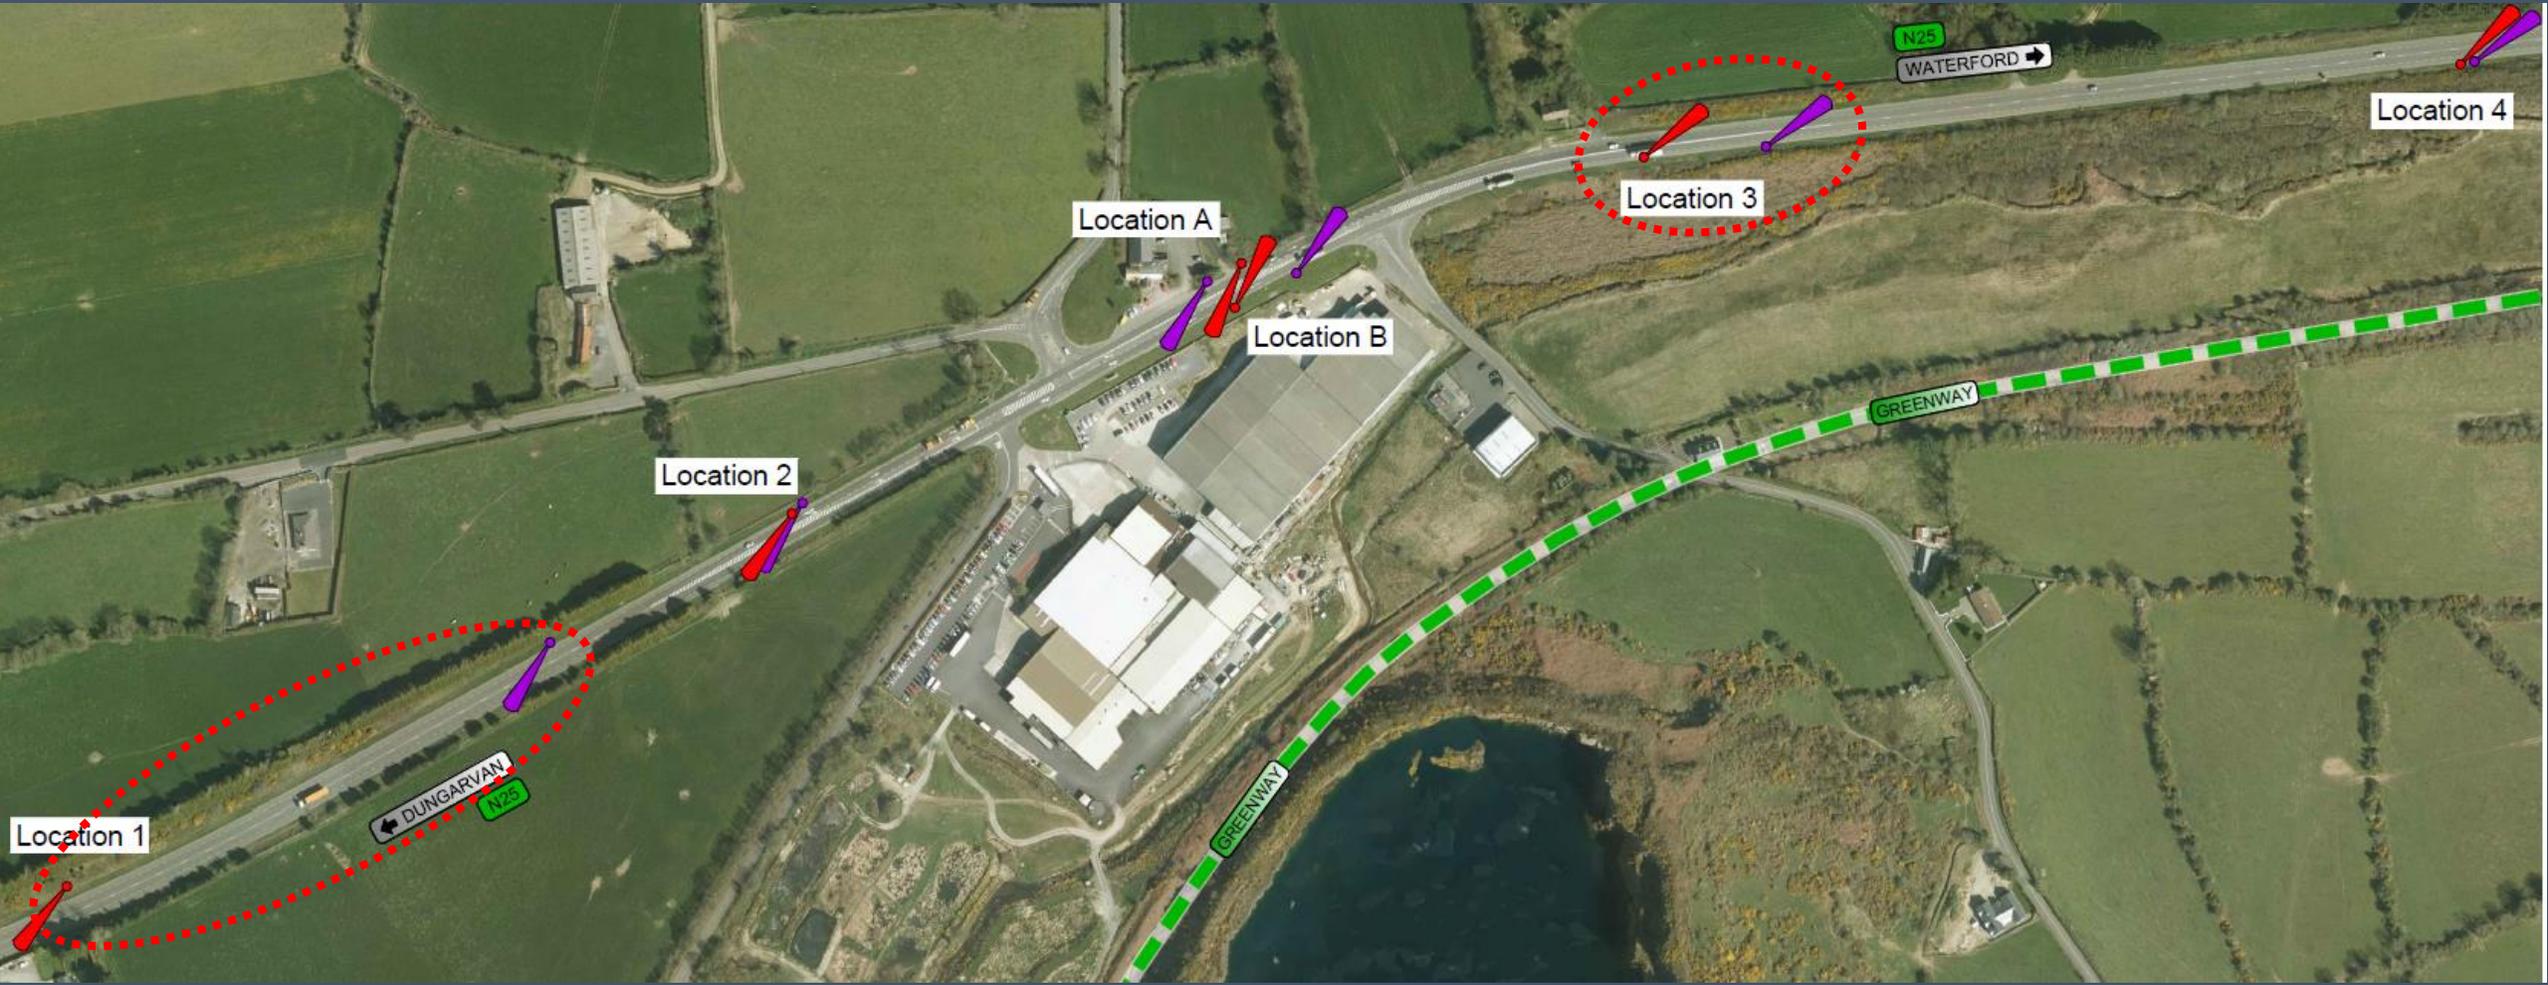
Traffic Speed Survey - Comparison

V85 (kph) Speed Survey - Comparison					
	Location 1 (Eastbound)	Location 2 (Eastbound)	Location A (Eastbound)	Location B (Westbound)	Location 3 (Westbound)	Location 4 (Westbound)
BEFORE	93	90	91	87	95	98
AFTER	101	88	79	79	85	92
Reduction (%)	n/a	3	13	10	10	6

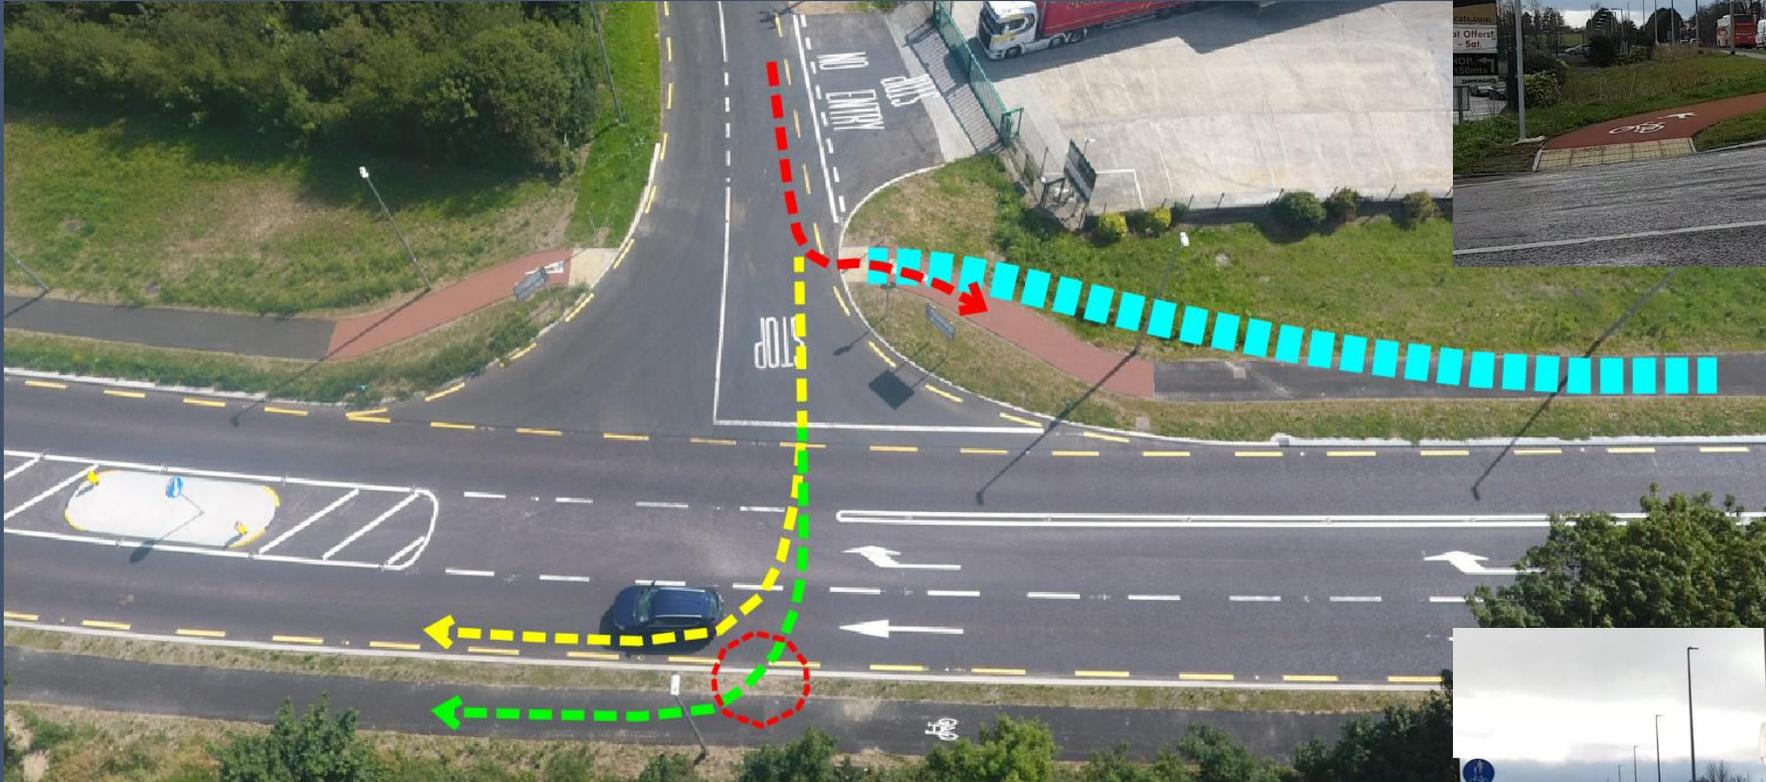
- **Offroad cycle facility vertical alignment (to avoid steep sections and possible drainage issues)**
