**TII Road Safety Engineering
and Audit Conference**

N25 CARROLL'S CROSS

**RURAL TRAFFIC CALMING
SCHEME**

**Branko Erak, Executive Engineer
Waterford City & County Council**

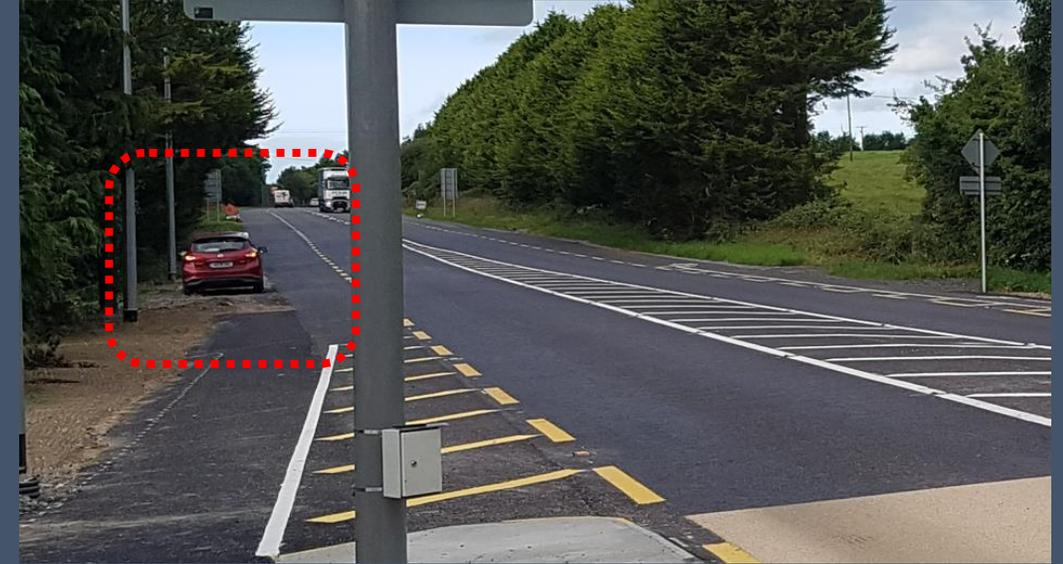
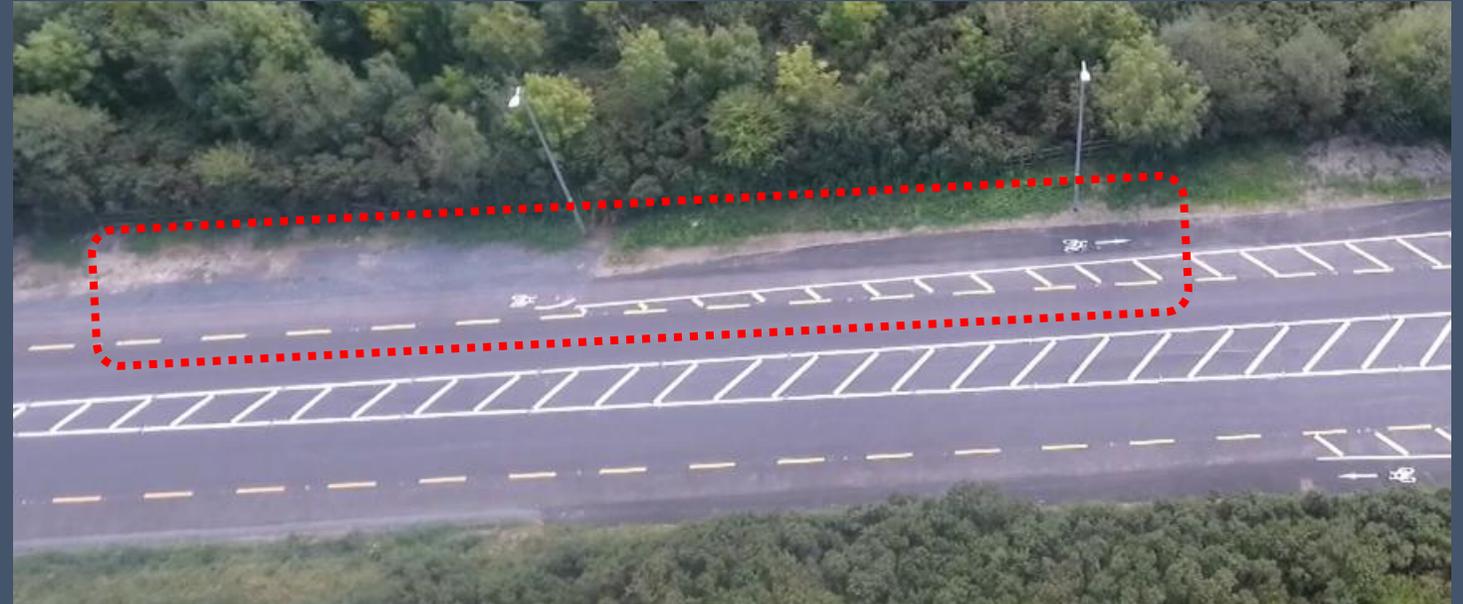
- Tie-in and transitions of cycle facility to hardsholuder

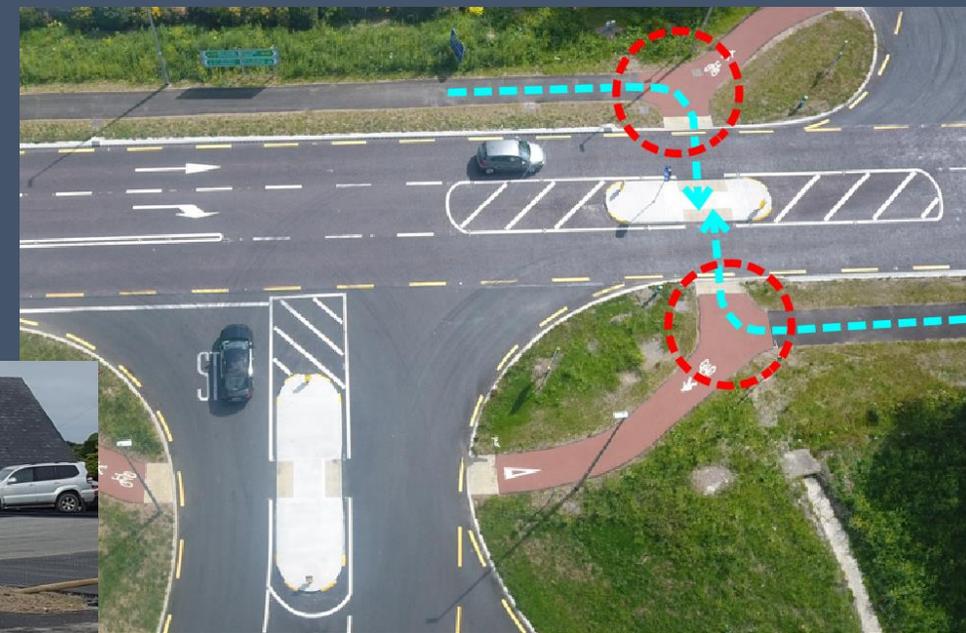
- **Position of street furniture adjacent to cycle facility**
- **Maximise separation between cycle facility and carriageway**
- **Good planning for traffic survey locations - before/after (to gain best possible comparison of results)**
- **Additional space for cyclists to turn to cross central islands**

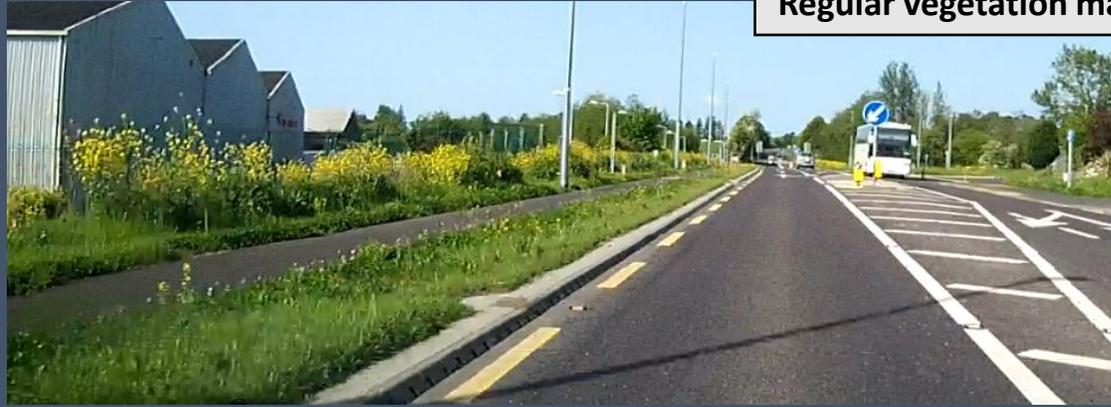
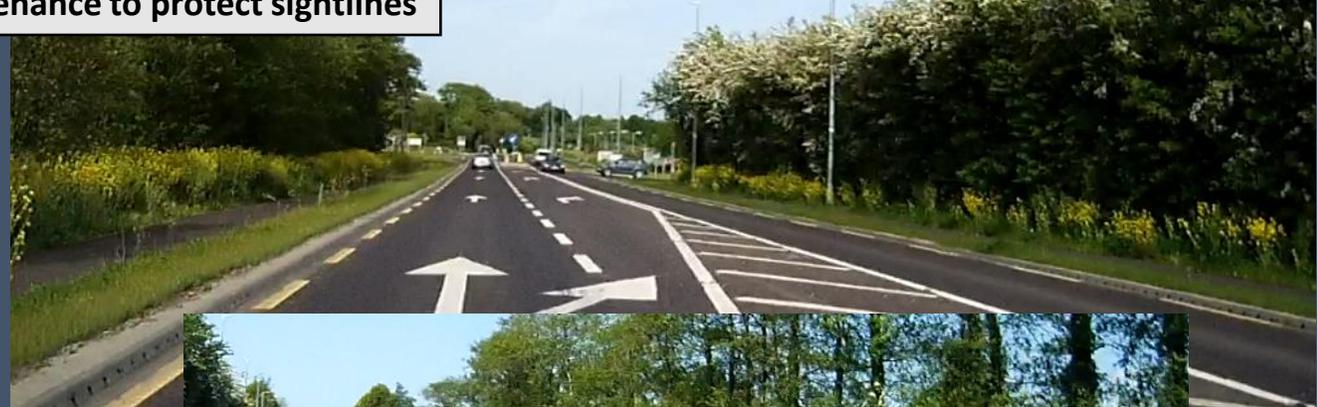
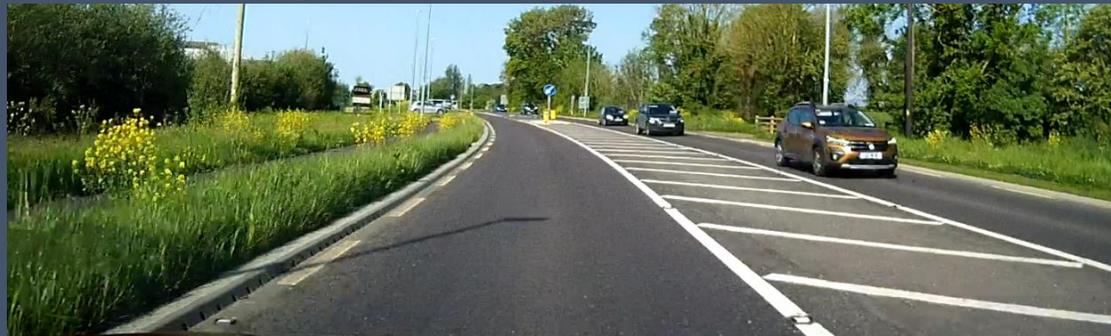
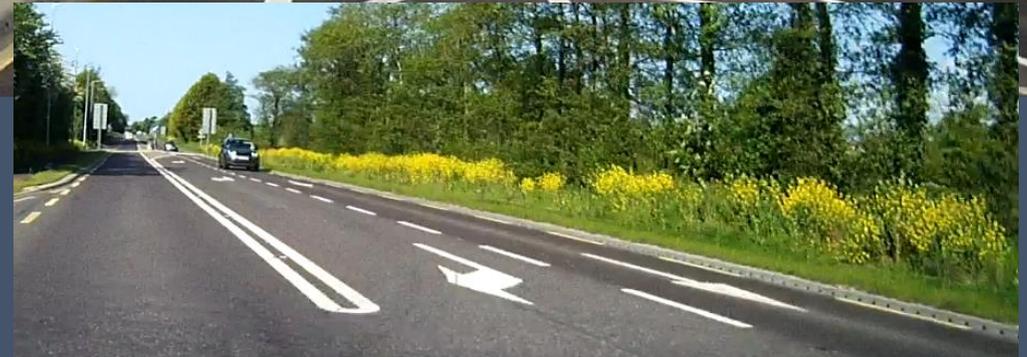
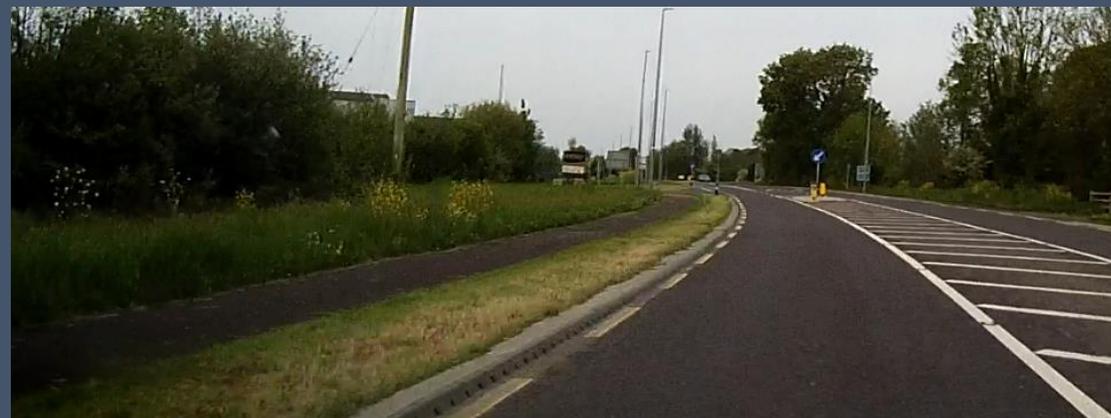
Regular vegetation maintenance to protect sightlines

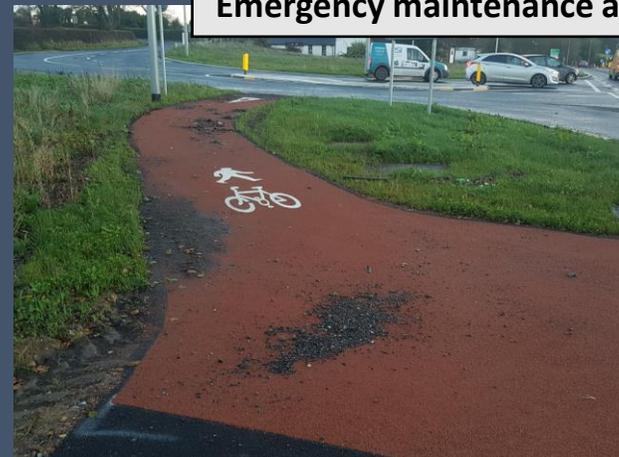
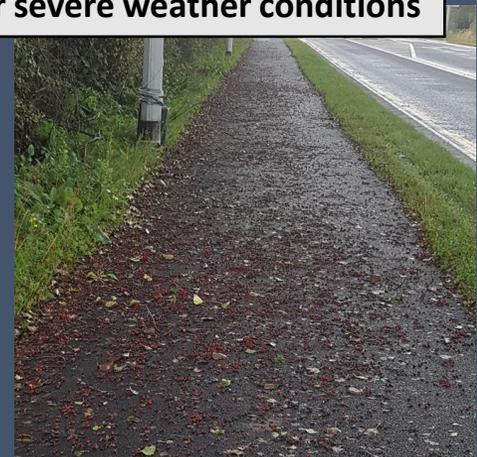
Emergency maintenance after severe weather conditions

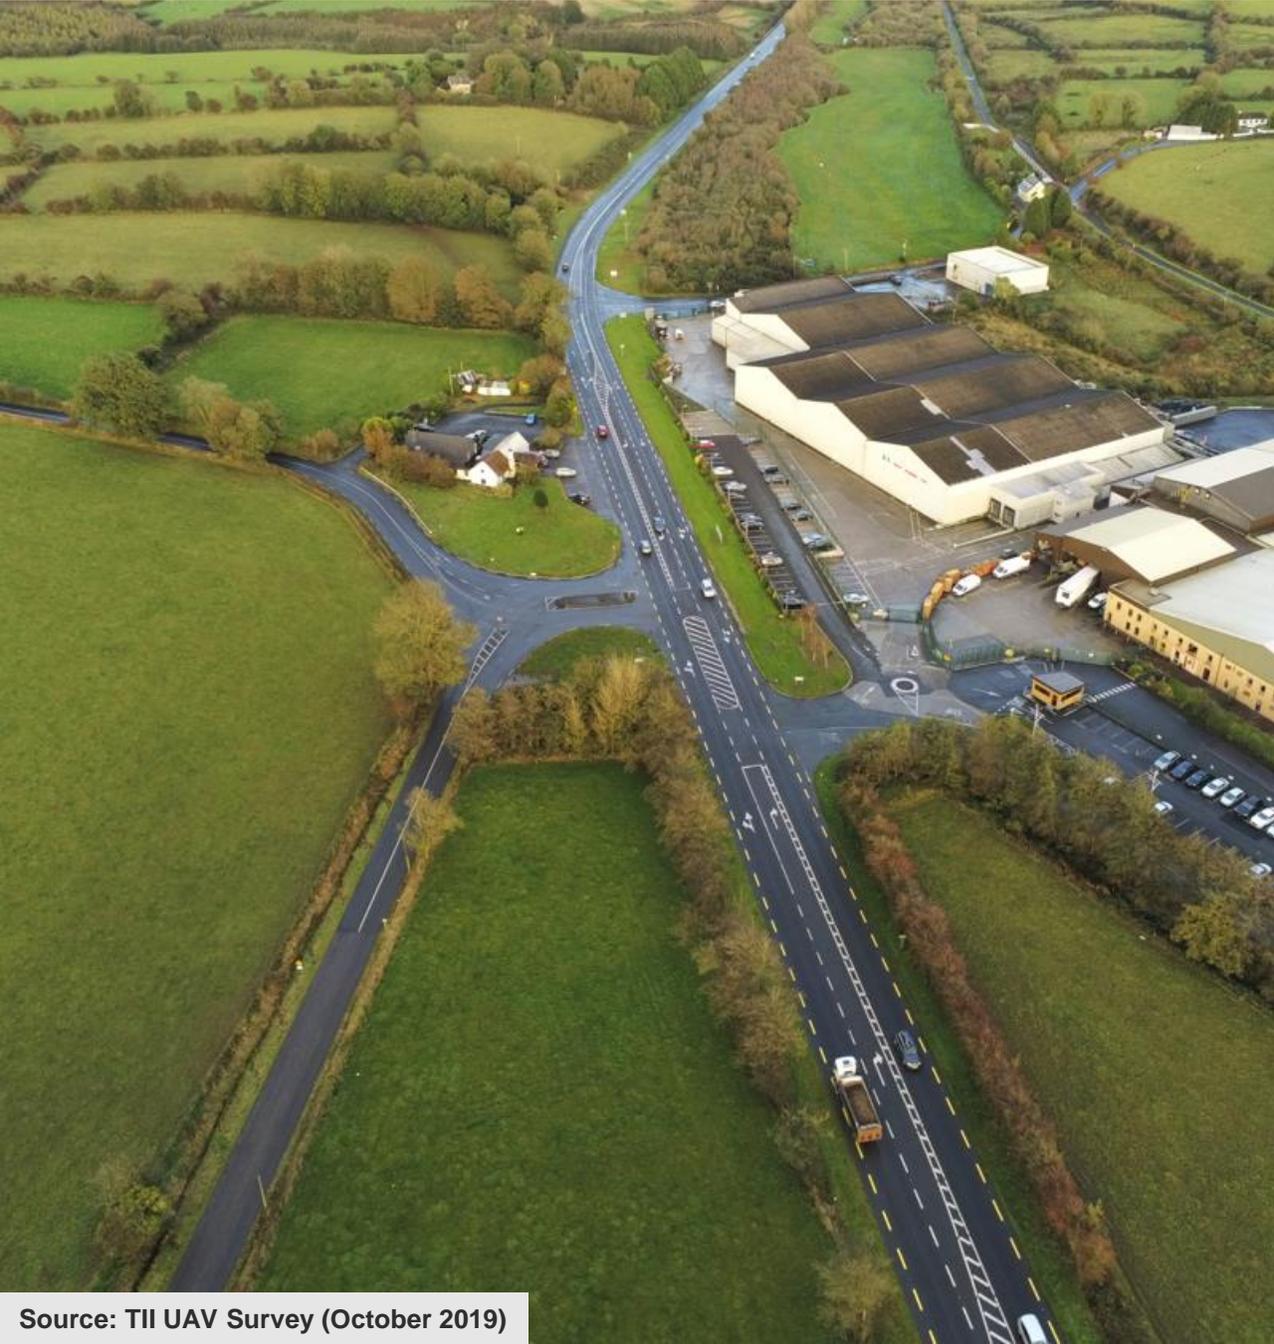
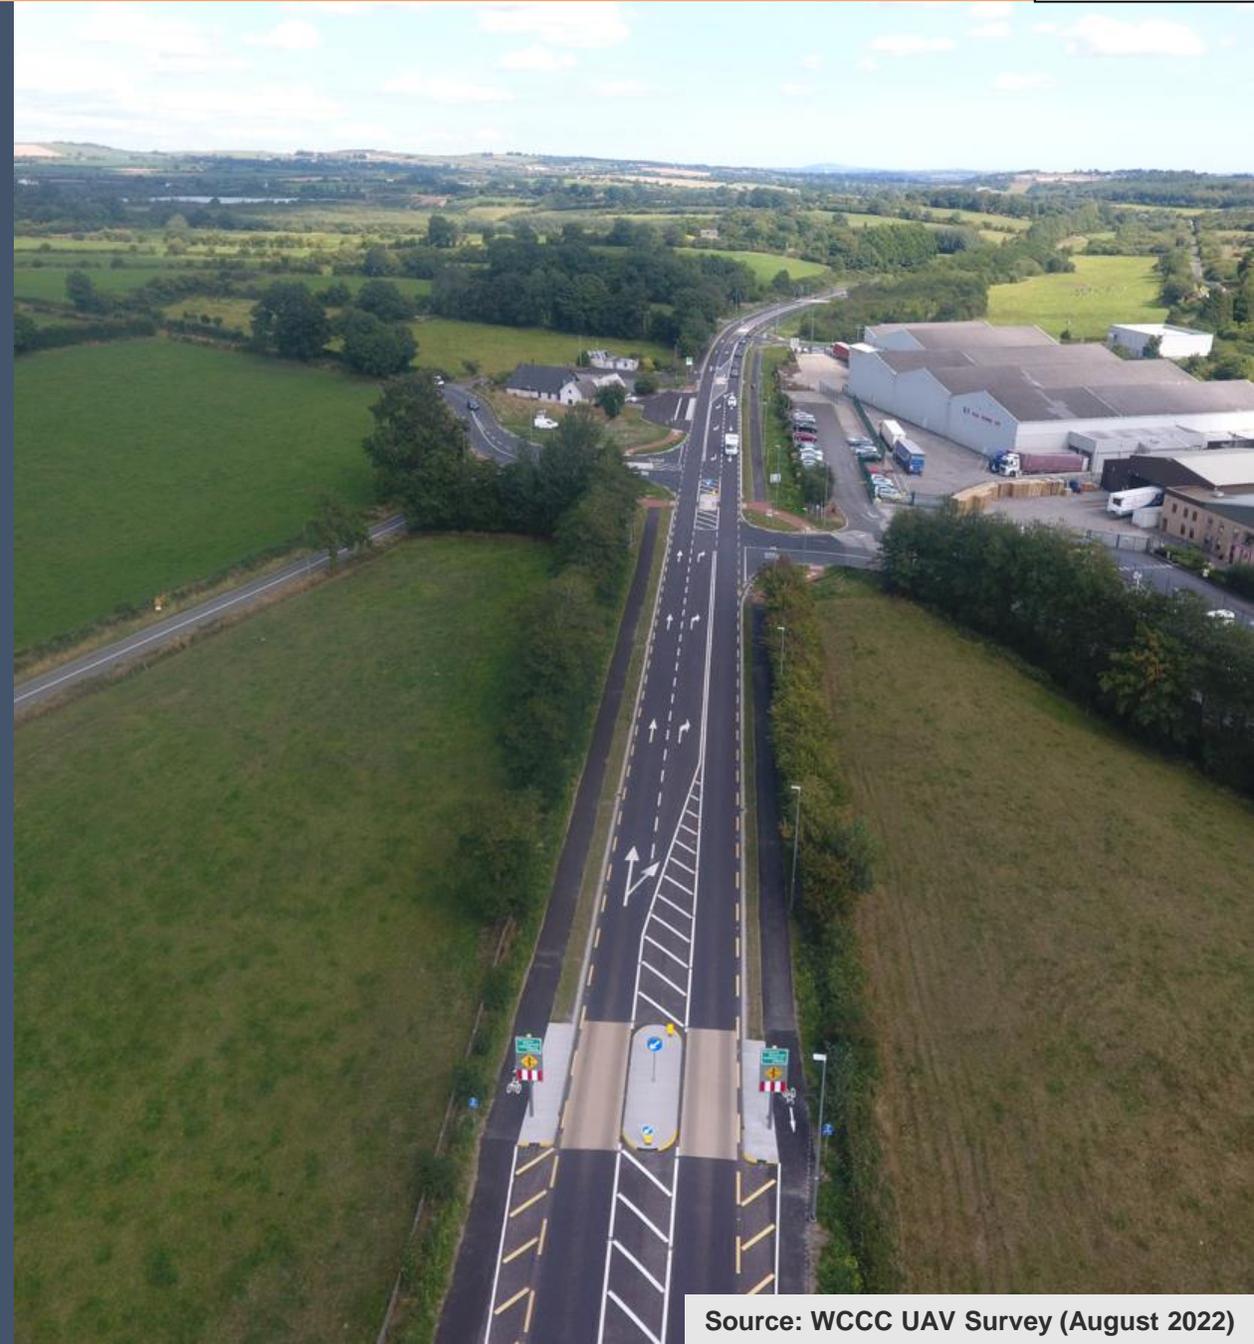
N25 Carroll's Cross – UAV Survey - Before/After

Source: TII UAV Survey (October 2019)

Source: WCCC UAV Survey (August 2022)

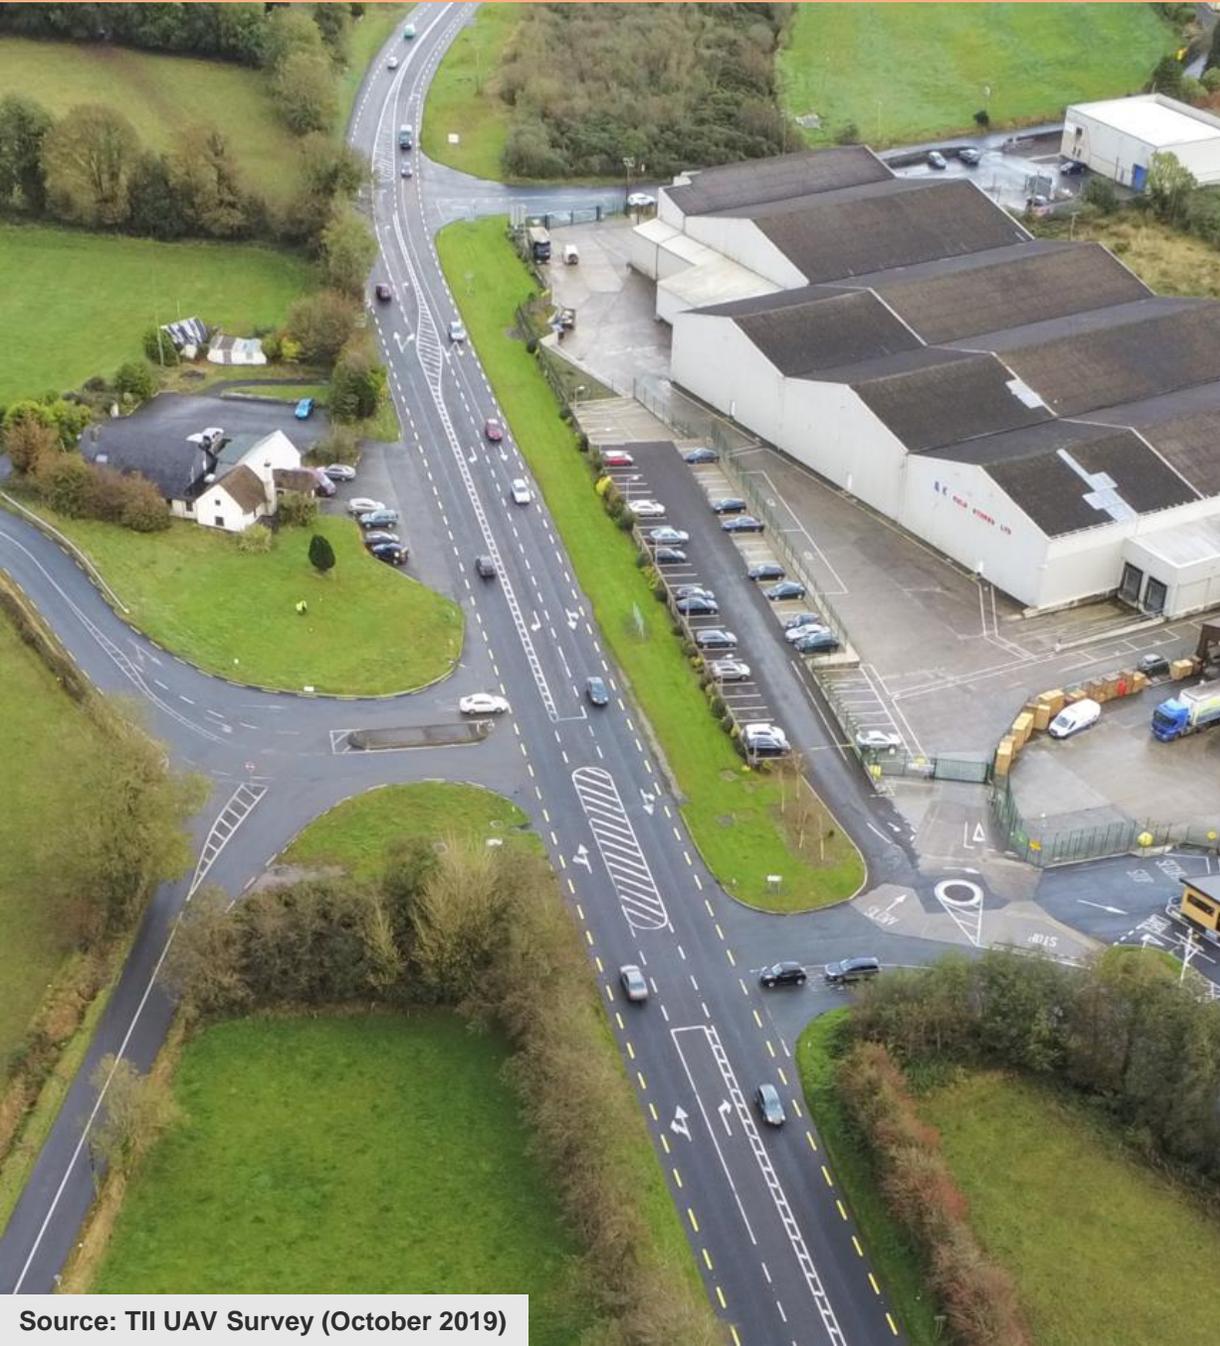
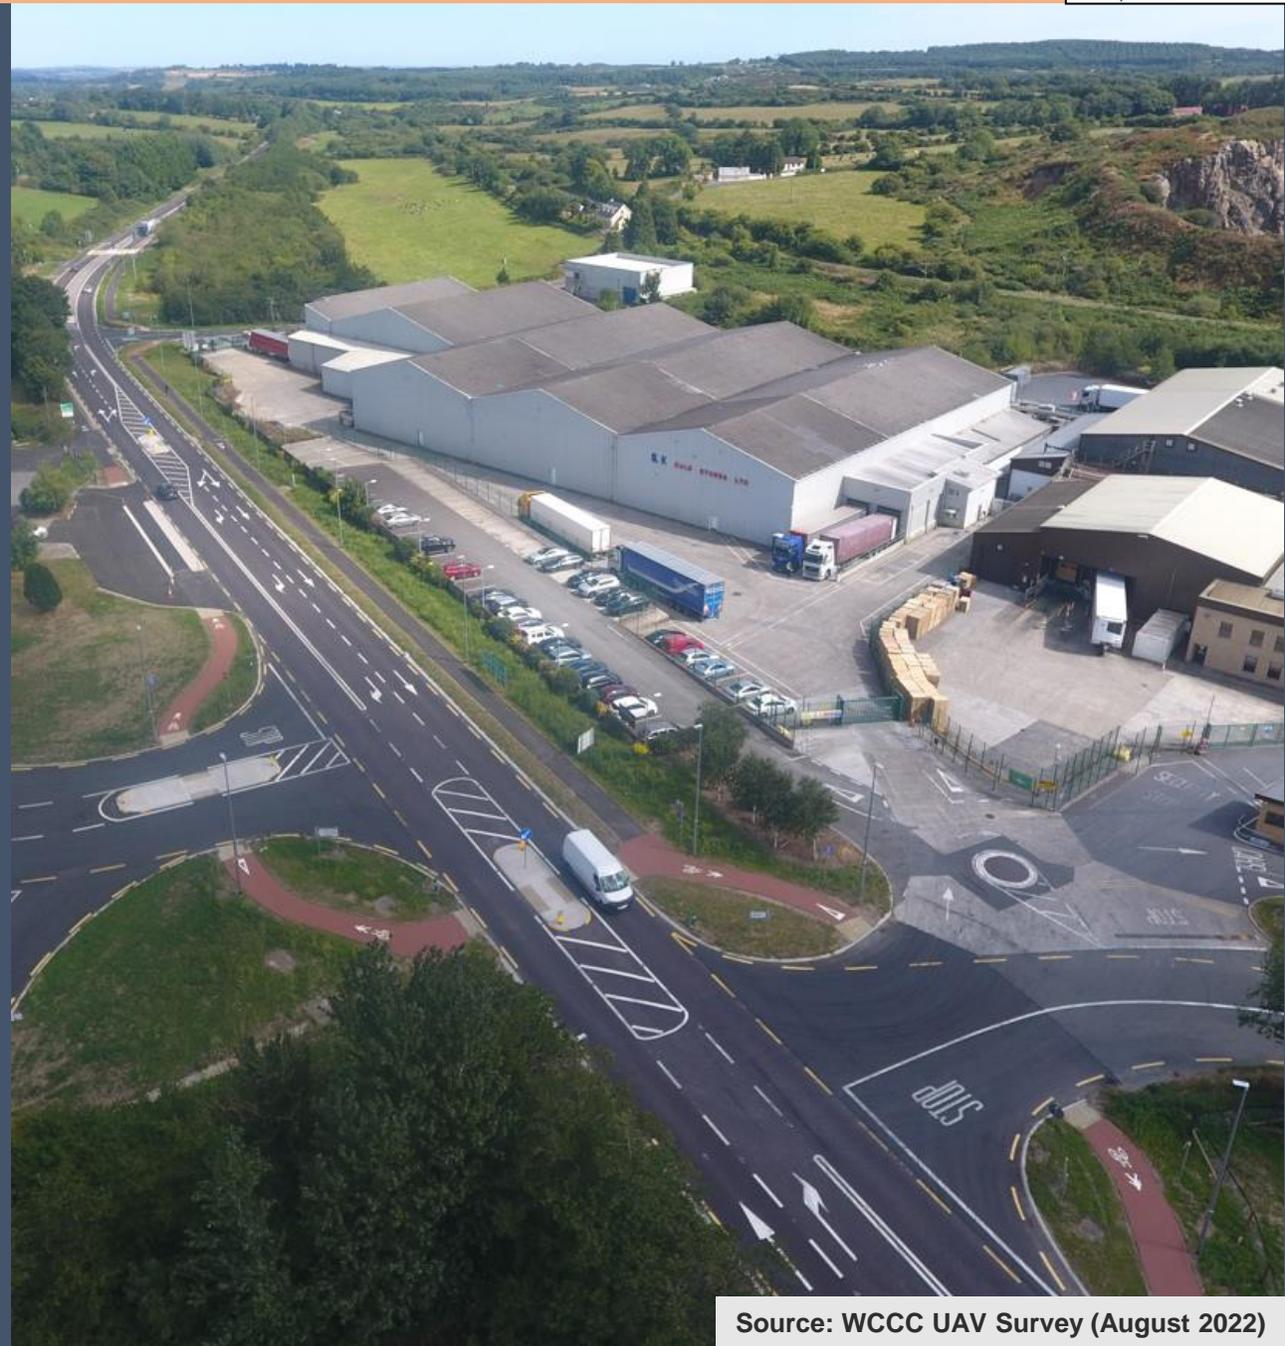
N25 Carroll's Cross – UAV Survey - Before/After

Source: TII UAV Survey (October 2019)

Source: WCCC UAV Survey (August 2022)

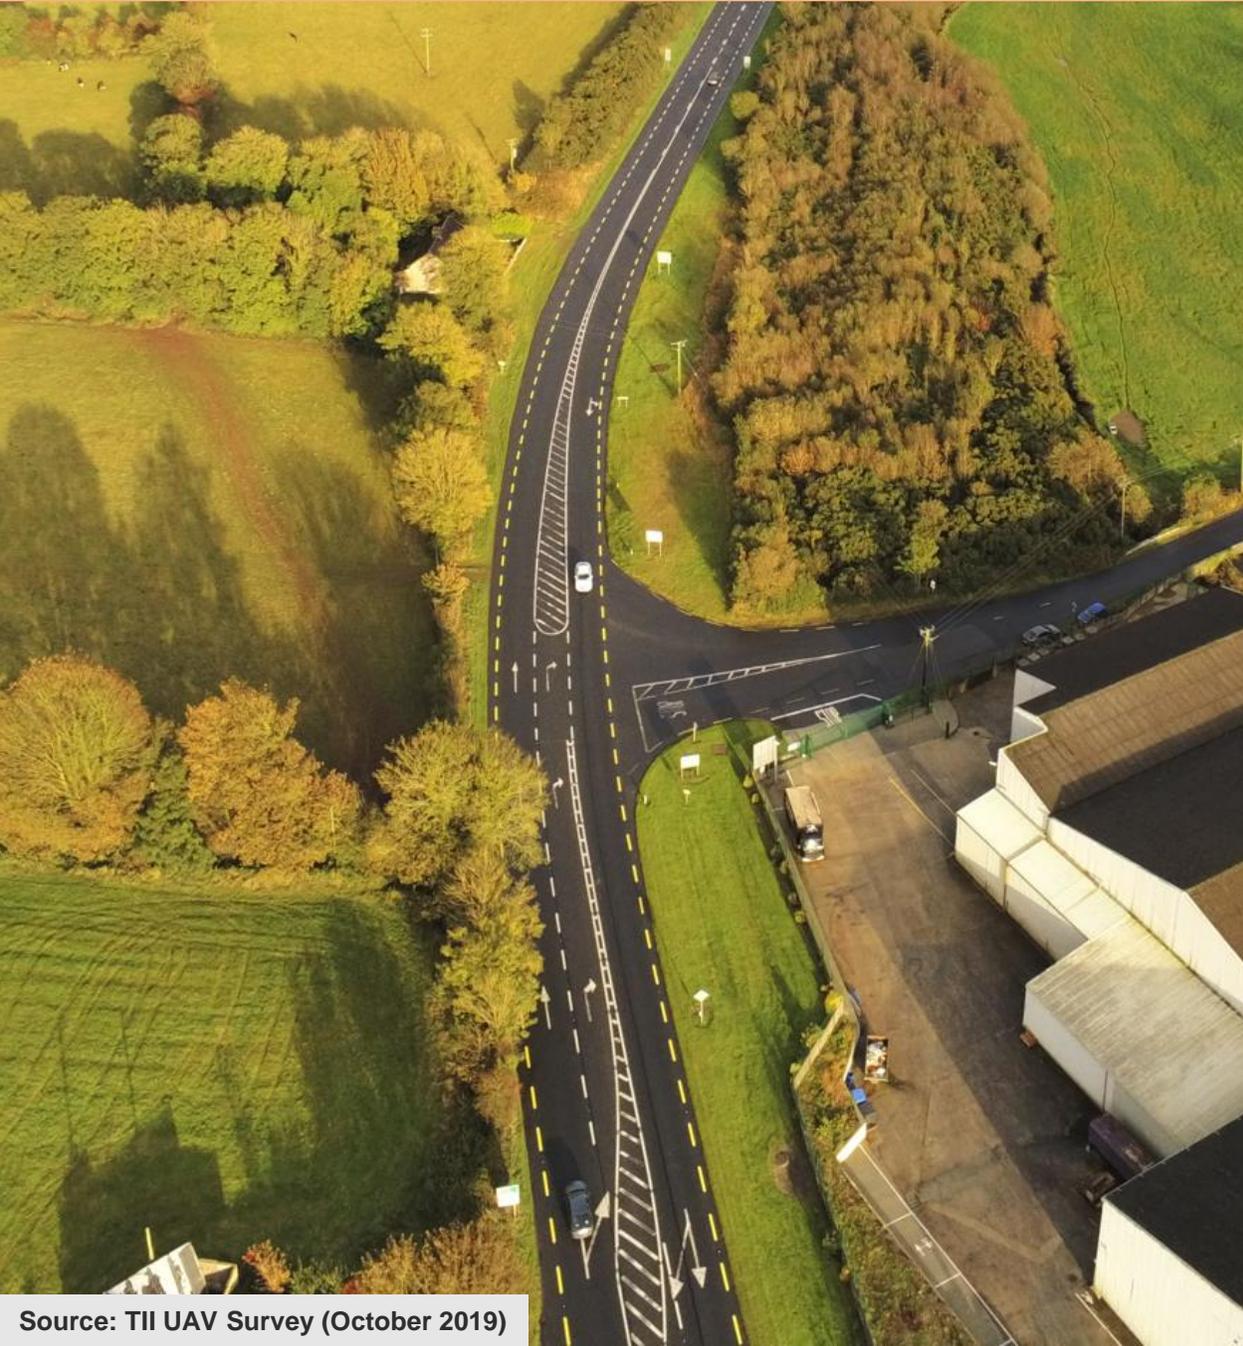
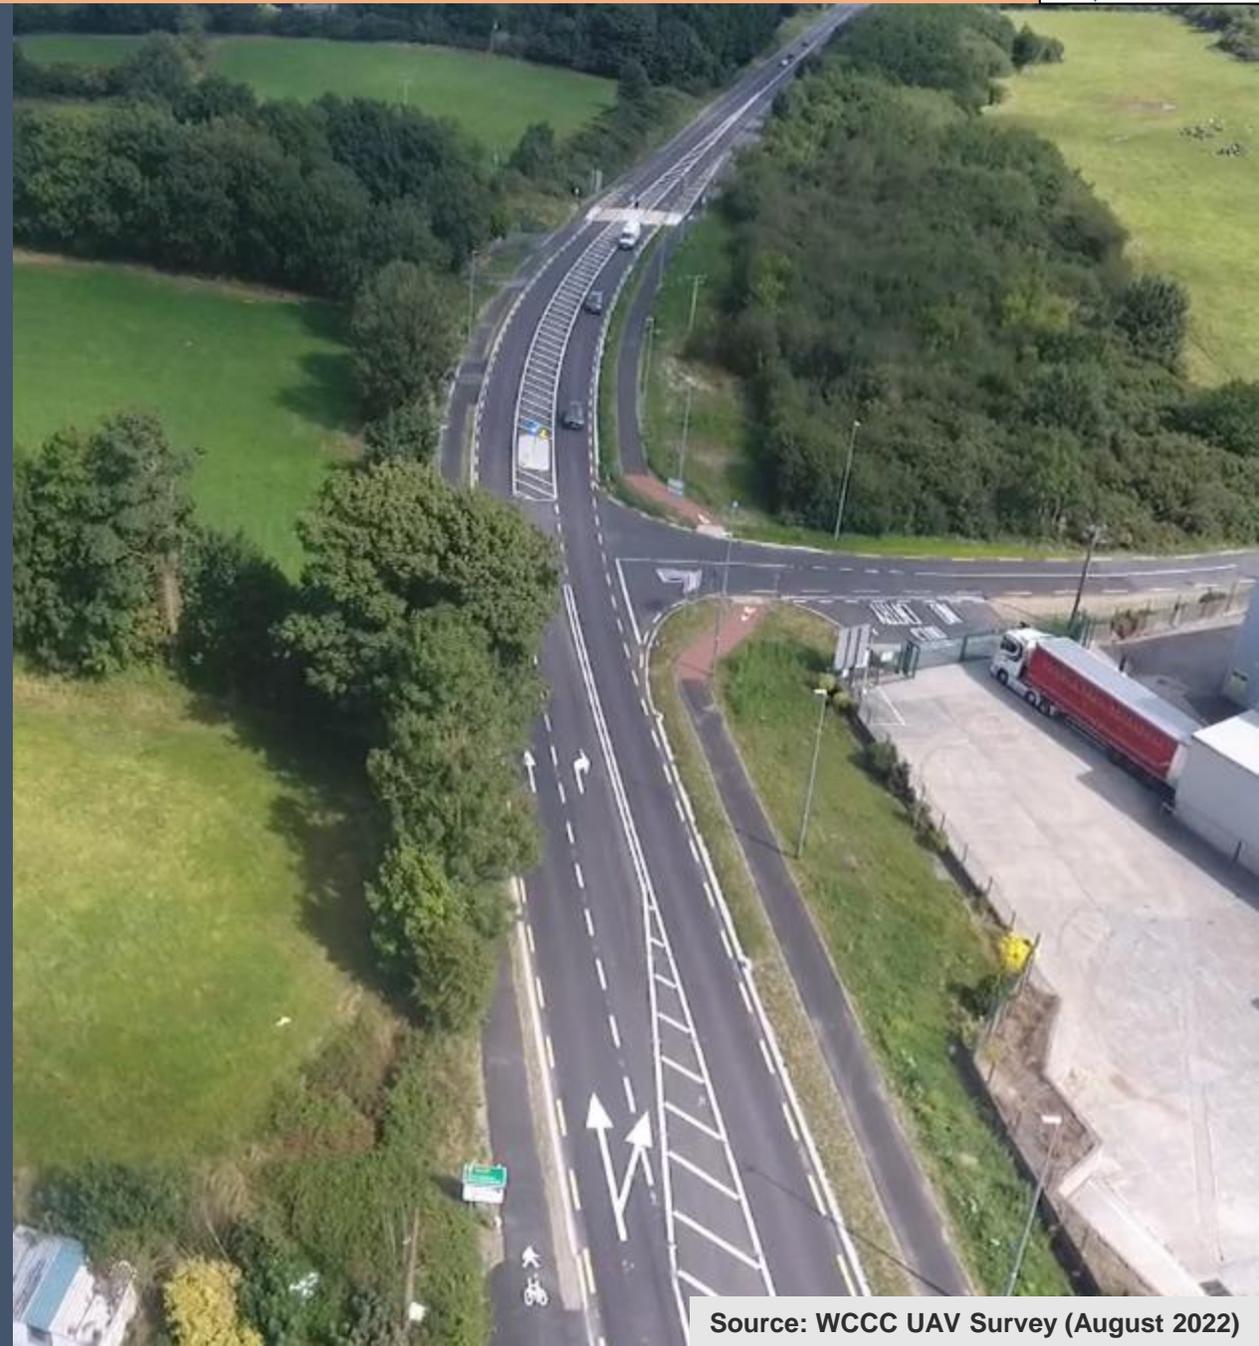
N25 Carroll's Cross – UAV Survey - Before/After

Source: TII UAV Survey (October 2019)

Source: WCCC UAV Survey (August 2022)
