# Munster Term Maintenance Contract No 3

Derreenamacken Bridge Ecology Note

Transport Infrastructure Ireland

31/08/2022

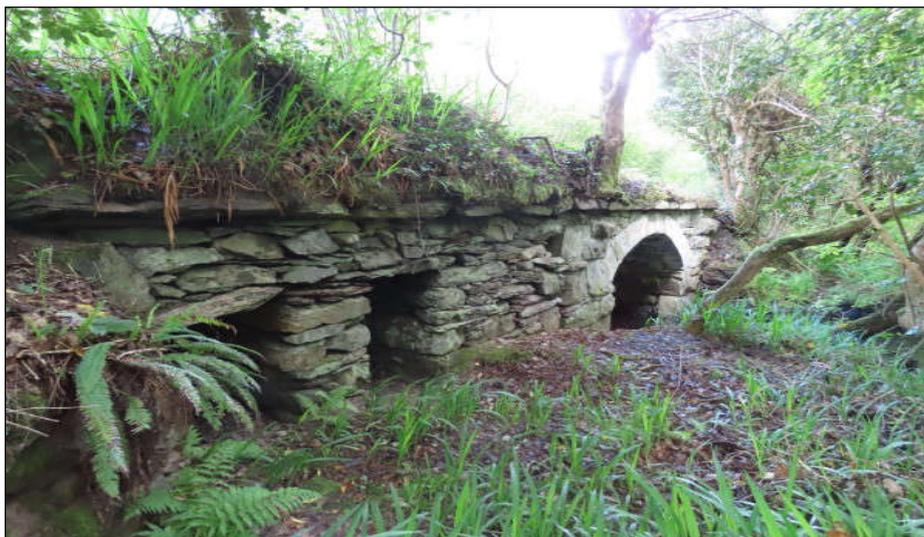
**Plate 1 Derreenamacken Bridge.**

The Derreenamacken Bridge is a single span stone masonry arch bridge with two stone culverts just west of the arch. The span is 3.04m. The substructure consists of 2 masonry abutments. There are no parapets on the structure. The structure is located 150m upstream of the Kenmare River SAC. Plate 1 shows the north elevation.

Derreenamacken Bridge was surveyed twice in 2020. On the first occasion a single Lesser horseshoe bat was recorded roosting under one of the stone culverts. This survey was followed up with a bat detector survey. Derreenamacken Bridge and surrounding watercourse are important foraging areas for Lesser Horseshoe bats. On 18/05/21 no bats were recorded roosting in the structure but a few bat droppings (most likely Lesser Horseshoe bat) were recorded on the floor of both culverts. A total of 7 crevices have been marked for retention under the arch. The culvert is characterised as being used intermittently as a resting site/feeding perch by small numbers of bats.

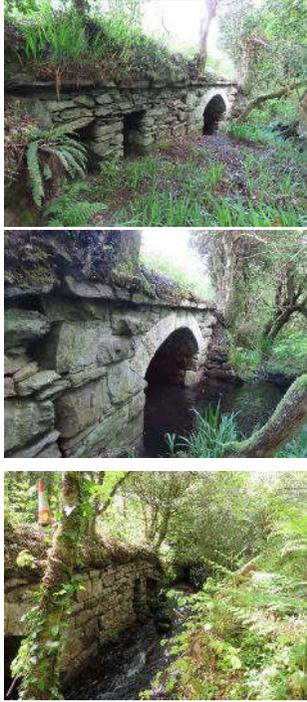
<p>No mention of otter in the bat survey report. Immediate environs of bridge sub-optimal location for an otterholt. [Lesser horseshoe bat were recorded at this structure]</p>
