**Transport Infrastructure Ireland (TII)**

## Characterisation of Calp Limestone in Dublin City Centre

### Summary Report

Job number 297502-00

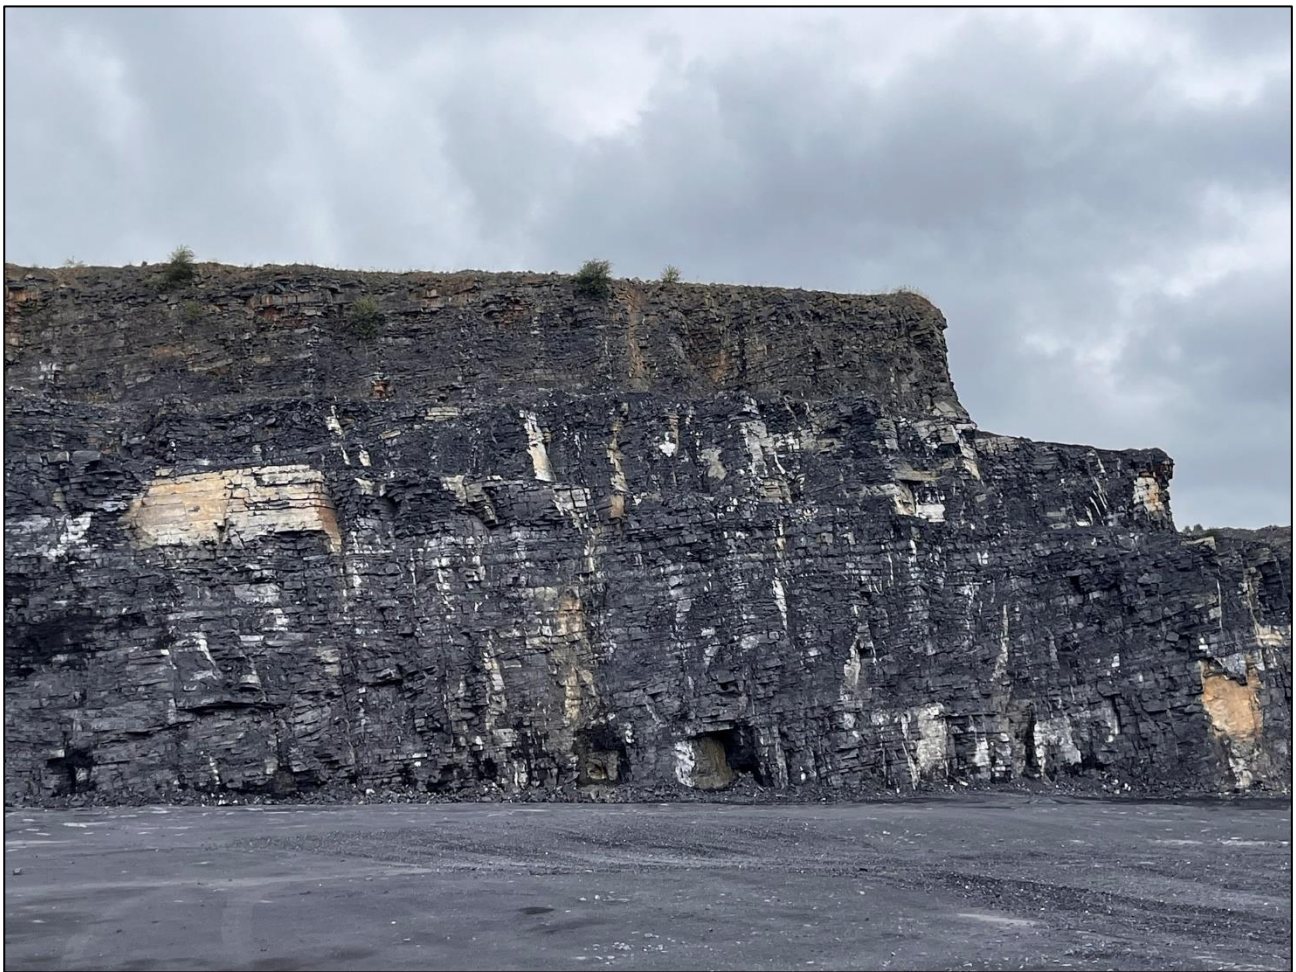
**Figure 1 Exposure of Calp Limestone at Belgard Quarry, west Dublin.**

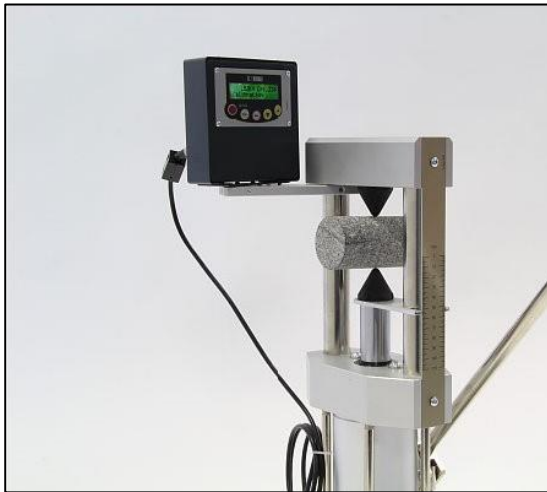
**Figure 22 Diametrical PLT** (<https://www.geotech.hr/en/point-load-test-plt/>).

Point Load testing (PLT) is an accepted rock mechanics method used to determine a rock strength index. It can be performed both in the laboratory and in the field. The simplicity and speed of the test allows an appreciable volume of testing to be conducted, making it a valuable tool for efficiently characterising rock material (**Figure 22**).

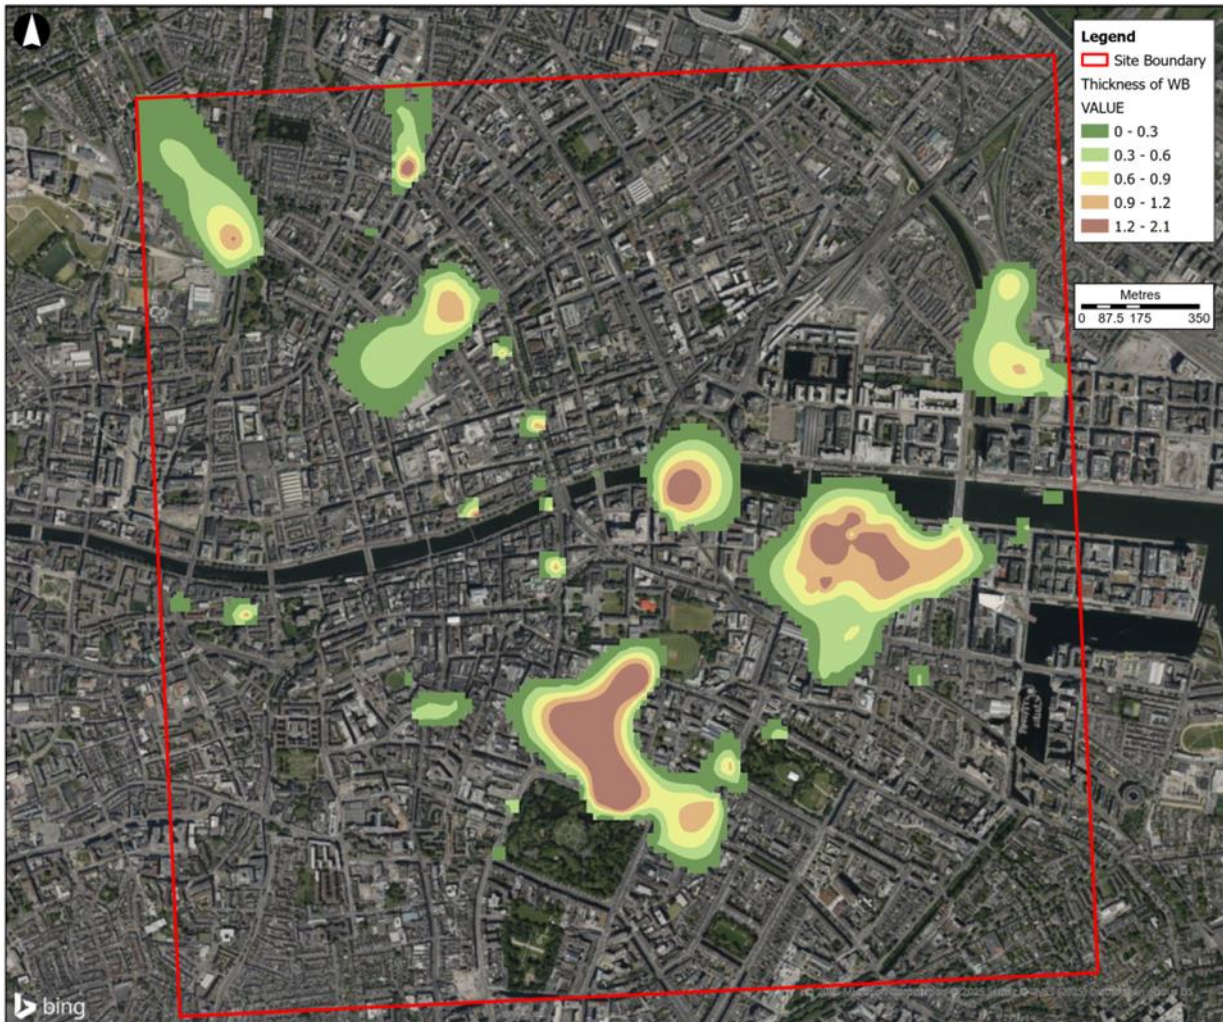
**Figure 32 Thickness of weathered bedrock generated in Leapfrog geological modelling software.**

Leapfrog® geological modelling software also allows for the creation of meshes that represent the thickness of specific lithological units, for example, weathered bedrock. The weathered bedrock was encountered in 65 boreholes out of 397 boreholes used for the model and, as illustrated in **Figure 32** below, the modelled thickness of ranges from 0 to 2.1 metres. The distribution appears irregular and does not exhibit a clear spatial trend across the study area. Instead, the weathered bedrock is concentrated in discrete clusters, primarily aligned with the footprints of major linear infrastructure projects. This pattern reflects a spatial bias in the input data, which is densest around proposed linear infrastructure works such as DART Underground, MetroLink, and Metro North. According to the heatmap, the areas where this layer is thickest are around St. Stephen's Green and the zone between Grand Canal Dock and Trinity College Dublin.

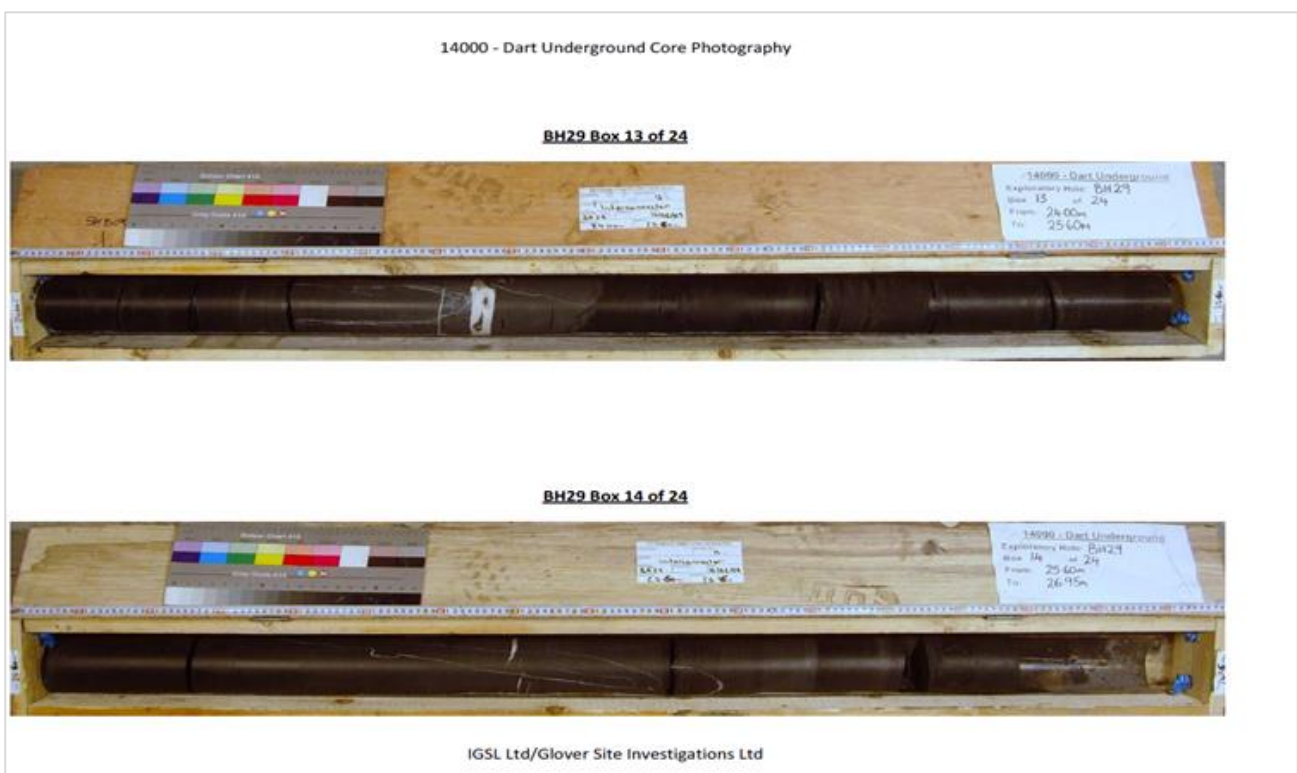
**Figure 54 Core photograph of DART Underground BH29 showing aperture range from open to wide (0.05m to 0.10m spacing) without infilling**

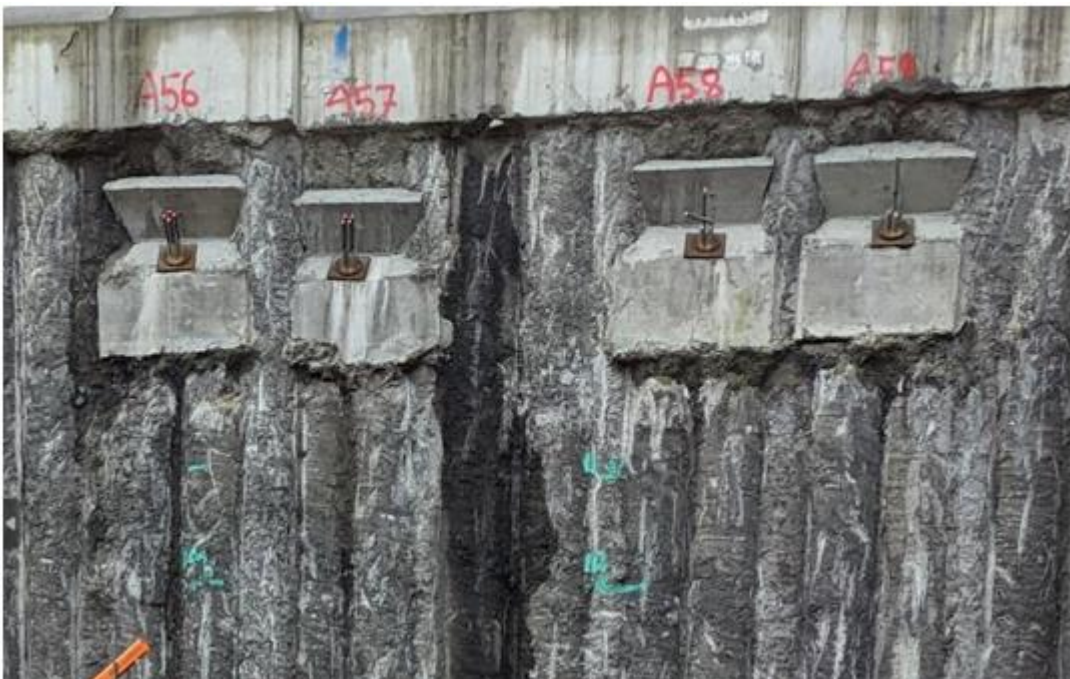
**Figure 71 Soft-soft-hard wall with anchors, eastern side of the site.**

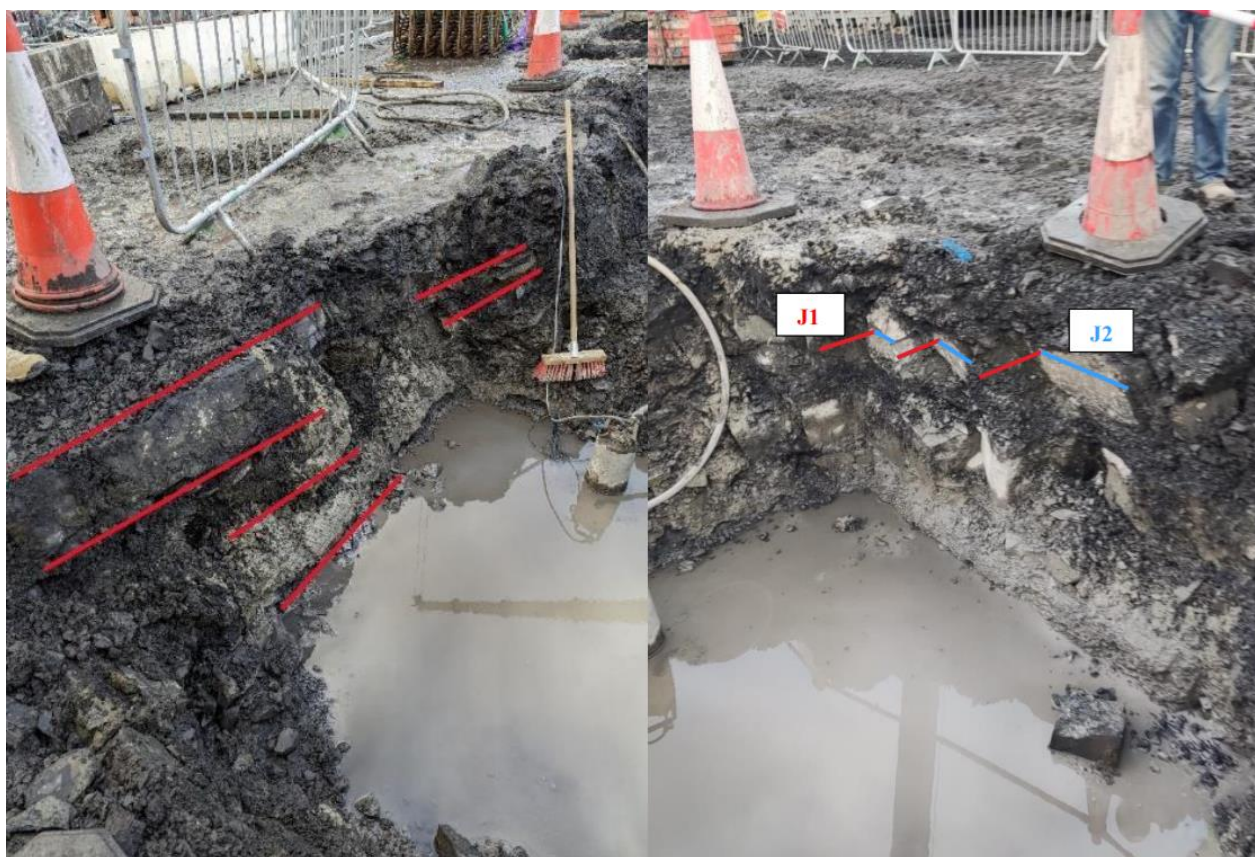
**Figure 72** On the left Image looking north-east into lift pit excavation and on the right Image looking northwest of lift pit excavation depicting the subvertical joints.

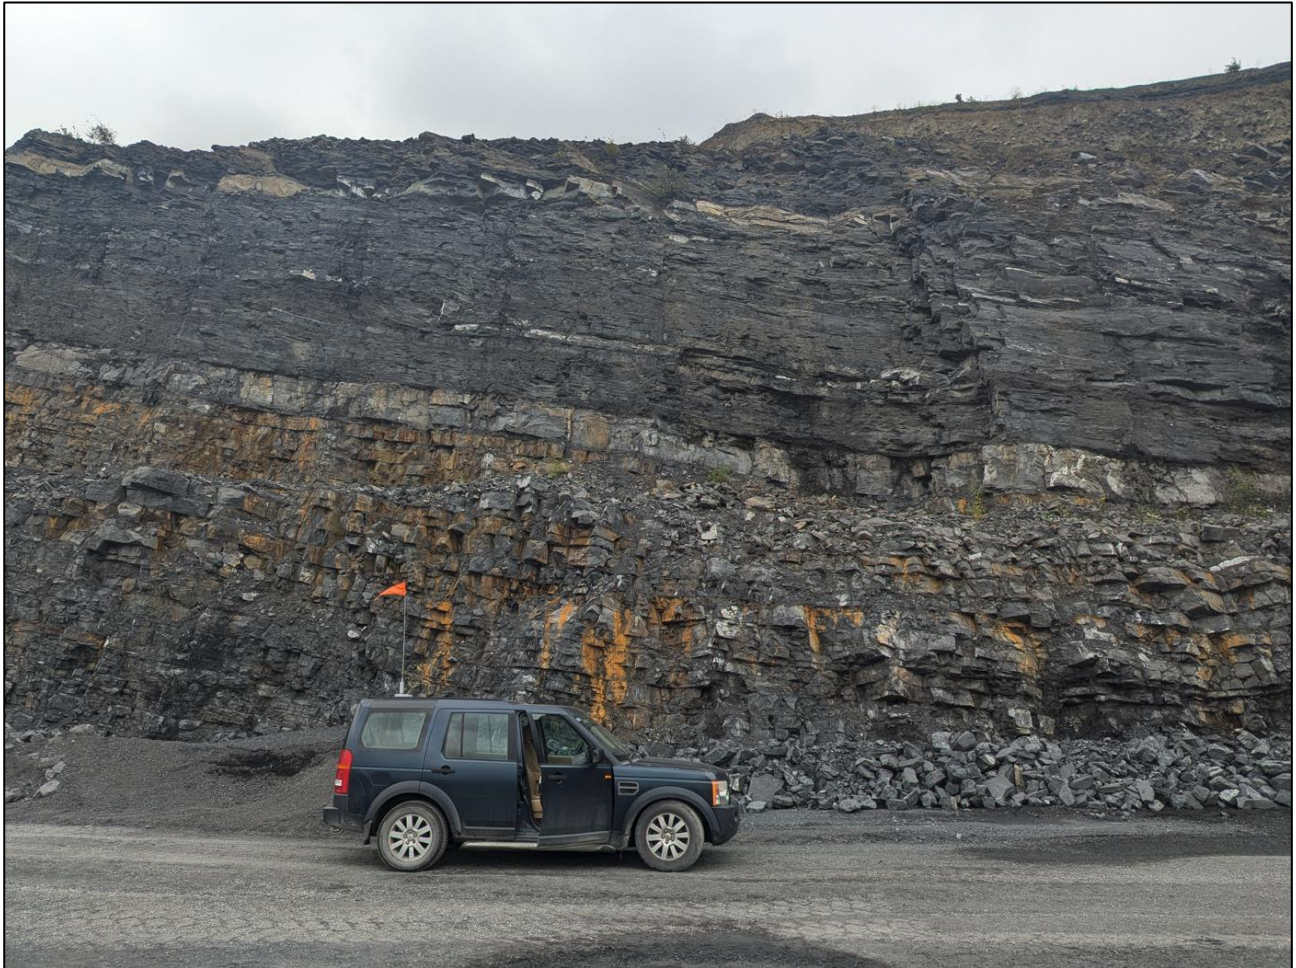
**Figure 81 Belgard Quarry (Location 2) – western section.**

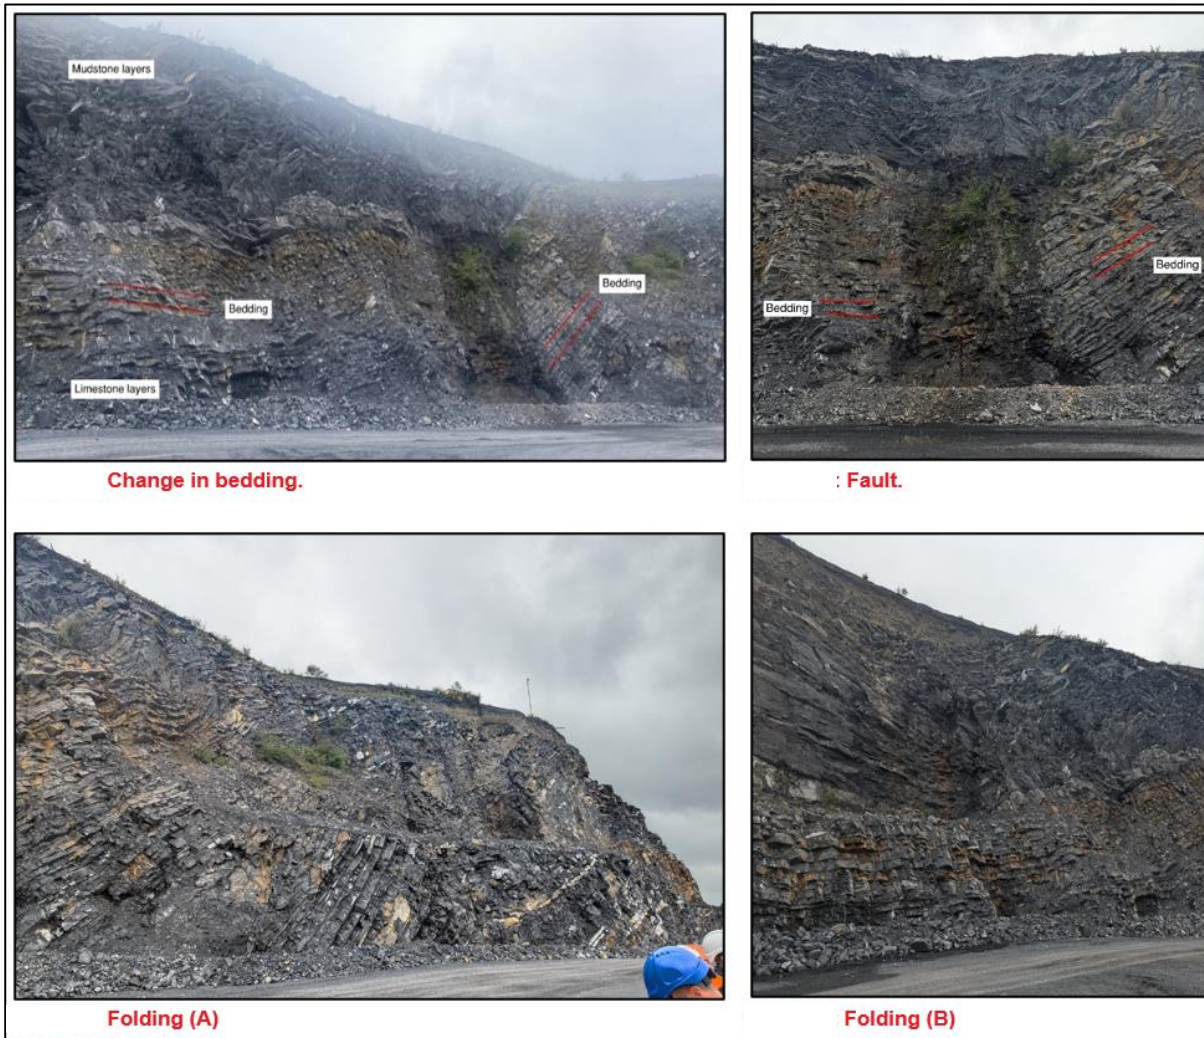
**Figure 82 Belgard Quarry (Location 2) – eastern section.**

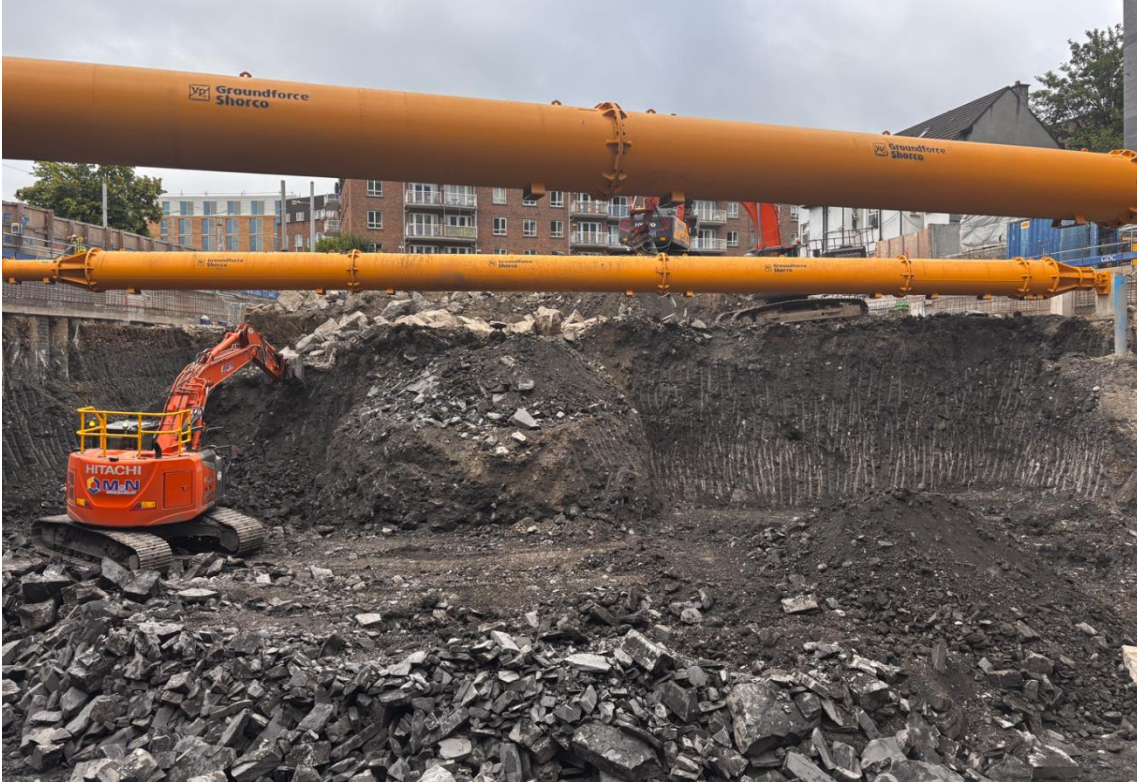
**Figure 85 Photograph of the face of the excavation.**

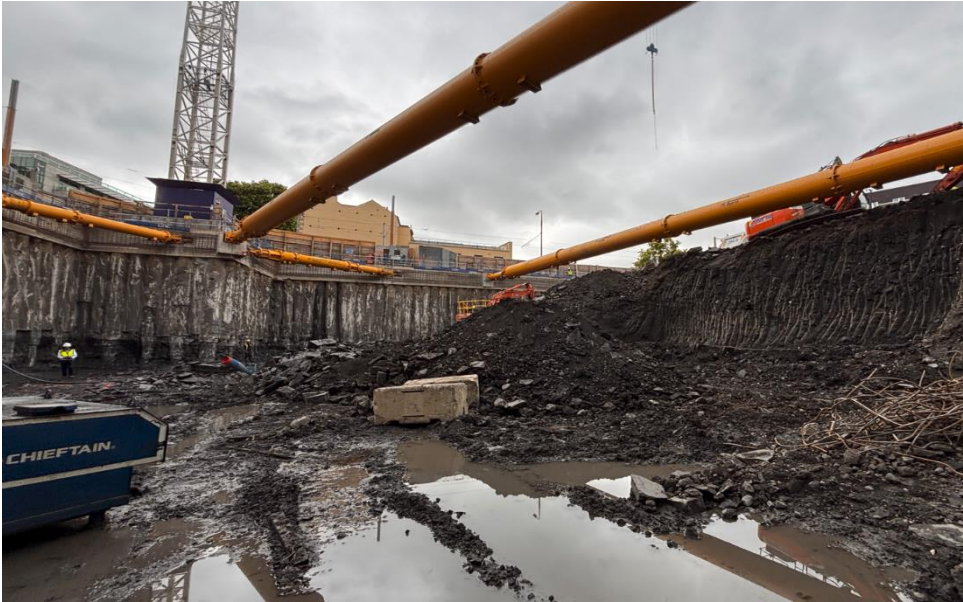
**Figure 86 Photograph showing the vertical faces of the excavation and the bedrock exposure at distance.**

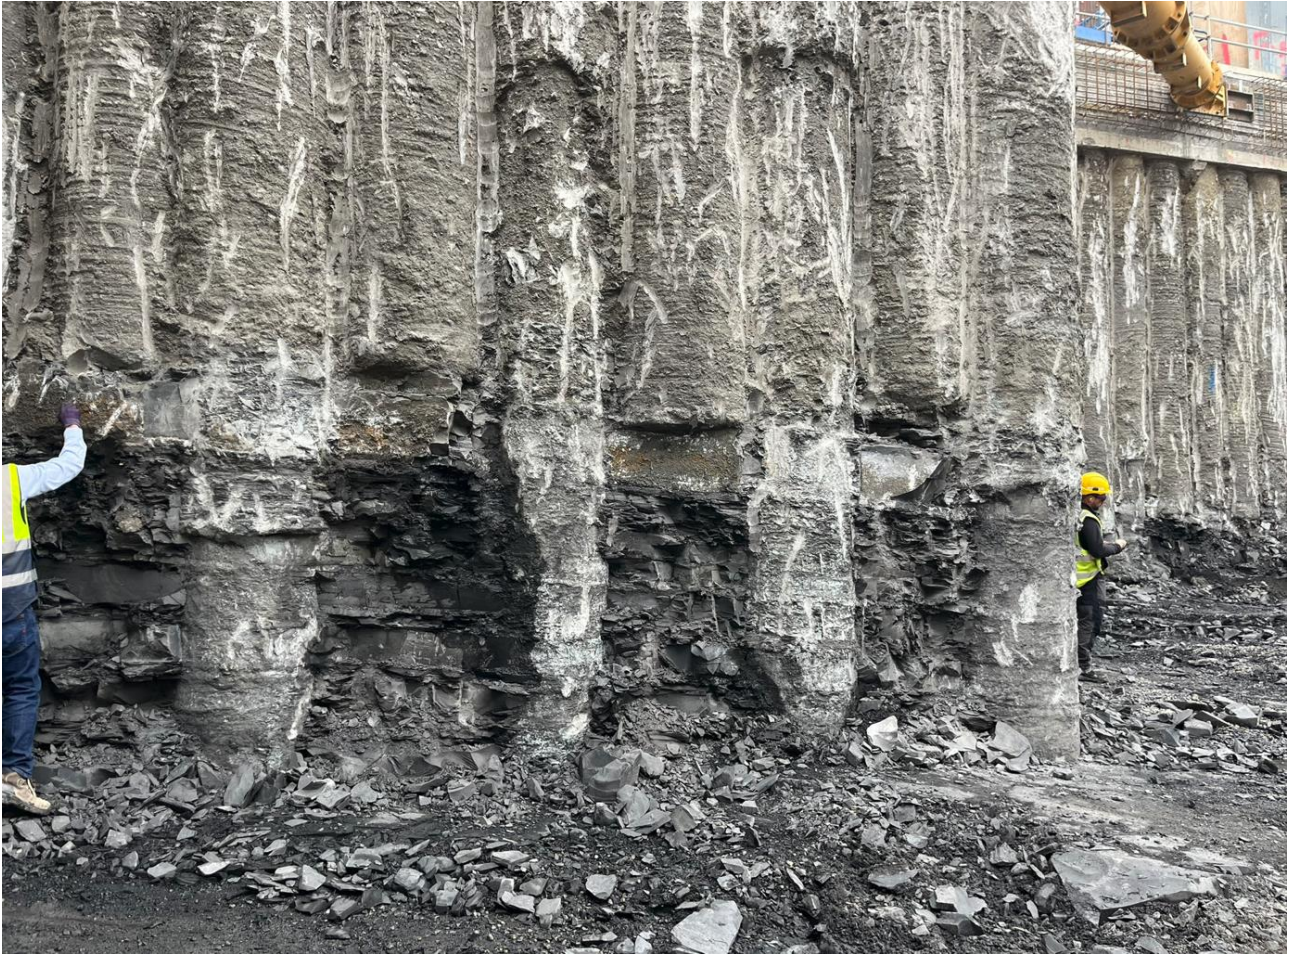
**Figure 87 Calp Limestone exposure at the One Adelaide Road site.**

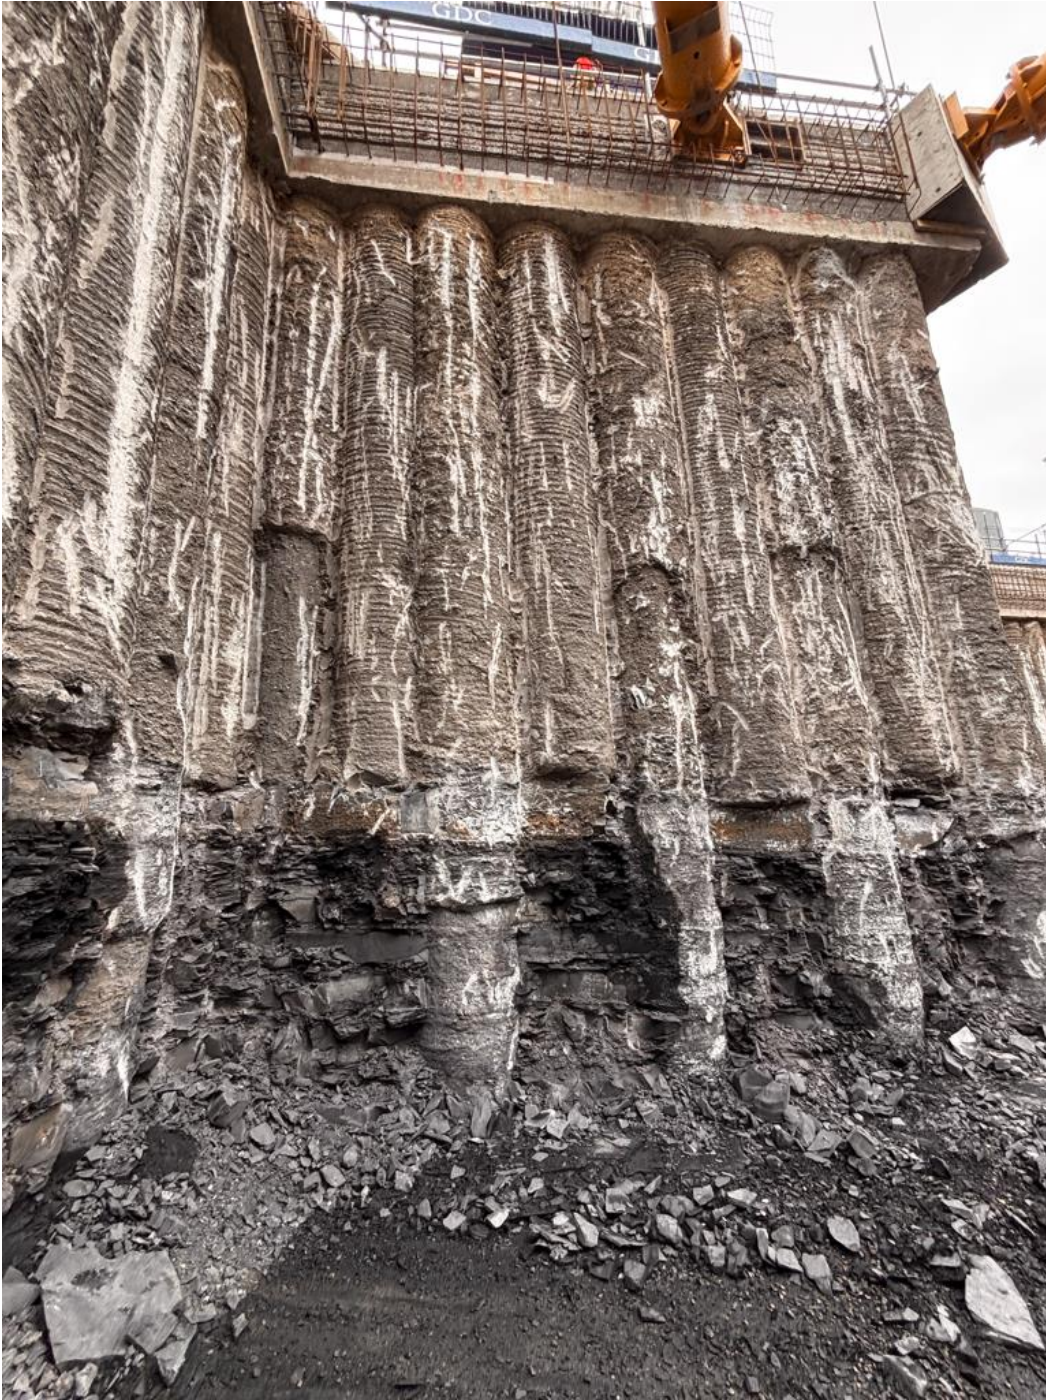
**Figure 88 Calp Limestone exposure at the One Adelaide Road site.**

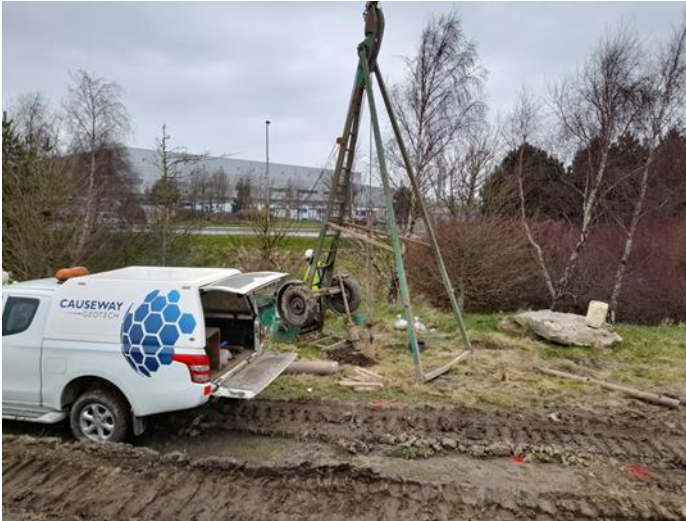
**Figure 100 Cable percussion borehole set up.**

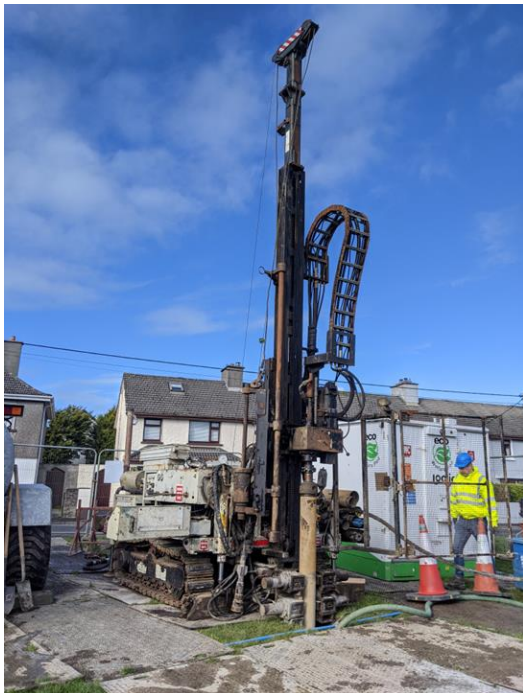
**Figure 101 Rotary drilling in residential/urban environment.**

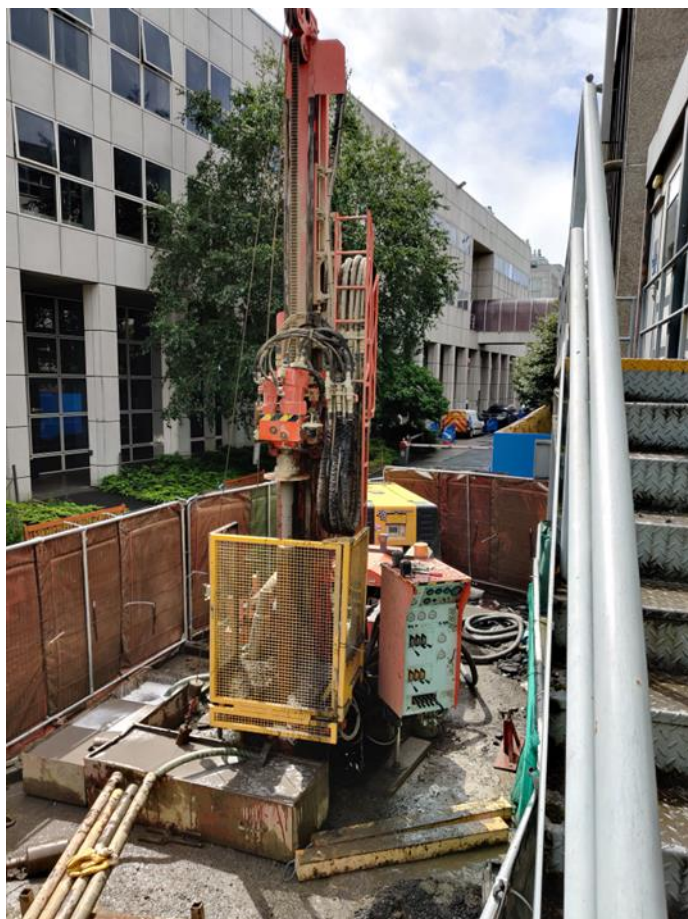
**Figure 102 Geobore-S in use in urban environment.**

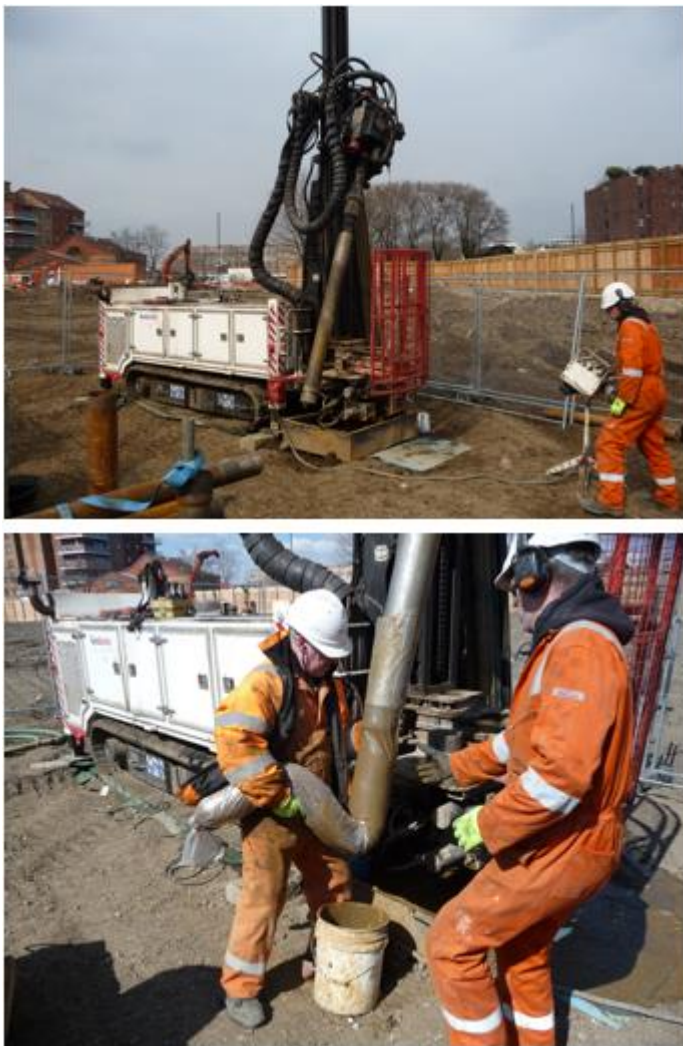
**Figure 103 Sonic Drilling**

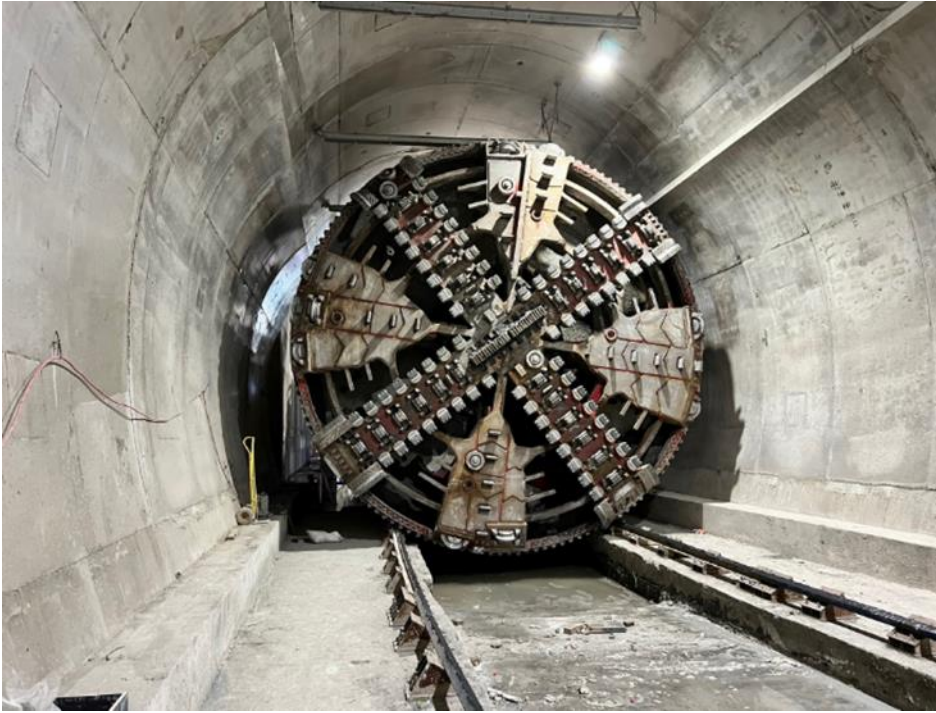
**Figure 112 TBM Cutter Head used in New Zealand's City Rail Link in Auckland (City Rail Link, 2022).**
