LEINSTER BRIDGES NON-ROUTINE MAINTENANCE

AA Screening Report

Castlecomer Bridge (KK-N78-007.00)

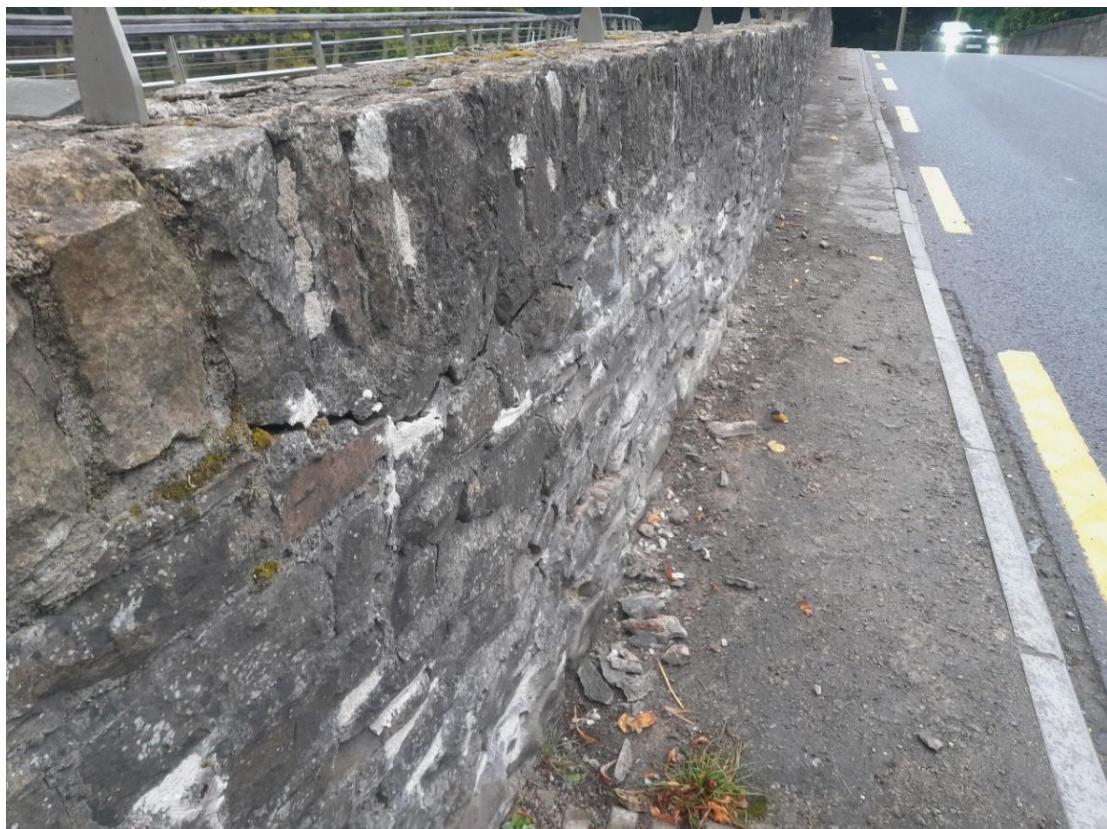
Plate 1

Northern parapet with footbridge visible in the background.

Castlecomer Bridge was damaged by a vehicle strike on the northern and southern parapets. On the northern parapet, the existing facia stone on the roadside of parapet will be removed and replaced (900mm long and 700mm high from ground level), starting from the existing bollard (no. 1022) in an easterly direction. The joint will be repointed (700mm long and 300mm high starting at a point 700mm from GL). The works to the northern parapet will be undertaken from the roadside.

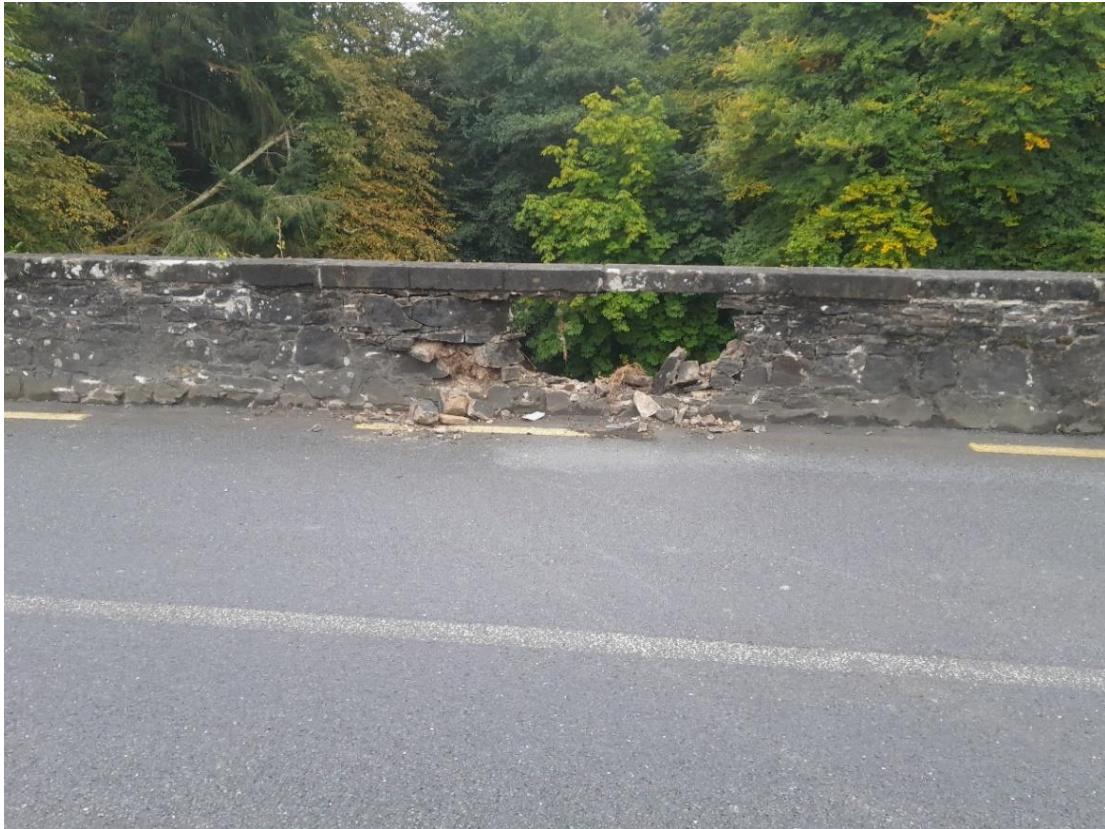
Plate 2

Recently, a collision led to damage to both parapets. The damage to the northern parapet is limited to cracked masonry joints, whereas the southern parapet has a large hole.

Southern parapet with damage resulting from vehicle strike.

On the southern parapet, the existing capping stone will be infilled and reconstructed. The parapet will be reconstructed (3400mm long x 900mm high x 530mm wide) with the dislodged stone, which has been knocked into river, and will be recovered. The recovery of the stone will be undertaken on foot. No machinery is permitted in the watercourse. If the quantity of existing stone recovered from the river is not sufficient to complete the reconstruction works, a stone of a similar nature and type as the existing one will be sourced from local quarries. The reconstruction of the southern parapet will include pointing with lime mortar. The works on the southern parapet will be completed from the roadside of the parapet and from the river side, using an underbridge unit.

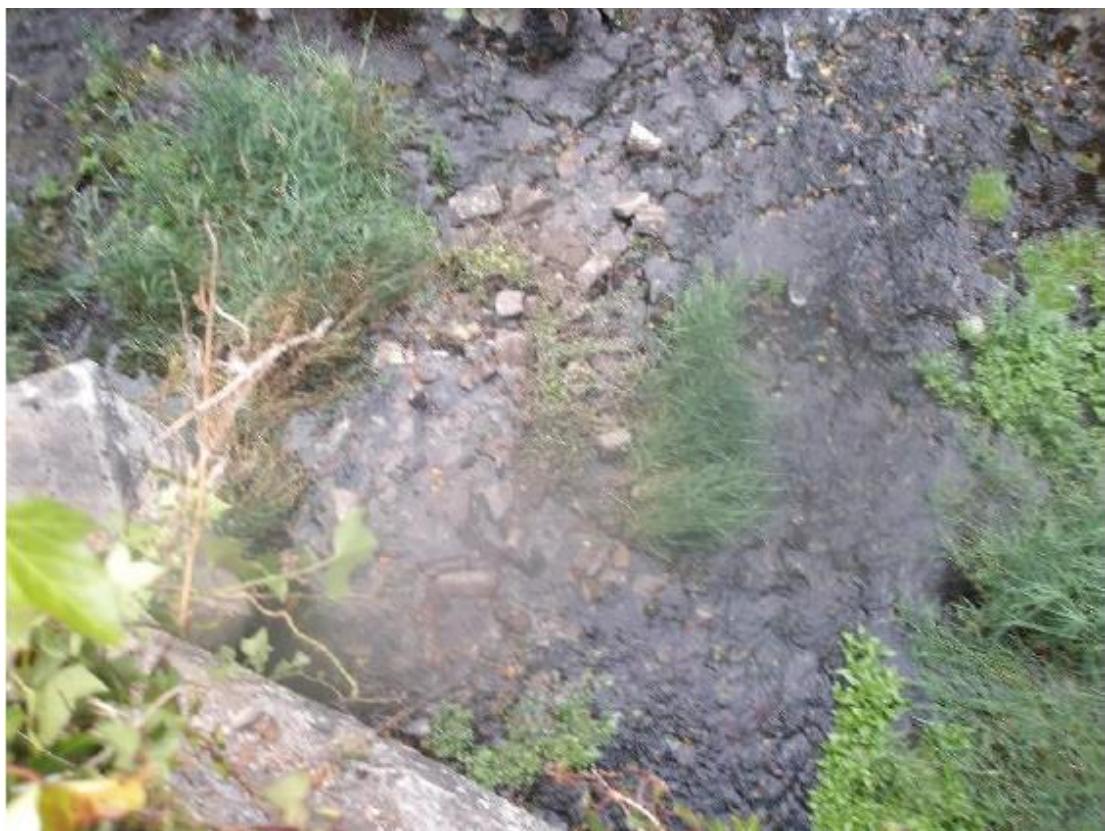
Plate 3

Stone from the parapet on the bridge apron below the structure.

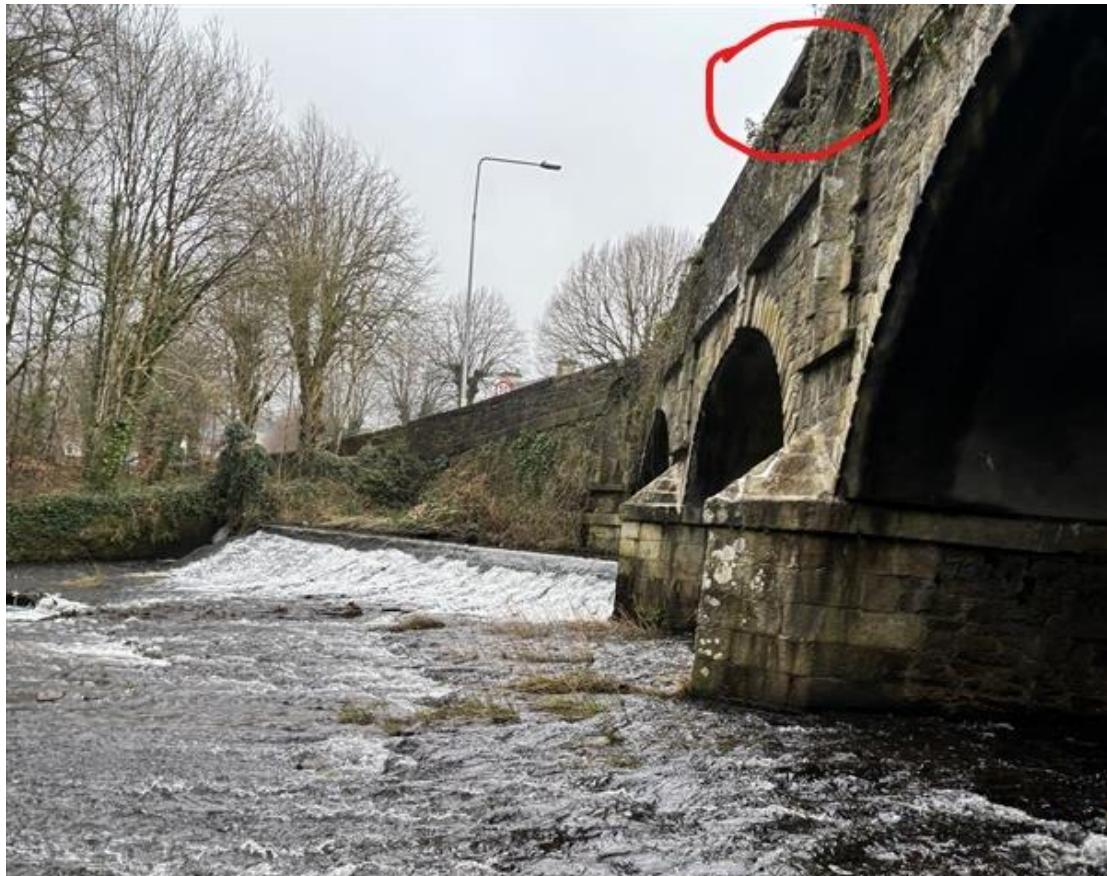
Plate 4 Castlecomer Bridge with damage to southern parapet circled in red.

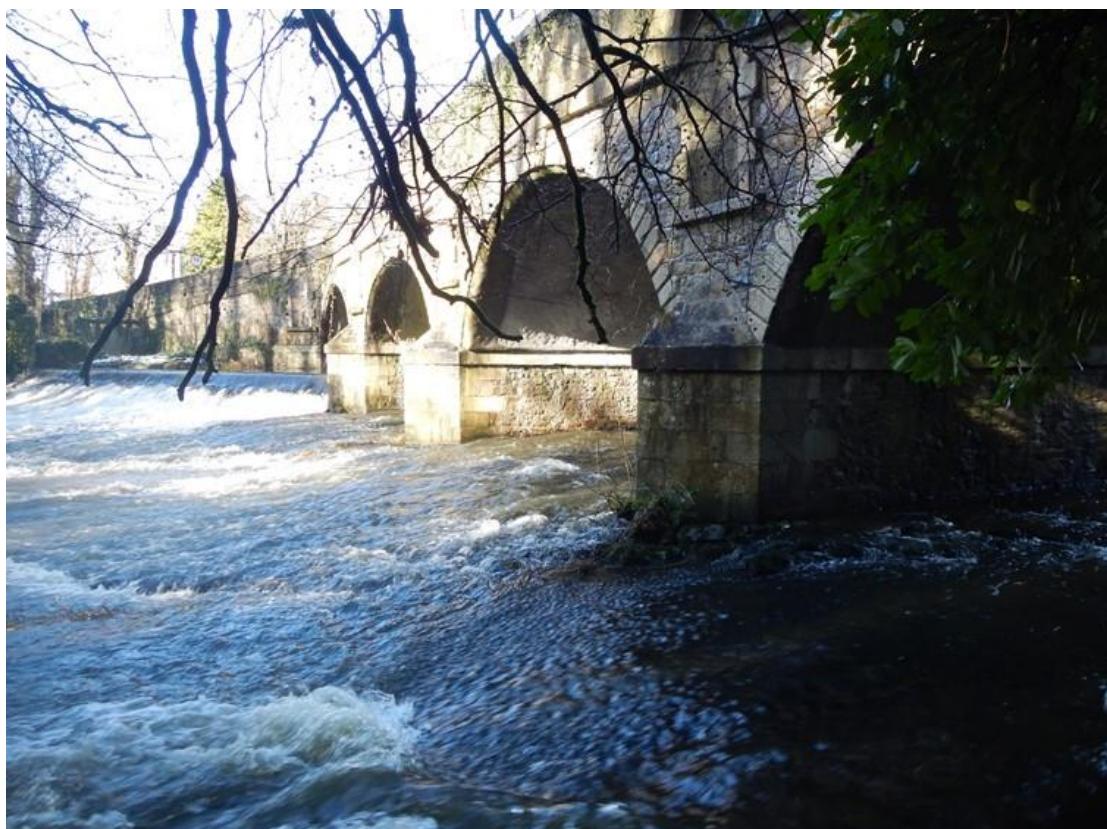
Plate 5 Southern / downstream side of Castlecomer Bridge.

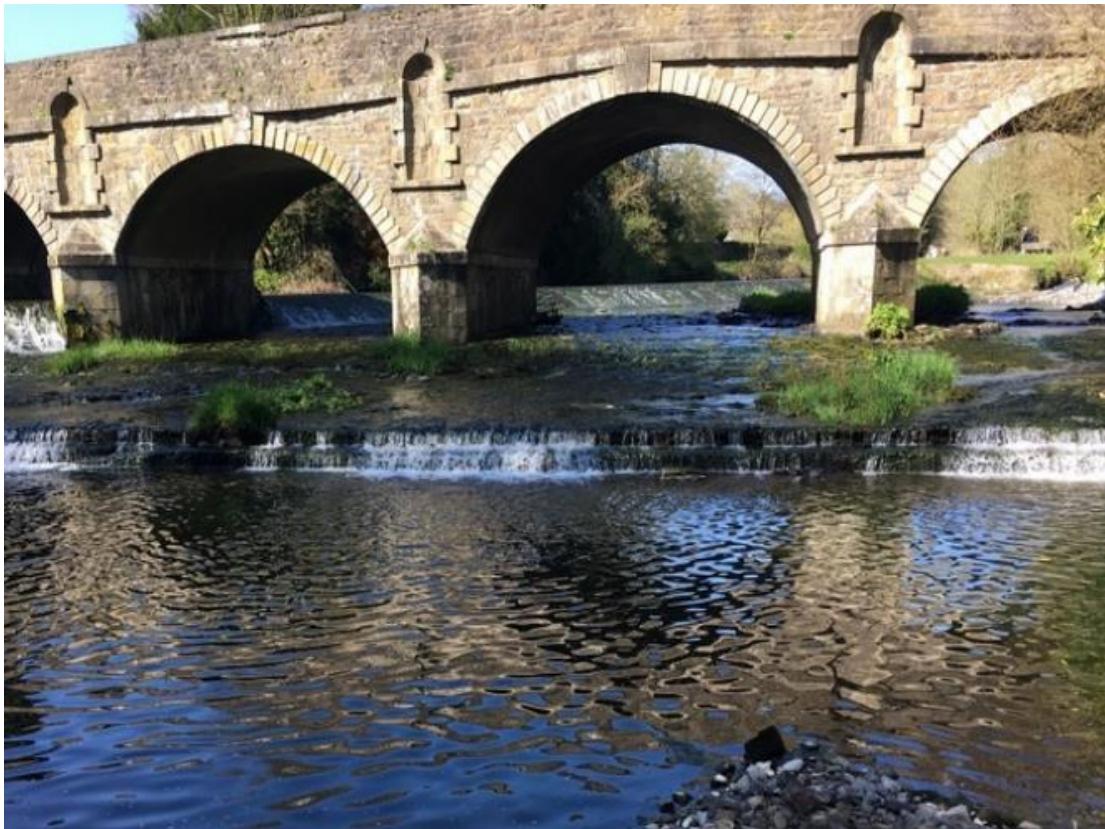
Plate 6

Castlecomer Bridge is a 5-span masonry arch bridge spanning the River Dinin, east of Castlecomer, Co. Kilkenny. The bridge is 40m in length with each span c. 7m long. The eastern span is on dry land. A weir runs diagonally across the river, through the western span. The arch barrels have all had gunite/ shotcrete added. The structure has a masonry apron extending to c. 5m downstream of the structure.

Downstream of bridge showing masonry apron.
