# NW Term Maintenance Contract No.3

Year 3 Structures – Natura Impact Statement  
Transport Infrastructure Ireland

12/03/2021

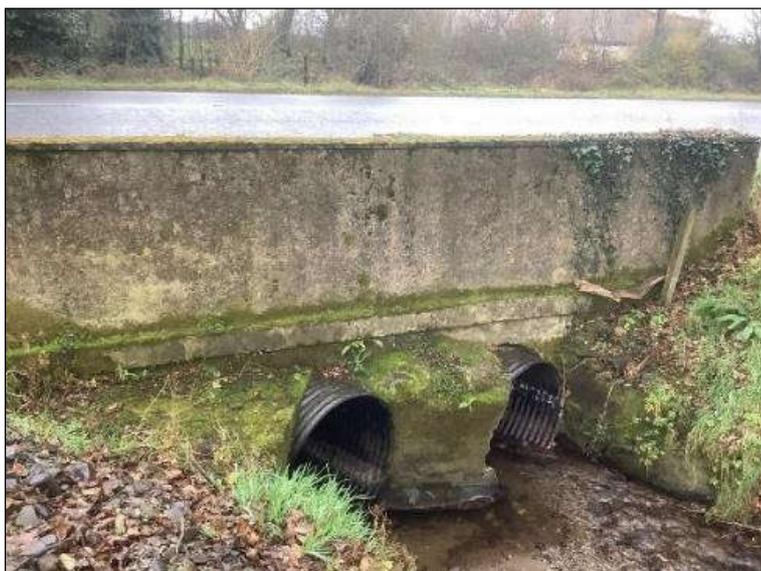
**Plate 2-1** Castlecooley Bridge.

The 2-span bridge crosses the Carrowen River. The bridge comprises a concrete structure with steel pipe culverts. There are concrete parapets on both sides of the carriageway. The bridge is located 3.7km upstream of Lough Swilly SAC and 700m of Lough Swilly SPA. Plate 2.1 shows Castlecooley Bridge.

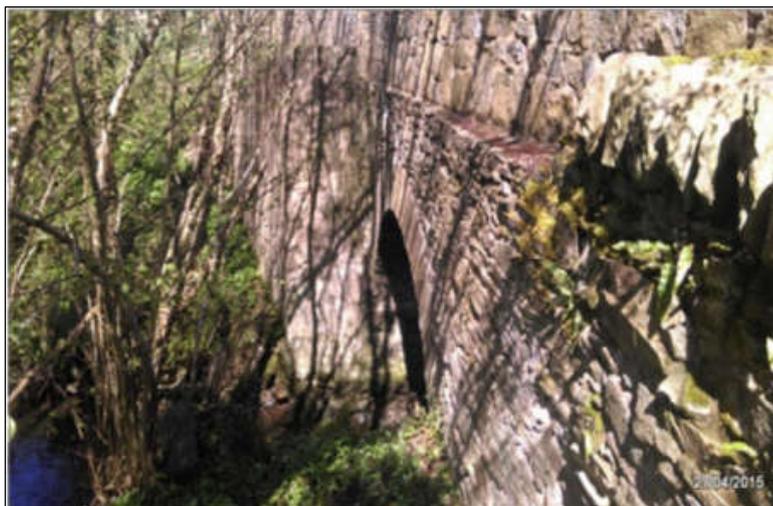
**Plate 2-2** Whitecross Bridge / Annie Tourish.

The Whitecross / Annie Tourish Bridge is a single span masonry arch bridge. The span is 4.08m. The substructure consists of 2 masonry abutments. There are masonry parapets on both sides of the carriageway. The structure is located 9.5km upstream of the River Finn SAC. Plate 2-2 shows the west elevation.

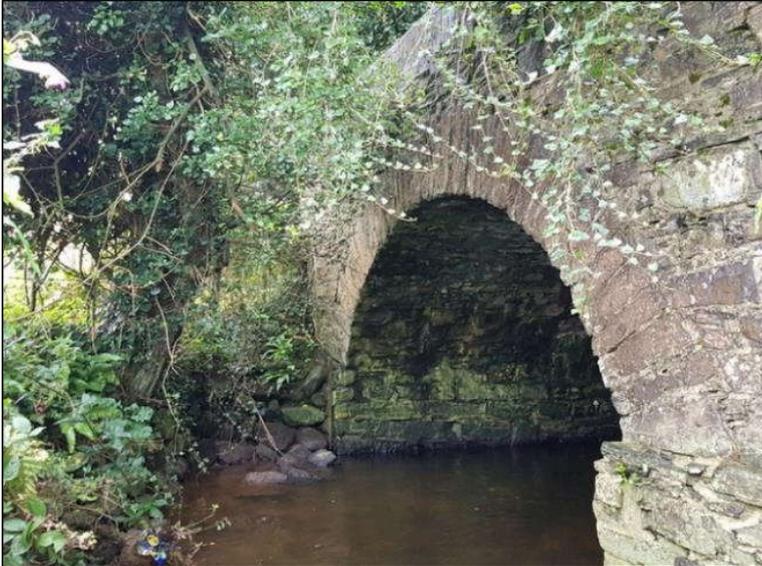
**Plate 2-3** Tullyrap Bridge.

Tullyrap Bridge is single span masonry arch bridge with masonry parapets along the carriageway. The Drumbeg River flows below the bridge. The structure is located 8.3km upstream of River Finn SAC. Plate 2.3 shows the bridge.

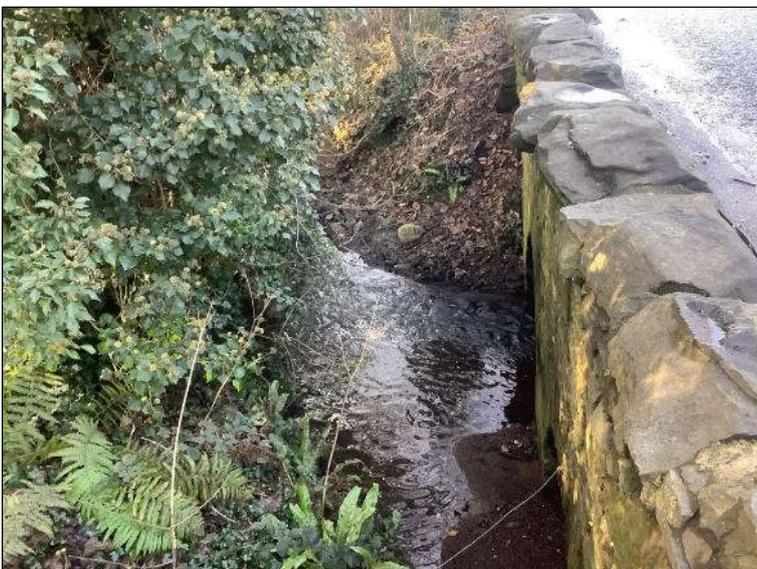
**Plate 2-4** Corcam Bridge.

Corcam Bridge is a single span masonry bridge. An unnamed EPA drain flows below the bridge and enters the River Finn downstream. Masonry parapet walls are present either side of the roadway. The structure is located 500m upstream of River Finn SAC. Plate 2.4 shows the bridge.

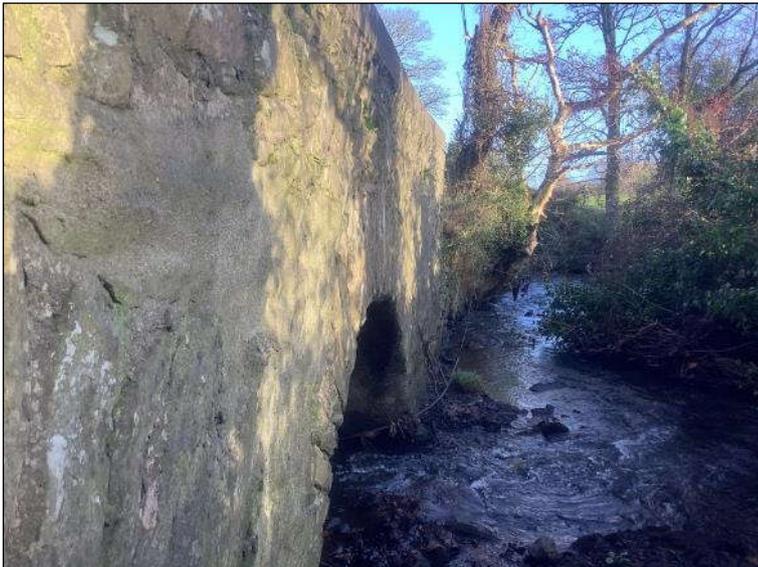
**Plate 2-5** Mullandrait Bridge.

Mullandrait Bridge is a double span masonry bridge. The Mullaghagarry River flows below the bridge. Masonry parapet walls line either side of the roadway. The structure is located 0.1km upstream of River Finn SAC. Plate 2.5 shows the bridge.

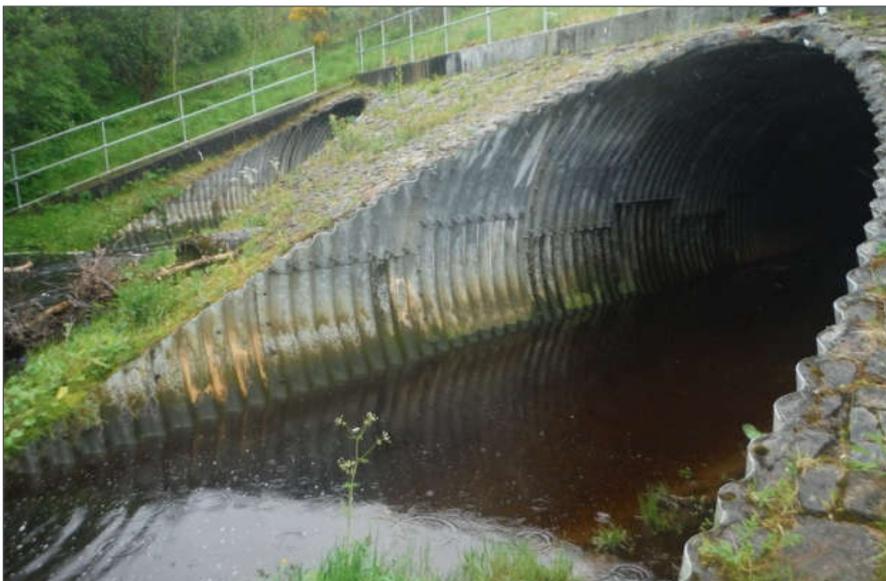
**Plate 2-6** Drumrath Bridge.

The structure is comprised of 2 corrugated steel pipes with 3.95m diameter each. There is steel safety barrier on both sides of the carriageway and a light steel railing on the headwalls. The structure carries the N15 over the River Drumenny. The structure is within Lough Eske and Ardnamona Wood SAC and located 3.2km upstream of the Donegal Bay SPA. Plate 2-6 shows the east elevation.

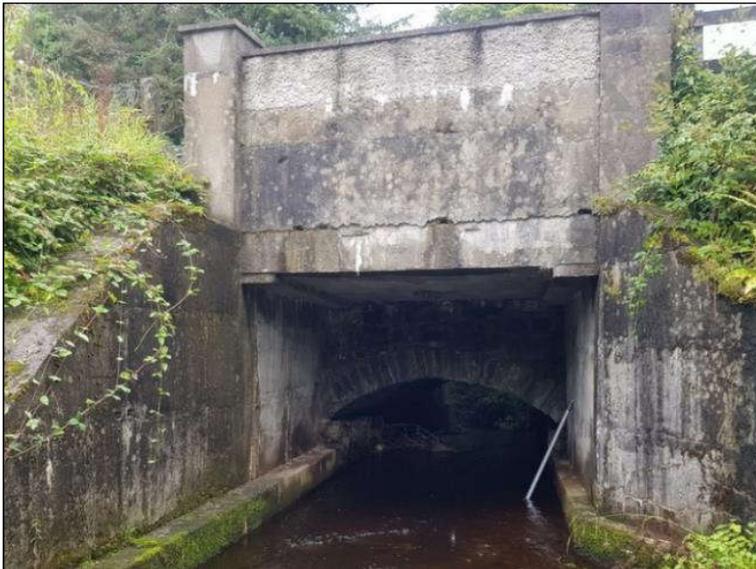
**Plate 2-7** Laghy Village Bridge.

Laghy Village Bridge is concrete slab with masonry arch substructure single span bridge. Concrete parapets are present along the carriageway. The bridge spans the Tullywee River 1.3km upstream of Donegal Bay (Murvagh) SAC and 1.7km upstream of Donegal bay SPA. Plate 2.7 shows Laghy Village Bridge.

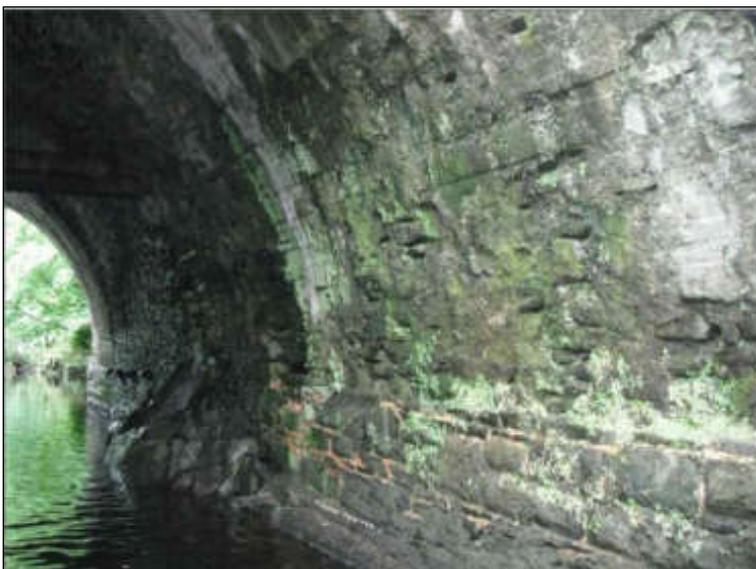
**Plate 2-8** Glenties Bridge.

The Glenties Bridge is a 7.23m single span bridge with masonry parapets. The abutments and parapets are also masonry. There is no guard rail in place. The bridge is located within the West Of Ardara / Maas Road SAC. Plate 2-8 shows the northern abutment.

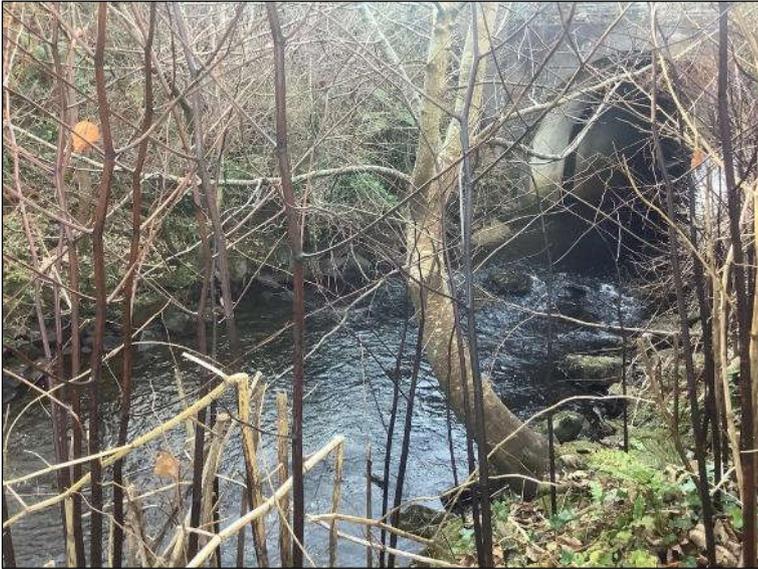
**Plate 2-9** Clon Bridge.

Clon Bridge is a single span masonry arch bridge which carries the N56 road across the Faymore River via a single span concrete bridge. Masonry parapets line the carriageway. Sheephaven SAC is located 600m downstream of the bridge. Plate 2.9 shows Clon Bridge.

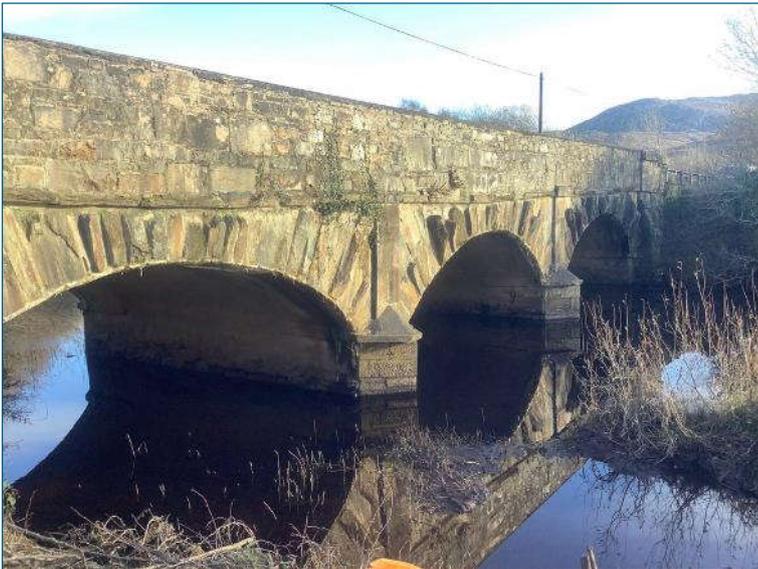
**Plate 2-10** Owencarrow River Bridge.

The Owencarrow River Bridge is a 3-span masonry bridge which carries the N56 over the Owencarrow River. Masonry parapets line the road. The bridge is located within the Cloghernagore Bog and Glenveagh National Park SAC. Derryveagh and Glendowan Mountains SPA is located 3.7km downstream of the bridge. Plate 2.10 shows the bridge.

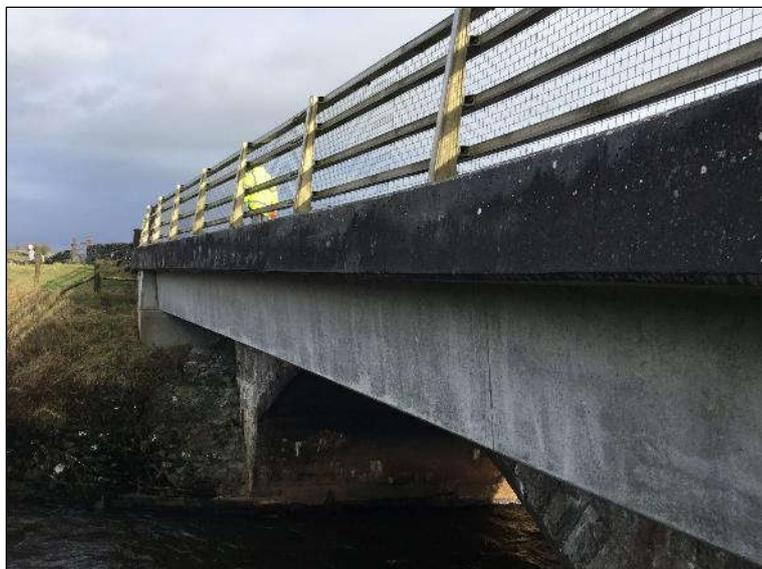
**Plate 2-11** Cloonmore Bridge.

Cloonmore Bridge is a concrete and masonry single span bridge which carries the N83 over the Clare River. Steel safety barriers line the road. The bridge is located within Lough Corrib SAC. Plate 2.11 shows Cloonmore Bridge.

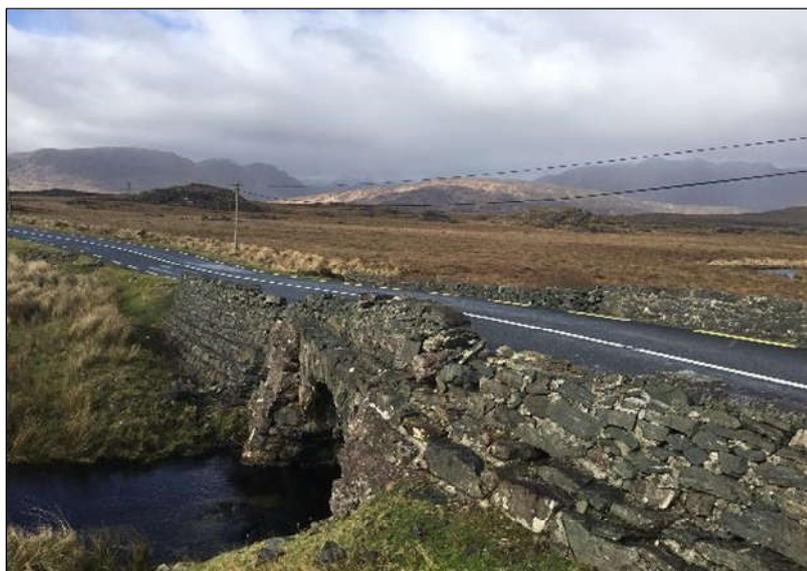
**Plate 2-12** Owenduff Bridge.

Owenduff Bridge is a masonry single span bridge which carries the N59 over the Culfin River. Masonry parapets line the road. The bridge is located within The Twelve Bens / Garraun Complex SAC and the Culfin ultimately discharges to the West Connaught Coast SAC. Plate 2.12 shows Owenduff Bridge.

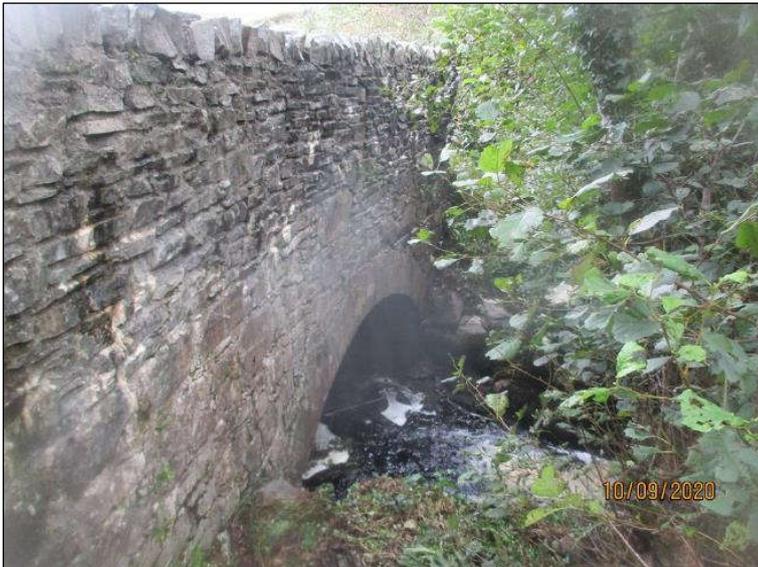
**Plate 2-13** Lettershea Bridge No. 2.

Lettershea Bridge No. 2 is a masonry single span bridge which carries the N59 over the Imleach Dhá Rú River. Masonry parapets line the carriageway. The bridge is located 50m downstream and 1.9km upstream of The Twelve Bens / Garraun Complex SAC and 5.1km upstream of the Connemara Bog Complex SPA. Plate 2.13 shows Lettershea Bridge No. 2 Bridge.

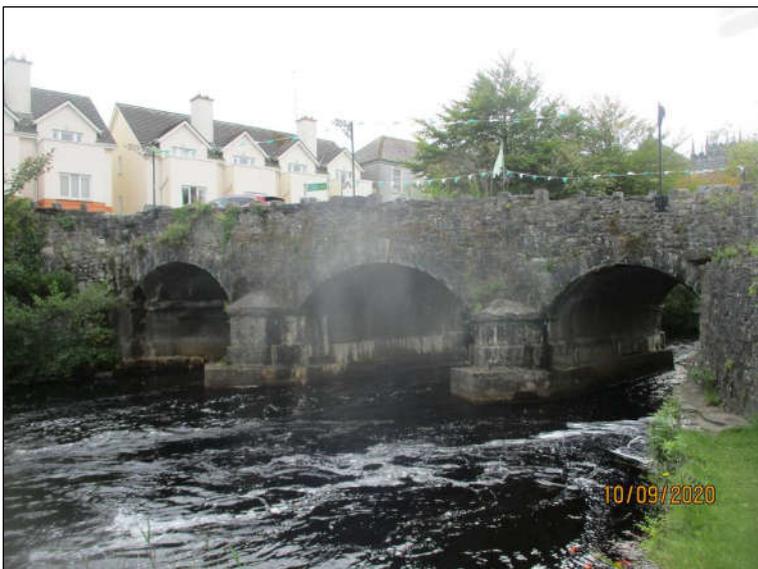
**Plate 2-14** Oughterard Bridge.

Oughterard Bridge is a masonry three-span bridge which carries the N59 over the Owenduff [Corrib] River. Masonry parapets line the carriageway. The bridge is located within the Lough Corrib SAC and 1.8km upstream of the Lough Corrib SPA. Plate 2.14 shows Oughterard Bridge.

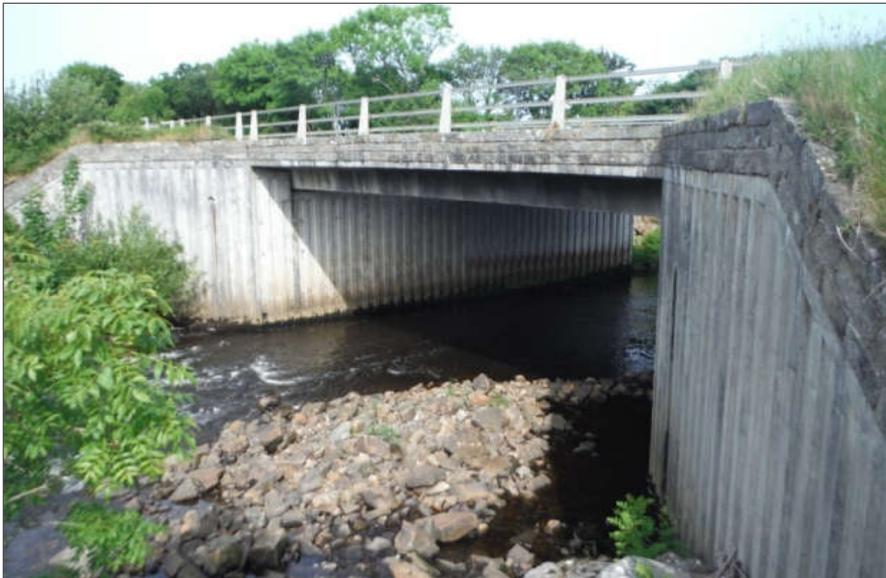
**Plate 2-15** Banduff River Bridge.

The Banduff River Bridge is a 15.5m single span reinforced concrete bridge with steel parapets on both sides of the structure. The structure is within the Bunduff Lough and Machair / Trawalua / Mullaghmore SAC. Plate 2-15 shows the south elevation.

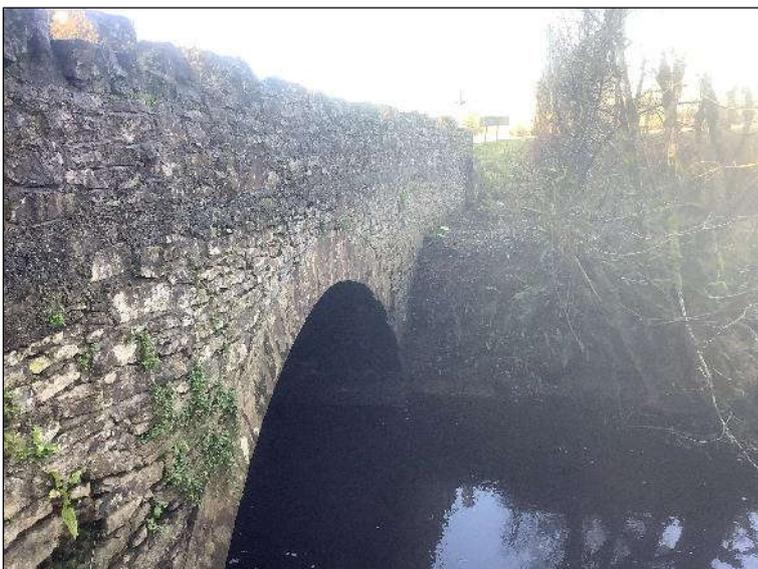
**Plate 2-16** Scarden River Bridge.

Scarden River Bridge is a masonry single span bridge which carries the N16 over the Owenmore [Manorhamilton] River. Masonry parapets line the road. The bridge is located within the Lough Gill SAC. Plate 2.16 shows Scarden River Bridge.

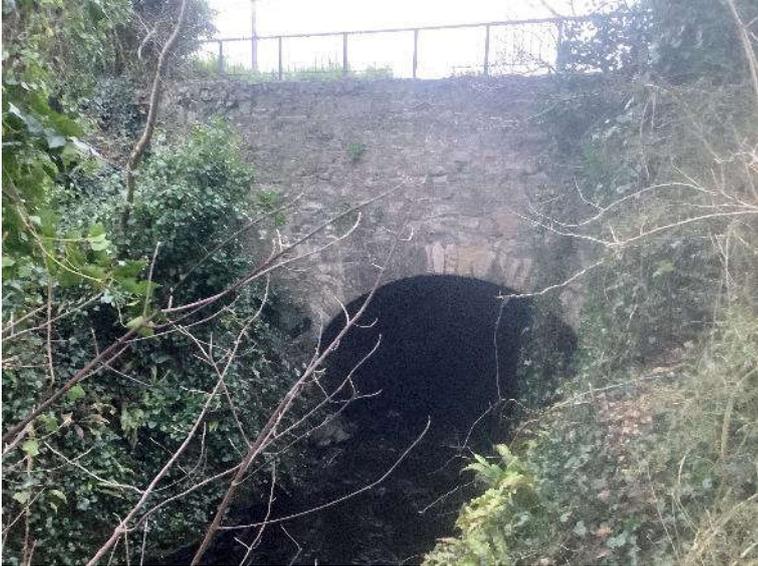
**Plate 2-17** Sracreeghan Bridge.

Sracreeghan Bridge is a masonry single span bridge which carries the N16 over an unnamed tributary of the Diffreen River. Steel safety barriers line the road above the bridge. The bridge is located 1.3km upstream of the Ben Bulben, Gleniff and Glenade Complex SAC and 12.1km upstream of Drumcliff Bay SPA. Plate 2.17 shows Sracreeghan Bridge.

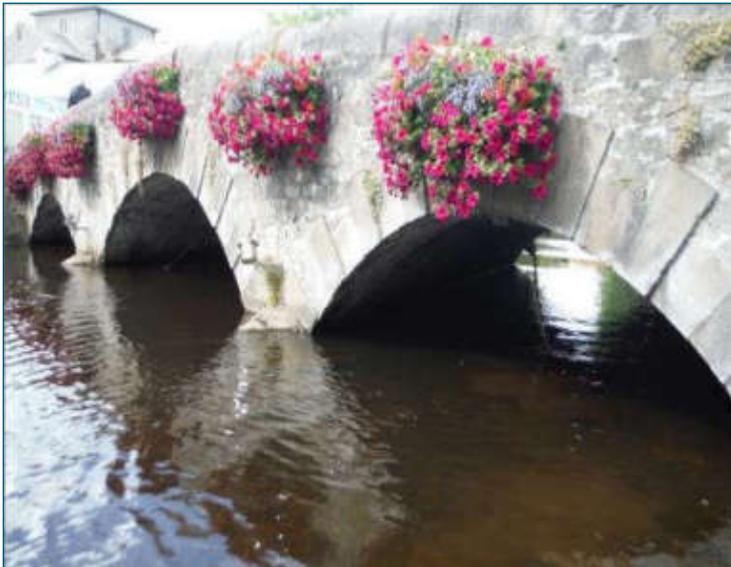
**Plate 2-18** Bridge Street Bridge.

The Bridge Street Bridge is a 3-span masonry arch bridge with masonry parapets on both sides of the structure. The maximum span is 7.75m and the minimum span is 4.2m. The rise of arch span barrel at crown is 1.47m. The structure is located 1.6km upstream of the Clew Bay Complex SAC. Plate 2-18 shows the east elevation.

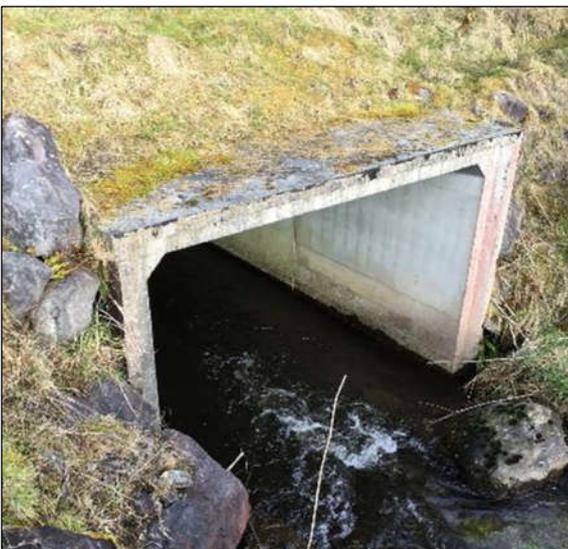
**Plate 2-19** Mullenmadoge Culvert West.

Mullenmadoge Culvert West is a single-span concrete culvert which carries the N05 over the Sonnagh [Moy] River. Steep grass embankments lead from the bridge to the road, with steel barriers lining the road. The bridge is located within the River Moy SAC. Plate 2.19 shows Mullenmadoge Culvert West.

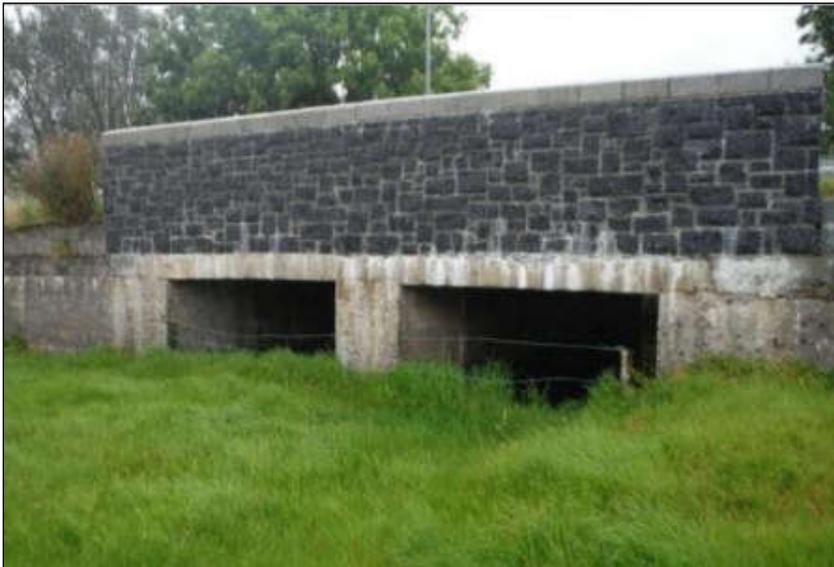
**Plate 2-20** Rathrusel Bridge.

The Rathrusel Bridge is a 2-span reinforced concrete slab bridge with masonry and concrete parapets on both sides of the carriageway. Both spans are 3.53m. The structure is located within River Moy SAC. Plate 2-20 shows the west elevation.

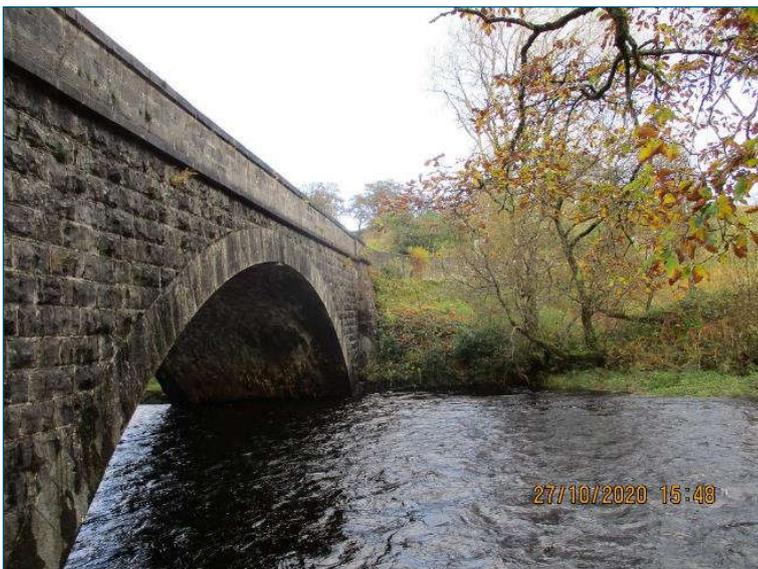
**Plate 2-21** Erriff Bridge.

Erriff Bridge is a single-span masonry bridge which carries the N59 over the Erriff River. Masonry parapets are present along the carriageway. The bridge is located within the Mweelrea/Sheeffry/Erriff Complex SAC. Plate 2.21 shows Erriff Bridge.

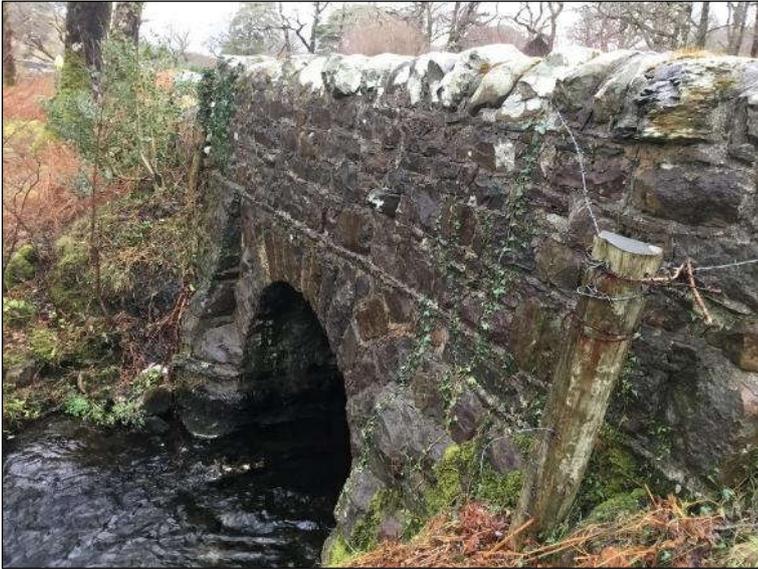
**Plate 2-22** Luga Buide Bridge.

Luga Buide Bridge is a single-span masonry bridge which carries the N59 over an unnamed tributary of the Erriff River. Masonry parapets line the road. The bridge is located within the Mweelrea/Sheeffry/Erriff Complex SAC. Plate 2.22 shows Luga Buide Bridge.

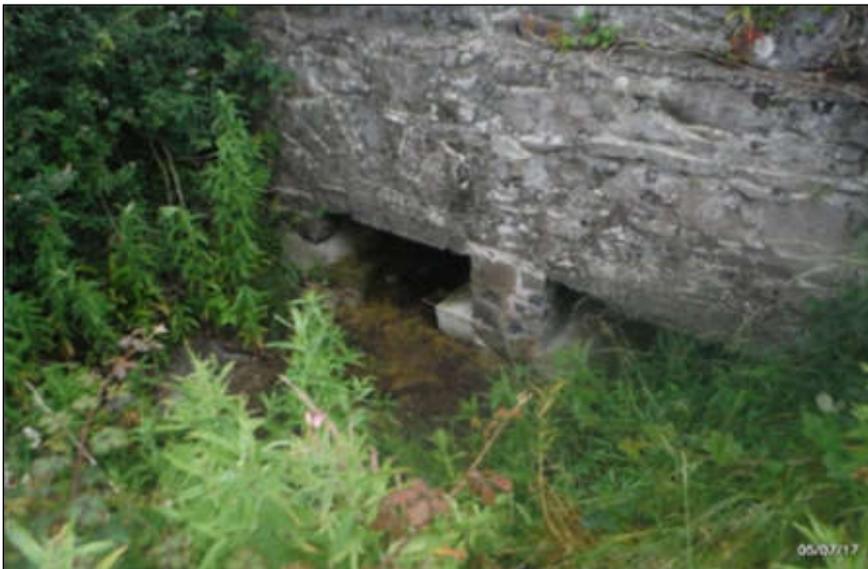
**Plate 2-23** Anriltabeg Bridge.

The Anriltabeg Bridge is a 2-span reinforced concrete slab bridge. The longest span is 1.16m and the shortest is 1.02m. The substructure consists of 2 mass concrete abutments and a mass concrete pier. There are masonry parapets on both sides of the carriageway. The structure is located 1.3km upstream of the Lough Ree SAC and 1.3km upstream of the Lough Ree SPA. Plate 2-23 shows the north elevation.

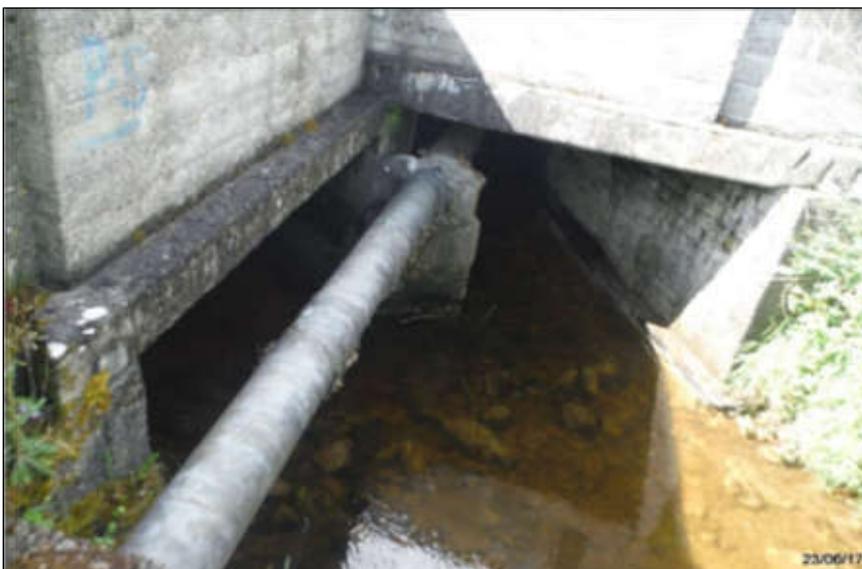
**Plate 2-24** Cloonfad Village Bridge.

The Cloonfad Village Bridge is a 2-span bridge. It is a masonry arch in the west side, and it has been widened using a reinforced concrete slab in the east side. The longest span is 3.00m and the shortest is 2.71m. The substructure consists of 2 masonry abutments and a masonry pier. There are masonry parapets on both sides of the carriageway. The structure is within Lough Corrib SAC. Plate 2-24 shows the east elevation.

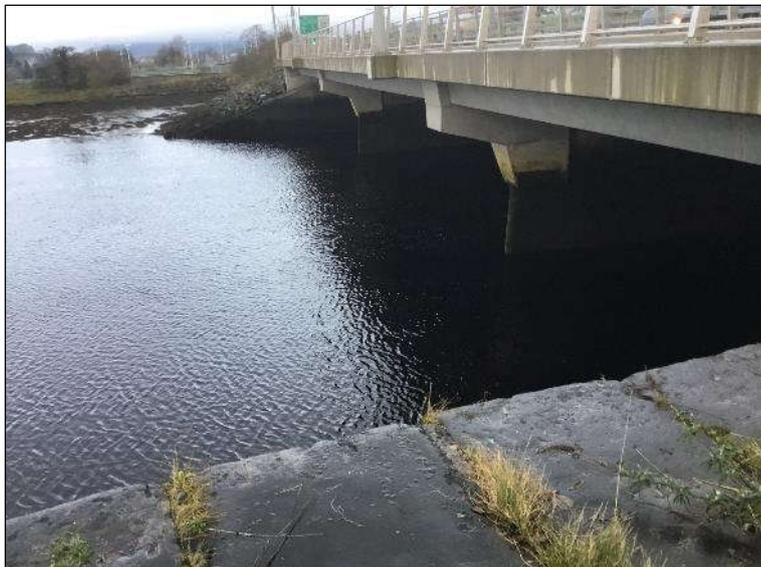
**Plate 2-25** Michael Hughes Bridge.

Michael Hughes Bridge is a three-span concrete bridge which carries the N04 over the Garavogue River with steel barriers along the road. The bridge is located within the Cummeen Strand/Drumcliff Bay (Sligo Bay) SAC and Cummeen Strand SPA. Plate 2.25 shows Michael Hughes Bridge.

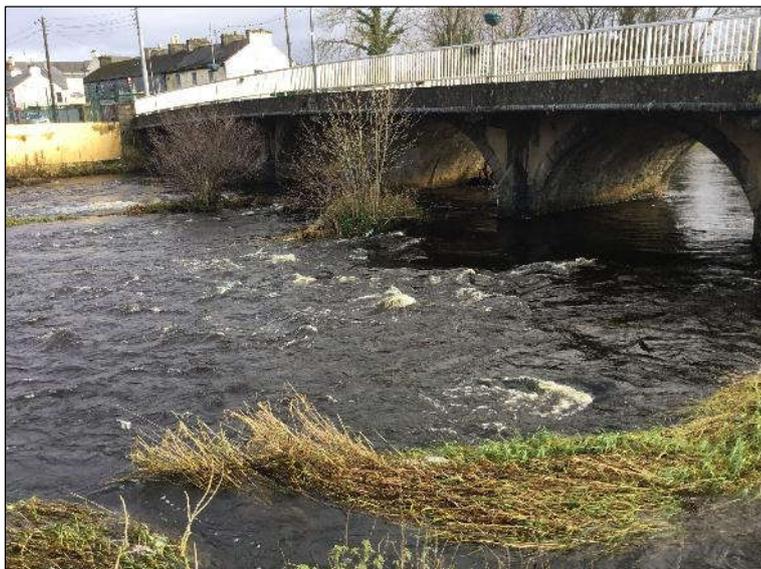
**Plate 2-26** Ballysadare River Bridge.

Ballysadare River Bridge is a seven-span concrete and masonry bridge which carries the N59 over the Ballysadare River. Steel safety barriers are present along the road. The bridge is located within the Unshin River SAC and 0.7km upstream of Ballysadare Bay SPA. Plate 2.26 shows Ballysadare River Bridge.

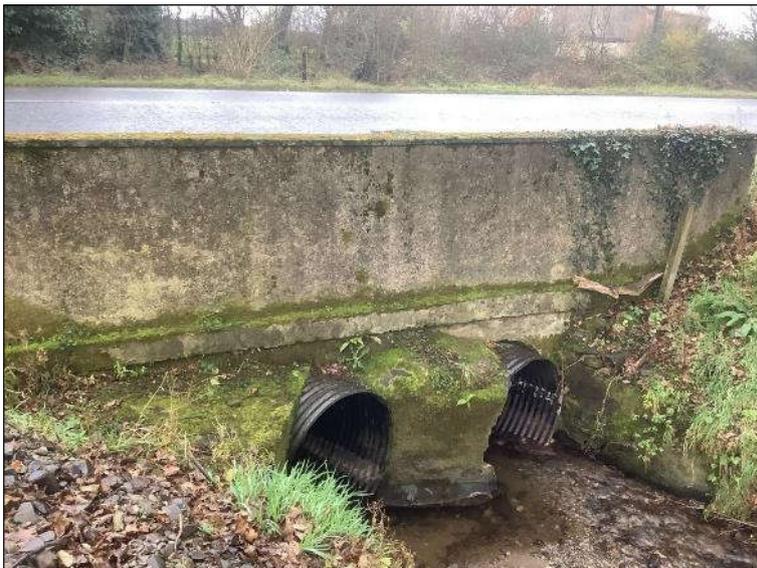
**Plate 5-1** Castlecooley Bridge

The 2-span bridge crosses the Carrowen River. The bridge comprises a concrete structure with steel pipe culverts. There are concrete parapets on both sides of the carriageway. The bridge is located 3.7km upstream of Lough Swilly SAC and 700m of Lough Swilly SPA. Plate 5.1 shows Castlecooley Bridge.

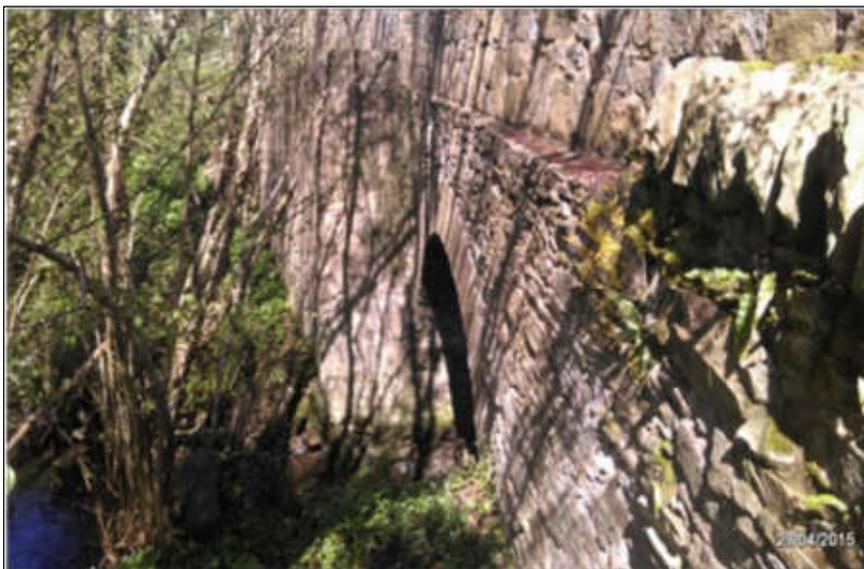
**Plate 5-2** Whitecross Bridge.

The Whitecross Bridge is a single span masonry arch bridge. The span is 4.08m. The substructure consists of 2 masonry abutments. There are masonry parapets on both sides of the carriageway. The structure is located 9.5km upstream of the River Finn SAC. Plate 5-2 shows the west elevation.

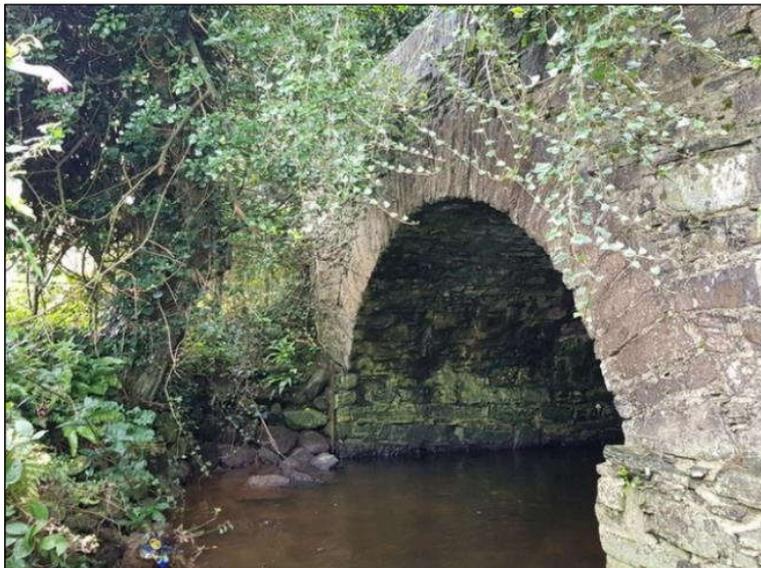
**Plate 5-3** Tullyrap Bridge.

Tullyrap Bridge is single span masonry arch bridge with masonry parapets along the carriageway. The Drumbeg River flows below the bridge. The structure is located 8.3km upstream of River Finn SAC. Plate 5.3 shows the bridge.

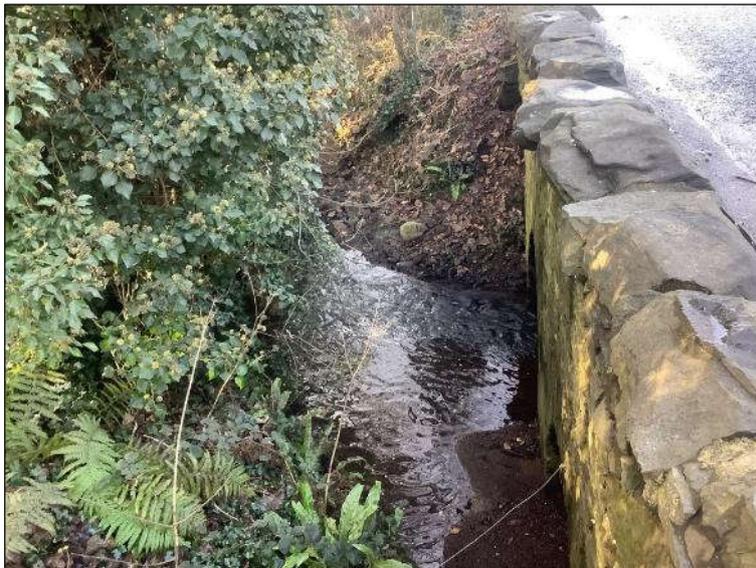
**Plate 5-4** Corcam Bridge.

Corcam Bridge is a single span masonry bridge. An unnamed EPA drain flows below the bridge and enters the River Finn downstream. Masonry parapet walls are present either side of the roadway. The structure is located 500m upstream of River Finn SAC. Plate 5.4 shows the bridge.

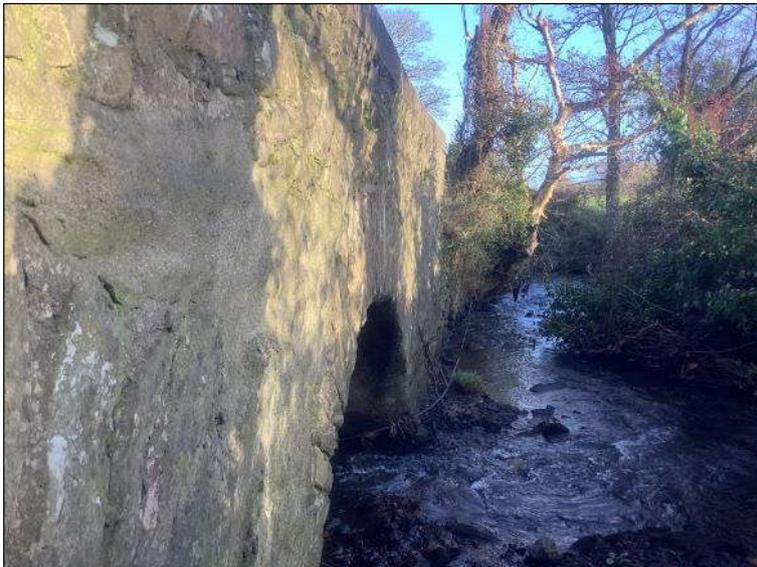
**Plate 5-5** Mullandrait Bridge.

Mullandrait Bridge is a double span masonry bridge. The Mullaghagarry River flows below the bridge. Masonry parapet walls line either side of the roadway. The structure is located 0.1km upstream of River Finn SAC. Plate 5.5 shows the bridge.

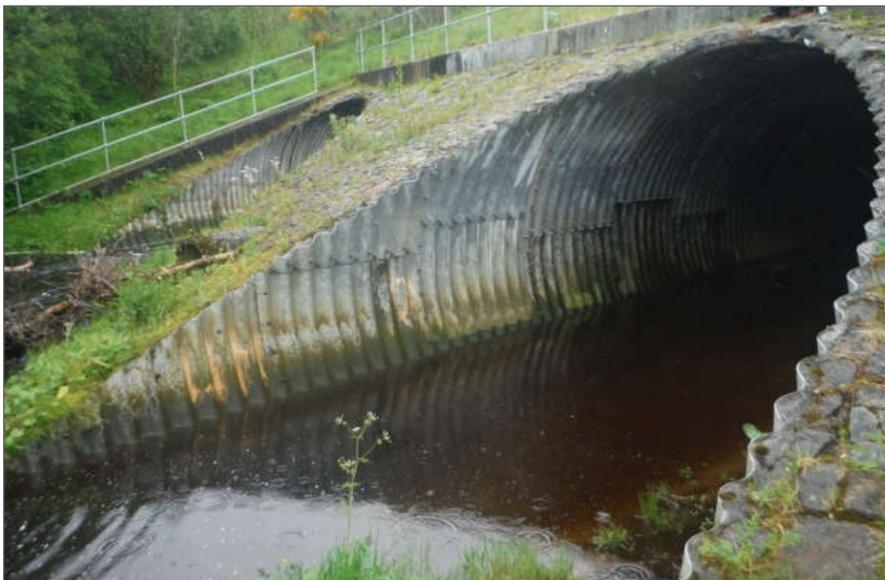
**Plate 5-6** Drumrath Bridge.

The structure is comprised of 2 corrugated steel pipes with 3.95m diameter each. There is steel safety barrier on both sides of the carriageway and a light steel railing on the headwalls. The structure carries the N15 over the River Drumenny. The structure is within Lough Eske and Ardnamona Wood SAC and located 3.2km upstream of the Donegal Bay SPA. Plate 5-6 shows the east elevation.

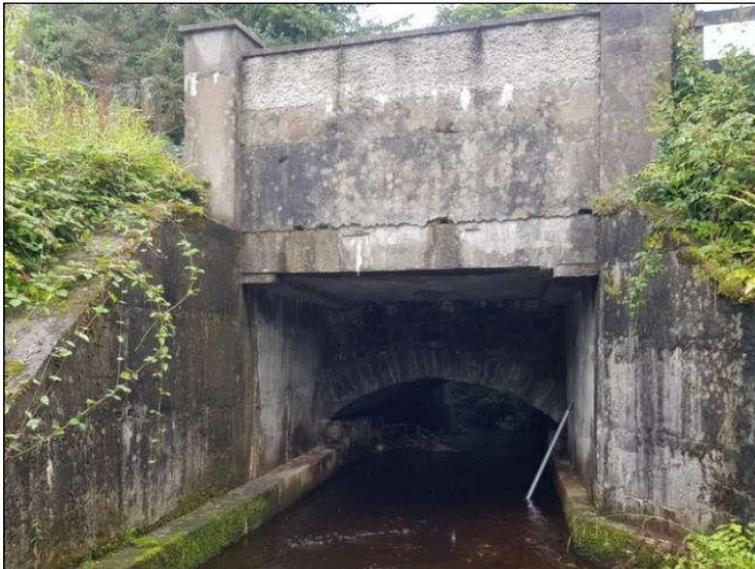
**Plate 5-7** Laghy Village Bridge.

Laghy Village Bridge is concrete slab with masonry arch substructure single span bridge. Concrete parapets are present along the carriageway. The bridge spans the Tullywee River 1.3km upstream of Donegal Bay (Murvagh) SAC and 1.7km upstream of Donegal Bay SPA. Plate 5.7 shows Laghy Village Bridge.

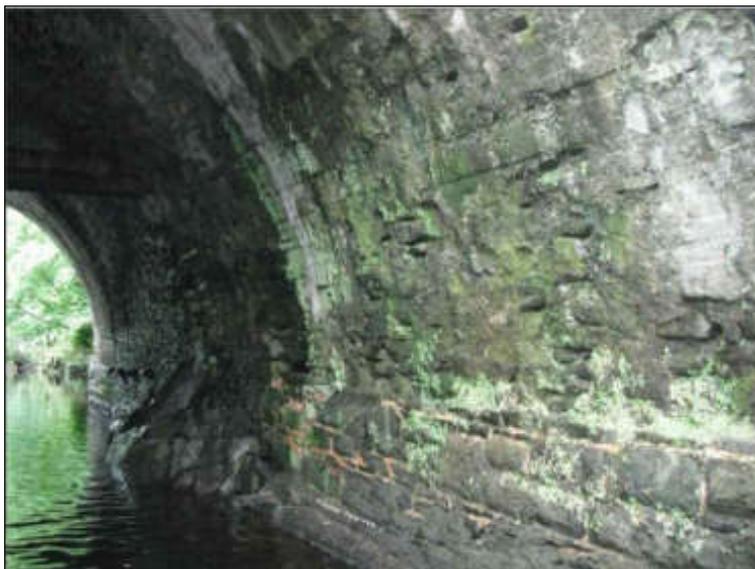
**Plate 5-8** Glenties Bridge.

The Glenties Bridge is a 7.23m single span bridge with masonry parapets. The abutments and parapets are also masonry. There is no guard rail in place. The bridge carries the N56 over the Stracashel River. The bridge is located within the West Of Ardara / Maas Road SAC. Plate 5-8 shows the northern abutment.

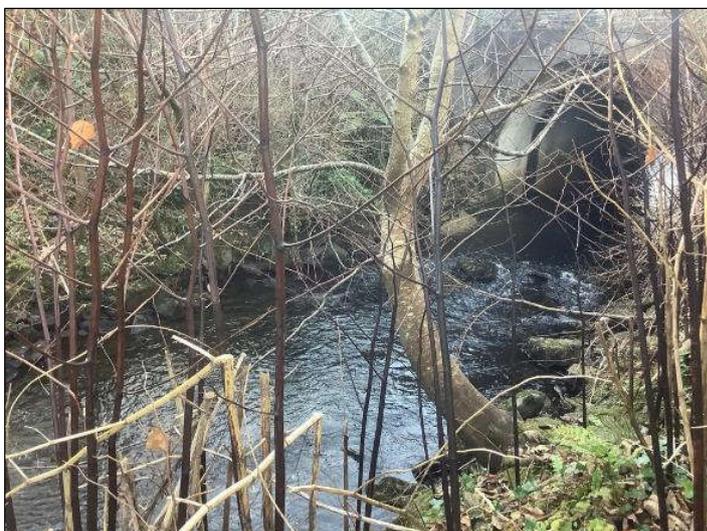
**Plate 5-9** Clon Bridge.

Clon Bridge carries the N56 road across the Faymore River via a single span concrete bridge. Sheephaven SAC is located 600m downstream of the bridge. Plate 5.9 shows Clon Bridge.

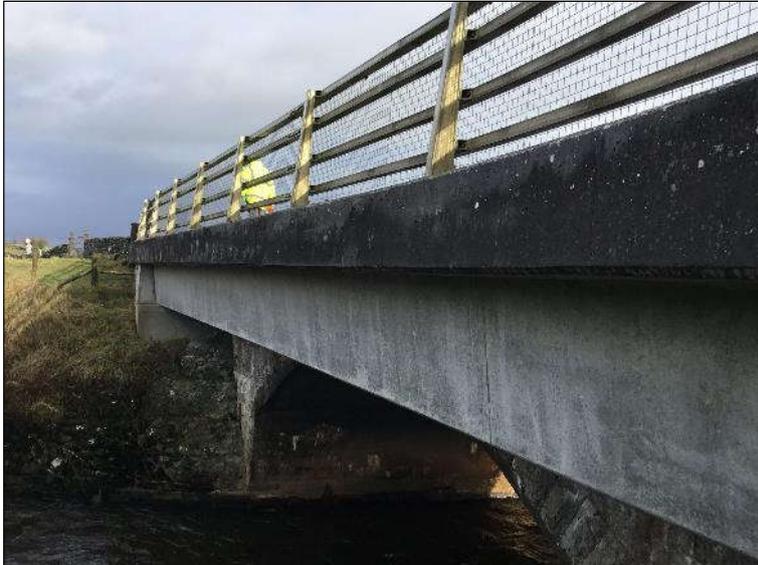
**Plate 5-11** Cloonmore Bridge.

Cloonmore Bridge is a concrete and masonry single span bridge which carries the N83 over the Clare River. Steel safety barriers line the road. The bridge is located within Lough Corrib SAC. Plate 5.11 shows Cloonmore Bridge.

Bridge Component	Work Element	Screening Recommendation
Abutments	Damaged concrete base protection to abutment faces on both sides of river to be repaired. (8 m)	Screened in – will require instream access.

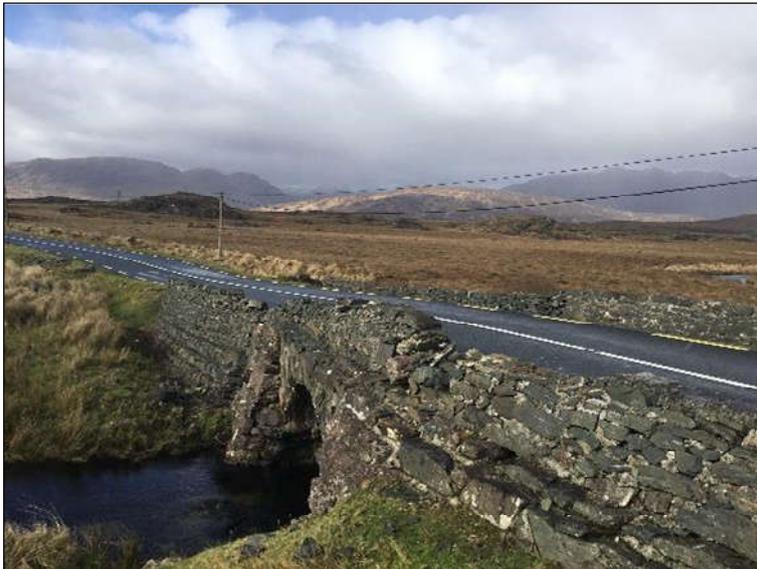
**Plate 5-12** Owenduff Bridge.

Owenduff Bridge is a masonry single span bridge which carries the N59 over the Culfin River. Masonry parapets line the road. The bridge is located within The Twelve Bens / Garraun Complex SAC and the Culfin ultimately discharges to the West Connaught Coast SAC. Plate 5.12 shows Owenduff Bridge.

Bridge Component	Work Element	Screening Recommendation
Abutments	Areas of mortar loss above water level on the north abutment to be repointed, 4m <sup>2</sup> . (4 m <sup>2</sup> )	Screened in – will require instream access.
Abutments	Areas of undermining (150mm deep) at the east end of the north abutment and the adjacent buttress is also undermined with up to 300mm deep to be repaired, 1m. (1 m)	Screened in – will require instream access.

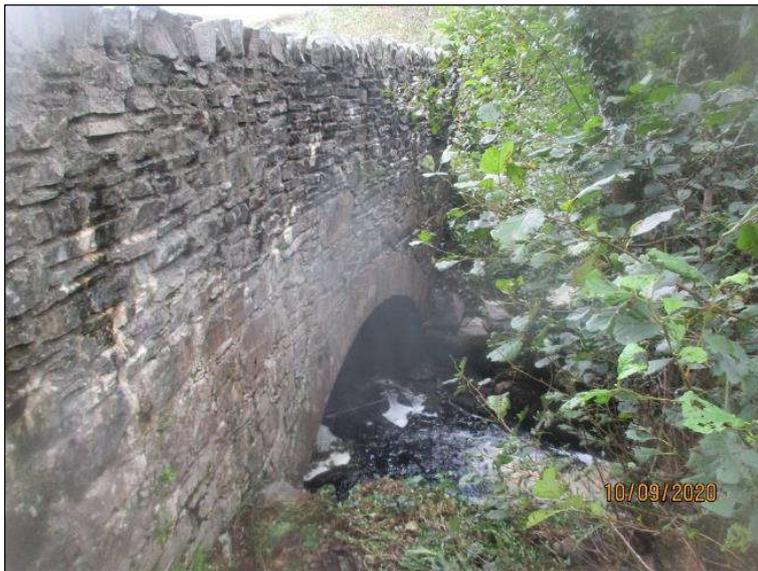
**Plate 5-13** Lettershea Bridge No. 2.

Lettershea Bridge No. 2 is a masonry single span bridge which carries the N59 over the Imleach Dhá Rú River. Masonry parapets line the carriageway. The bridge is located 50m downstream and 1.9km upstream of The Twelve Bens / Garraun Complex SAC and 5.1km upstream of the Connemara Bog Complex SPA. Plate 5.13 shows Lettershea Bridge No. 2 Bridge.

Bridge Component	Work Element	Screening Recommendation
Riverbed	Removal of debris including a bicycle at upstream from the water course (2 m <sup>2</sup> )	Screened in – will require instream access.

Bridge Component	Work Element	Screening Recommendation
Parapets/Safety barrier	Removal of vegetation mostly moss and weeds from all parapet faces including the top (1 m <sup>2</sup> )	Screened out – works can be carried out on foot.
Embankments/Revetments	Areas of vegetation to be removed from the embankments at both sides of structure. (40 m <sup>2</sup> )	Screened in – this activity could result in the exposure of loose soils, resulting in a sediment load to the river.
Bridge surface	Drainage tube to be installed installed at the east end of the south rubbing strip/ parapet to allow the water to drain into the embankment. Outfall pipe to clear the masonry parapet by min 500 mm (1 no.)	Screened in – potential for hydrocarbon pollution

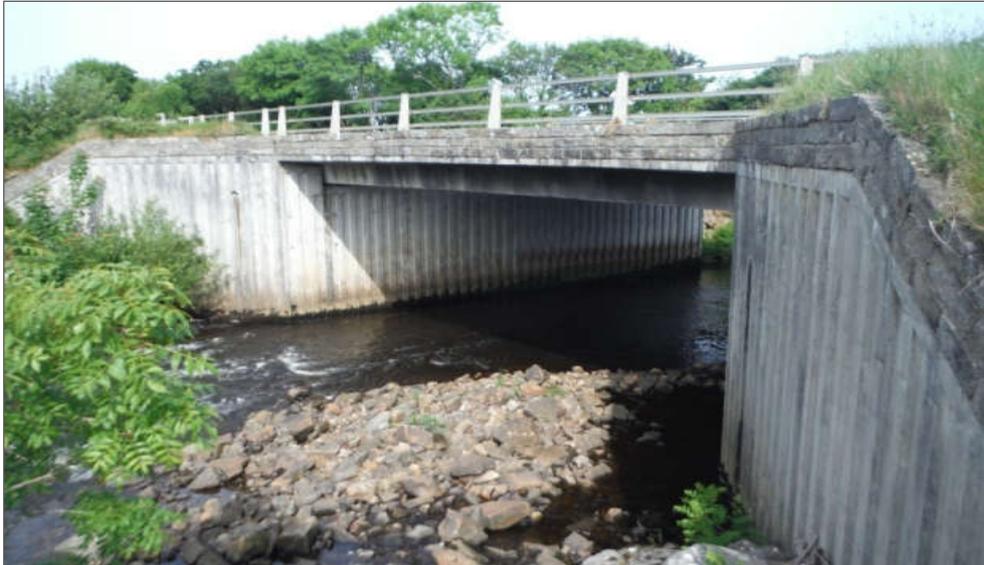
**Plate 5-15** Banduff River Bridge.

The Banduff River Bridge is a 15.5m single span reinforced concrete bridge with steel parapets on both sides of the structure. The bridge carries the N15 over the River Duff. The structure is within the Bunduff Lough and Machair / Trawalua / Mullaghmore SAC. Plate 5-15 shows the south elevation.

Bridge Component	Work Element	Screening Recommendation
Riverbed	Removal of build-up of stones in the downstream riverbed (36m <sup>2</sup> ). (36 m <sup>2</sup> )	Screened in – will require instream access

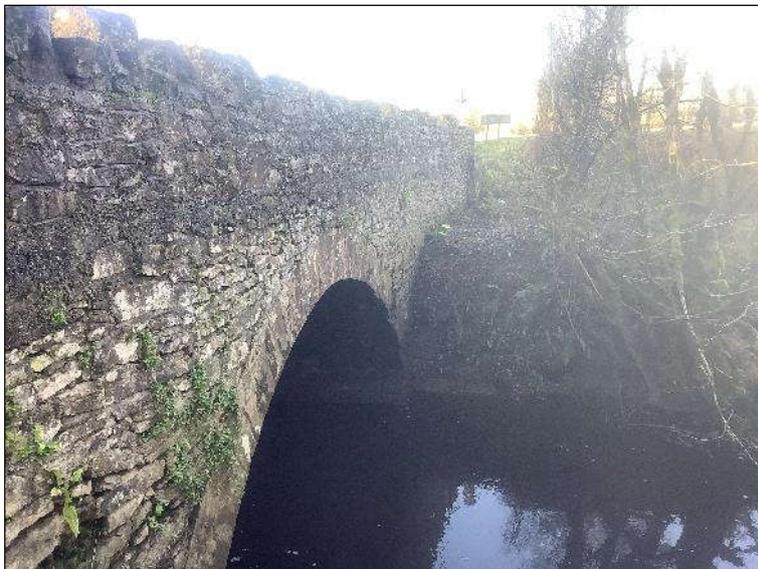
**Plate 5-16** Scarden River Bridge.

Scarden River Bridge is a masonry single span bridge which carries the N16 over the Owenmore [Manorhamilton] River. Parapets etc. The bridge is located within the Lough Gill SAC. Plate 5.16 shows Scarden River Bridge.

Bridge Component	Work Element	Screening Recommendation
Deck/slab/arch barrel	Repointing of the arch barrel in the river. (10 m <sup>2</sup> )	Screened in – use of wet mortar over water and therefore a surface water pathway is present.

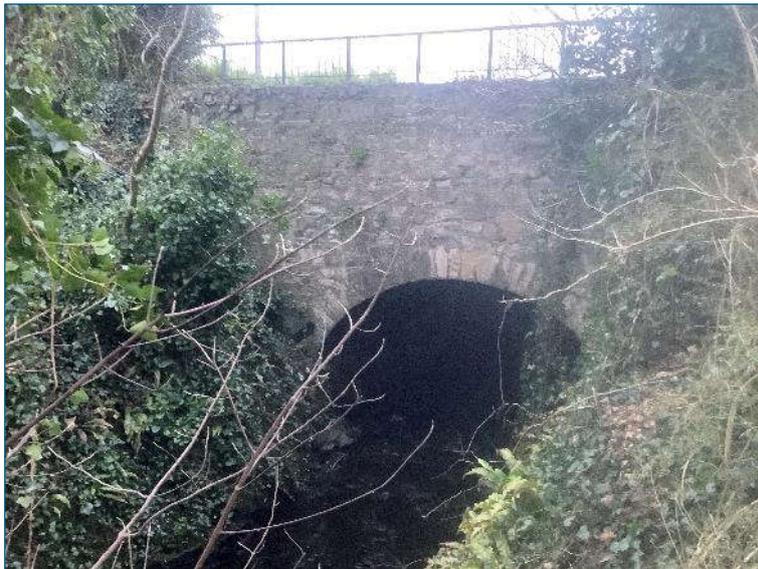
**Plate 5-17** Sracreeghan Bridge.

Sracreeghan Bridge is a masonry single span bridge which carries the N16 over an unnamed tributary of the Diffreen River. Steel safety barriers line the road above the bridge. The bridge is located 1.3km upstream of the Ben Bulben, Gleniff And Glenade Complex SAC and 12.1km upstream of Drumcliff Bay SPA. Plate 5.17 shows Sracreeghan Bridge. Reactive maintenance works which were separately considered for this bridge have been completed.

Bridge Component	Work Element	Screening Recommendation
Parapets/Safety barrier	Removal of vegetation from parapets including 1 tree on the north parapet external face (7 m <sup>2</sup> )	Screened in - removal of vegetation may require instream access and the erection of scaffolding.
Embankments/Revetments	Cut back all vegetation on embankments 1m offset from bridge - 15m <sup>2</sup> on each corner. (60 m <sup>2</sup> )	Screened in – this activity could result in the exposure of loose soils, resulting in a sediment load to the river.
Wing/Spandrel/Retaining Walls	Vegetation removal from wing walls and spandrel walls (70 m <sup>2</sup> )	Screened out – works can be carried out on foot.

Bridge Component	Work Element	Screening Recommendation
Wing/Spandrel/Retaining Walls	Tree removal from north wingwalls and spandrel walls. (5 m <sup>2</sup> )	Screened in - removal of vegetation may require instream access and the erection of scaffolding.
Abutments	Removal of vegetation (15 m <sup>2</sup> )	Screened in – will require instream access
Wing/Spandrel/Retaining Walls	Masonry repair to north wingwalls and spandrel walls after removal of trees (4 m <sup>3</sup> )	Screened in – use of wet mortar over water and therefore a surface water pathway is present.
