# NW Term Maintenance Contract No.3

Year 3 Structures – Natura Impact Statement  
Transport Infrastructure Ireland

12/03/2021

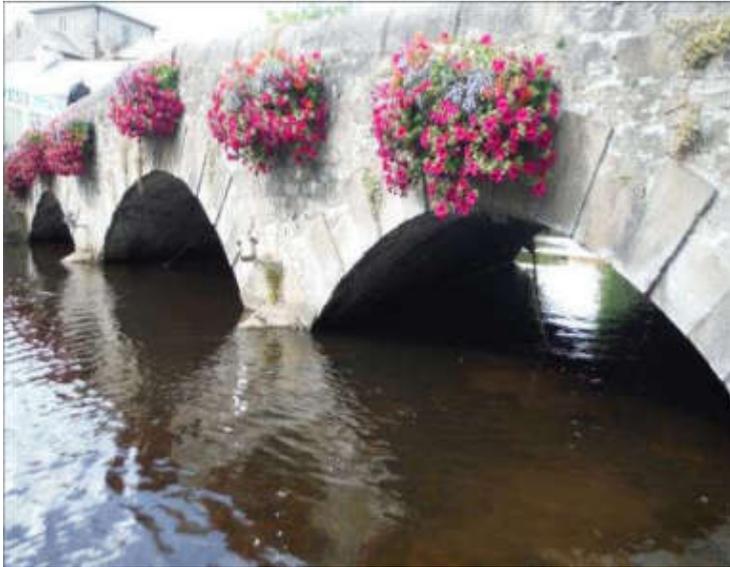
**Plate 5-18** Bridge Street Bridge.

The Bridge Street Bridge is a 3-span masonry arch bridge with masonry parapets on both sides of the structure. The maximum span is 7.75m and the minimum span is 4.2m. The rise of arch span barrel at crown is 1.47m. The structure is located 1.6km upstream of the Clew Bay Complex SAC on the Carrowbeg [Westport] River. Plate 5-18 shows the east elevation.

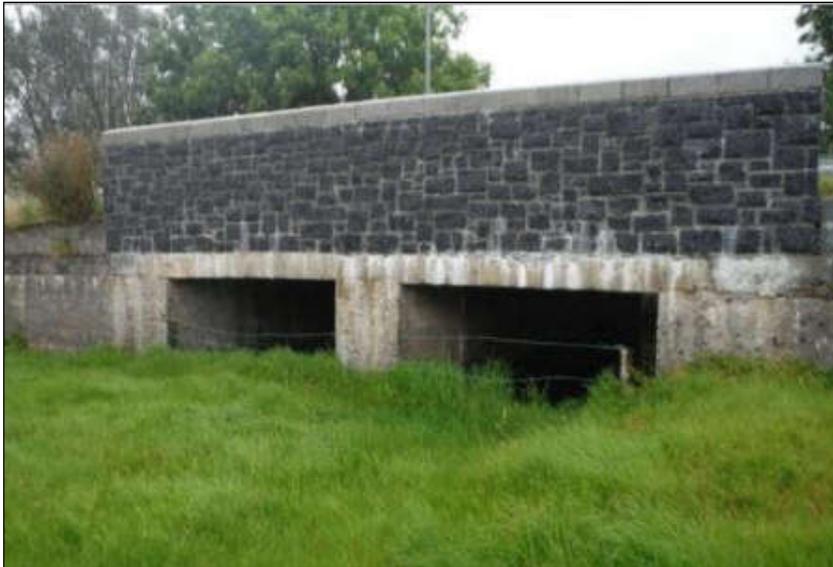
**Plate 5-20** Rathrusel Bridge.

The Rathrusel Bridge is a 2-span reinforced concrete slab bridge with masonry and concrete parapets on both sides of the carriageway. Both spans are 3.53m. The structure carries the N58 across an unnamed drain which enters the River Moy 130m downstream of the bridge. Rathrusel Bridge is located within River Moy SAC. Plate 5-20 shows the west elevation.

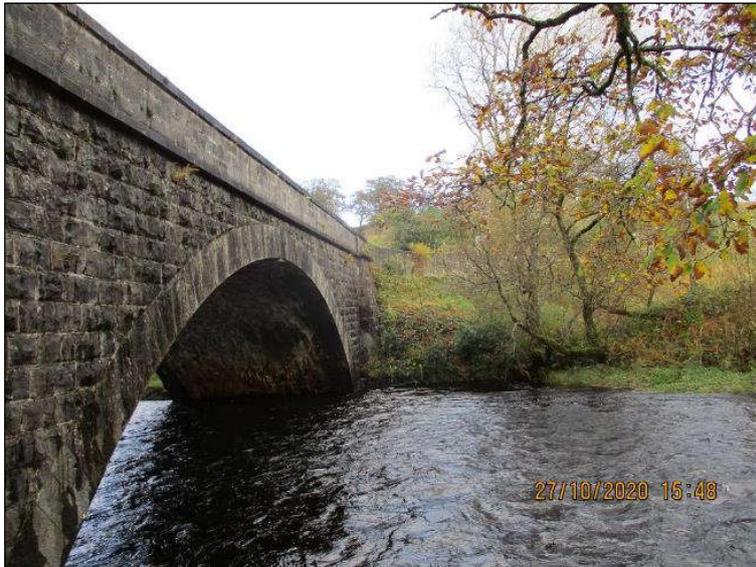
**Plate 5-21** Erriff Bridge.

Erriff Bridge is a single-span masonry bridge which carries the N59 over the Erriff River. Masonry parapets are present along the carriageway. The bridge is located within the Mweelrea/Sheeffry/Erriff Complex SAC. Plate 5.21 shows Erriff Bridge.

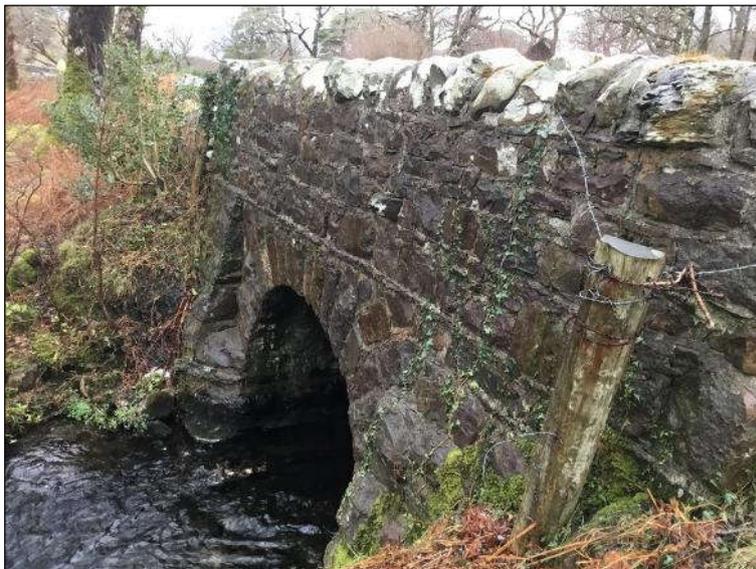
**Plate 5-22** Luga Buide Bridge.

Luga Buide Bridge is a single-span masonry bridge which carries the N59 over an unnamed tributary of the Erriff River. Parapets etc. The bridge is located within the Mweelrea/Sheeffry/Erriff Complex SAC. Plate 5.22 shows Luga Buide Bridge.

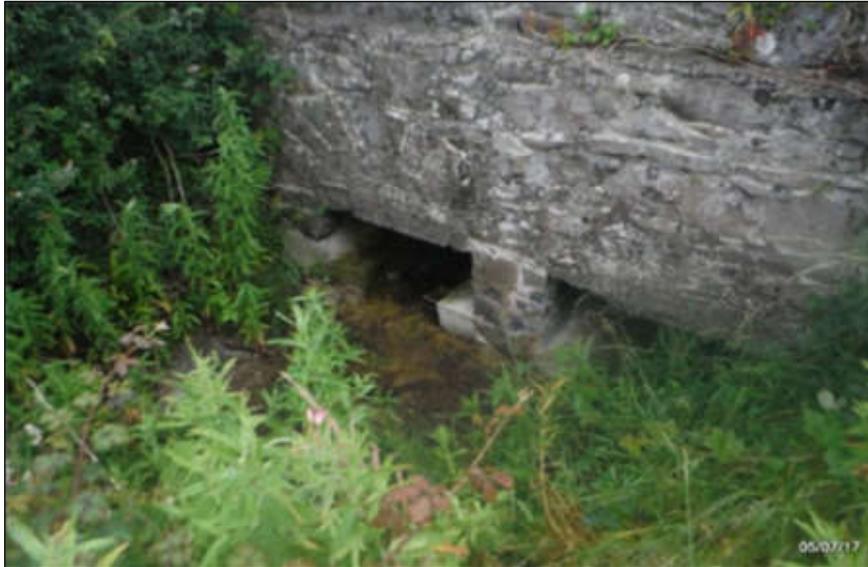
**Plate 5-23** Anriltabeg Bridge.

The Anriltabeg Bridge is a 2-span reinforced concrete slab bridge. The longest span is 1.16m and the shortest is 1.02m. The substructure consists of 2 mass concrete abutments and a mass concrete pier. There are masonry parapets on both sides of the carriageway. The bridge carries the N63 over the Kilnacloghy River. The structure is located 1.3km upstream of the Lough Ree SAC and 1.3km upstream of the Lough Ree SPA. Plate 5-23 shows the north elevation.

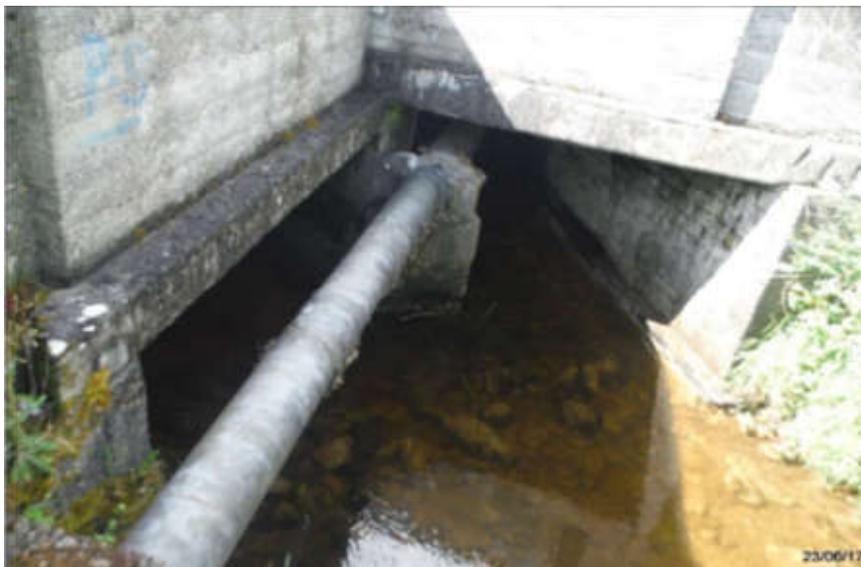
**Plate 5-24** Cloonfad Village Bridge.

The Cloonfad Village Bridge is a 2-span bridge. It is a masonry arch in the west side, and it has been widened using a reinforced concrete slab in the east side. The longest span is 3.00m and the shortest is 2.71m. The substructure consists of 2 masonry abutments and a masonry pier. There are masonry parapets on both sides of the carriageway. The structure crosses the Cloonfad River and is within Lough Corrib SAC. Plate 5-24 shows the east elevation.

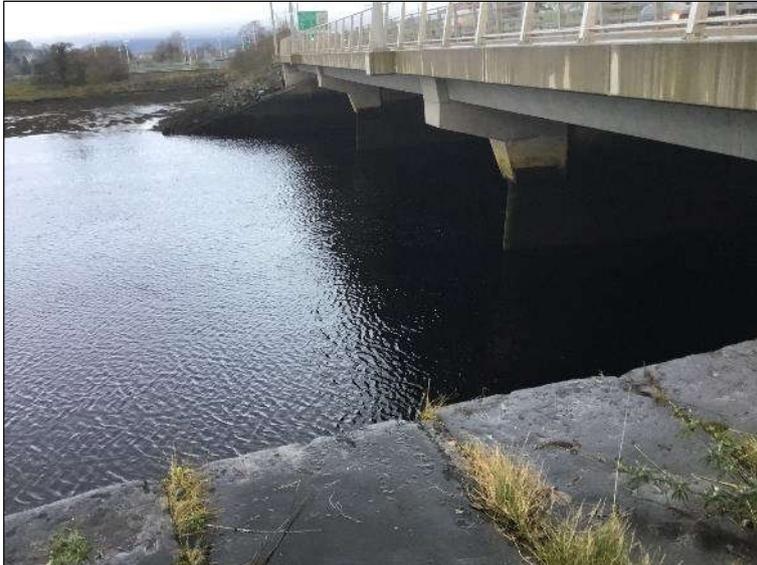
**Plate 5-25** Michael Hughes Bridge.

Michael Hughes Bridge is a three-span concrete bridge which carries the N04 over the Garavogue River with steel barriers along the road. The bridge is located within the Cummeen Strand/Drumcliff Bay (Sligo Bay) SAC and Cummeen Strand SPA. Plate 5.25 shows Michael Hughes Bridge.

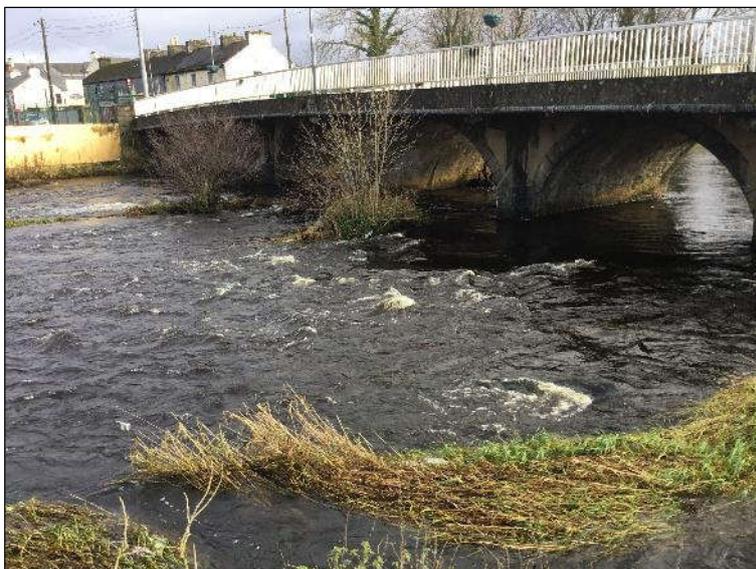
**Plate 5-26** Ballysadare River Bridge.

Ballysadare River Bridge is a seven-span concrete and masonry bridge which carries the N59 over the Ballysadare River. Steel safety barriers are present along the road. The bridge is located within the Unshin River SAC and 0.7km upstream of Ballysadare Bay SPA. Plate 5.26 shows Ballysadare River Bridge.
