what we found

N30 ENNISCORTHY TO CLONROCHE SCHEME, County Wexford

archaeological DISCOVERIES

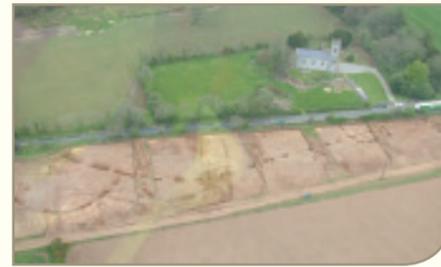
Aerial view of enclosure ditches in the vicinity of **Rosdroit Church** during excavation.

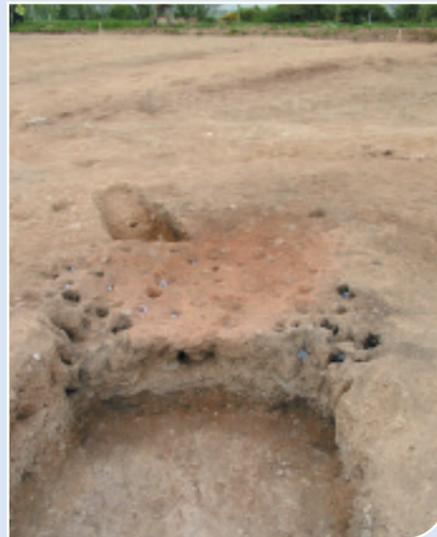
A trough from the *fulacht fiadh* in **Coolamurry**. The reddened soil in the background marks the location of the hearth. Stones heated in the hearth could easily have been rolled into the trough to heat the water.

A trough from the *fulacht fiadh* in **Coolamurphy**. The reddened soil in the background marks the location of the hearth.

Fulachta fiadh typically consist of one or more wood, stone or clay-lined troughs to hold water; hearths to heat stones, and low mounds of discarded burnt and broken stone. It is thought that these sites were used for cooking meat; in folklore *fulachta fiadh* are associated with hunting exploits of Fionn and the Fianna. However, it is quite possible that the hot water was used for a variety of other activities, such as bathing, brewing, textile production, leather working and so on. Located close by and upslope of this *fulacht fiadh* is an area of possible industrial activity. A curvilinear slot-trench partially enclosed a hearth and

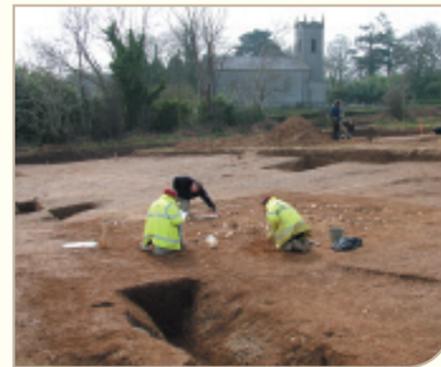
Excavating stake-holes of probable prehistoric date in the vicinity of **Rossdroit Church**. The 18th-century St. Peter's parish church is visible in the background.

Excavations to the north of the church and graveyard revealed at least three phases of human activity. The earliest phase of activity was represented by four groups of post-holes representing the remains of wooden structures possibly dating to the prehistoric period. The lack of finds from these structures makes it difficult to make an immediate estimation of date, however, further specialist analysis of soil and charcoal

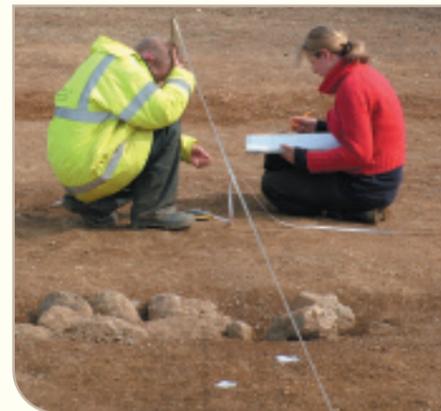
Recording the foundations of a probable 18th-century house across the road from **Rossdroit Church**.

samples collected during excavation may throw light on their date. Further analysis may also clarify the function of all four structures. The second phase of activity was represented by a ditch over 120m in length; this ditch probably demarcated the extent of Rossdroit church lands in the medieval period. Several other ditches have also been uncovered that represent old field boundaries. One of these ditches underlay the remains of a probable 18th-century house which consisted of a stone wall footing enclosing a beaten earth floor. This house would have fronted onto the Enniscorthy-Clonroche road.

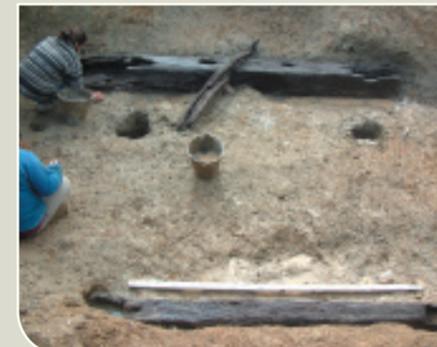
Timber base plates of the entrance structure for the **Coolamurry** moated site. (Photo Valerie J Keeley Ltd.)

the ditch separated the living area from the area which may have been used for livestock and other farming activities. Shallow trenches uncovered in the living area suggest that the house would have been constructed on large timber base plates. Large worked timbers uncovered in the base of the ditch represent the remains of the entrance to the site; it is possible that this entrance would originally have been by way of a drawbridge. A cobbled path led from the entrance to the south-western corner of the site. Locally made medieval pottery has been recovered from the ditch and internal habitation area, and other finds include a possible copper coin, a copper-alloy dividers and an object of twisted lead of unknown function.

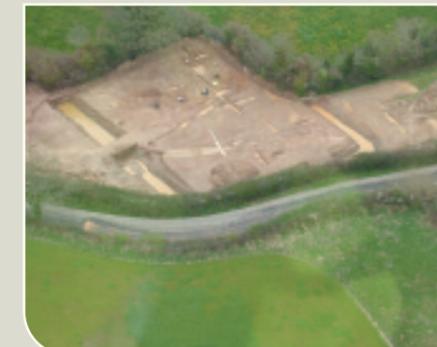
Aerial view of **Coolamurry** moated site during excavation.

A moated site dating to the Anglo-Norman period was discovered in **Coolamurry** townland. This site consisted of a large perimeter ditch (3-4m wide) enclosing a rectangular area (c. 35 x 27m).

In their lifetime these large ditches would have been filled with water from a nearby stream and along with an internal bank and palisade (closely-set upright posts) would have enclosed the settlement of a single family unit. The enclosed area was divided into almost two equal halves by a shallow ditch, it is thought that

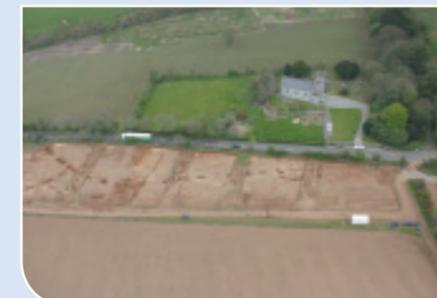
Aerial view of the enclosure ditches in the vicinity of **Rossdroit Church**. The 18th-century St. Peter's parish church is visible in the background. (Photo Valerie J Keeley Ltd.)
