# what we found

The 6km route of the N25 Youghal Bypass was archaeologically investigated during 2001 and 2002.

N25 YOUGHAL BYPASS,  
County Cork

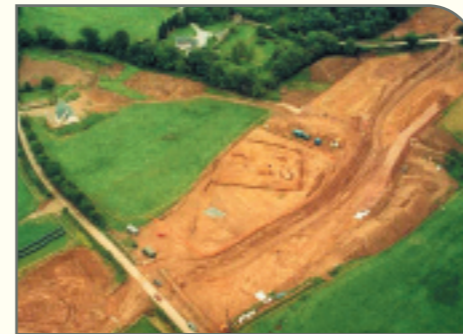
Aerial view of early medieval enclosure uncovered at **Ballynacarriga**. (Photo A.C.S. Ltd.)

At **Ballynacarriga** excavations revealed an uncharacteristic example of a multi-phased farming settlement dating to the early medieval period. Two large conjoined sub-rectangular enclosures were located on the northern slope of the small valley in Ballynacarriga. The main enclosure, which dated to AD 420-670, measured 35m by 40m. It was formed by a large enclosing ditch, the profile of which varied from a wide U-shape on the lower slope to the south to a narrower V-shape on the higher slope to the north.

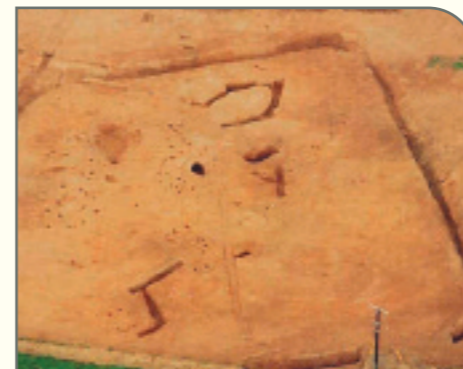
Aerial view of early medieval enclosure uncovered at **Ballynacarriga**. (Photo A.C.S. Ltd.)

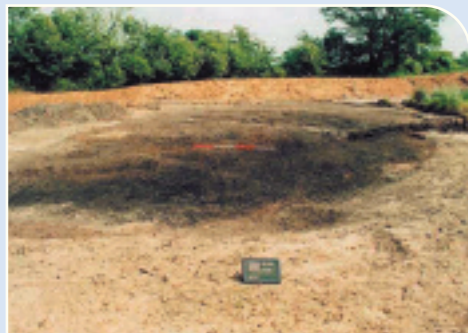
Burnt spread from exposed *fulachta fíadh* uncovered at **Muckridge**. (Photo A.C.S. Ltd.)

Three *fulachta fíadh* were uncovered along the route. One particularly early example from **Muckridge** has been dated to the transitional period between the Late Neolithic and the Early Bronze Age period (c. 2620 BC-2280 BC). This site was located to the west of the Blackwater River and just north of **Youghal** town. The excavation revealed two large timber-lined troughs in association with an apparently random array of stake-holes. Another example from **Clashadunna East**, dated to 1130-1030 BC, revealed three circular stake-holes cut into the base of the trough. A single fragment of flint was recovered from this site. Another *fulachta fíadh*, dated to 940-860 BC, was excavated in the townland of **Propoge**. This consisted of a thin spread of burnt stone material and an unlined circular trough.

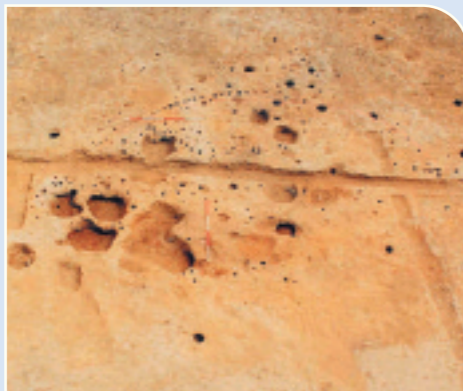
Dense cluster of Bronze Age settlement features uncovered at **Ballyvergan West** after excavation. (Photo A.C.S. Ltd.)

A cluster of Bronze Age activity was uncovered at **Ballyvergan West**, nestled between the River Blackwater and Womagh River, 2km to the east of **Youghal** town. The main area of activity centred on an unenclosed area measuring 10m x 10m, which contained a large number of pits, stake-holes and post-holes. These features represented the remains of several timber-built structures (including at least one oval house structure), fence lines and a possible lean-to structure. These secondary structures are thought to have been used as animal huts with a surrounding post-and-wattle fence. The post and stake-holes were found in association with a high concentration of hearths and large refuse pits, which

produced courseware pottery, whetstones, rubbing stones, fragments of saddle querns, burnt bone and burnt hazelnut shells. The evidence suggests that the site was domestic in nature and the presence of rubbing stones and quern stones indicate that its inhabitants practised arable farming. This substantial Bronze Age settlement site has been radiocarbon-dated to 1190-1070 BC.

To the south-east of the main settlement was a large structure (11m in diameter), which survived as a sub-circular ring of 20 post-holes. Internally, two shallow pits were uncovered. It was not clear if the structure was roofed or whether it was contemporary with the main settlement. A heavily corroded iron object and a piece of copper-alloy were found, along with sherds of prehistoric pottery in a later drainage ditch.
