**LUAS  
Archaeological Monitoring  
Final Report**

**Line A**

**Licence No. 01E0733**

By  
Franc Myles with Peter Kerins  
Margaret Gowen & Co. Ltd.  
Job No. 99216-R11

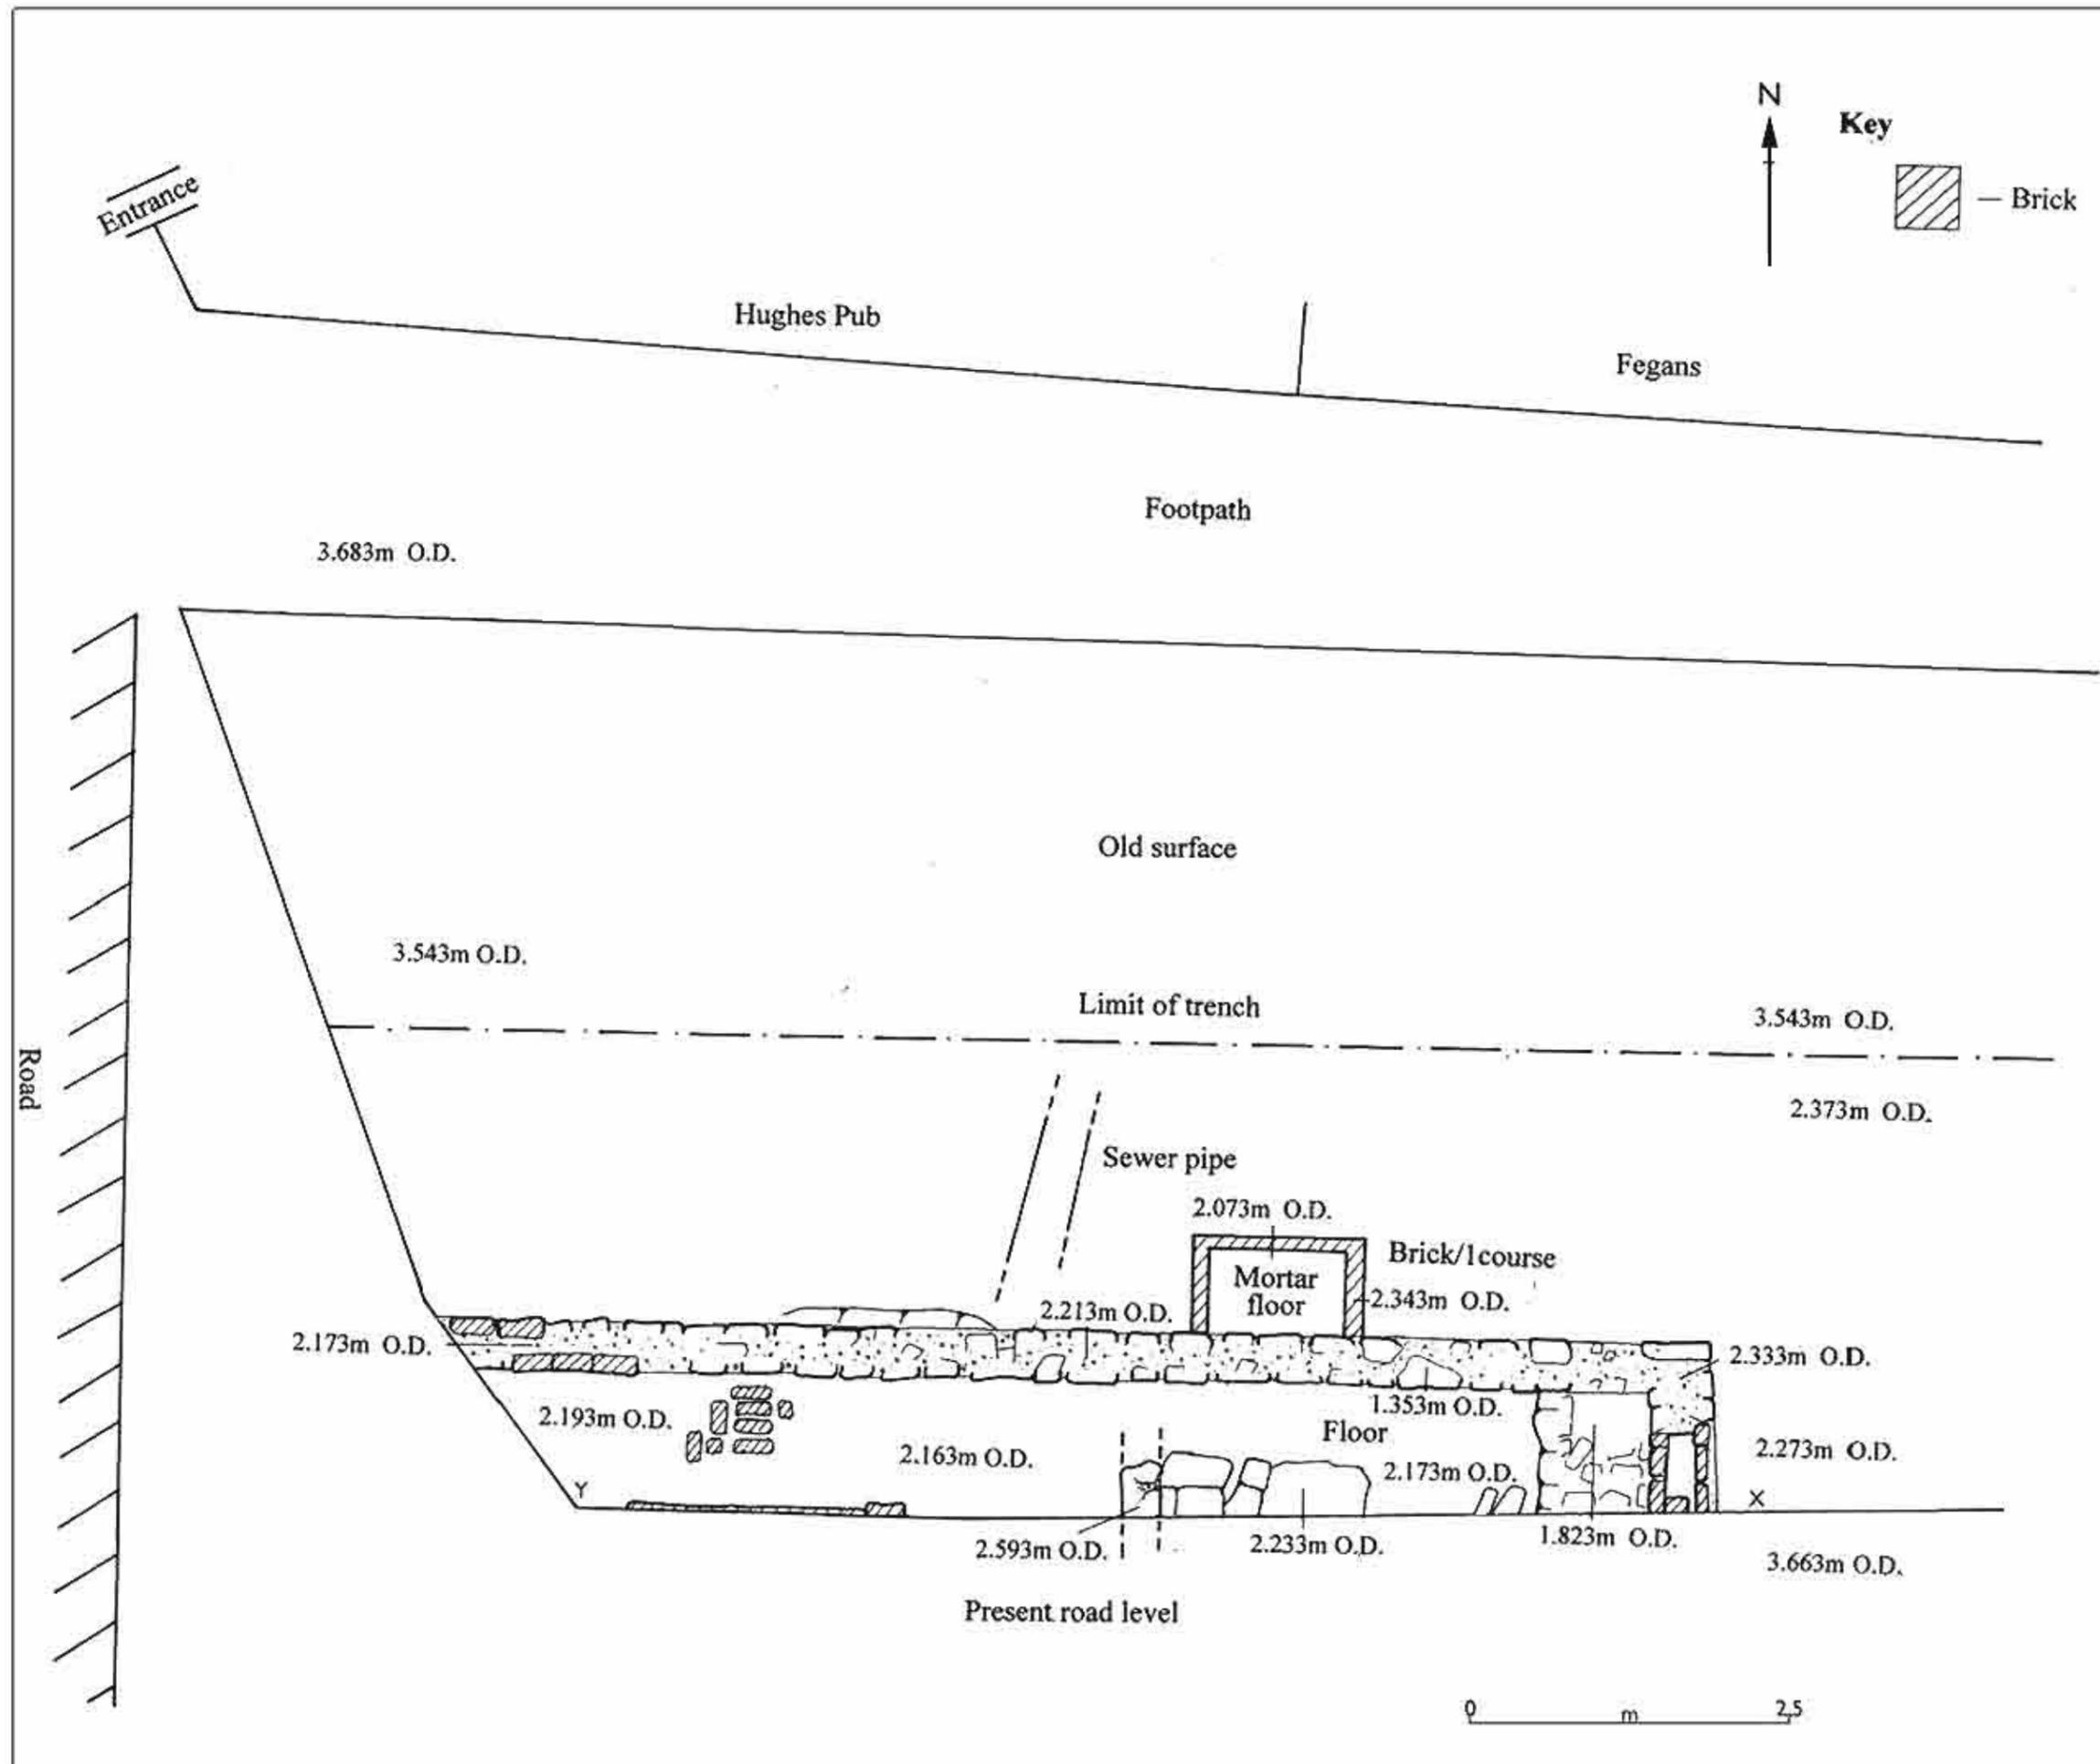
Job LRT Line A Monitoring,  
 Dublin  
 Ref. 99216-R11  
 Date 23.05.05  
 Client RPA  
 Scale As indicated  
 Fig. 12 Plan of excavated features on  
 Chancery Street

- A – Mid -brown sandy- silt with gravel inclusions
- B – Fine grayish-black sand with pebble inclusions
- C – Grey sandy-clay with large gravel inclusions
- D – Rubble
- E – Mortar
- F – Rubble with 60% mortar

The plan shows a gap in the stonework of the main wall, corresponding to the alignment of the drain cut and eastern wall. This gap was blocked with a rough mix of mortar and brick, over a loose fill. A rectangular slab, similar to those in the wall face, was disturbed at some stage and lay just outside the blocked section of wall.

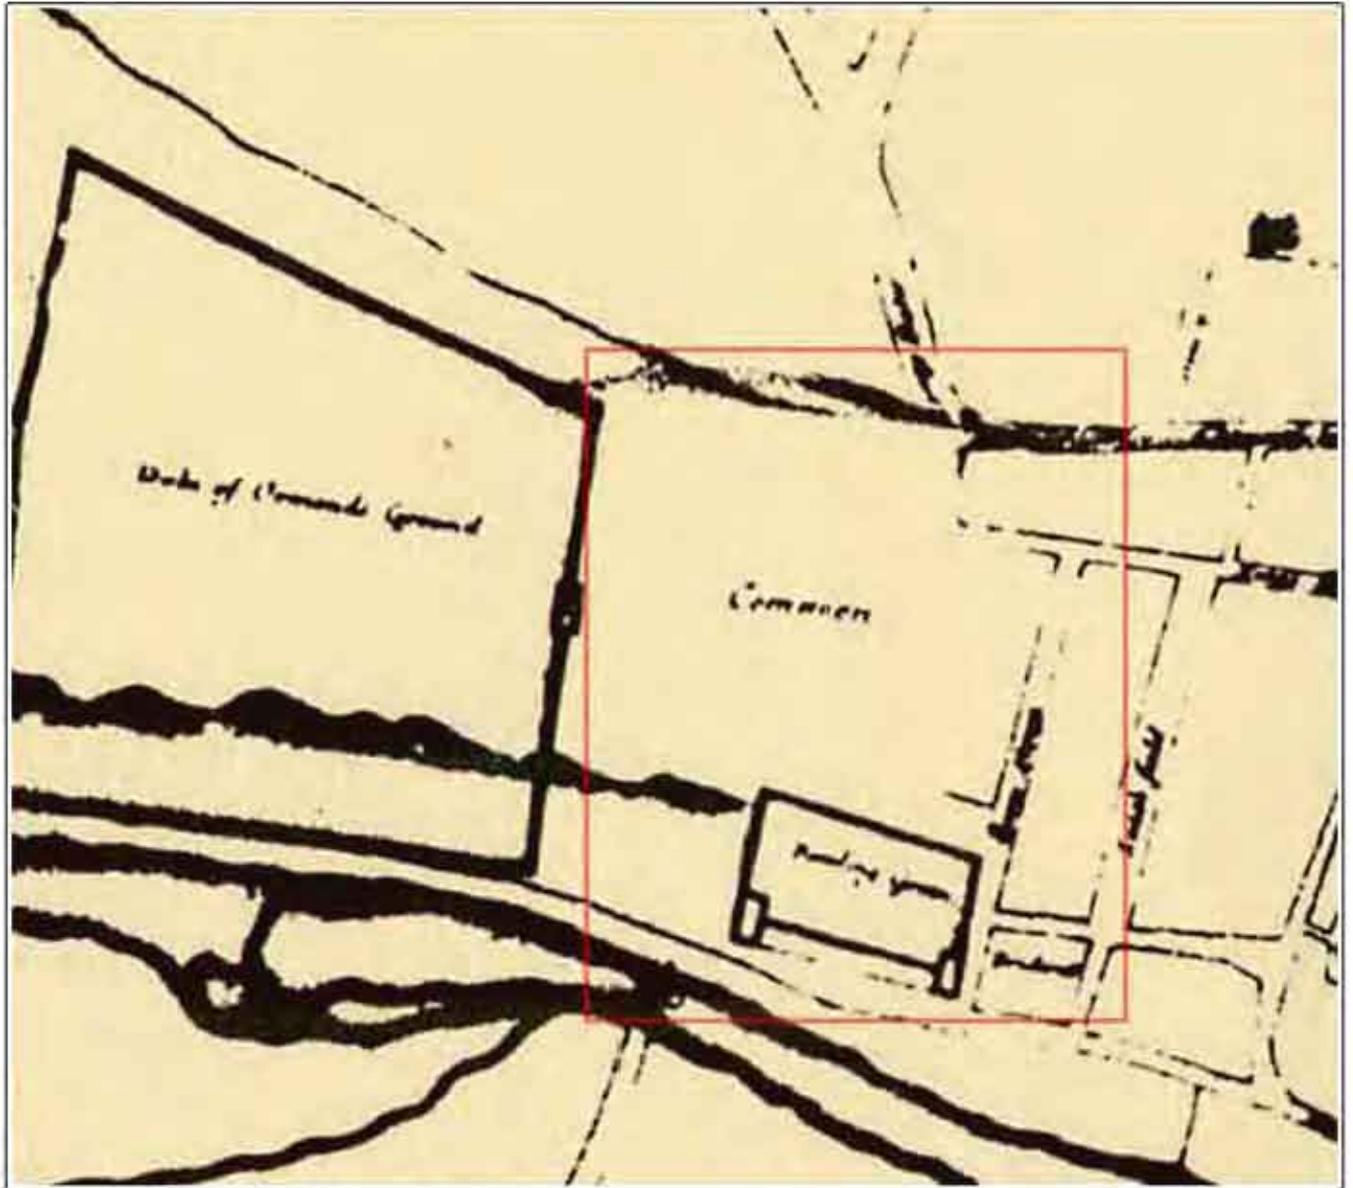
Fig. 18 Bernard de Gomme, 1673, bowling green detail, Smithfield

Speed's map does not illustrate this section of suburbs of Dublin but it appears from both the de Gomme and Pratt maps that settlement was confined to the north of this section of the western route up to the great expansion of the suburb in the early eighteenth century. De Gomme and Pratt show a bowling green on the north side of the present Smithfield/Arran Quay Terrace junction (Fig. 18). By 1728 and Booking's map the present street layout was established and the site of the bowling green had been developed.

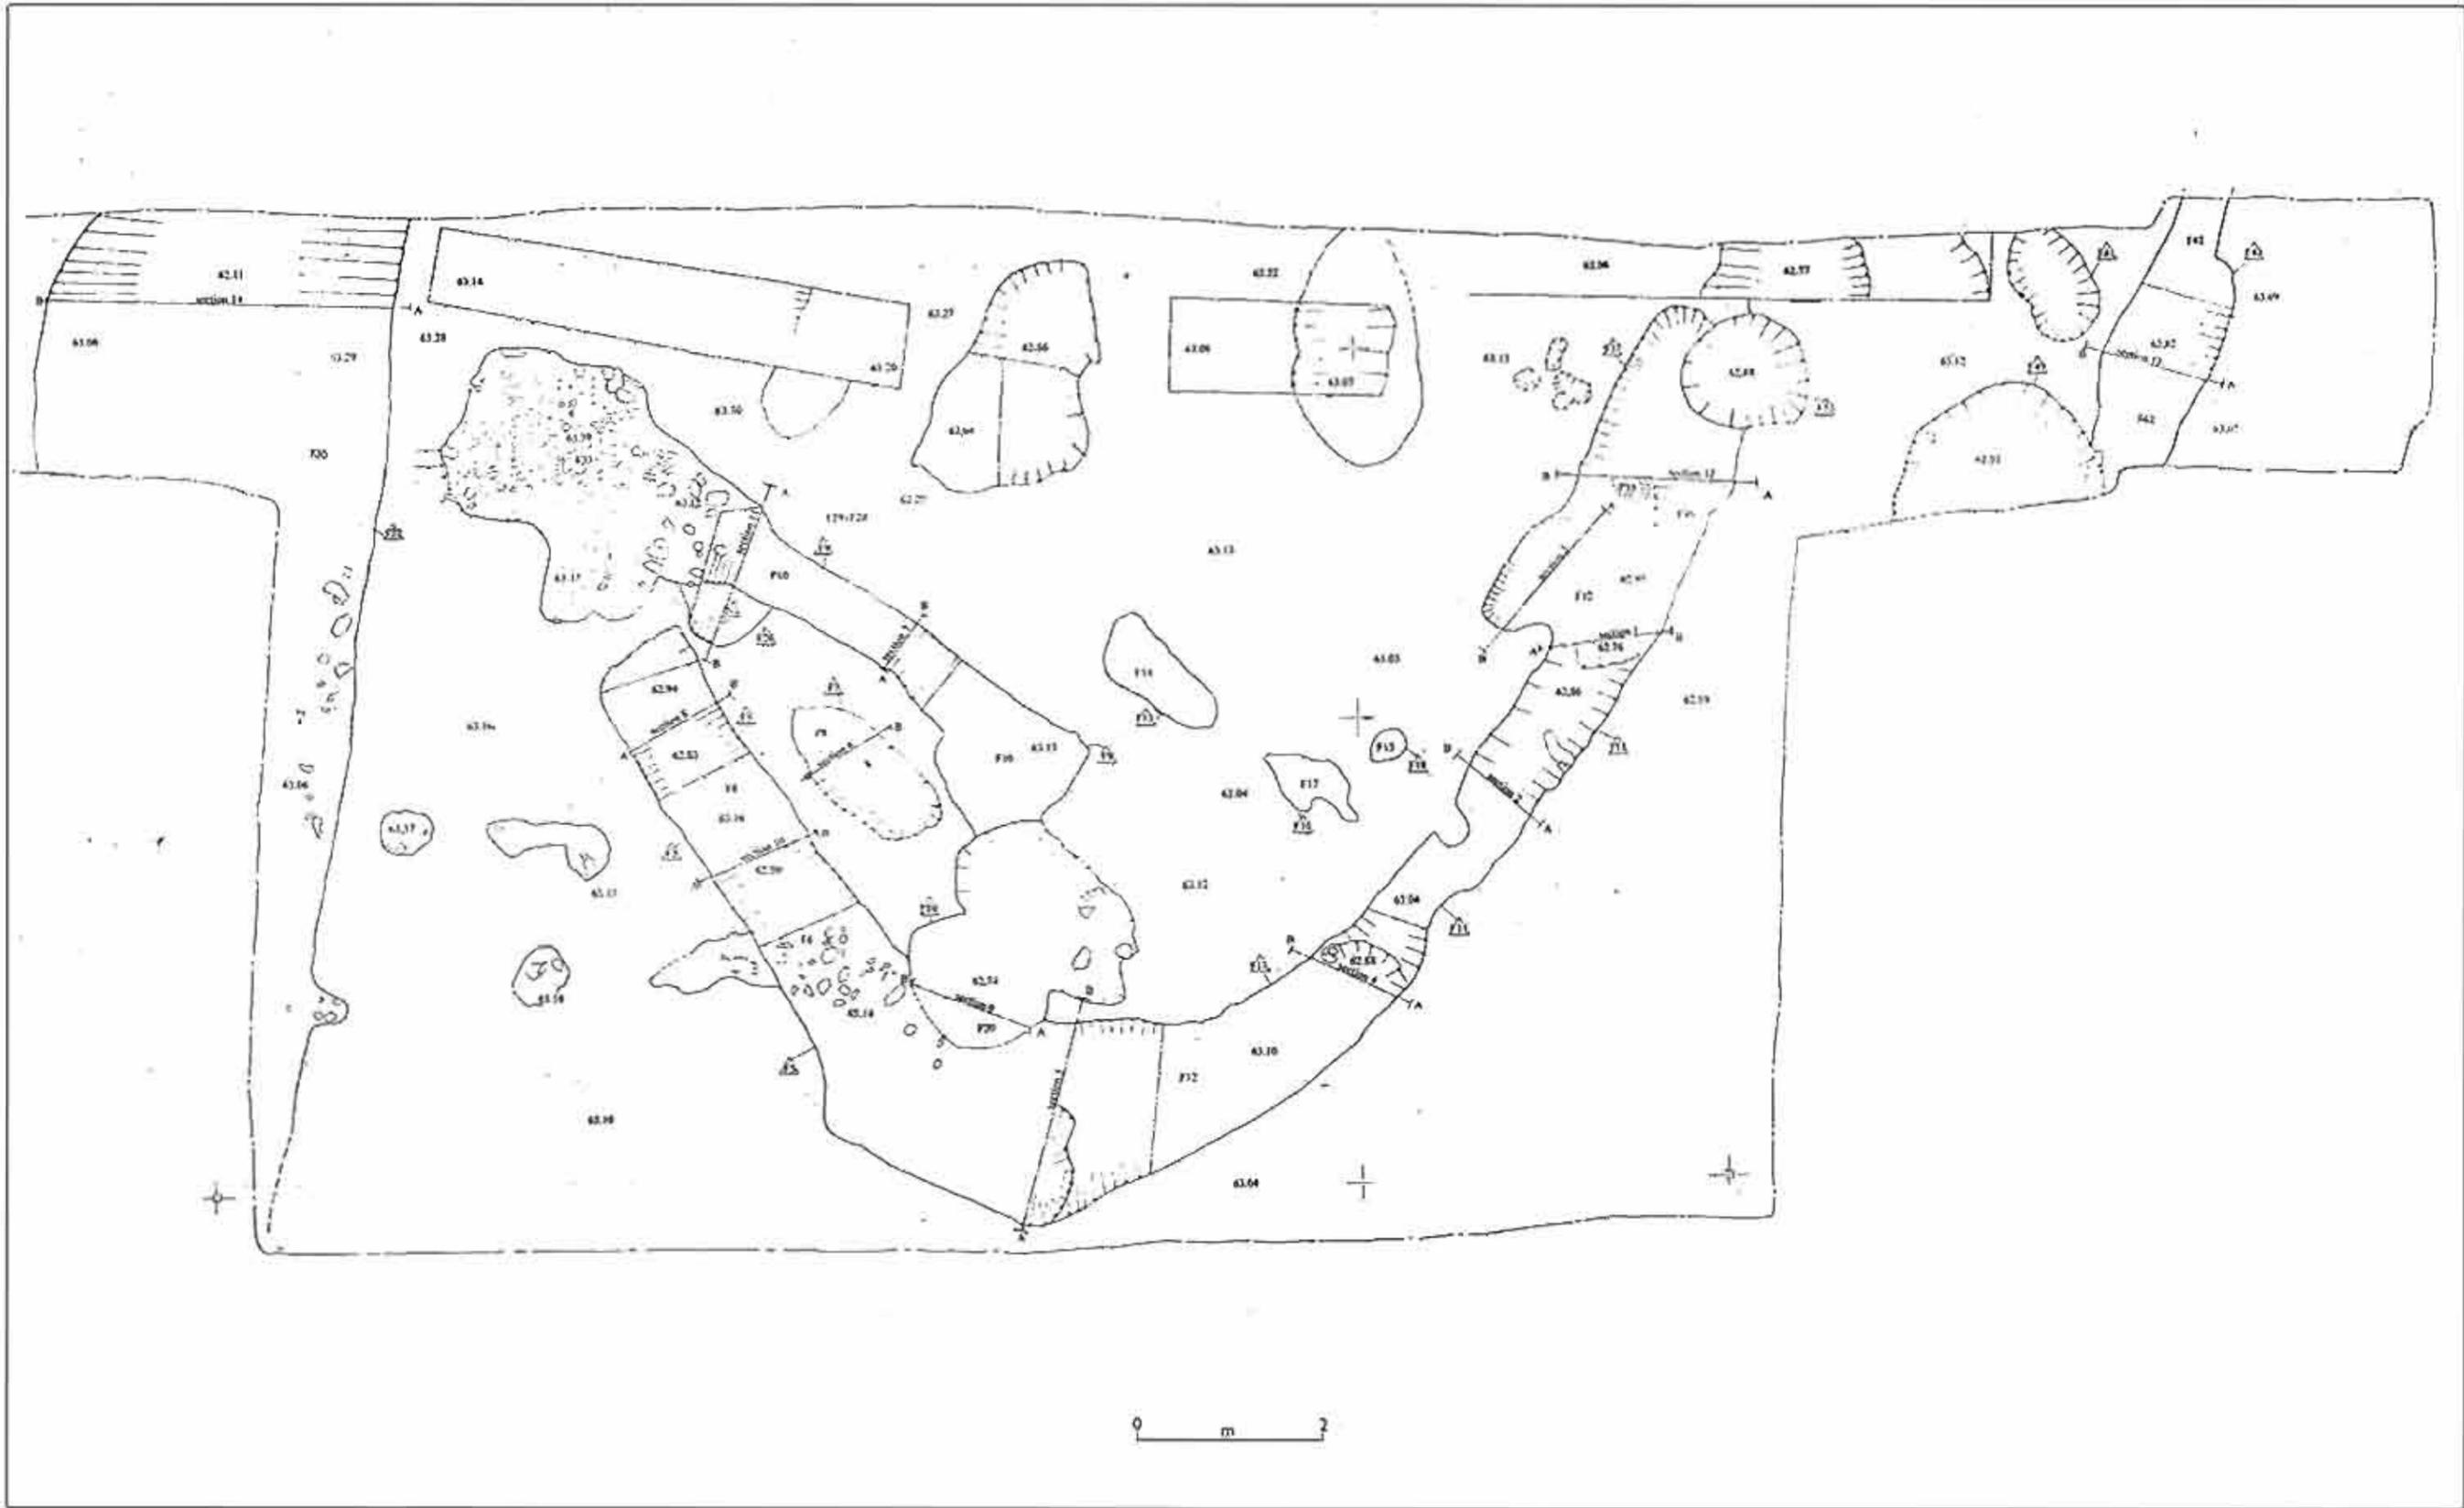
- Fig. 24 Features excavated at Ballymount Great

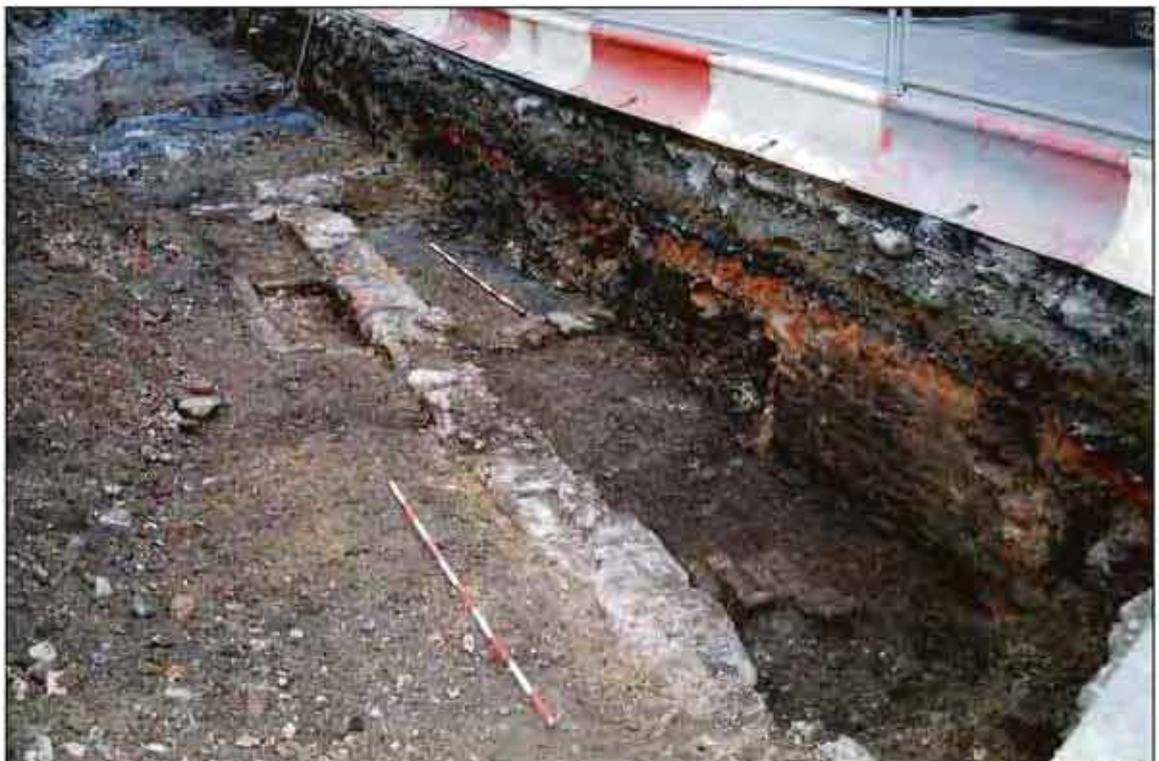
Plate 4 Remains of eighteenth-century houses on Chancery Street demolished in the 1880s

The external walls were 420mm in width and composed of mixed masonry and brick, bonded with a white lime mortar. The wall faces were variable and were unevenly coursed, with sections of the walling using large quantities of mortar and loose stone and brick. They survived to 800mm in height but their full depth and formation level was not established. The north-facing wall was 10m in length and extended beyond the limits of excavation to the west.

The style of construction changed at the western end of the northern wall from solid masonry/brick to parallel brick courses with a central gap filled with loose organic clay. The latter form of construction could also be seen in the small section of the east-facing wall that was exposed.

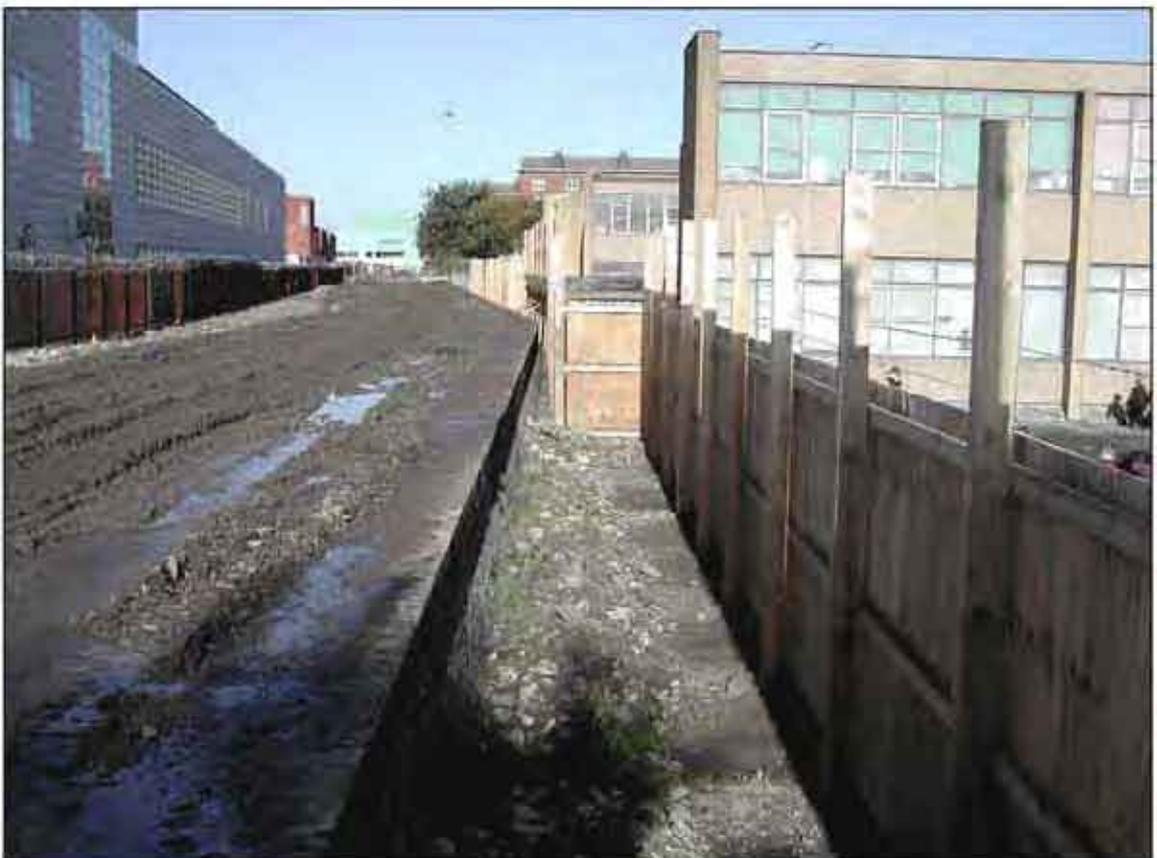
Plate 8 Alignment through City Basin, looking north

The *Luas* alignment runs through the grounds of St. James's Hospital and through the grounds of the old City Basin on the eastern flank of the hospital (Plate 8), before exiting along the old course of the Grand Canal at James's Walk.

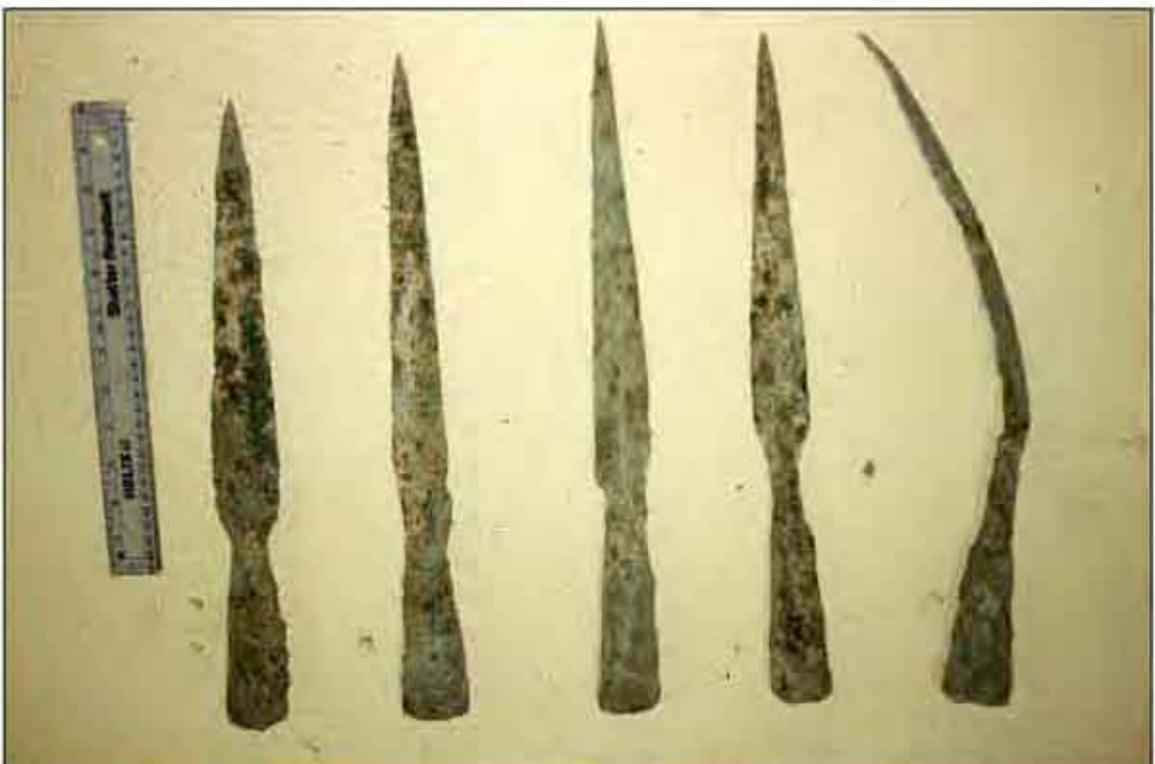
Plate 10 Pike heads from underneath Rialto Bridge

The artefacts were recovered in a corroded state but retained their sharp points (Plate 10). The hoard consists of five simple socketed pike heads, broadly similar in construction, three with central mid-ribs. There was no evidence for the hooks usually illustrated in depictions of the rebellion. There are fragments of ash surviving in all of the sockets. An iron plaque was recovered with the pike heads, but is probably unconnected. The pike heads and plaque underwent conservation in *ArchCon Laboratories* and have been deposited in the National Museum of Ireland.

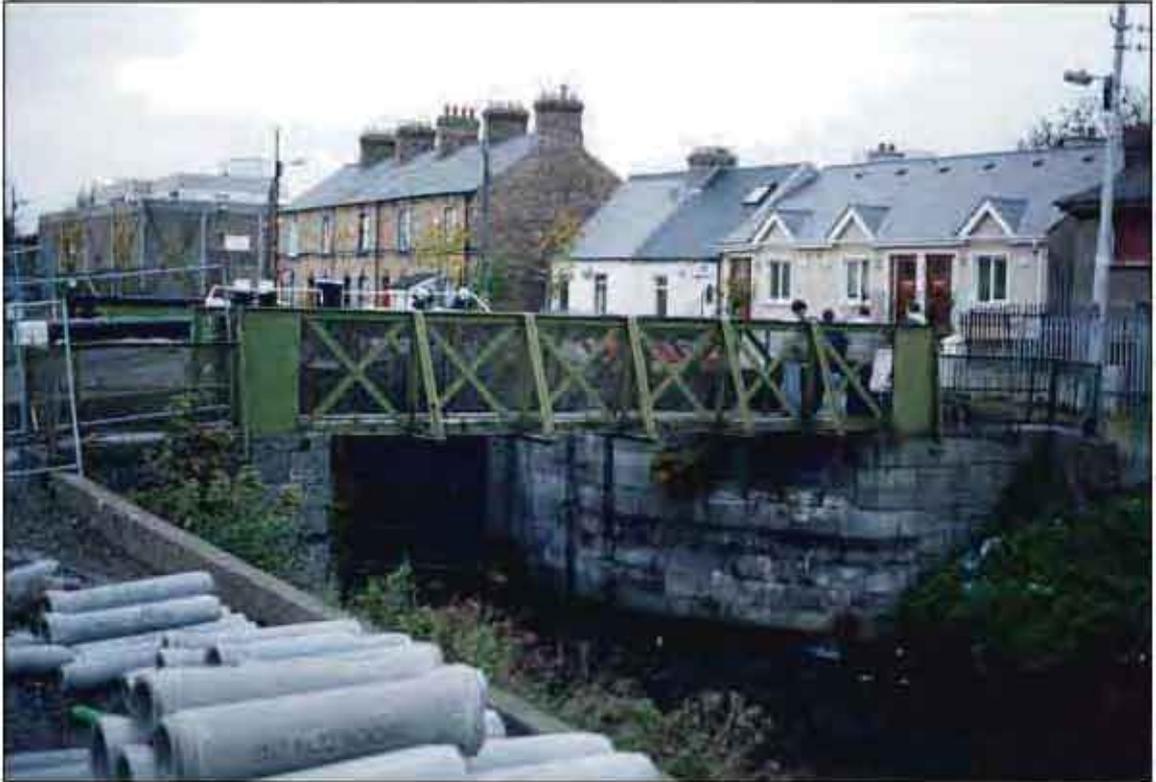
Plate 11 Metal bridge at the second lock, Grand Canal

A metal bridge spanning the canal at the second lock was replaced as part of the development and a photographic record of its fabric was taken prior to its dismantling (Plate 11).

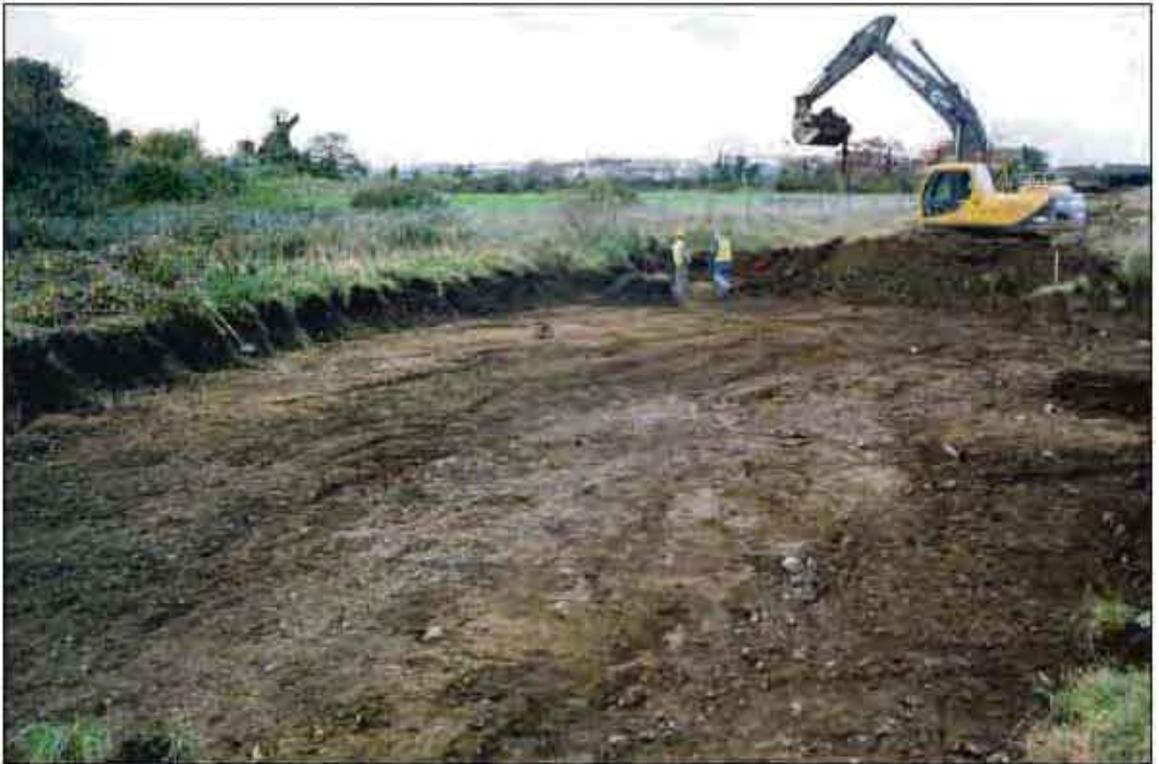
Plate 13 Monitoring at Ballymount, with mound behind

There was a general ground reduction of 600mm for the track. Service diversion and renewals included trenches of up to 2.5m in depth in the present road and off-road margins (Plate 13).
