Final Excavation Report

**Tram Street and Phoenix Street
Dublin 7**

Licence no. 01E0229
Planning Ref. n/a

By
Franc Myles
Margaret Gowen & Co. Ltd

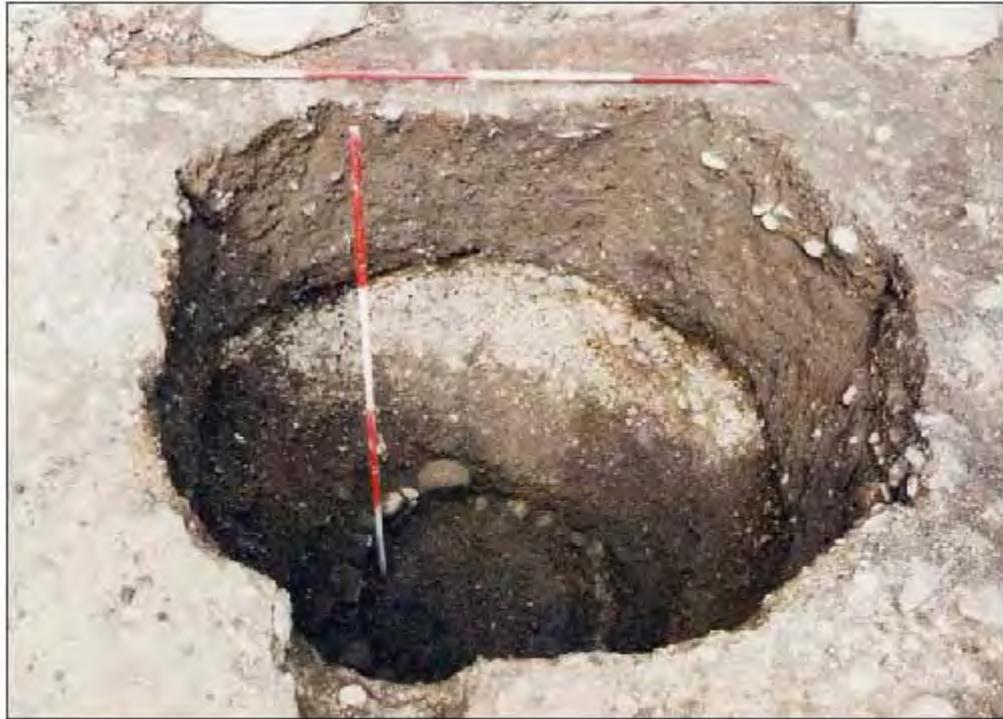
Plate 1 F14 masonry well with gravel and garden soil (F70) in the section

The well located in the yard to the rear is typical of similar structures recorded elsewhere in the city. Two similar examples were recorded in Phoenix Street to the west. It is likely that the well went out of use as piped water was introduced to the area towards the middle of the eighteenth century. In 1741, the Piped Water Committee of the City Assembly (later to be known as the Committee for Better Supplying the City of Dublin with Piped Water) recommended that the Liffey be tapped at Islandbridge, to relieve pressure from the city basin at James Street (Gilbert 1889-1922, ix, 32-33). In 1746 a consignment of timber consisting of 800 to 900 yards of 'good round fir... 10 feet to 14 feet long, 15" to 18" diameter exclusive at the butt end' was awaited from Norway (Gilbert 1889-1922, ix, 198). The main ran along the north quays into the city and the Smithfield area would have been one of the first beneficiaries of the new water supply.

The base plate associated with the well would appear to be the foundations of a canopy or hoist. Unlike the wells recorded in Phoenix Street, there was no wooden pump surviving in the shaft, indicating that a winch system may have been in use to raise buckets from the bottom. Spruce was only planted on a large scale in Ireland in the last few centuries. The origin of this wood species is therefore either European (Baltic or Scandinavian) or from Irish plantations, and not from natural woodland. Apart from the absence of *Picea* from the indigenous vegetation of Ireland after the Ice Age, another indication for this assumption is the fact that most wood shows very regular, relatively fast growth. The presence of *Picea* indicates the sample is of relatively recent antiquity (*pers. comm.* Dr. Ingelise Stuijts).

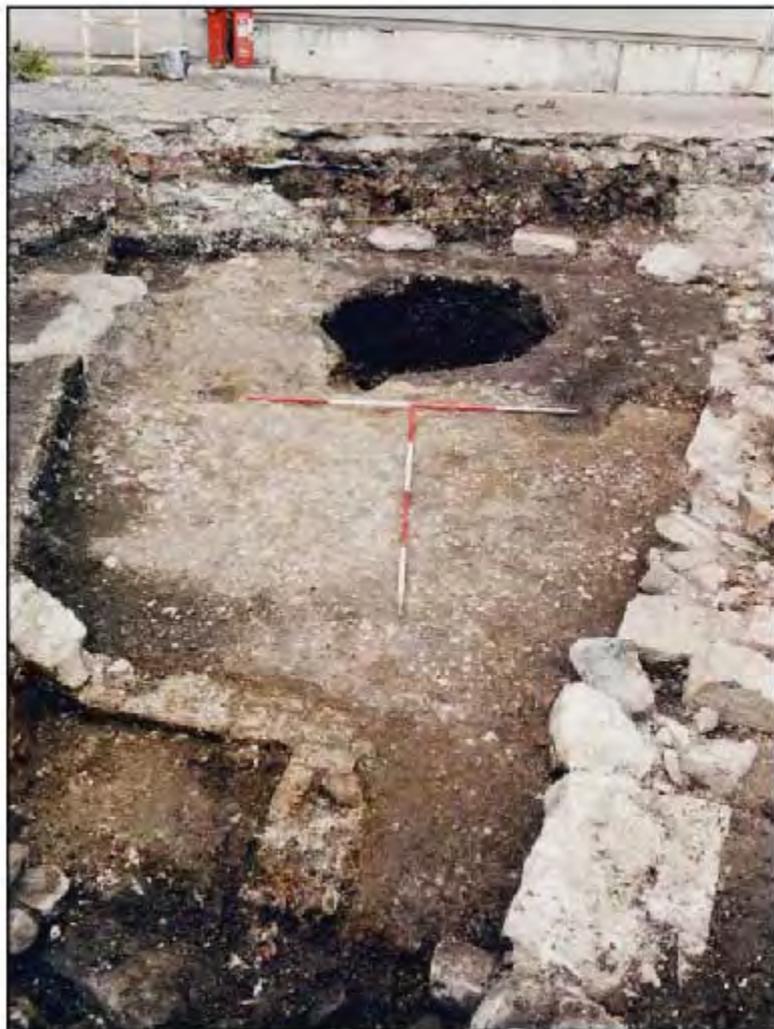
Plate 2 Western end of Trench 1 with well cut F31, surface F89, masonry wall, F2 (right) and cellar F45 (right)

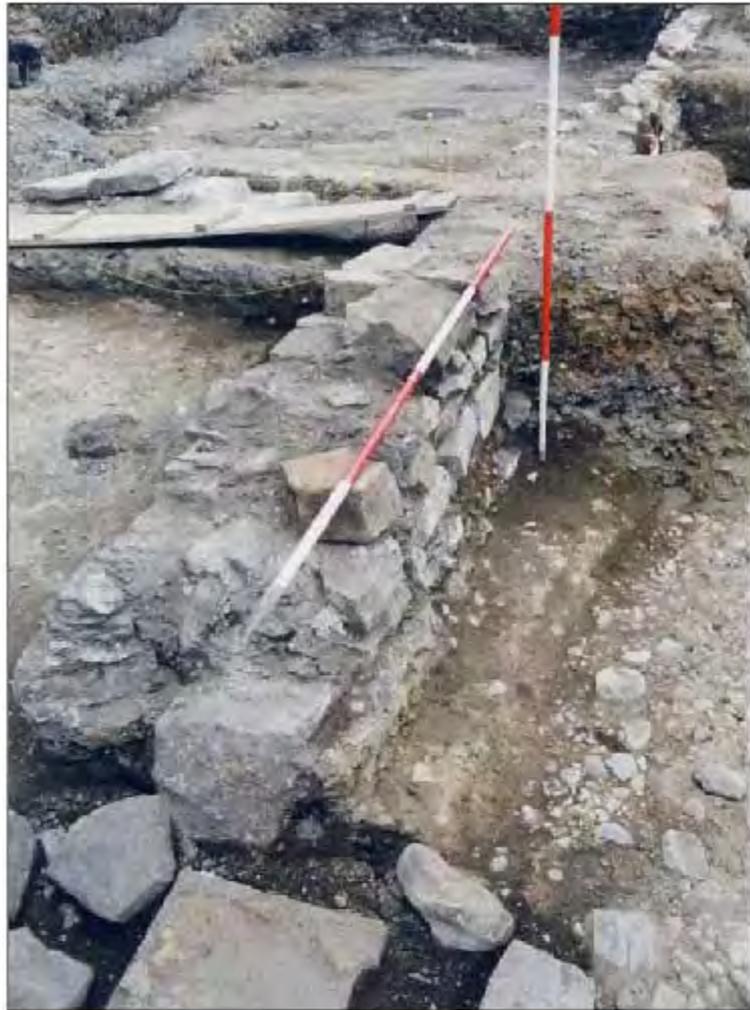
Plate 3 Early surface in laneway, FI 19 (right) slightly sunken into garden soil (F70) with masonry wall F4 stratigraphically above (left)

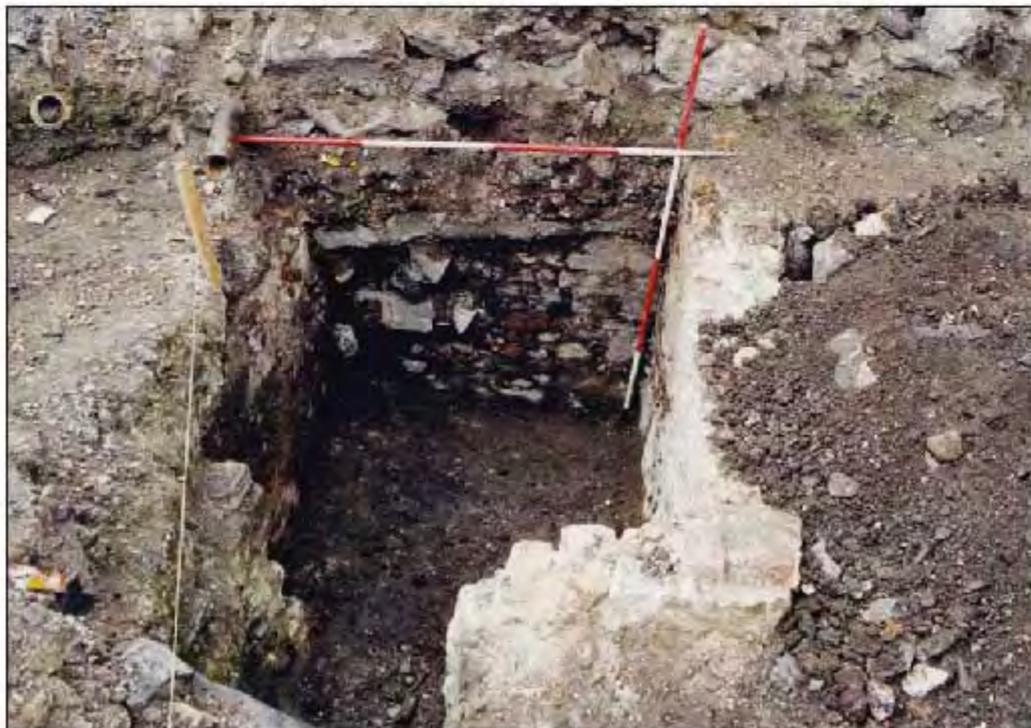
Plate 4 Cellar F45 after excavation

The material backfilling the cellar was significant in the quantity, quality and condition of the artefacts recovered. Three fills were recorded; F42 was a loose demolition deposit, 600mm in depth, consisting of rubble stone, brick and mortar. It also contained pottery, glass, slate, pan-tile and animal bone. This material sealed an undisturbed dump deposit, F43, which was 420mm in depth. This deposit contained a plate inscribed 'Ireland 1748' around a harp, along with intact wine bottles, two almost intact wine glasses, a fragment of an erotic wall tile (Plate 5), an intact sgraffito plate and an almost intact mottled ware tankard (Plate 6). The latter was recovered upright on the floor surface. This material is currently undergoing conservation and analysis. The contents of an almost intact chamber pot are described in Appendix 2 below. A lower fill, F44, was a deposit similar to F43, and was 120mm in depth, while containing a greater amount of ash.

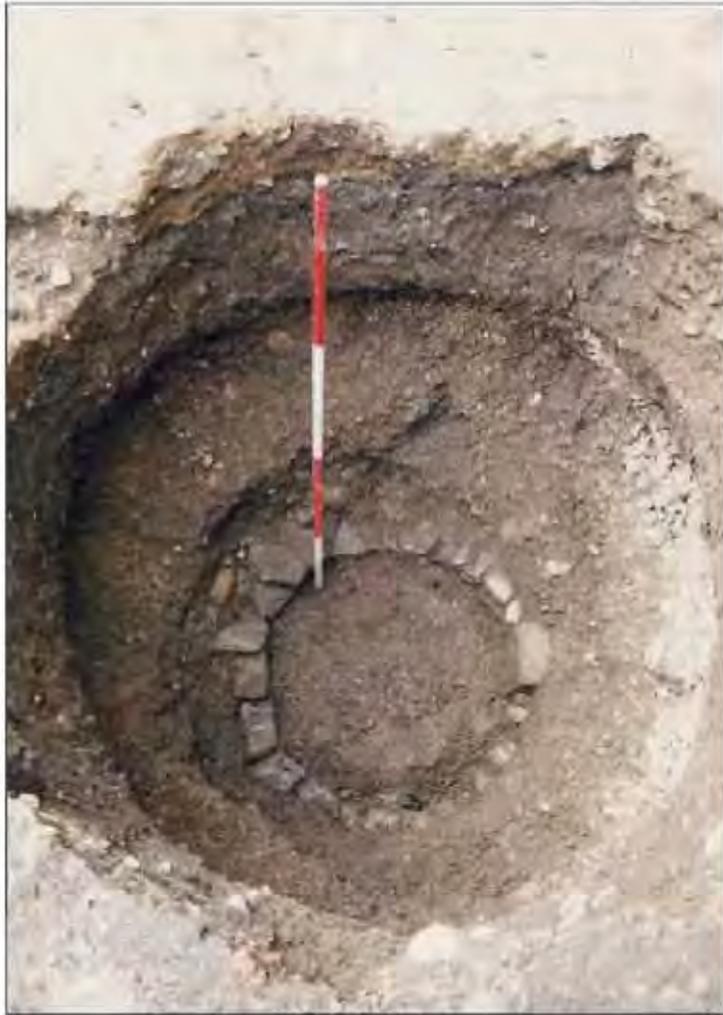
Plate 7 Masonry well F14 after the excavation of the recuts

The second section (working to the east) extended for 3.6m and ran adjacent to the backfilled well F14 to the junction with F2. The well (or perhaps the recut) had undermined the primary build of the wall and a new foundation course of red brick was constructed under the calp blocks. The bricks were hand made and badly fired with grey, red and white seams. They measured 9" x 4" x 2^{1/2}" and were laid on their sides. The bricks were recessed by 110mm from the wall face. The wall foundation was two stretchers wide (460mm) at this level, however the masonry above gave the wall an above ground width of 600mm. One course survived on the south face and the deposits on the northern side were not excavated.

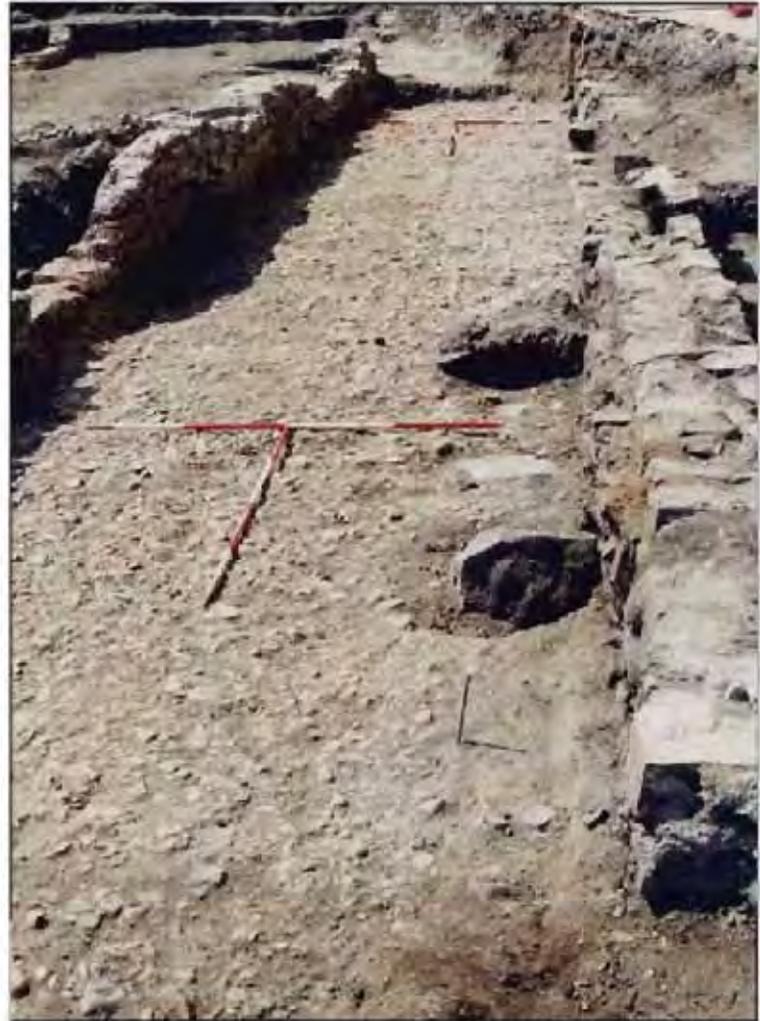
Plate 8 F10 cobbling in laneway, looking west

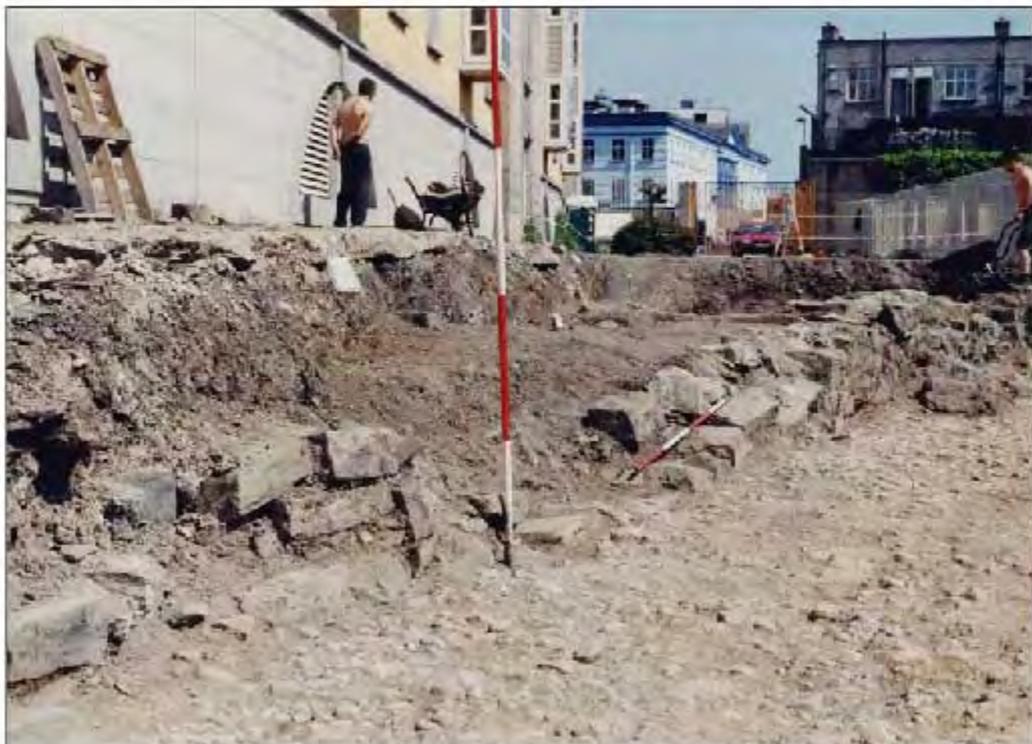
Plate 10 Section of masonry wall F4, with F10 surface (foreground)

The F10 surface was associated with a short length of masonry walling which survived in poor condition (Plate 10). The western 6m-8m of F4 (the feature number allocated to the wall delineating the northern extent of the lane) was cut below the level of the F10 cobbles. The masonry here survived to a maximum height of 450mm and was constructed from irregular blocks of limestone rubble. The southern face (facing the lane) survived to one course and there was no surviving northern face, which appears to have been removed in antiquity. The surviving thickness of the wall was on average 300mm, however, the disturbance north of the wall under the baulk would suggest an original thickness of 450mm. The remaining extent of the wall to the west post-dated the F10 surface.

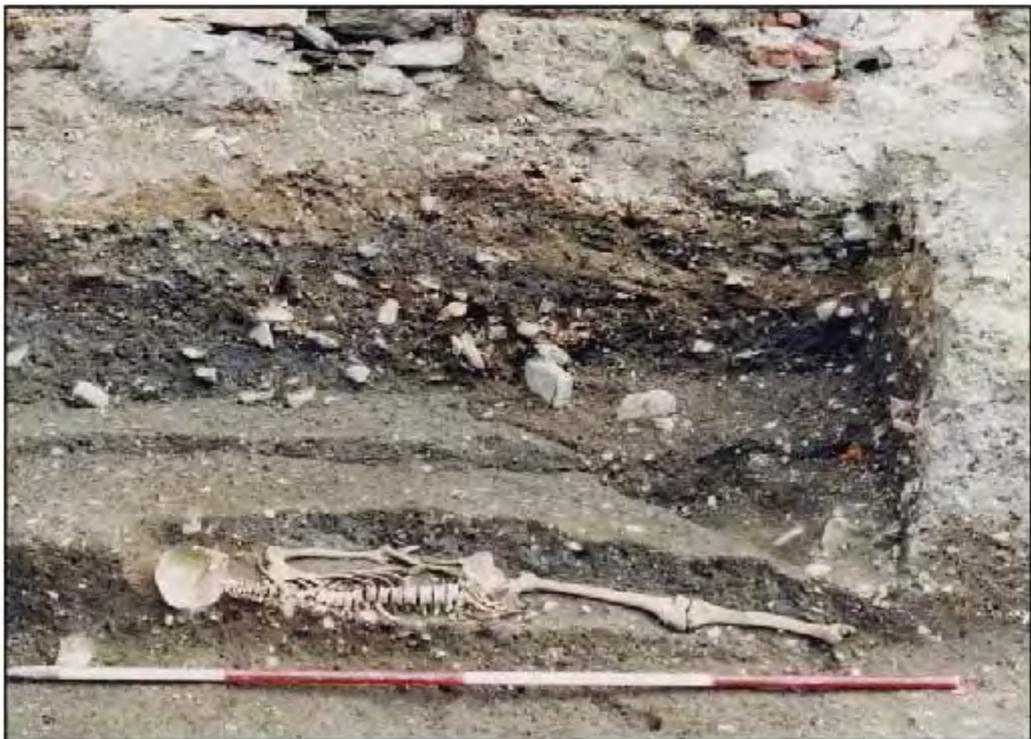
Plate 12 Inhumation B1

Further east, in the disturbed area east of F194, a human skeleton was recovered in the baulk from a section, which had been created when a massive concrete foundation was inserted in the foundry during the last century (Plate 12). The skeleton was truncated just to the right of the vertebrae and was missing its right leg and arm, mandible and the right half of the skull. It had a maximum length of 1.54m and was correctly orientated east-west. Its skull was located at 3.11m OD. The burial is discussed in detail in Appendix 1 below.

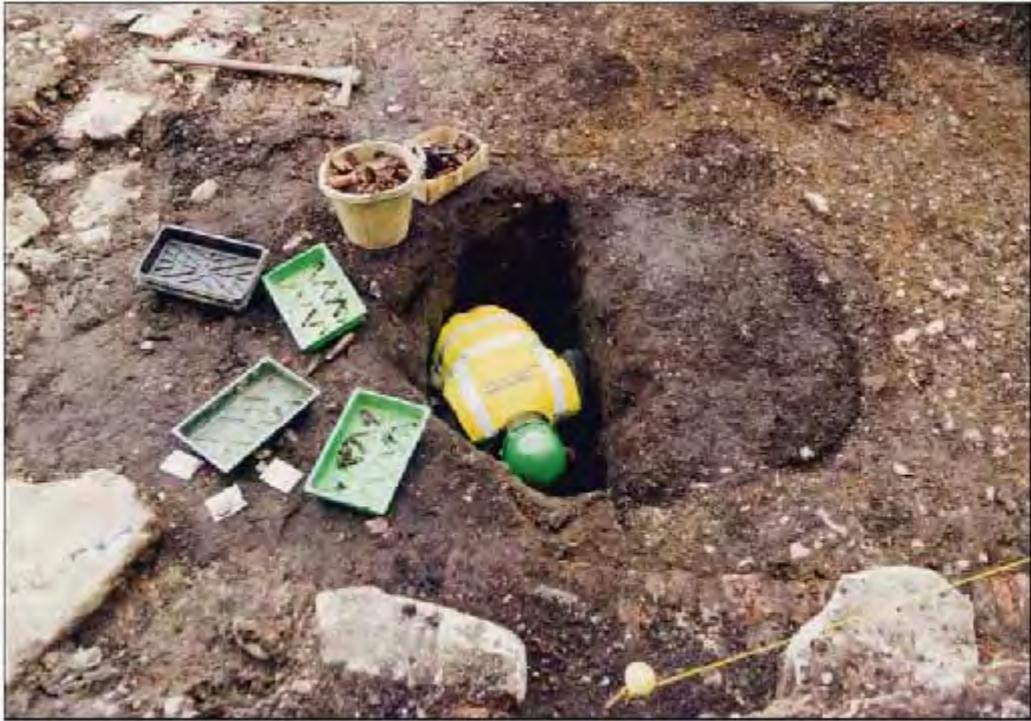
Plate 13 Rubbish pit F7/F14 (recut of well) under excavation

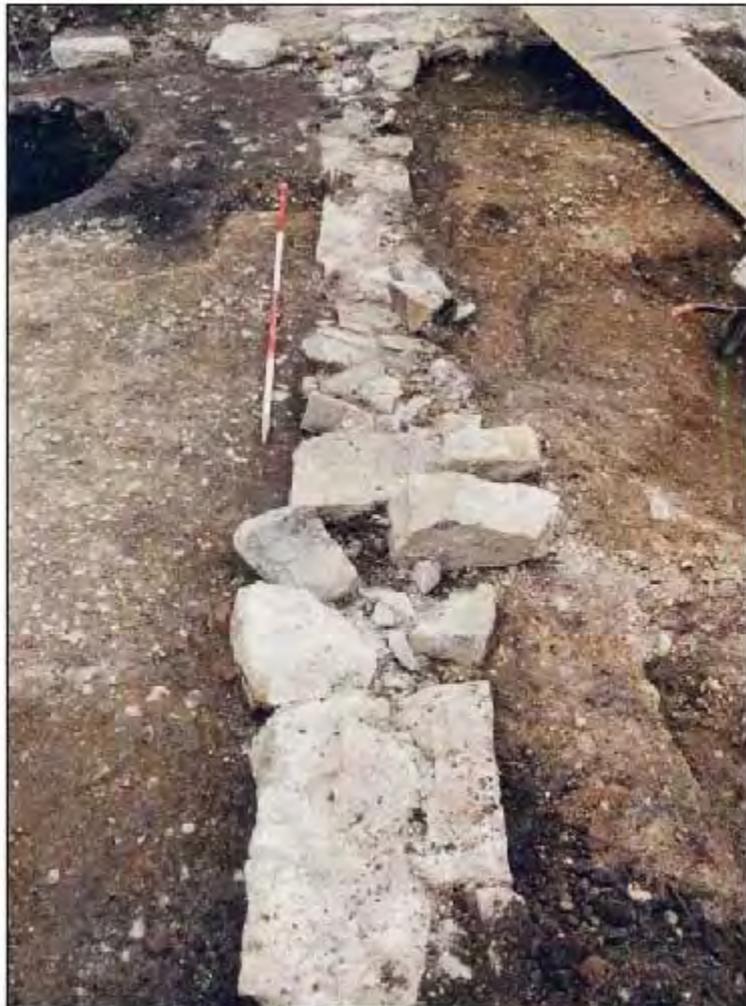
Plate 14 Masonry wall F2, looking north

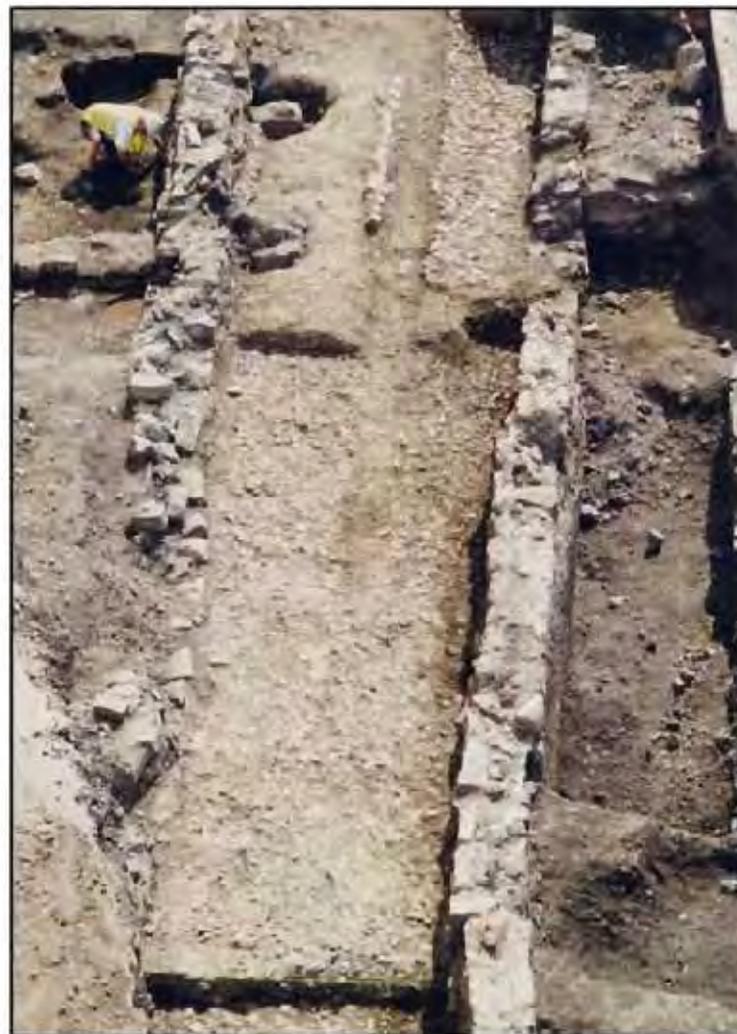
Plate 16 Surfaces F119 (foreground), F10 (centre) and F95 (background) within the laneway

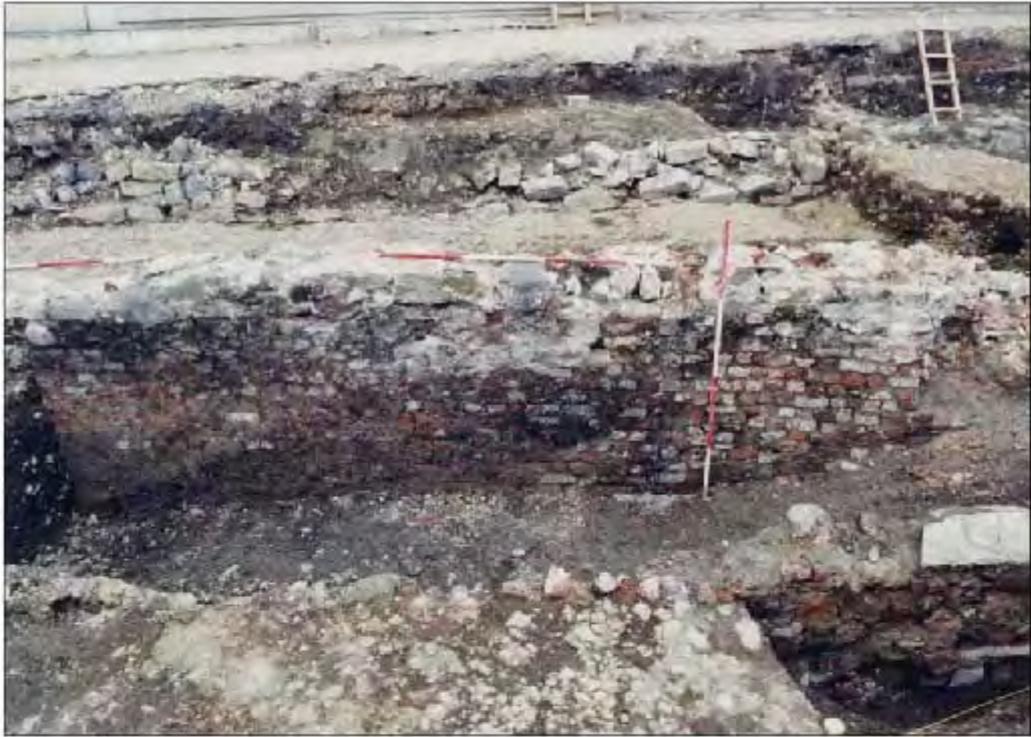
Plate 17 Brick revetting wall F19

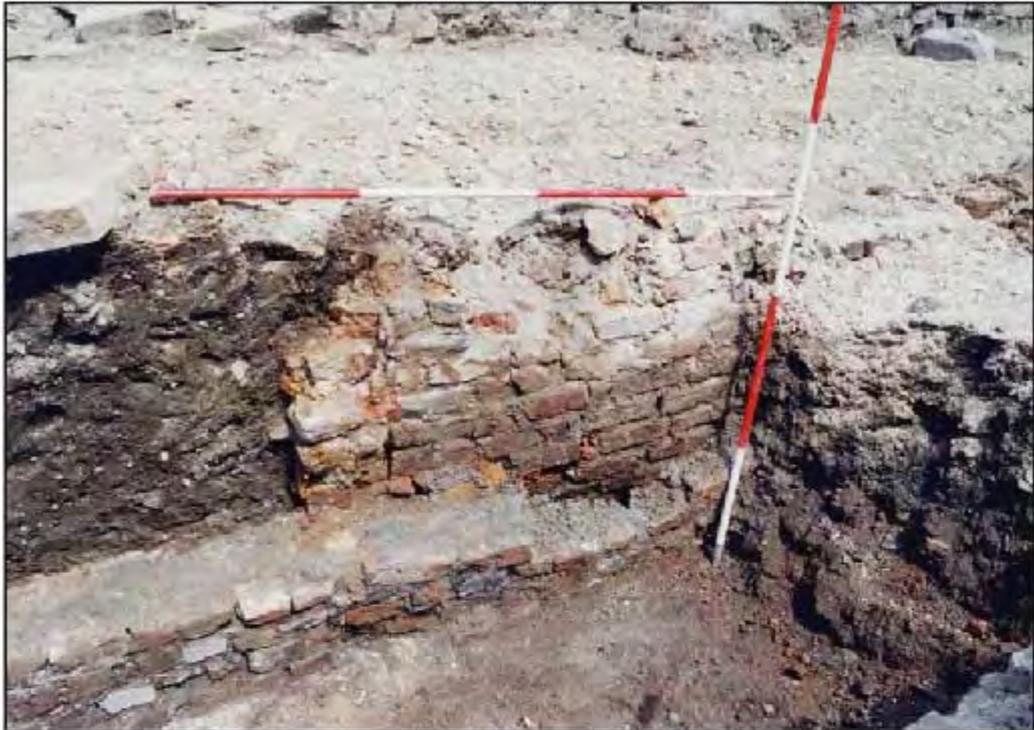
Plate 19 Detail of F19 wall with F70 garden soil exposed behind (left)

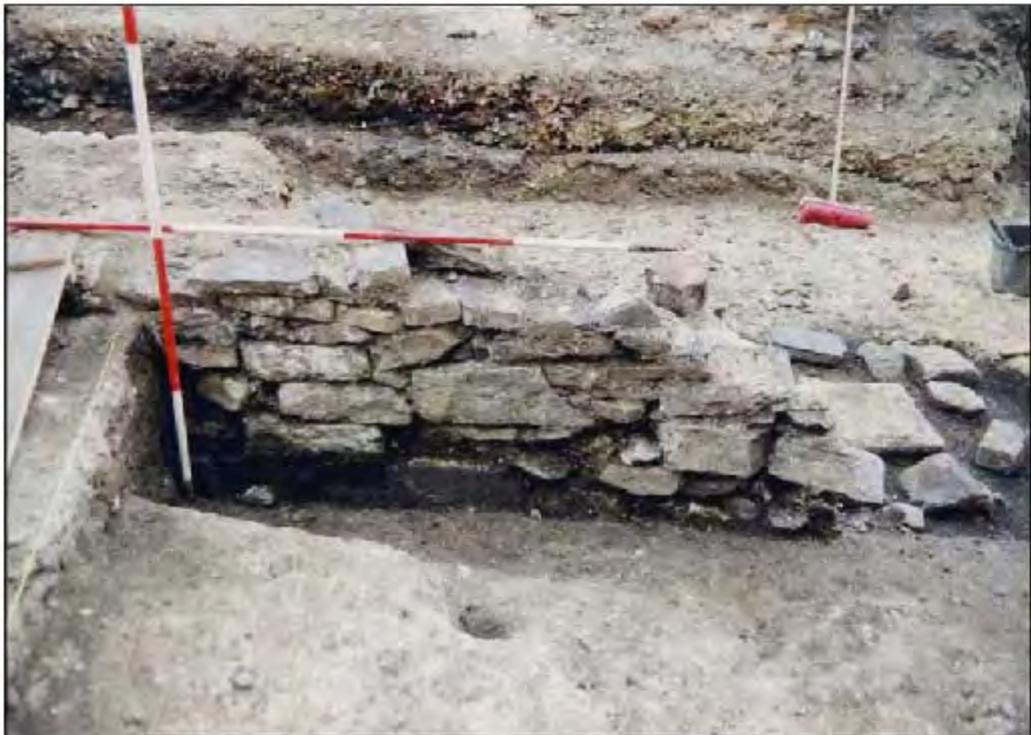
Plate 20 Detail of F4 masonry wall within its foundation cut

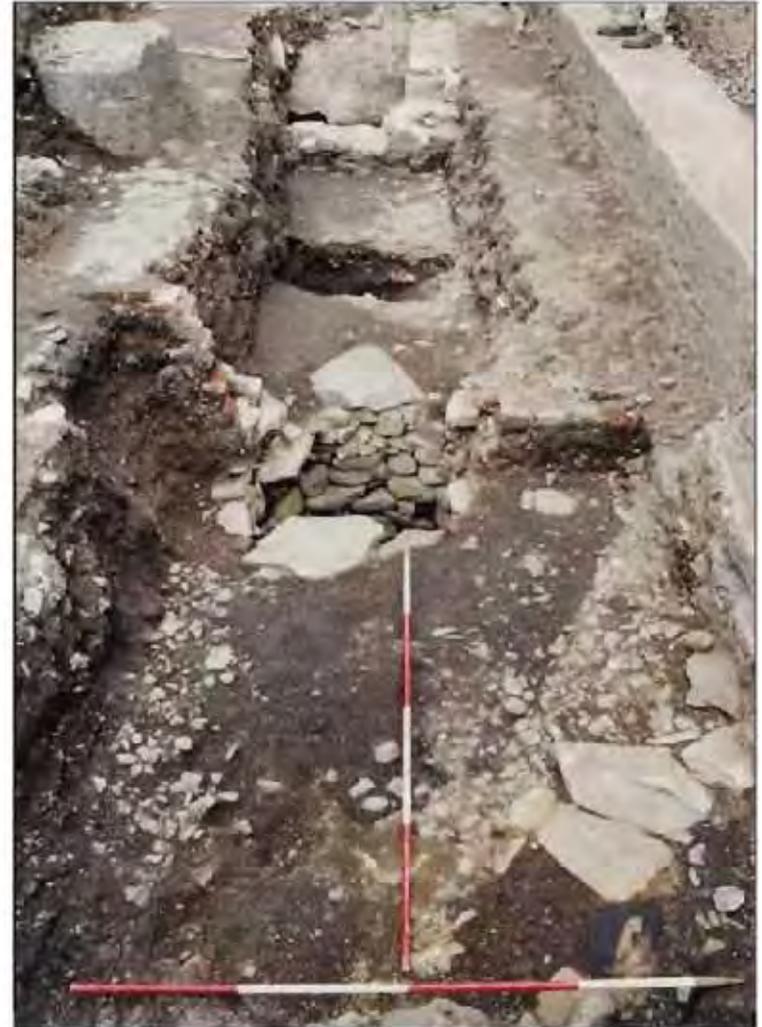
Plate 22 Surface F539 (foreground) well F540 well behind, looking west

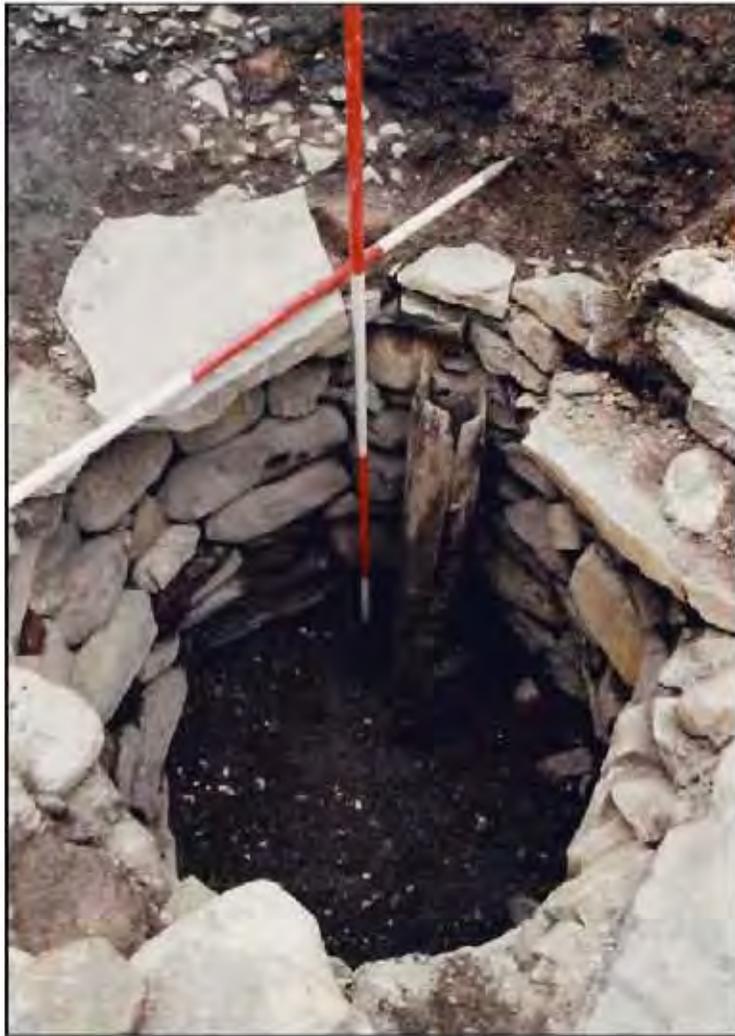
Plate 23 Detail of F540 well

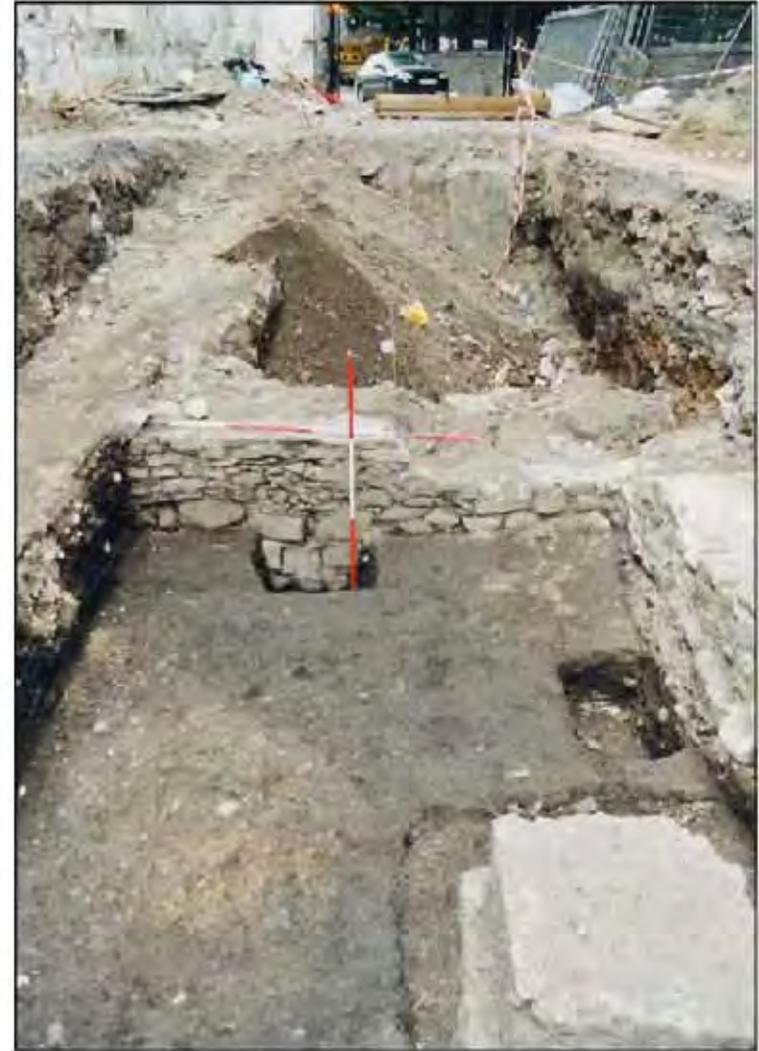
Plate 24 Structure B with excavated construction cut for F514 wall, looking west

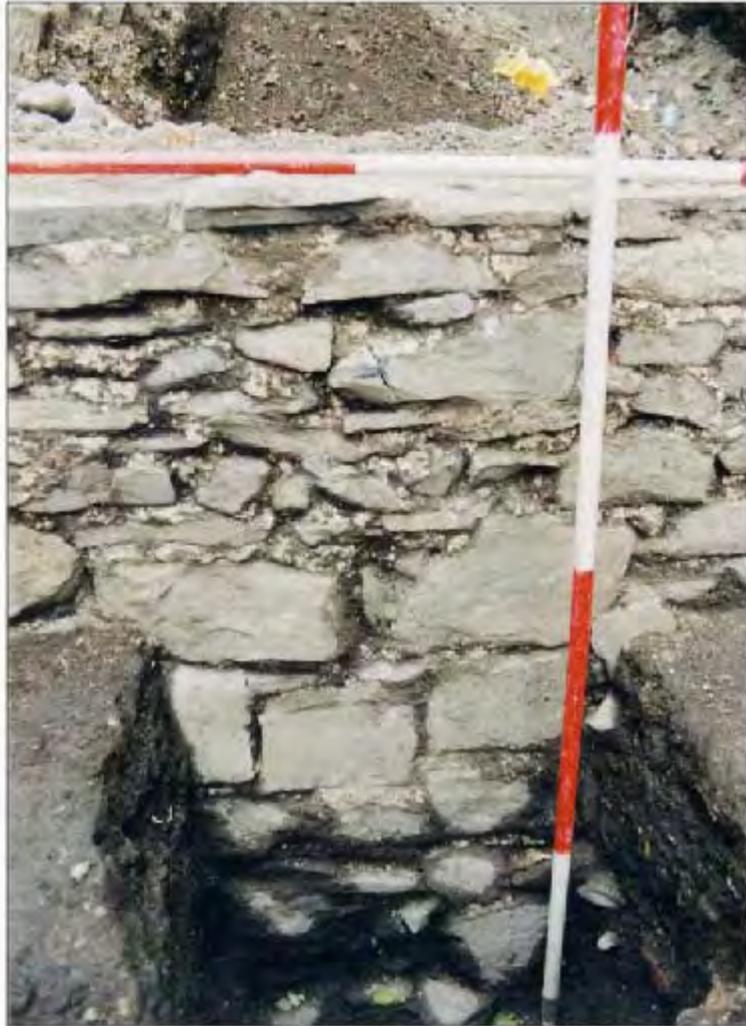
Plate 25 Detail of masonry in Structure B (F514 wall)

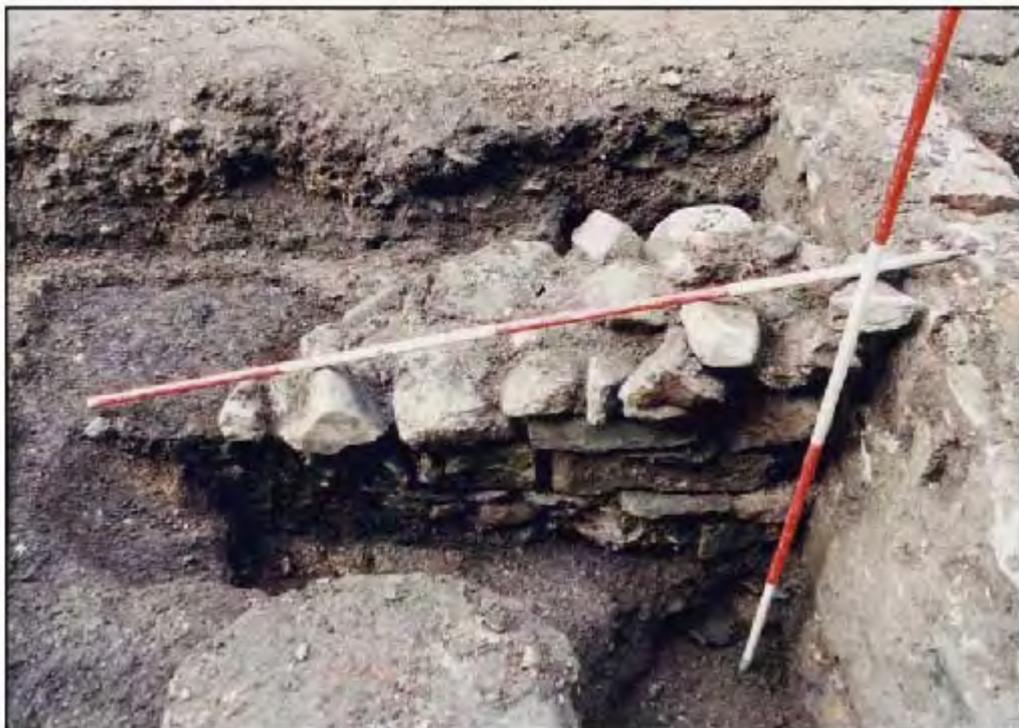
Plate 26 F571 buttress after the removal of F570 wall, looking south

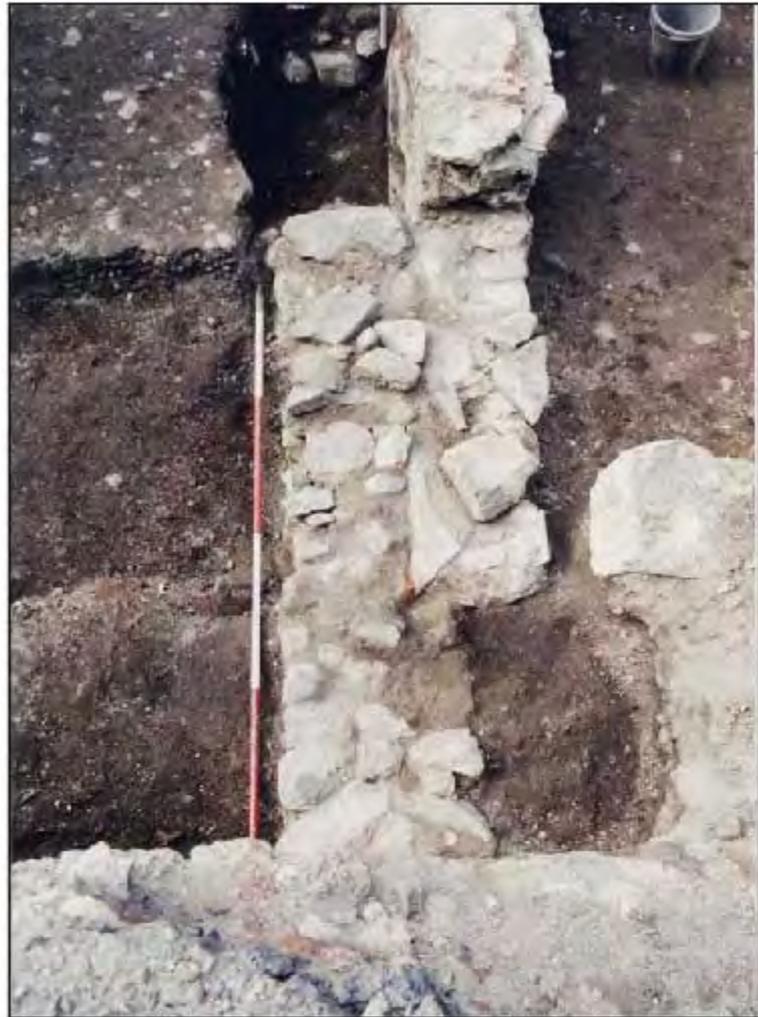
Plate 27 F570 wall (left) abutting F549 wall at junctions of Structures B and C, looking north

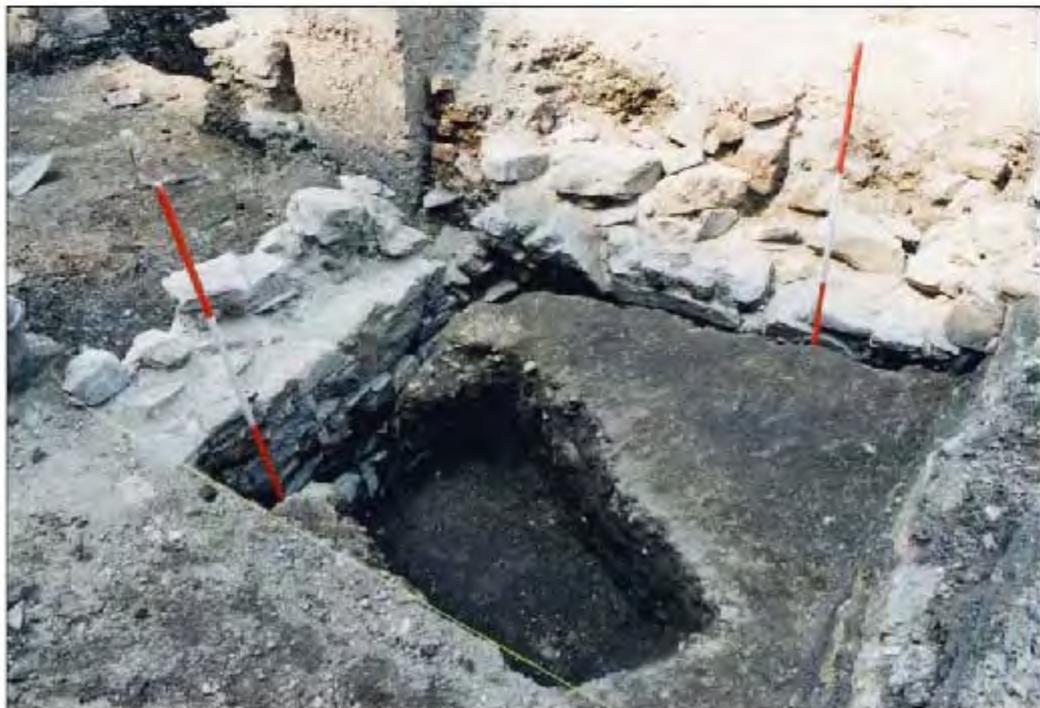
Plate 28 Structure F showing sondage through dump deposits below

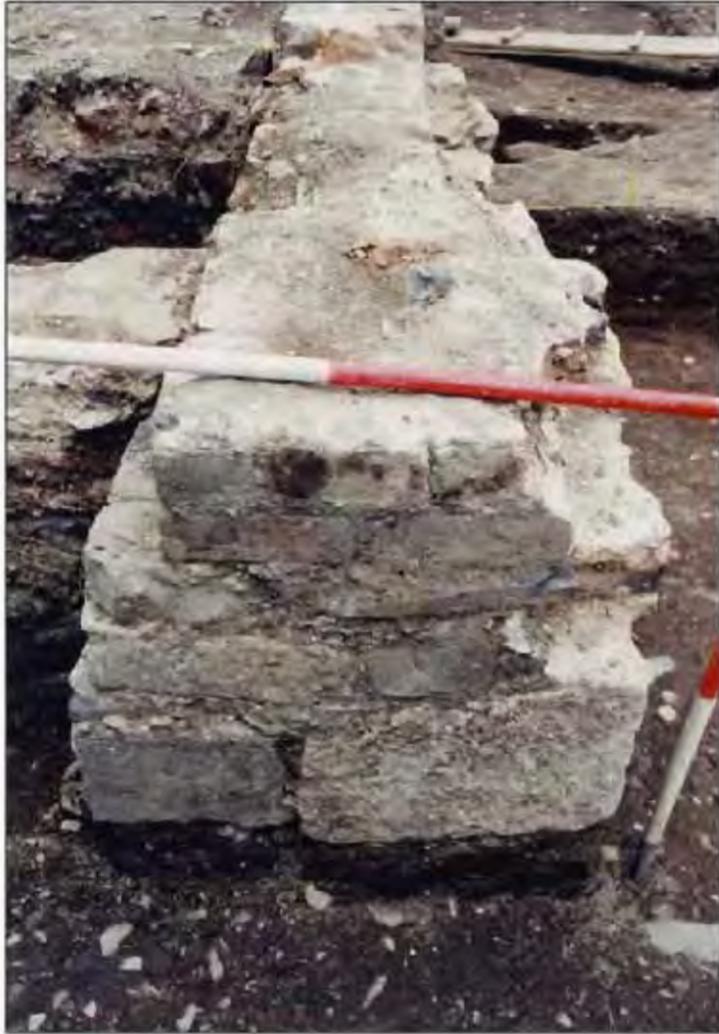
Plate 29 Detail of F507 wall at eastern side of gateway

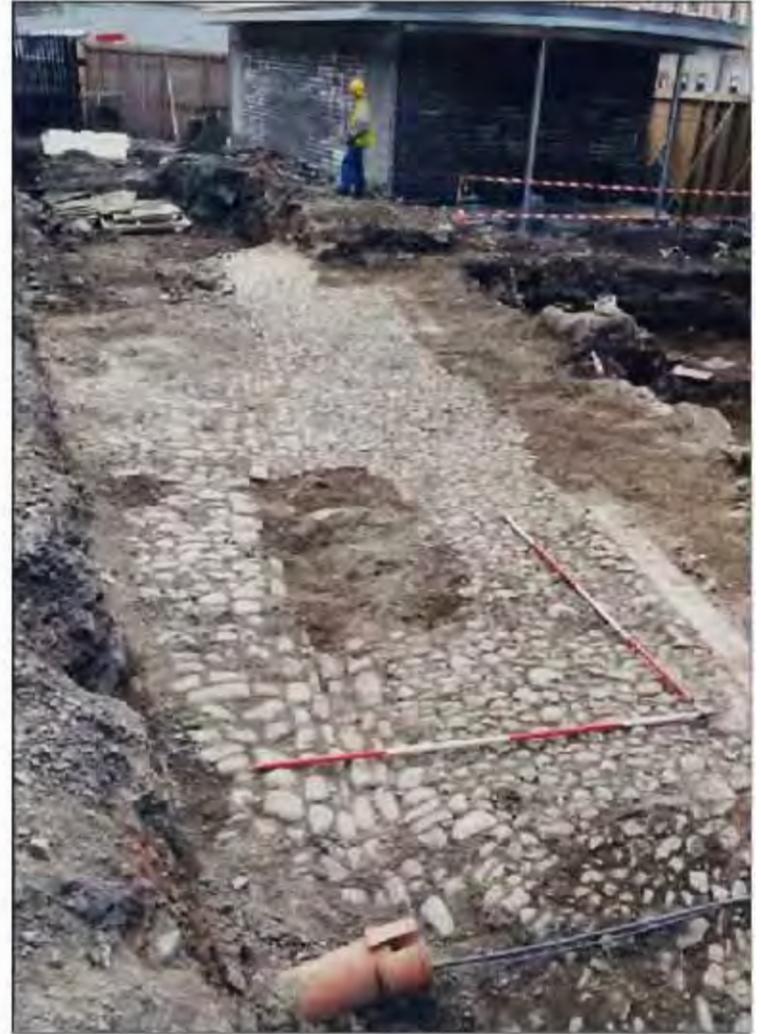
Plate 30 F501 cobbled surface, looking east
