Archaeological Monitoring of Geotechnical Site Investigations

Luas Broombridge (BXD)

Archaeological Licence Ref: 11E0459

Sept 2012

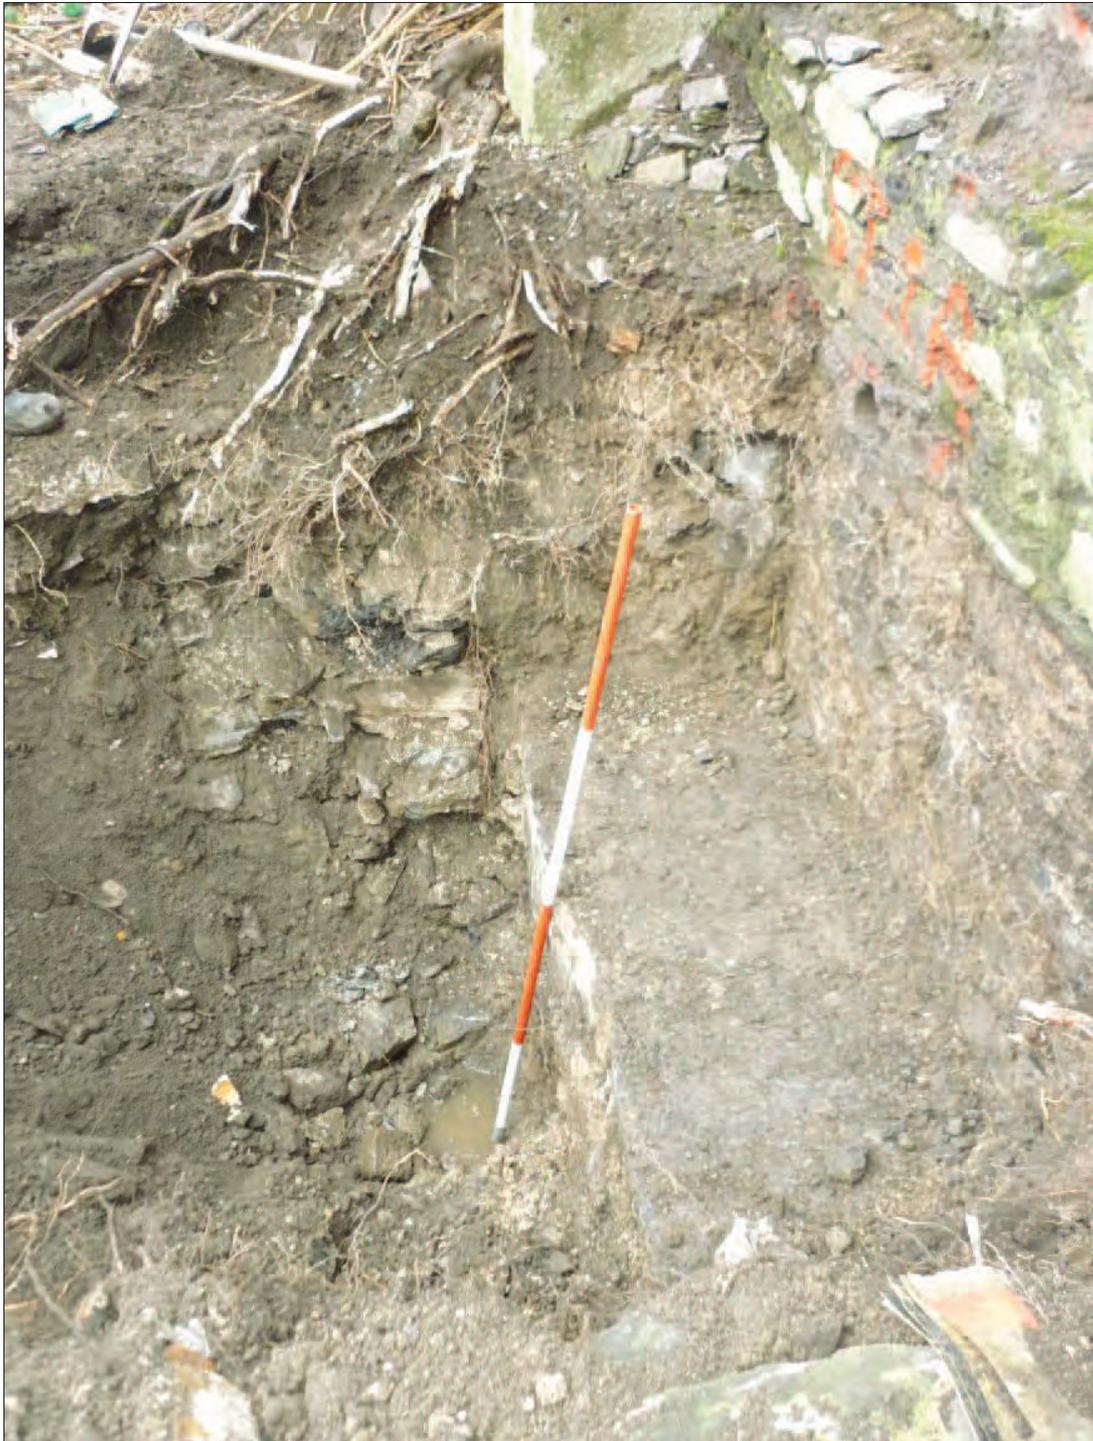
Plate 2 ST 01, Grangegorman

The trench measured 2.4m long and 2m wide (Plate 2). A section through the western leaf of a double retaining wall was revealed in the slit trench (Plate 3). The profile in the trench uncovered the wall core between the two walls at its eastern end and the deposits on the western side of these structures (Plate 4). The inner (eastern) wall had a plinth 0.22m wide and 1.5m or 8 courses deep and it appeared that the foundations of this wall was considerably stepped (although these lie mostly buried behind the western wall (described below).

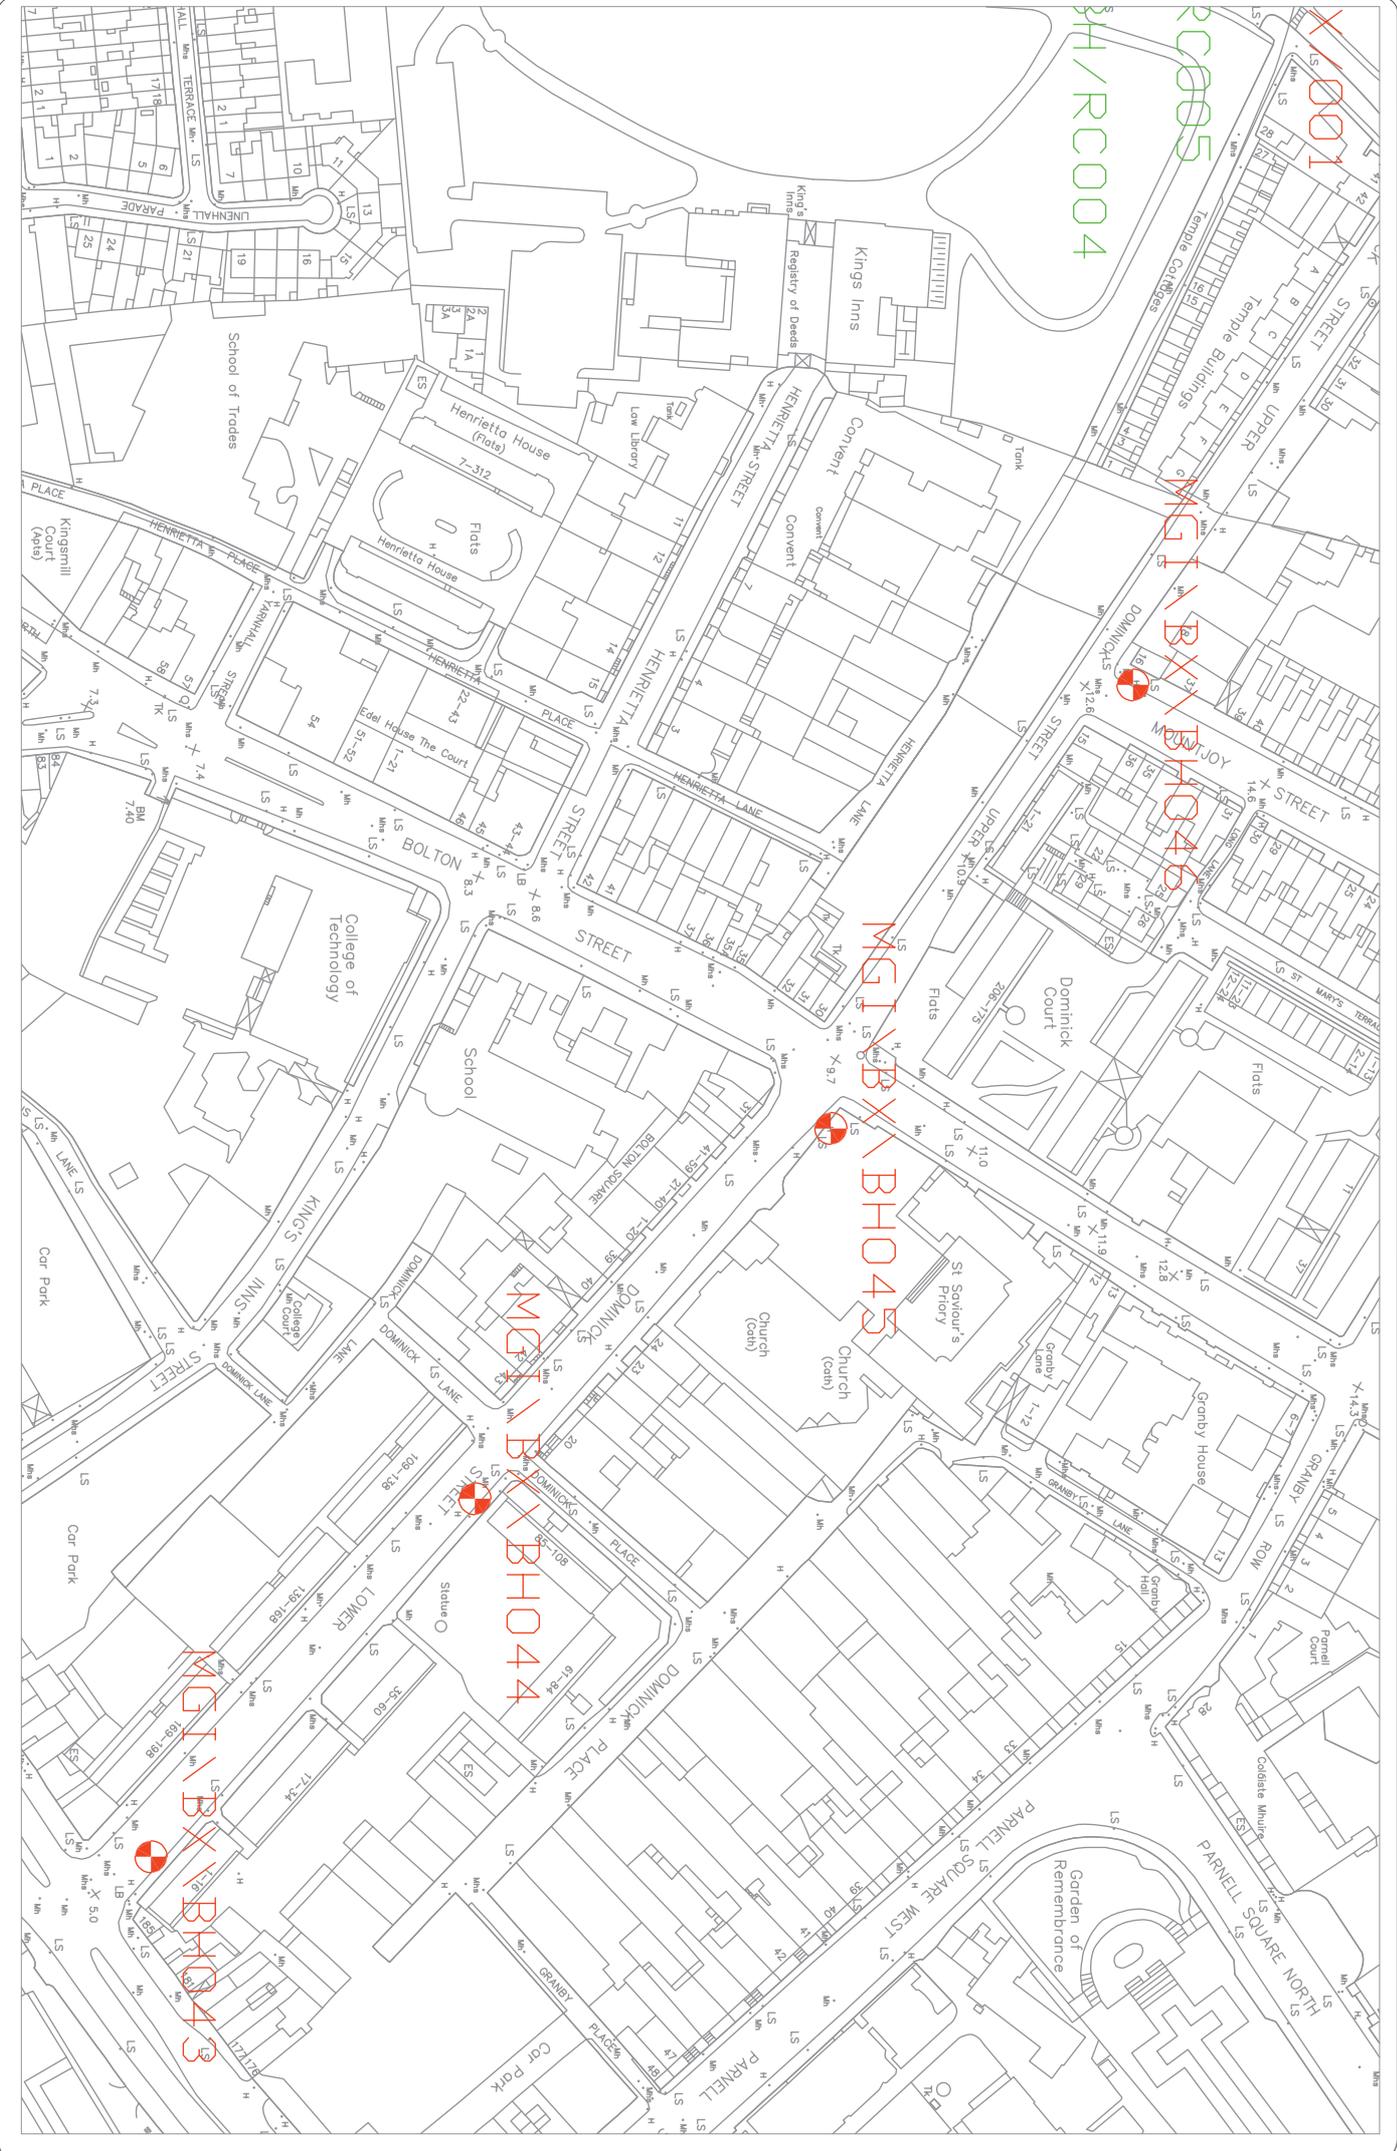
16121-000-002

Project:			
Luas Broombridge BMD			
Component:			
Ground Investigation			
Location Plan			
Drawn by:	CK	Date:	2/08
Checked:	CK	Date:	2/08
Drawn by:	CK	Date:	2/08
Checked:	CK	Date:	2/08
Drawn by:	CK	Date:	2/08
Checked:	CK	Date:	2/08
Drawn by:	CK	Date:	2/08
Checked:	CK	Date:	2/08

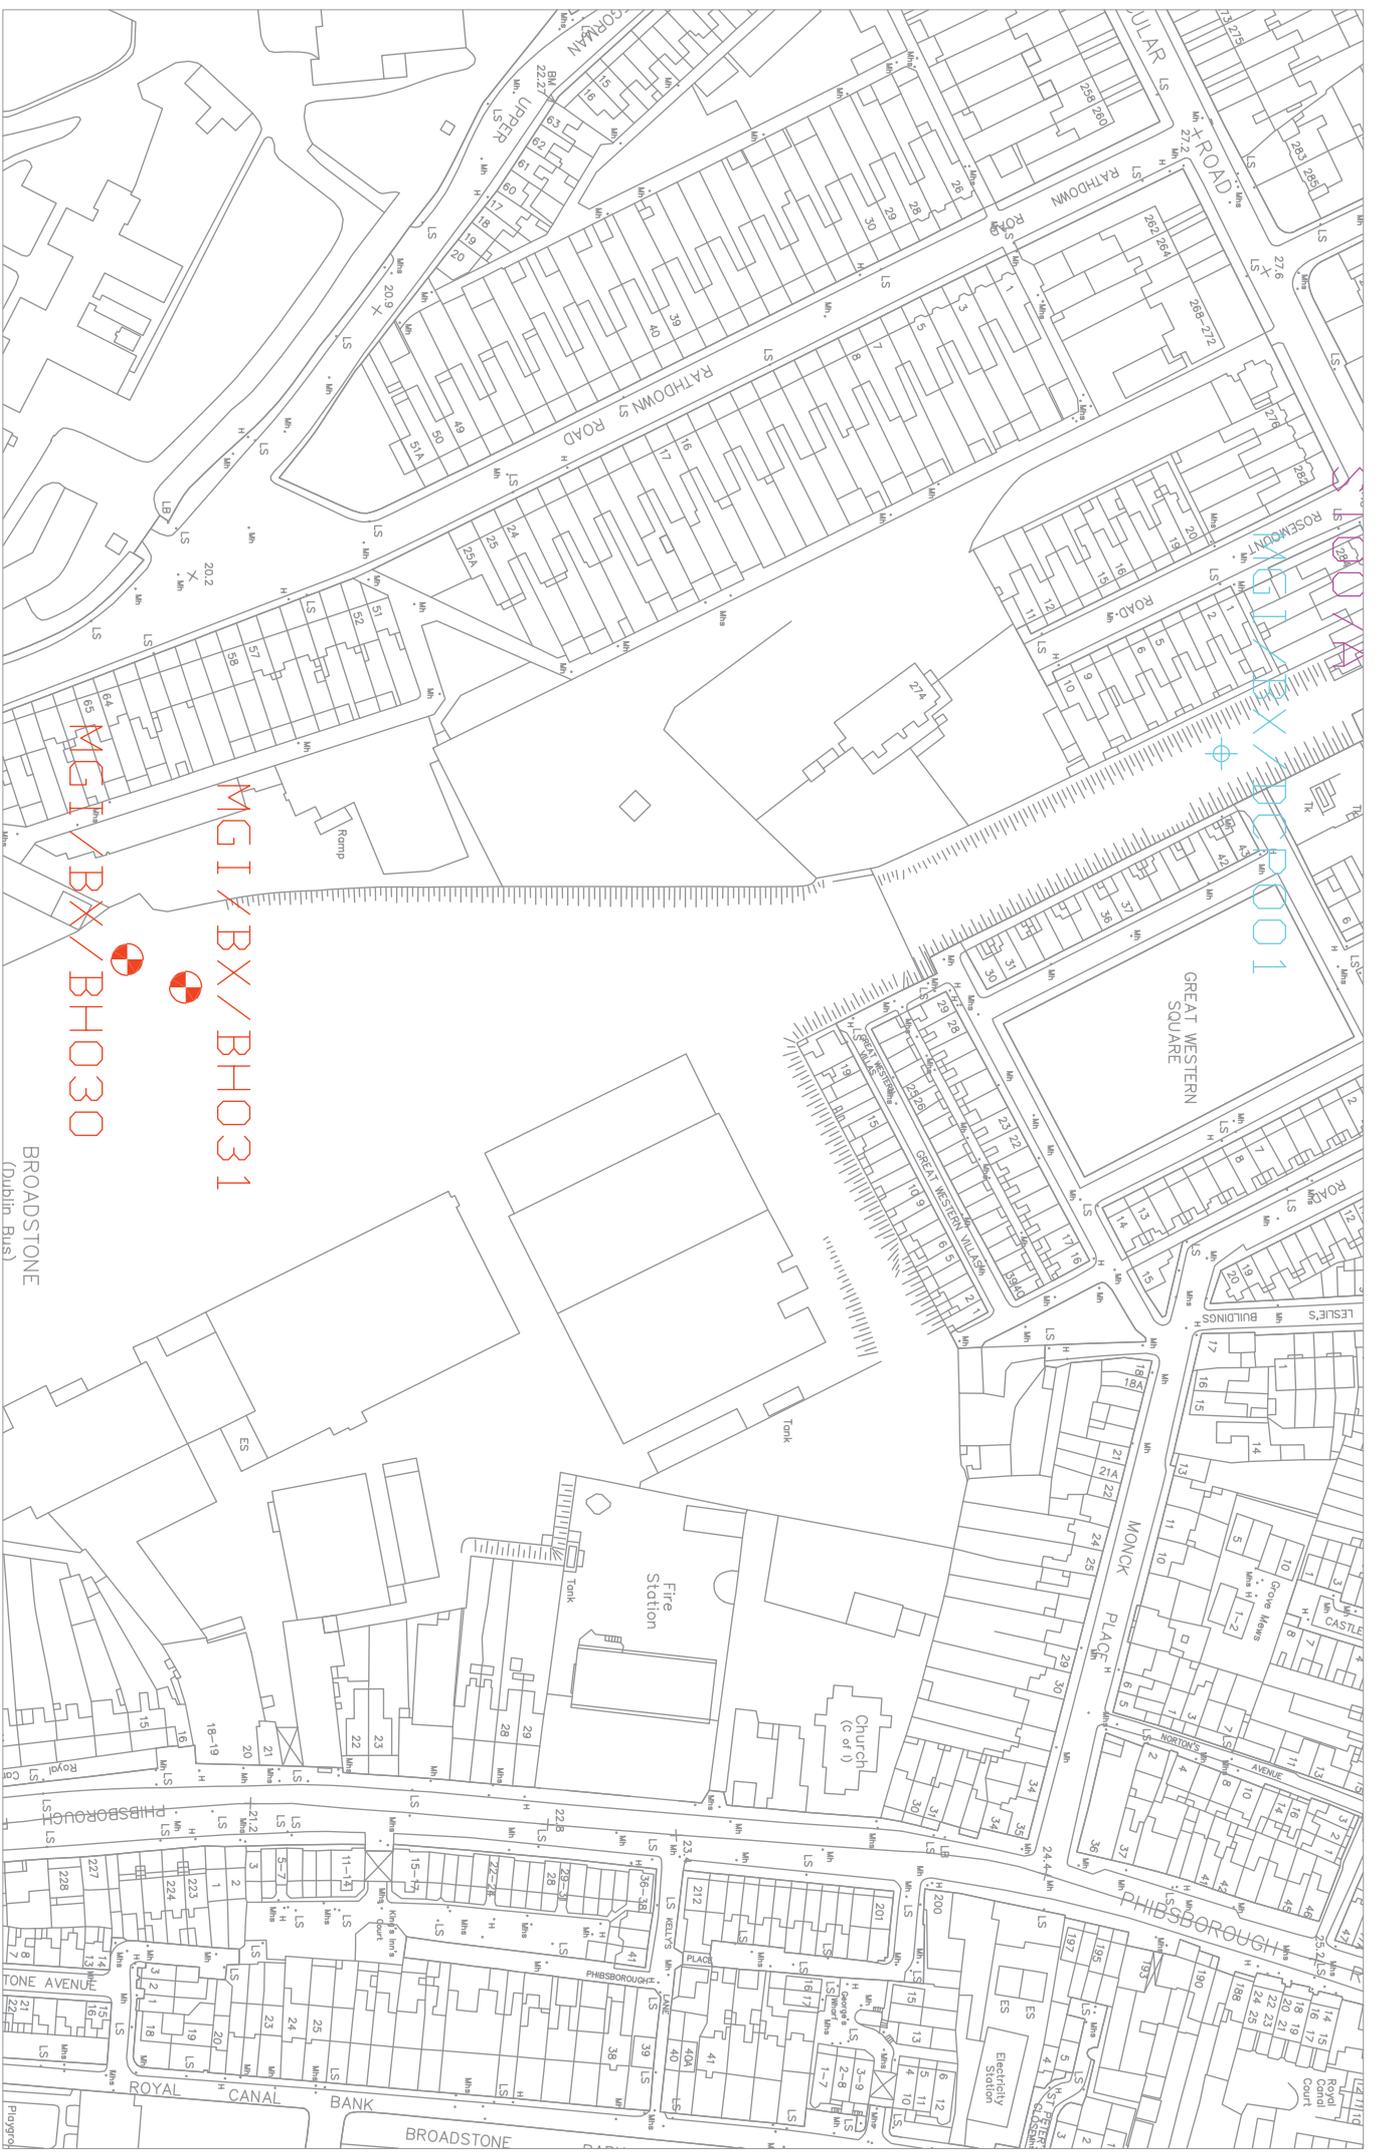
16121-000-003

Cable Percussion Location
	Cable Percussion/Recovery Location
	SMI Trench Locations
	Dynamic Probe Locations
	Tidal Pit Locations
	Rotary Corehole Locations
	Metro North Boreholes

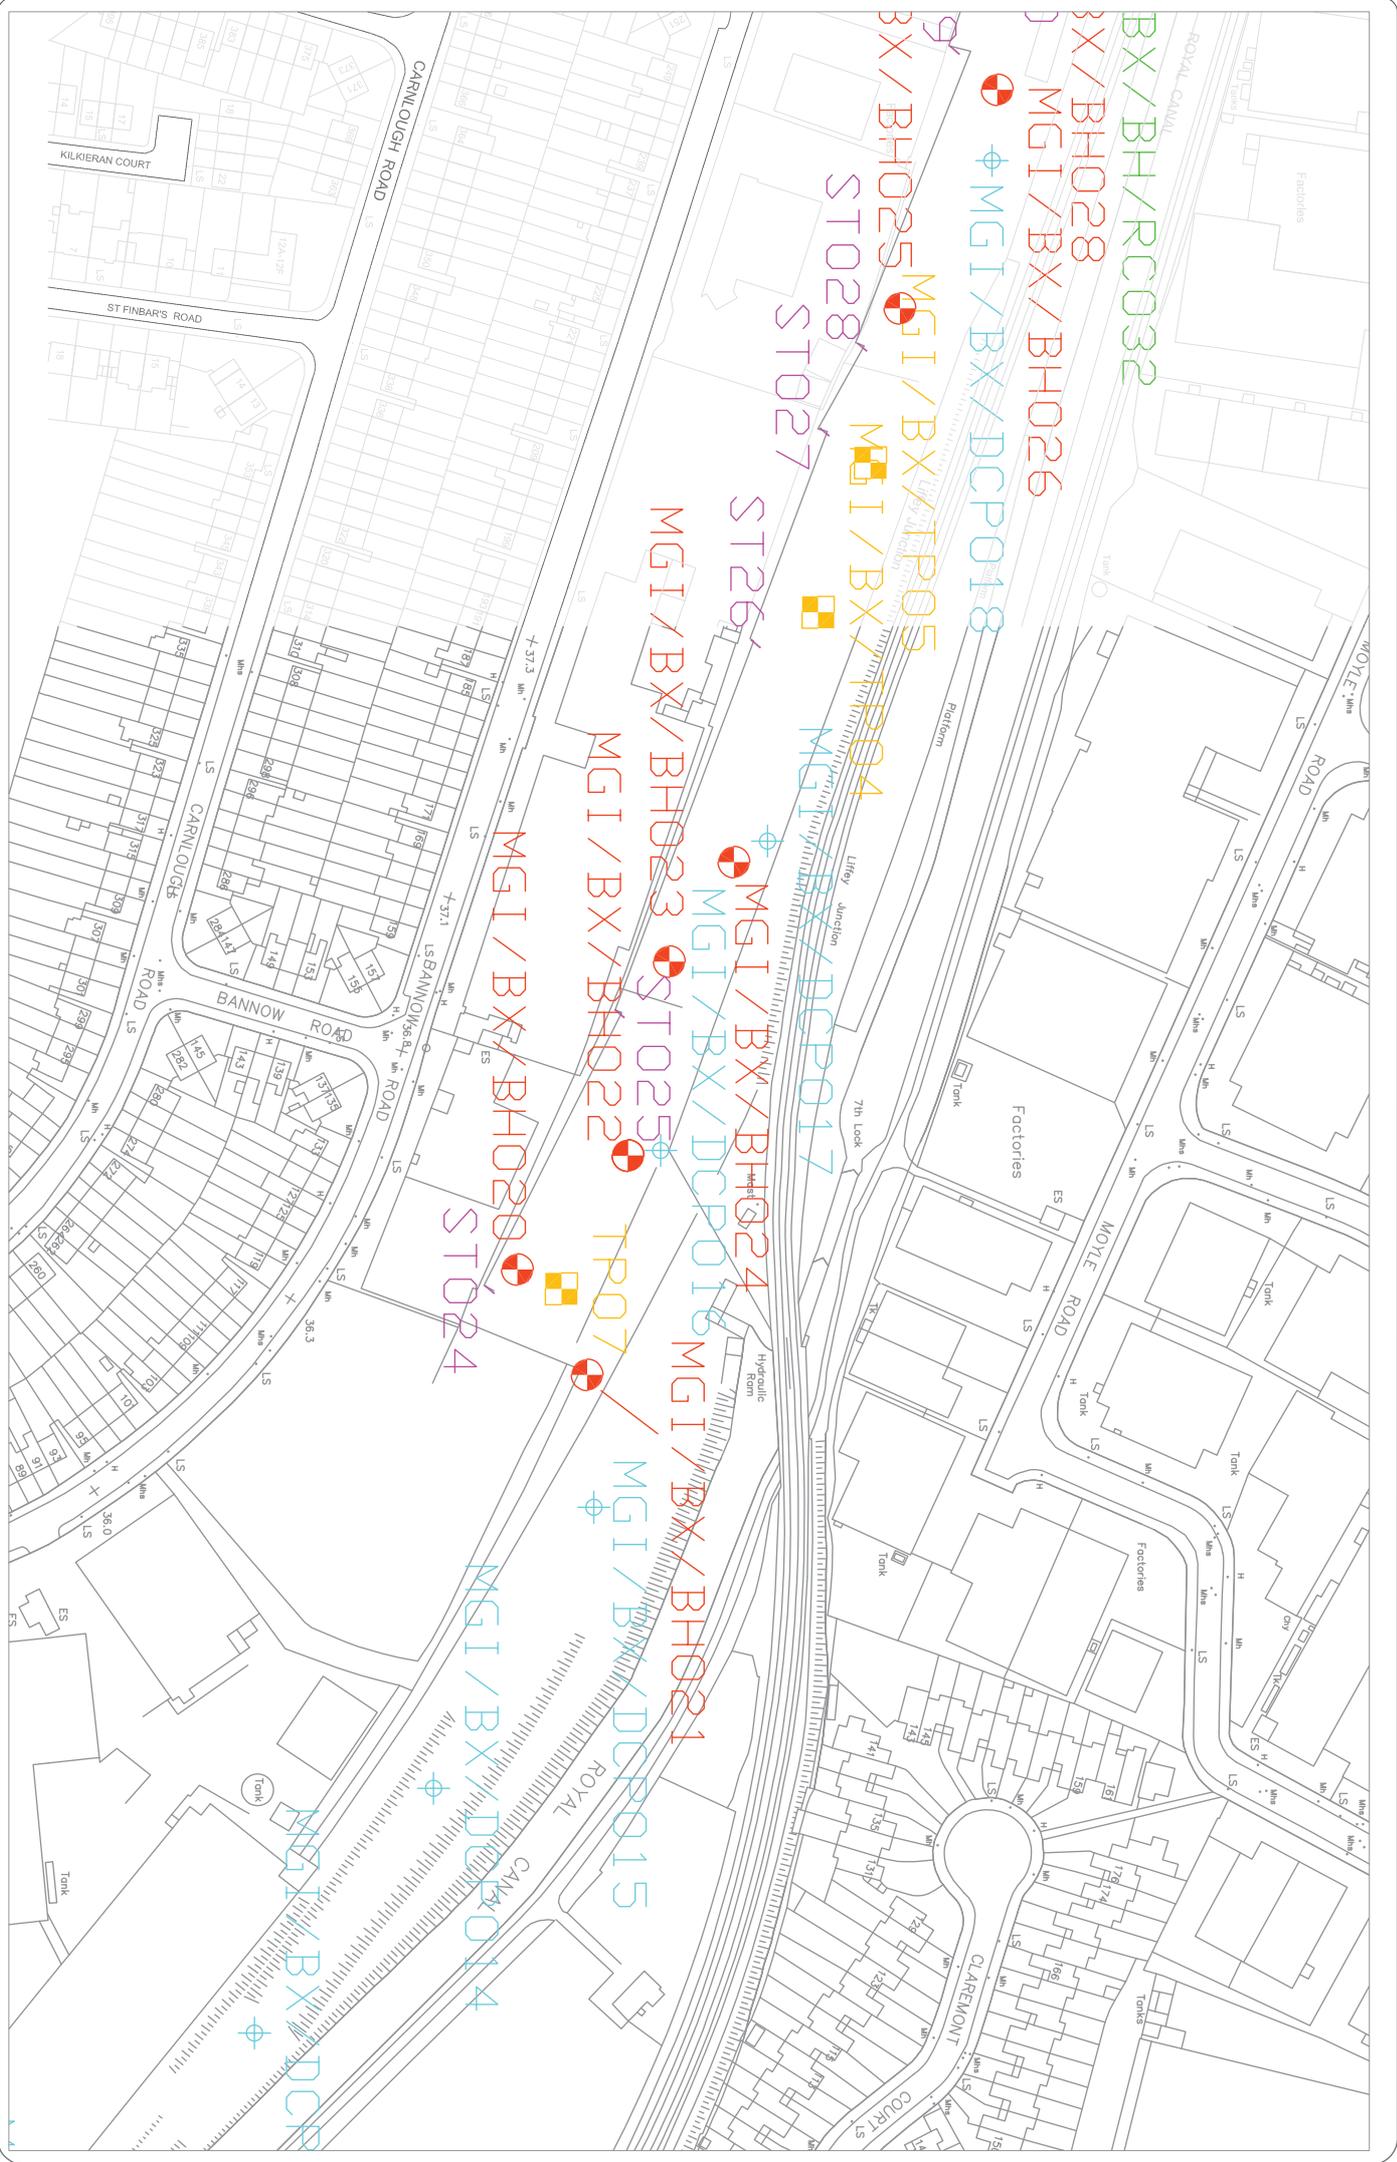
Cable Percussion Location
	Cable Percussion/Recovery Location
	Dynamic Probe Locations
	Tidal Pit Locations
	Rotary Corehole Locations
	SM Trench Locations

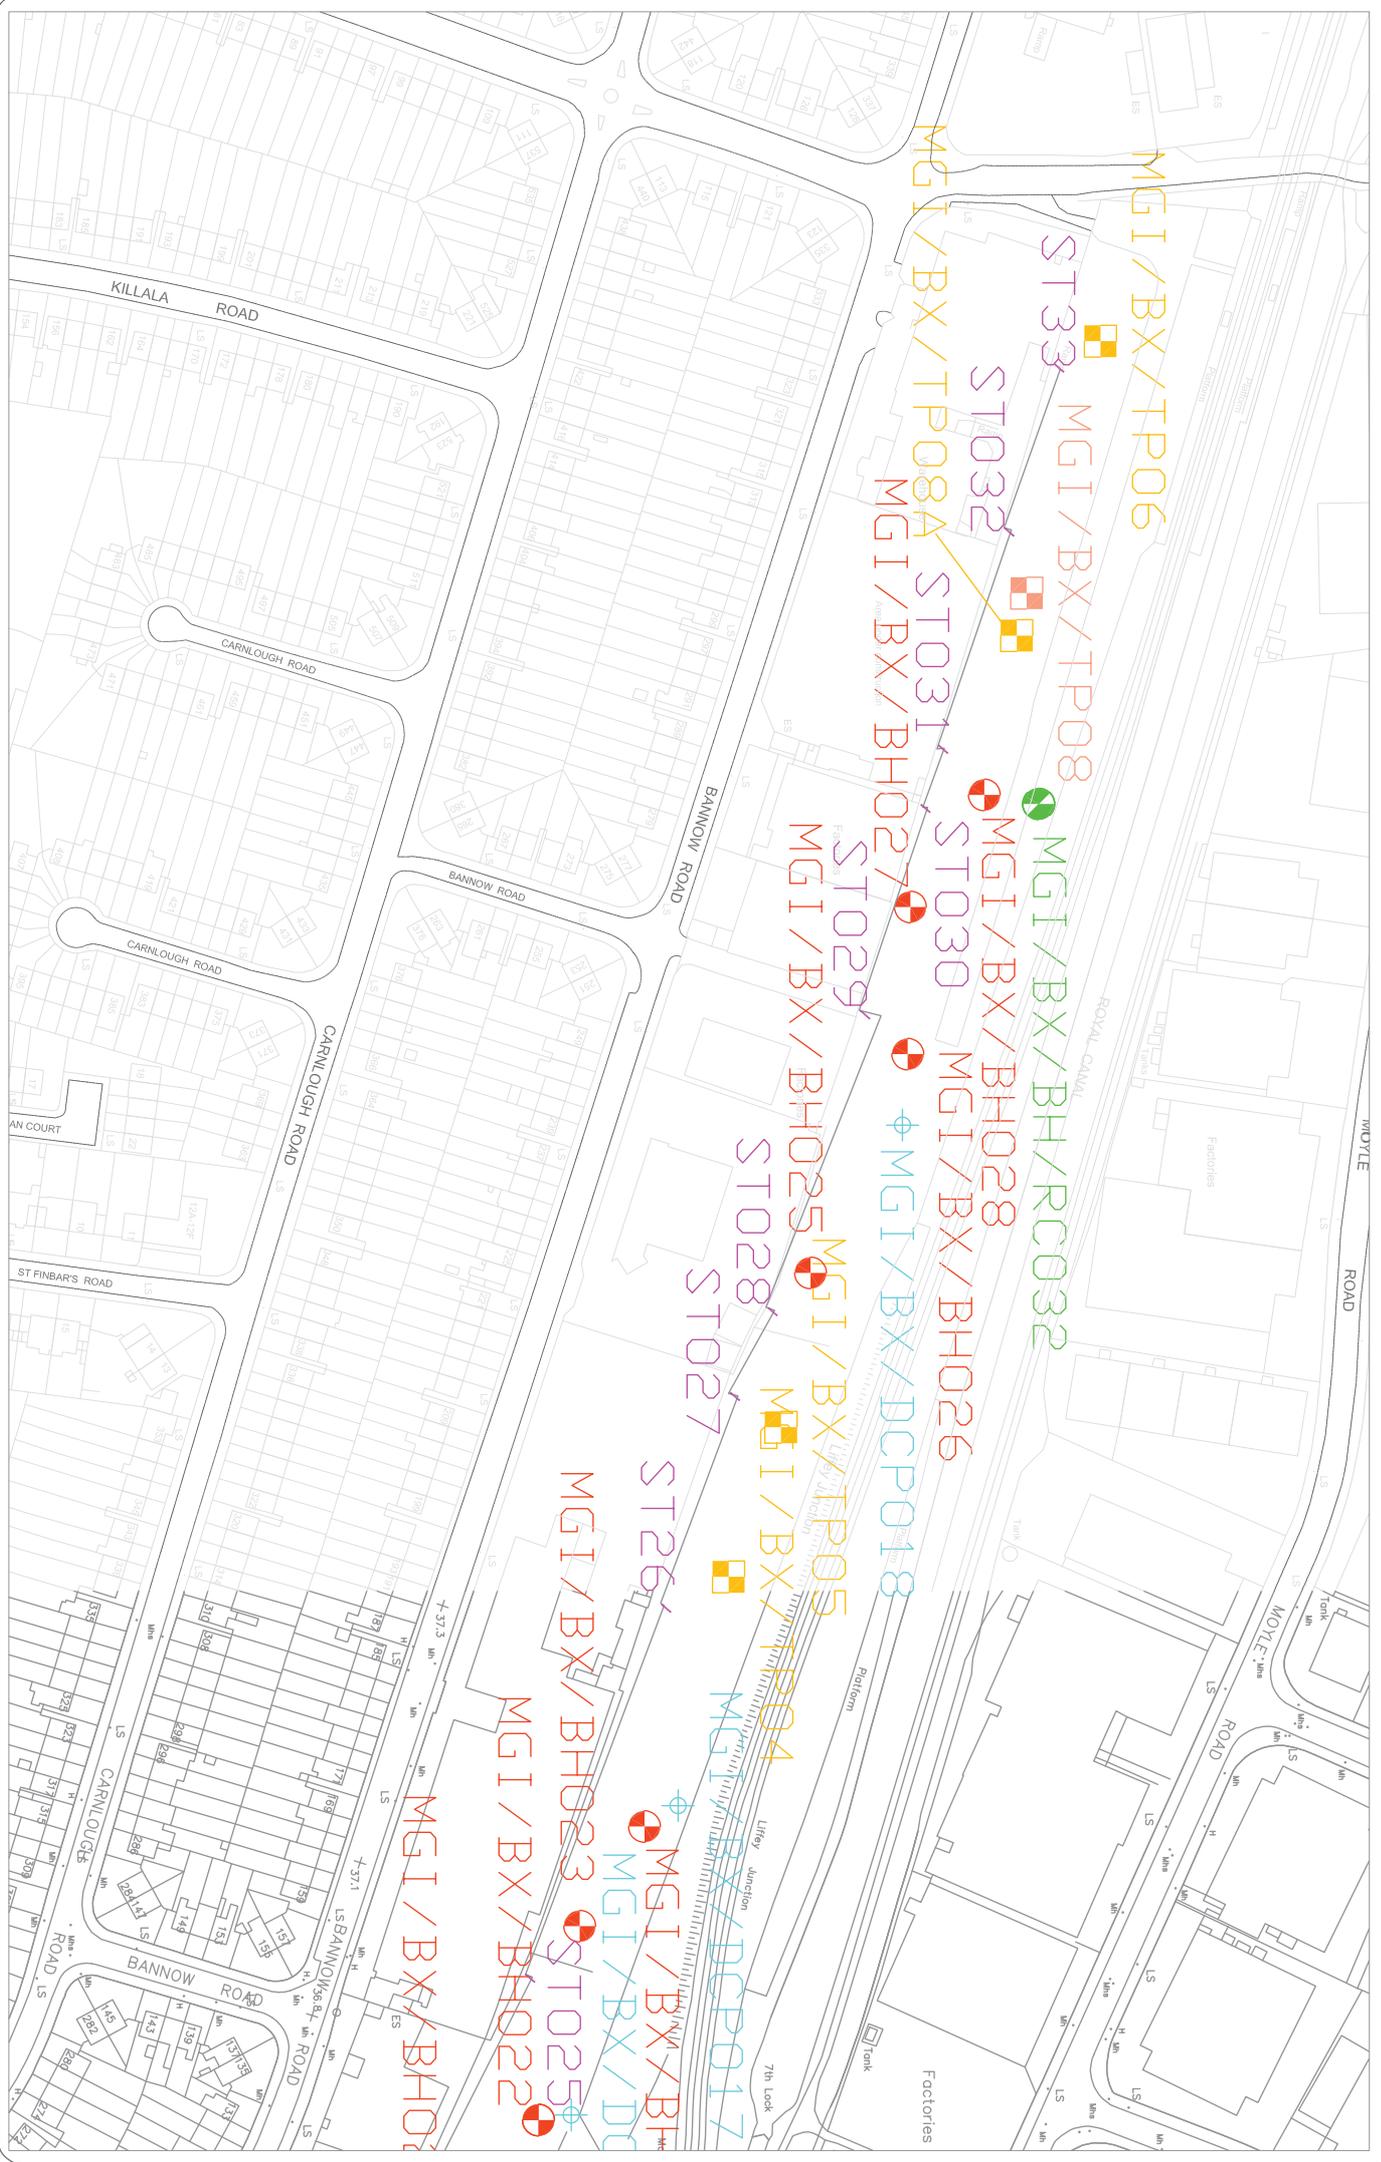
16121-000-010

Cable Percussion Location		Dynamic Probe Locations
	Cable Percussion/Recovery Location		Trail Pit Locations
	SRI Trench Locations		Rotary Corehole Locations
