Project code: LBTM12
Client: GMC (Ireland) Ltd on behalf of Railway Procurement Agency
Date: March 2013

Report on Archaeological Slit Trenches at Broadstone – Future Luas Works – Luas Broombridge (BXD) Dublin

Director: Teresa Bolger
Report Author: Teresa Bolger
Licence No: 12E0310 (ext)
Planning Reference: N/A
Report Status: Final

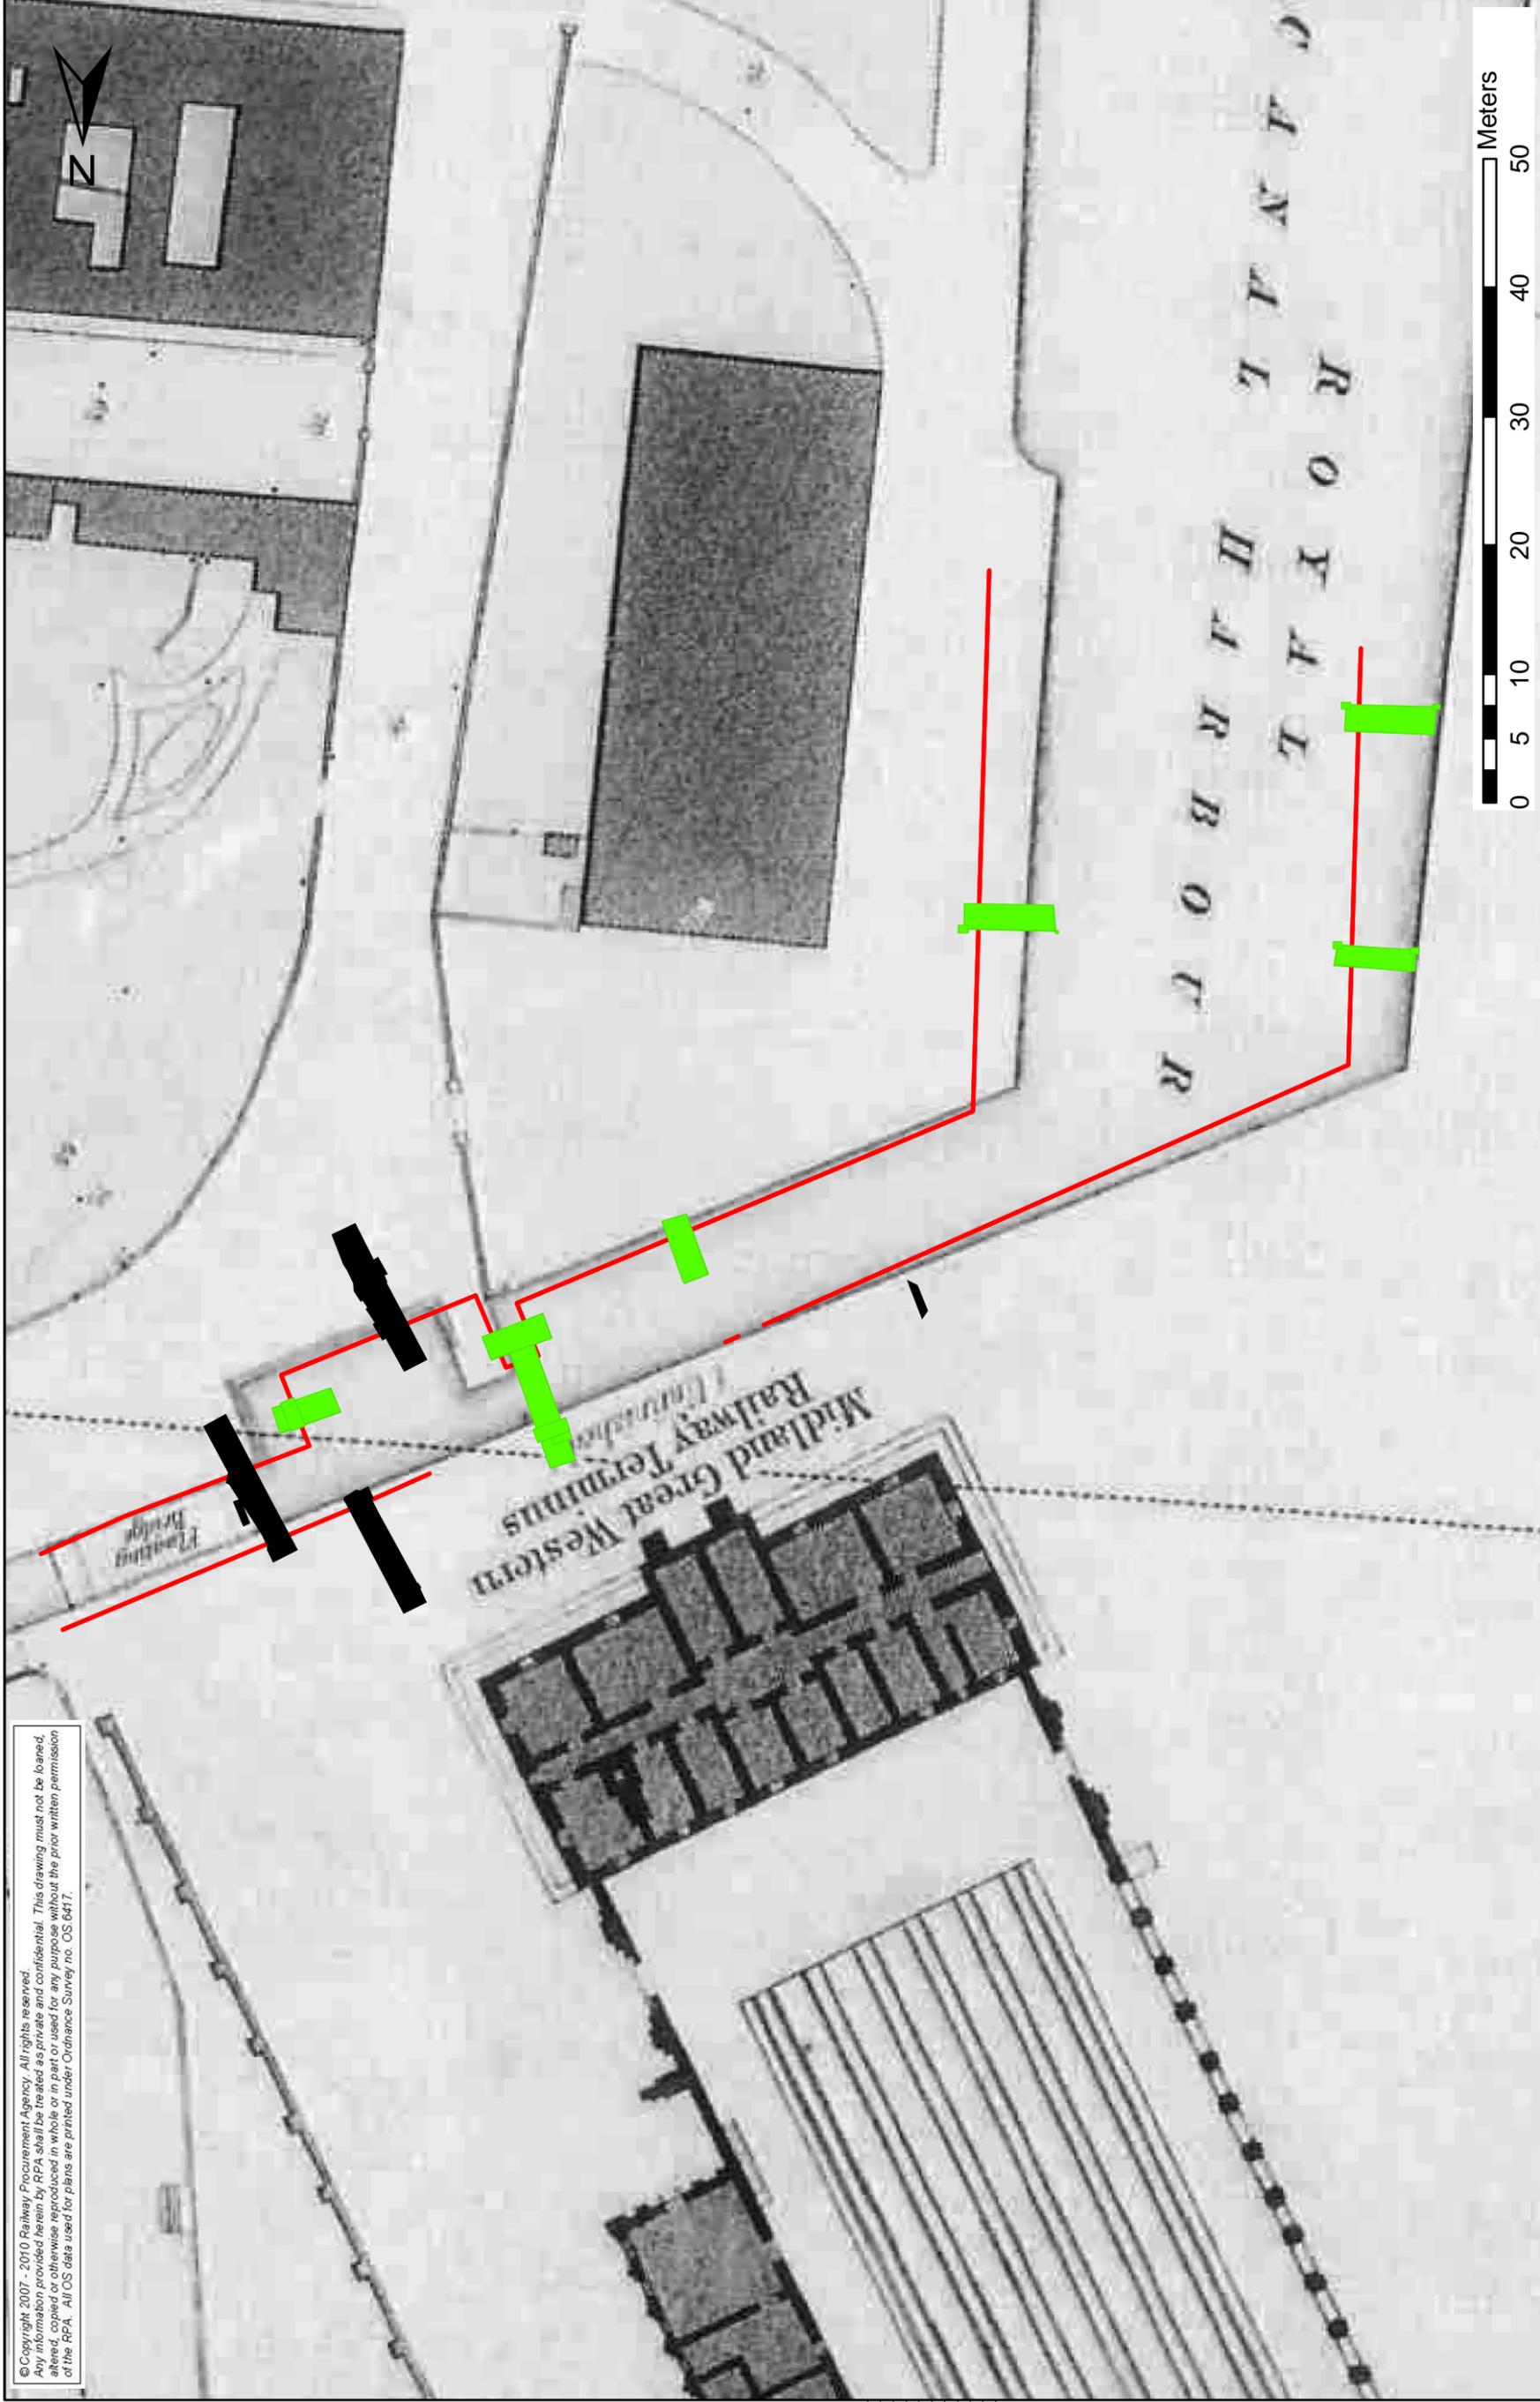
PLAN NO. Figure 3

- Slit trenches
- Previous trenches
- Alternative canal footprint based on MGWR Survey, 1877

SUBJECT: TRENCH LOCATION

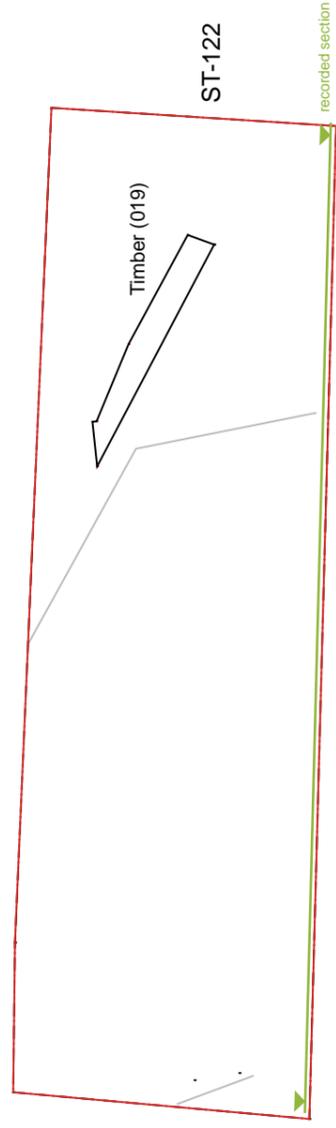
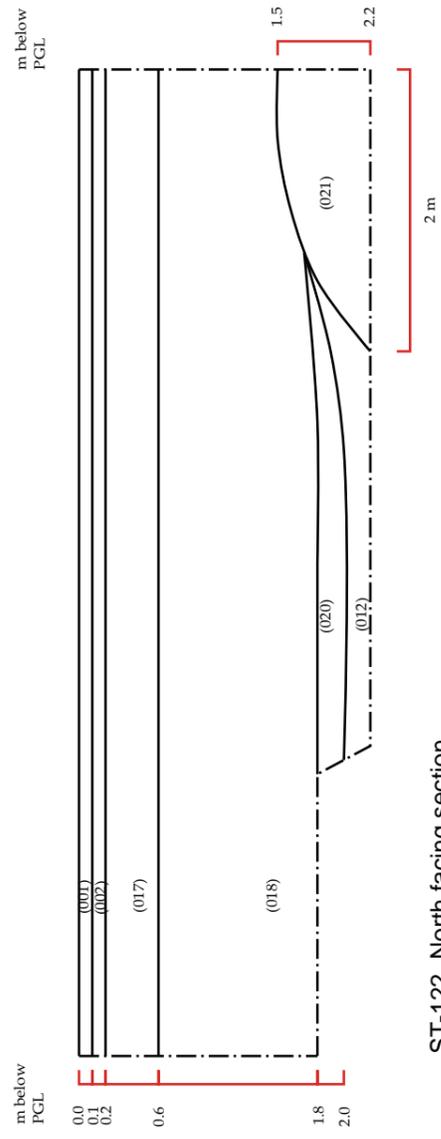
Figure 4 - Plan and scaled sketch section of ST-122.

ST-122, North facing section
Scaled sketch - measures are indicative only

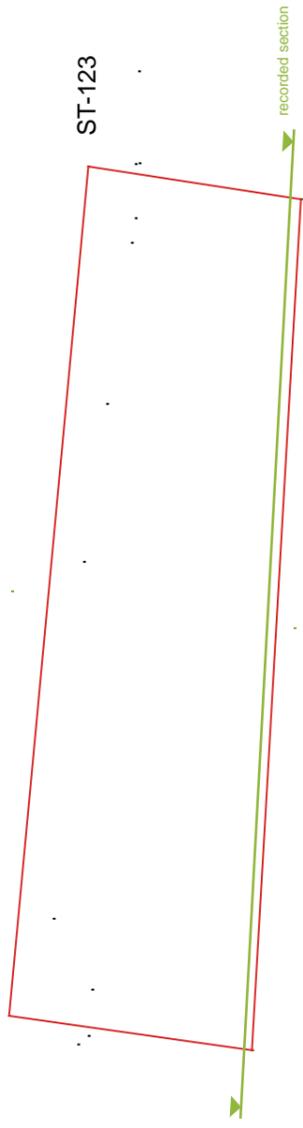
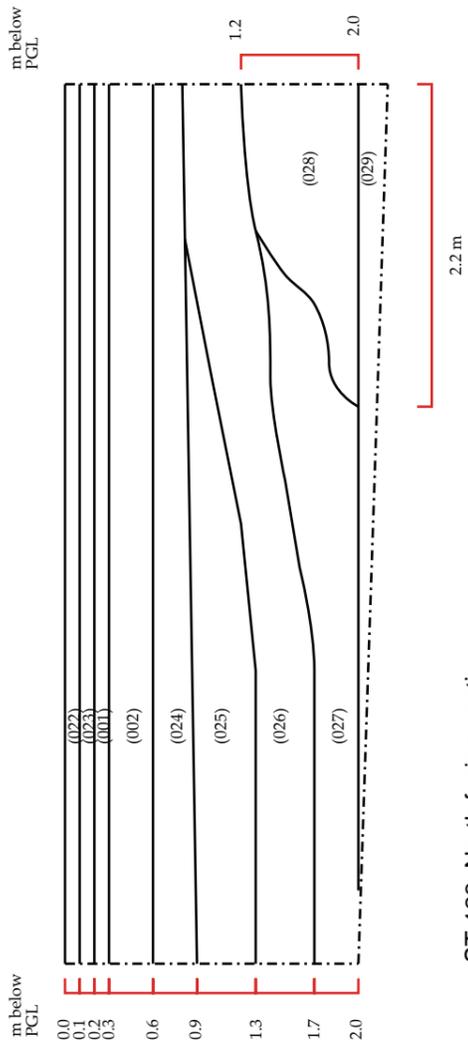
Figure 5 - Plan and scaled sketch section of ST-123.

ST-123, North facing section
Scaled sketch - measures indicative only

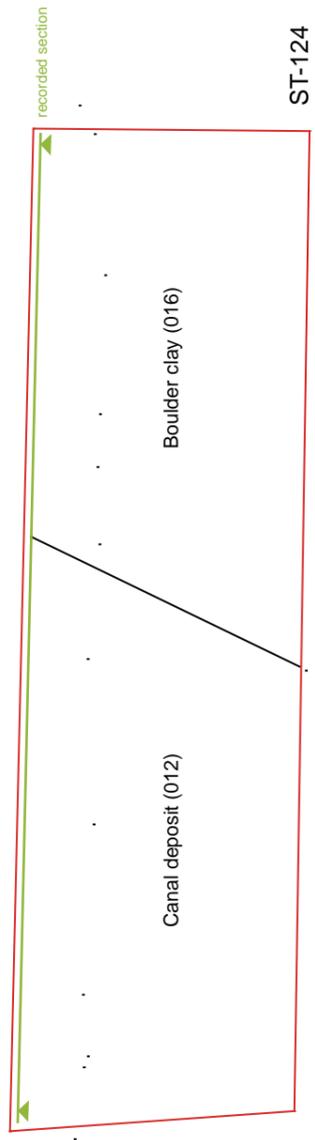
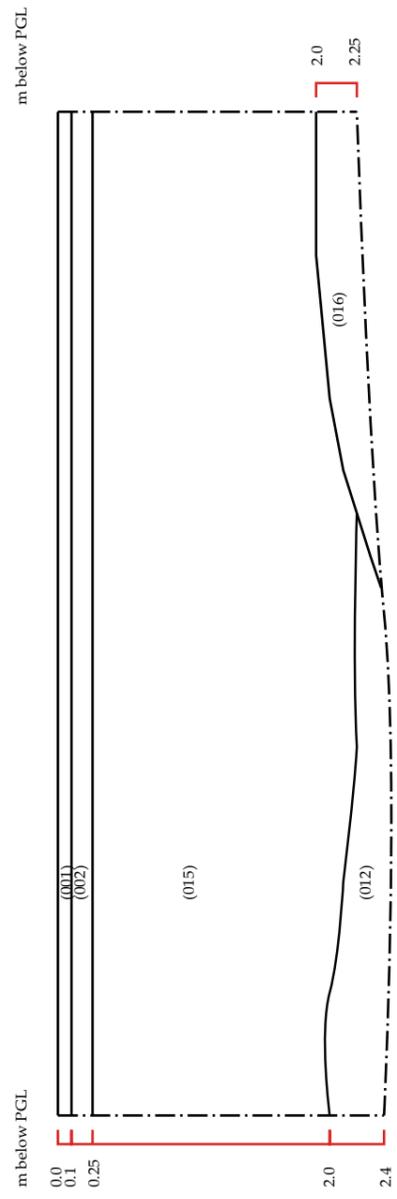
Figure 6 - Plan and scaled sketch section of ST-124.

ST-124, South facing section
Scaled sketch - measures indicative only

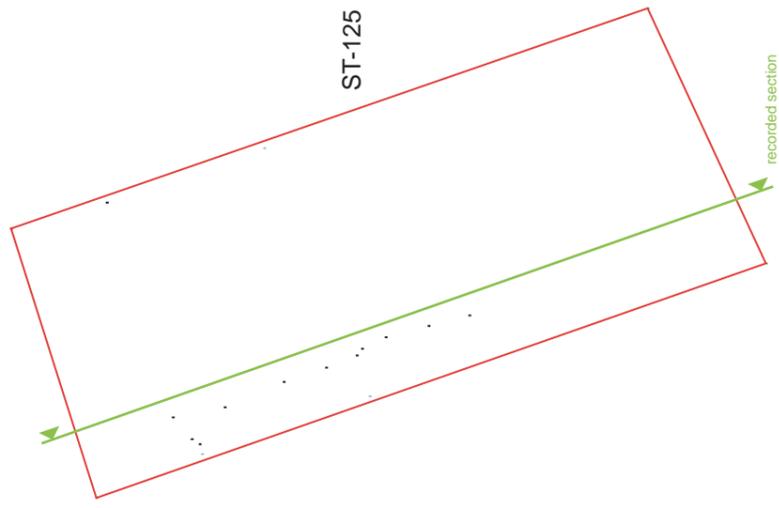
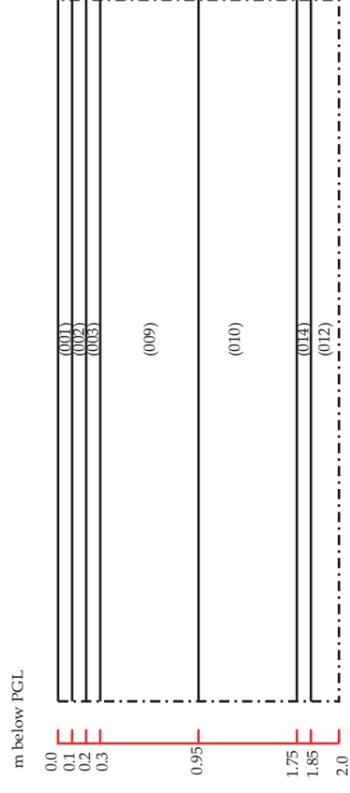
Figure 7 - Plan and profile of ST-125.

ST-125, West facing profile
Measured profile with scaled section data added

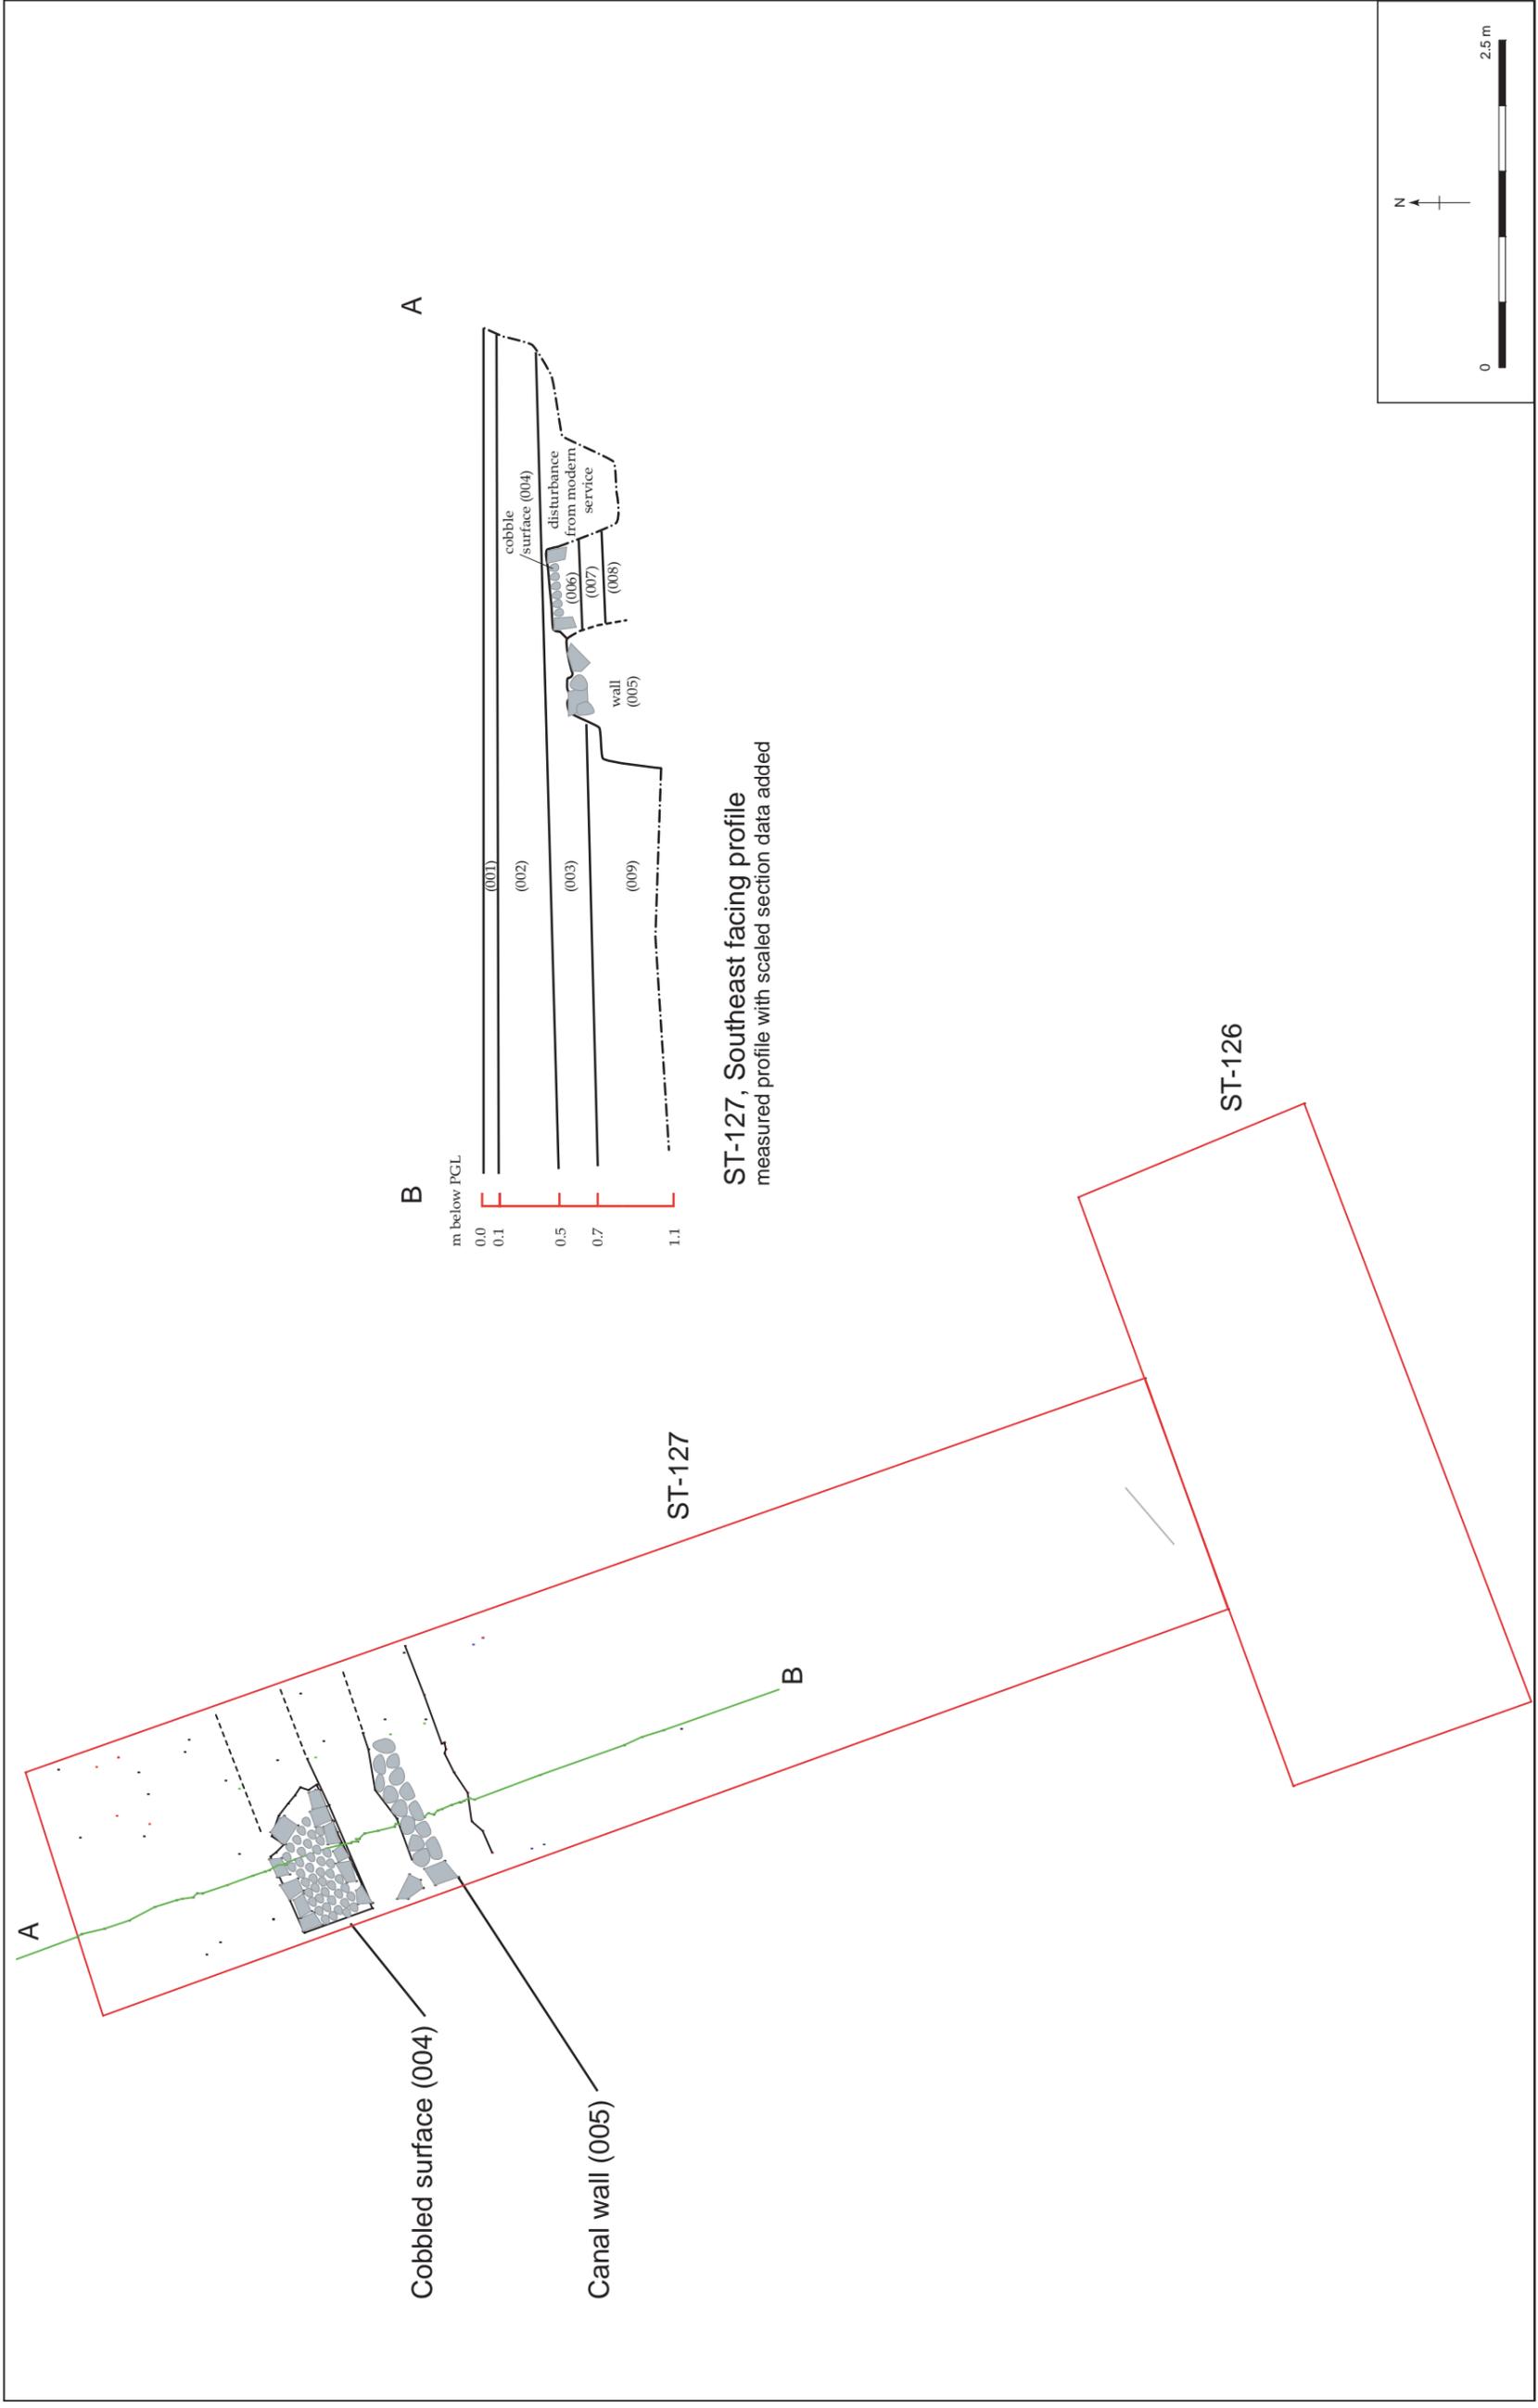
Figure 8 - Plan of ST-126 and ST-127 and profile of ST-127.

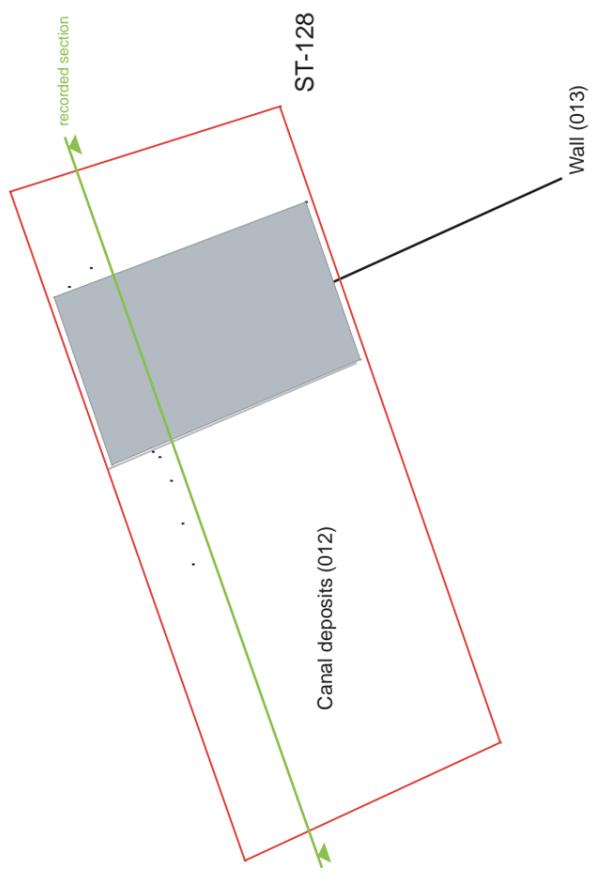
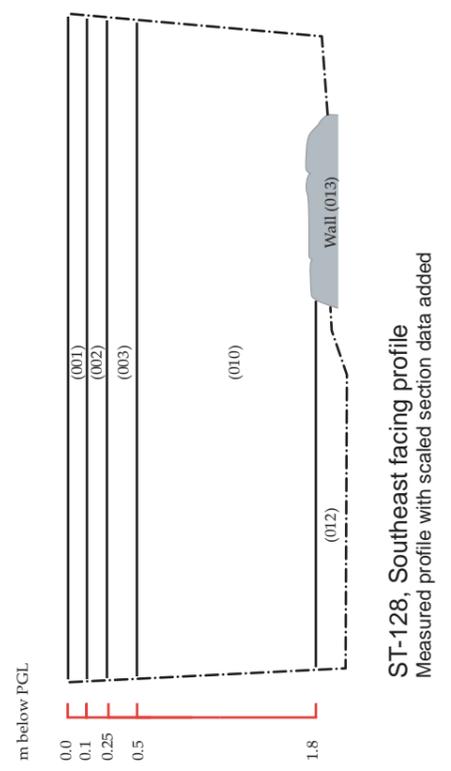
Figure 9 - Plan and profile of ST-128.

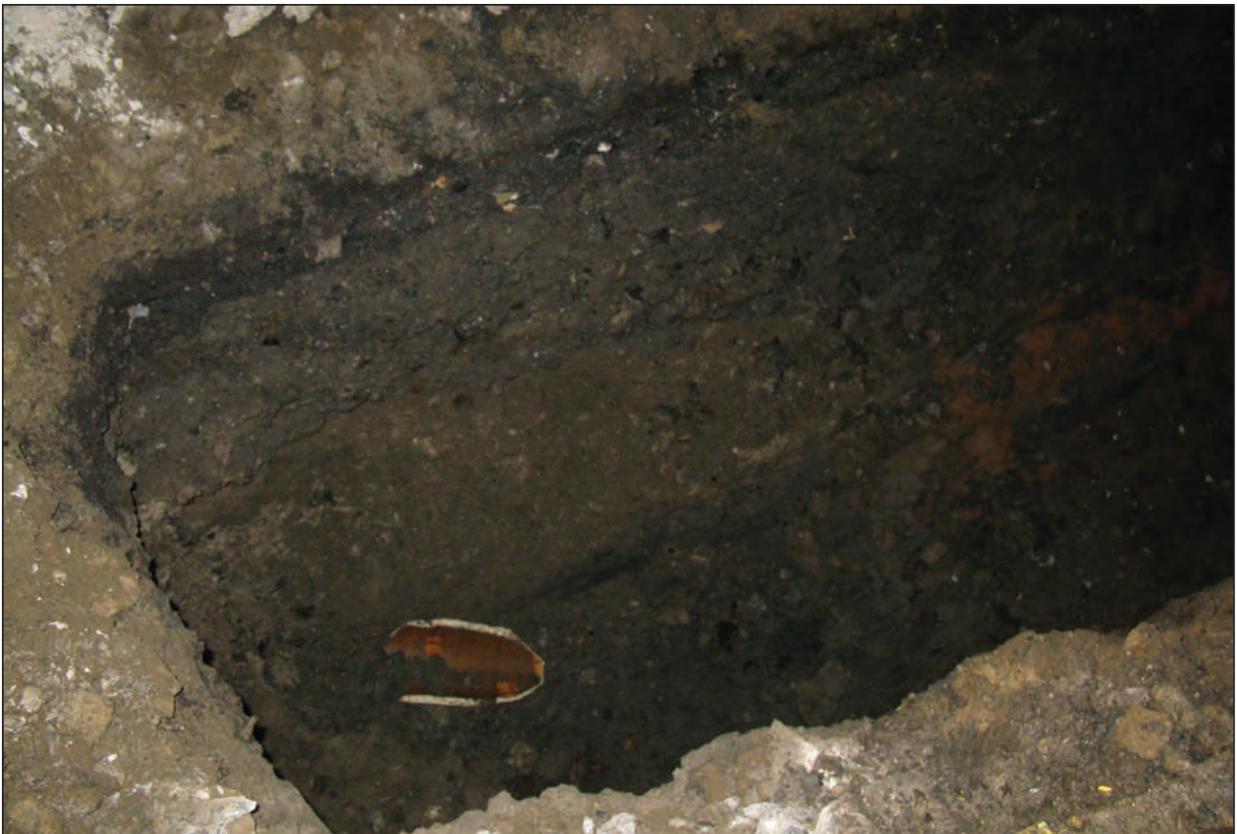
Plate 2 - ST-122, S facing section of trench, showing rubble deposit (021)

| Context No | Type | Trench | Length (m) | Width (m) | Depth (m) | Description | Interpretation |
|---|---|---|---|---|---|---|---|
| 021 | Layer | ST122 | 2 | 2 | 0.25 | Loose rubble deposit largely comprising limestone blockwork with evidence for mortar | Probable modern disturbance but could be western limit of canal harbour |

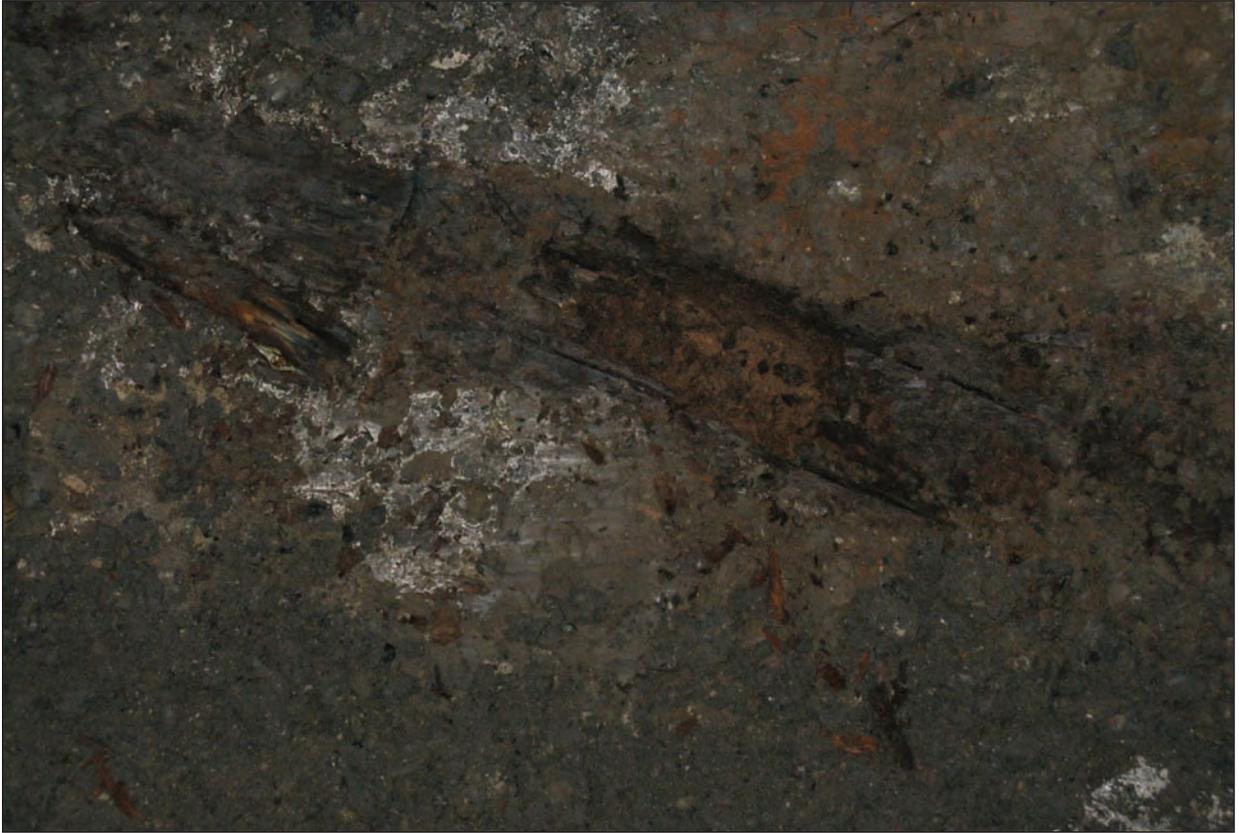
A timber (019) running NW-SE across the trench was encountered at the east end of the trench lying within the red gravelly deposit (020) at the interface with the overlying deposit (018; Plate 3). The timber was not directly investigated as it occurred at a depth of c.1.80m below present ground level and could not be safely accessed. However, it was noted that part of the upper surface was damaged or flaked away suggesting that the timber may be hollow, perhaps indicating that it was originally a wooden pipe or conduit. This timber was left *in situ* and confirms the potential for anaerobic preservation at the site.

Plate 3 - ST-122, Timber (019) in situ, facing S

| Context No | Type | Trench | Length (m) | Width (m) | Depth (m) | Description | Interpretation |
|---|---|---|---|---|---|---|---|
| 019 | Timber | ST122 | S | S | - | In situ timber at interface between deposit (018) and (020). Part of upper surface had broken away suggesting that timber was hollow (perhaps deliberately). | Possible timber pipe/conduit |

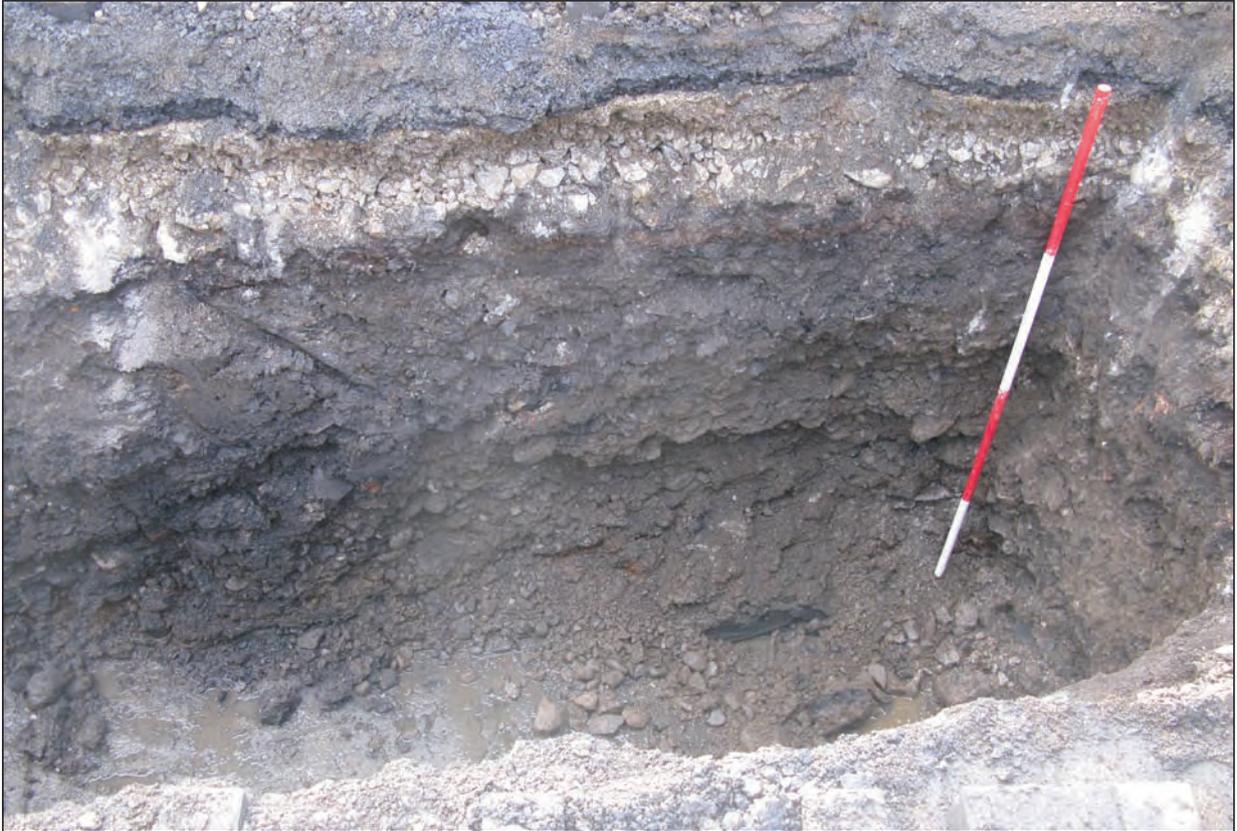
Plate 5 - ST-123, N facing section of trench showing gravel embankment (028)

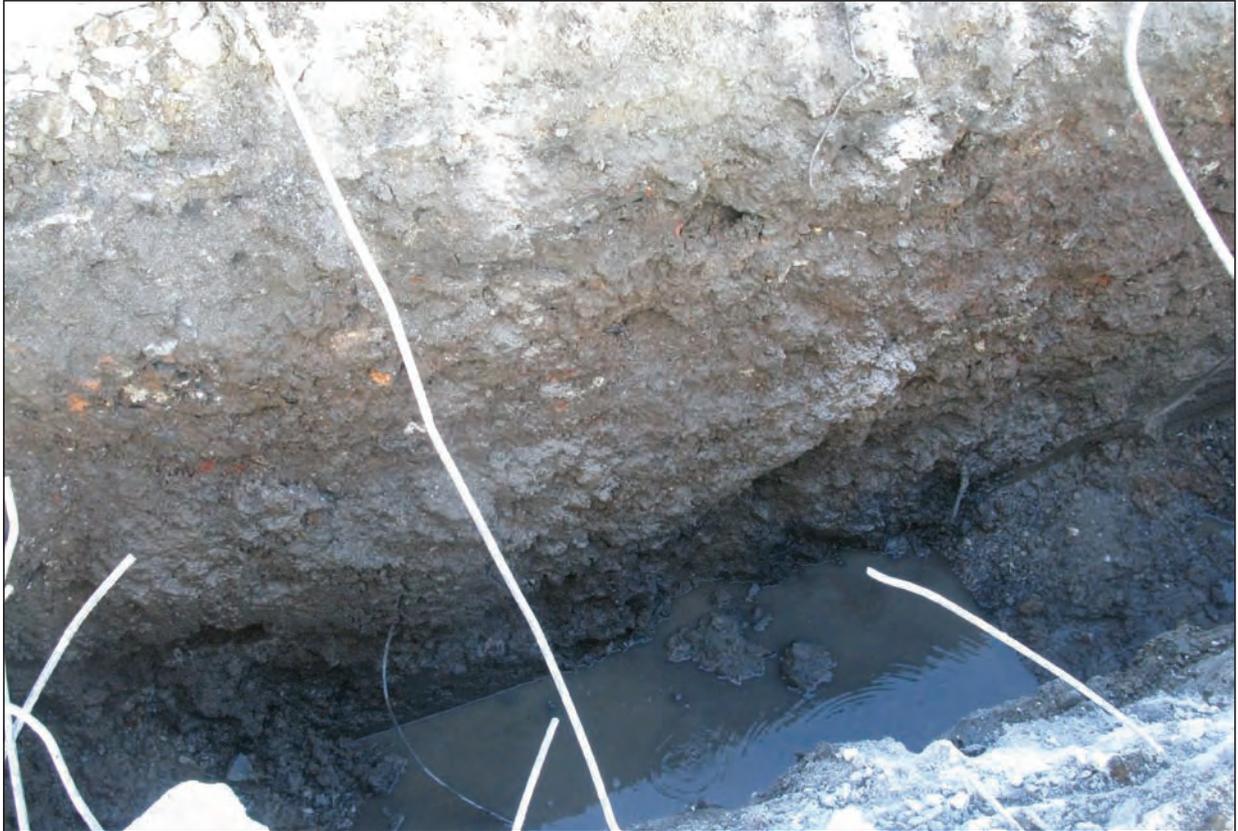
Plate 7 - ST-124, S facing section of trench showing interface between canal deposit (012) and natural boulder clay (016)

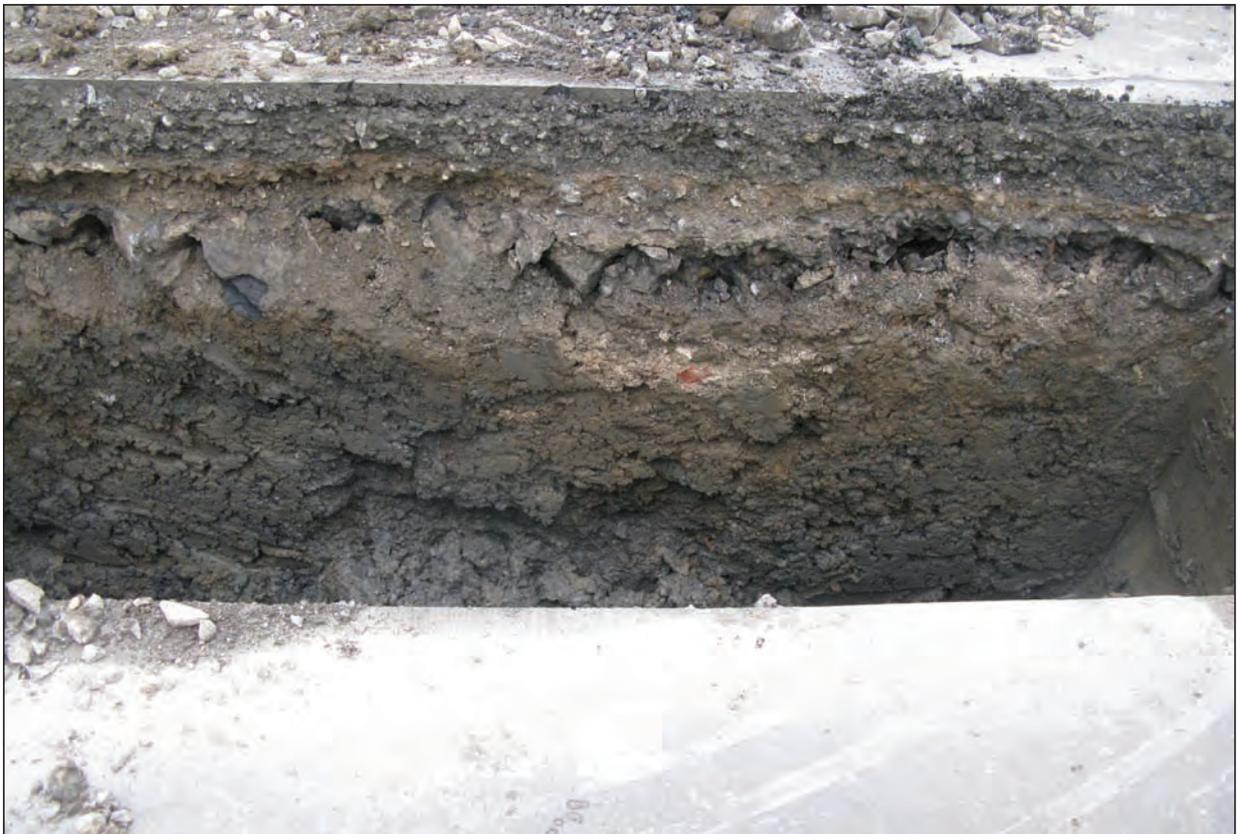
Plate 8 - ST-125, overview of NW facing section of trench

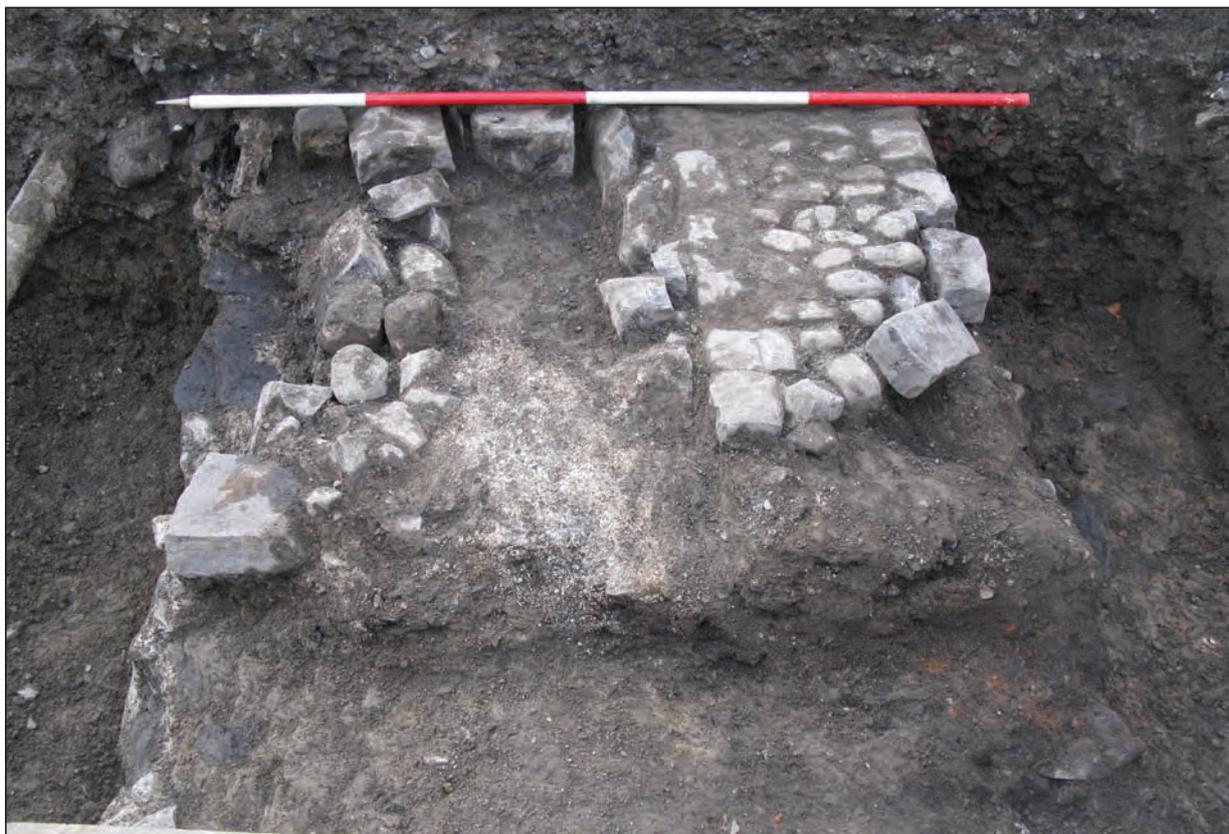
The cobble surface might have originally capped the wall or ran flush-level to it to define a tow path. However, this interpretation is tentative and could not be determined definitively due to disturbance to the upper courses of the exposed section of the wall. The cobble surface (004) was set over a bedding layer comprising grey-brown gravelly clay with occasional decaying mortar (006), which in turn sealed a layer of dark brown to black gravelly clay 0.14m in depth (007) (Plate 13). Deposit (007) could be an occupation layer predating the canal construction and sealed a layer of light yellow-brown clay with frequent large and small stones (008) that could be a layer of natural boulder clay. This could not be definitively confirmed within the restrictions of the trench extents and the necessity to achieve *in situ* preservation of the cobble surface (004).

Plate 11 - ST-127, overview of canal wall (005) and cobble surface (004), facing NW

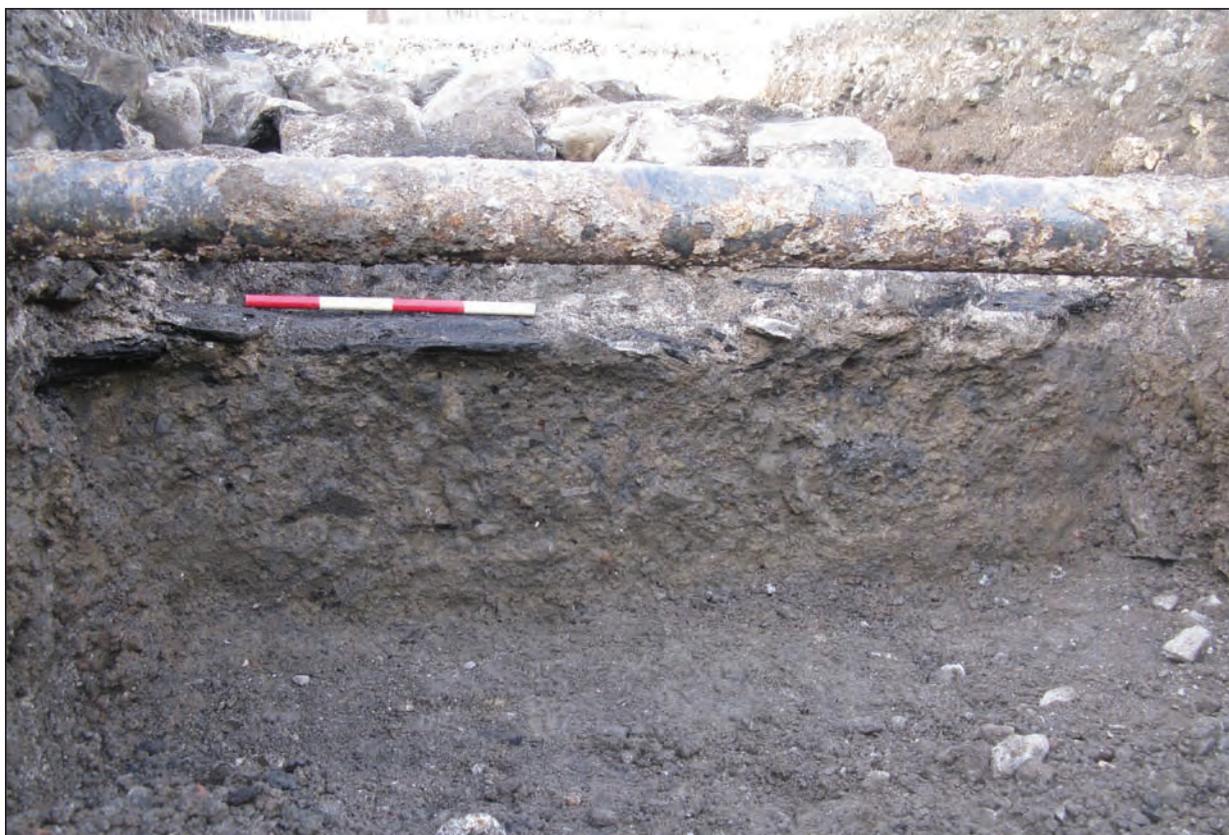
Plate 12 - ST-127, upper courses of canal wall (005) overlying possible exposed clay wall core, facing NE

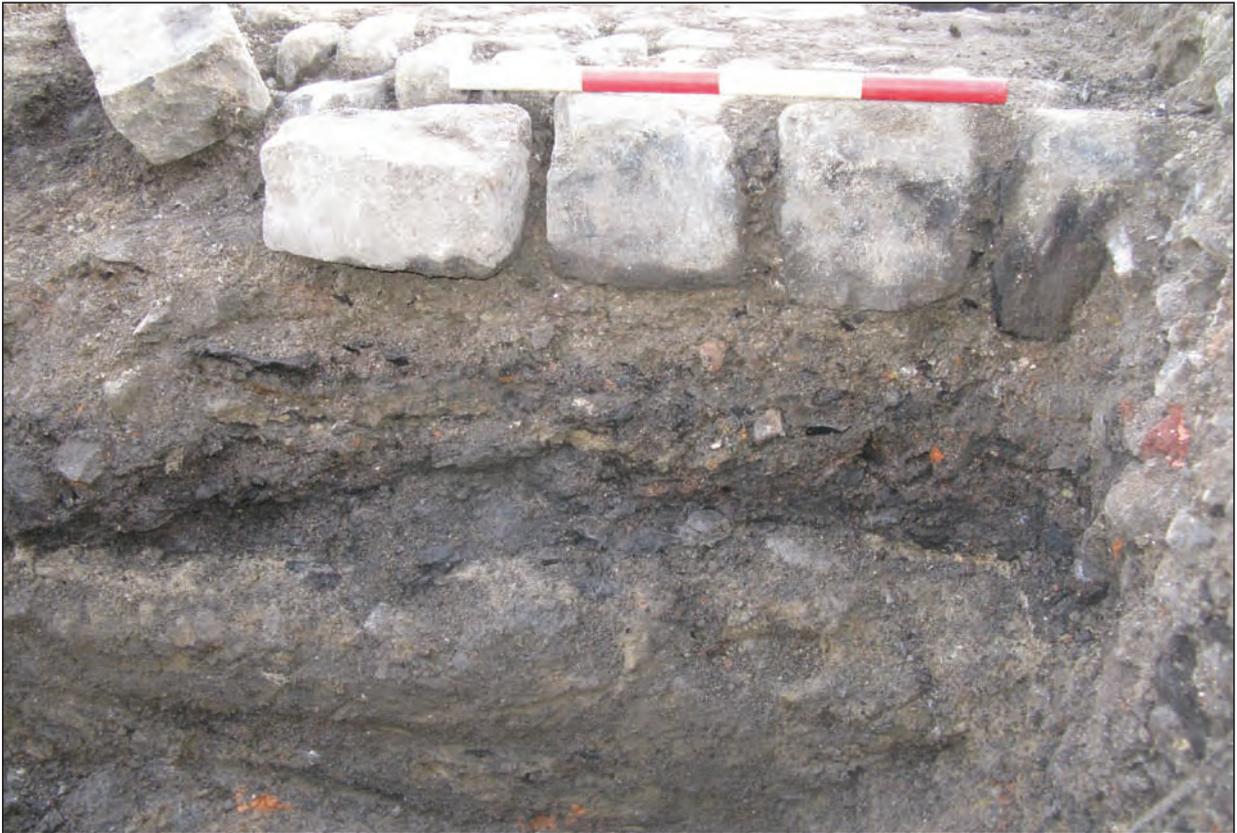
Plate 13 - ST-127, bedding layer (006), possible occupation layer (007) and possible natural boulder clay (008) underlying cobbled surface (004), facing SW

| Context No | Type | Trench | Length (m) | Width (m) | Depth (m) | Description | Interpretation |
|---|---|---|---|---|---|--|--|
| 006 | Layer | ST127 | 2 | 0.6 | 0.1 | Firm grey-brown gravelly clay with occasional decaying mortar and small angular stones; beneath cobbles (004) | Bedding layer for cobble surface |
| 007 | Layer | ST127 | 2 | 0.5 | 0.14 | Loose dark brown to black gravelly clay with small angular stones underlying deposit (006) | Occupation or activity layer possible pre-dating canal |

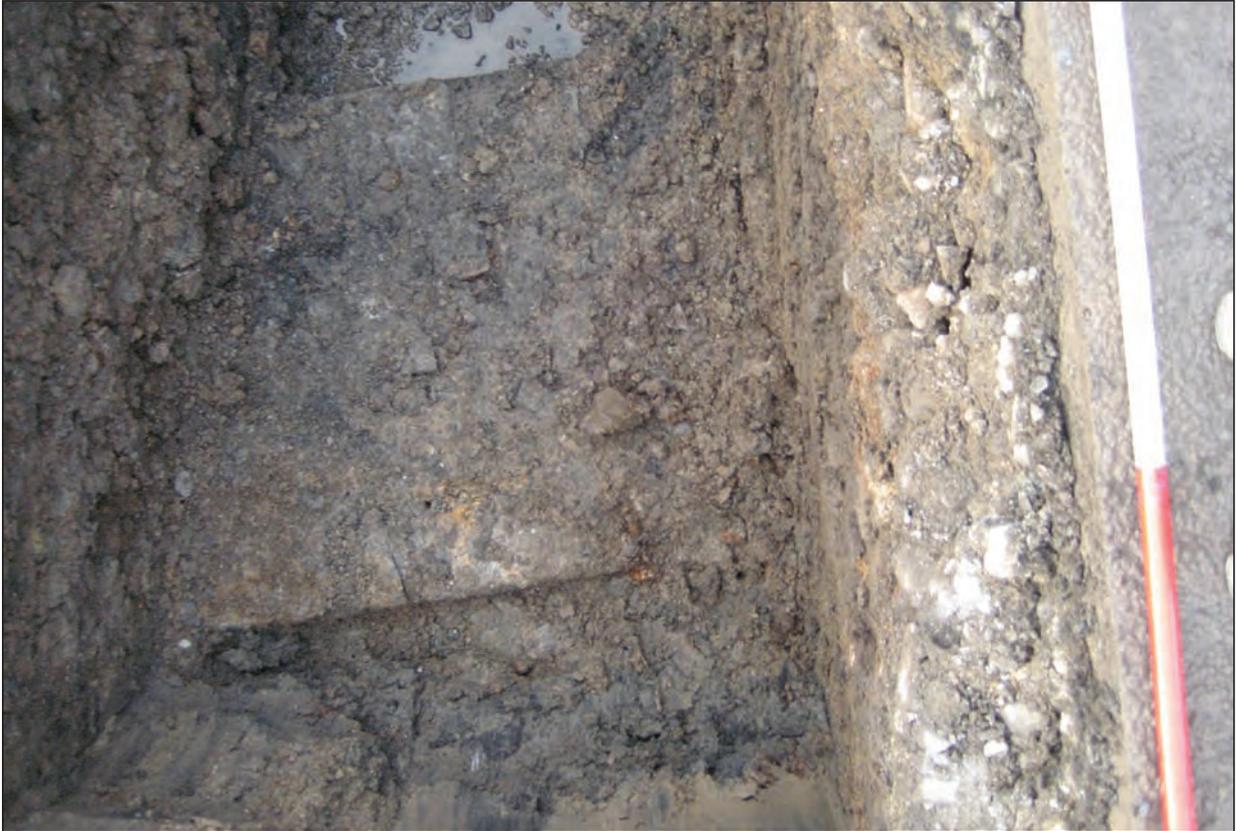
mortared limestone blocks (average block size 0.50m x 0.30m x 0.20m) and was faced on both sides (Plate 15). The stones appear to have been laid in flat bedding planes with a rubble stone construction; there was no indication of ‘snecked’ bonding. Lime mortar seemed to be in a poor to friable condition, however, for the most part, the *in situ* masonry appeared to be relatively securely bonded. The wall ran across the full width of the trench and was 1.26m wide. It is possible that the wall (013) represents the base of a sidewall of the canal (with the upper courses removed during decommissioning in the late 19th century). However, as this wall defines part of a stepback in the south wall of the canal channel (Figure 3), there is a possibility that it could represent the base of a set of steps (though further structural evidence to the east of the wall and within the east section face of the trench might be expected in such an instance). Immediately to the west of the wall the basal trench deposit comprised a dark organic clay (012) with potential for anaerobic preservation; this is believed to be an original canal siltation deposit and was also recorded in a number other trenches— ST-122, ST-124 and ST-125. The main deposit overlying both this siltation deposit (012) and the wall (013) was a deep mixed deposit of dark brown gravelly clay with frequent pockets of rubble and darker clay throughout (011). This deposit appears to relate to the infilling and decommissioning of the canal channel in the late 19th century.

Plate 15 - ST-128, overview of canal wall (013), facing SW
