Project code: LBTM12
Client: GMC (Ireland) Ltd on behalf of Railway Procurement Agency
Date: March 2013

Report on Archaeological Slit Trenches at Broadstone – Future Luas Works – Luas Broombridge (BXD) Dublin

Director: Teresa Bolger
Report Author: Teresa Bolger
Licence No: 12E0310 (ext)
Planning Reference: N/A
Report Status: Final

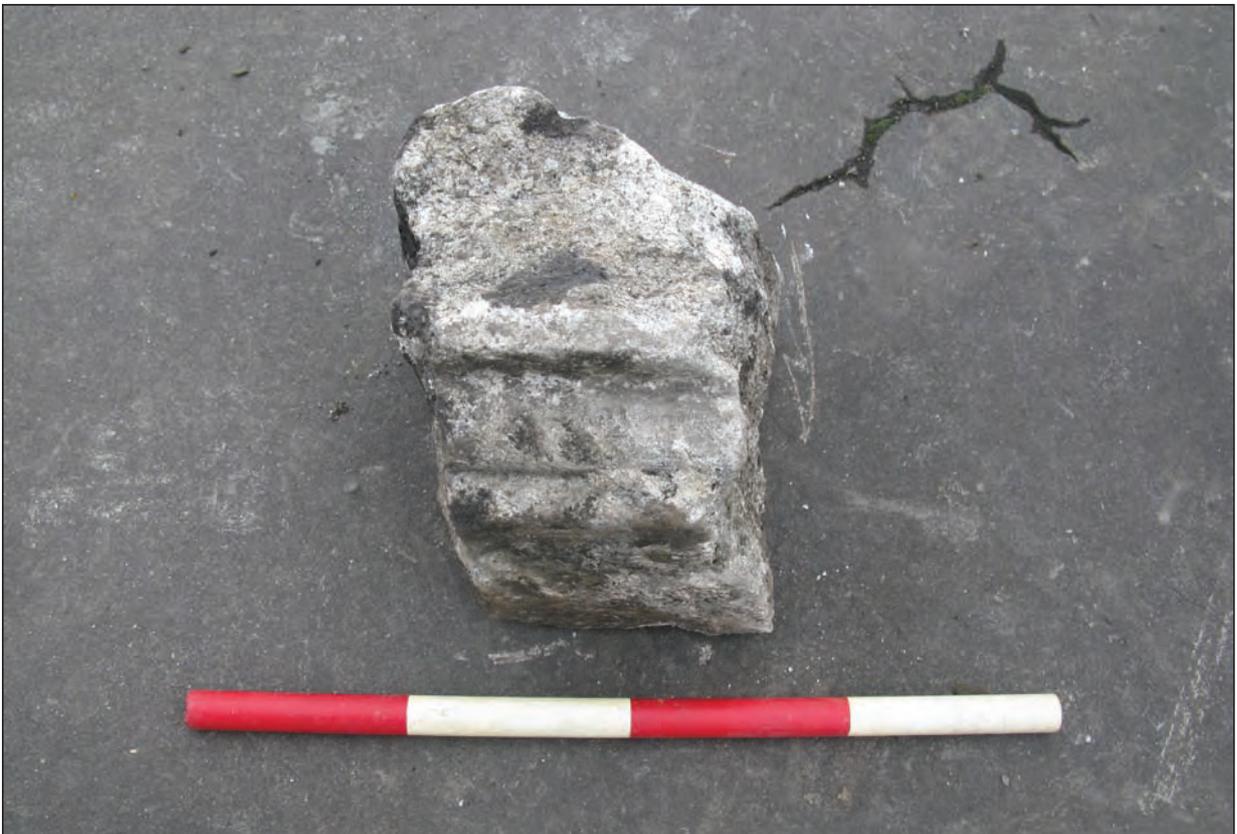
Plate 16 - Dressed architectural stone (12E0310:003:001)

A single architectural stone was recovered from ST-126, from within the rubble stone deposit (003) that overlay the deposits infilling the canal channel. It comprises a broken squared piece of granite (190x190x170mm) with a moulding along one corner, beside a chamfered edge (Plate 16). The moulding consists of a single bead recessed into the corner of the block. Traces of mortar survive on the side faces of the block.
