## GEOPHYSICAL SURVEY REPORT

LUAS F1 LINE

COUNTY DUBLIN

**Geophysical Survey Summary**  
**Luas F1 Line**  
**Lucan – Blackhorse, County Dublin**

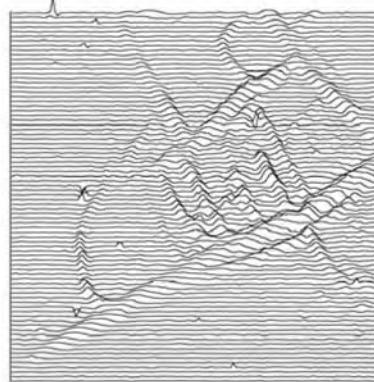
### XY Trace\*

The data are presented as a series of linear traces, enabling a semi-profile display of the respective anomalies along the X and Y-axes. This display option is essential for distinguishing between modern ferrous materials (buried metal debris) and potential archaeological responses. The XY trace plot provides a linear display of the magnitude of the response within a given data set.

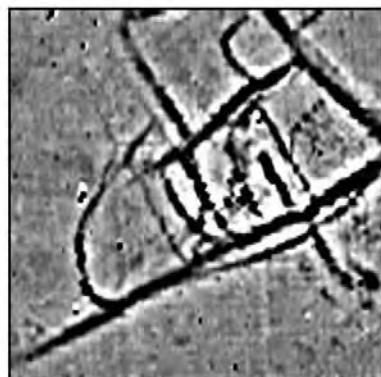
### Greyscale\*

As with dot density plots, the greyscale format assigns a cell to each datum according to its location on the grid. The display of each data point is conducted at very fine increments, allowing the full range of values to be displayed within the given data set. This display method also enables the identification of discrete responses that may be at the limits of instrument detection. In the summary diagrams processed, interpolated data is presented. Raw un-interpolated data is presented in the archive drawings along with the xy-trace plots.

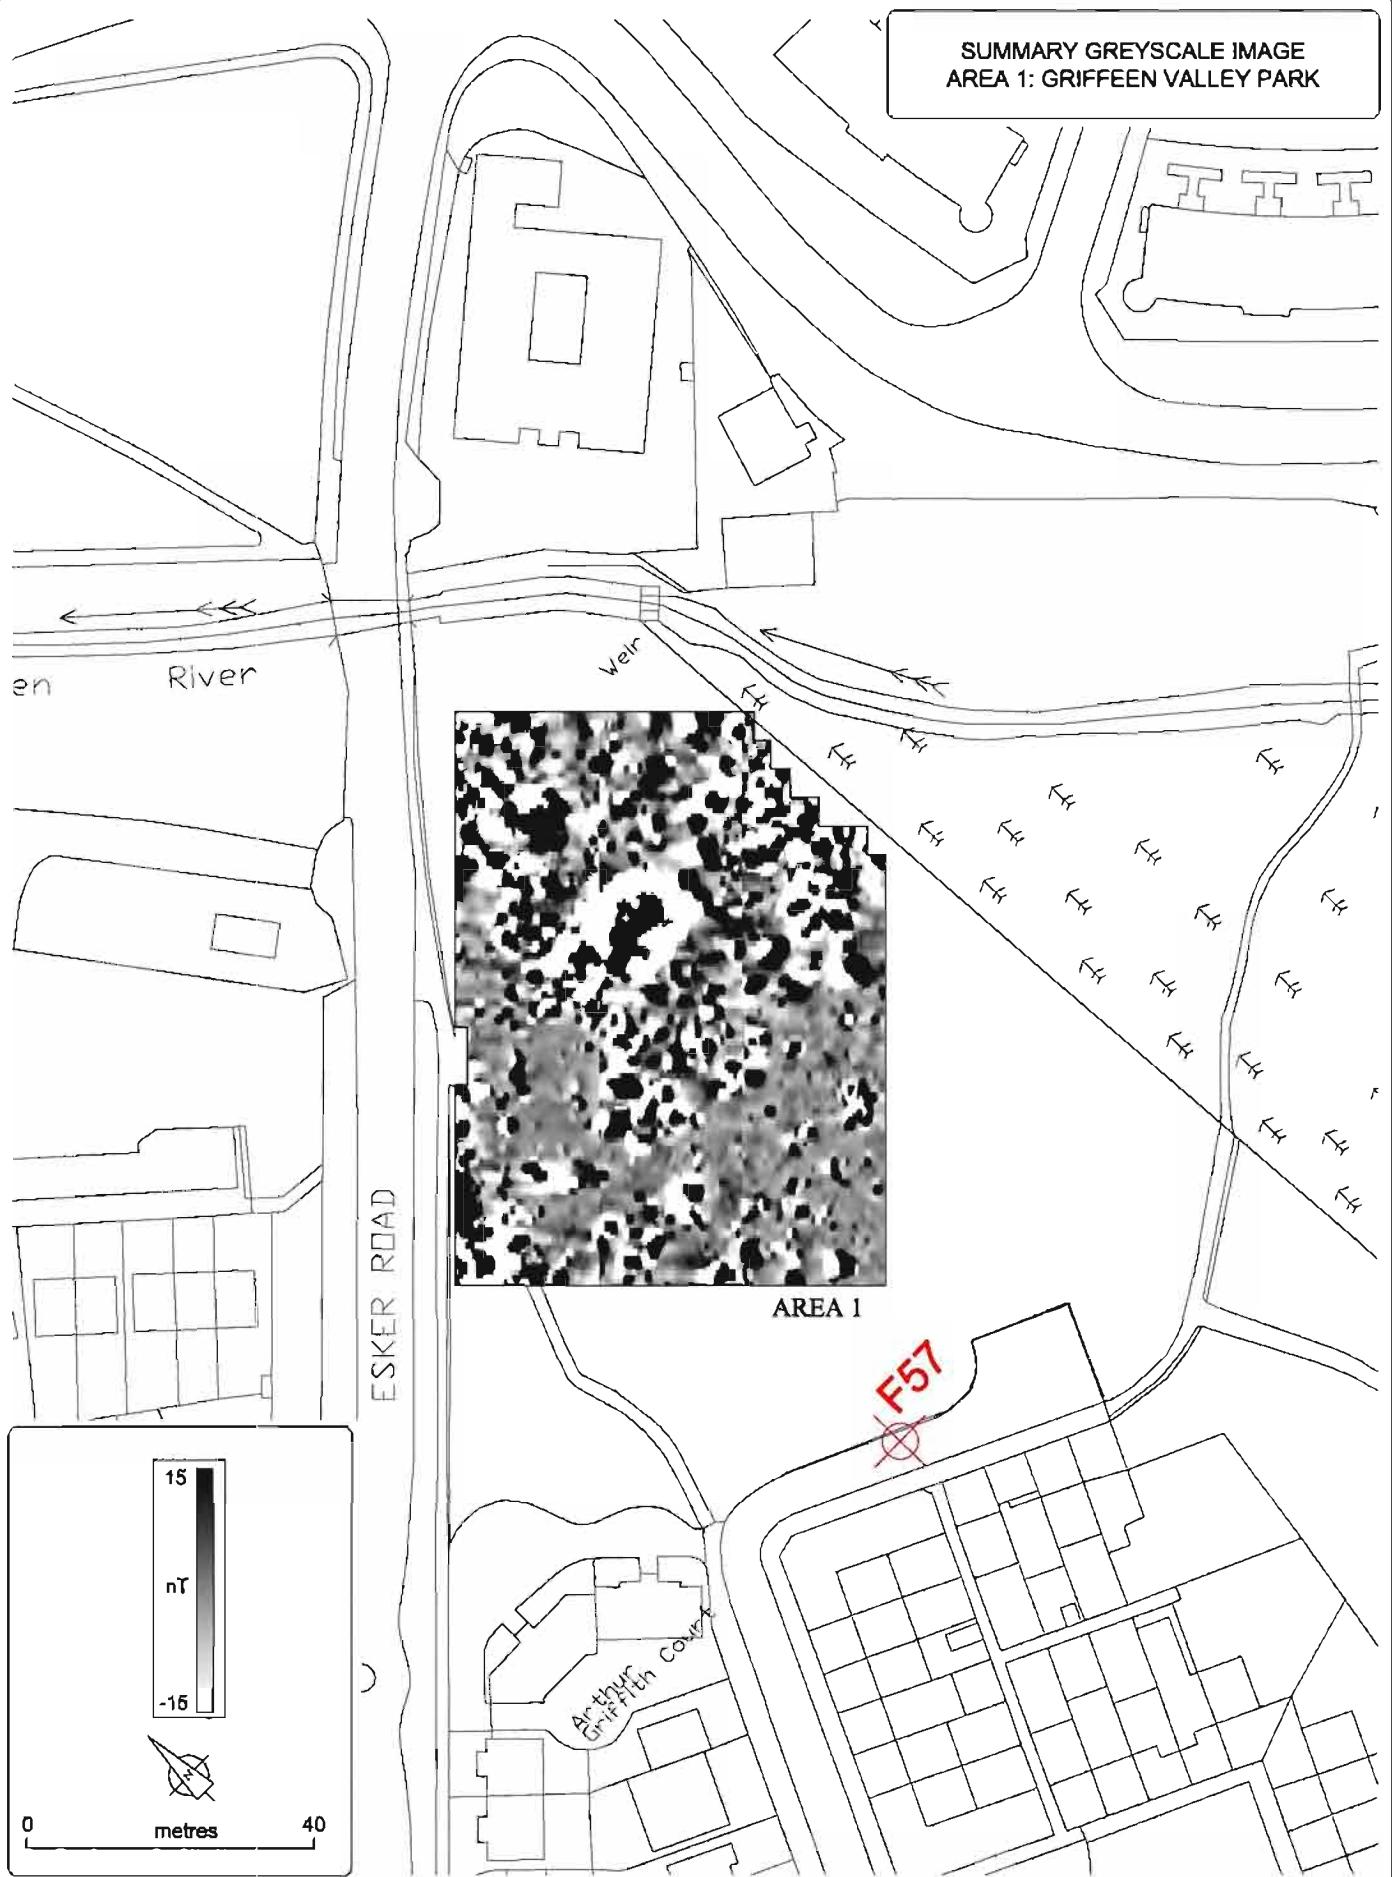
SUMMARY GREYSCALE IMAGE  
AREA 1: GRIFFEEEN VALLEY PARK

- 5.1 The detailed survey in Area 1 presented a high level of magnetic disturbance. The disturbance is the result of modern landscaping and has complicated the survey results.

- 5.2 The disturbance appears to increase in magnetic intensity towards the north of the data set, suggesting significant ground disturbance. Archaeological interpretation of the results is cautious, as it is likely that any responses of potential interest are masked by the broad magnetic disturbance, and remain undetected.

- 5.3 Within the broad magnetic disturbance are better defined spreads of disturbance (A), forming vague rectilinear patterns. The disturbance is suggestive of significant quantities of rubble material. It is possible that structural remains are represented here. However, the strength of the disturbance is suggestive of modern activity and it is likely that disturbance from modern landscaping is represented here. An archaeological interpretation is cautious.

- 5.4 In the south of Area 1 are numerous broad ferrous responses. These are typical of modern ferrous debris and are not considered to be of archaeological interest.

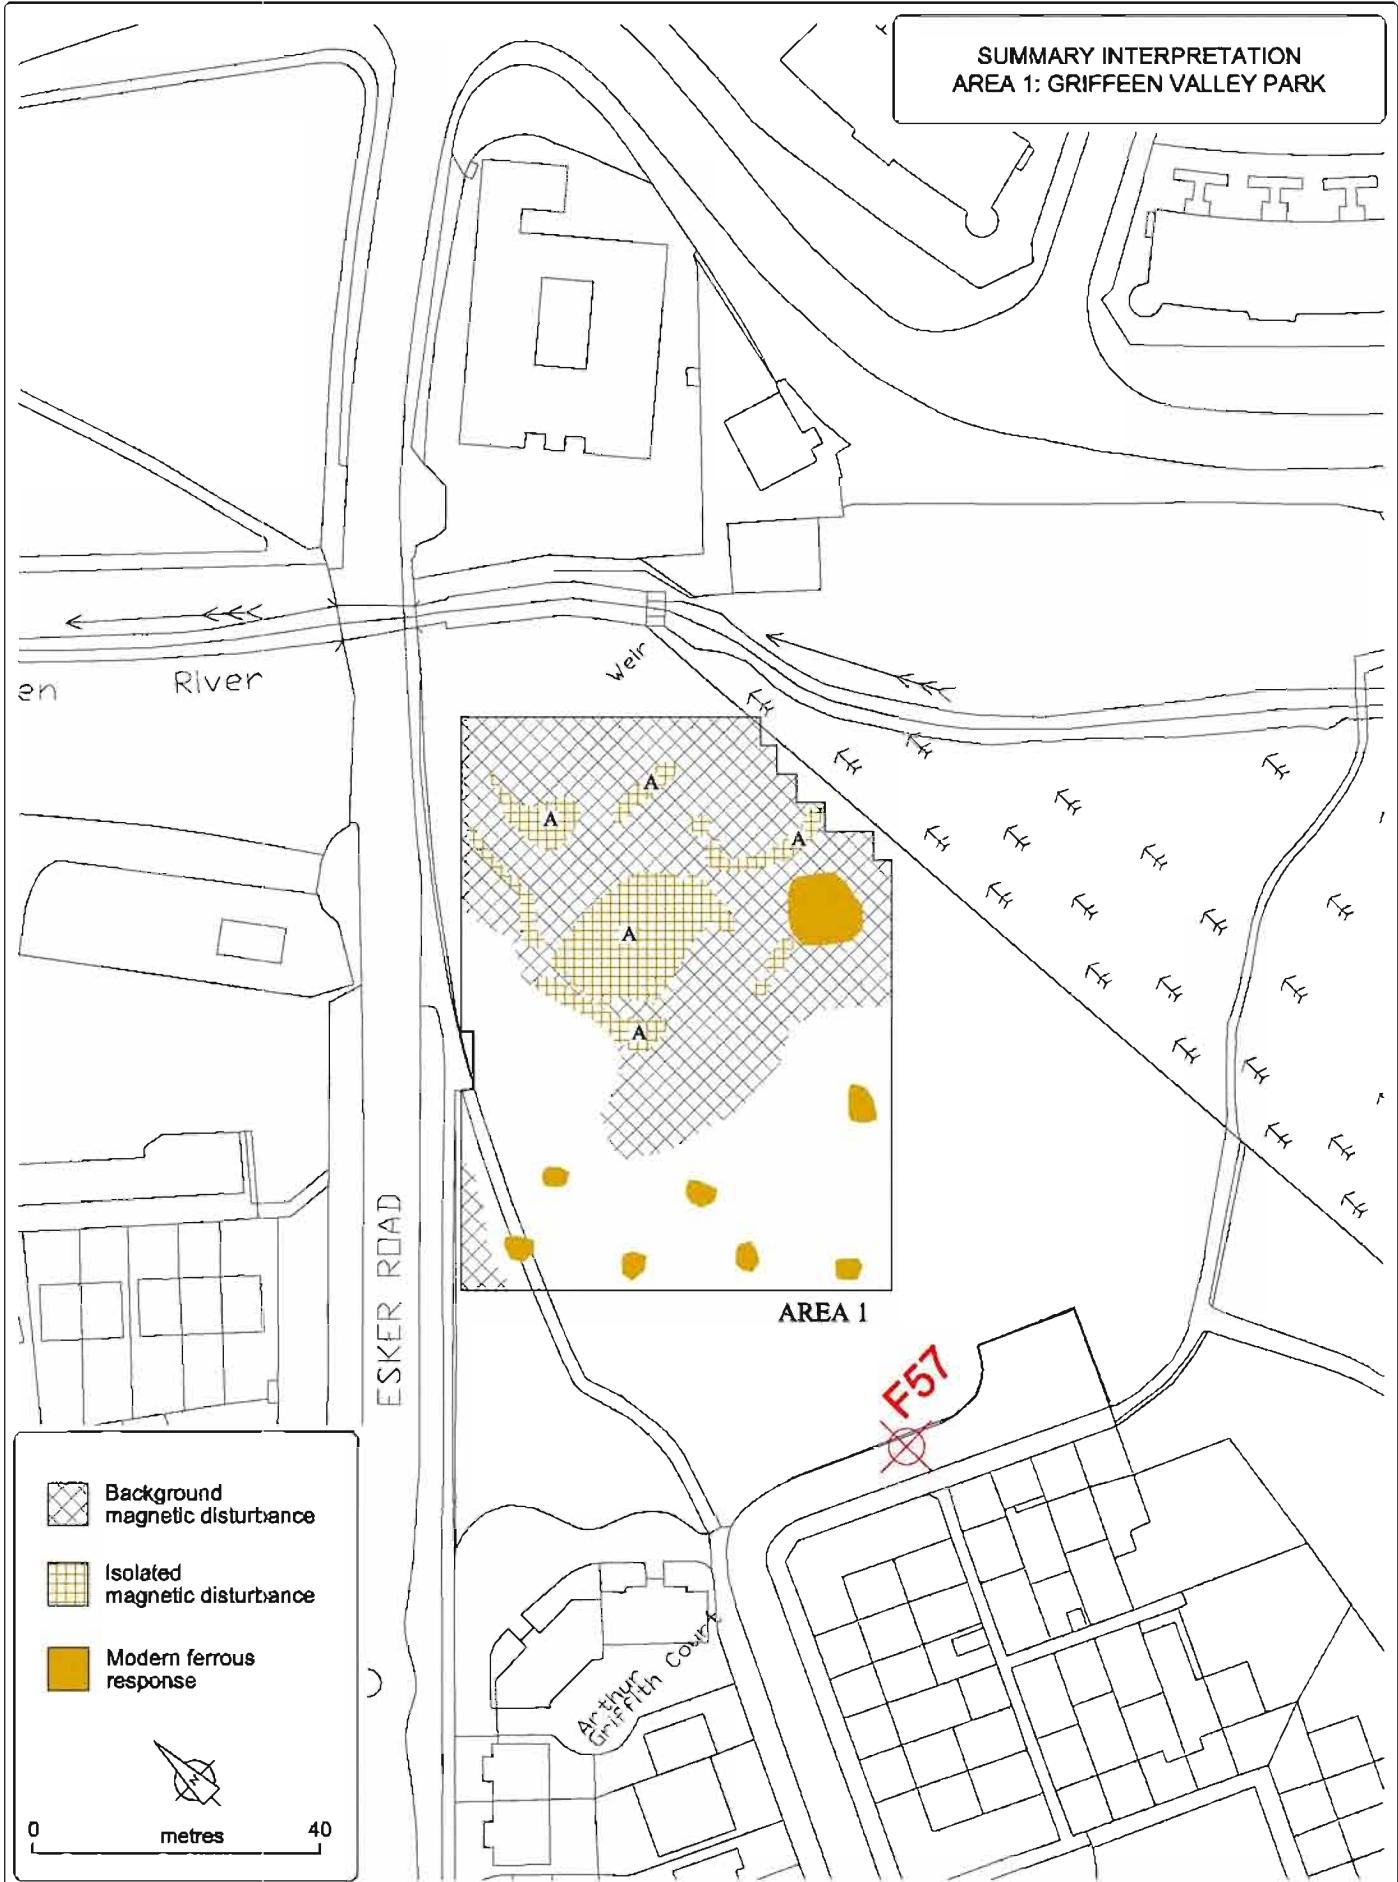
SUMMARY INTERPRETATION  
AREA 1: GRIFFEEEN VALLEY PARK

- 9.2 Area 1 was notably magnetically disturbed, most likely from modern landscaping. Although areas of distinct magnetic disturbance were identified, the archaeological potential is unclear. It is interpreted that modern ground disturbance has been recorded in the data.

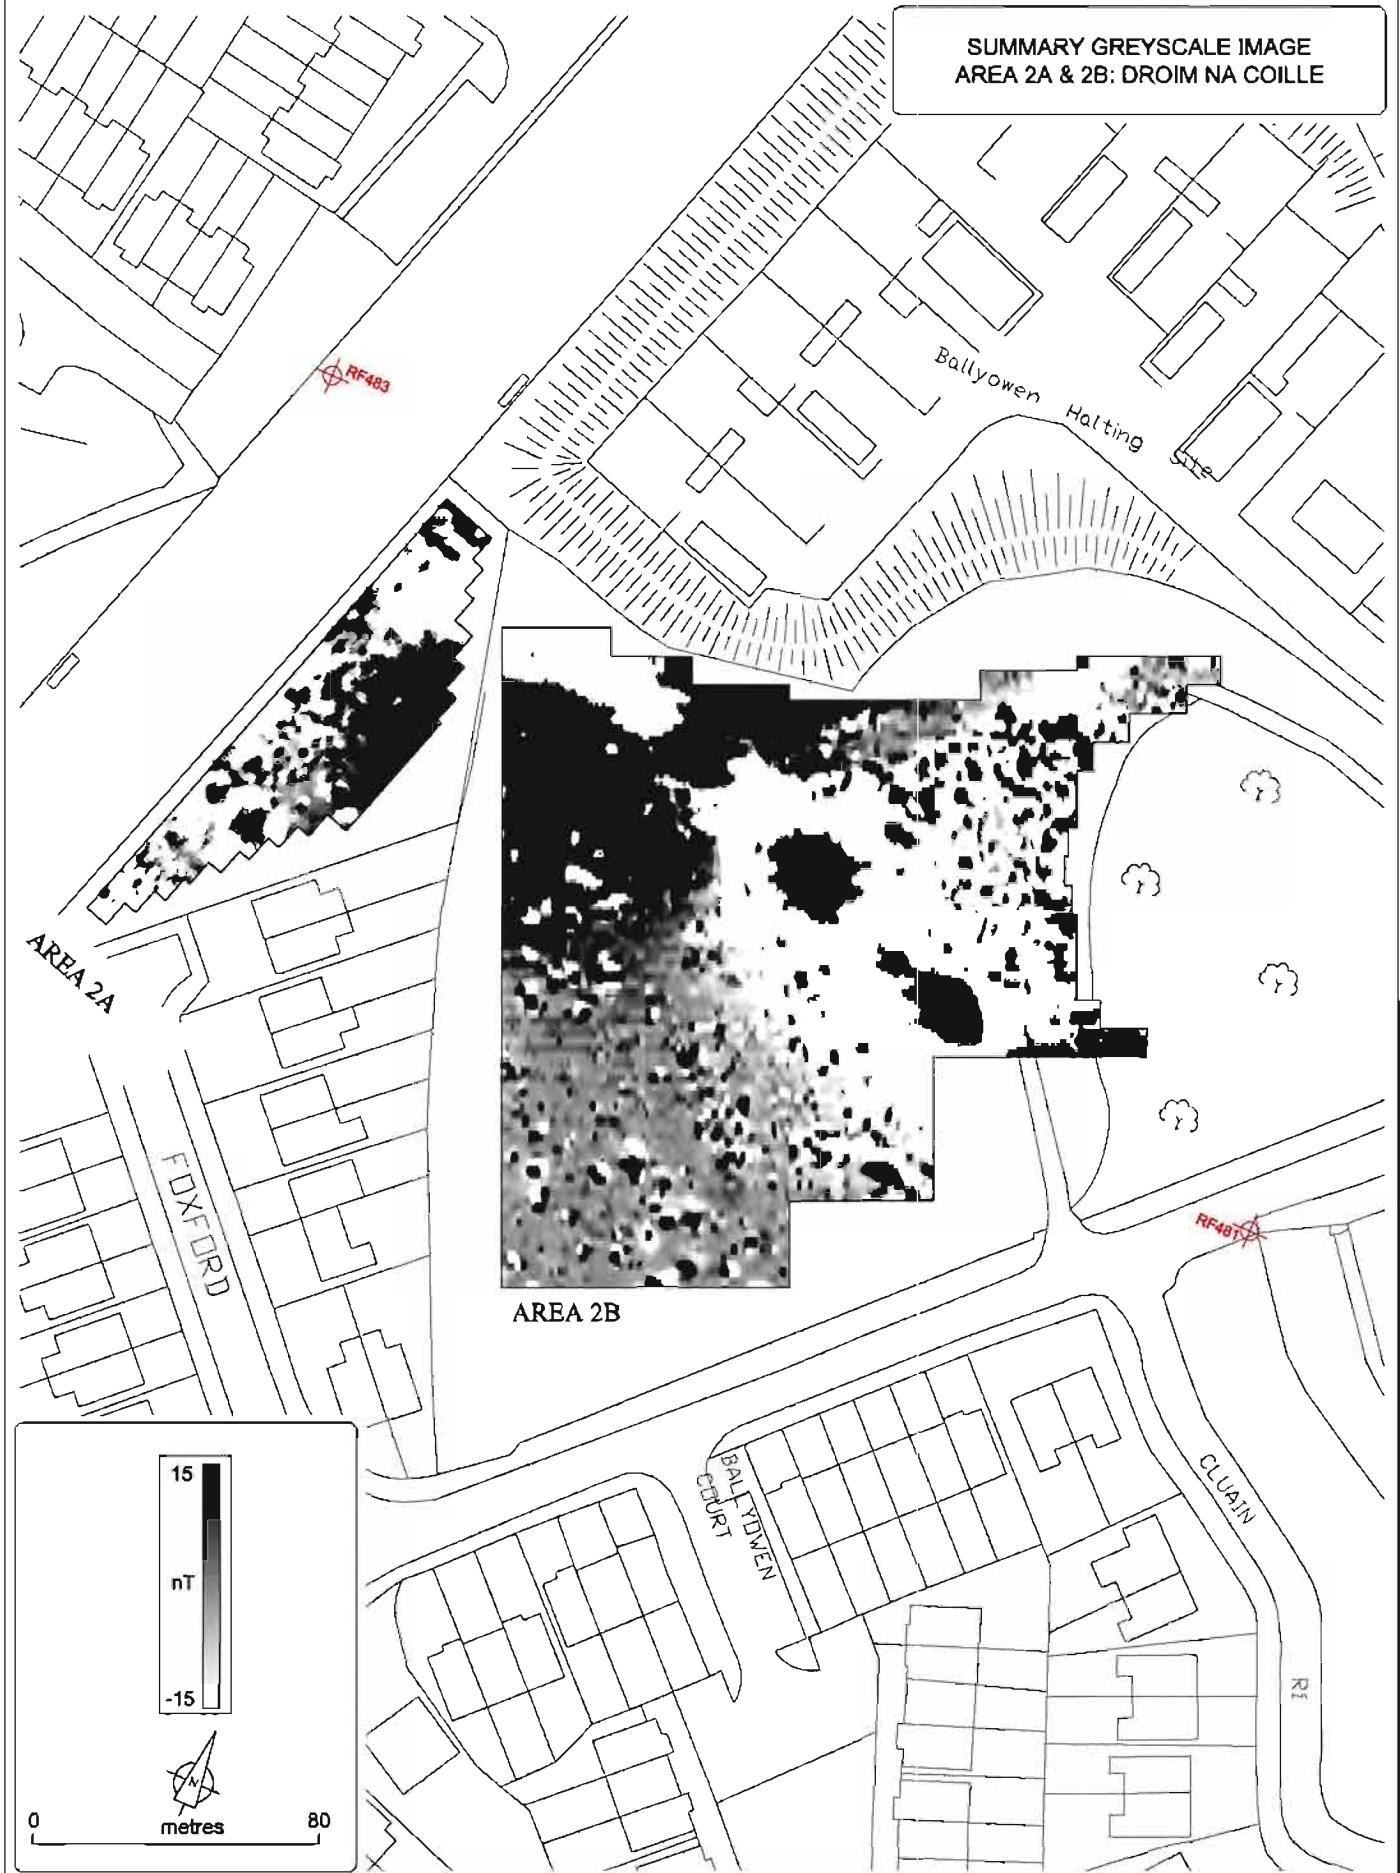
SUMMARY GREYSCALE IMAGE  
AREA 2A & 2B: DROIM NA COILLE

- 6.1 Magnetic disturbance is dominant in survey Area 2. The disturbance is evident as a linear series of bi-polar responses (B), resulting in a broad magnetic 'shadow' (C) throughout Area 2A and much of Area 2B. The bi-polar response is typical of an iron pipe, and appears to traverse Area 2, from the south-east of the survey area to the north-west. The magnetic shadow will mask any responses of possible archaeological interest and interpretation of the results is cautious. However, some responses in the north east of the data set may be of interest.

- 6.2 An area of magnetic disturbance (D) appears relatively well defined in the north east of Area 2B. Although the disturbance is characteristic of modern activity, it is possible that the demolished remains of a structure are represented here. The southern limit of the disturbance is ill defined due to the magnetic shadow of the probable pipe. Although it is possible that the magnetic disturbance is the result of more recent activity, an archaeological interpretation can be considered. It is possible that the demolished remains of a structure have been identified. Although the disturbance may represent more recent activity and ground disturbance, it is speculated that the demolished remains of Ballyowen House are represented here.

- 6.3 The magnetic shadow from the probable pipe has obscured the remainder of the data sets and no archaeological interpretation can be provided here. Numerous magnetically strong ferrous responses are evident in the south of Area 2B. The responses are interpreted as modern in origin and are not considered to be of archaeological potential.

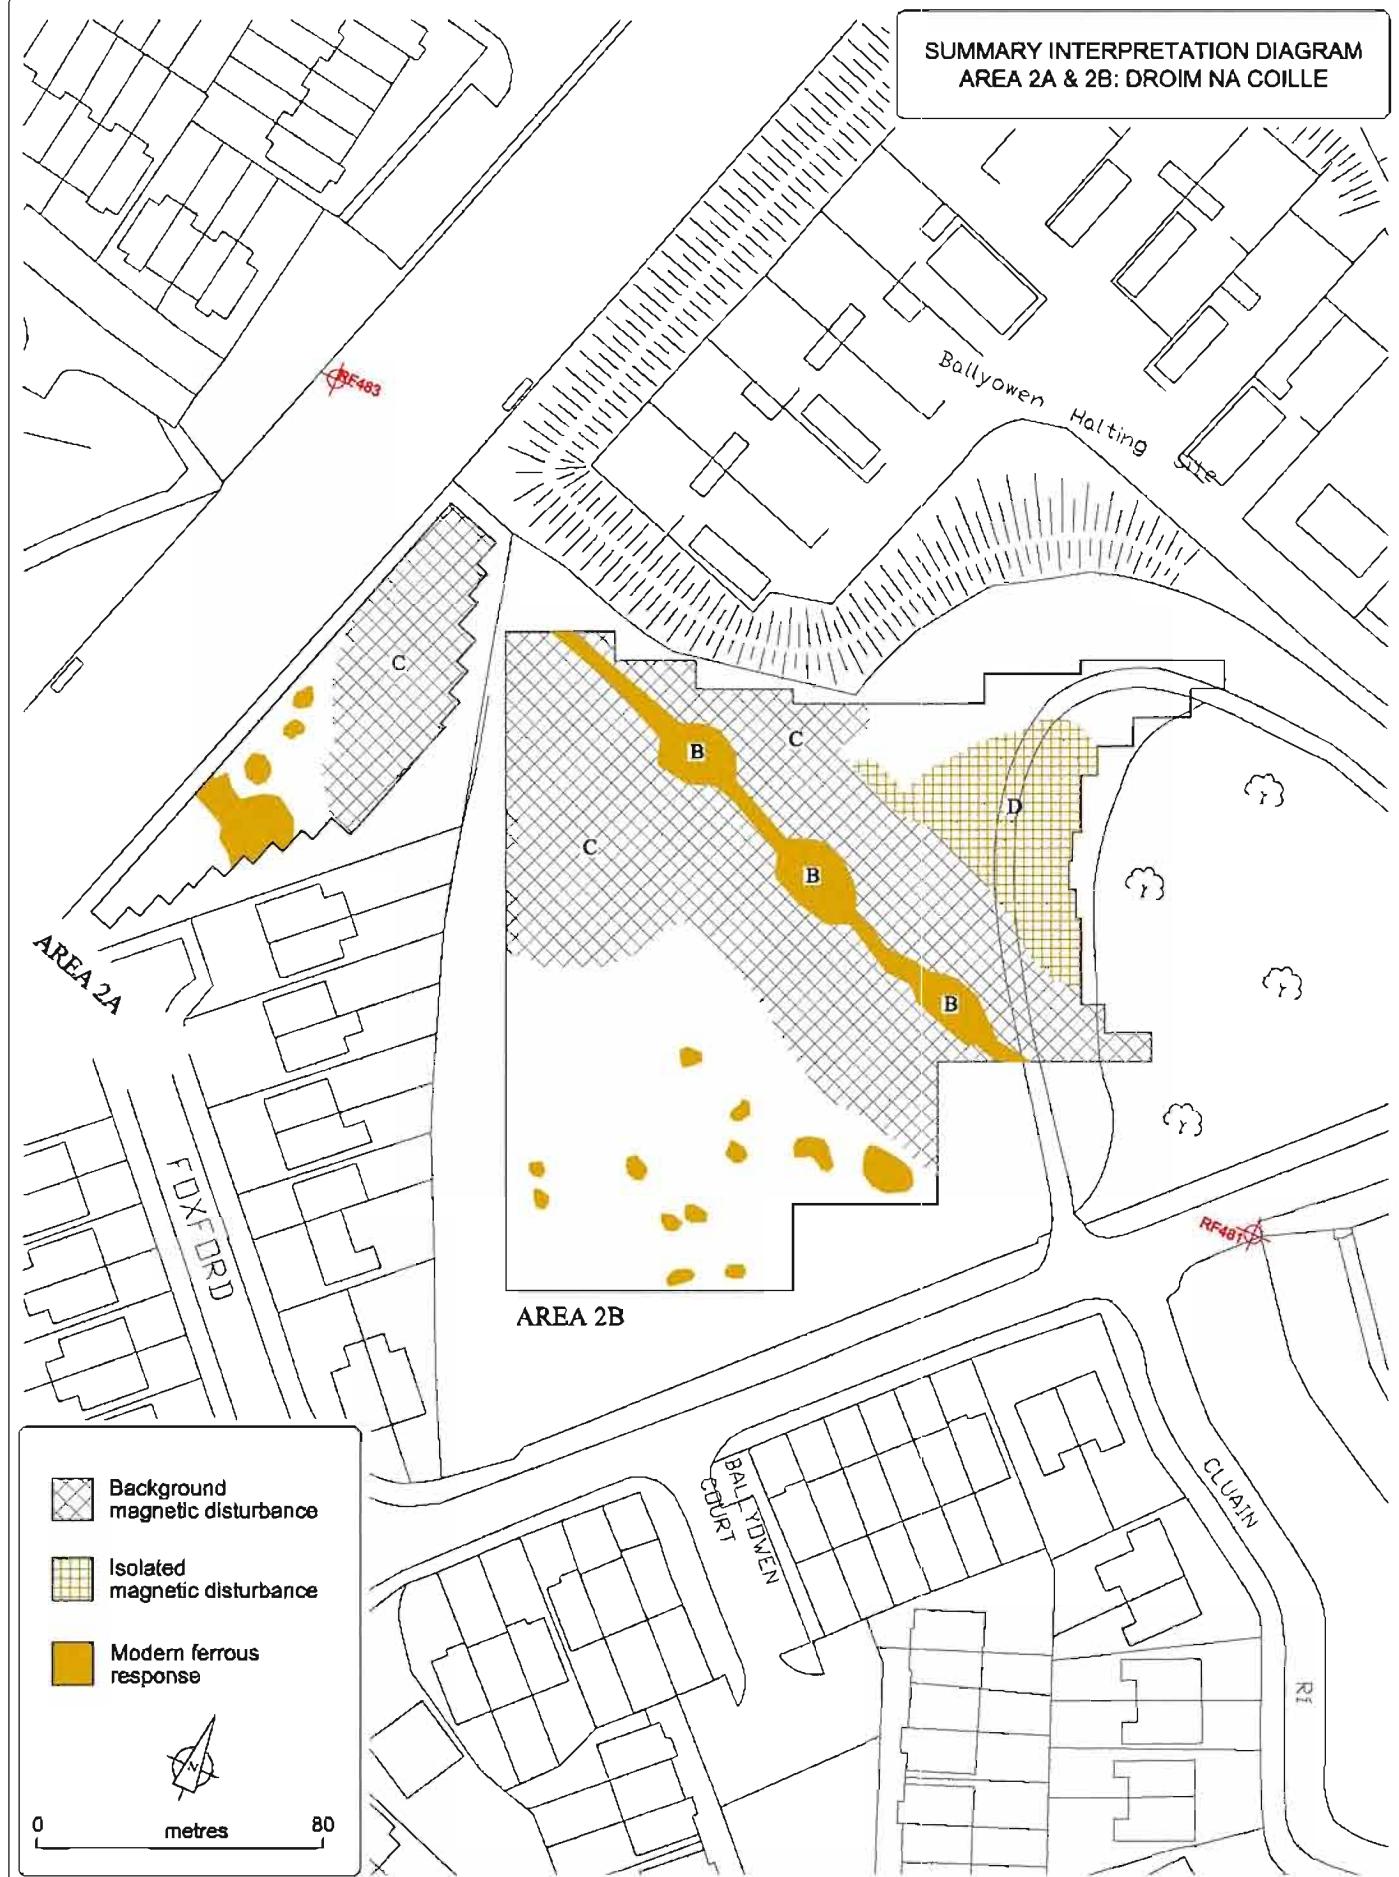
SUMMARY INTERPRETATION DIAGRAM  
AREA 2A & 2B: DROIM NA COILLE

- 9.3 Detailed survey in Area 2 was hindered due to magnetic disturbance resulting from a probable iron pipe. However, a distinct area of magnetic responses in the north-east of Area 2 may be of interest. The responses correlate with the approximate former location of Ballyowen House, identified on the 1<sup>st</sup> edition ordnance survey map. Although the responses identified may represent more recent landscaping activity, it is possible that the demolished remains of Ballyowen House have been identified.

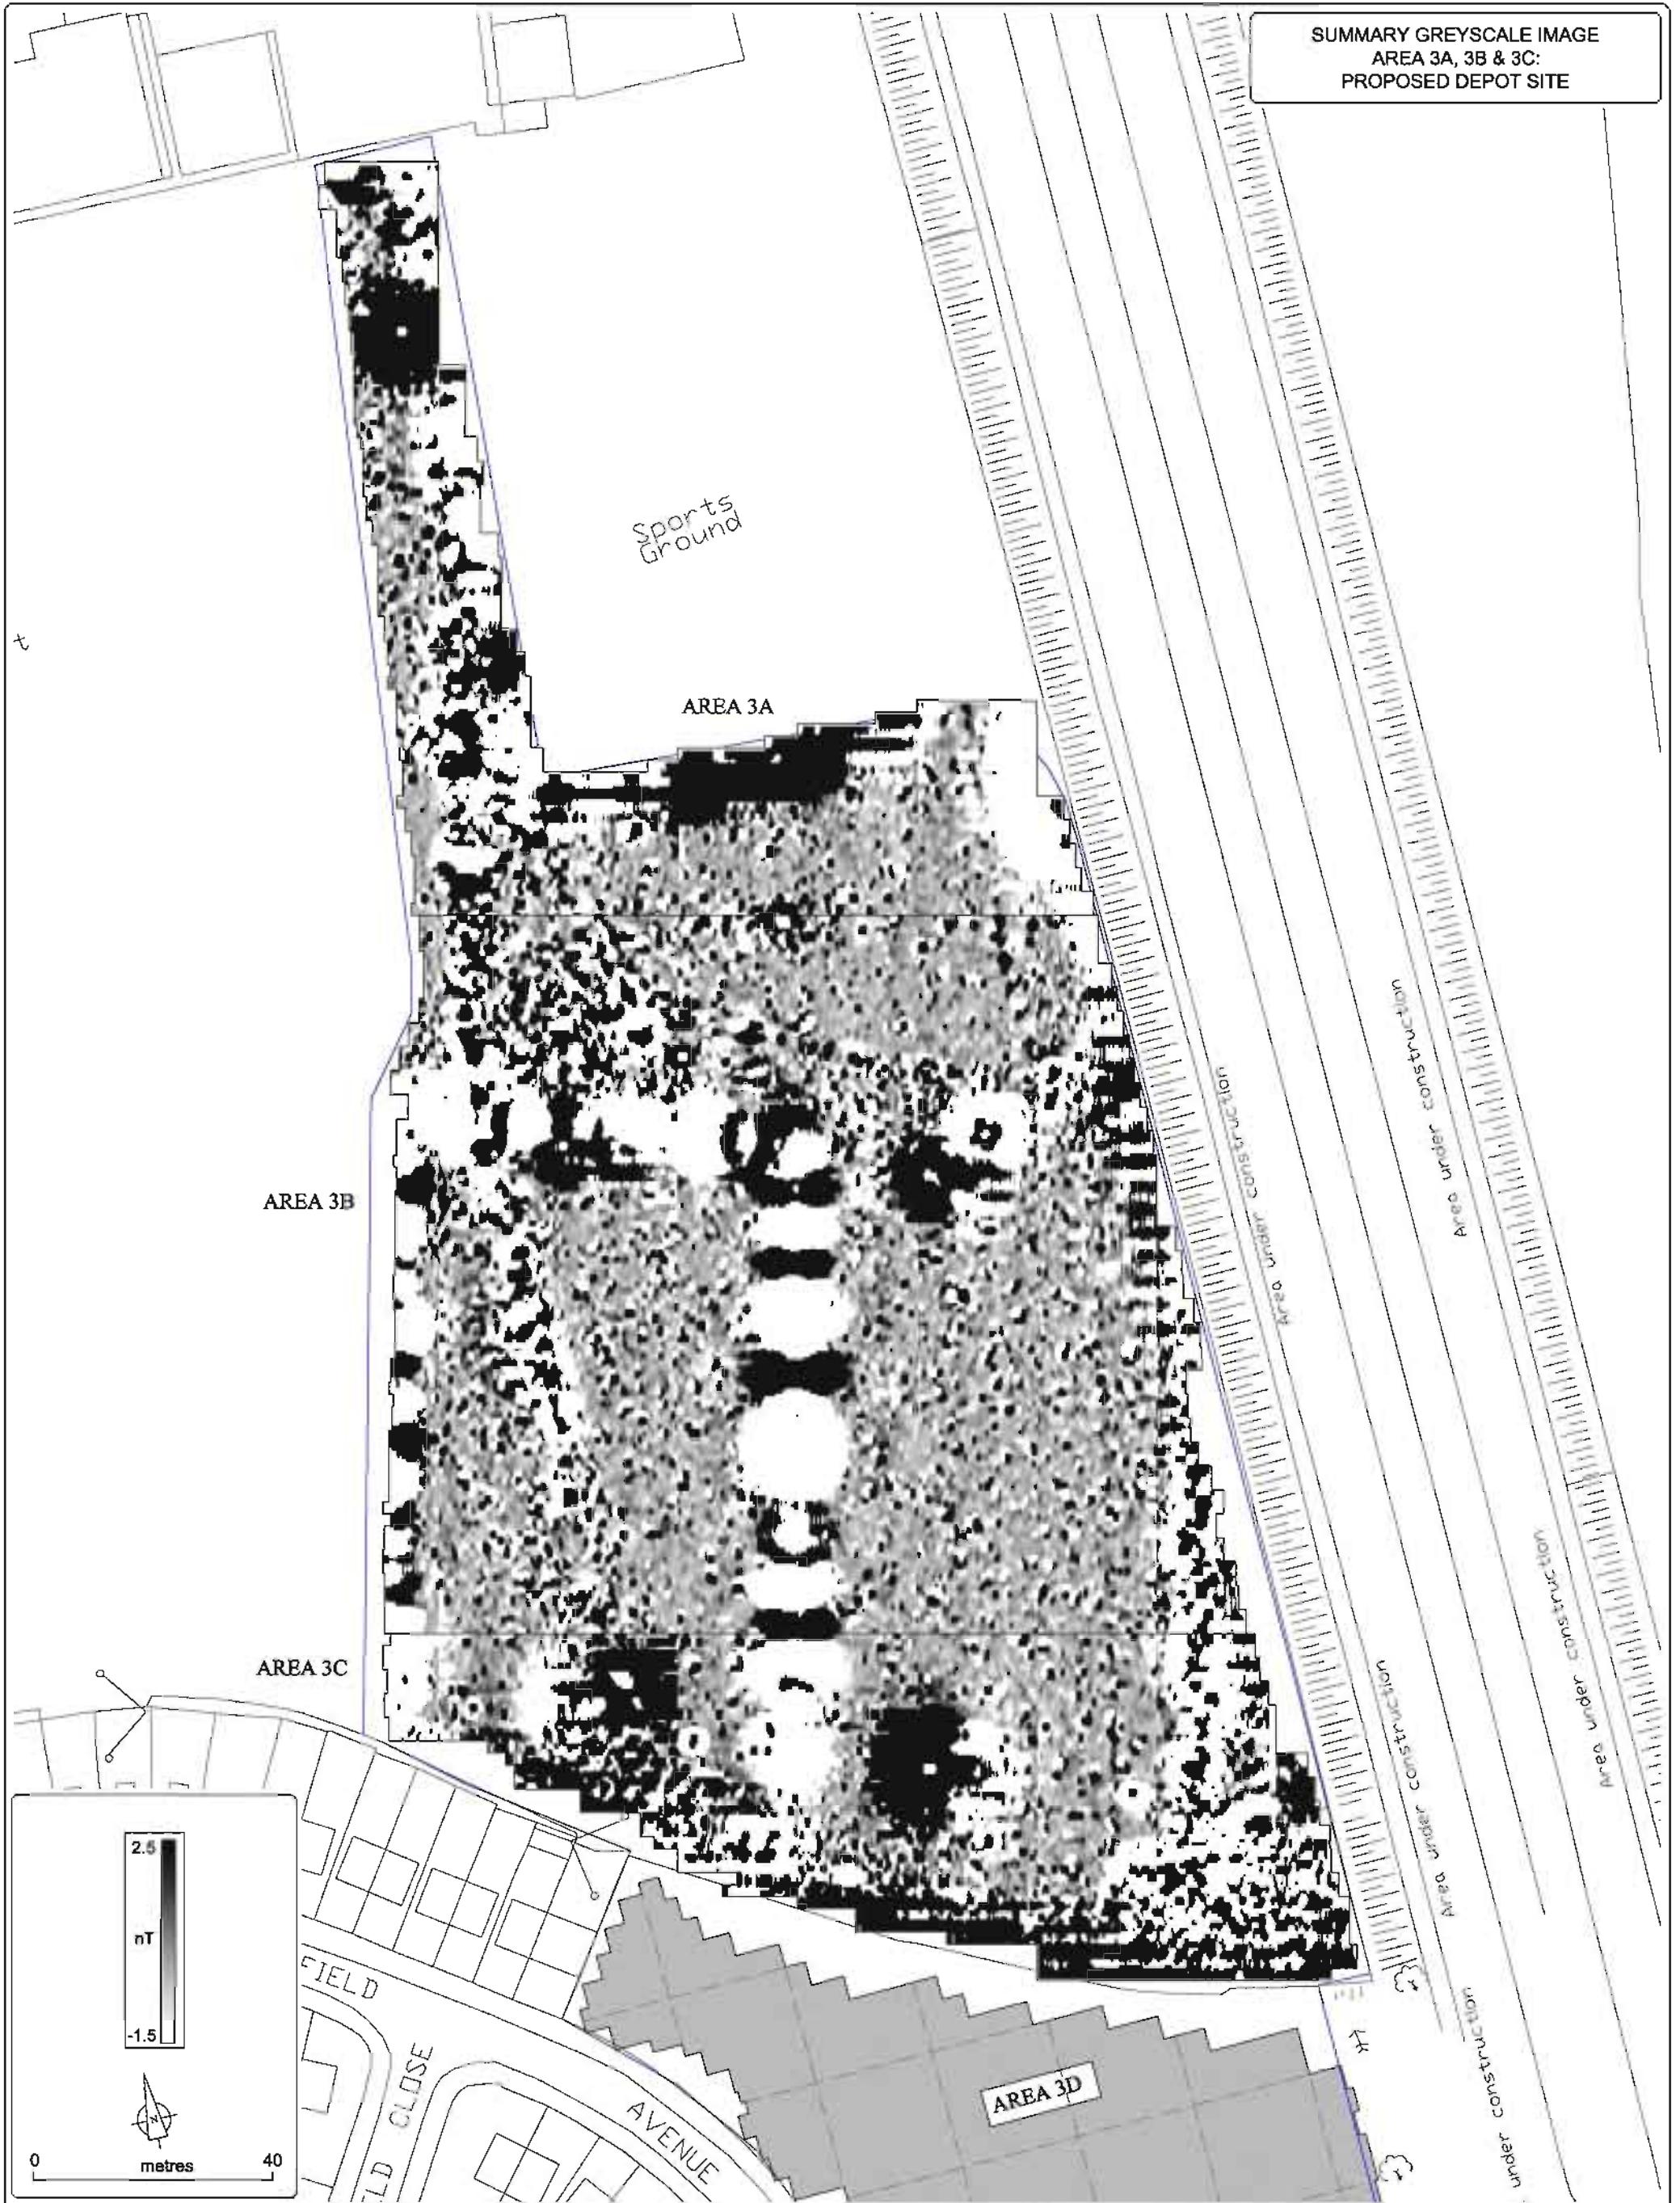
SUMMARY GREYSCALE IMAGE  
AREA 3A, 3B & 3C:  
PROPOSED DEPOT SITE

- 7.1 The detailed survey in Area 3 was notably disturbed. The area is currently used as playing fields, with levelled football pitches, goal posts, railings and lighting fixtures; all producing significant magnetic disturbance. In addition, disturbance along the eastern edge of survey was considerable, and results from the M50 motorway infrastructure.

- 7.2 In the north of Area 3A, and also in the east of Area 3B, the data sets are dominated by magnetic disturbance (E) caused by the lighting fixtures for the sports ground, and the M50 Motorway. The disturbance is considerable, and would mask any subtle responses resulting from archaeological features. No Interpretation within this disturbance can be provided.

- 7.3 A defined area of disturbance and linear responses (F) is evident in the south of Area 3A and continues into Area 3B. It is likely that the disturbance and responses are modern in origin. It is interpreted that a spread of rubble or gravel is represented here.

- 7.4 Another spread of magnetic disturbance (G) is evident within Areas 3A and 3B. This disturbance has little shape or form and is interpreted as modern in origin. The disturbance most likely represents a feature associated with the sports and social club. No archaeological interpretation can be provided.

- 7.5 A series of isolated ferrous responses (H) in the north east of Area 3B is most likely modern in origin, perhaps resulting from the landscaping and levelling of the playing fields. The ferrous responses are not considered to be of archaeological potential.

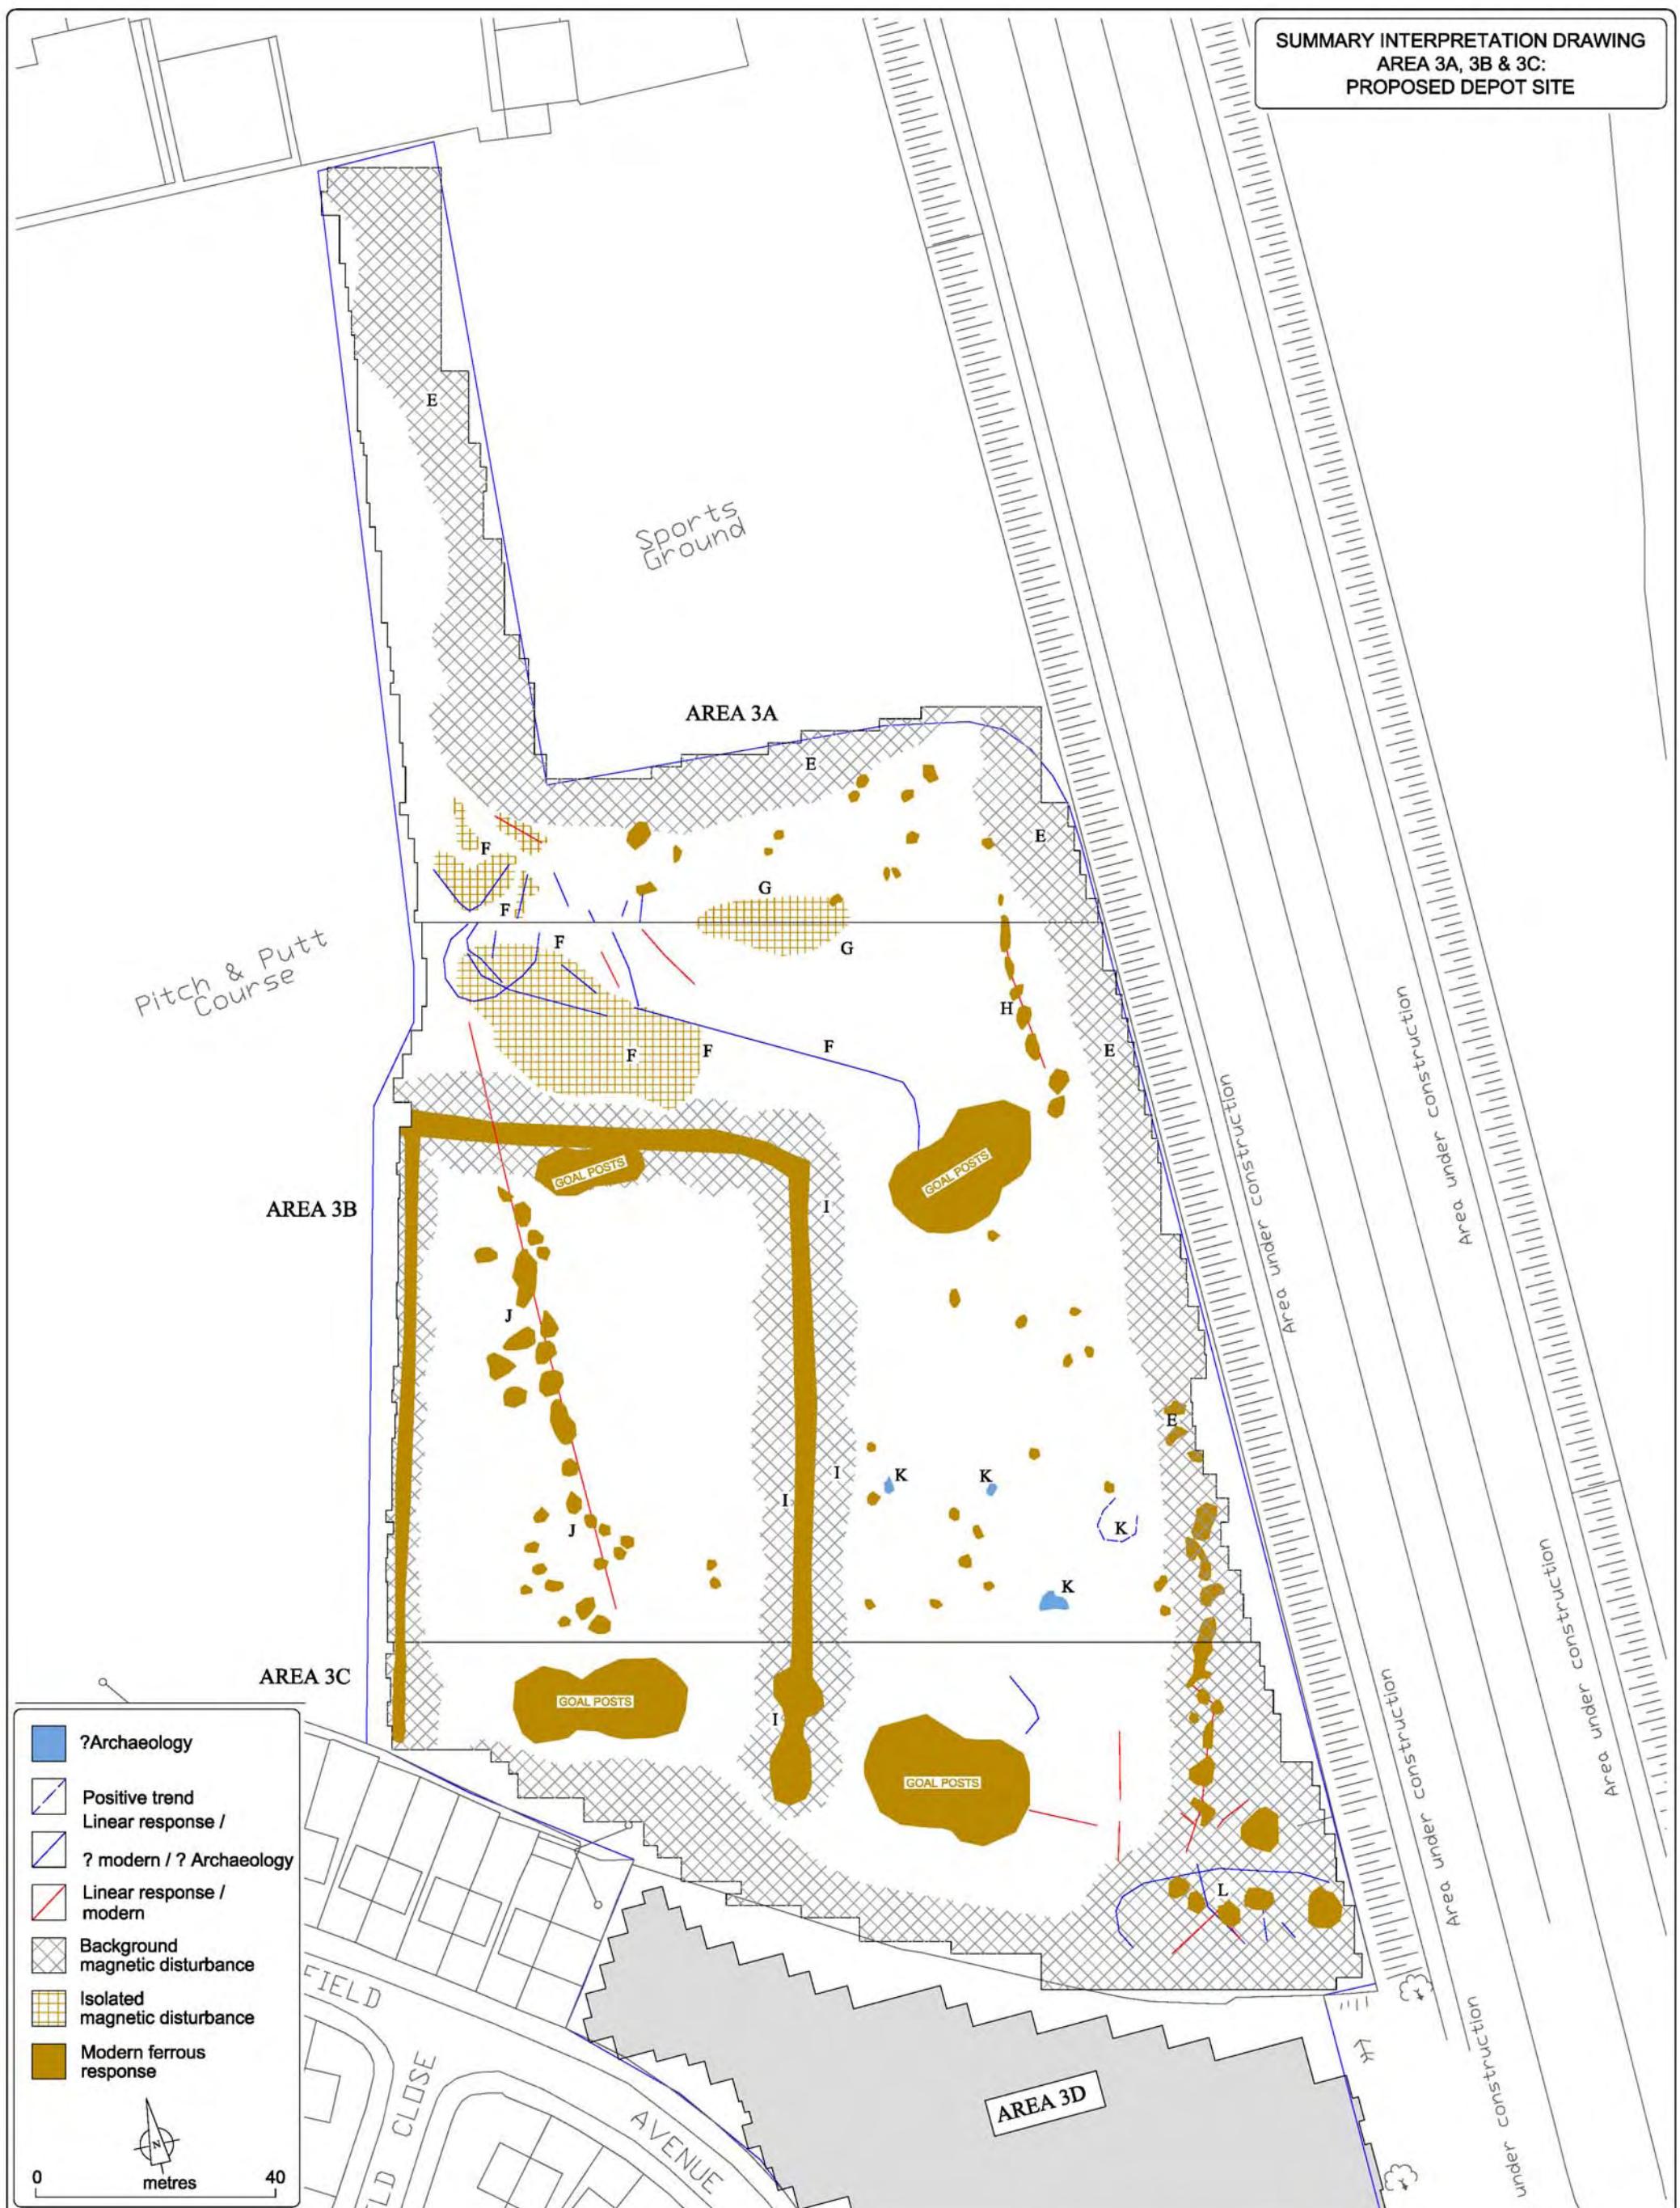
SUMMARY INTERPRETATION DRAWING  
AREA 3A, 3B & 3C:  
PROPOSED DEPOT SITE

- 7.6 An extant modern railing encompassing a football pitch in Area 3B and 3C is evident in the data as a magnetically strong ferrous response (I). Within this are a cluster of isolated ferrous responses (J). The ferrous responses are magnetically strong and are interpreted as modern in origin. It is unclear as to what the ferrous responses represent, but an archaeological origin is considered unlikely.

- 7.7 To the east of the metal railings (I) are several responses (K) of potential archaeological origin, evident in Area 3B. The responses are of archaeological strength and it is possible that pit type features are represented here. However, there are numerous isolated ferrous responses throughout Area 3B and it is equally likely that responses (K) represent more deeply buried ferrous debris. No

- clear archaeological pattern is evident and an archaeological interpretation is tentative.
- 7.8 In the south east of Area 3C a broad spread of magnetic disturbance has been recorded. Although the disturbance is considered to be modern in origin, there are curvilinear responses (L) visible in the data. It is possible that an archaeological feature, masked by the disturbance is located here. This is speculative, and the linear responses may equally represent a continuation of the modern disturbance. Archaeological interpretation of the curvilinear responses (L) is unclear.
- 7.9 To the north of the linear responses (L) is another series of ferrous responses and form a roughly linear pattern. This is considered modern in origin, and most likely results from more recent landscaping.
- 7.10 Two sets of iron goal posts have resulted in large ferrous responses in Areas 3B and 3C.
