## GEOPHYSICAL SURVEY REPORT

LUAS F1 LINE

COUNTY DUBLIN

**Geophysical Survey Summary**  
**Luas F1 Line**  
**Lucan – Blackhorse, County Dublin**

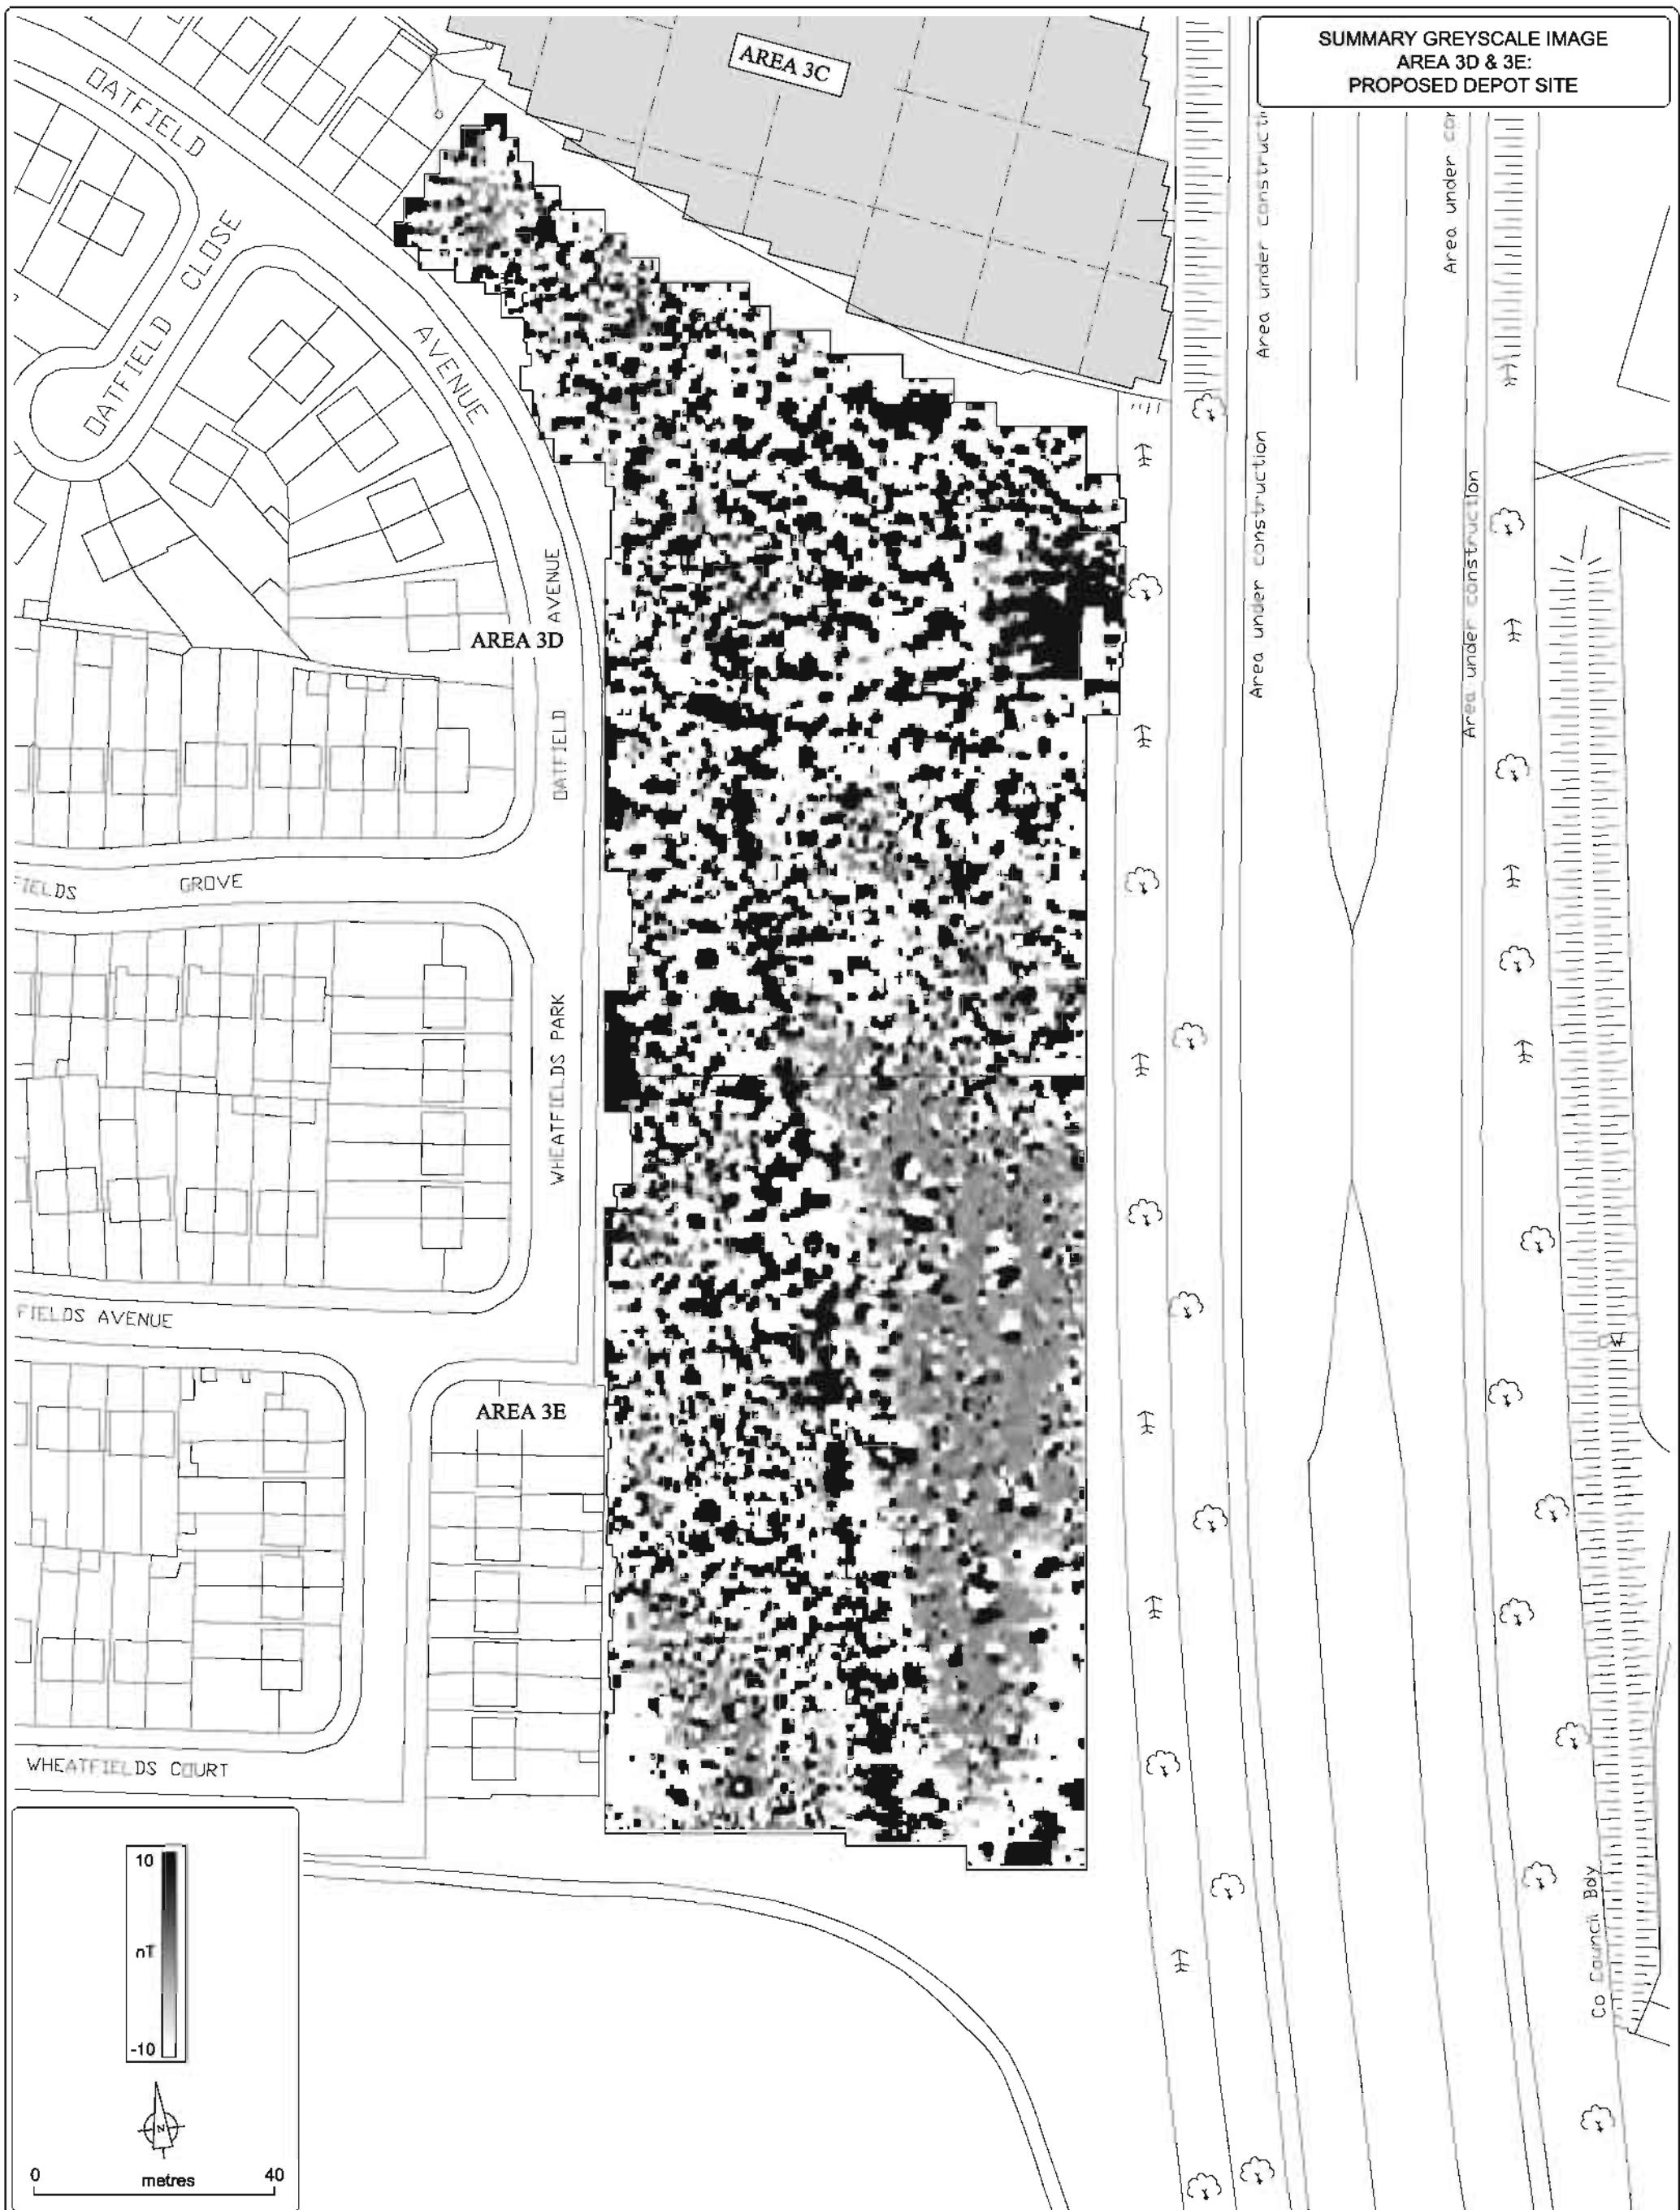
Scale @ A3: 1:1,000  
Figure: 11  
Licence No.: 10 - R - 9  
Issue Date: 12.04.2010

- 8.1 Further magnetic disturbance dominates the data recorded in Areas 3D and 3E. This most likely represents ground disturbance and spreads of modern material resulting from the adjacent housing estate. Few responses distinct from the disturbance can be identified, and subtle responses of potential archaeological interest may be masked by this disturbance.

- 8.2 A series of broad magnetically strong responses (M) are discernable in Areas 3C and 3D, and appears to form a linear pattern. The responses (M) appear to delimit the extent of the magnetic disturbance to the west, and it is likely that a former division or boundary feature is represented here.

- 8.3 In the south-east of Area 3D, a curvilinear response (N) is evident. The background magnetic disturbance makes interpretation cautious, and it is possible that the response (N) represents a continuation of the magnetic disturbance. However, an archaeological interpretation must be considered. It is possible that a ditched feature c.17m in diameter is represented here. Although an archaeological interpretation is tentative the response is considered to be of potential archaeological interest.

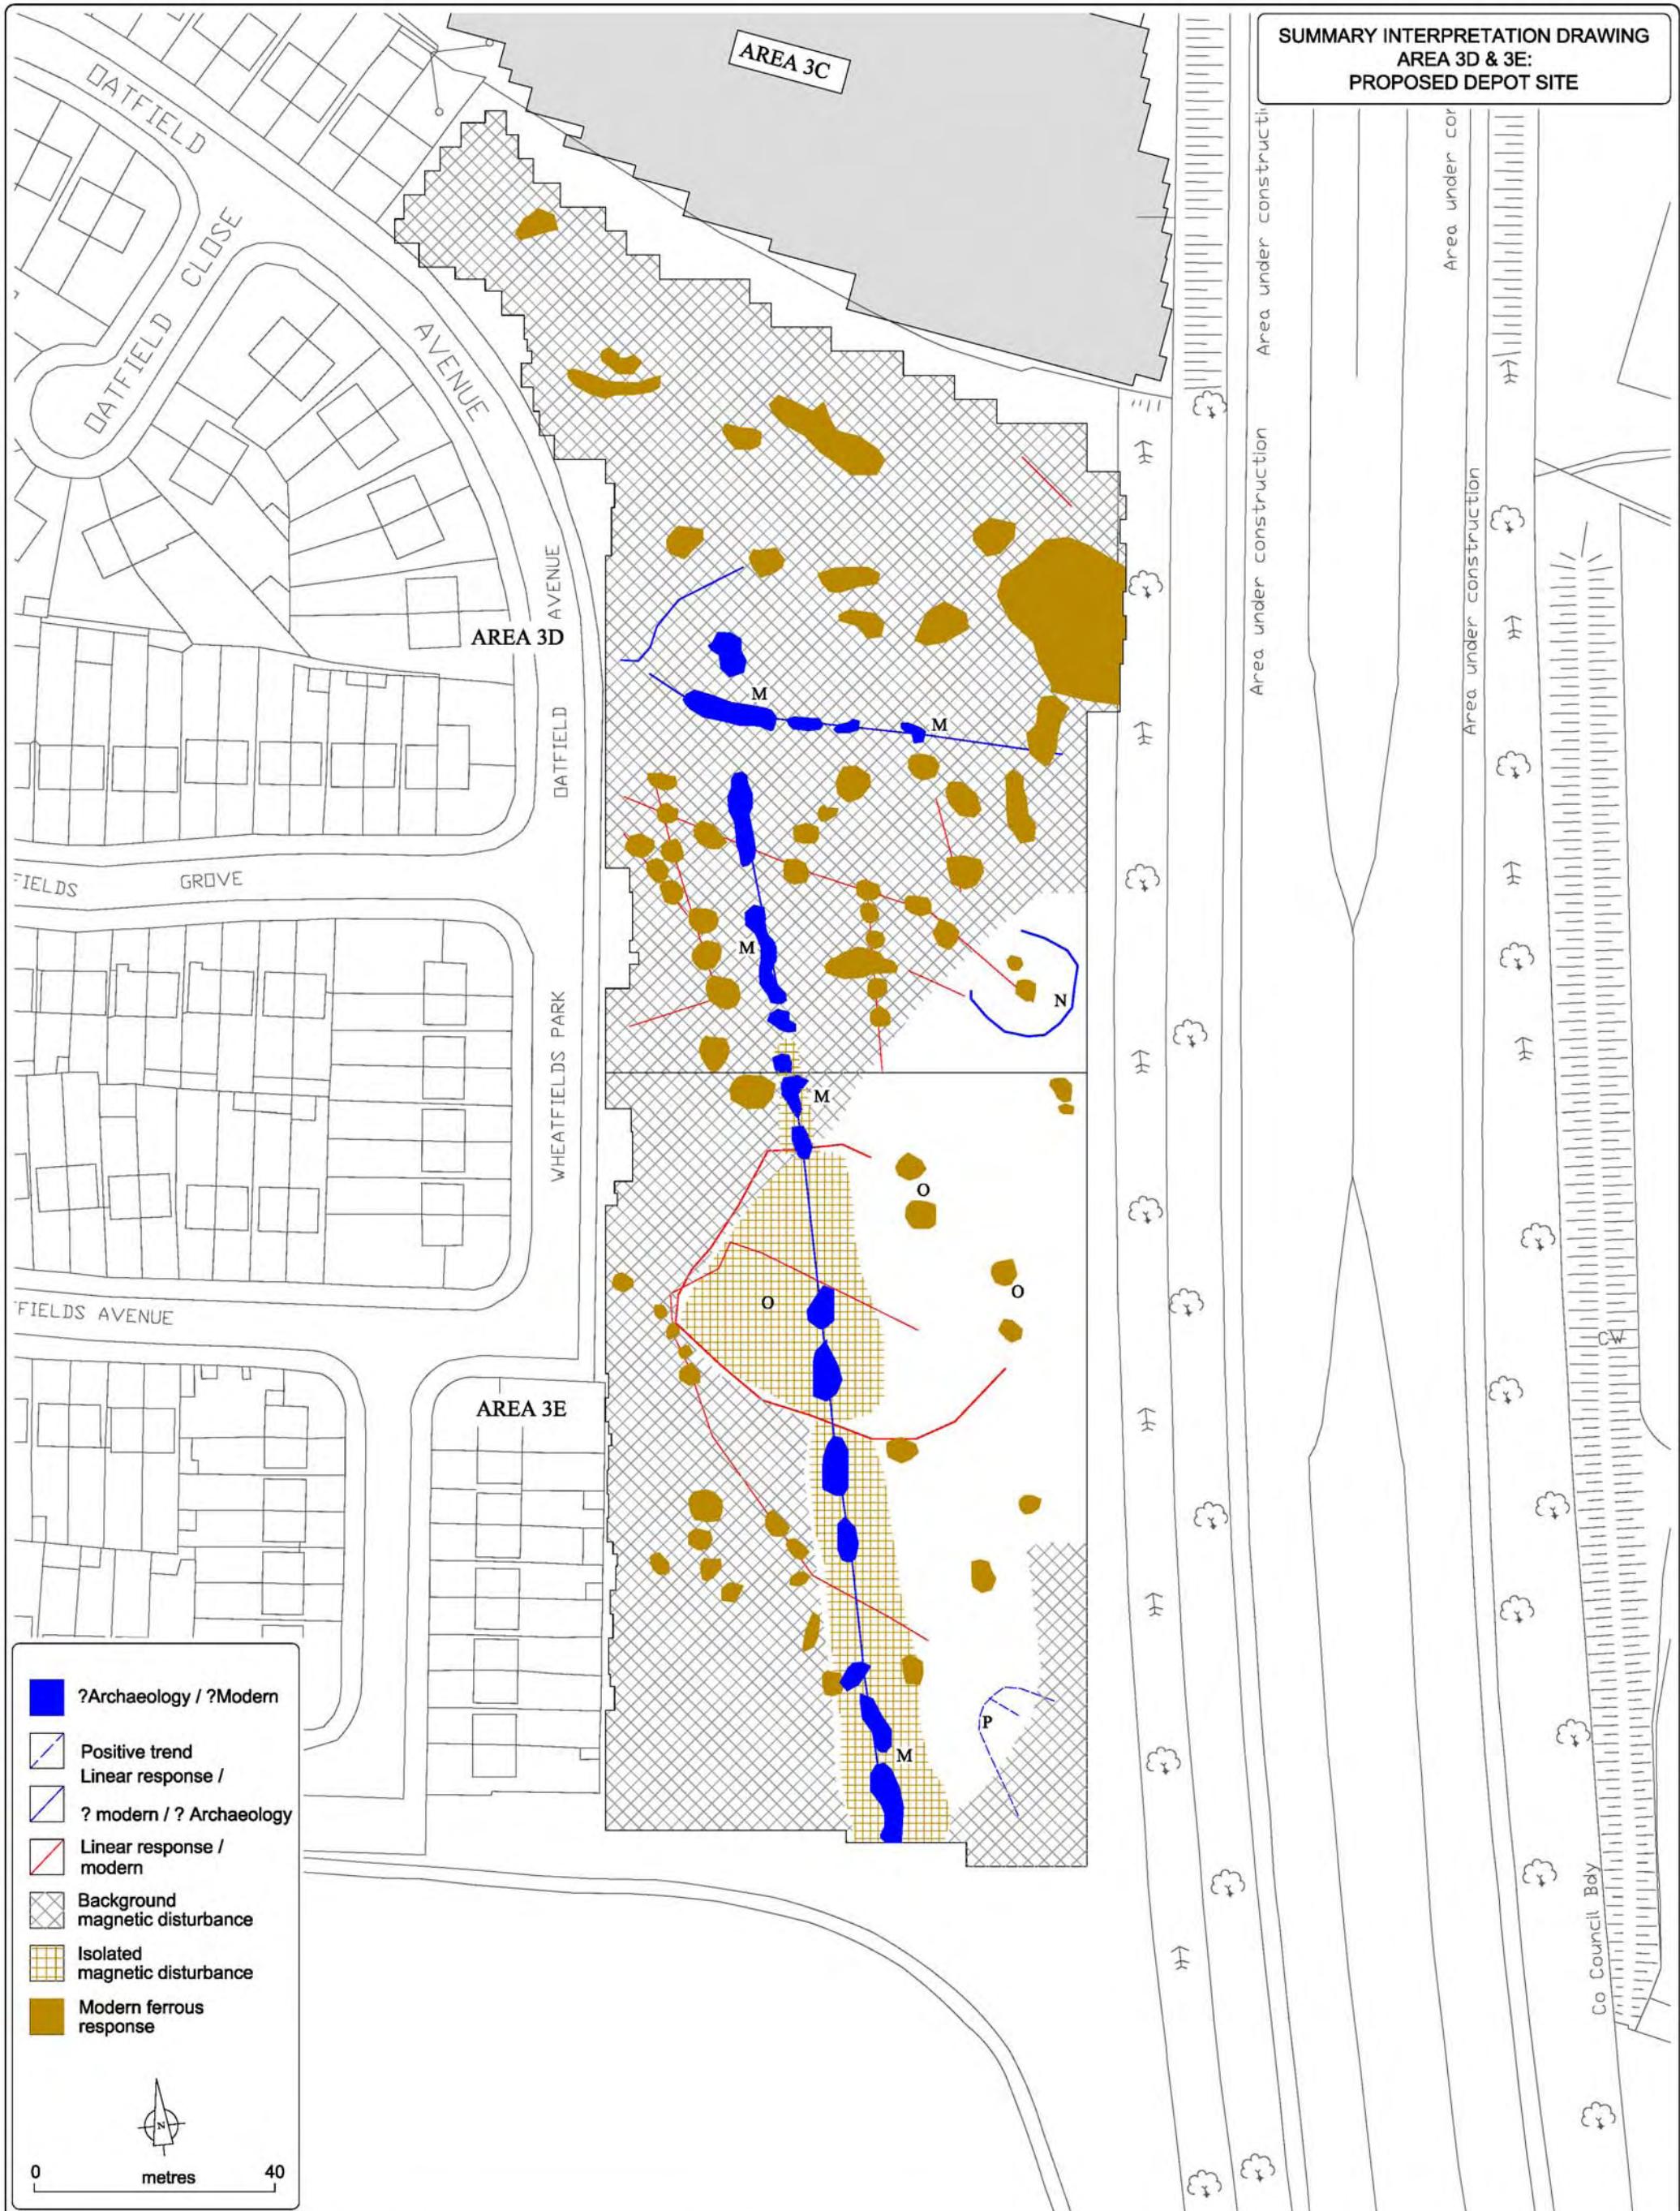
- 8.4 In the north of Area 3E, a series of ferrous responses and a spread of magnetic disturbance (O), is distinct from the background disturbance and appears to form a rectilinear pattern. This may represent a spread of modern material. The origin of the disturbance and ferrous responses is unclear, and no archaeological interpretation can be provided.

- 8.5 In the south-east of Area 3E a curvilinear trend (P) is barely discernable from the broad background magnetic disturbance. Although the response is of potential interest, there is no clear archaeological pattern. It is likely that the response represents landscaping in this area. The curvilinear trend is of limited archaeological potential.

- 9.7 In the south-east of Area 3D a sub-circular response of c.17m diameter is discernable in the data. Interpretation is cautious due to the modern background disturbance. However, that shape and form of the response is of archaeological potential. A ditched feature may be represented here.
- 9.8 The gradiometer survey has highlighted the modern disturbance within the pre-defined survey areas. Although the magnetic disturbance would mask any subtle archaeological responses, some areas of potential interest were identified and further archaeological investigation of the responses can be considered.
