Geophysical Survey Report

**Metro North
Bellinstown to St Stephens Green, Dublin**

Licence No. 08R0117

For
Railway Procurement Agency

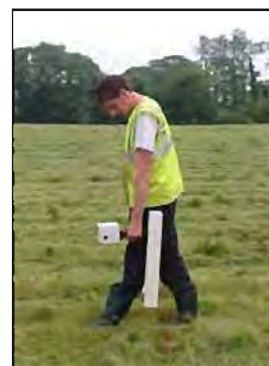
Geoscan FM36

The FM36 gradiometer operates with two sensors, at constant 0.5m vertical separation. The near surface variations within the vertical component of the earth's magnetic field are measured. Mounted to an ST1 sample trigger the instrument is used in reconnaissance and detailed modes. For detailed survey, data are recorded at virtual fixed sample intervals of 0.25m or 0.5m along 1m traverses, giving 800 or 1600 readings per 20m x 20m grid.

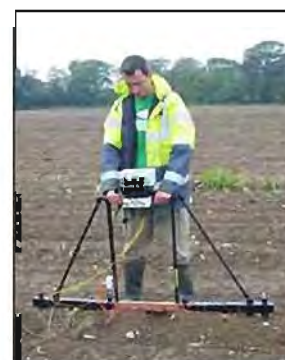
The mobile electrodes (one current and one potential, usually 1m apart) are mounted on a survey frame and connected to a Geoscan RM15 resistance meter, which records the specific resistance of the soil (measured in ohms).

The resistance meter is connected to the pair of remote probes (one current and one potential), which remain in a fixed location. Data are collected as the survey frame and mobile probes reach each designated sample interval. Surveys are usually undertaken at 1 m sample intervals along 1 m traverses (i.e., 400 readings per 20m x 20m grid. The adaptability of the instrument enables increased sampling intervals, as well as a range of probe separations and arrays to operate at varying depth penetration.

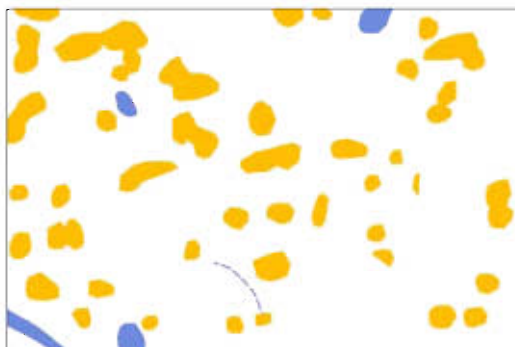
G84: XY-TRACE, DOT DENSITY PLOT & INTERPRETATION

- 6.15 A curvilinear response within AS52 (G84) corresponds to the townland boundary between Hampstead South and Drishoge. Given the curving nature of the response an archaeological interpretation should be considered. Test trench excavation is recommended
- 6.16 Isolated pit-type responses have been identified within Area AS49 (G79), AS50 (G82) and AS52 (G83). These responses may represent ephemeral or plough-damaged archaeological remains and test trench excavation should be undertaken to investigate.

- 5.74 Areas of modern magnetic disturbance have been identified throughout the datasets. Disturbance within the south of (G80 and G81) results from nearby goalposts whilst a broad area of magnetic disturbance within the west of (G82) is thought to originate from a modern service pipe at this location. Isolated areas of magnetic disturbance within areas (G81 and G82) are thought to relate to larger ferrous objects within topsoil and an area of magnetic disturbance towards the north of (G84) is caused by ferrous material within an adjacent boundary.

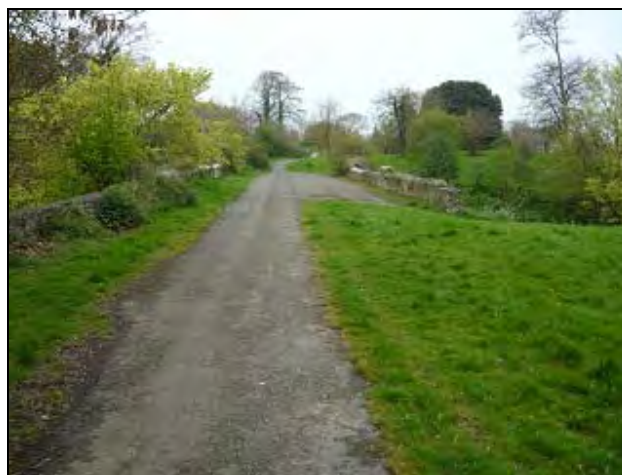
Photograph One: Site at Lissenhall Bridge

The survey area is approximately 78 by 12 square meters and has been surveyed in to the Irish National Grid using a Trimble RTK GPS system. The presence of vegetation and street furniture (bench) at the site limited the GPR data coverage in some locations within the survey area. These areas are marked on dwg ref 09460_C1 as not surveyed by GPR.

Only one arch, which is partially visible on the west side of Lissenhall Bridge, has been clearly identified on the GPR data even though the presence of underground utility right above it affected the structure response. However, on the southeast side of Lissenhall bridge a linear anomaly is clearly visible and extend towards Balheary bridge over a distance of approximately 30m and it disappears as the embankment material rises over the old road level .This is interpreted as the response of the old road wall or its foundations and that could suggest a continuous bridge structure within the survey area.

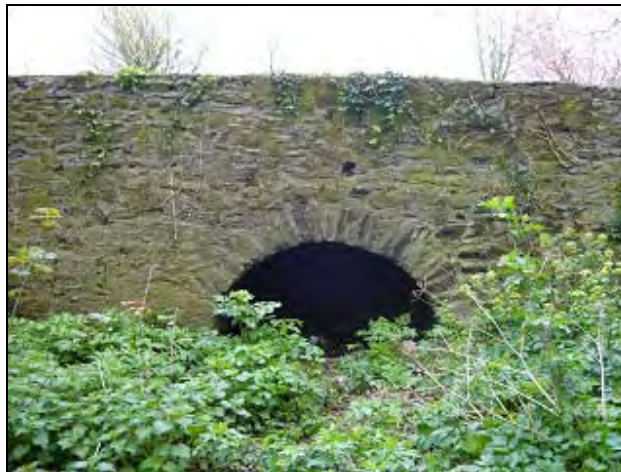
Photograph Two: Visible arch on West side of Lissenhall Bridge
