**UNDERWATER ARCHAEOLOGICAL ASSESSMENT
METRO NORTH PROJECT**

**BROADMEADOW RIVER, LISSENHALL BRIDGE
BALHEARY DEMESNE/ LISSENHALL GREAT,
SWORDS, CO. DUBLIN
08D093, 08R311**

**WARD RIVER, BALHEARY BRIDGE
BALHEARY DEMESNE, SWORDS, CO. DUBLIN
08D092, 08R312**

20 April 2009

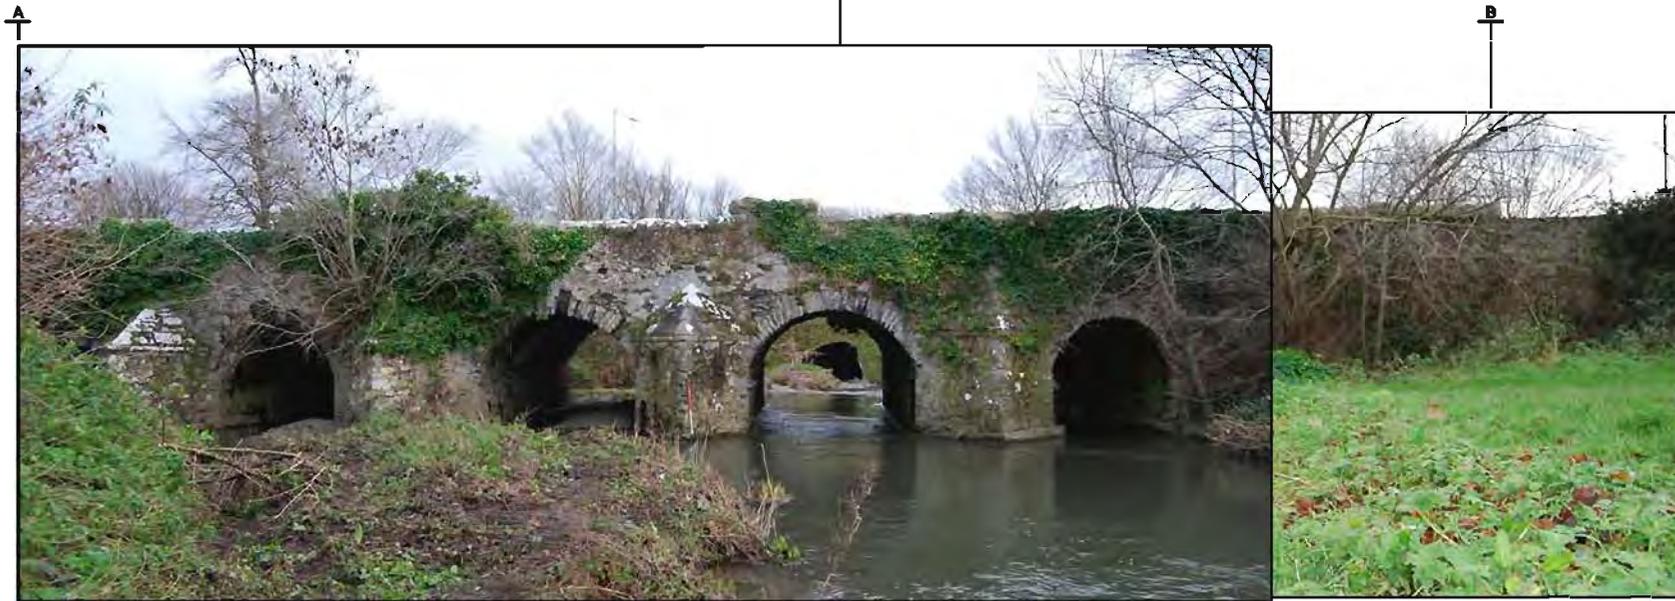
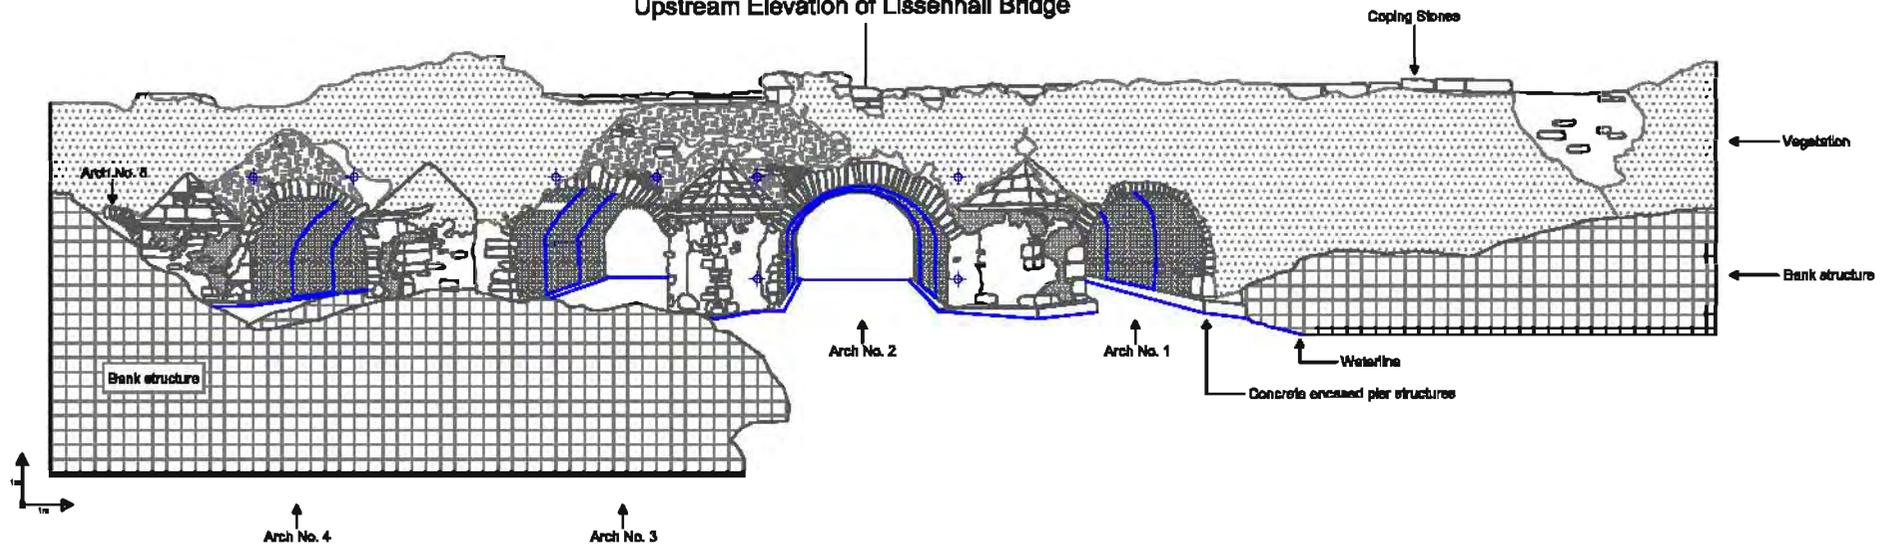
Upstream Elevation of Lissenhall Bridge

In contrast, a degree of riverbed scouring is taking place along the upstream side of the Lissehnall Bridge, across a 10m north-south section of riverbed running between the northern flood plain and southern bank structure. This scouring has dropped the river level by c.0.69m and has exposed a large section of poured mass-concrete placed to underpin the foundations of Lissehall Bridge. The concrete is visible extending from the base of the southern bank for a distance of 9.7m before disappearing into the riverbed, along the northern side of Arch number 2. Timber shuttering, running north-south between two iron I-beams, was encountered along the western extent of the concrete area (Figure 12). These elements represent the residue of a cofferdam placed to allow access to the bridge foundations and the placement of the concrete underpinning. A maximum water depth of 1.3m was recorded for this section of riverbed.

Upstream Photomosaic Elevation of Lissenhall Bridge

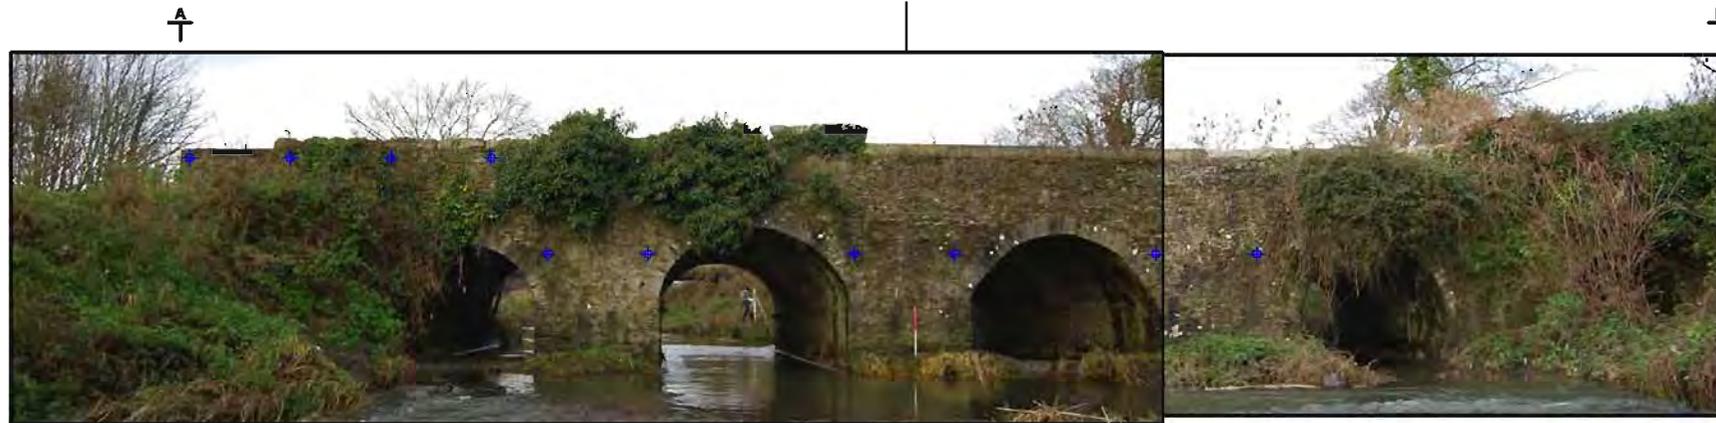
Downstream Photomosaic elevation of Lissenhall Bridge

Title
 Figure 17- Photomosaic and Drawn
 Elevation of Upstream side of Lissenhall
 Bridge (Feature 1).

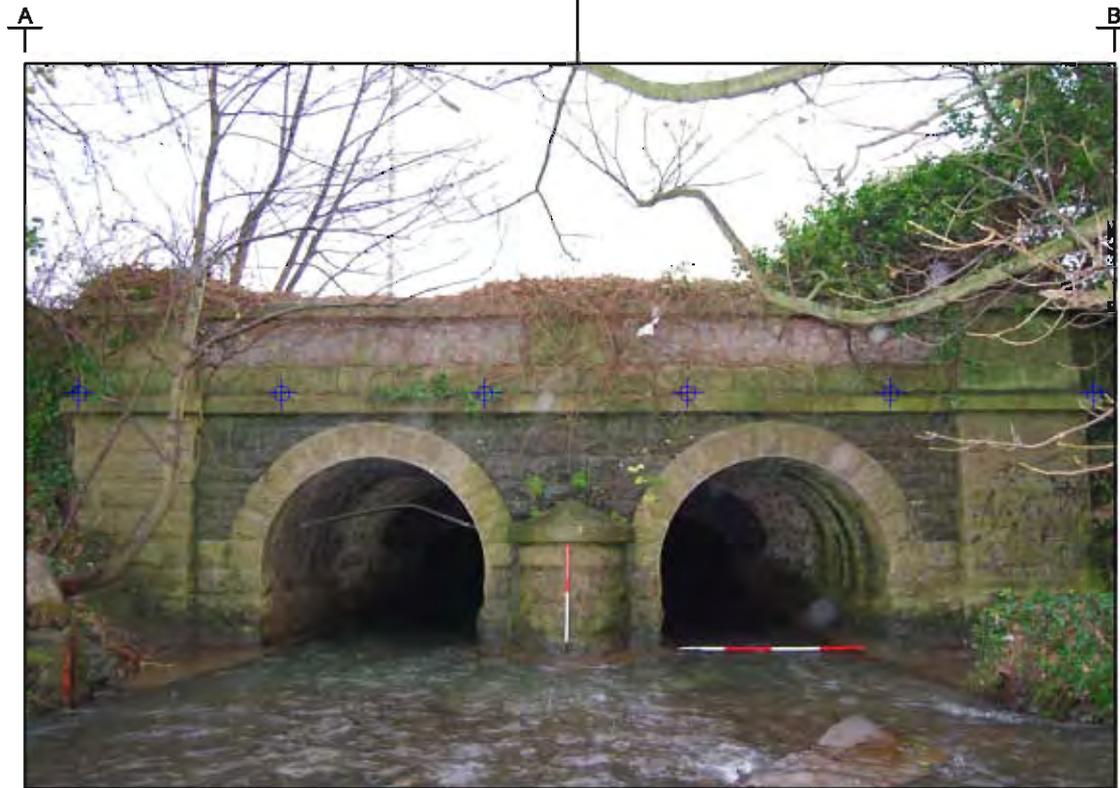
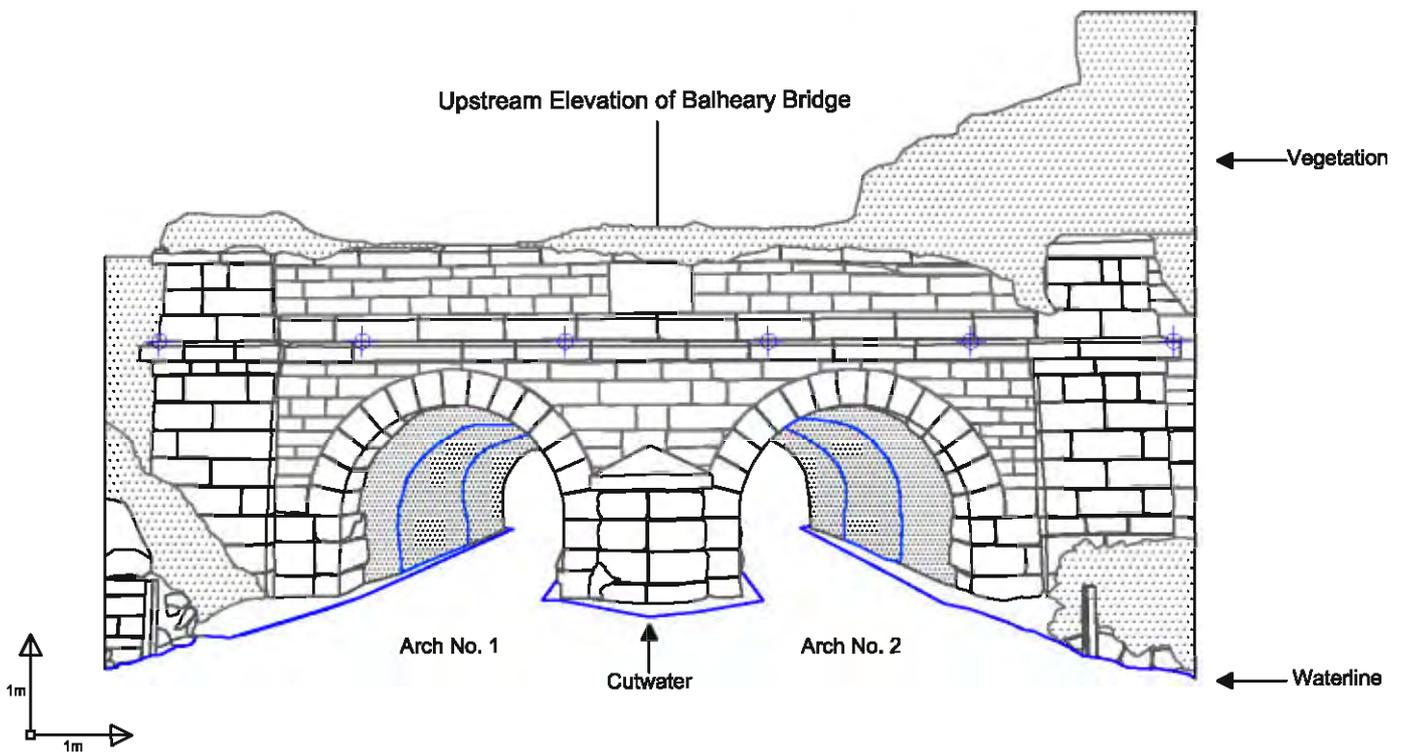
Upstream Elevation of Balheary Bridge

The upstream (east) side of Balheary Bridge represents a nineteenth-century replacement of the original (Phase 2) bridge extension at this location. The upstream section of bridge comprises of two archways, a semicircular cutwater, and two rectangular pillars that protrude from the façade. Granite blocks have been used to

Upstream Photographic Elevation of Balheary Bridge

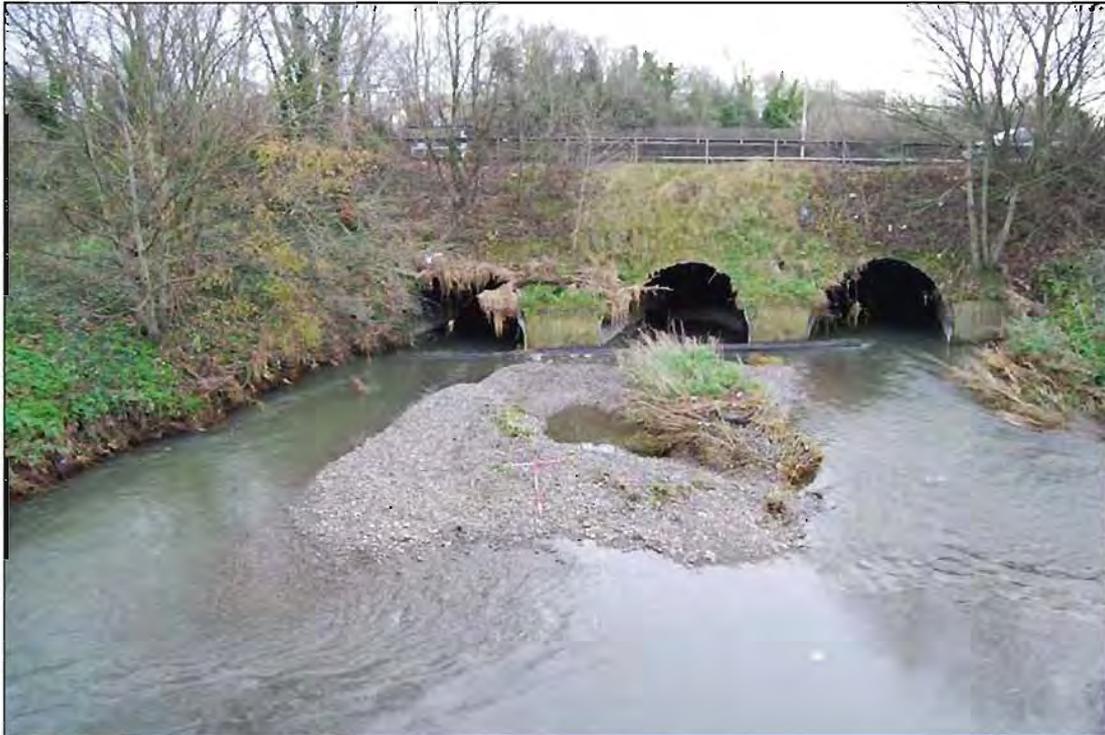
Plate 1: East-facing view of downstream side of Lissenhall Bridge showing pebble island and three-arched culvert that accommodates the N1 Link-Road (1m horizontal and 2m vertical scale).

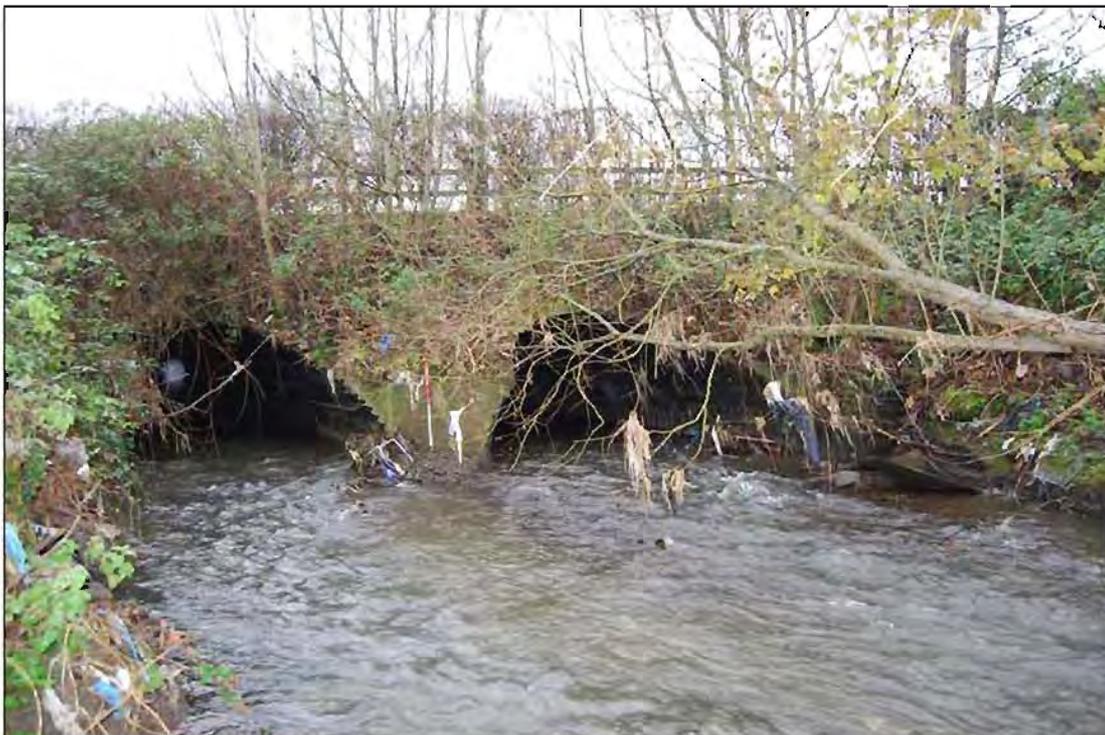
Plate 2: West-facing view of the two-arched culvert that accommodates the N1 Link-Road located on the downstream side of Balheary Bridge (1m scale).

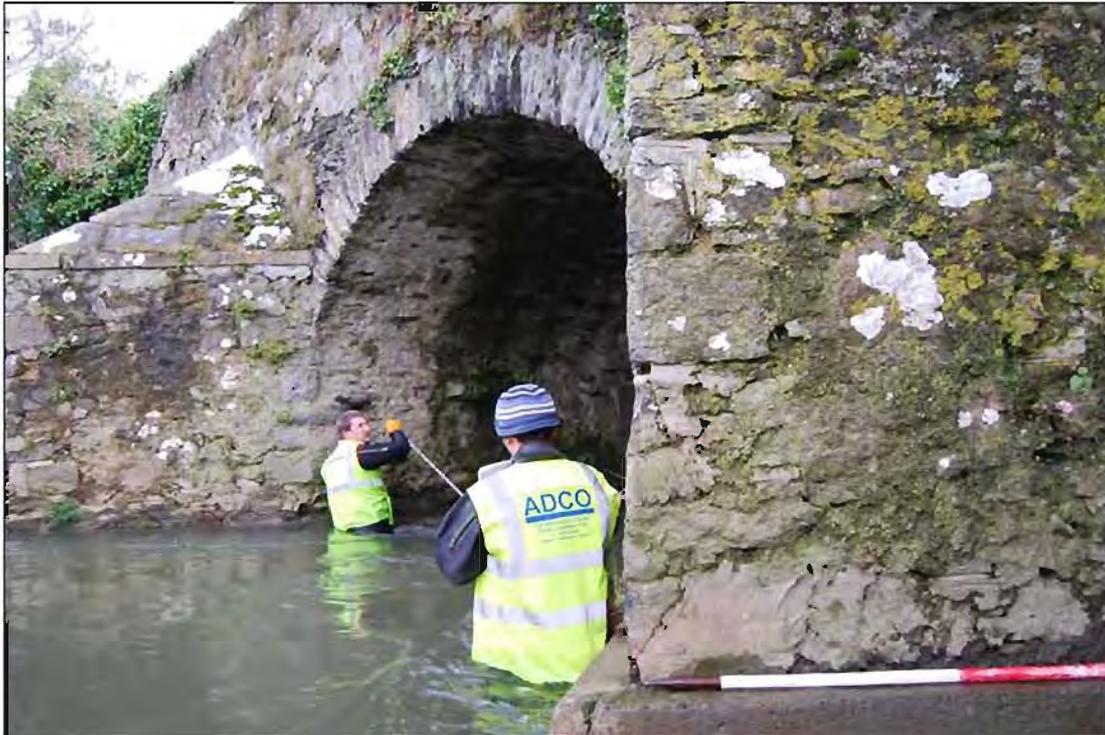
Plate 3: Working-shot of bridge recording along the upstream side of Arch No. 2, Lissenhall Bridge.

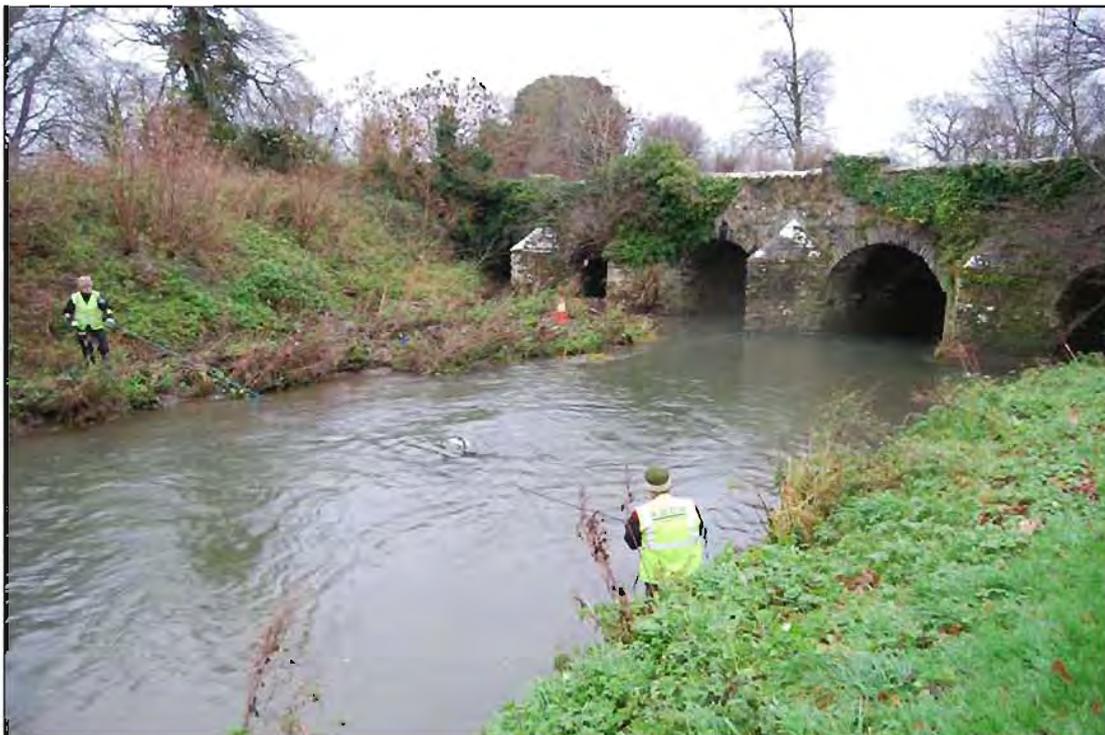
Plate 4: Working-shot of diver undertaking riverbed survey along upstream side of Lissenhall Bridge, Broadmeadow River. Note: diver tethered to counteract against river-flow.

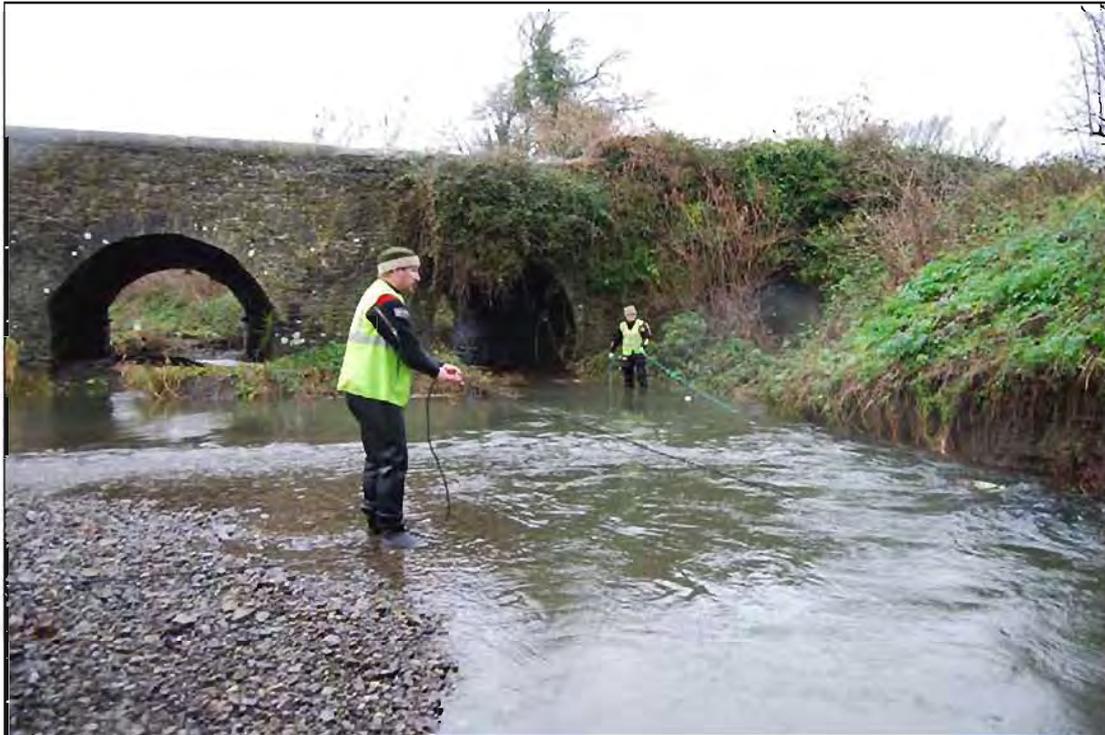
Plate 5: Working-shot of diver undertaking riverbed survey along downstream side of Lissenhall Bridge, northern flow-channel of Broadmeadow River. Note: diver tethered to counteract against river-flow.

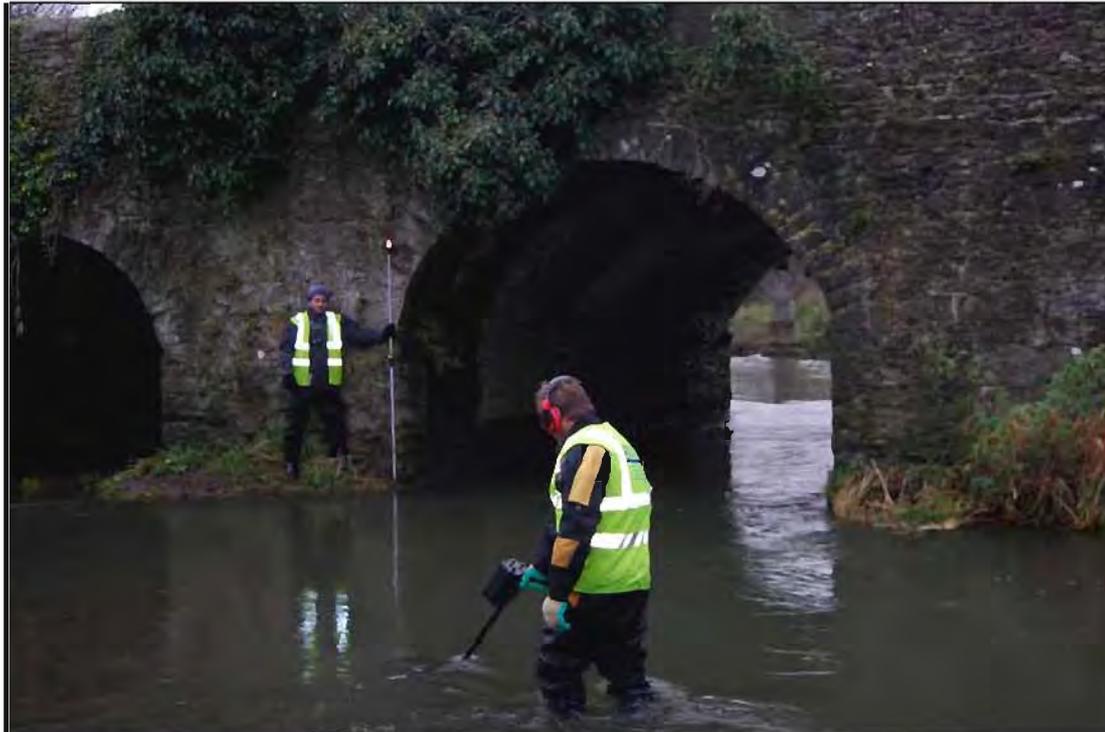
Plate 6: Working-shot of metal-detector and Station survey in progress along the downstream side of Lissenhall Bridge (Feature 1), Broadmeadow River.

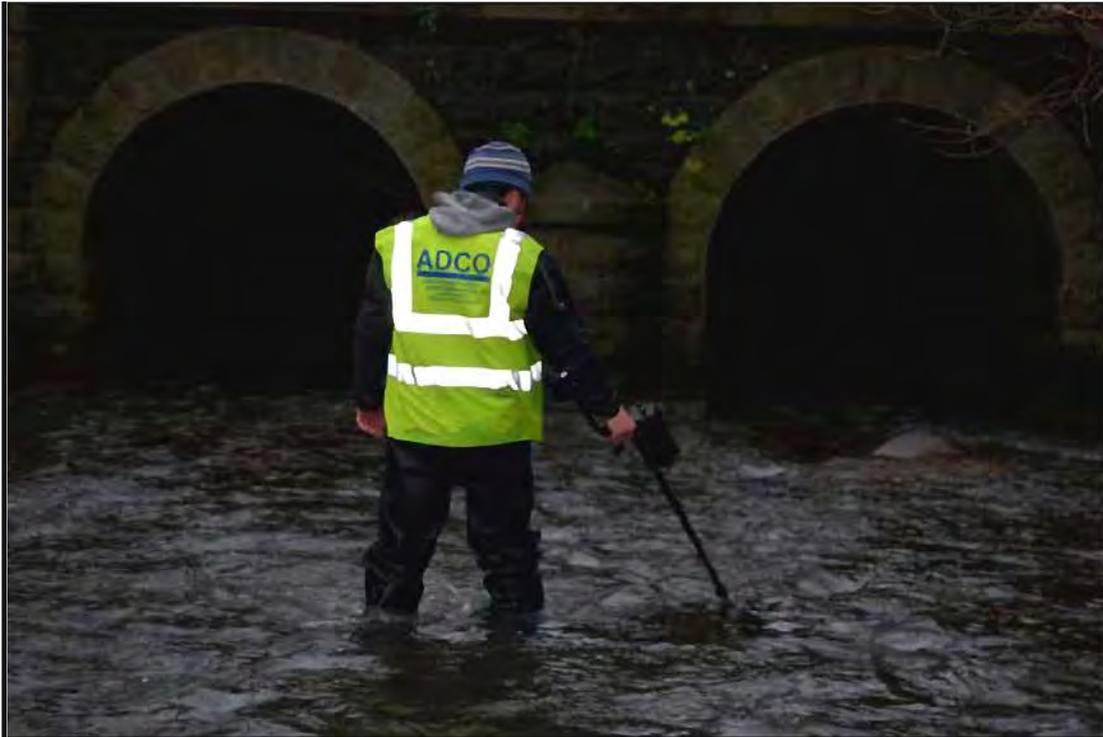
Plate 7: Working-shot of metal-detector survey undertaken across upstream side of Balheary Bridge, Ward River.

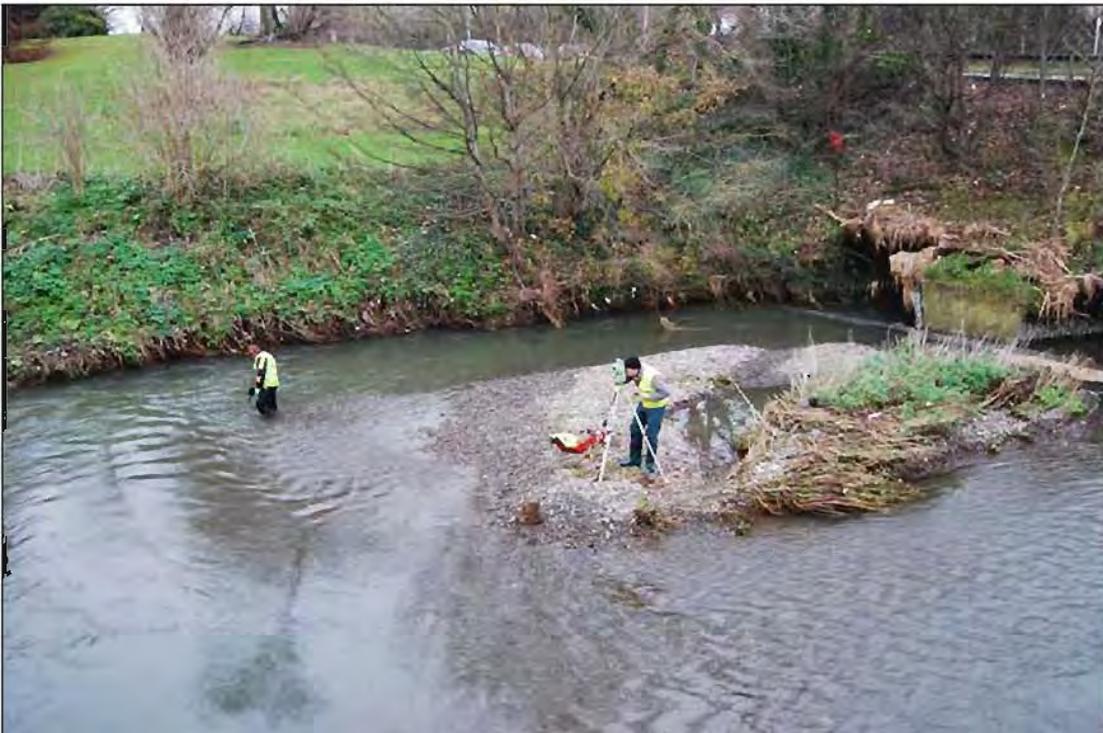
Plate 8: Working-shot of metal-detector survey and Total Station survey undertaken along downstream side of Lissenhall Bridge (Feature 1), Broadmeadow River.

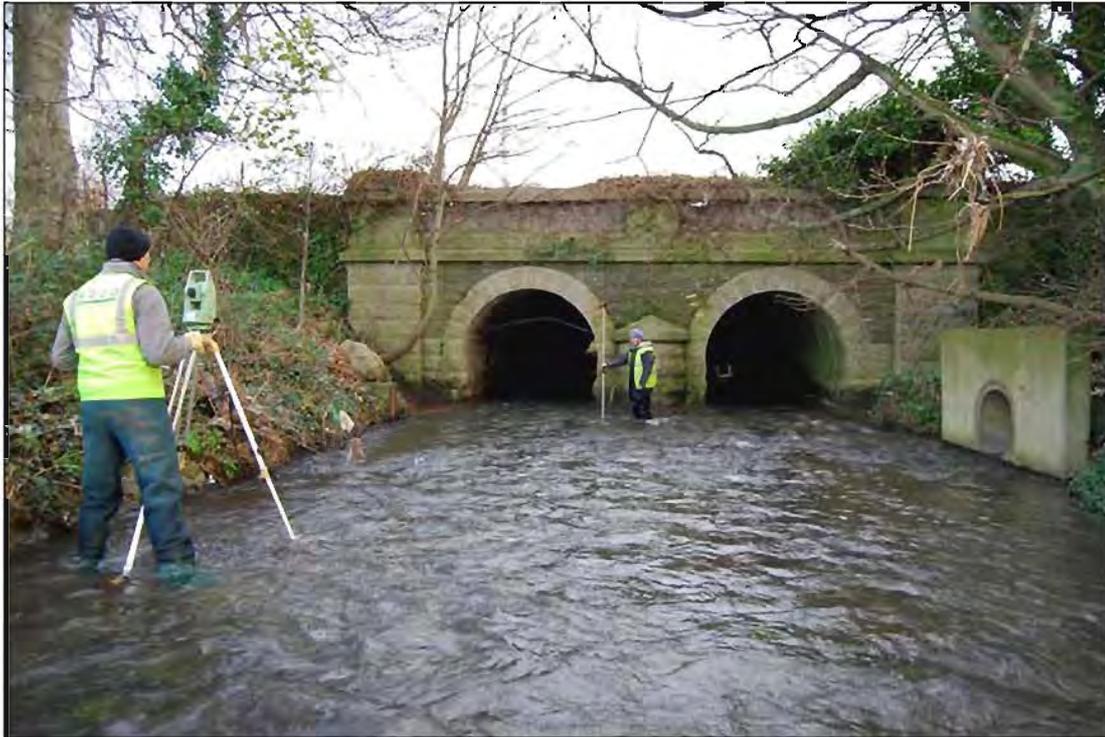
Plate 9: Working-shot of Total Station survey undertaken along upstream side of Balheary Bridge (Feature 3), Ward River.

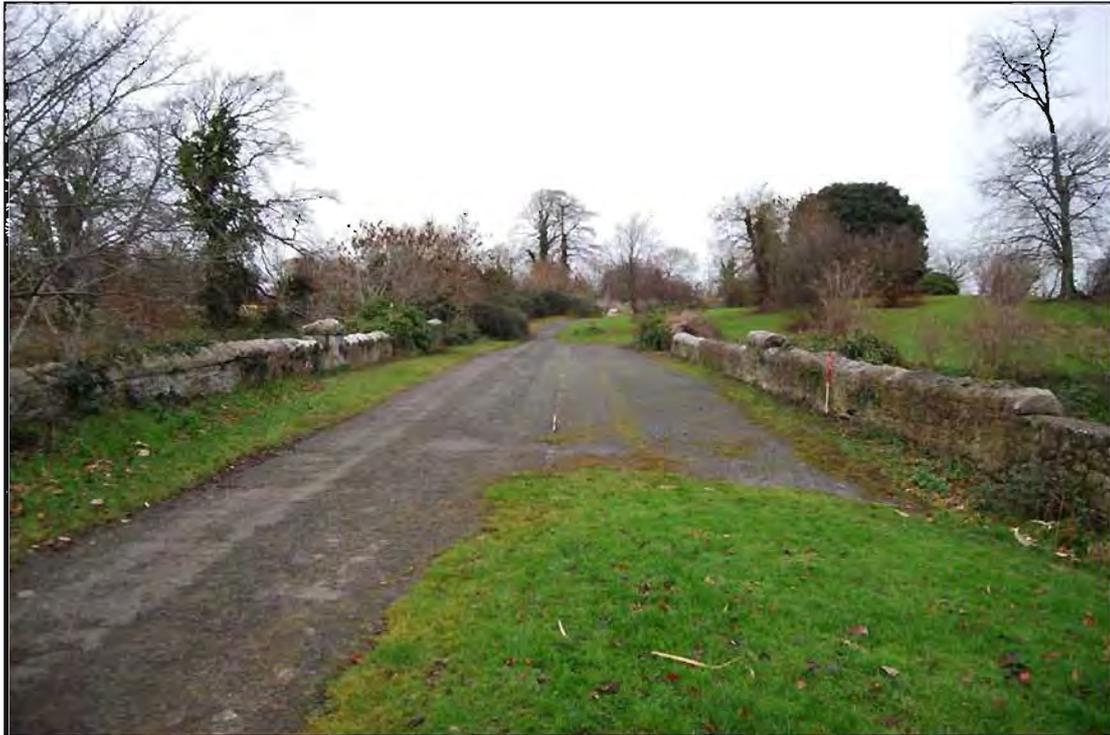
Plate 11: North-facing view of upper surface of Lissenhall Bridge (Feature 1) showing residue of tarmacadam from the R127 (1m scale).

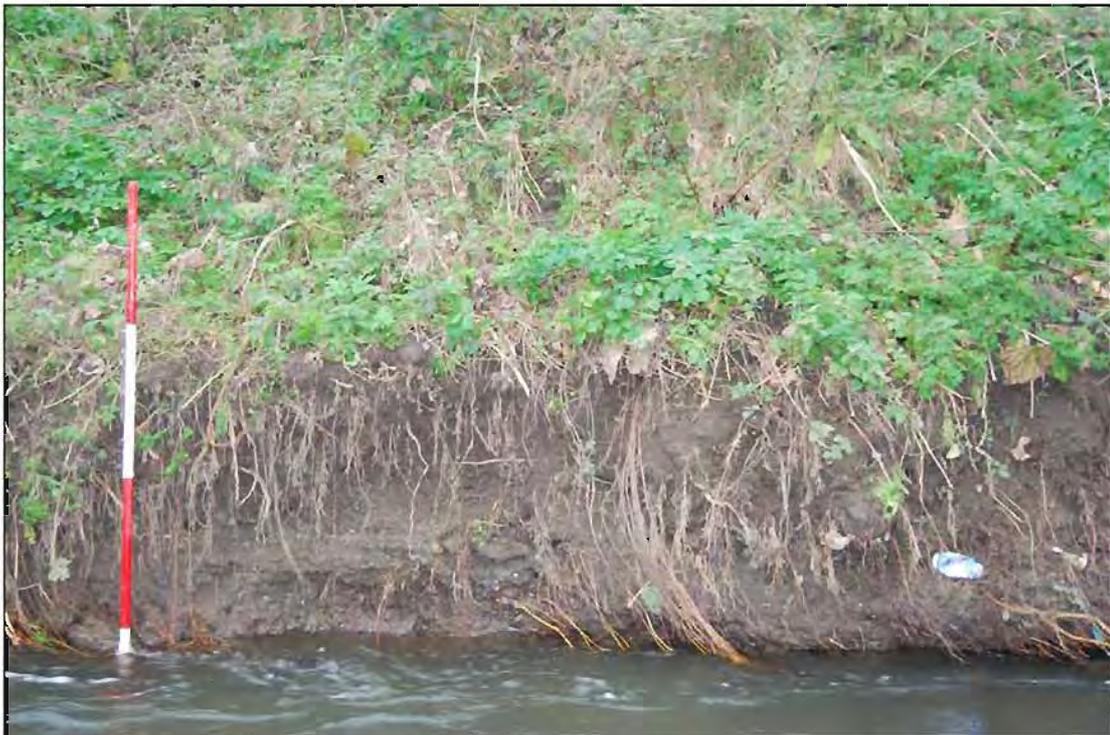
Plate 12: North-facing view of bankside erosion taking place along the base of the northern bank structure, downstream side of Lissenhall Bridge, Broadmeadow River (2m scale).

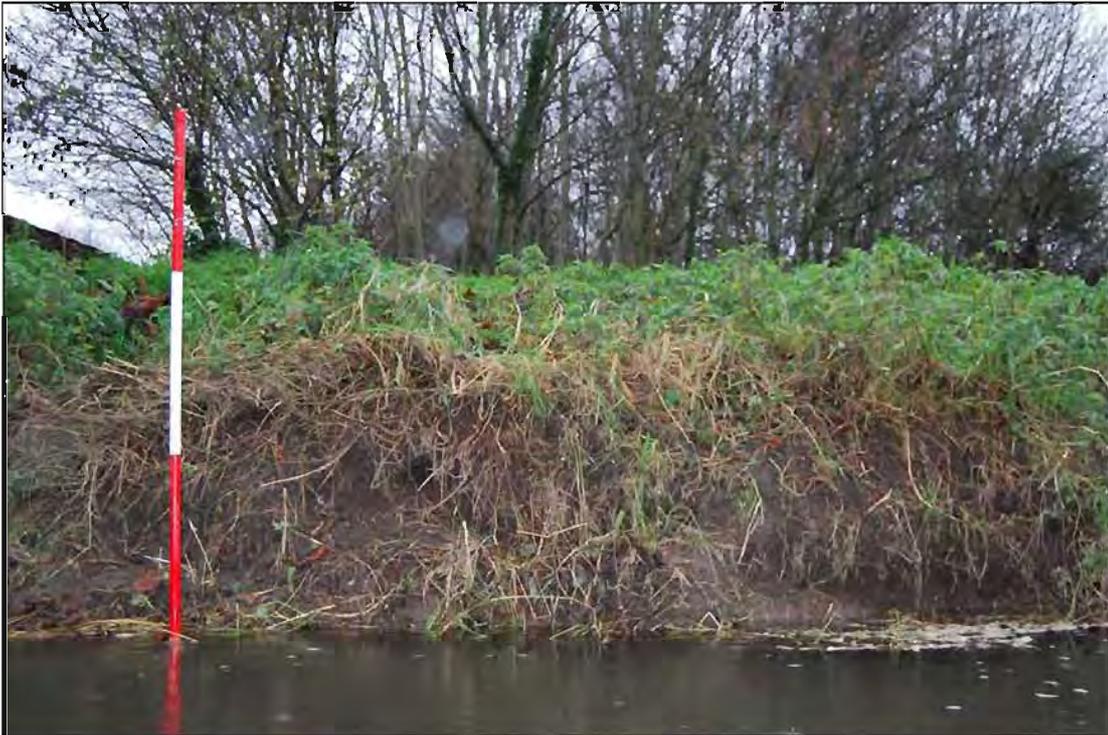
Plate 13: South-facing view of southern bank structure located along the upstream side of Lissenhall Bridge, Broadmeadow River (2m scale).

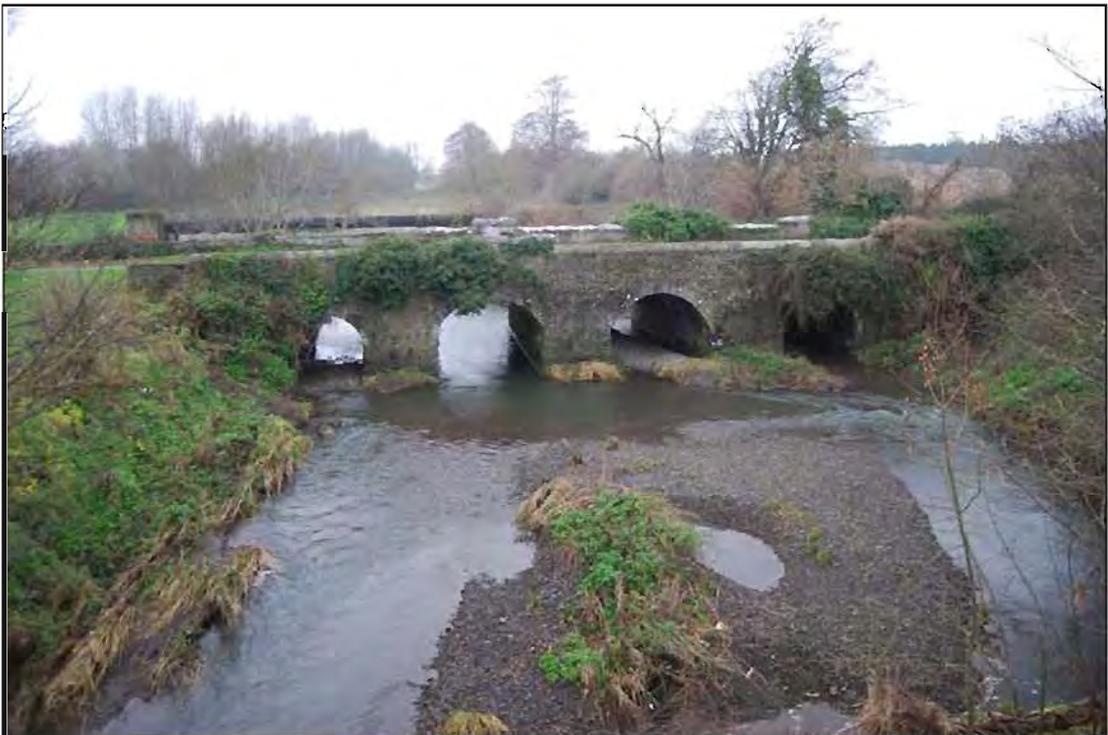
Plate 14: West-facing view of the Broadmeadow River and downstream (east) side of Lissenhall Bridge (Feature 1).

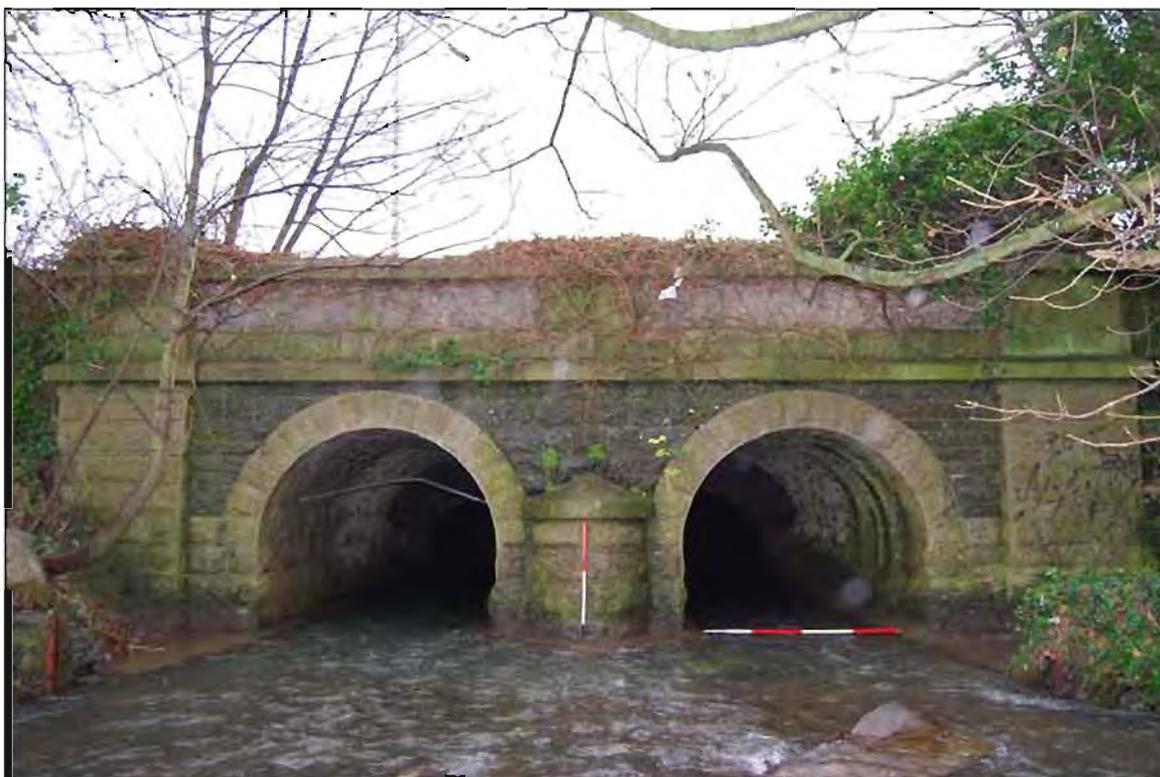
Plate 15: East-facing view of upstream (west) side of Balheary Bridge, Feature 3, Build-phase 3 (1m vertical and 2m horizontal scale).

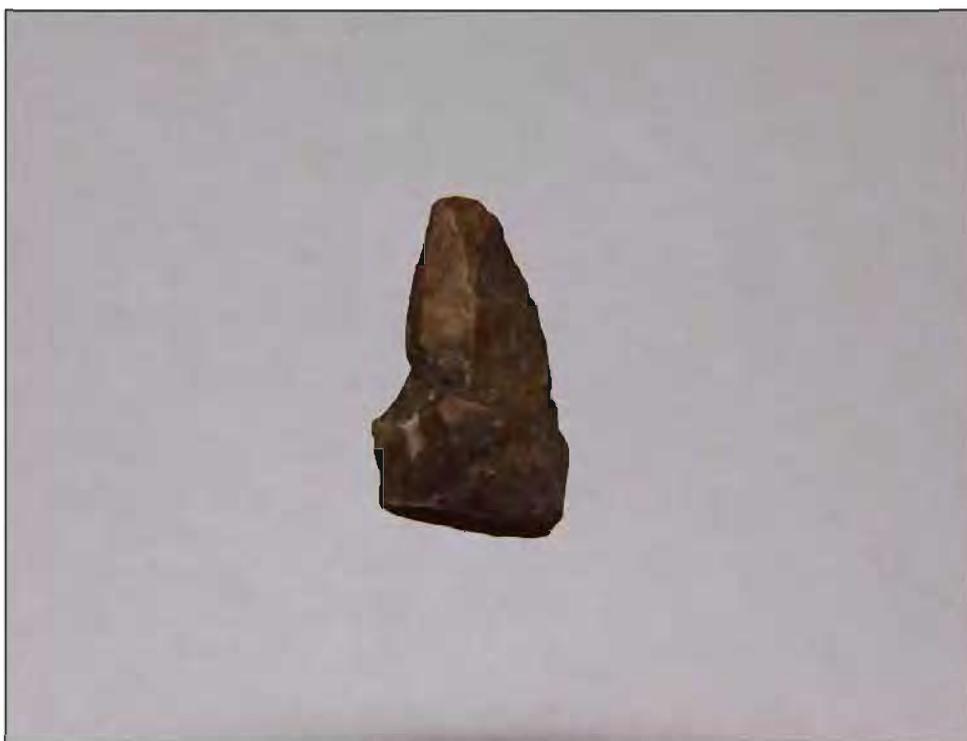
Plate 16: Detail shot of flint artefact recovered from south bank of the Ward River, find number 08D092:01. Find measures 25mm in length, 15mm in width, and between 2mm-9mm in depth.

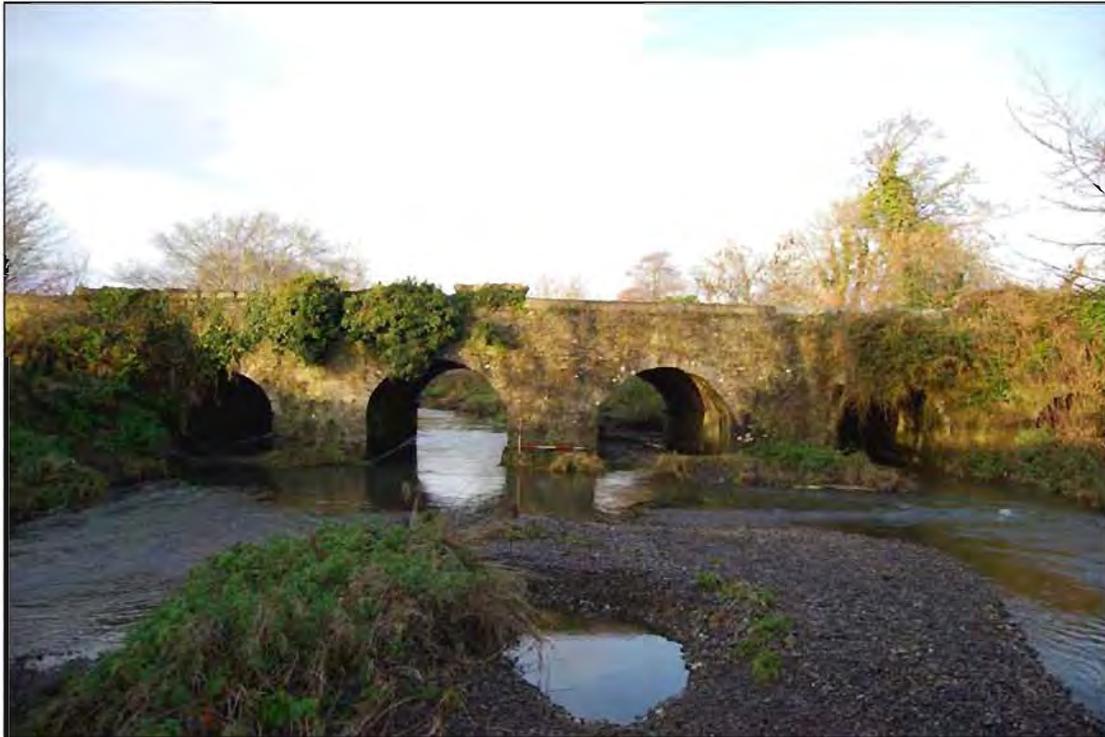
Plate 17: West-facing view of downstream side of Lissenhall Bridge, Feature 1, Build-phase 2 (1m vertical and 2m horizontal scale).

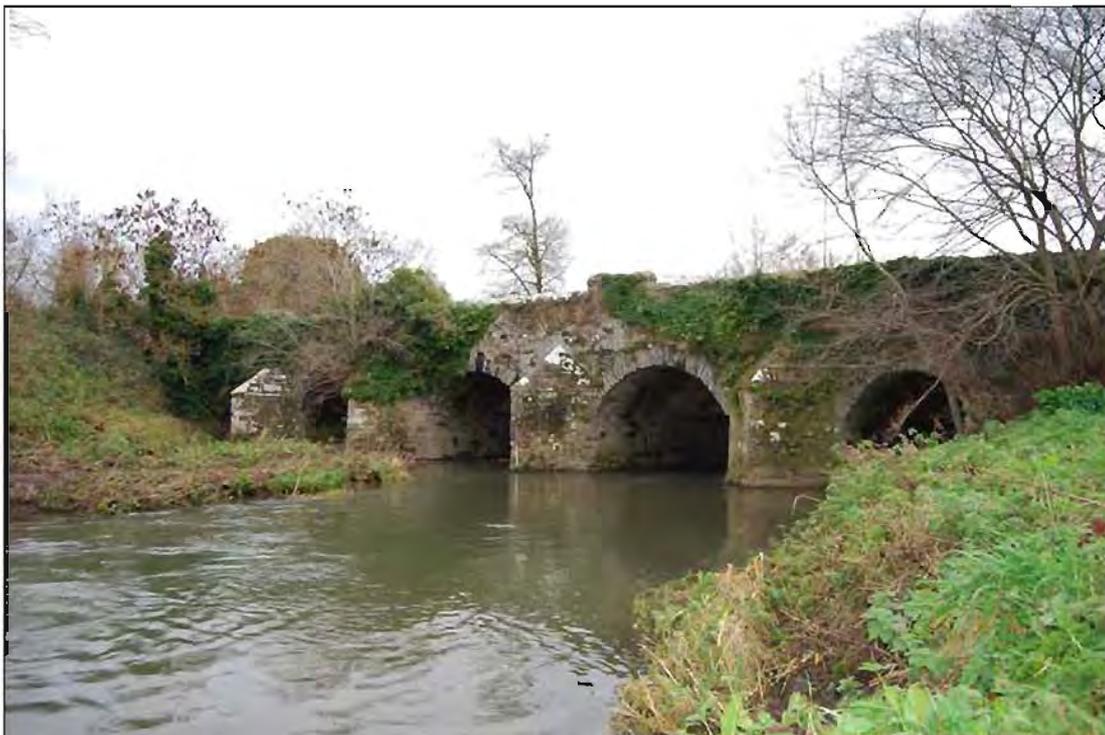
Plate 18: Northeast-facing view of upstream side of Lissenhall Bridge, Feature 1, Build-phase 2 (1m scale).

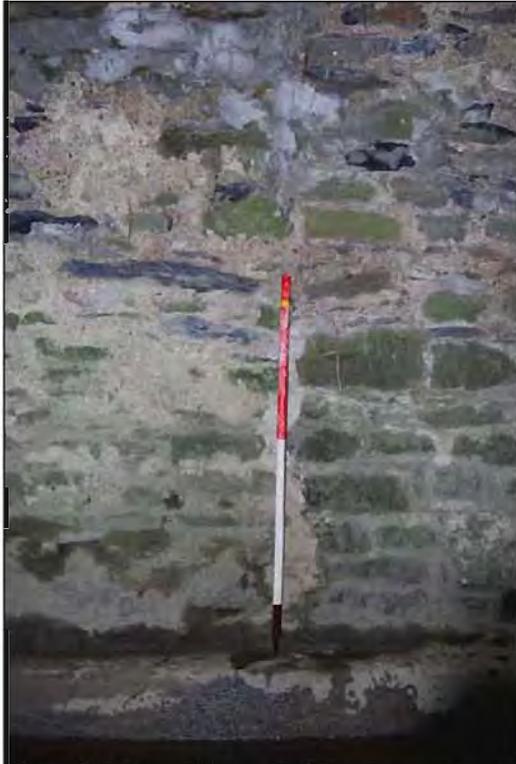
Plate 19: Transition-point between mid-section (Phase 1) and upstream section (Phase 2), south side of **Arch no. 1** (1m scale).

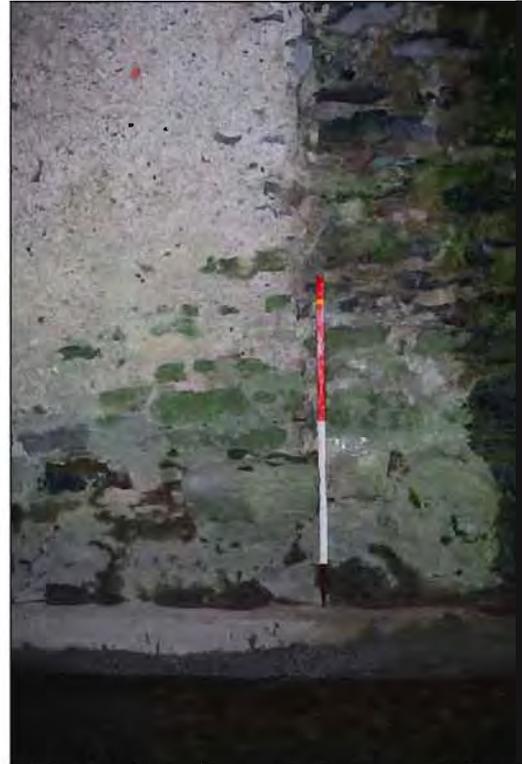
Plate 20: Transition-point between mid-section (Phase 1) and upstream section (Phase 2), north side of **Arch no. 1** (1m scale).

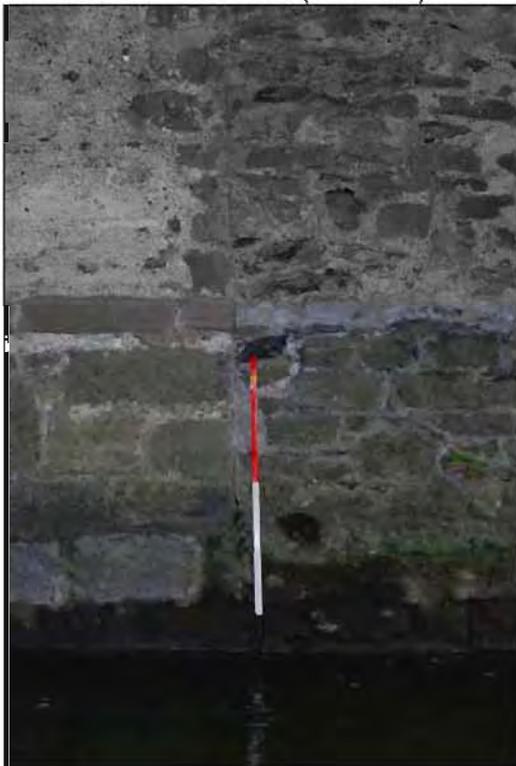
Plate 21: Transition-point between mid-section (Phase 1) and upstream section (Phase 2), south side of **Arch no. 2** (1m scale).

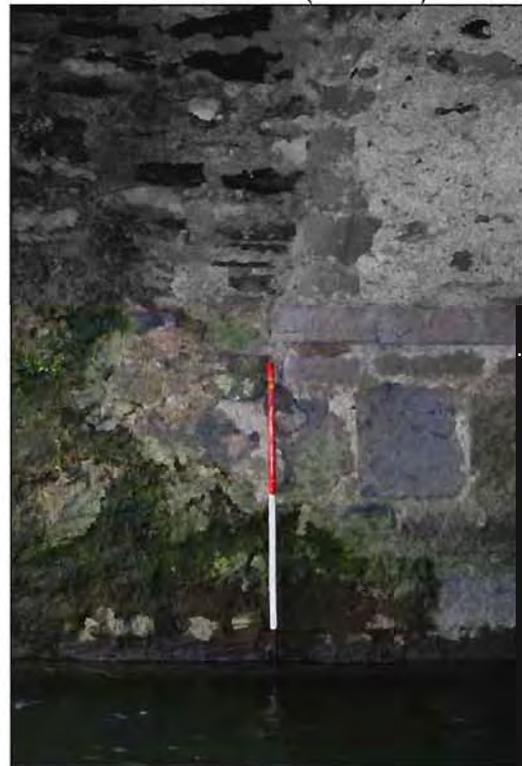
Plate 22: Transition-point between mid-section (Phase 1) and upstream section (Phase 2), north side of **Arch no. 2** (1m scale).

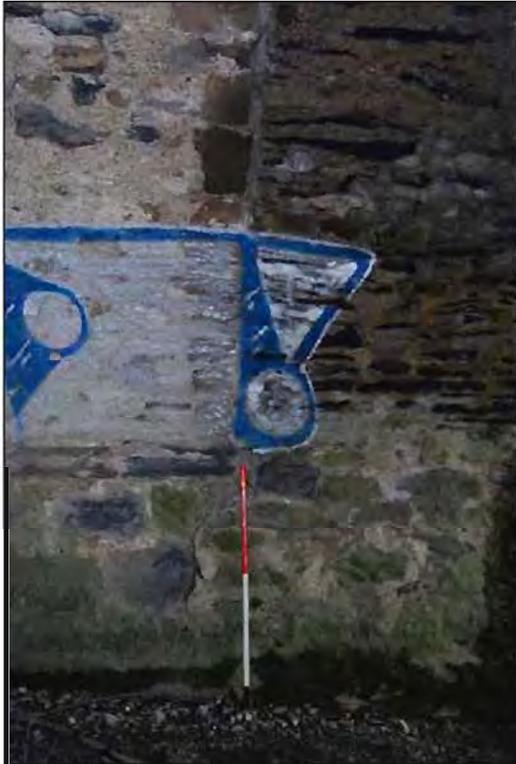
Plate 23: Transition-point between mid-section (Phase 1) and upstream section (Phase 2), south side of **Arch no. 3** (1m scale).

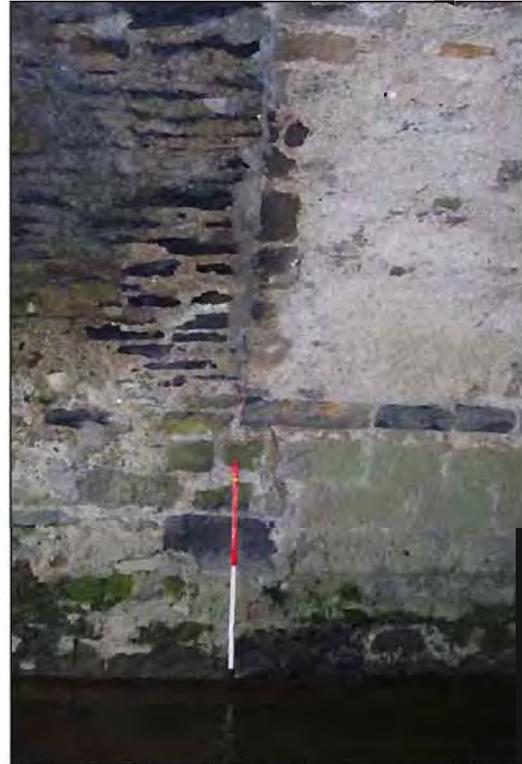
Plate 24: Transition-point between mid-section (Phase 1) and upstream section (Phase 2), north side of **Arch no. 3** (1m scale).

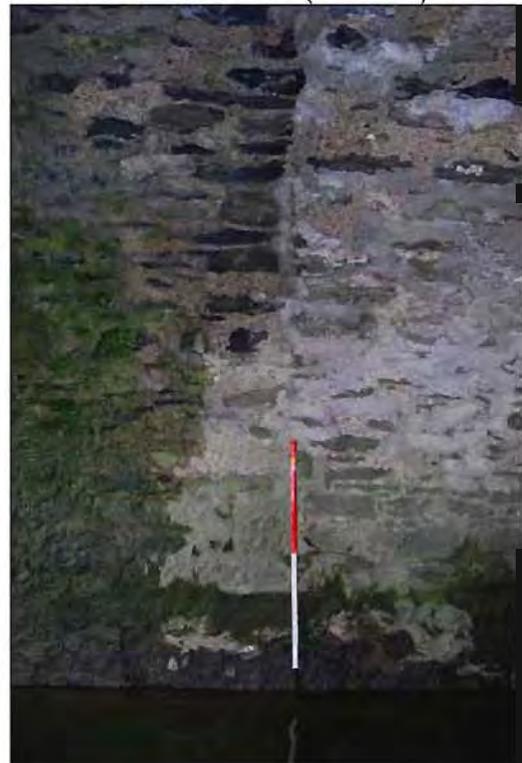
Plate 26: Transition-point between mid-section (Phase 1) and upstream section (Phase 2), north side of **Arch no. 4** (1m scale).

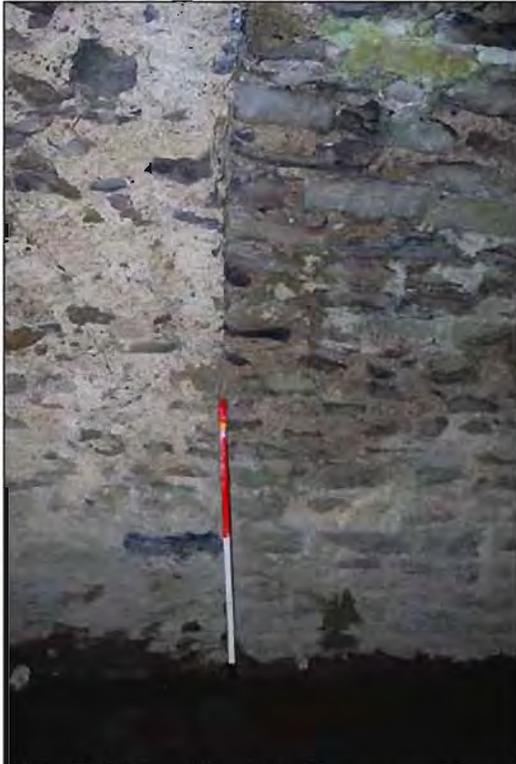
Plate 27: Transition-point between mid-section (Phase 1) and upstream section (Phase 2), south side of **Arch no. 5** (1m scale).
