**UNDERWATER ARCHAEOLOGICAL ASSESSMENT
METRO NORTH PROJECT**

**BROADMEADOW RIVER, LISSENHALL BRIDGE
BALHEARY DEMESNE/ LISSENHALL GREAT,
SWORDS, CO. DUBLIN
08D093, 08R311**

**WARD RIVER, BALHEARY BRIDGE
BALHEARY DEMESNE, SWORDS, CO. DUBLIN
08D092, 08R312**

20 April 2009

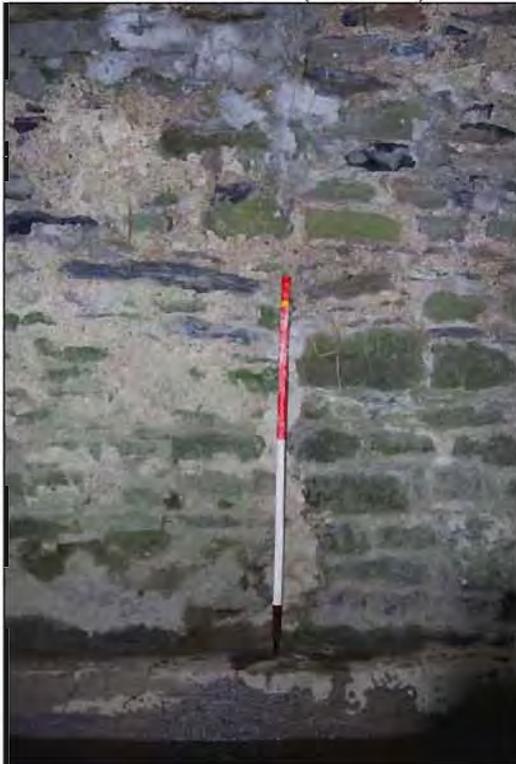
Plate 29: Transition-point between mid-section (Phase 1) and downstream section (Phase 2), south side of **Arch no. 1** (1m scale).

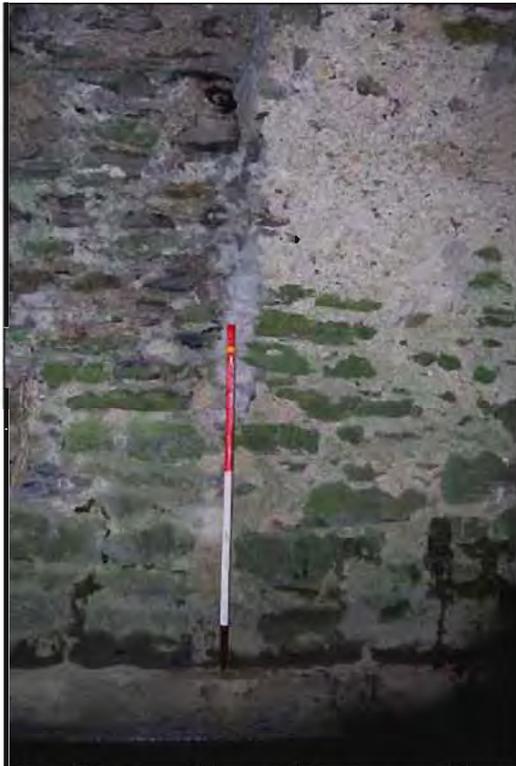
Plate 31: Transition-point between mid-section (Phase 1) and downstream section (Phase 2), south side of **Arch no. 2** (1m scale).

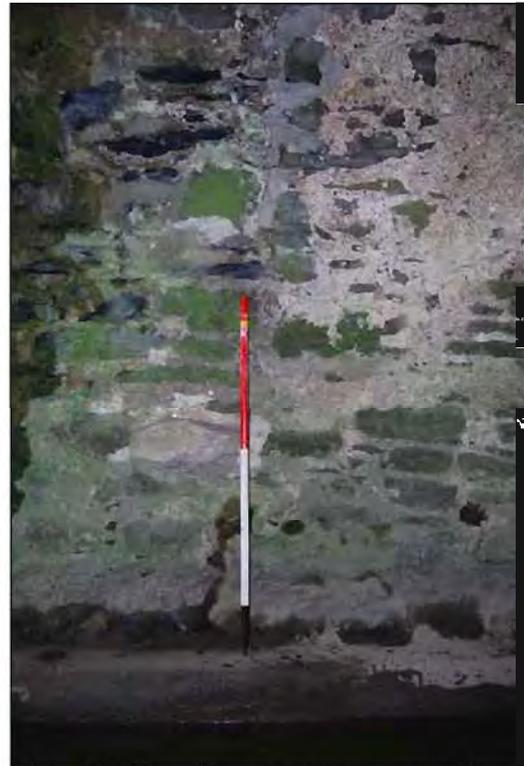
Plate 32: Transition-point between mid-section (Phase 1) and downstream section (Phase 2), north side of **Arch no. 2** (1m scale).

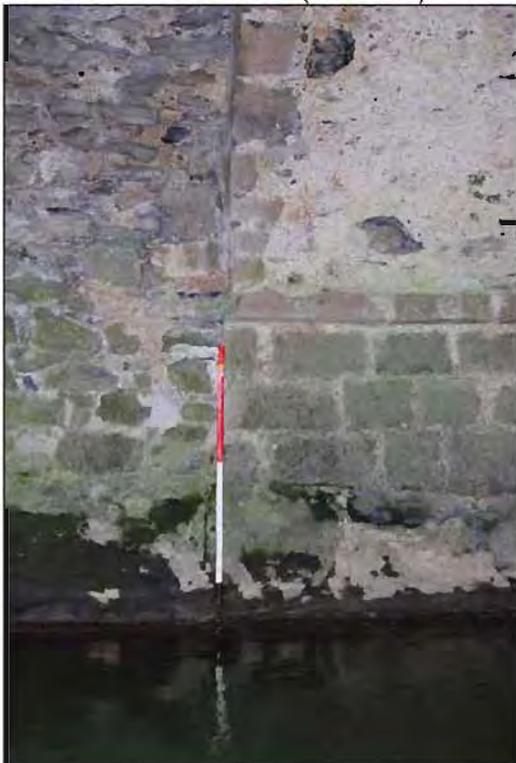
Plate 33: Transition-point between mid-section (Phase 1) and downstream section (Phase 2), south side of **Arch no. 3** (1m scale).

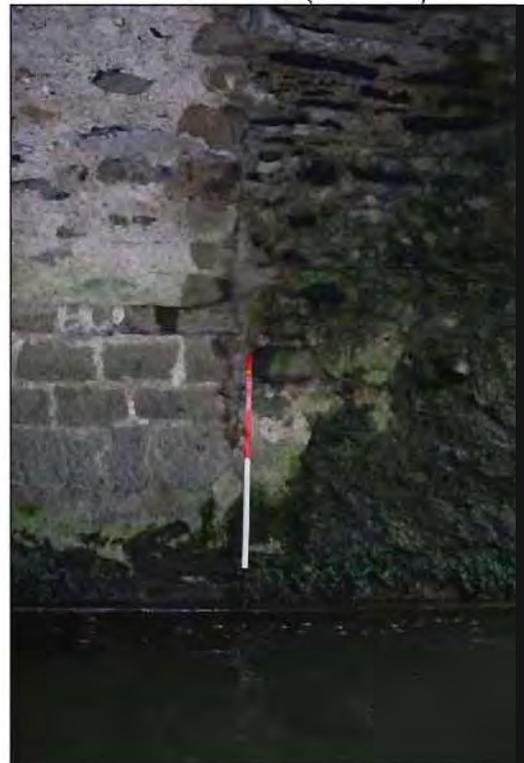
Plate 34: Transition-point between mid-section (Phase 1) and downstream section (Phase 2), north side of **Arch no. 3** (1m scale).

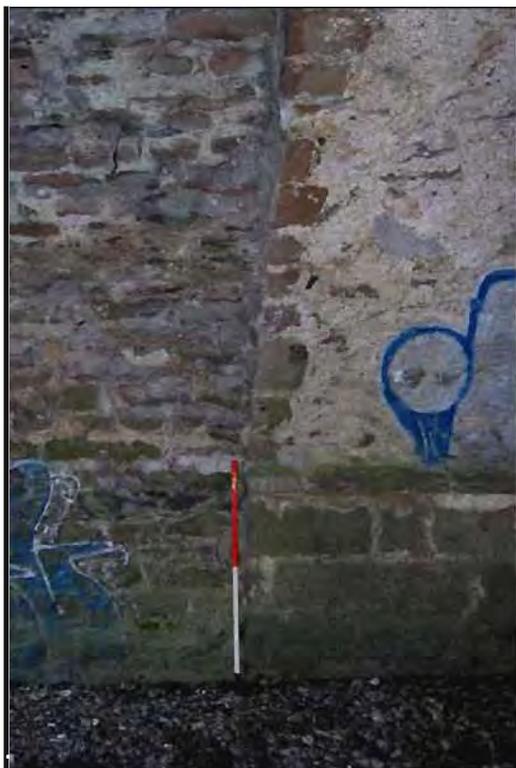
Plate 35: Transition-point between mid-section (Phase 1) and downstream section (Phase 2), south side of Arch no. 4 (1m scale).

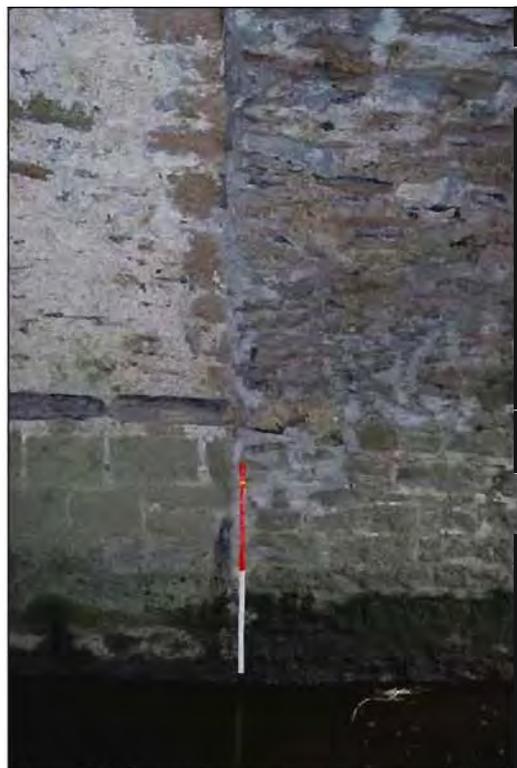
Plate 36: Transition-point between mid-section (Phase 1) and downstream section (Phase 2), north side of Arch no. 4 (1m scale).

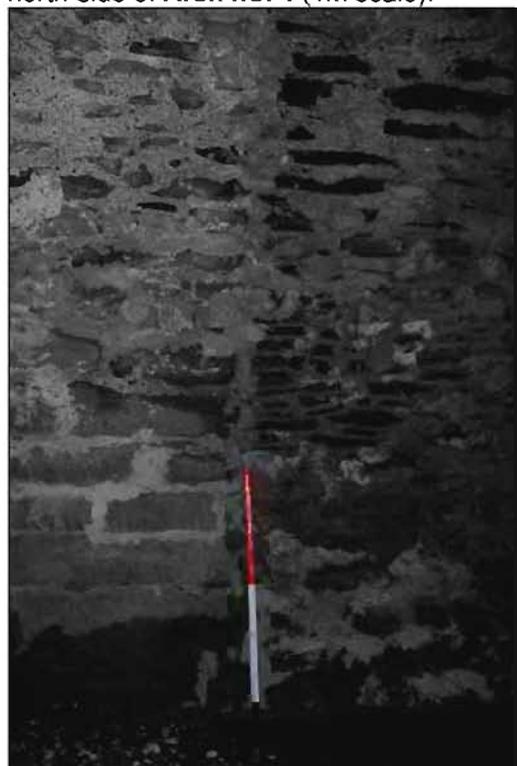
Plate 38: Transition-point between mid-section (Phase 1) and downstream section (Phase 2), north side of Arch no. 5 (1m scale).

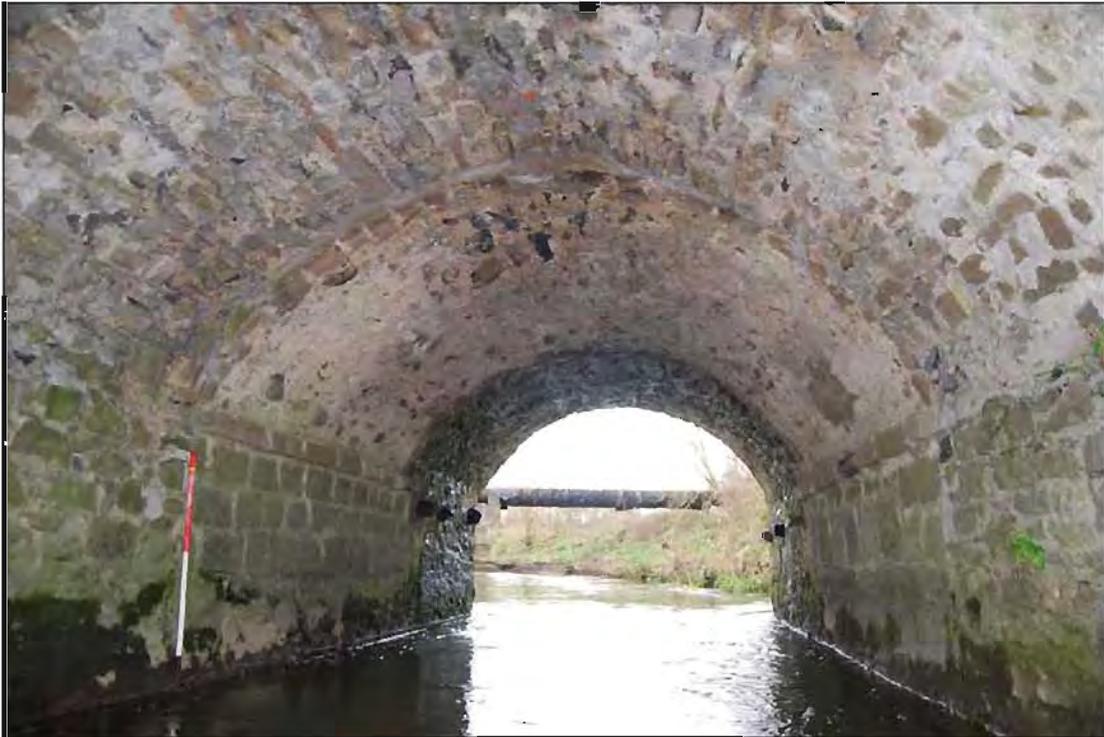
Plate 39: West-facing view of arch-walls and intrados from **Arch no. 2**, Lissenhall Bridge, Feature 1 (1m scale).

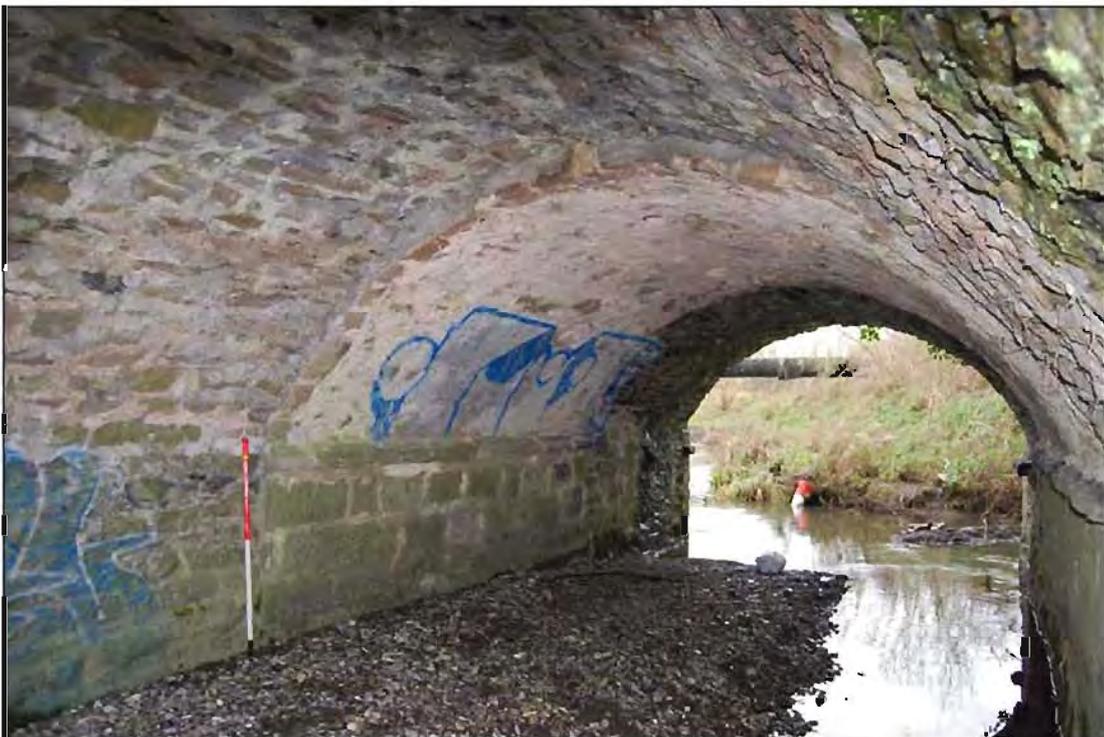
Plate 40: West-facing view of arch-walls and intrados from **Arch no. 3**, Lissenhall Bridge, Feature 1 (1m scale).

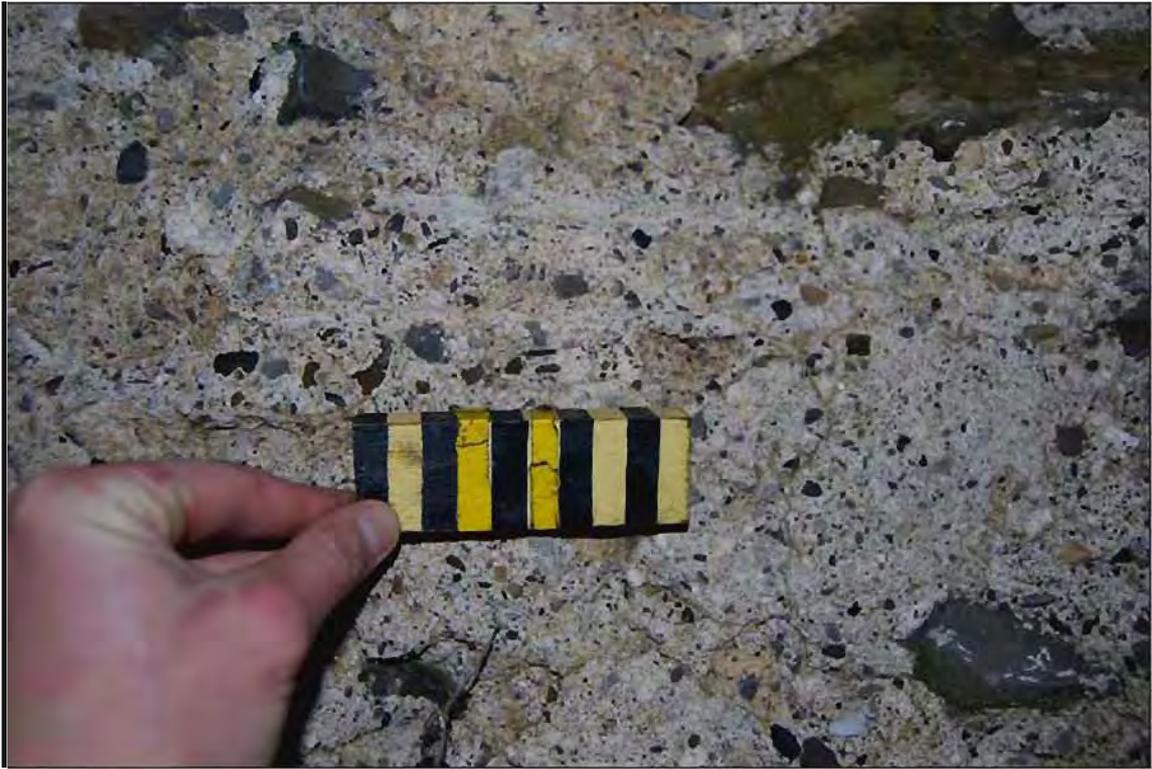
Plate 41: Detail shot of coarse mortar covering the intrados of the mid-section of Lissenhall Bridge. (10cm scale).

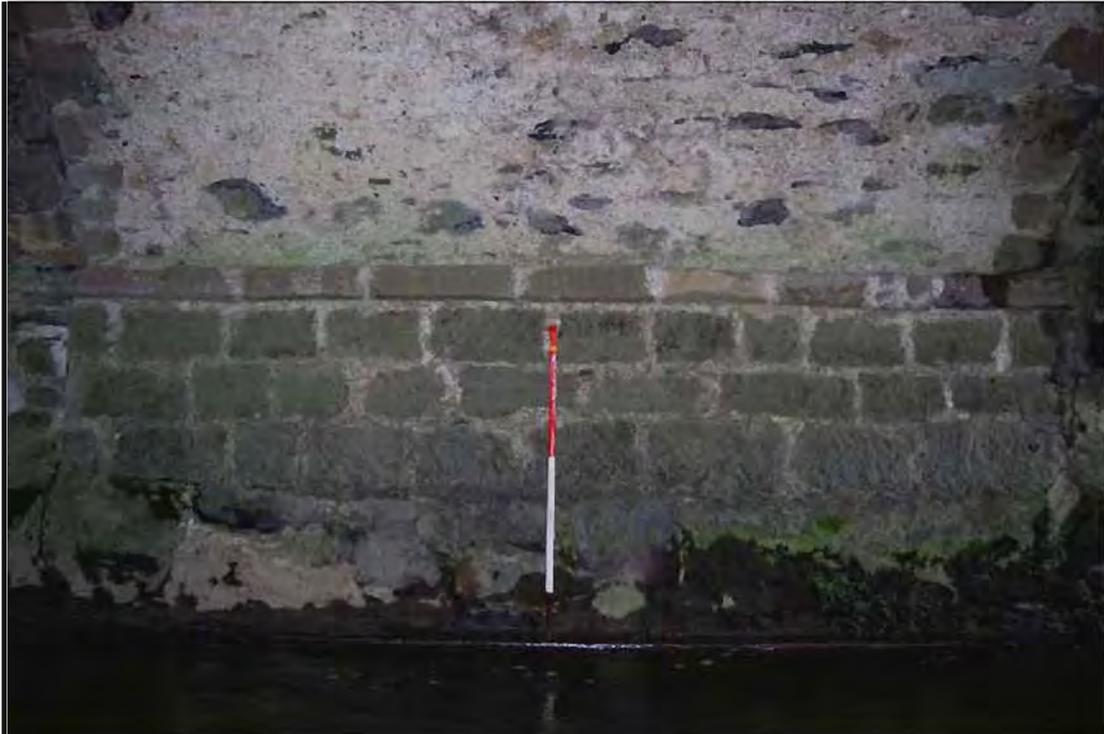
Plate 42: South-facing view of arch wall from the re-built mid-section, south side of Arch no. 2, Lissenhall Bridge, Feature 1 (1m scale).

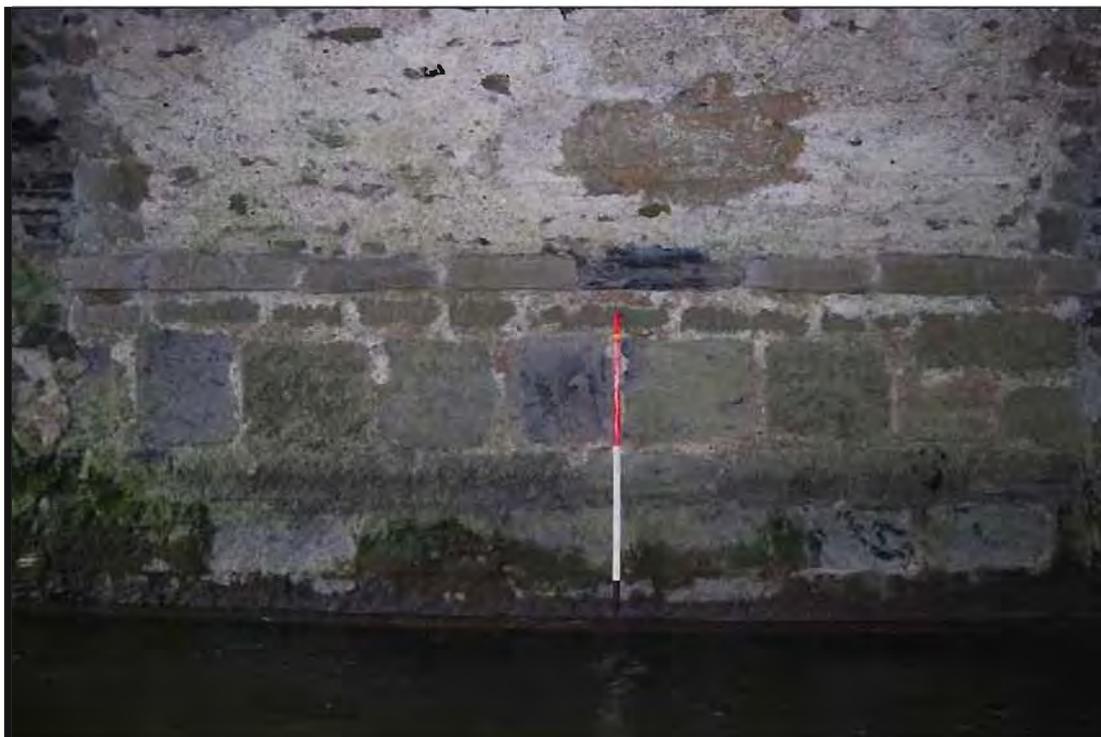
Plate 43: North-facing view of arch wall from the re-built mid-section, north side of Arch no. 2, Lissenhall Bridge, Feature 1 (1m scale).

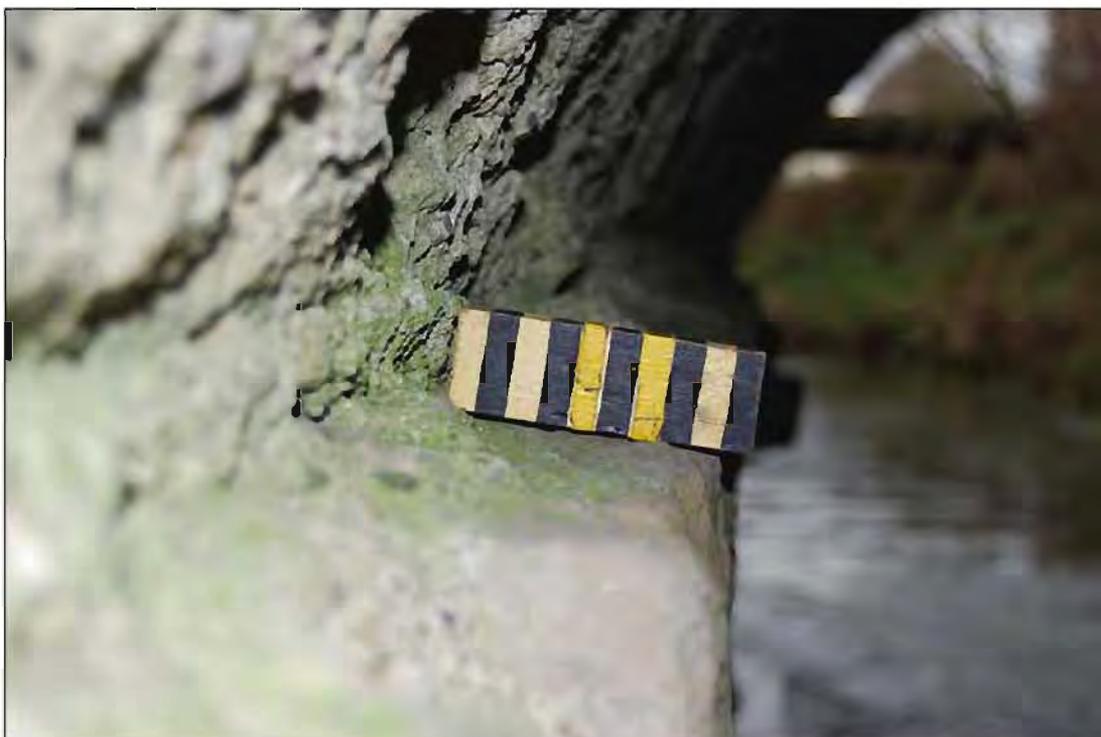
Plate 44: West-facing view across lintel forming at top of arch-wall on south side of the mid-section of Arch no. 2, Lissenhall Bridge, Feature 1 (10cm scale).

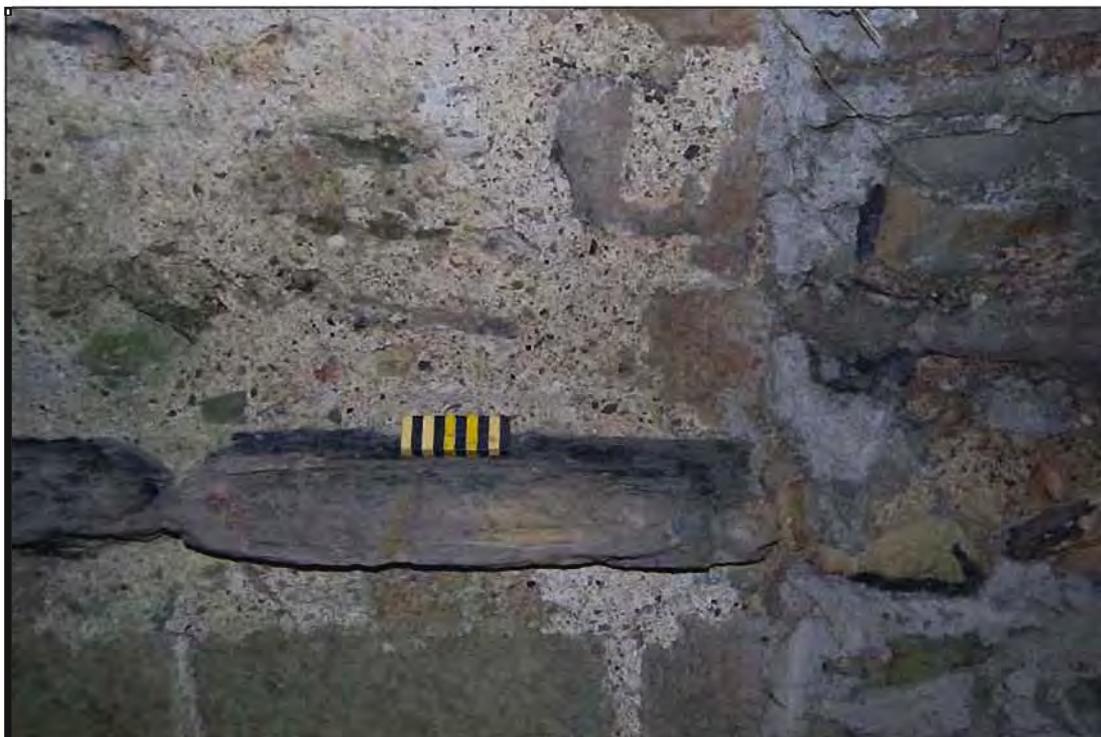
Plate 45: North-facing view across lintel forming at top of arch-wall on north side of the mid-section of **Arch no. 2**, Lissenhall Bridge, Feature 1 (10cm scale).

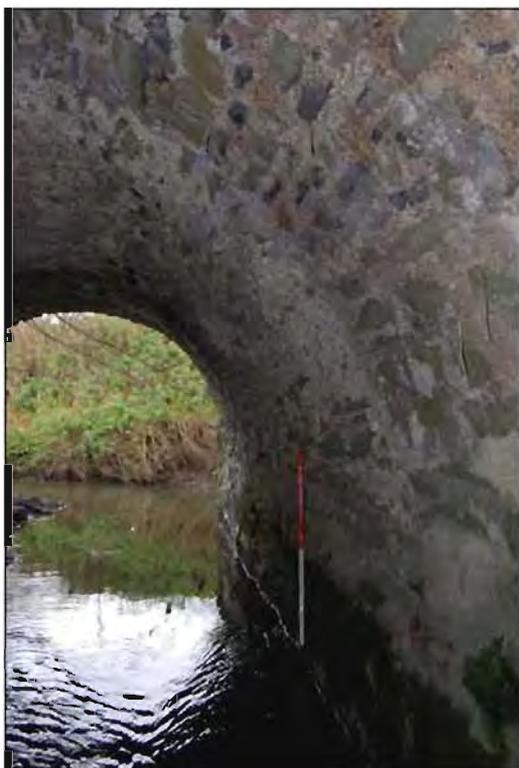
Plate 46: West-facing view of intrados on north side of **Arch no. 4**, showing bulge located across the arch-ceiling of the phase 1 mid-section, Lissenhall Bridge, Feature 1 (1m scale).

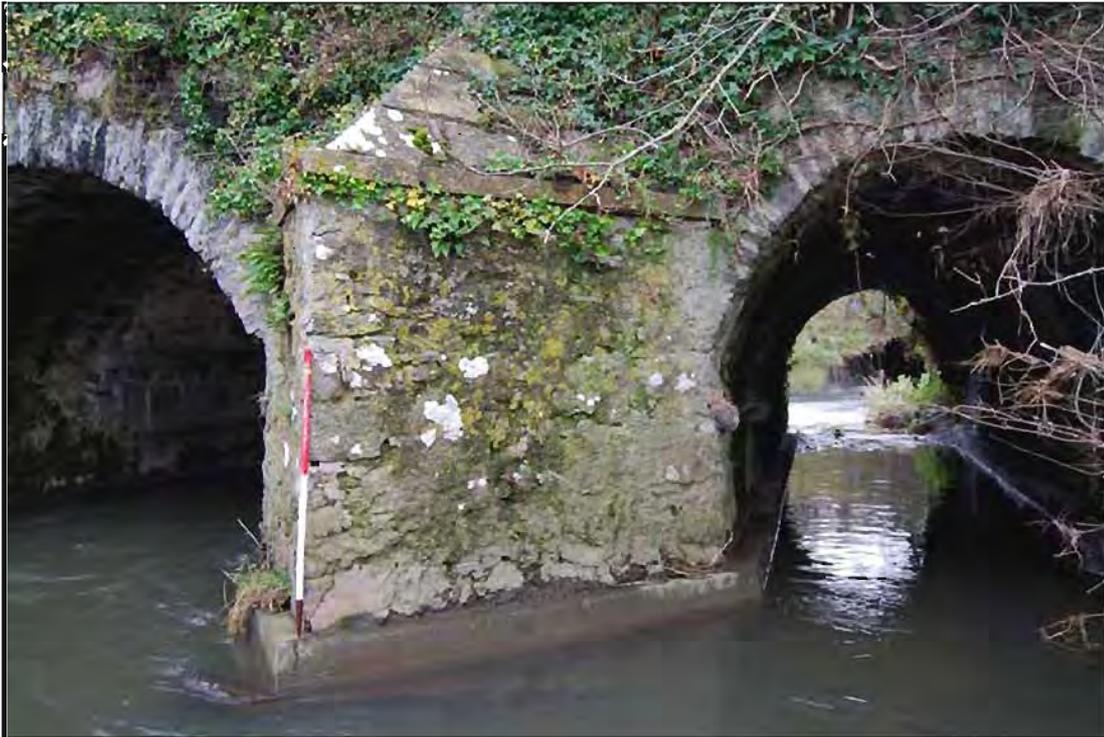
Plate 47: East northeast-facing view of Cutwater No. 1, located between Arch nos. 1 and 2, Lissehanll Bridge, Feature 1 (1m scale).

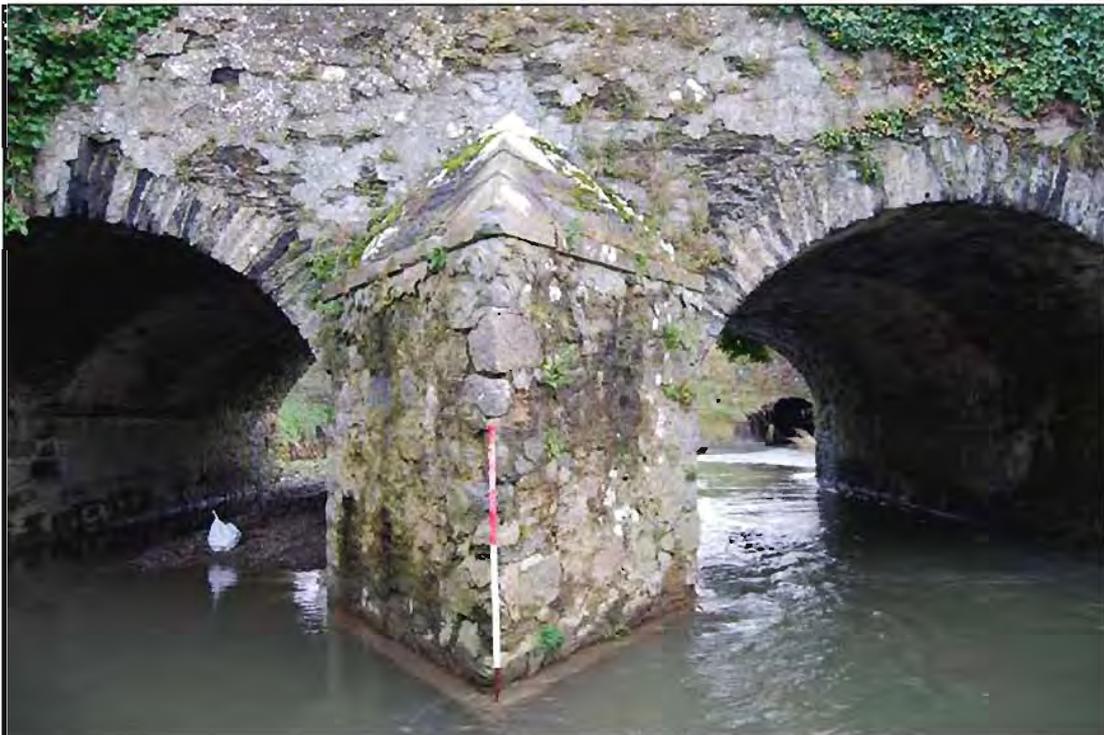
Plate 48: East-facing view of Cutwater No. 2, located between Arch nos. 2 and 3, Lissehanll Bridge, Feature 1 (1m scale).

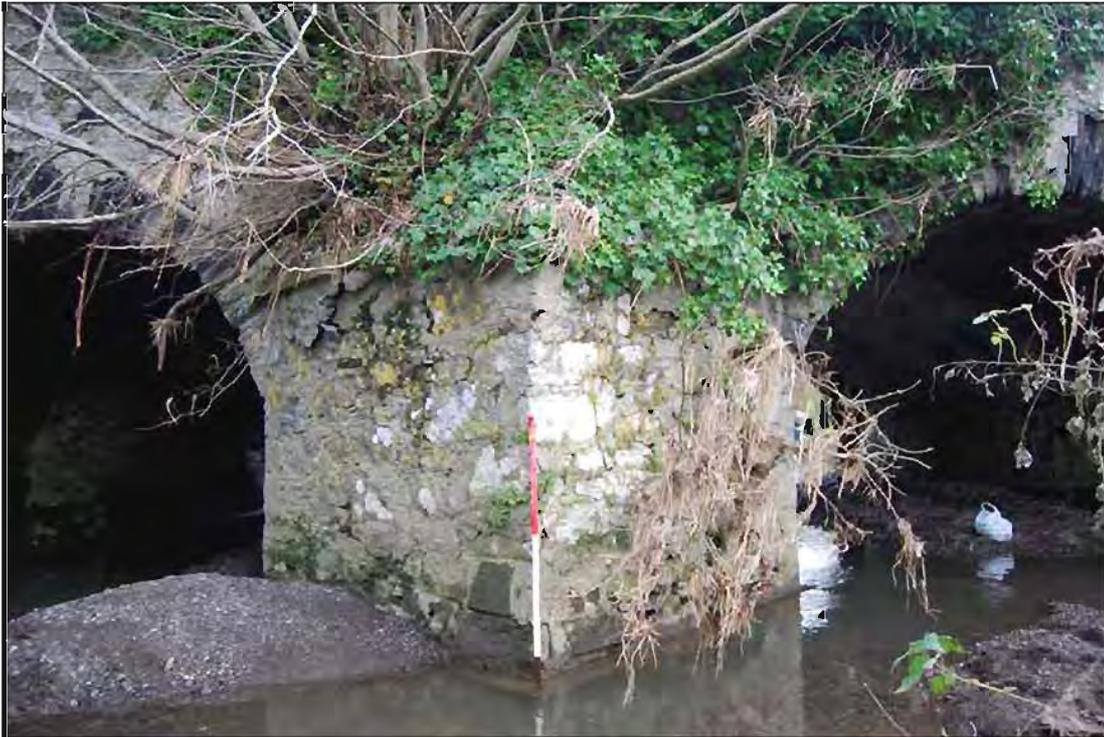
Plate 49: East-facing view of Cutwater no. 3, located between Arch nos. 3 and 4, Lissehanll Bridge, Feature 1 (1m scale).

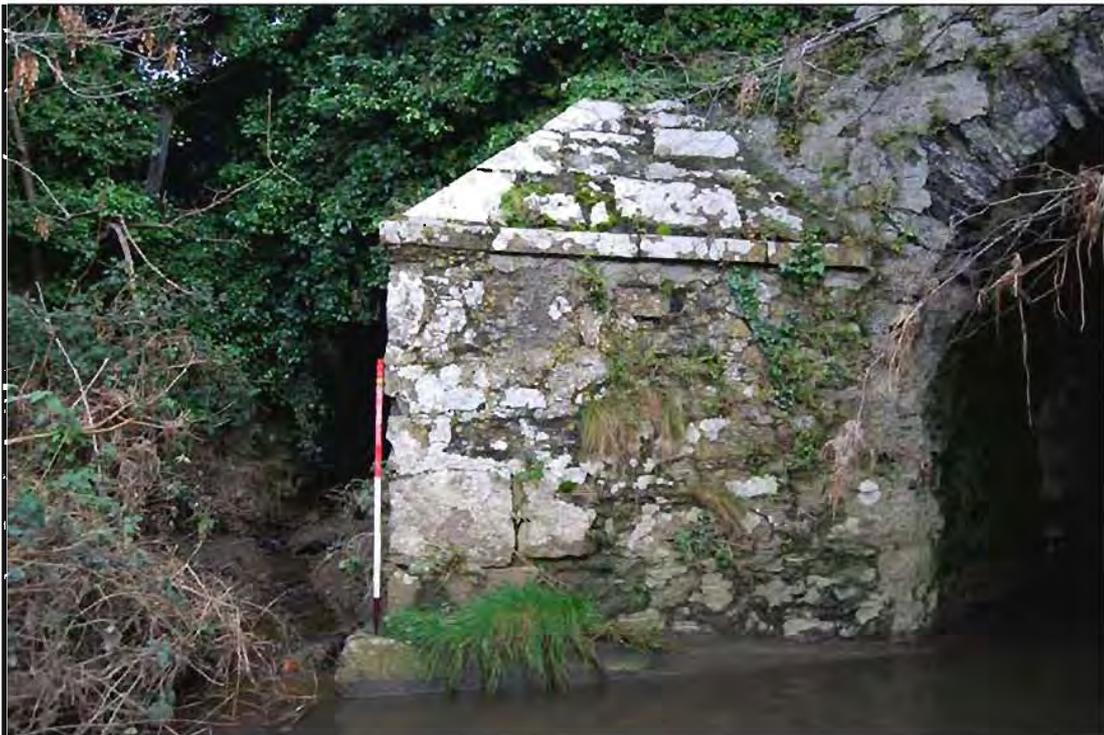
Plate 50: Northeast-facing view of south side of Cutwater no. 4, located between Arch nos. 3 and 4, Lissehanll Bridge, Feature 1 (1m scale).

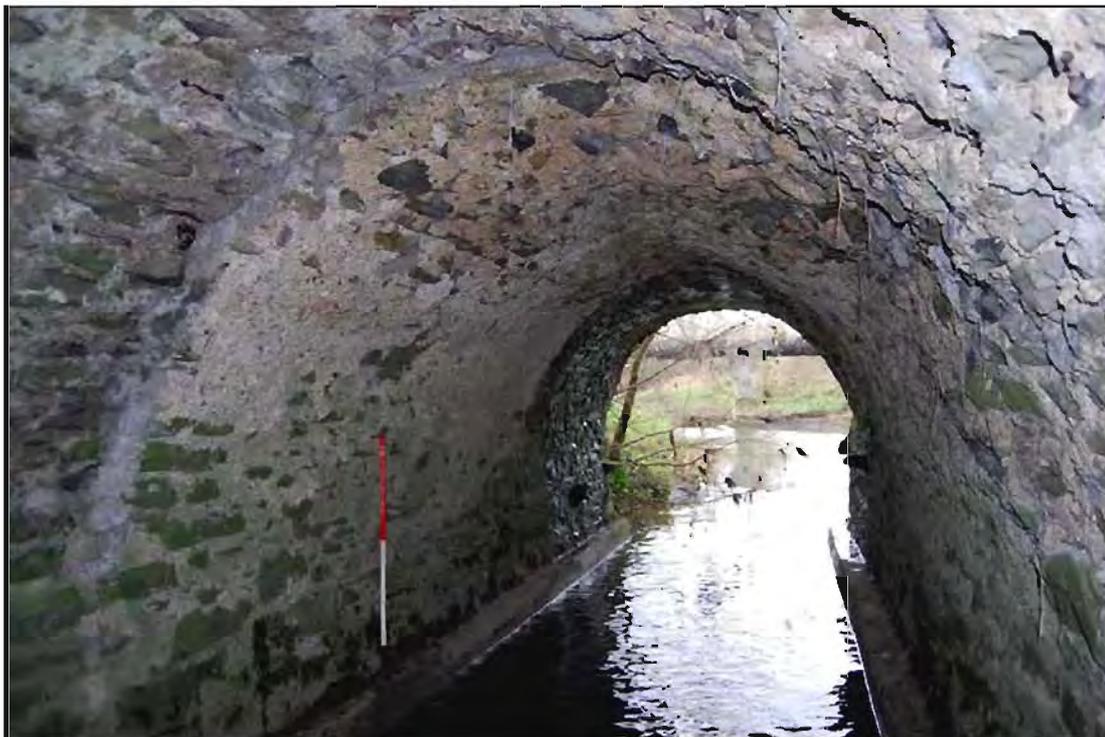
Plate 52: West-facing view across arch-ceiling (intrados) of Arch no. 1, Lissenhall Bridge (Feature 1). Note: differing composition of intrados and concrete underpinning of bridge footings (1m scale).

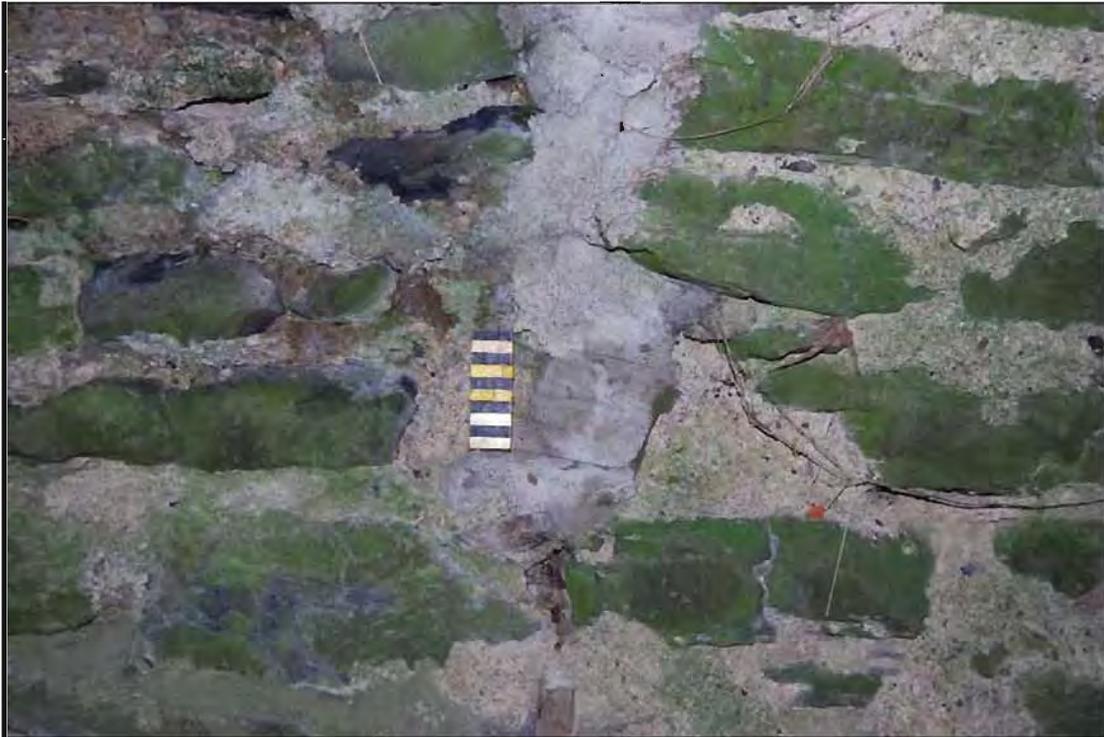
Plate 53: Detail shot of intrados transition-point between the upstream section (Phase 2) and the middle section (Phase 1) from **Arch no. 1**, Lissenhall Bridge, Feature 1 (10cm scale).

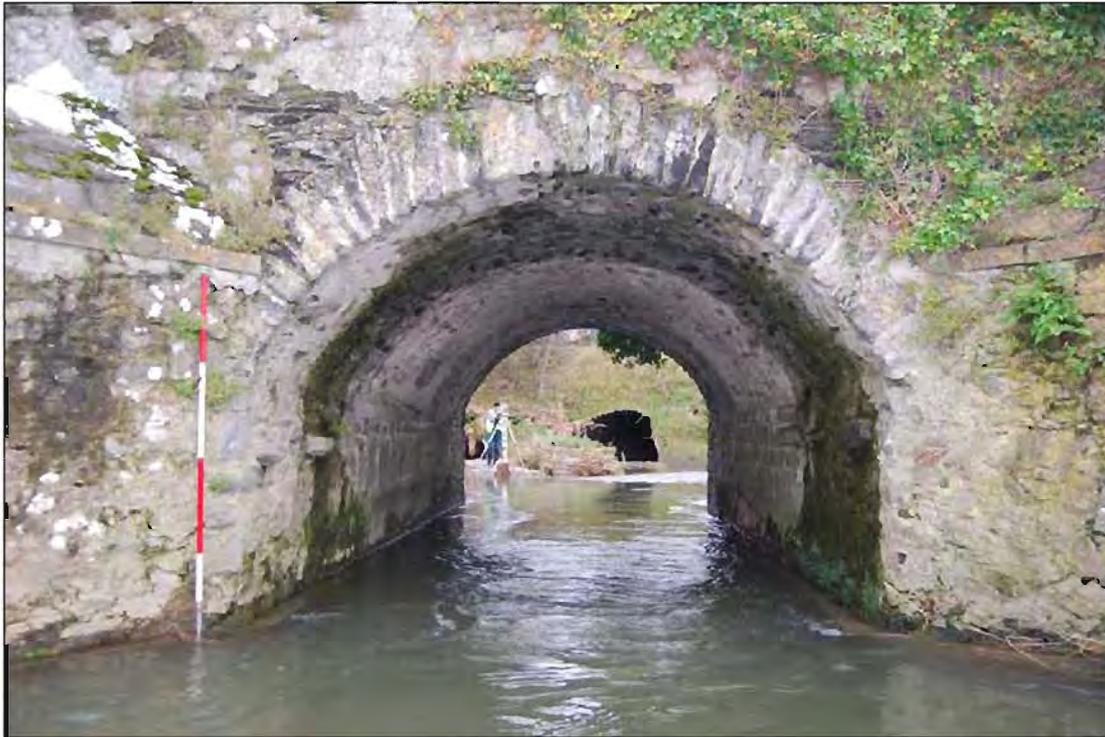
Plate 55: East-facing view of Arch no. 2, upstream side of Lissenhall Bridge, Feature 1 (2m scale).

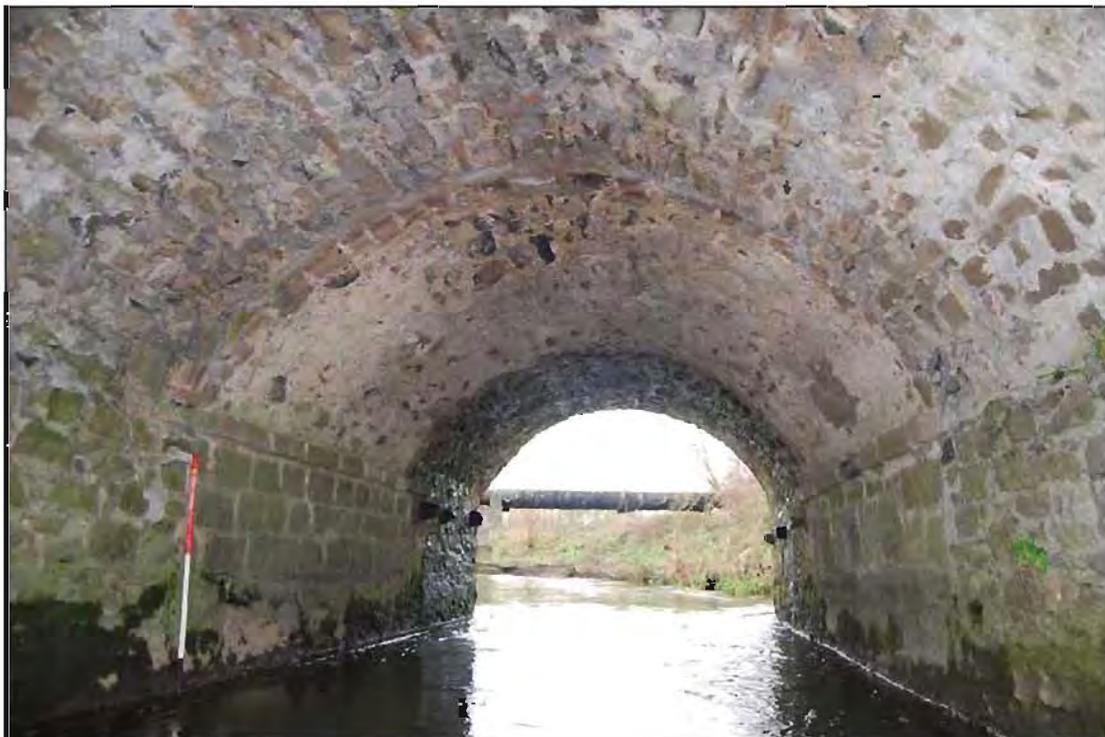
Plate 56: West-facing view across arch-ceiling (intrados) of Arch no. 2, Lissenhall Bridge (Feature 1). Note: differing composition of intrados and protruding arch-stones from downstream side of mid-section (1m scale).

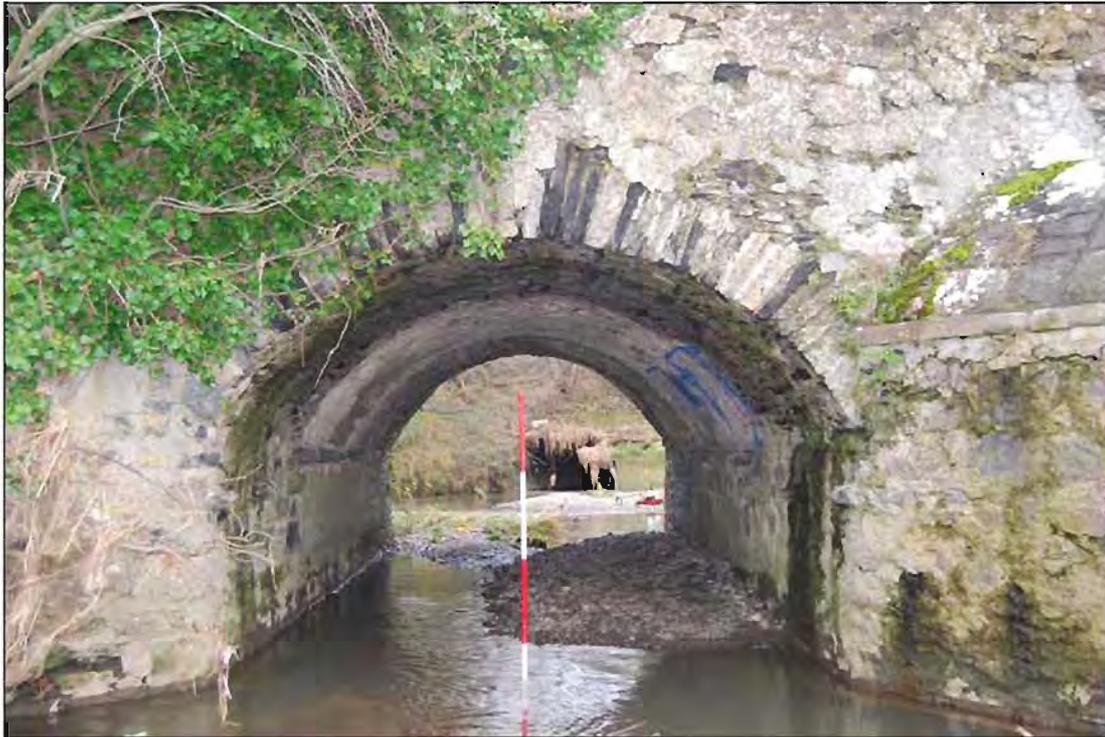
Arch no. 3 (Plate 57-58) is in a medium state of preservation with marginal flattening visible along the northern side of the archway. The archway measures 3.6m (11.8ft) in width/span (max.) and 2.6m (8.53ft) in height (max.) and has identical dimensions to that of Arch no. 2. The archway is segmental in form and the arch-ring is composed of 30 (visible) arch stones. As with Arch no. 1, the arch stones are irregular in size and measure between 0.40m - 0.56m in length, 0.08m - 0.17m in width, and 0.17m – 0.22m in depth. No keystone is visible within the arch-ring. As found with the other arches, the first arch stones are adjusted to give the necessary arch tilt rather than the skewbacks. Cement plastering has been used to reinforce the arch intrados and overlies an earlier lime mortar. The intrados is composed of shaped, rectangular, blocks of varying width and length (average size: 0.20m length x 0.17m width). The intrados runs eastwards for a distance of 2.95m (9.67ft) to join the internal bridge section (Phase 1) and 6.95m (22.8ft) to join the downstream section (Phase 2). A series of three offset stones protrude from either side of the upstream section of Arch

Plate 57: East-facing view of Arch no. 3, upstream side of Lissenhall Bridge, Feature 1 (2m scale).

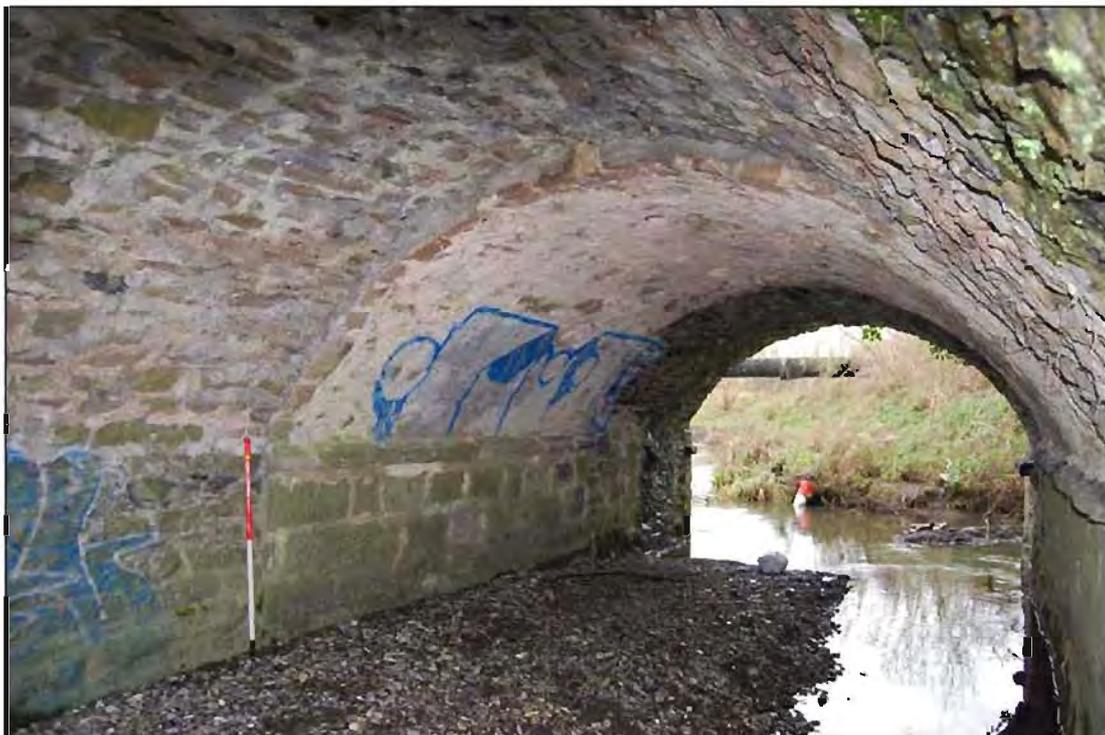
Plate 58: Southwest-facing view across arch-ceiling (intrados) of Arch no. 3, Lissenhall Bridge (Feature 1). Note: differing composition of intrados and protruding arch-stones from downstream side of mid-section (1m scale).

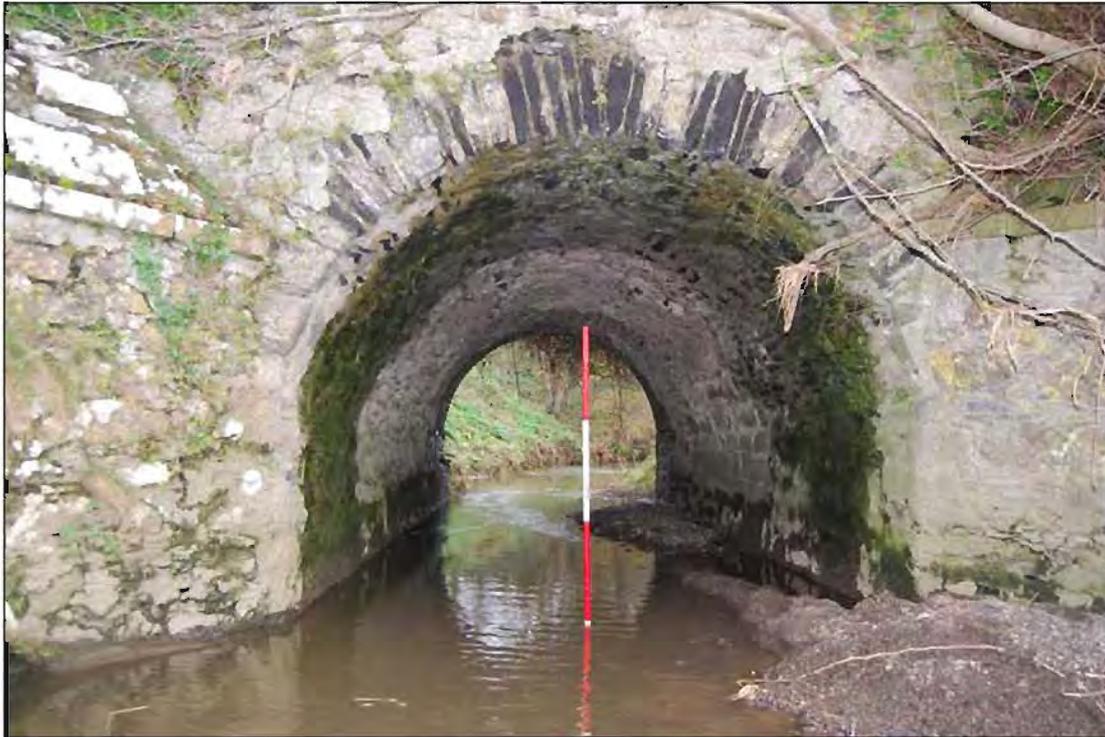
Plate 59: East-facing view of Arch no. 4, upstream side of Lissenhall Bridge, Feature 1 (2m scale).

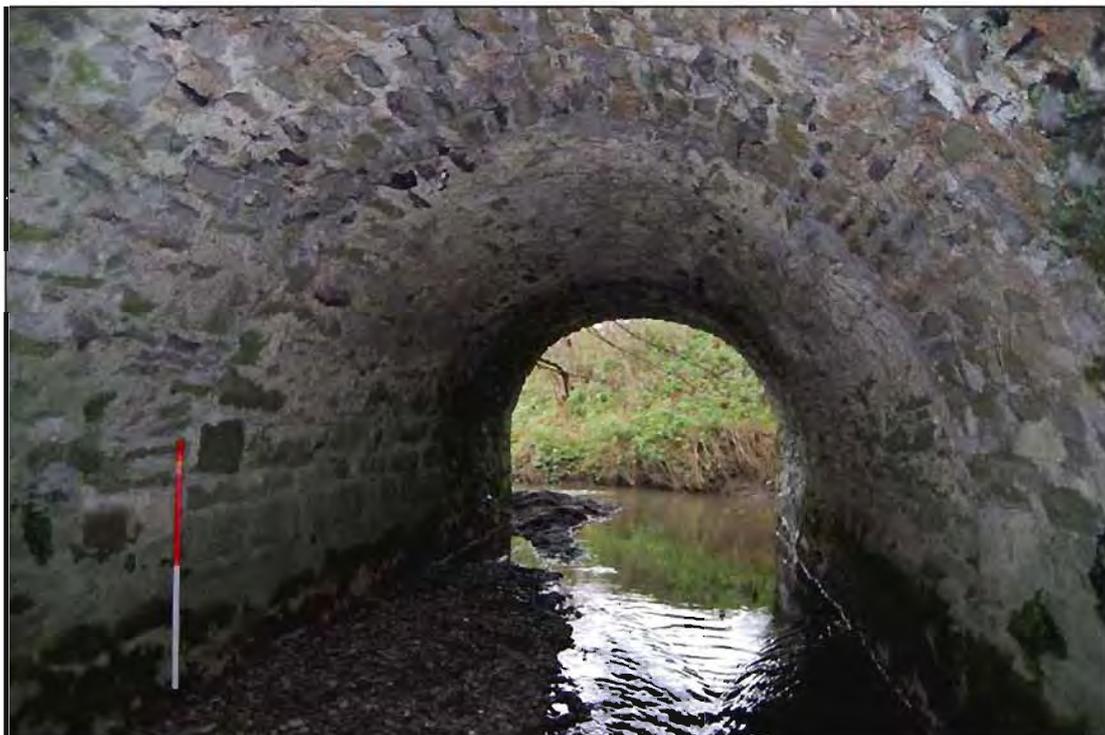
Plate 60: West-facing view across arch-ceiling (intrados) of Arch no. 4, Lissenhall Bridge, Feature 1, (1m scale).

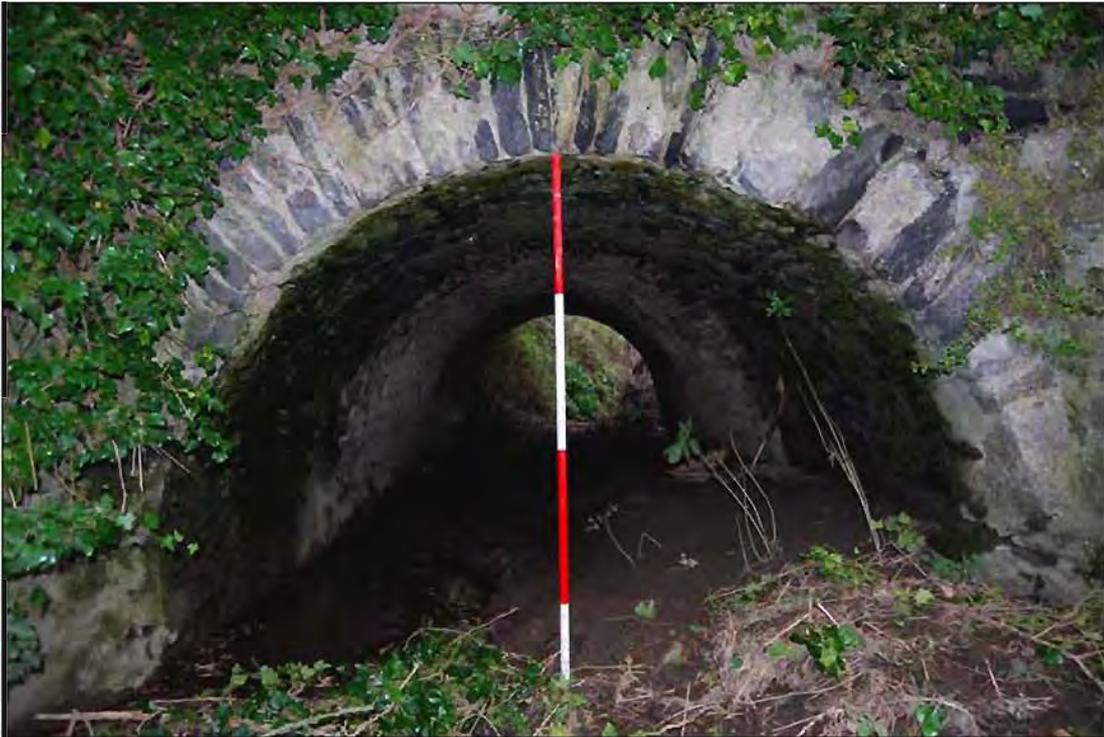
Plate 61: East-facing view of Arch no. 5, upstream side of Lissenhall Bridge, Feature 1 (2m scale).

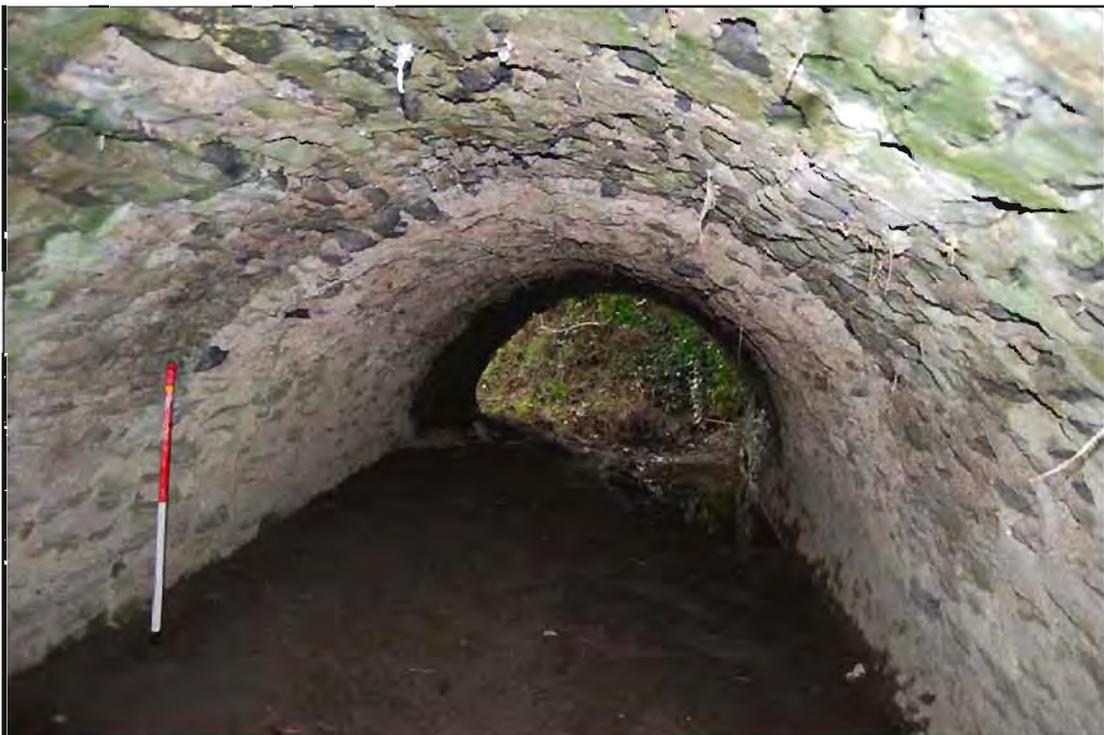
Plate 62: Southwest-facing view across arch-ceiling (intrados) of Arch no. 5, Lissenhall Bridge, Feature 1, (1m scale).
