**UNDERWATER ARCHAEOLOGICAL ASSESSMENT
METRO NORTH PROJECT**

**BROADMEADOW RIVER, LISSENHALL BRIDGE
BALHEARY DEMESNE/ LISSENHALL GREAT,
SWORDS, CO. DUBLIN
08D093, 08R311**

**WARD RIVER, BALHEARY BRIDGE
BALHEARY DEMESNE, SWORDS, CO. DUBLIN
08D092, 08R312**

20 April 2009

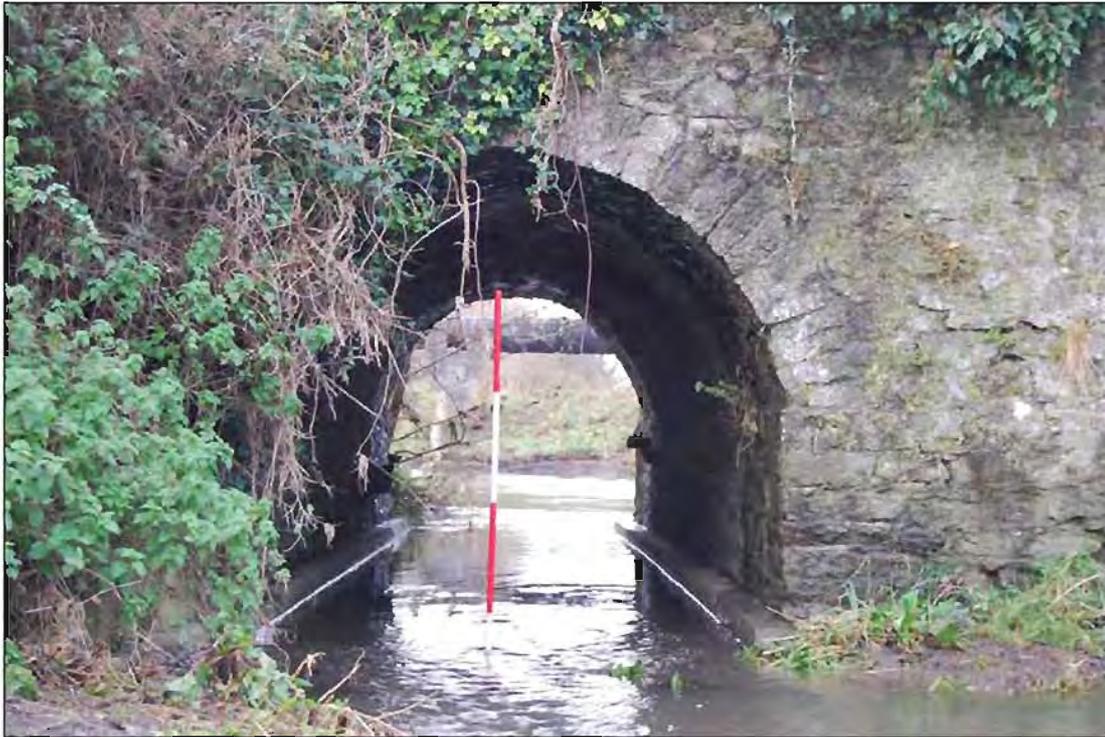
Arch no. 1 (Plate 63) is in a good state of preservation and retains its original semi-circular shape. The arch measures 2.4m (2.87ft) in width/span (max.) and 2.4m (7.87ft) in height (max.). The archway is segmental in form and the arch-ring is composed of 30 (visible) arch stones. In contrast to the upstream arch-rings, the downstream arches comprise neatly-faced masonry blocks of a more regular in size and shape. The arch stones measure 0.31m-0.32m in length, between 0.09m - 0.14m in width, and 0.20m – 0.24m in depth. Cement plastering has been used to reinforce the arch intrados and overlies an earlier mortar. The intrados is composed of shaped, rectangular, blocks of varying width and length (average size: 0.30m length x 0.14m width). The intrados runs westwards for a distance of 3.6m (11.81ft) to join the internal bridge section (Phase 1) and 7.6m (24.9ft) to meet the upstream (Phase 2) bridge section.

Plate 63: West-facing view of **Arch no. 1**, downstream side of Lissenhall Bridge, Feature 1 (2m scale).

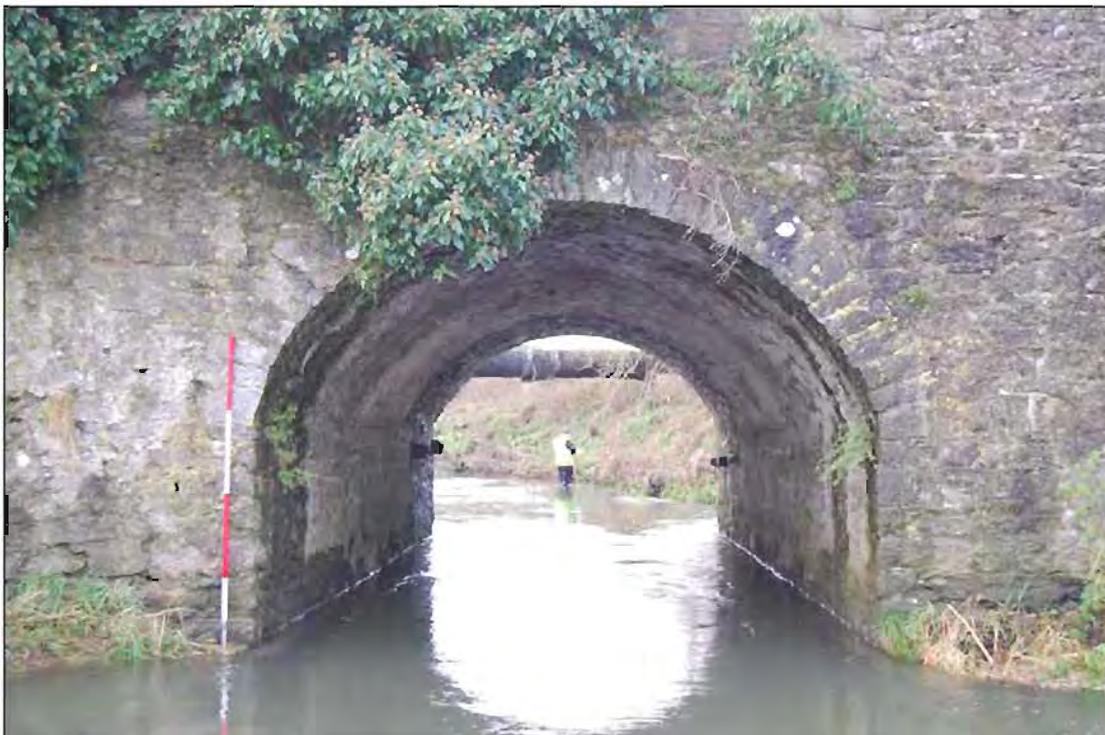
Arch no. 2 (Plate 64) is in a good state of preservation, retaining its original semi-circular shape. The arch measures 3.6m (11.8ft) in width/span (max.) 2.6m (8.53ft) in height (max.). The archway is segmental in form and the arch-ring is composed of 32 arch stones. The arch stones are fairly uniform in size, measuring 0.31m-0.33m in length, between 0.12m - 0.29m in width, and 0.20m – 0.25m in depth. Cement plastering has been used to reinforce the arch intrados and overlies an earlier lime mortar. The intrados is composed of shaped, rectangular, blocks of varying width and length (average size: 0.30m Length x 0.14m width). The intrados runs westwards for a distance of 3.6m (11.81ft) to join the internal bridge section (Phase 1) and 7.55m (24.77ft) to join the upstream bridge extension.

Plate 64: West-facing view of **Arch no. 2**, downstream side of Lissenhall Bridge, Feature 1 (2m scale).

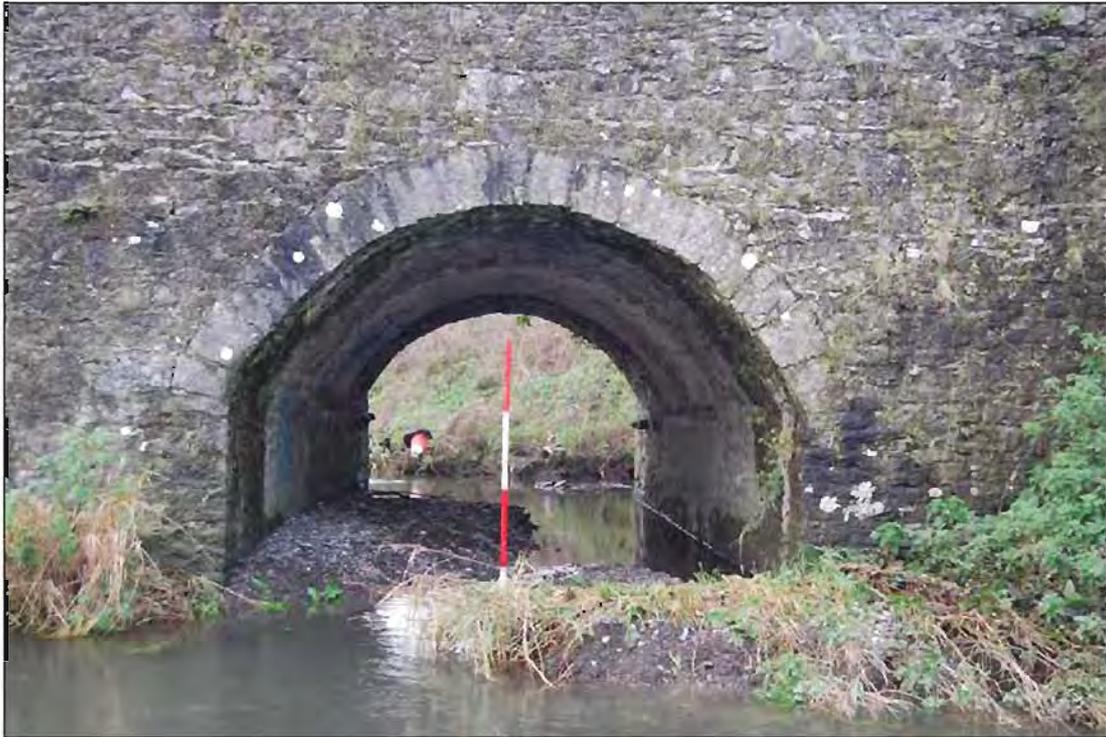
Arch no. 3 (Plate 65) is in a good state of preservation and retains its original semi-circular shape. The arch measures 3.6m (11.8ft) in width/span (max.) 2.6m (8.53ft) in height (max.). The archway is segmental in form and the arch-ring is composed of 32 arch stones. The arch stones are fairly uniform in size, measuring 0.32m-0.34m in length, between 0.15m - 0.21m in width, and 0.19m – 0.25m in depth. The keystone is visible and measures 0.34m length x 0.21m width. Cement plastering has been used to reinforce the arch intrados and overlies an earlier lime mortar. The intrados is composed of shaped, rectangular, blocks of varying width and length (average size: 0.30m length x 0.14m width). The intrados runs westwards for a distance of 3.56m (11.68ft) to join the internal bridge section (Phase 1) and 7.35m (24.1ft) to join the upstream extension.

Plate 65: West-facing view of **Arch no. 3**, downstream side of Lissenhall Bridge, Feature 1 (2m scale).

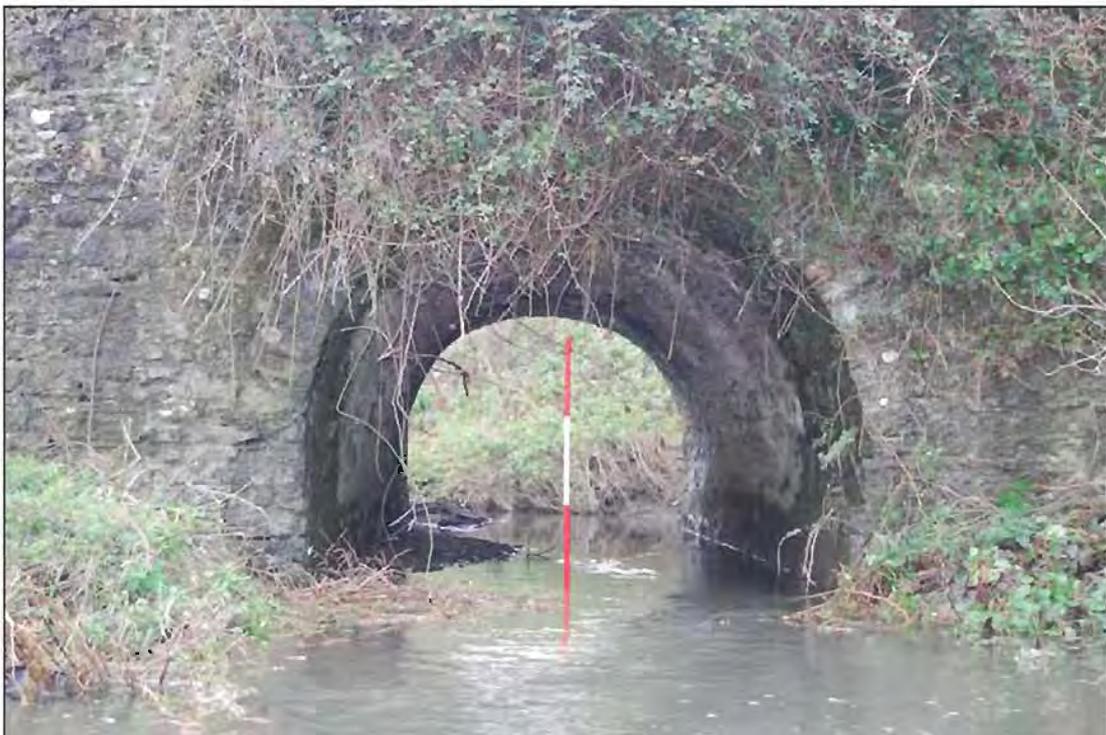
Arch no. 4 (Plate 66) is in a good state of preservation and retains its original semi-circular shape. The arch measures 3.4m (11.15ft) in width/span (max.) and 2.4m (7.87ft) in height (max.). The archway is segmental in form and the arch-ring is composed of 32 arch stones. The arch stones are fairly uniform in size, measuring 0.32m-0.33m in length, between 0.08m - 0.20m in width, and 0.18m – 0.24m in depth. Cement plastering has been used to reinforce the arch intrados and an earlier lime mortar. The intrados is composed of shaped, rectangular, blocks of varying width and length (average size: 0.30m length x 0.14m width). The intrados runs westwards for a distance of 3.41m (11.18ft) to join the internal bridge section (Phase 1) and 7.2m (22.96ft) to join the upstream extension.

Plate 66: West-facing view of **Arch no. 4**, downstream side of Lissenhall Bridge, Feature 1 (2m scale).

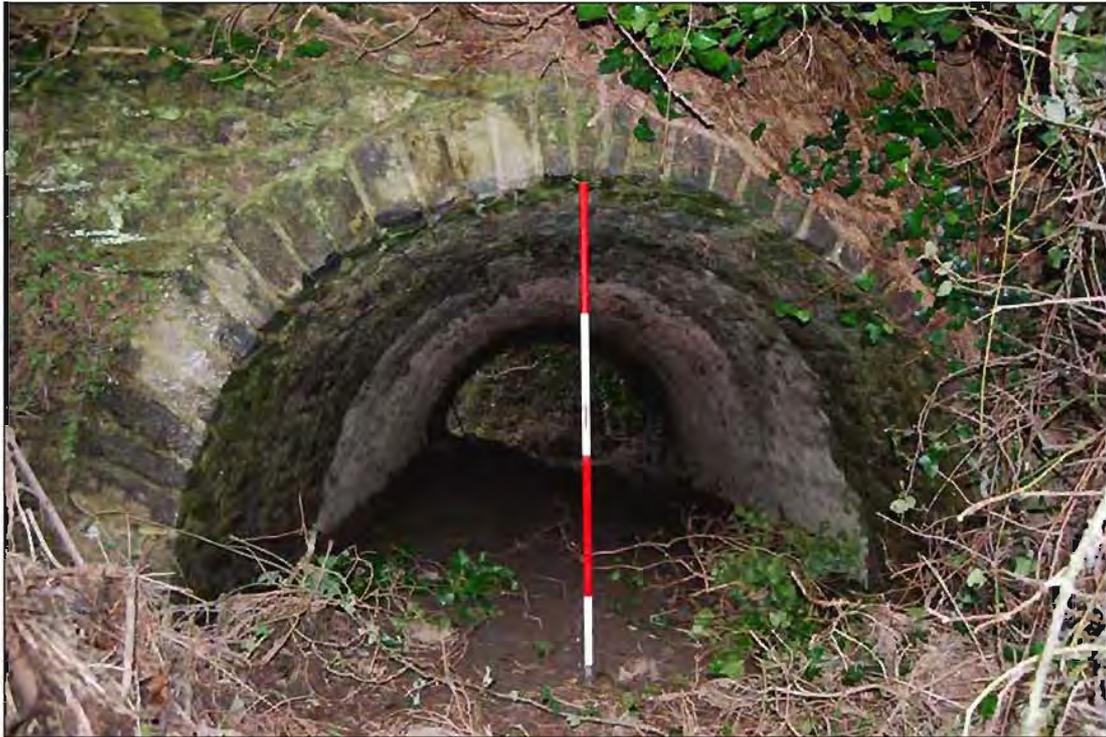
Arch no. 5 (Plate 67) is in a good state of preservation and retains its original semi-circular shape. The arch measures 2.4m (2.87ft) in width/span (max.) and 2.4m (7.87ft) in height (max.). The archway is segmental in form and the arch-ring is composed of 30 (visible) arch stones. The arch stones measure 0.31m-0.32m in length, between 0.09m - 0.14m in width, and 0.20m – 0.24m in depth. Cement plastering has been used to reinforce the arch intrados and an earlier lime mortar. The intrados is composed of shaped, rectangular, blocks of varying width and length (average size: 0.30m length x 0.14m width). The intrados runs westwards for a distance of 3.33m (10.92ft) to join the internal bridge section (Phase 1) and 7.05m (23ft) to join the upstream extension.

Plate 67: West-facing view of **Arch no. 5**, downstream side of Lissenhall Bridge, Feature 1 (2m scale).

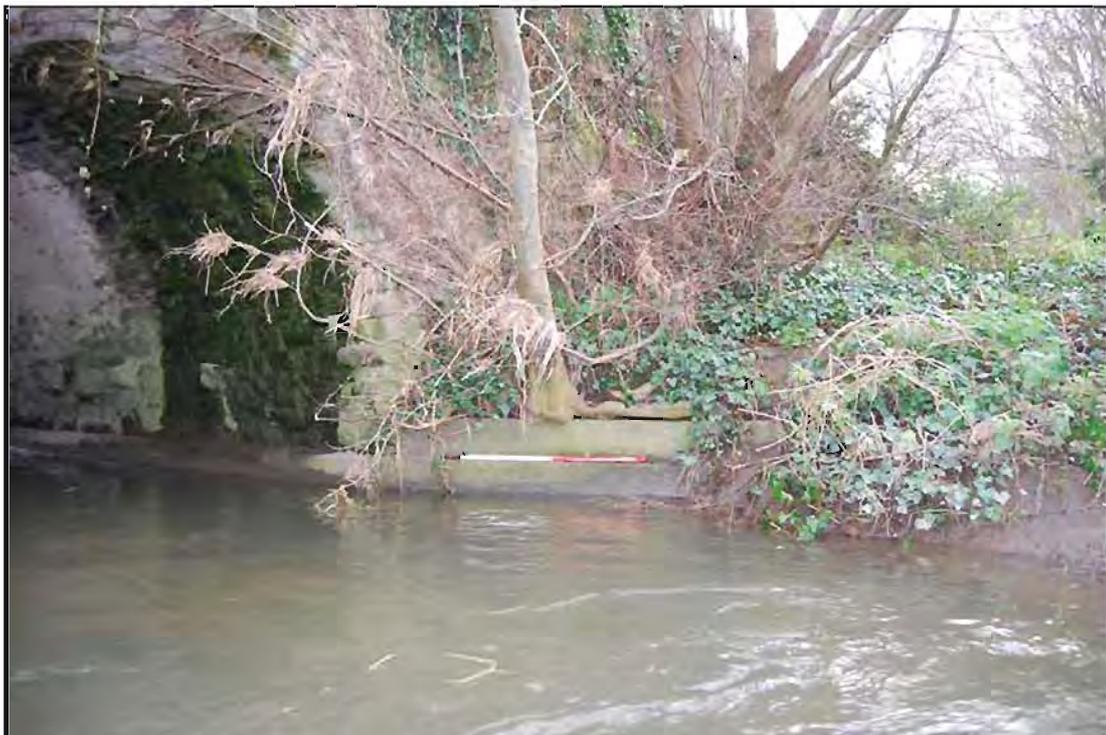
Inspection of these bridge elements was not possible due to the modern concrete consolidation measures present (Plate 68). The bridge footings and pier structures being covered by poured mass concrete. While the exact dimensions, composition, and build quality of the bridge foundations cannot be assessed, it is likely that the pier structures are composed of a cut-stone facing with a heavily mortared internal rubble core.¹¹ The bridge footings and pier structures protrude a maximum of 0.23m from the base of the arch-walls. The western (upstream) end of each pier structure is triangular in shape and the eastern (downstream) ends are rectangular in shape.

Plate 68: Southeast-facing view of concrete encased bridge footings located along the base of **Arch no. 1**, upstream side of Lissenhall Bridge, Feature 1 (1m scale).

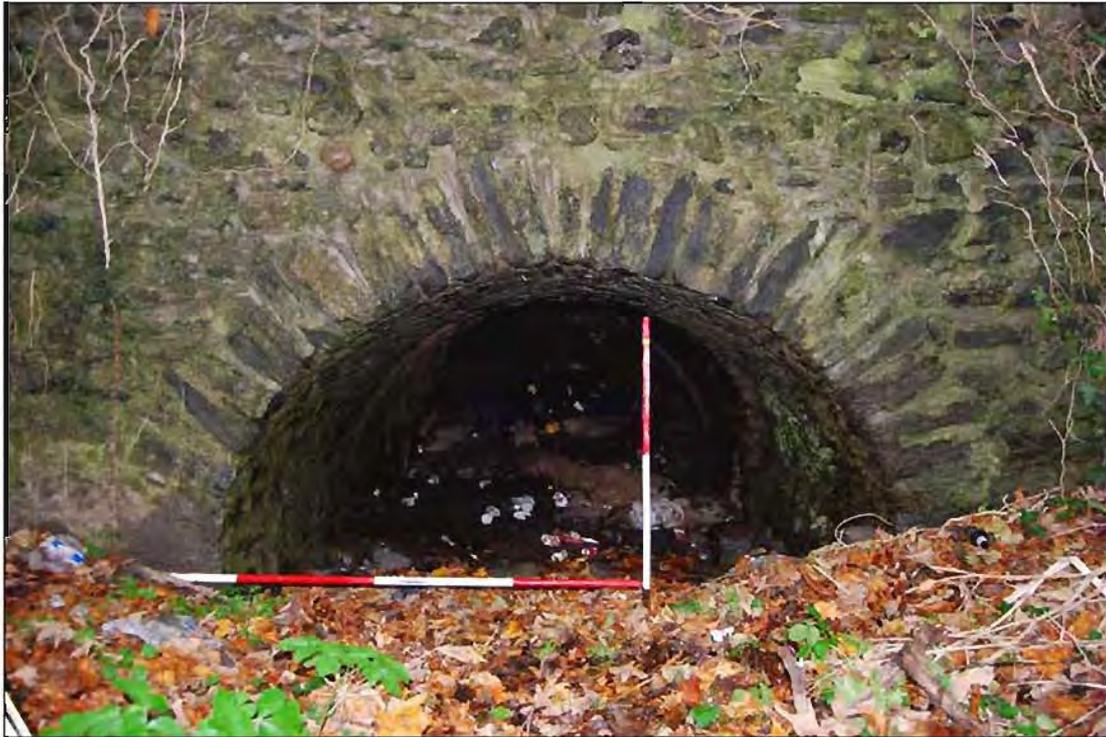
The arch intrados has been rendered using a cement mortar and extends eastwards for a distances of 2.4m (7.87ft) to a transition-point with an earlier culvert-arch (Plate 70). The intrados of the earlier structure is rendered with a white coloured lime mortar that matches the mortar found within the mid-sections of Lissenhall Bridge. This intrados extends eastward for 0.9m to meet an earth and rubble wall comprising of back-fill material. By extrapolating a line between the eastern and western limits of Lissenhall Bridge, coupled with a line extended from the build-phase transition points, it is possible to calculate the east-west extent of the buried section of this structure. It is anticipated that internal arch section measures 4m in width and that the eastern section of arch measures 2.8m in width (9.18ft); giving the structure and overall width of 9.2m (30.18ft).

Plate 69: East-facing view of the single-arched culvert comprising Feature 2, located approximately mid-point between Lissenhall Bridge, Feature 1, and Balheary Bridge, Feature 3 (1m vertical and 2m horizontal scale).

A direct impact to this structure is anticipated as part of the proposed Metro North Project. Feature 2 has been fully-recorded and no further archaeological mitigation measures are deemed necessary prior to commencement of the construction phase of the project. As previously discussed this feature contains a mid-section of possible pre seventeenth-century date (build-Phase 1) and as such it is recommended that an architectural conservation assessment should be undertaken prior to commencement of the proposed development. This recommendation would correspond with the requirements outlined for Lissenhall Bridge (Feature 1) in the Archaeological Strategy for the Metro North. In addition, it is recommended that archaeological monitoring of all construction works on/ around Feature 2 is undertaken during the construction phase.

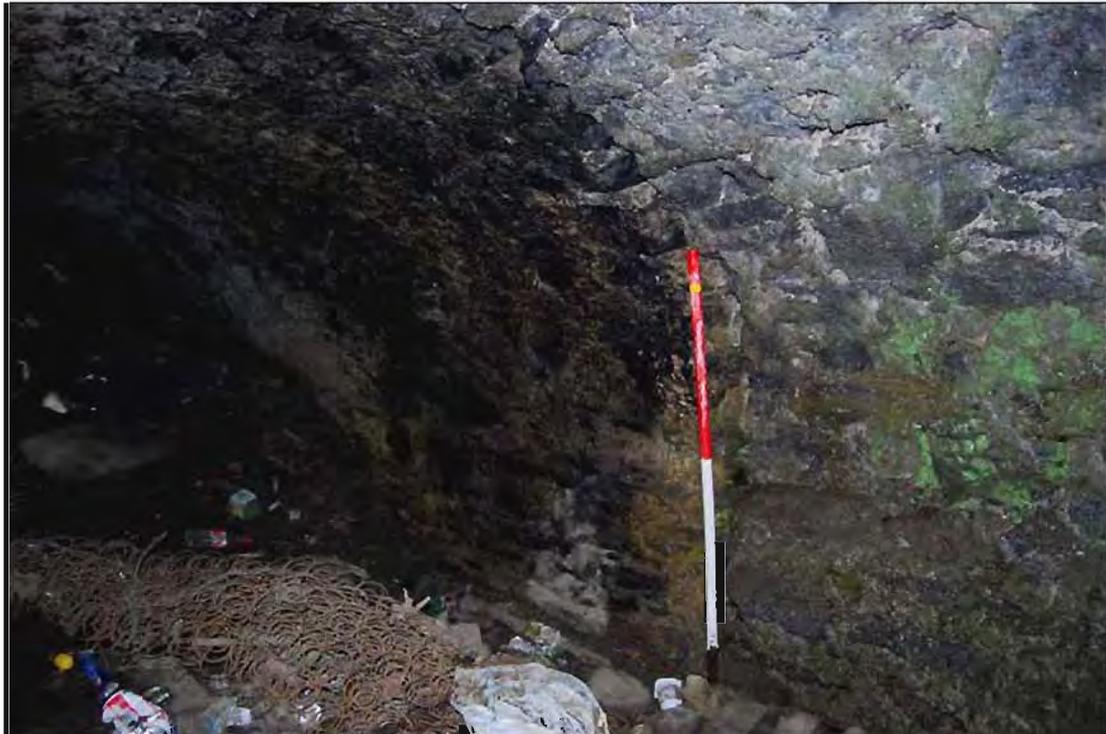
Plate 70: Southeast-facing view of the transition-point, on southern side of the arch, between the western section (Phase 2) and middle section (Phase 1) from Feature 2 (1m scale).

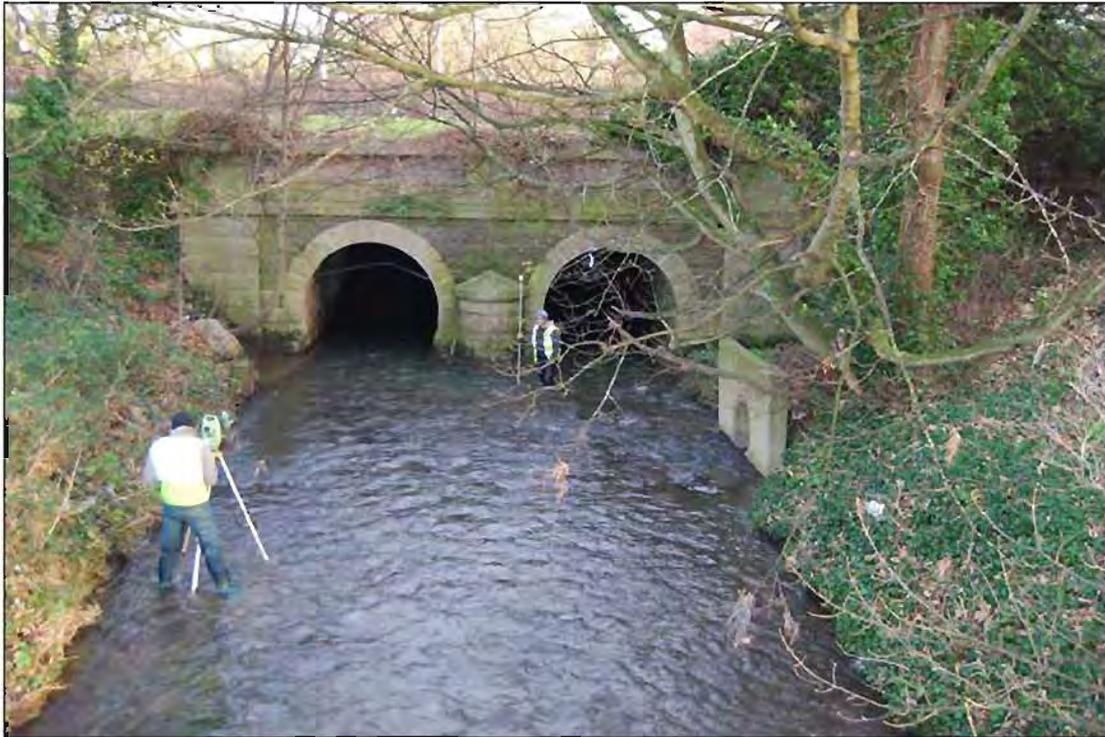
Balheary Bridge comprises of a two-arched bridge structure crossing the Ward River at NGR: 318744E, 248140N, centre-point (Plate 71). The bridge measures 10.55m

Plate 71: East-facing shot showing upstream (Phase 3) side of Balheary Bridge, Feature 3. Note: Total Station survey at this location in progress.

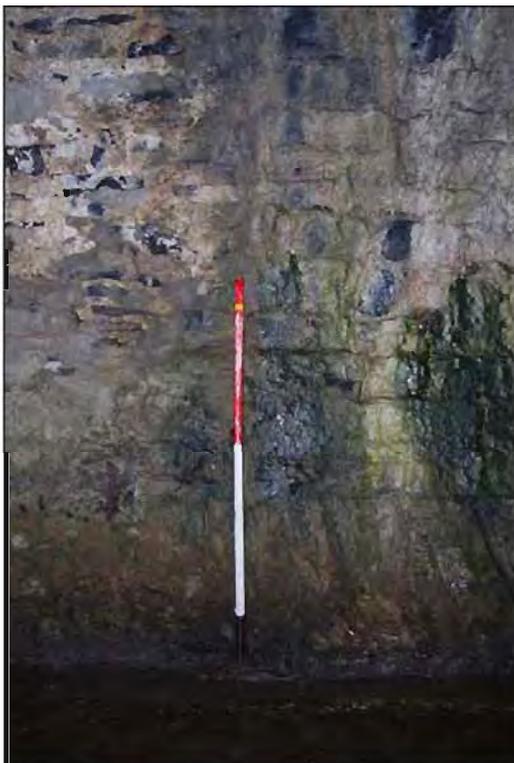
Plate 72: Transition-point between mid-section (Phase 1) and upstream section (Phase 3), north side of Arch no. 1 (1m scale).

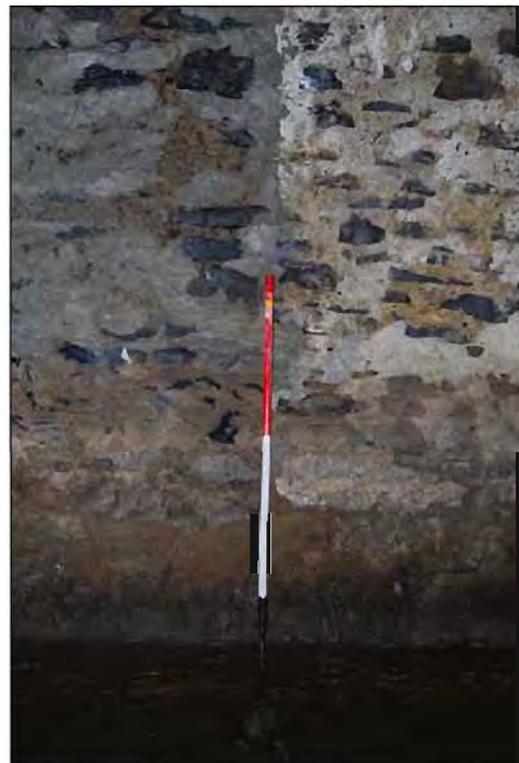
Plate 73: Transition-point between mid-section (Phase 1) and downstream section (Phase 2), north side of Arch no. 1 (1m scale).

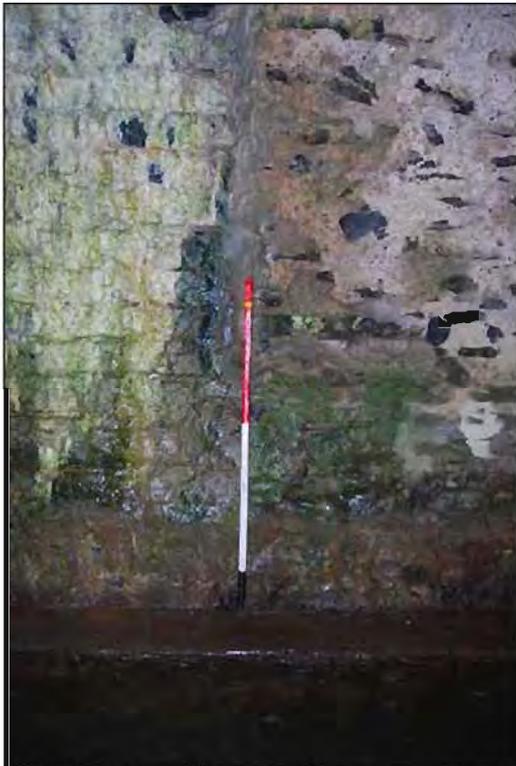
Plate 74: Transition-point between mid-section (Phase 1) and upstream section (Phase 3), north side of Arch no. 2 (1m scale).

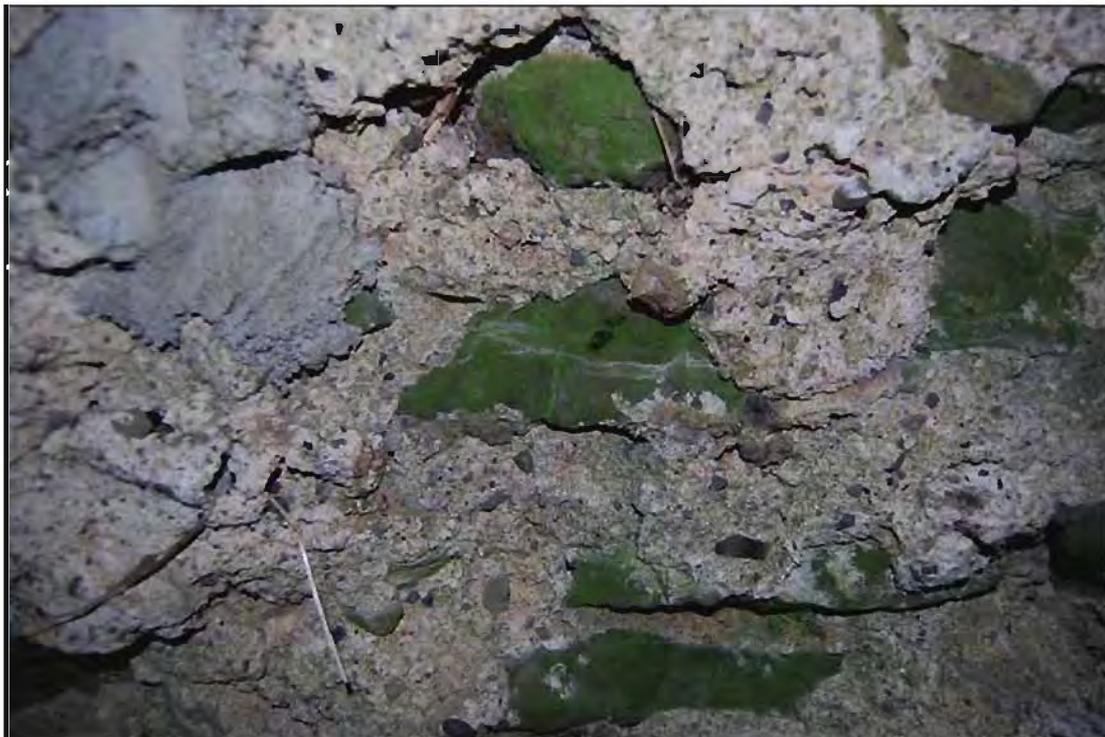
Plate 76: Detail shot of mortar located across intrados of middle section (Phase 1) of Arch nos. 1 and 2 from Balheary Bridge (Feature 3).

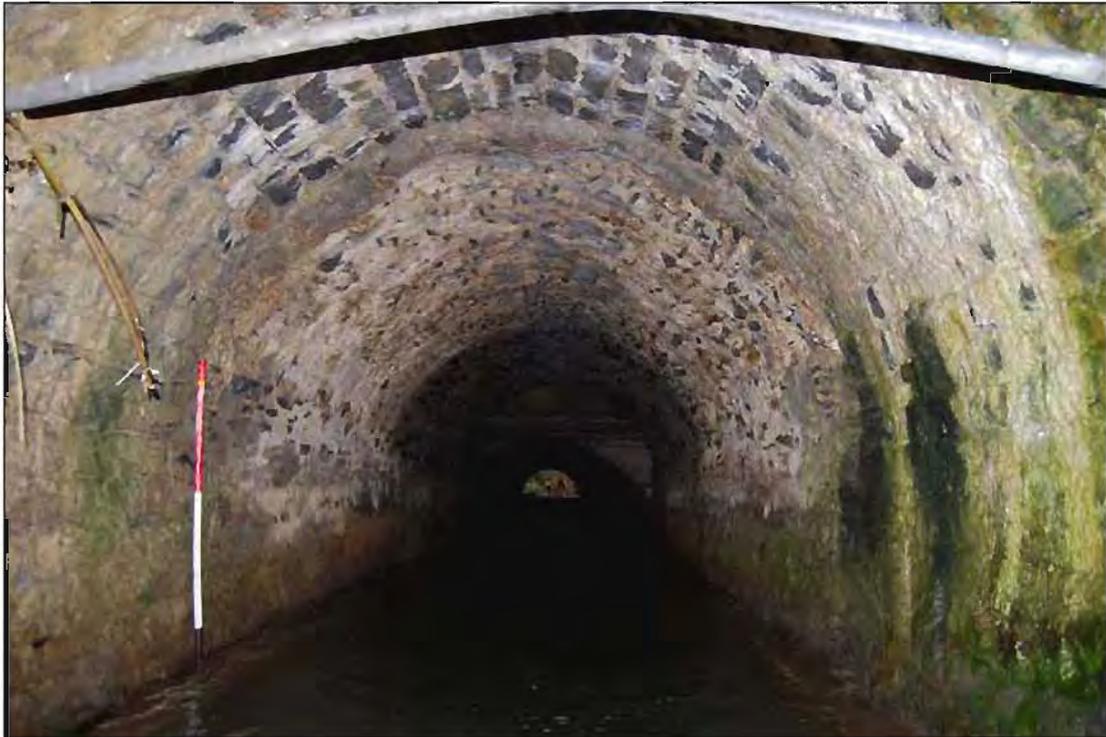
Plate 77: East-facing view through **Arch no. 1** showing transition between the upstream (Phase 3) and middle section (Phase 1) at Balheary Bridge, Feature 3 (1m scale).

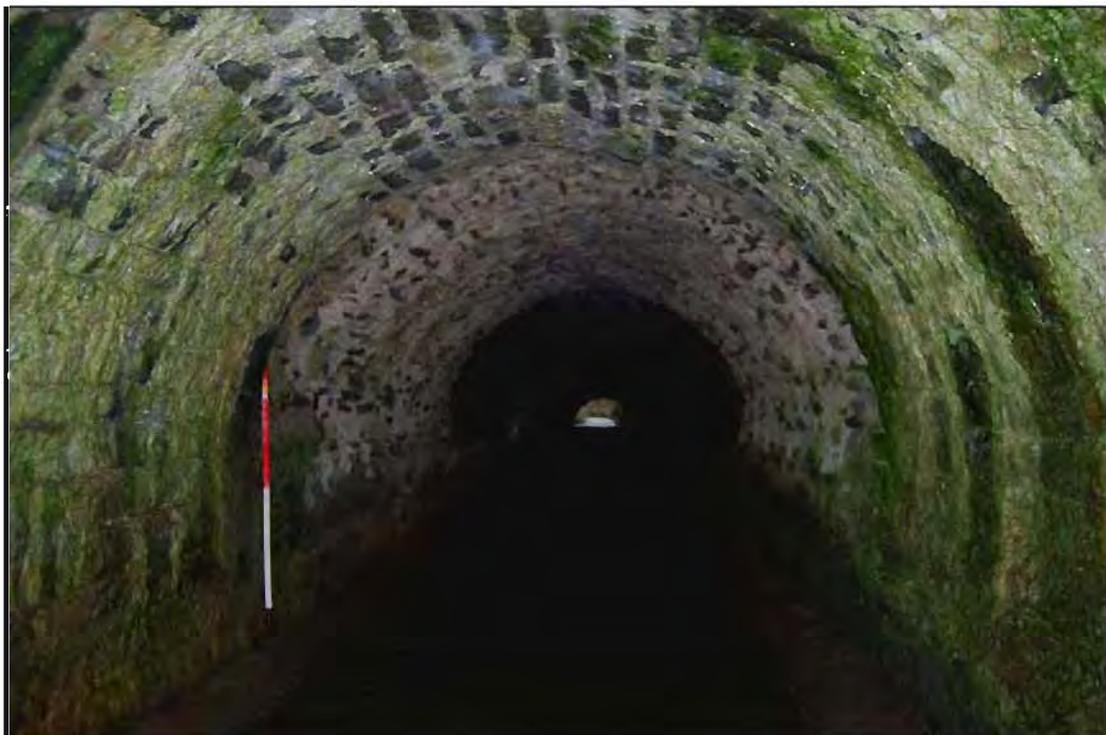
Plate 78: East-facing view through **Arch no. 2** showing transition between the upstream (Phase 3) and middle section (Phase 1) at Balheary Bridge, Feature 3 (1m scale).

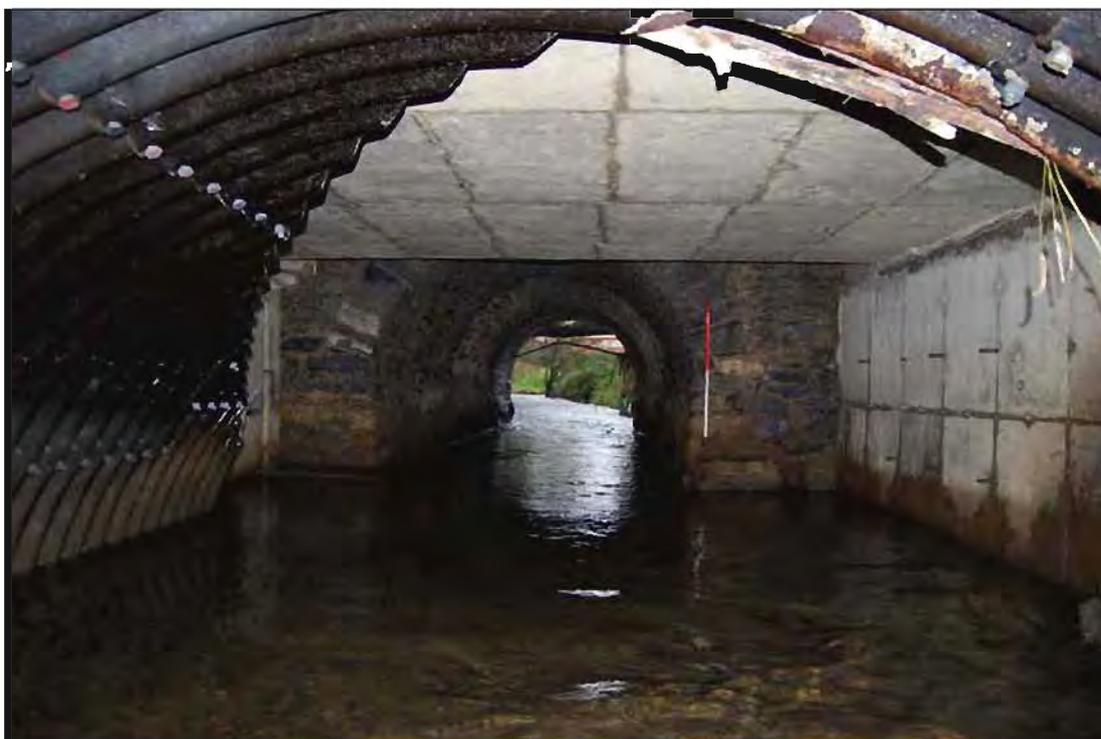
Plate 79: West-facing view of **Arch no. 1** on downstream side of Balheary Bridge, Feature 3 (1m scale). Shot take from within adjoining concrete culvert.

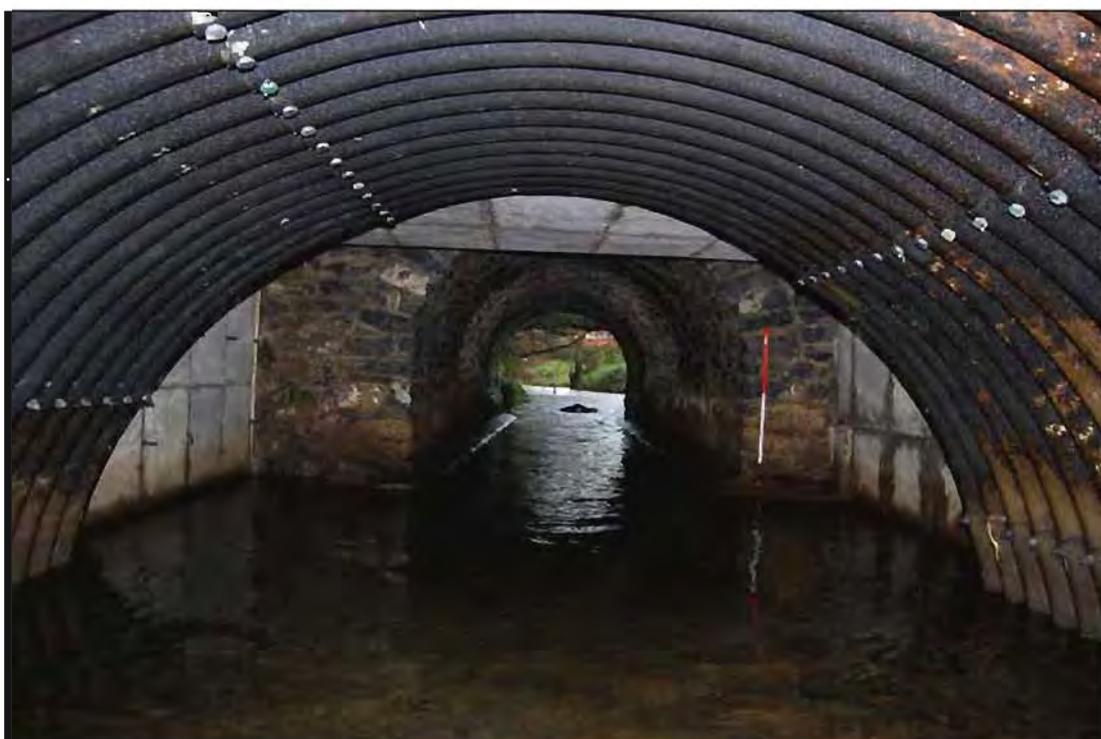
Plate 80: West-facing view of **Arch no. 2** on downstream side of Balheary Bridge, Feature 3 (1m scale). Shot take from within adjoining concrete culvert.

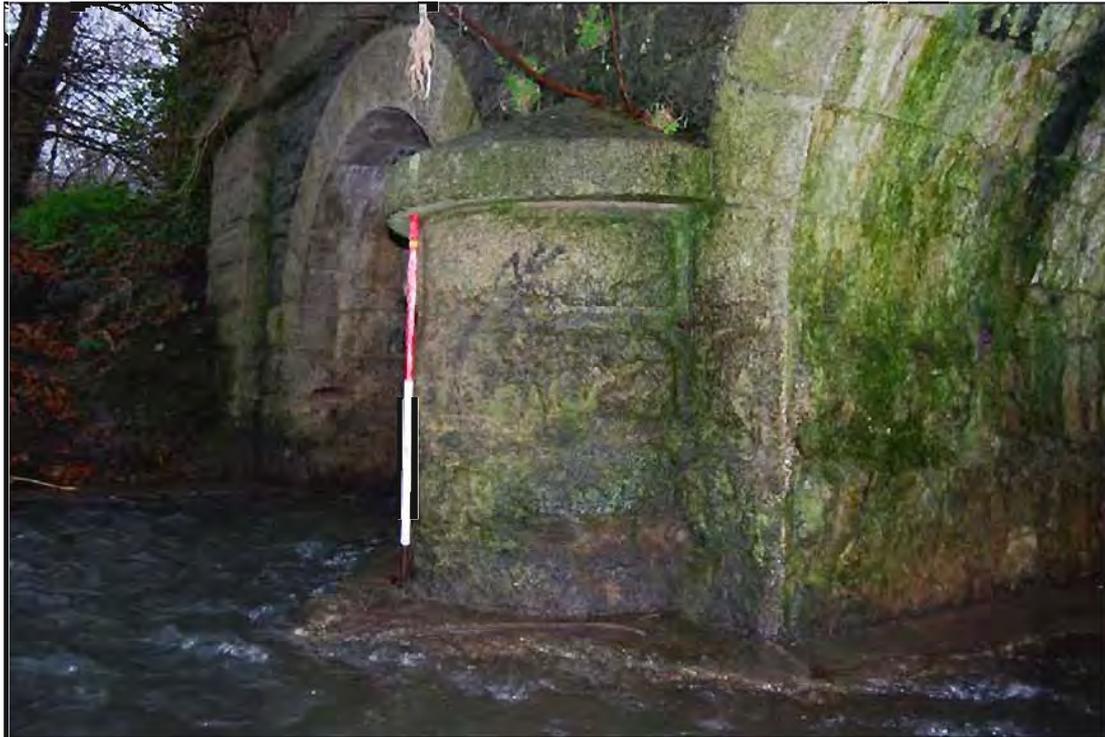
Plate 81: North-facing view of semi-circular cutwater located between Arch nos. 1 and 2 on upstream side of Balheary Bridge, Feature 3 (1m scale). Note: concrete underpinning of bridge structure.

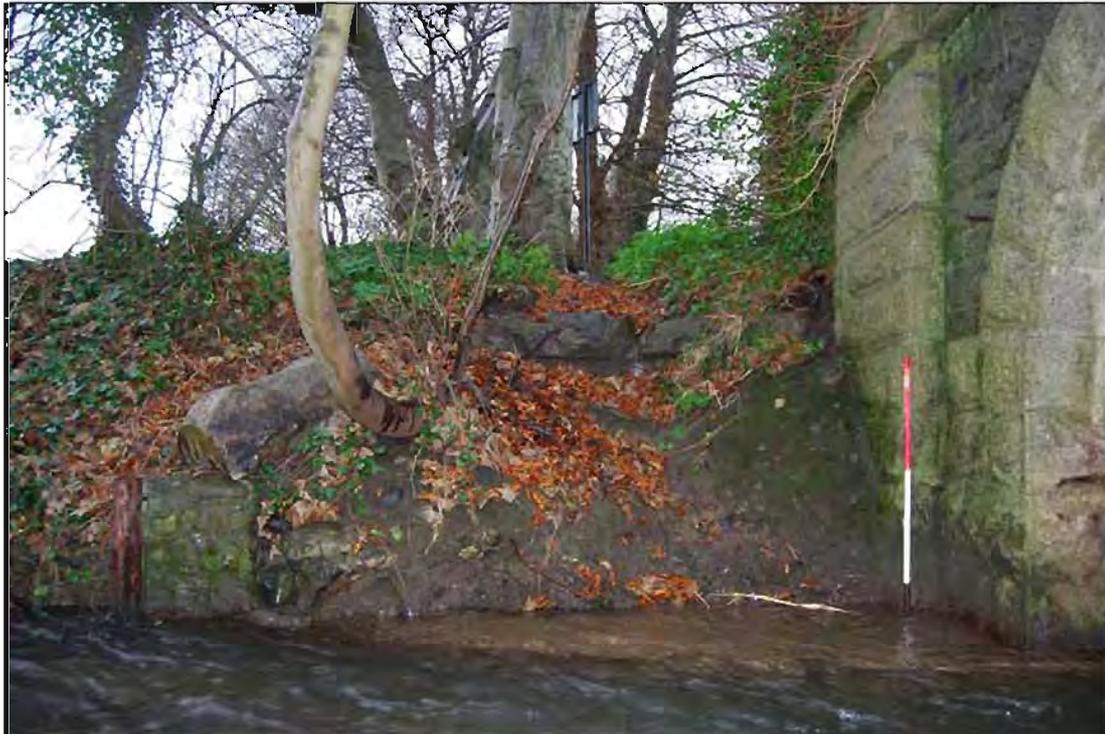
A weir is marked on the OS Third Edition Map of 1906, c.3m upstream (west) of Balheary Bridge. The in-water elements of this structure are no longer present, having been removed sometime in the in the twentieth-century (possibly during the bridge consolidation works undertaken in 1960s). This feature is not marked on the First Edition map of 1837, suggesting that the structure was of late nineteenth-century date. However, two masonry walls forming part of, or associated with, the weir structure remain. These structures are located on either side of the Ward River, running parallel (north-south) to Balheary Bridge (c.3m upstream of the bridge). The northern section of walling is located at NGR: 318738E, 248143N (southern end) and measures 0.45m in width; it is upstanding 0.72m from the riverbed (Plate 82). The northern end of the structure is covered by the adjacent riverbank, leaving only a

Plate 82: North-facing view showing concrete underpinning of upstream side of Balheary Bridge and section of masonry wall (Feature 4) located to right of picture, on north side of the Ward River (1m scale).

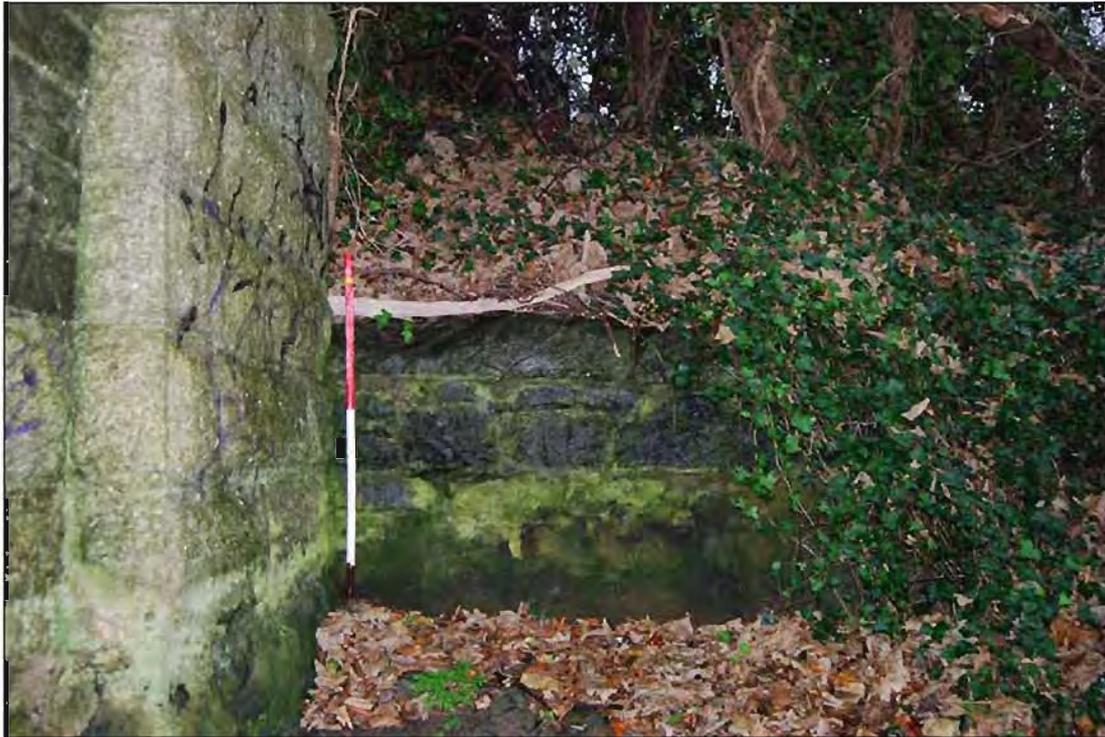
Feature 4 comprises of four sections of limestone walling associated with a late nineteenth to early twentieth-century weir structure that was located c.3m upstream of Balheary Bridge. The structures are of relatively modern origin and are of historic, rather than archaeological, interest. The weir structure depicted on the OS Third Edition mapping has been completely removed and there is no indication of any foundations associated with this structure being present.

Plate 83: South-facing view of masonry wall, part of Feature 4, abutting upstream side of Balheary Bridge located to right of picture, on south side of the Ward River (1m scale).

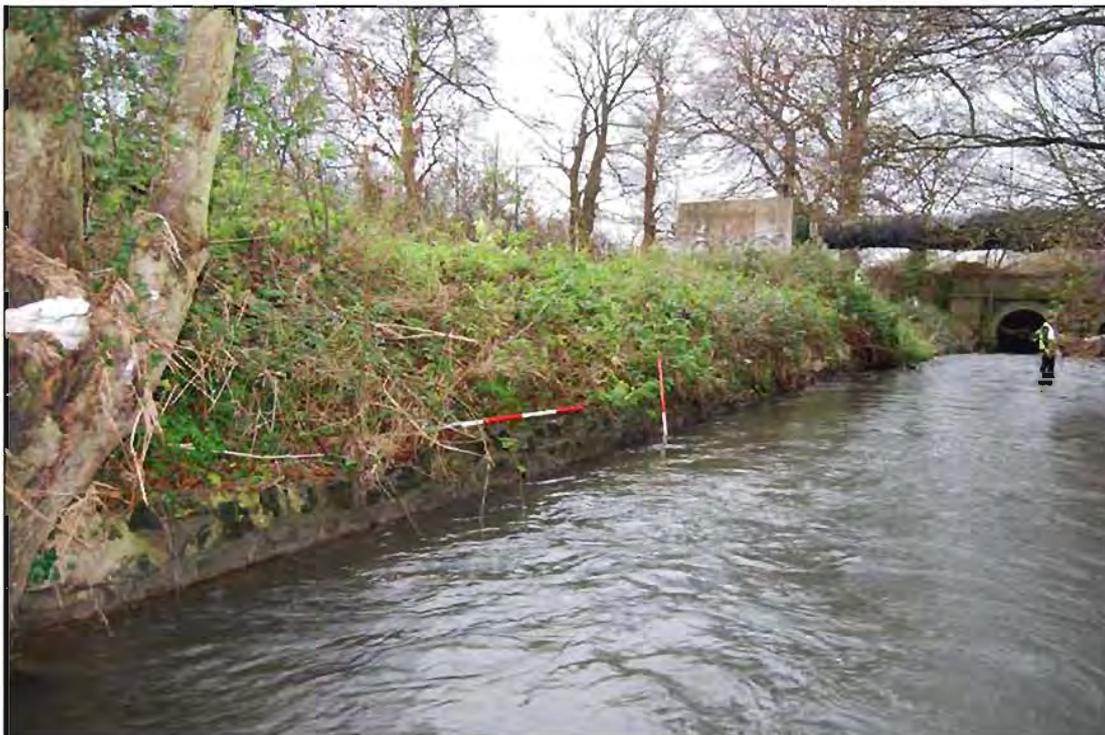
Plate 84: Northeast-facing view of Ward River showing location of revetment wall (Feature 5, Section 1) located along north side of the river (1m vertical and 2m horizontal scale).

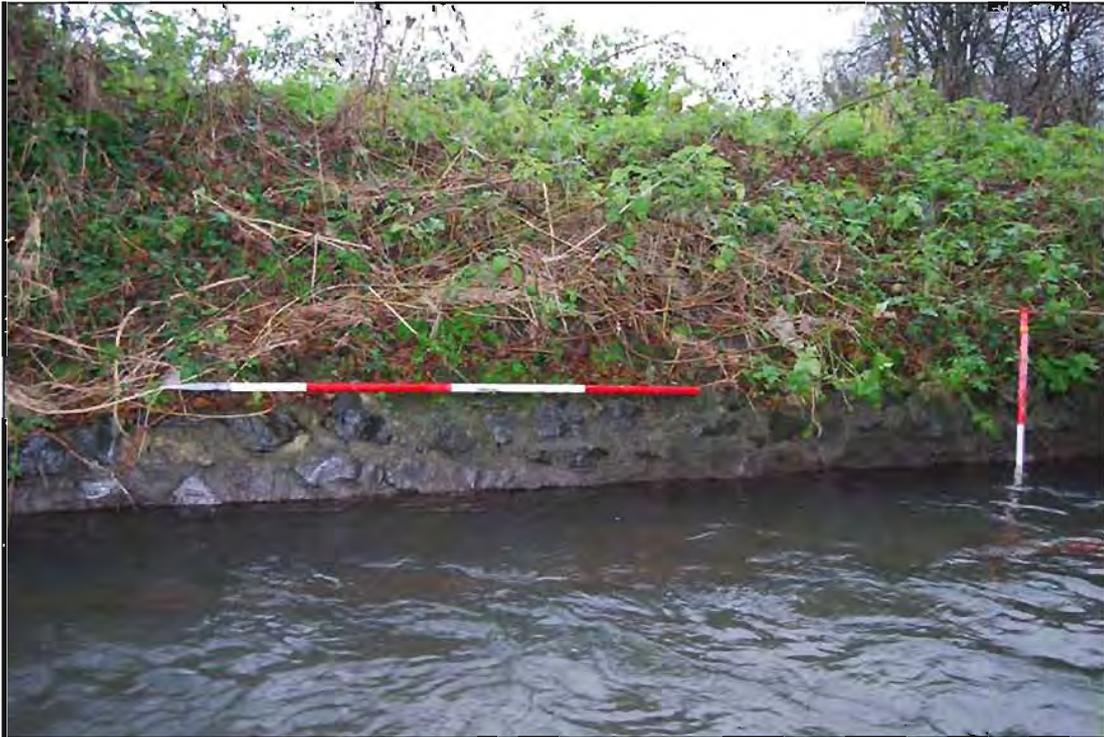
Plate 85: North-facing detail shot of revetment wall (Feature 5, Section 1) located along north side of the river (1m vertical and 2m horizontal scale).

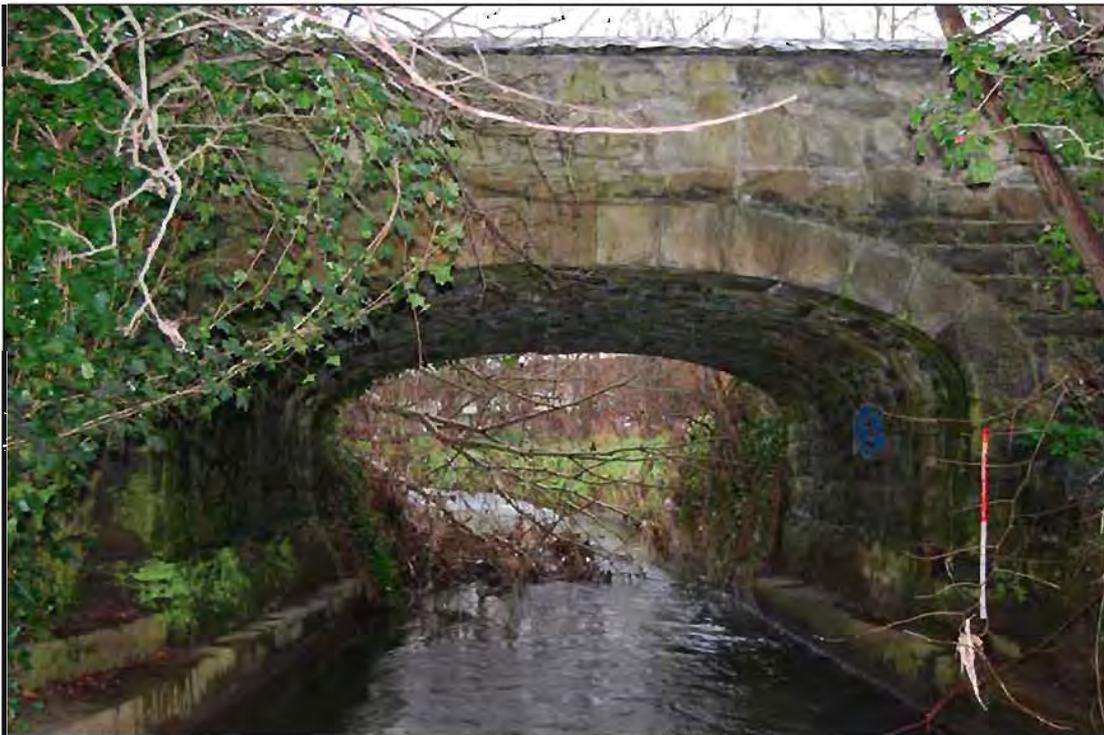
Plate 86: West-facing view of downstream side of a single-arched bridge (Feature 6) located 92m upstream of Balheary Bridge (1m scale).

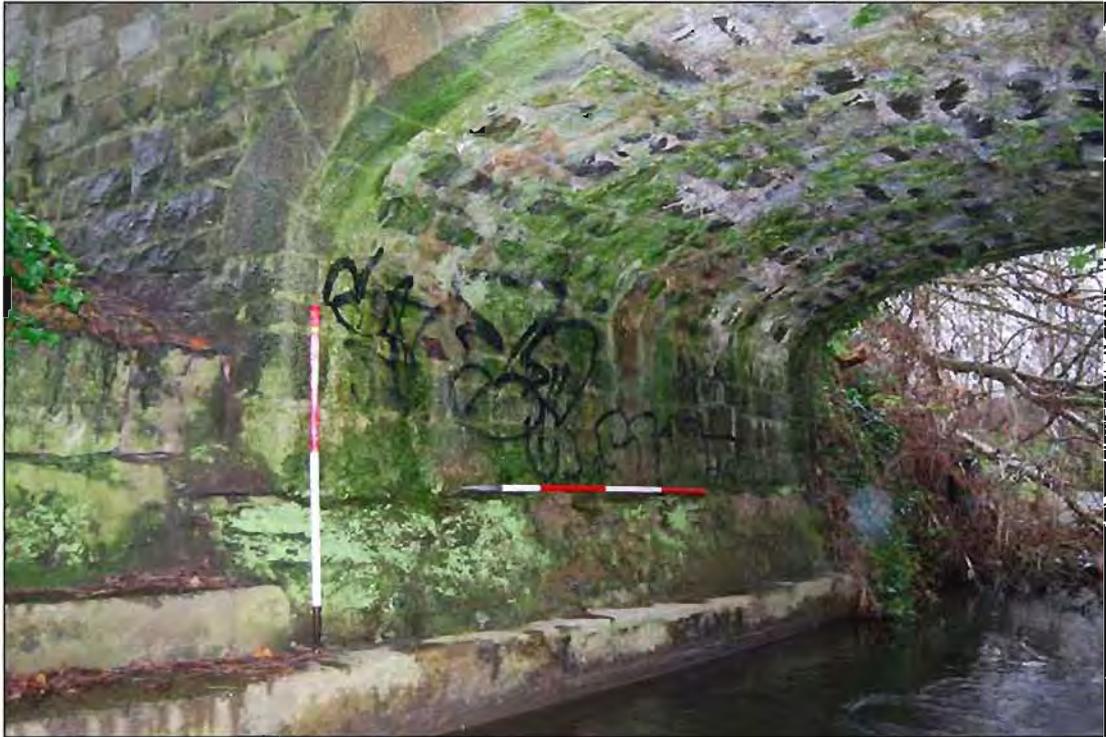
Plate 87: Southwest-facing view of southern side of a single-arched bridge (Feature 6) located 92m upstream of Balheary Bridge (1m vertical and 2m horizontal scale).
