**UNDERWATER & INTER-TIDAL
ARCHAEOLOGICAL ASSESSMENT
RIVER LIFFEY, 100M WEST OF O'CONNELL BRIDGE
TO BUTT BRIDGE, DUBLIN CITY**

08D094, 08R310

Client: The Railway Procurement Agency

27 January 2008

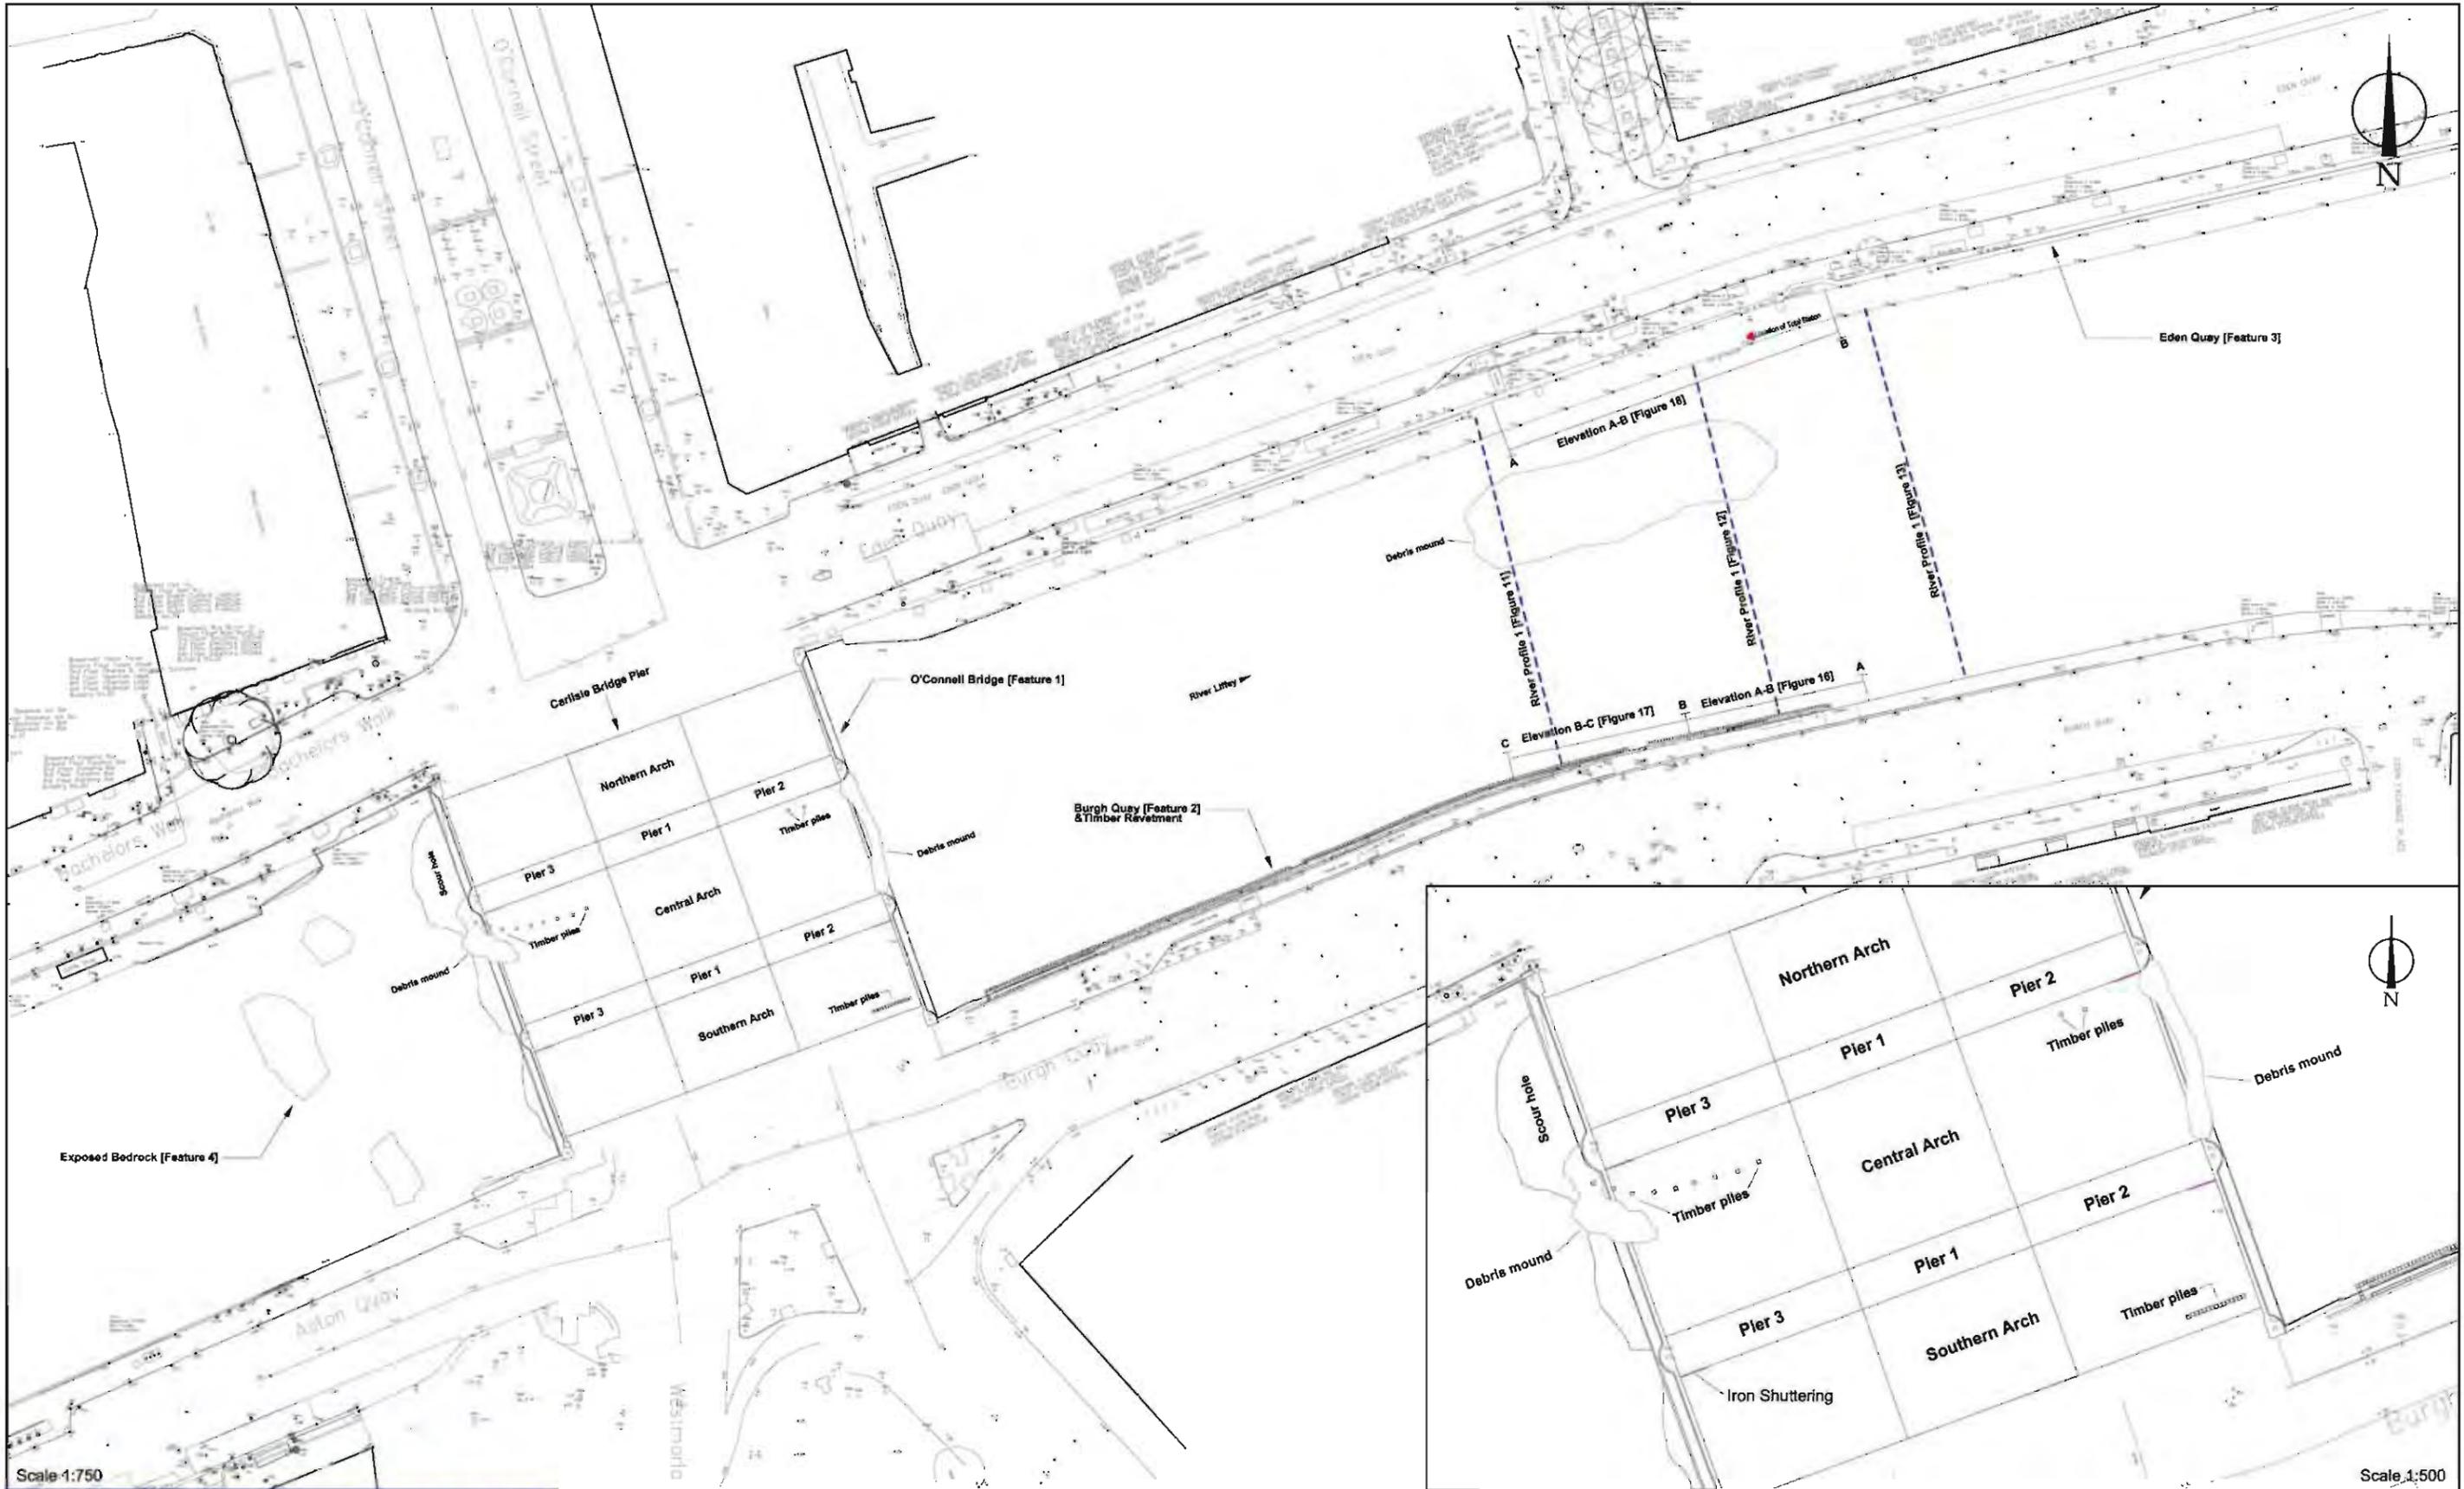
Drawing No.
Figure 9

Title
Figure 9- Extract from OS 6" RMP
Archaeological Mapping with ADCO River
Survey Area superimposed.

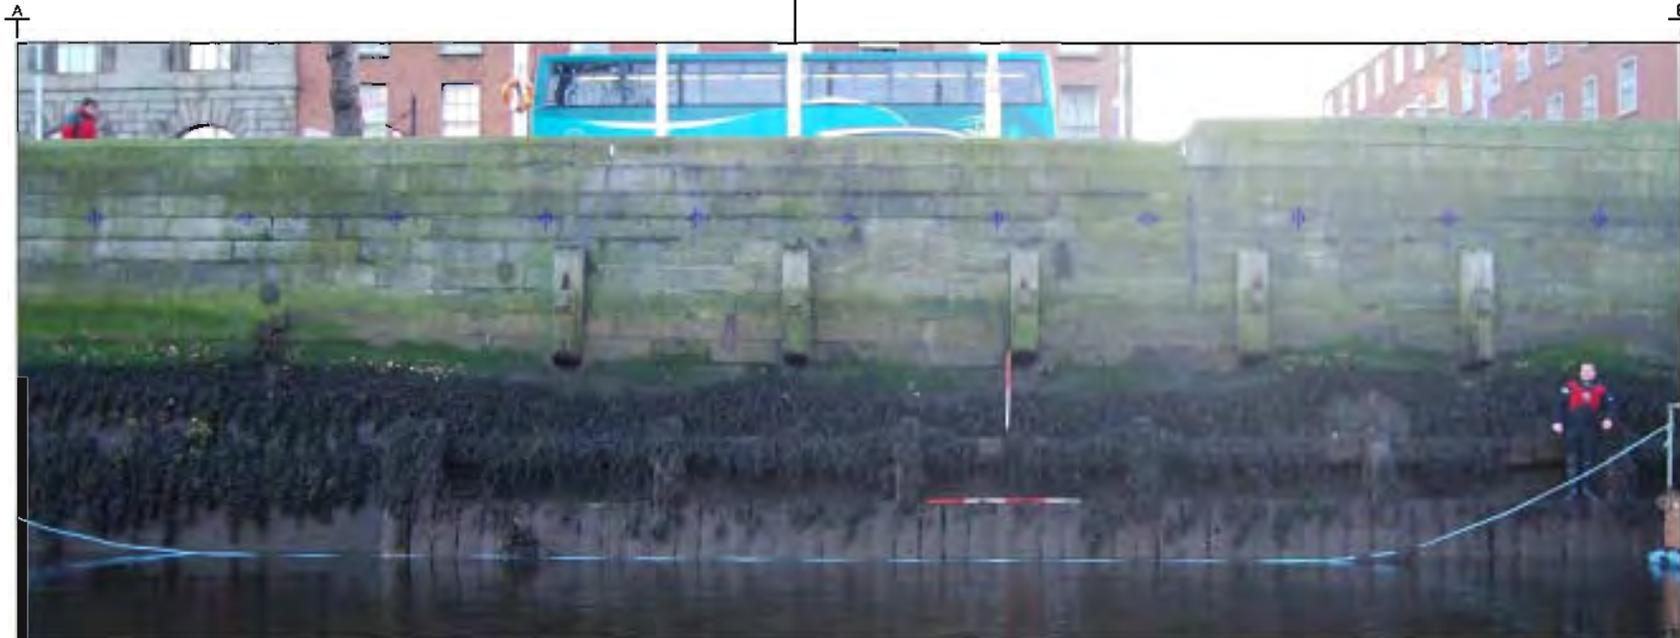
Figure 17

North-Facing Photographic Elevation of Burgh Quay

North-Facing Elevation of Burgh Quay

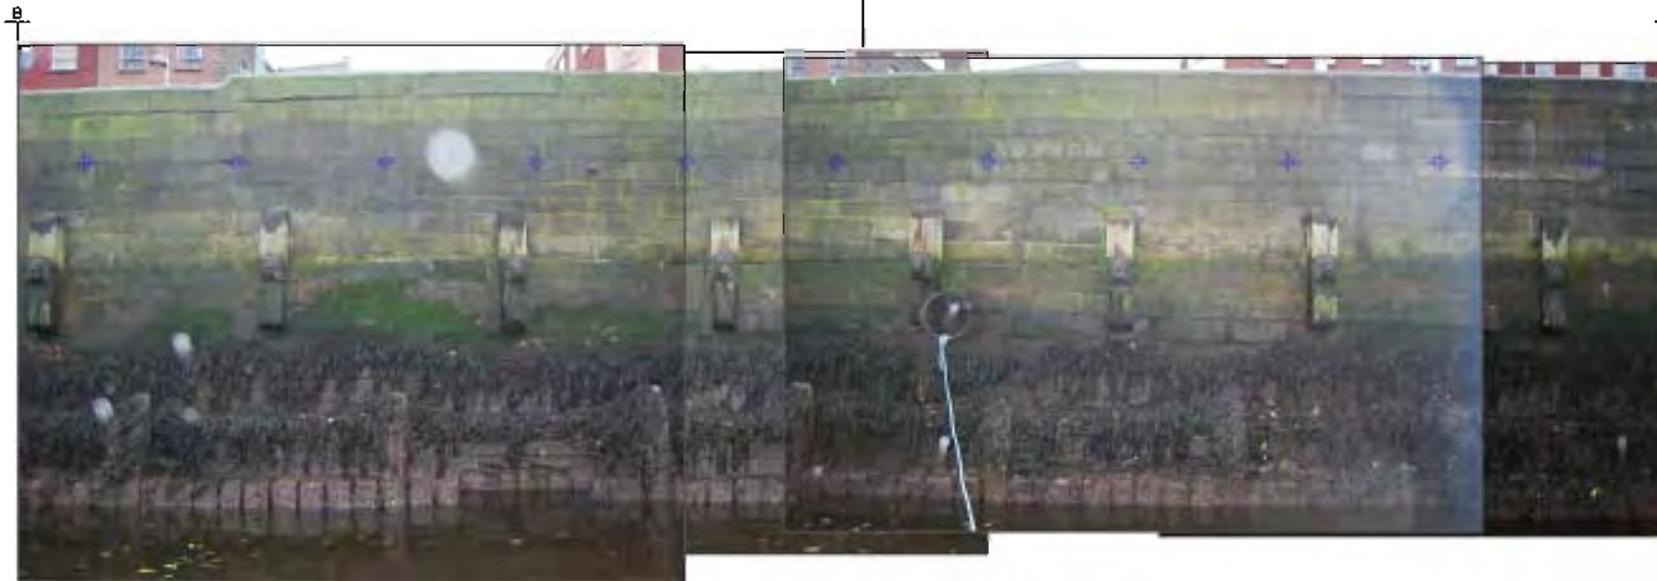
Figure 16

Title
Figure 16- Photographic and Drawn
Elevation of Burgh Quay [see Figures 10
& 15 for location].

North-Facing Photomosaic Elevation of Burgh Quay

The quayside was originally bonded with a hydraulic lime mortar, and it is evident that a large section of the structure was subsequently re-pointed using modern cement bonding. A section of possible structural repair work is also evident (Figure 15).

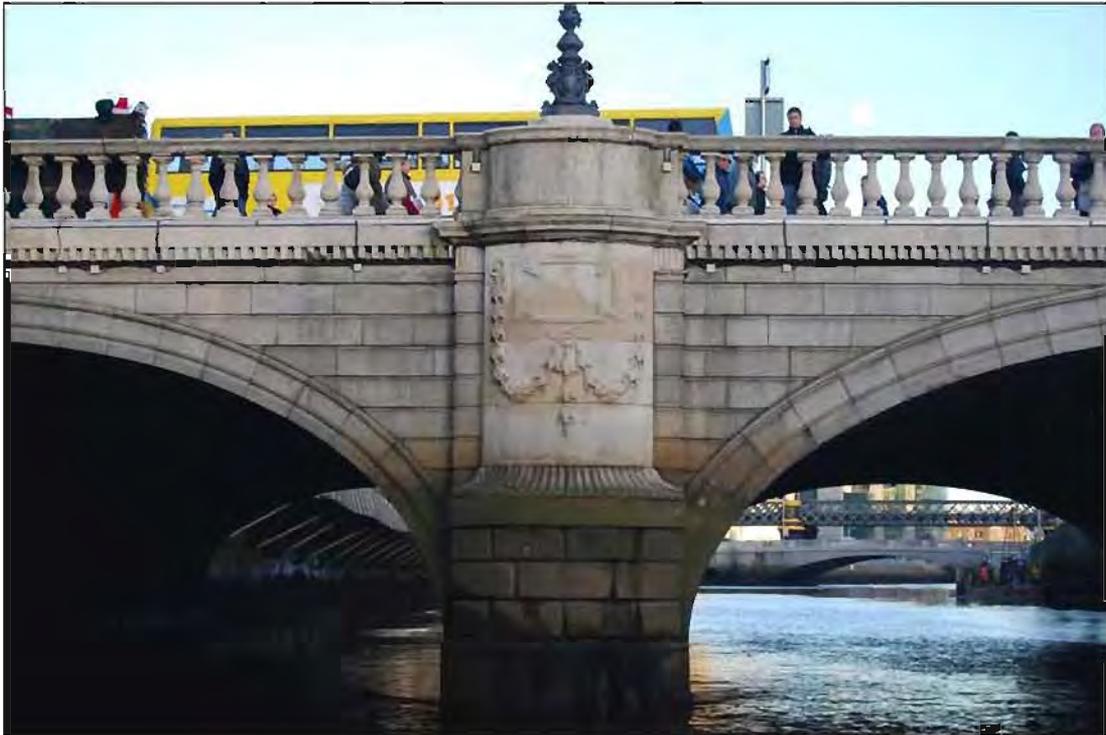
Plate 3: East-facing view of upstream cutwater, located between the northern and central archway.

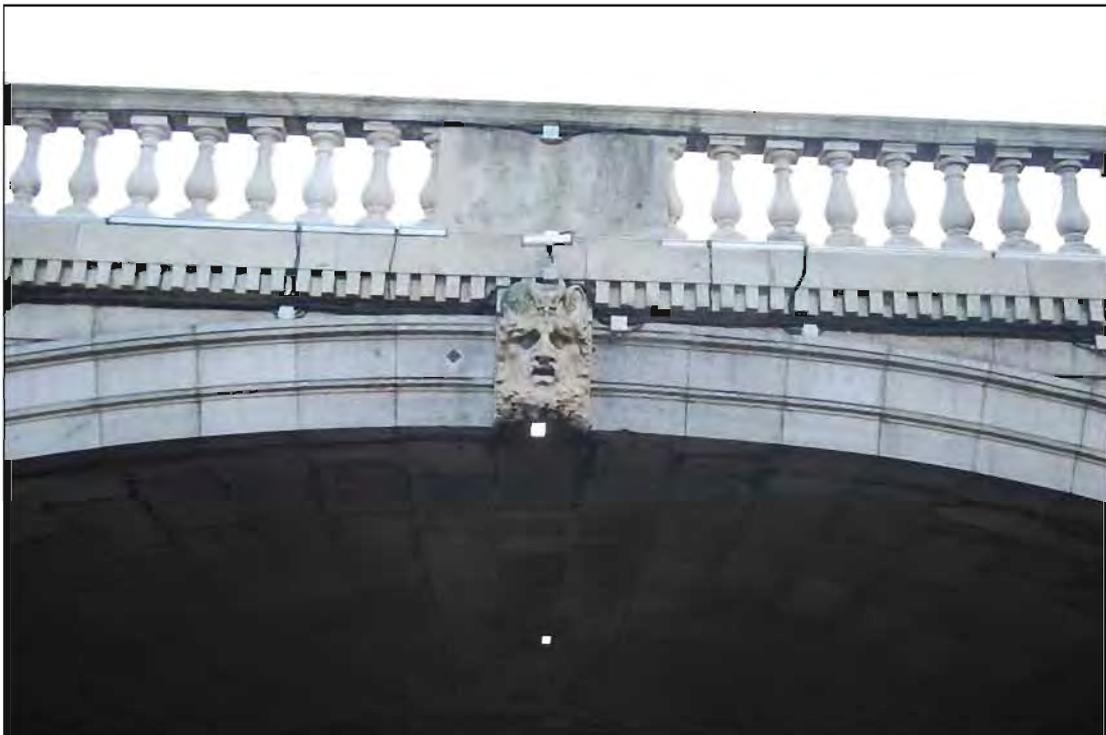
Plate 4: Detail shot of River God located above the downstream side of the central arch of O'Connell Bridge; this feature has been re-used from the original Carlisle Bridge façade.

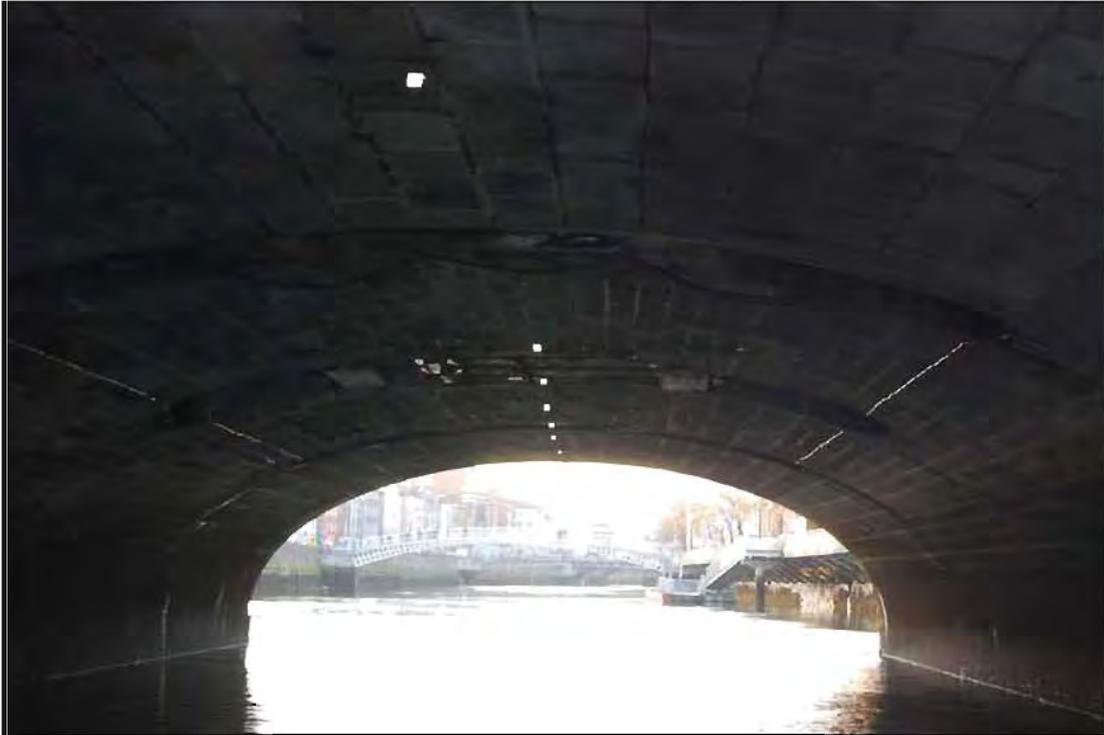
Plate 5: West-facing view of arch *intrados* (internal-arch ceiling) of the central-arch of O'Connell Bridge.

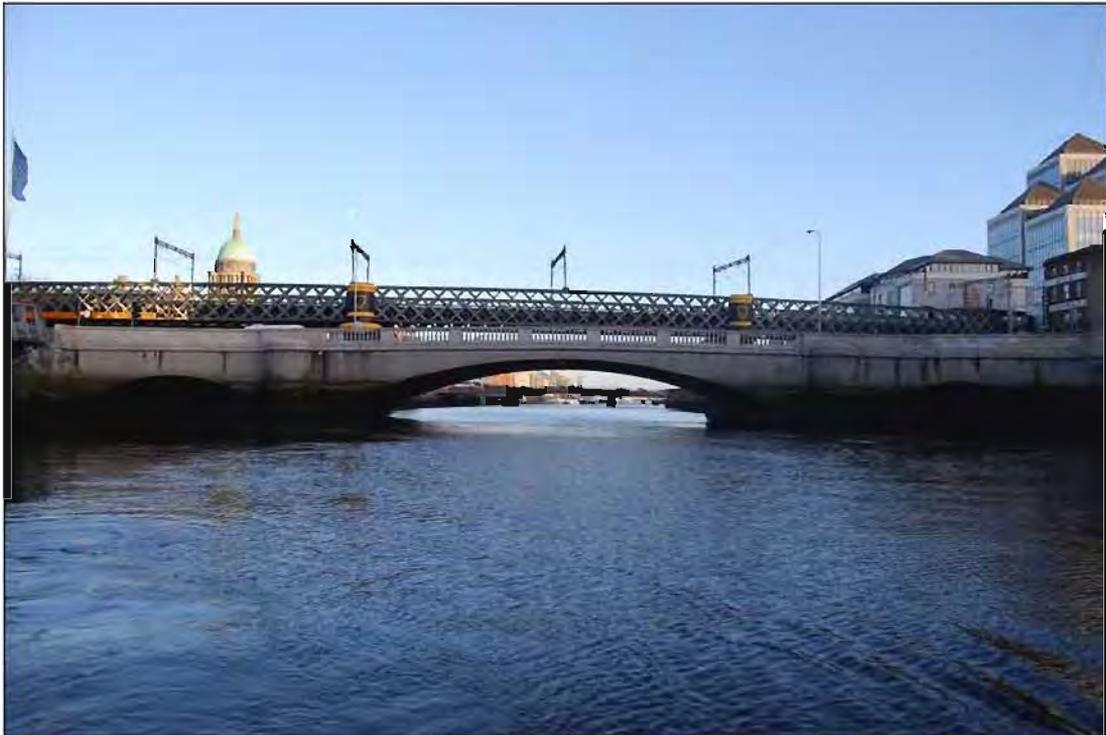
Plate 11: East-facing view of upstream façade of Butt Bridge.

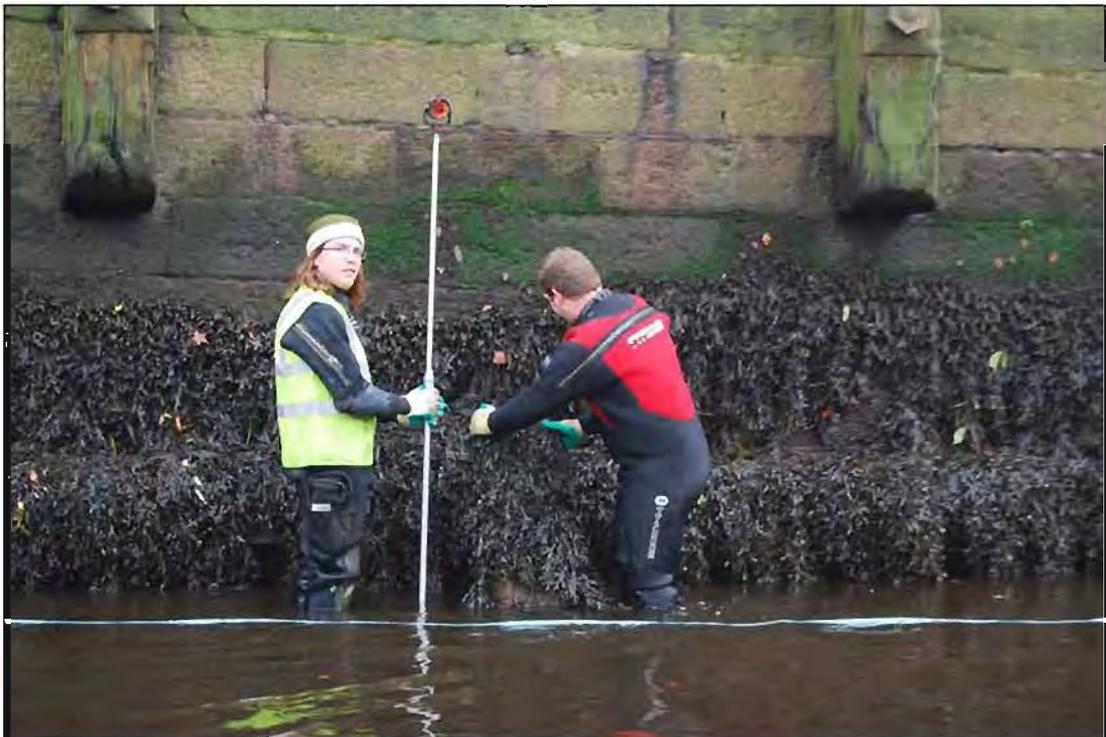
Plate 12: Working shot of Total Station survey of the Timber Revetment located alongside Burgh Quay (Feature 2).

A systematic visual inspection of all exposed inter-tidal riverbed areas was undertaken at Low Water, allowing a detailed written and photographic record of any features encountered to be made. This record was supplemented by GPS position-fixing and total-station survey (Plates 13 & 18). Particular attention was paid to the inspection and recording of a timber revetment (Feature 2) located along the northern half of Bugh Quay (Figures 14-16). In addition, two sections of quayside located within the proposed impact area for Marlborough Street Bridge underwent detailed survey, recording the quay structures in plan, cross-section, and elevation (Figures 15-18). A team of three maritime archaeologists and a certified surveyor undertook the inter-tidal survey work.

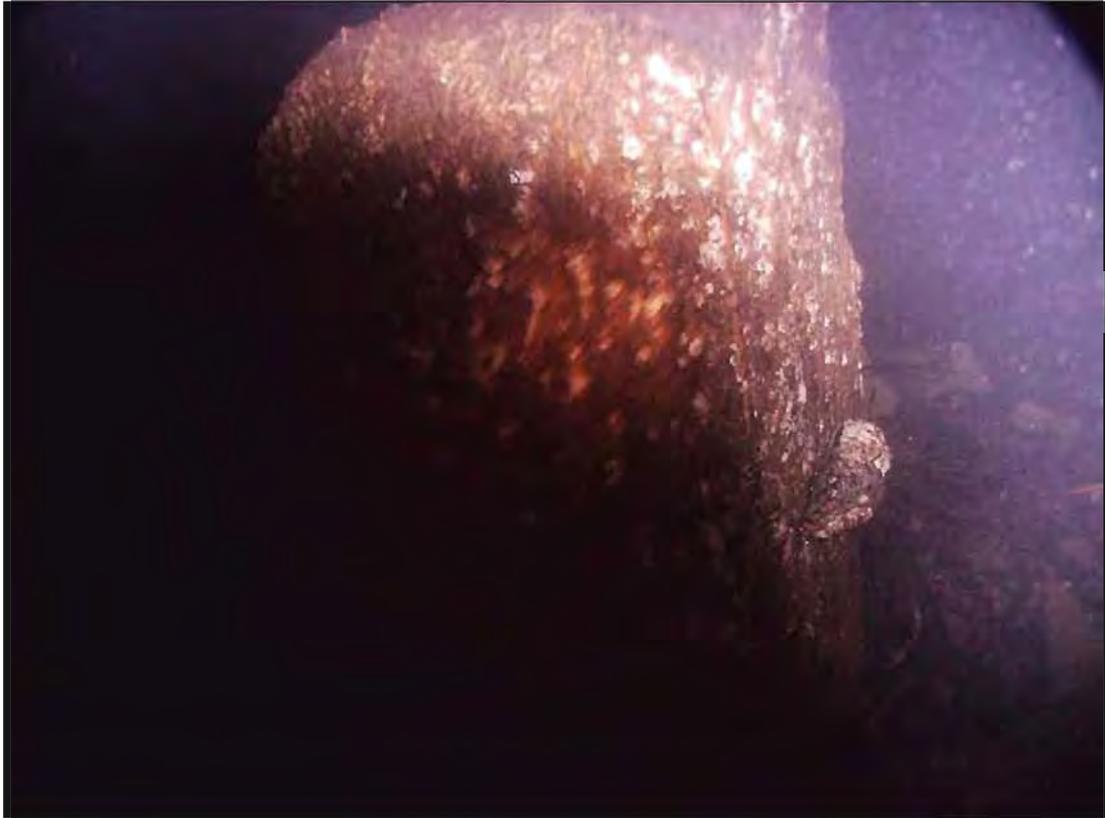
Plate 14: West-facing view of top of timber pile upstanding 0.60m from riverbed, c. 0.85m from arch-wall on north side of central archway.

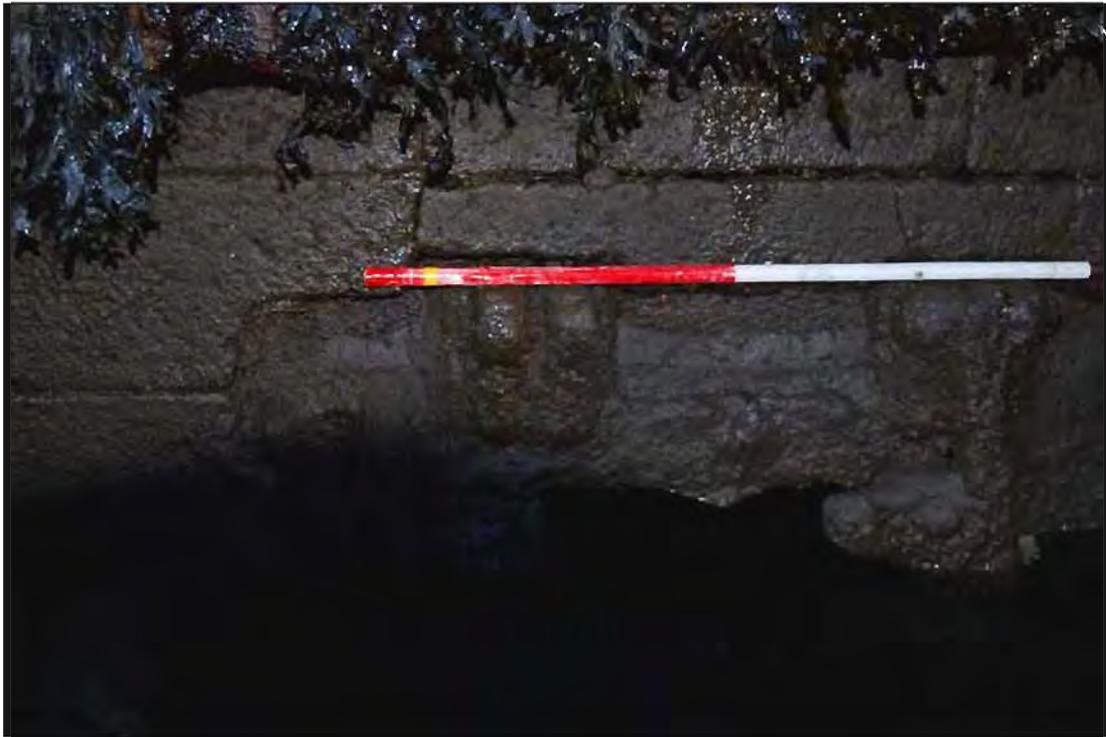
Plate 20: Detail shot of top section of nineteenth-century drain located along the base of Burgh Quay (1m scale).

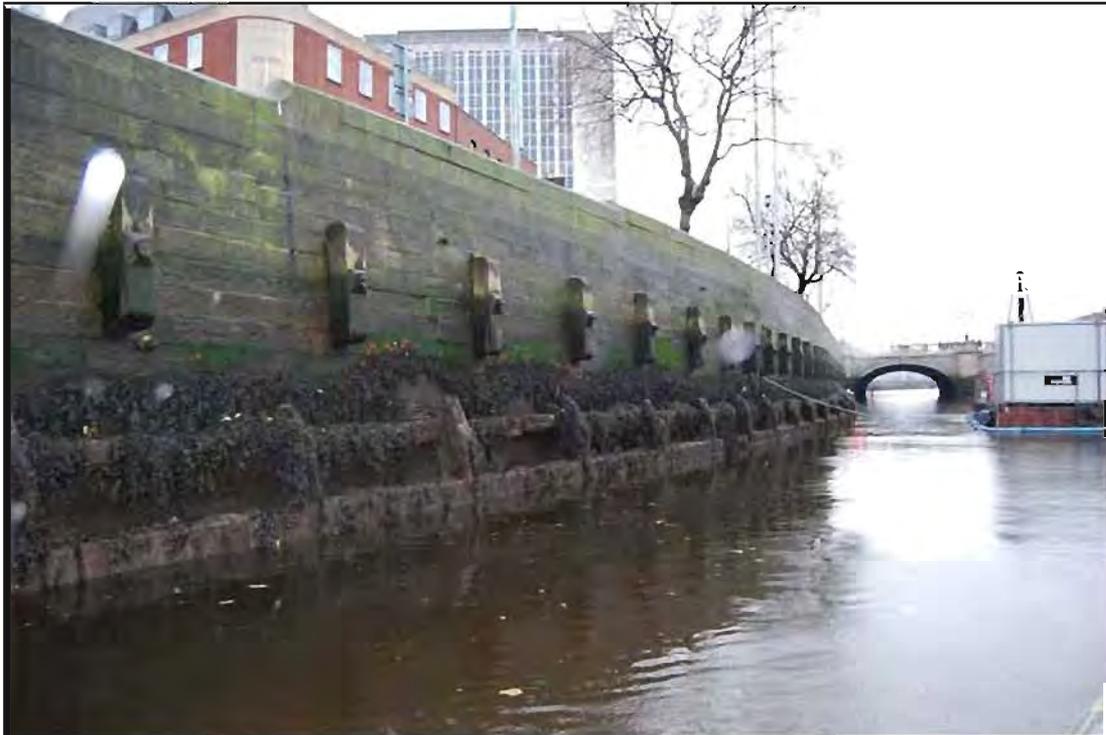
Plate 22: Southwest-facing view along Burgh Quay (Feature 2) and its associated timber revetment; O'Connell Bridge in distance.

A 160m long section of timber revetment is located between NGR: 316024E, 234381N and NGR: 316128E, 234416N. (Figure 14, Plate 22). The revetment served the purpose of consolidating the base of Burgh Quay at this location. The structure stands out between 0.77m and 1m from the quayside. It was not possible to inspect the base of the revetment as it is obscured by a 0.50m+ deposit of river-silts and mud. The timbers which comprise the revetment may be grouped into seven distinct types (Types A-G), which are discussed below:

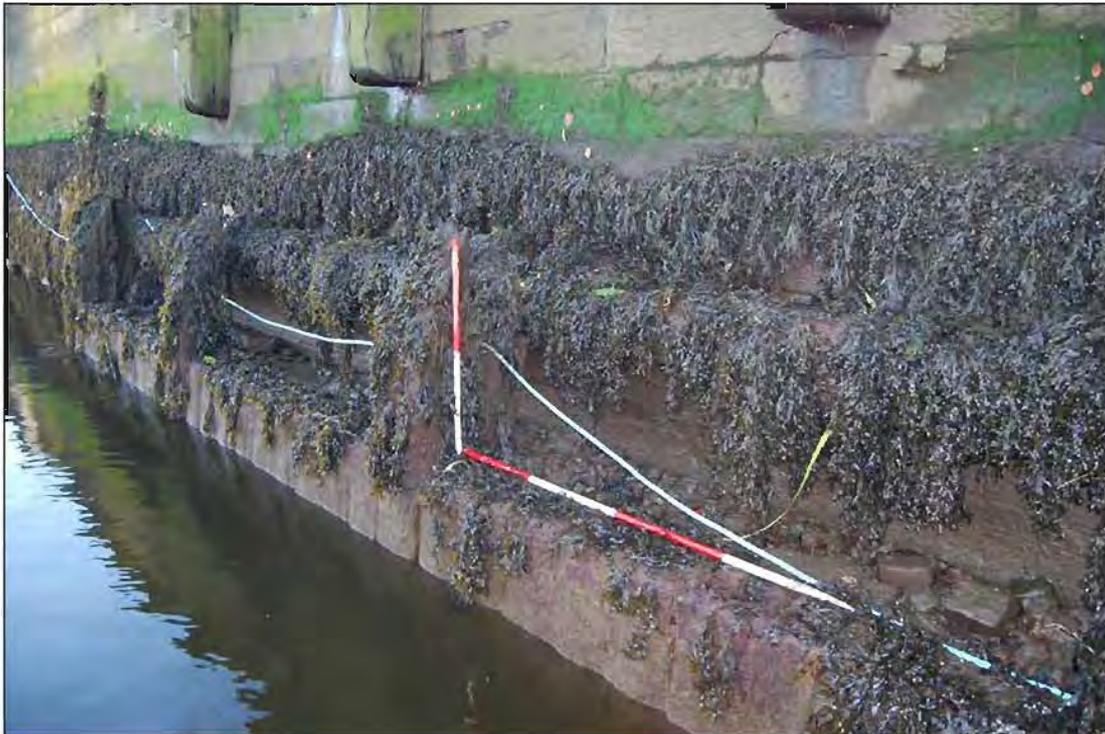
Plate 24: Detail shot of timber revetment at Burgh Quay (Feature 2) showing vertical Timber Types A, B, and C; horizontal scale 2m, vertical scale 1m.

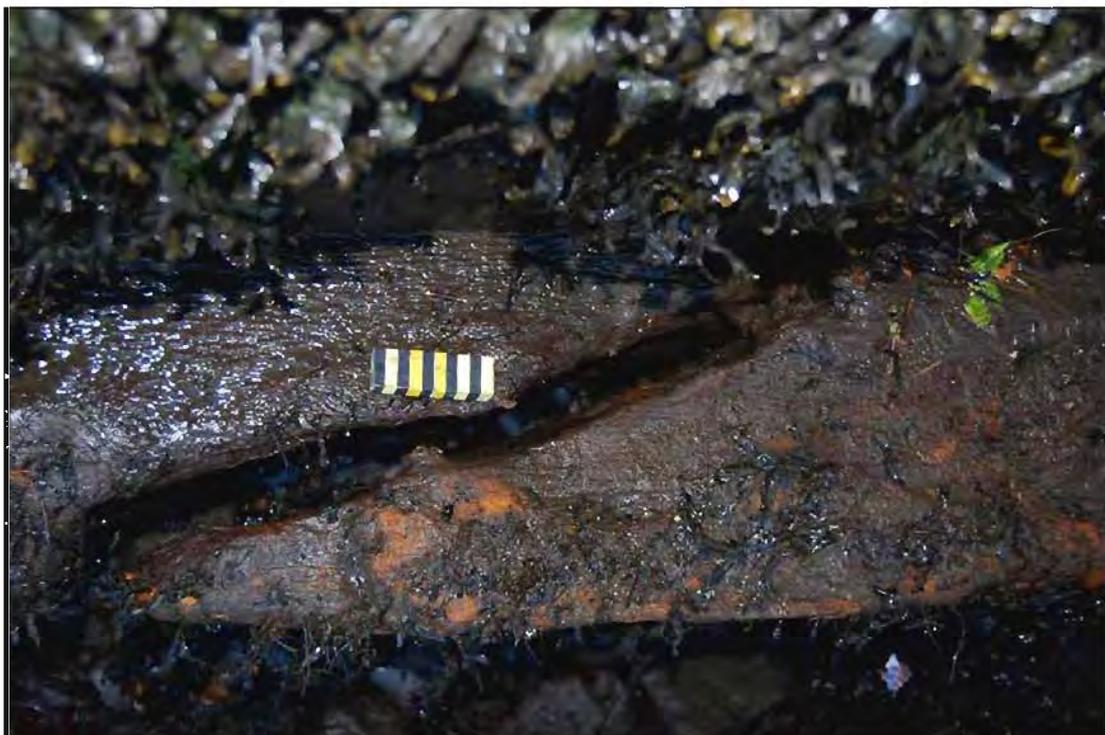
Plate 25: Detail shot of vertical Scarph-joint used to fasten the horizontal timbers (Type D) that run along Burgh Quay (Feature 2); 0.10m scale.

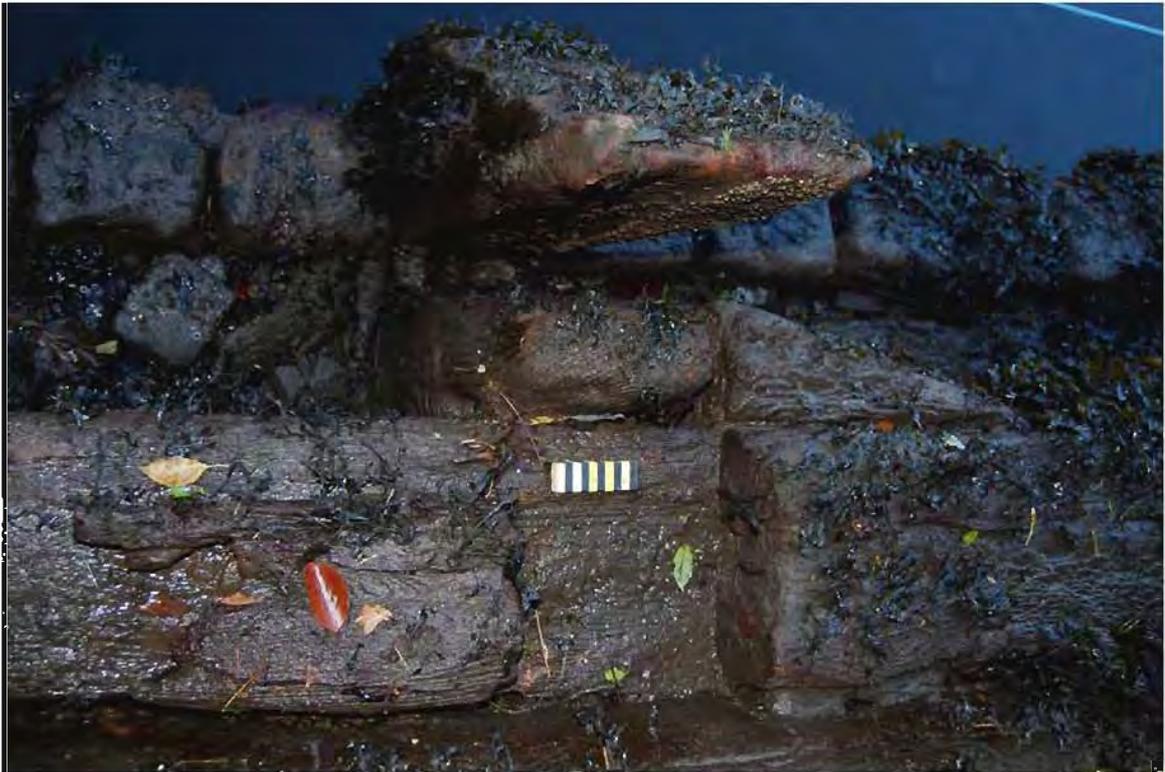
Plate 26: Plan view of composite section of timber revetment at Burgh Quay (Feature 2) showing timber types A, B, C, D, and the wedge-shape timber type E.; 0.10m scale.

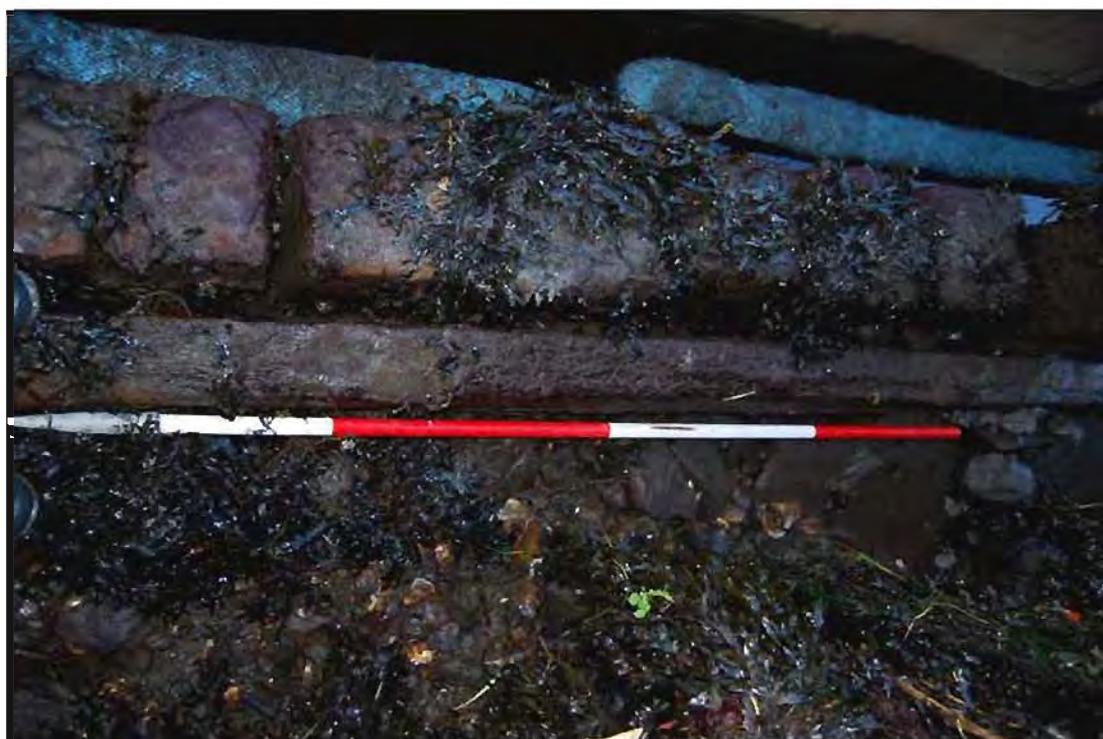
Plate 28: Plan view of timber vertical timber piles (Type A) and adjacent horizontal timbers (Type F); 2m scale.

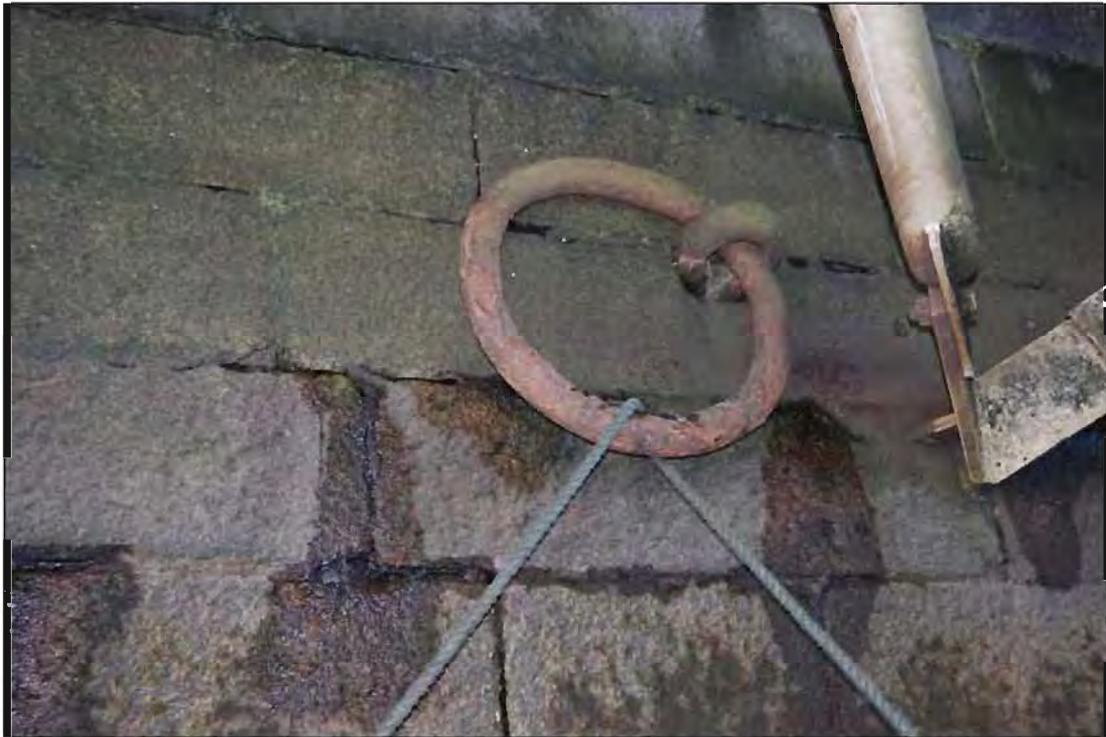
Plate 30: Detail shot of iron mooring hoop located along HWM of Eden Quay (Feature 3).

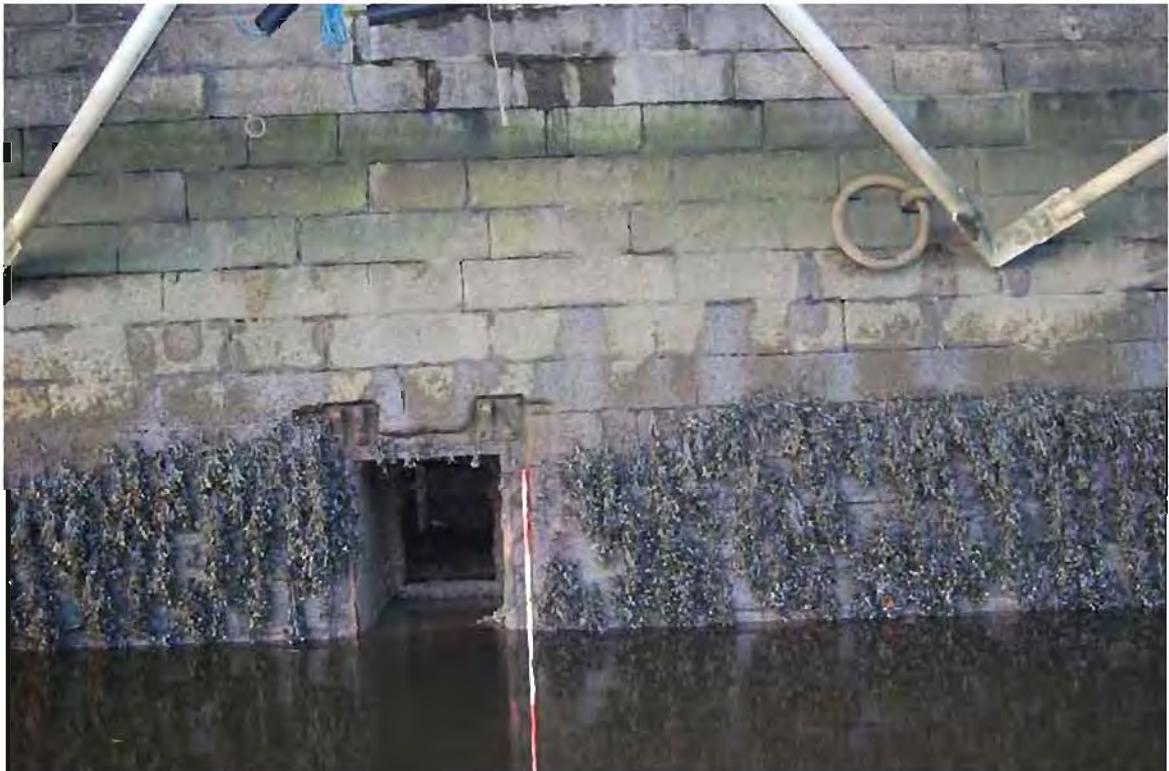
Plate 31: North-facing view of nineteenth-century drain located along the base of Eden Quay (Feature 3); 1m scale.

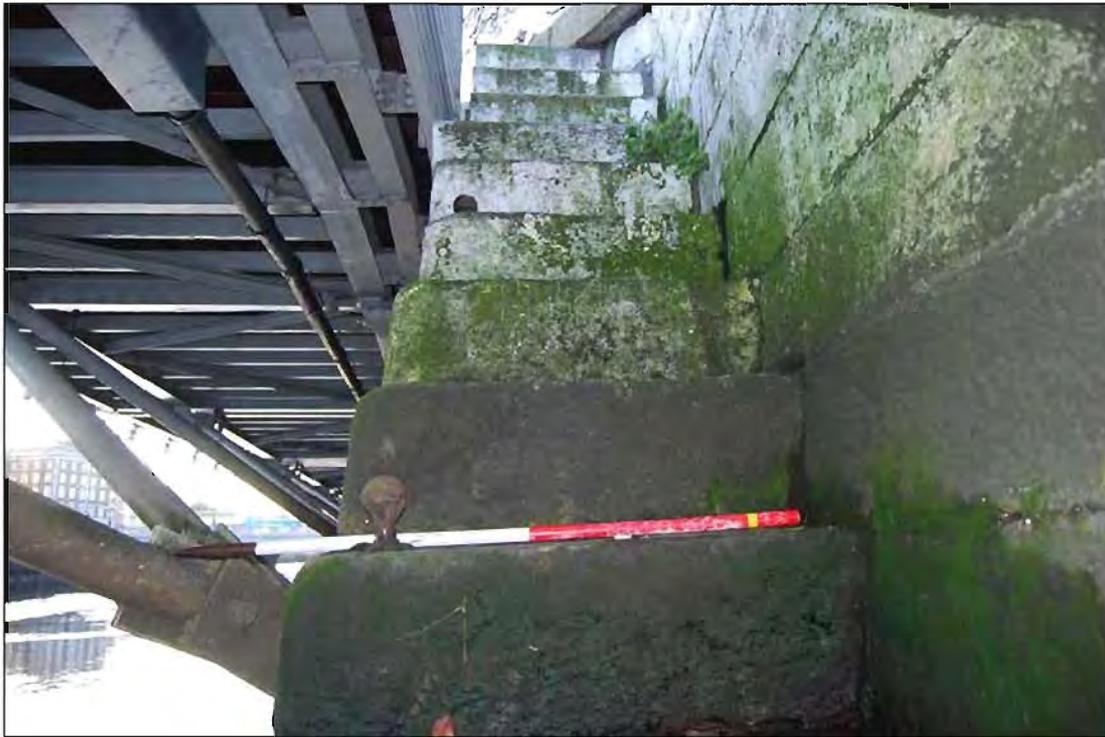
Plate 32: East-facing detail shot of masonry steps providing access to the river from Eden Quay (Feature 3); 1m scale.

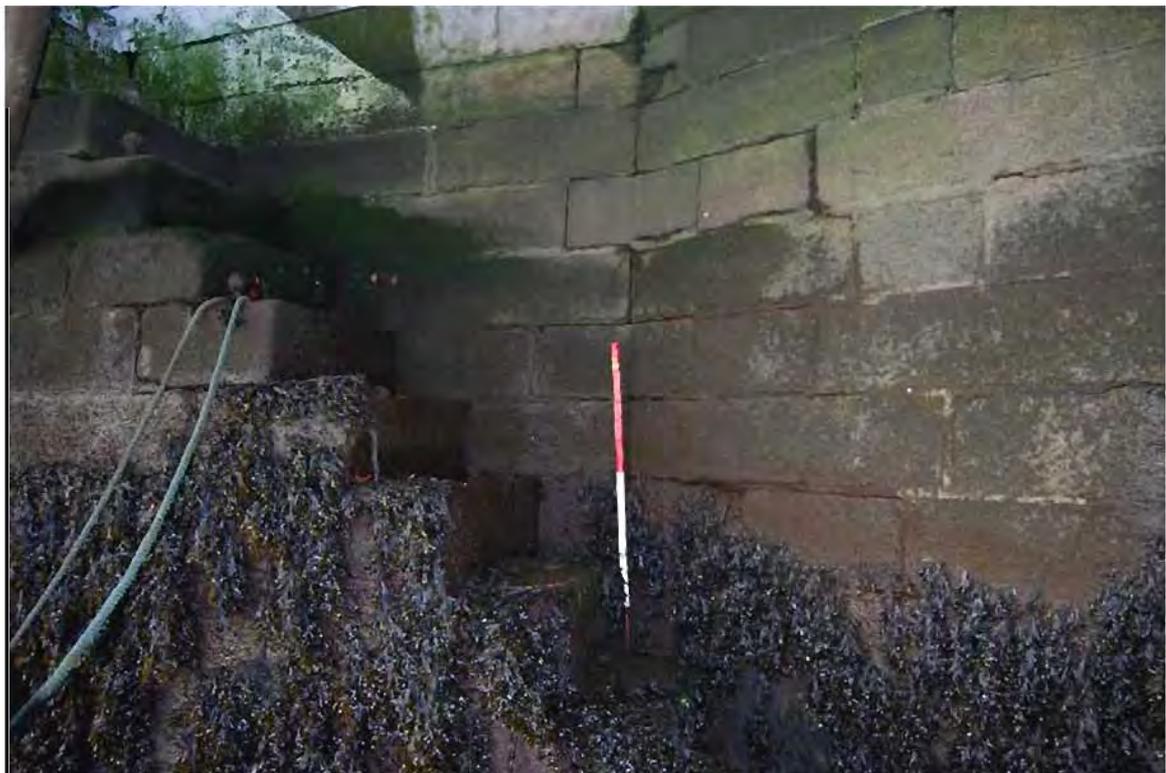
Plate 33: North-facing view of masonry steps providing access to the river from Eden Quay (Feature 3); 1m scale.
