7.0 ARCHAEOLOGY, ARCHITECTURAL AND CULTURAL HERITAGE

7.1 ASSESSMENT METHODOLOGY

7.2 ARCHAEOLOGY

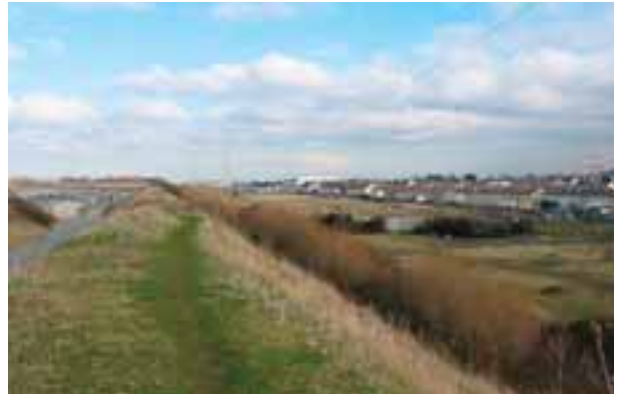
No features of an archaeological nature were identified during the course of the field inspection. The route of the proposed line crosses modern road surfaces, derelict backlands and some agricultural lands, all of which show signs of significant disturbance. Section A consists of a mixture of landscaped green areas, road surface and open scrub pasture between Cookstown Way and the embankments of Roadstone Quarries. The field boundaries in this area are overgrown but appear to be of ditch and low bank construction.

View of Section A from West

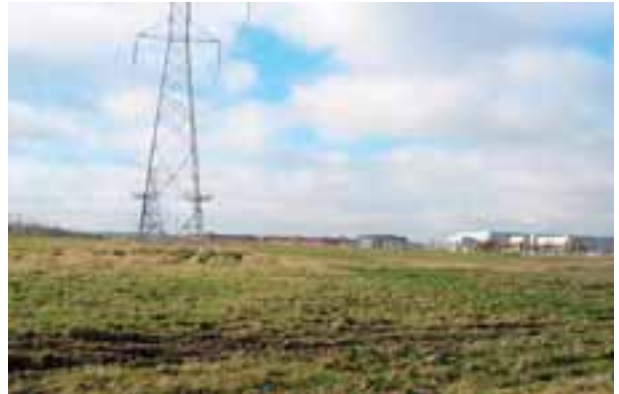
Section B passes through open ground to the south of Citywest Business Park. Although a green area, the ground surface has been levelled and the adjacent watercourses and open ditches, including a drainage ditch of the River Camac, show signs of recent dredging. The only remaining trace of the watercourse and marshy area noted in cartographic sources consists of an overgrown field drain.

View of Section B from East

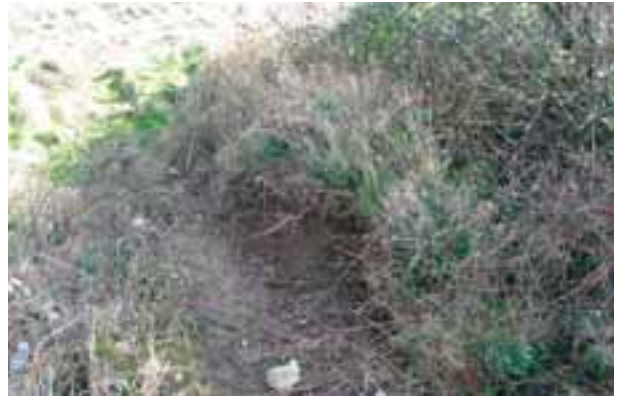
On the west side of the N82 Section B crosses a watercourse feeding the Camac River. This is free flowing with overgrown banks on either side.

Watercourse to West of N82

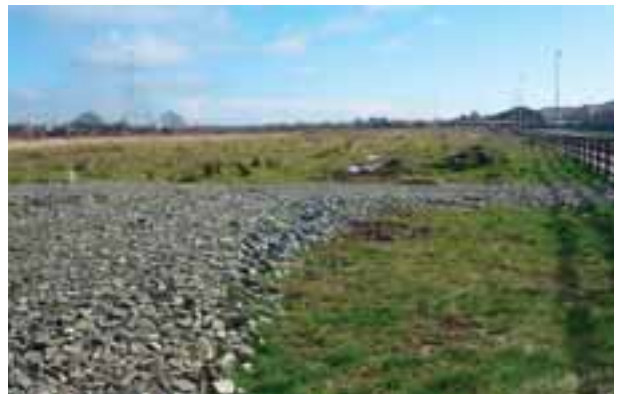
Another watercourse which feeds the River Camac is located in Section C; this is visible as an overgrown ditch and bank, the dimensions of which could not be ascertained. Section C is predominately rough pasture with the exception of a number of structures, noted below, and an area of hardcore at the Saggart terminus of the proposed route.

Fortunestown Lane (Section C) from West

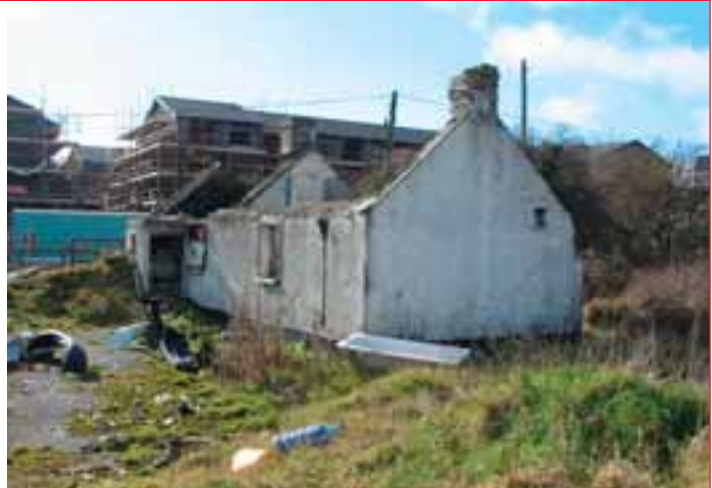
■ **ID 1** is an unoccupied, semi-ruinous cottage of probable nineteenth-century date located on the north side of Fortunestown Lane. It is aligned with its gable to the roadside and has a painted rough-dash façade. A small porch projects from its front, east-facing elevation. The surviving windows are timber casements. The roof is entirely missing and the interior is overgrown with vegetation. One intact gate pier survives at the entrance to the property. The surrounding site is overgrown and strewn with debris.

The properties ID1 & ID3 are of local architectural heritage merit and as they are being demolished a photographic survey must be compiled of these two 19th century structures. As no other structures of architectural heritage merit will be subject to impacts, no other mitigation measures are considered necessary.

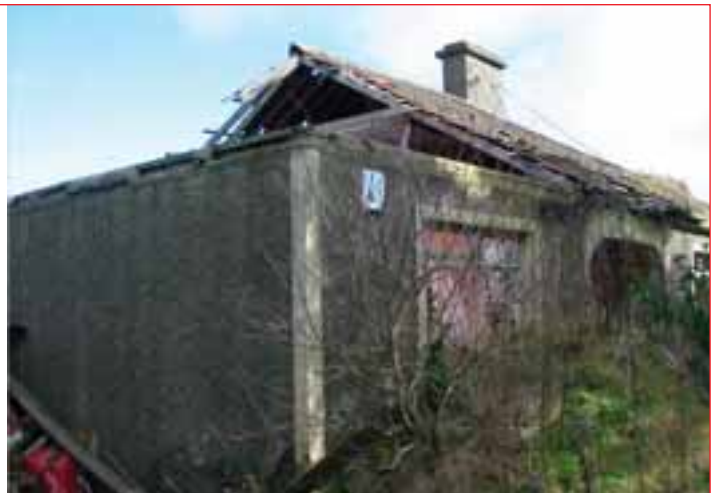
■ **ID 2** is an unoccupied and semi-ruinous property of c. 1950s date located on the north side of Fortunestown Lane. It is a single-storey, three-bay structure with an unpainted pebble-dashed façade and a recessed front entrance. The western half of the roof is missing. A flat-roofed, single-storey extension is attached to the rear. The front of the property is very overgrown and disturbed as is the side garden. A number of derelict sheds are located in the rear site.

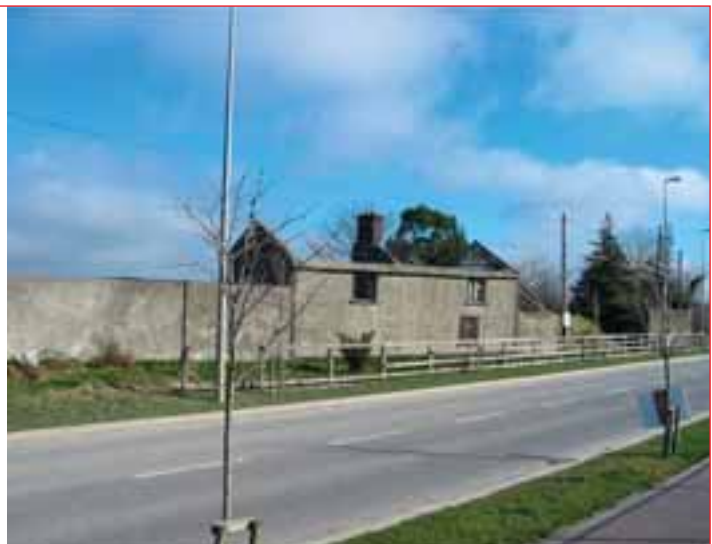
■ **ID 3** is an unoccupied and semi-ruinous property of probable nineteenth century date located on the north side of Fortunestown Lane. It comprises a two-storey, two-bay dwelling fronting onto the roadside with a single-storey modern extension at the rear. A single-storey shed is attached to either side of the dwelling. The façade is unpainted and pebble-dashed and the roof is entirely missing. A single storey, semi-ruinous, rubble stone cottage flanks the west side of the rear yard. The foundations of a concrete shed are located in the northwest corner of the yard. There is no boundary to the rear site and debris is strewn throughout

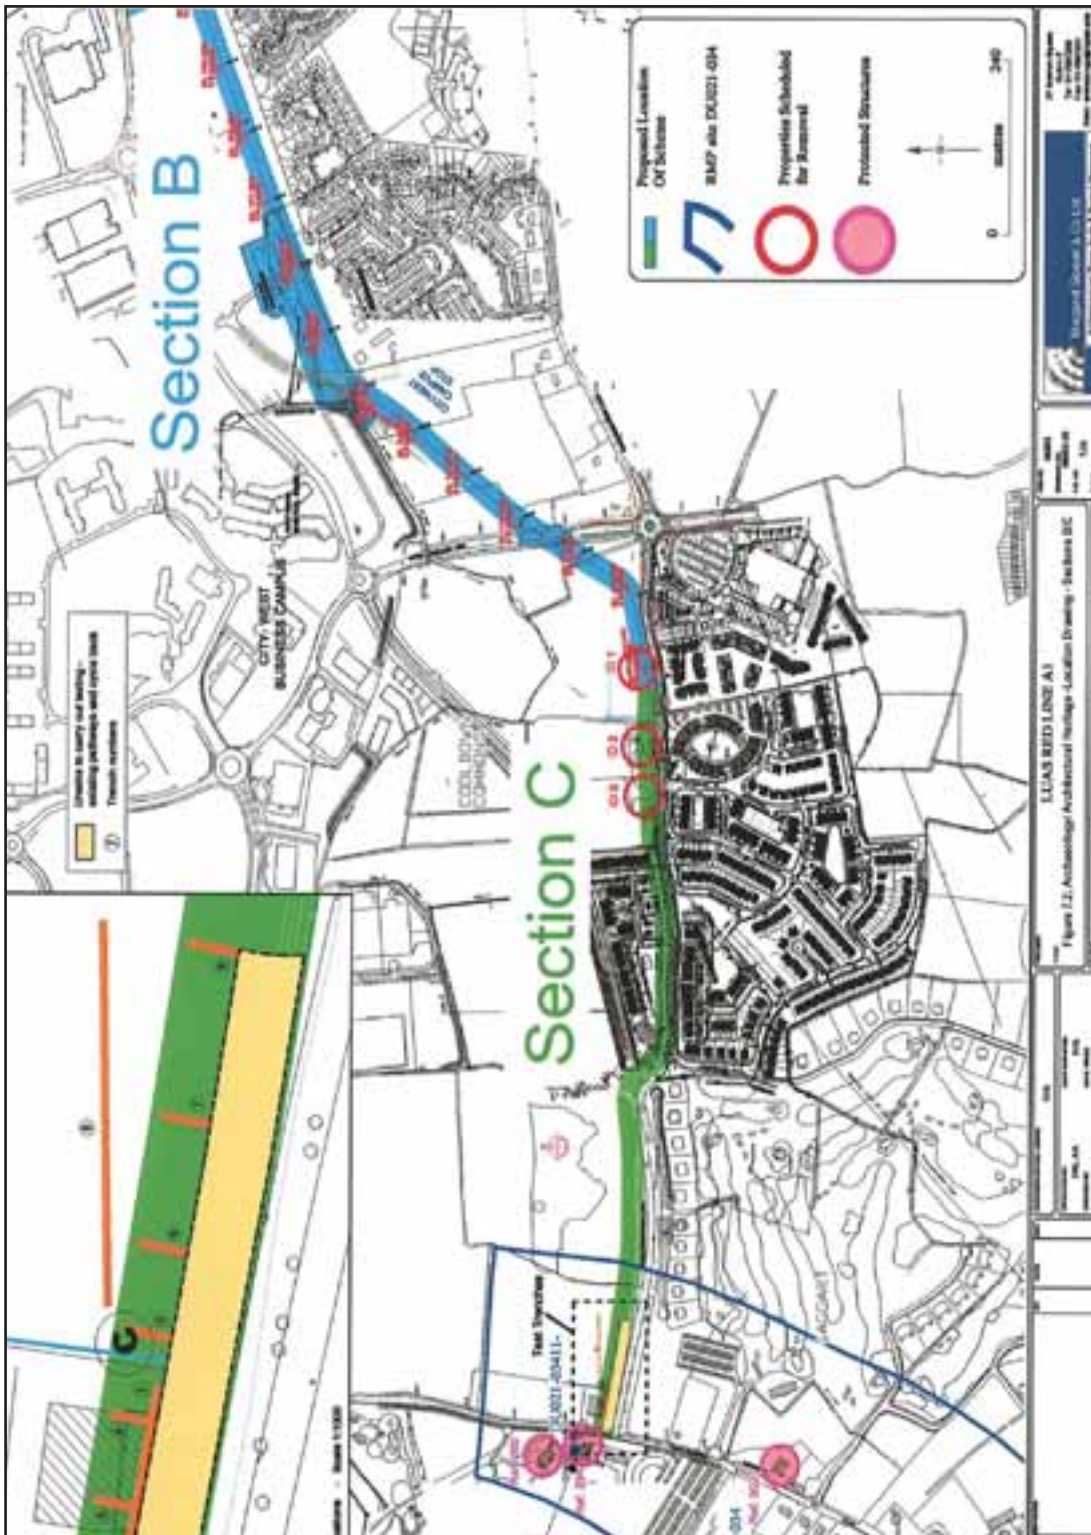
Figure 7.2 Archaeology/ Architectural Heritage – Location Drawing - Sections B/C

Figure 7.1 and 7.2 show the recorded archaeological sites (RMP sites) in the vicinity of the proposed Luas Line A1 route corridor.

Archaeological test excavation was conducted along the western extremity (c.50m) of Section C of the proposed route (Figure 7.2). Approximately 250 linear metres of central line testing was undertaken by Margaret Gowen and Co. Ltd, under licence (06E572) to The National Monuments Section of the Department of Environment, Heritage & Local Government and the National Museum of Ireland. The work was carried out on the 13th & 14th July 2006 to ascertain if any subsurface archaeological features are along the line of the proposed route as it passes the RMP archaeological constraint area of Saggart Village (DU021:034), in the vicinity of a tower house (DU021:3411). No features of an archaeological significance were identified during this archaeological assessment, the details of which are contained within a stand alone report produced by Margaret Gowen & Co. Ltd.

In Section C, a number of structures are indicated in the Ordnance Survey maps and the structures which remain today are detailed below. IDs 1 & 3 which are on the first edition Ordnance Survey map are to be demolished as part of the scheme (Figure 7.2). The field patterns of the area remain relatively unaltered between the Ordnance Survey maps. Two north-south trending watercourses are indicated; the western watercourse appears to correlate with that noted in Rocque's 1760 map.

Three unoccupied, semi-ruinous properties flank the north side of Fortunestown Road within Section C and will be removed by the proposed scheme (See Figure 7.2). ID 1 & ID 3 are examples of local vernacular architecture and therefore are structures of local architectural heritage merit. The three structures are as follows:
