# **SCHEDULE OF CONDITION**

**ST. PATRICK'S WELL  
TRINITY COLLEGE  
NASSAU STREET  
DUBLIN 2**

**RAILWAY PROCUREMENT AGENCY  
PARKGATE BUSINESS CENTRE  
PARKGATE STREET  
DUBLIN 8**

*Date: November 2009*

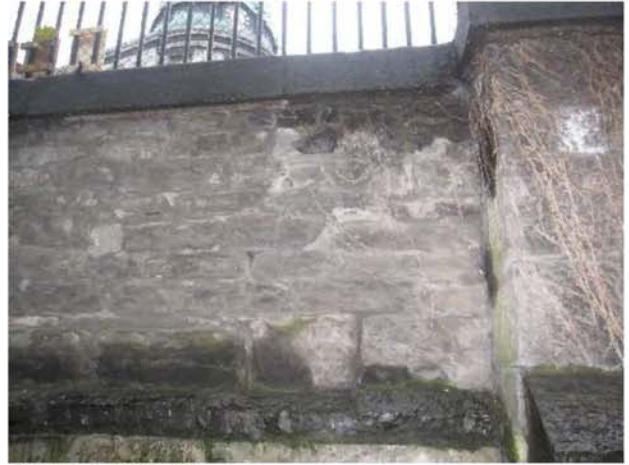
Photograph No.10

10.           Right hand section of stone wall over concrete.
11.           Mid section of wall.
12.           Left hand section of the above wall.
13.           Missing pointing, front right hand corner of pier at high level.

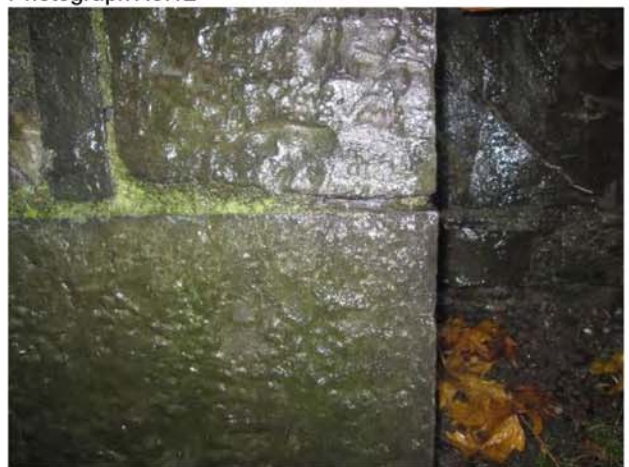
Photograph No.14

14.           Ditto at low level.
15.           Cracking to horizontal joint at left hand face of pier.
16.           Missing pointing to left hand face of pier at low level.

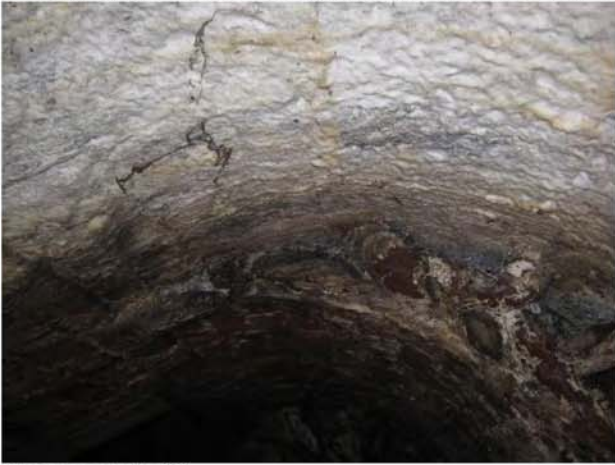
Photograph No.33

- 32. Ditto towards top.
- 33. Ditto to left hand side.
- 34. Spalling to brickwork at top section of front of brick arch.
- 35. Cracking to front of brick arch right hand side (overhead).

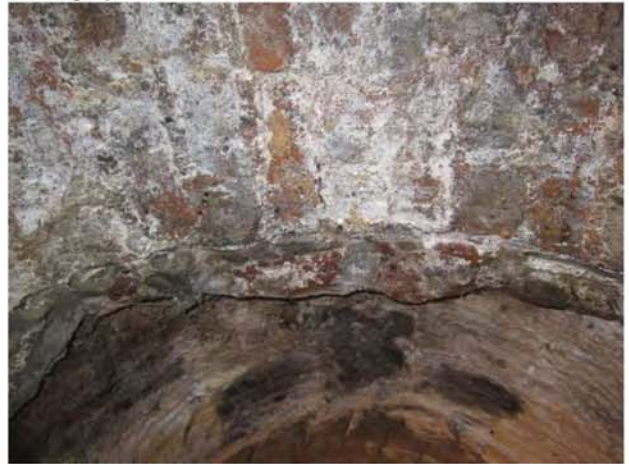
Photograph No.36

- 36. Ditto to centre.
- 37. Ditto to left hand side.
- 38. Stepped cracking towards front of right hand brick wall to top section.
- 39. Ditto mid section.

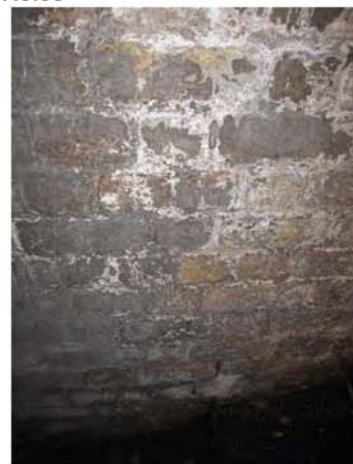
Photograph No.40

- 40. Ditto bottom section.
- 41. Brickwork to right hand side wall at juncture with steps.
- 42. Crack to right hand side of arch (front section).
- 43. Ditto mid section.

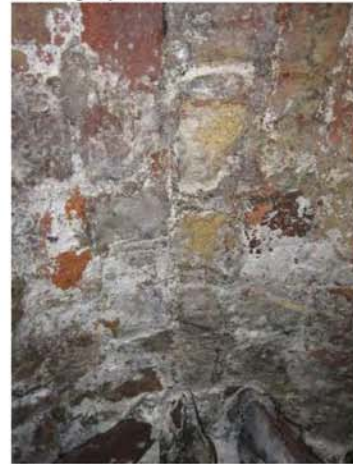
Photograph No.44

- 44. Ditto rear section.
- 45. Cracking on top section of brick arch overhead (front section).
- 46. Ditto mid section.
- 47. Ditto to rear.
- 48. Horizontal and stepped crack at low level to rear of right hand brick wall.

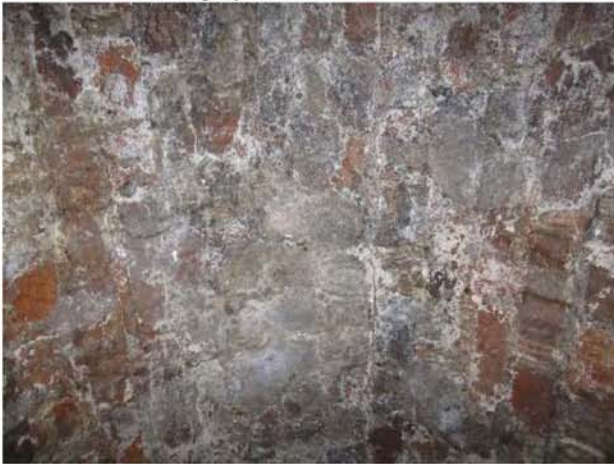
Photograph No.50

49. Vertical crack at juncture between right hand wall and rear wall (low level).
50. Light cracking and spalled brickwork on top section of arch towards rear.
51. Ditto mid section.
52. Ditto front section.
53. General surface spalling to brickwork over head of entrance to well.
54. Stepped cracking at a height of approximately 1.6m on left hand wall above step.
55. Horizontal crack on rear wall.
56. Vertical crack to left side of rear wall at entrance to well (high level).
57. Ditto at low level.
58. Cracking at bottom left side of entrance to well.
59. Cracking underfoot at mouth of well.
60. Overview of rear brick wall at right side of well entrance.

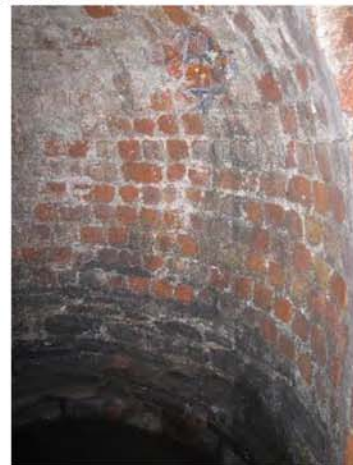
Photograph No.61

61. Overview of rear brick wall over well.
62. Ditto to right hand section.
63. Ditto to left hand side.
64. Ditto to top section.
65. Overview of stonework beneath bricks to rear section of well.
66. Ditto to right hand side.
67. Ditto to left hand side.
68. Left hand section of well where stepped cracking is evident (photograph at low level).
69. Ditto mid section.
70. Ditto top section of this area.
71. Horizontal crack extending across brickwork to right hand side of entrance at mouth of well.

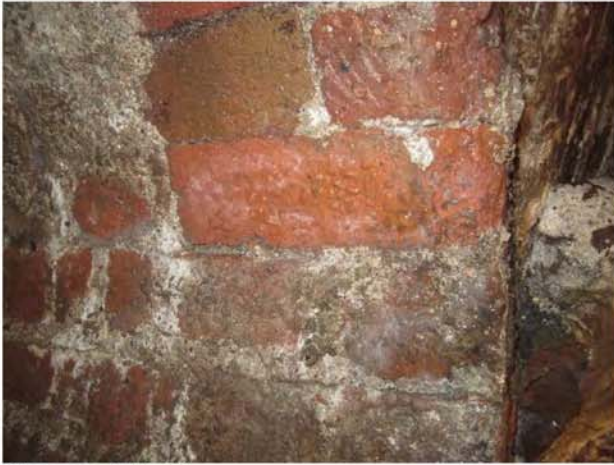
Photograph No.72

2.4.4			Section of brickwork missing towards top of brick vault over right hand side of well.
2.4.5			Stepped cracking evident to left hand side of well extending approximately from top of vault to level of stonework beneath.

- 72. Missing section of brickwork to top right hand side of well.
- 73. Crack through brickwork joints on overhead at entrance to mount of well.
- 74. Main horizontal crack on rear wall (left hand side).
- 75. Ditto to right side of wall.
- 76. Vertical crack to right hand side of well entrance.

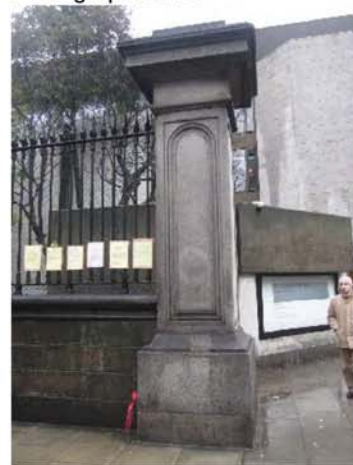
Photograph No.77

- 77. Overview of front wall from footpath.
- 78. Overview of large pier to right hand side of the above wall.
- 79. Close up to left hand section of wall.
- 80. Ditto to mid section.
- 81. Ditto to right hand side towards pier.
- 82. Close up of bottom section of large pier.
- 83. Ditto towards mid section.
- 84. Ditto on top of pier.
- 85. Overview of right hand face of large pier.
- 86. Close up of cracking extending through stonework.
- 87. Damage to capping at centre of wall.
