## TII268 OPEN RESEARCH CALL

# LOT 6: LIFESPAN OF STEEL SAFETY BARRIERS

### FACTUAL REPORT

MGT0613RP0002  
P02  
15 October 2024

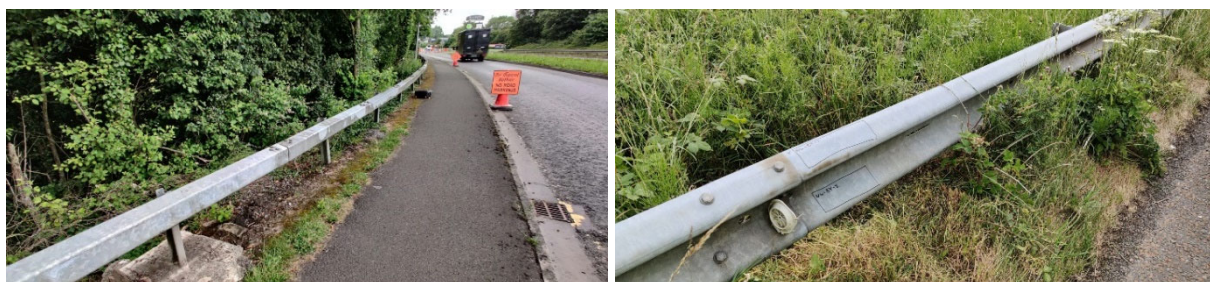
Figure 2.1 – Examples of old Open Box Beam (OBB) and Tensioned Corrugated Beam (TCB) barriers

The specific focus of this research project is on older steel safety barriers which were installed prior to the introduction of European performance-based systems which now come with manufacturer-defined lifespans. Many of these older systems are non-proprietary British standard systems commonly referred to as open box beam, tensioned corrugated beam and untensioned corrugated beam (OBB, TCB and UCB). Some newer systems tested and specified to EN1317 may also fall into this age bracket. As these systems were installed on Irish roads from circa 1970 to 2002, many of them have been in place for between 20 and 50+ years.

The durability and therefore residual life of these old barriers is directly related to the condition of their galvanizing zinc coating. If this coating continues to provide protection to the steel components of the barrier system (e.g. beams, posts, bolts, washers, spacers, etc), then the system may be capable of providing more years of service. If the zinc coating has deteriorated, then the function will be affected, and preventative maintenance will need to be programmed to ensure road safety is not compromised.

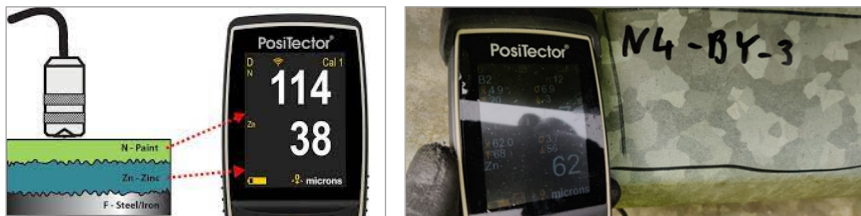
Figure 3.4 – (Left) Illustration of Positector Probe; (Right) Test area markings and Positector Probe results

- The thickness of the galvanised zinc coating on the existing barriers was measured using two techniques:
  - Non-invasive probe tests:** These tests were carried out at all VRS locations using a handheld contact probe - a Positector 6000 Dual Probe. This was done either on site, or in the lab where components were removed from site for additional lab testing (see paragraph 2 below). Prior to taking a reading the area of the VRS component to be tested was marked and the surface was thoroughly cleaned to remove dirt/corrosion product.

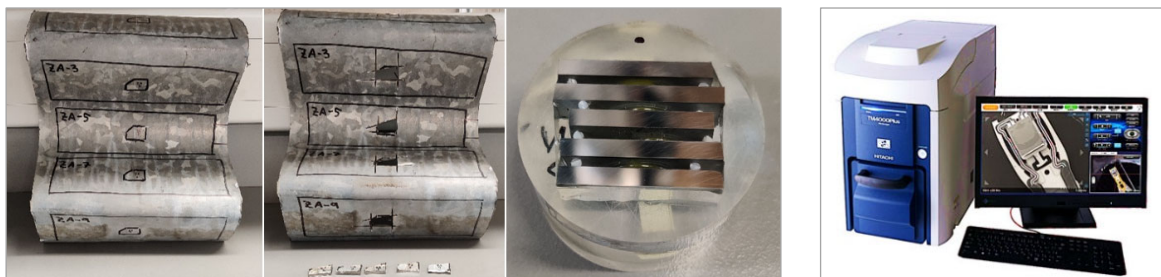
Figure 3.5 – (Left) Illustration of VRS samples and resin mounting; (Right) Tabletop Hitachi TM4000 scanning electron microscope

- Invasive laboratory testing:** These tests involved removing components from selected VRS installations on site, replacing them with like-for-like components, and then bringing them to the laboratory for testing. In the laboratory, small samples were cut from the VRS steel components using an angle grinder. These samples were then cleaned to ASTM standards and mounted in a clear set epoxy resin, before being ground and polished to a smooth surface finish suitable for electron microscopy. Each sample was then examined using a tabletop scanning electron microscope (SEM) – the Hitachi TM4000. As a secondary check, energy dispersive x-ray (EDX) analysis was also performed on each sample to ensure the correct identification of the galvanised zinc layer and steel substrate.

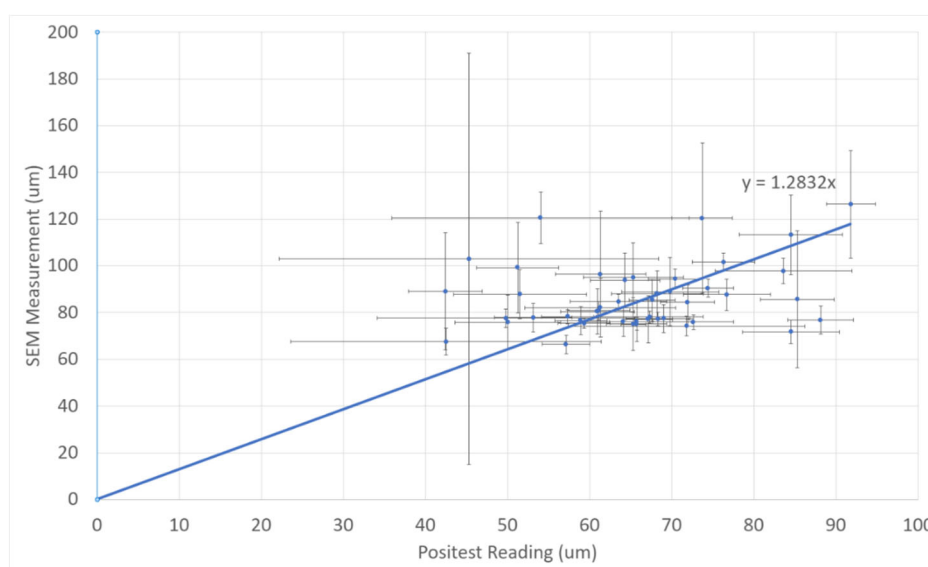
Figure 5.1 - Graph of SEM Measurement versus corresponding Positector Probe Reading

Figure 5.1 shows a plot of the measured coatings using SEM analysis plotted against the measurements taken using the Positector Probe for all five locations. If the two techniques were near identical, then a best fit line (shown in blue on the chart) would have a slope of '1' while passing through the origin. However, the slope of the line for these results is 1.2832 which indicates that the Positector Probe is a more conservative estimate of the galvanised zinc thickness.

The Positector Probe is a much simpler and quicker 'non-destructive' measurement technique and can be performed on-site without damaging the barrier, while the SEM measurement technique can take several days in sample preparation and is a destructive test. The SEM data quoted included the full coating including the corrosion product while the Positector distinguished between the surface zinc and corrosion product. Therefore given that the Positector Probe results are more conservative, they will be used for analysis and discussion in the sections below.

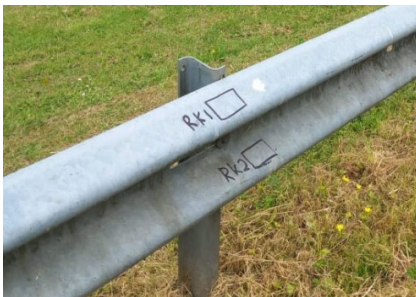
Figure 5: Top Face Markings

The zinc thickness measurement on the steel substrate was performed using a handheld contact probe (Positector Dual Probe). The area to be tested was marked on the barrier using a permanent marker and the surface was cleaned using wipes. After cleaning, the zinc thicknesses were measured using the probe. The measurements were then recorded by photograph and stored online.

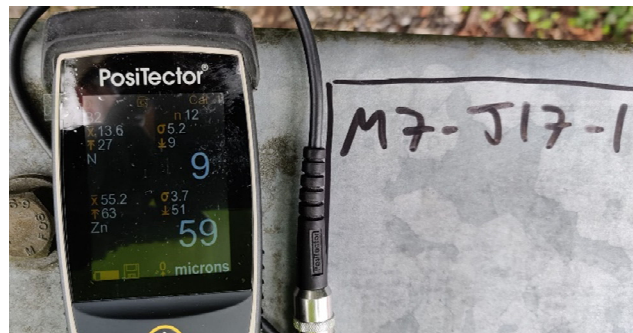
Figure 9: Top Face Markings & Record

The zinc thickness measurement on the steel substrate was performed using a handheld contact probe (Positector Dual Probe). The area to be tested was marked on the barrier using a permanent marker and the surface was cleaned using wipes. After cleaning, the zinc thicknesses were measured using the probe. The measurements were then recorded by photograph and stored online.

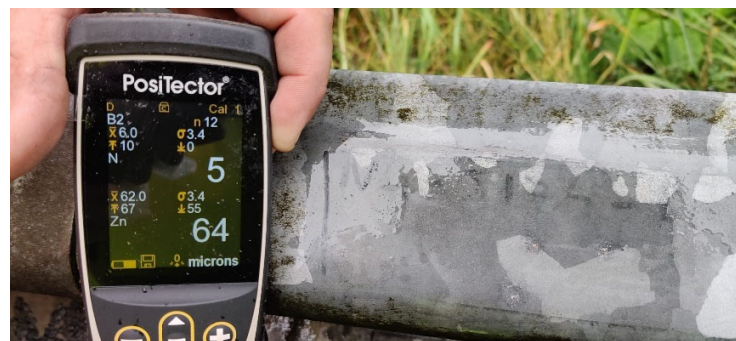
Figure 9: Top Face Markings & Record

The zinc thickness measurement on the steel substrate was performed using a handheld contact probe (Positector Dual Probe). The area to be tested was marked on the barrier using a permanent marker and the surface was cleaned using wipes. After cleaning, the zinc thicknesses were measured using the probe. The measurements were then recorded by photograph and stored online.

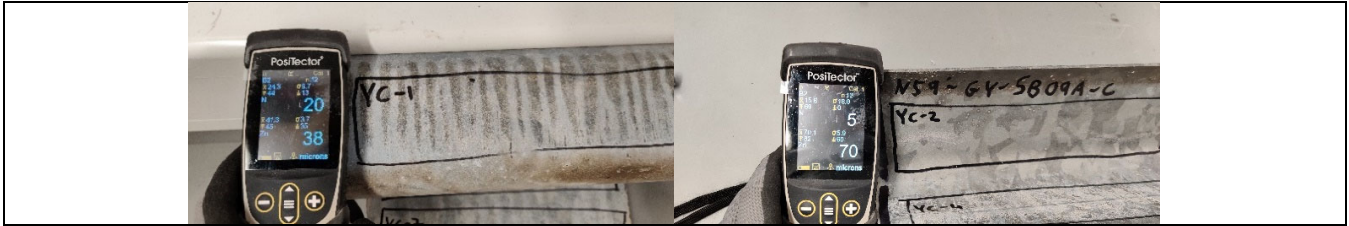
**Figure 1: Example of measurement on area '1' (left) and '2' (right) for crash barrier labelled 'N59-GY-SB09A'.**

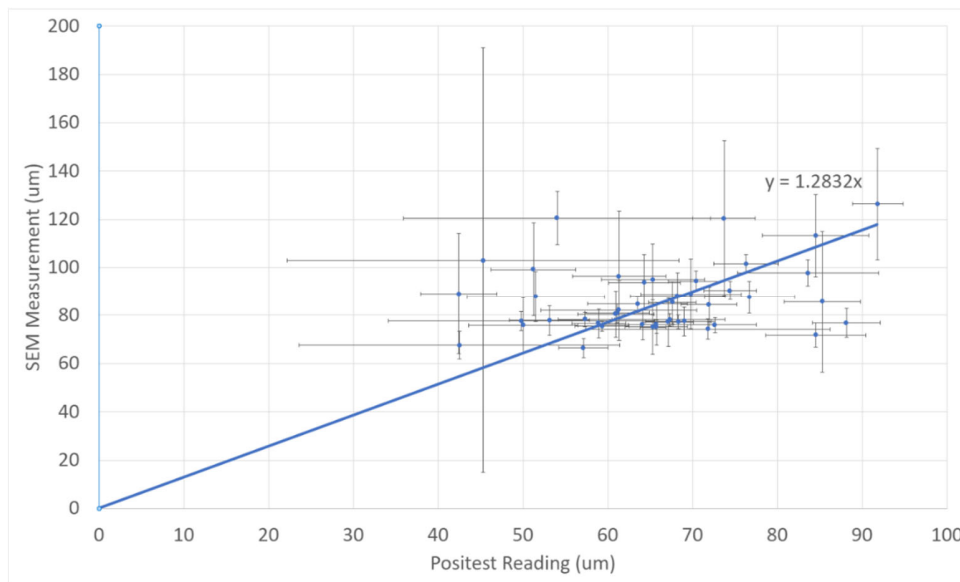
Several crash barrier locations were measured using both the Positector Probe and SEM Analysis techniques and allowed both methods to be directly compared. Figure 10 shows a plot of the galvanised thickness as measured via SEM plotted against that measured via the Positector Probe for all such locations. If the two techniques were near identical, then a best fit line (shown in blue in Figure 10) would have a slope of '1' while passing through the origin. As was found, the slope of the line is 1.2832. This indicates that that Positector Probe is a more conservative estimate of the galvanised zinc thickness. The SEM measurement results in a thickness approximately 28% greater than that from a Positector Probe. Obviously, the Positector Probe is a much quicker measurement technique and can be performed on-site without damaging the crash barrier while the SEM measurement technique can take several days in sample preparation.

**Figure 10:** Graph of SEM Measurement versus corresponding Positector Probe Reading.

All average readings from these x11 crash barrier locations from the Positest Probe were above 40µm while all average measurements via SEM analysis were above 60µm (refer to **Figure 10**). However, there was significant variability (i.e. error bars) at several sites that resulted in areas with relatively thin zinc coatings (e.g. approximately 20µm on N03-CN-0042 (DA), see Section 3.5). There was also one barrier that produced an erroneous negative galvanised thickness (see Section 3.8 for the N59-GY-SB09A crash barrier). However, this was believed to be due to noticeable rust on the barrier. Several selected crash barriers will be discussed in more detail over the following Sections 4.1 to 4.6.

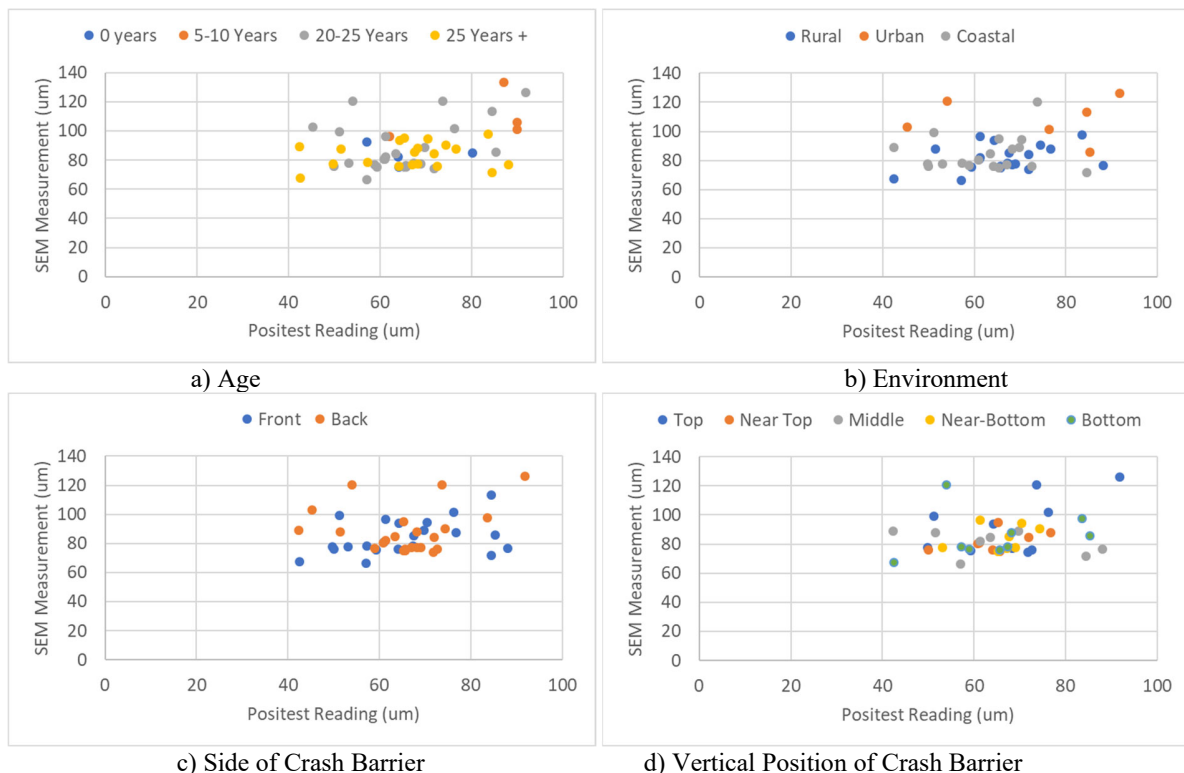
**Figure 11 (a)** shows the data from Figure 10 broken down by Age. There was considerable overlap in the average data values with no clear difference between 20-to-25-year-old and 25+ year old barriers. It was interesting to note that the Aximum and C501 reference crash barriers had a noticeably thicker galvanised zinc coating on the older barriers (i.e. 5-to-10 Year Old / orange data points in **Figure 11 (a)**) versus the new barriers. **Figure 11 (b)** shows the data broken down by environment (i.e. Rural, Urban or Coastal). Once again there was considerable overlap in the data obtained via the Positest readings. The SEM measurements suggest that the Urban barriers had slightly higher zinc coating thicknesses compared to Rural or Coastal. However, more data points would be needed to form a more definite conclusion. **Figure 11 (c)** shows the data split between the Front (i.e. facing the road) and Back (i.e. facing away from the road). This split still contained an overlap between the front and back of the crash barrier. Finally, **Figure 11 (d)** shows the data divided by vertical position on the crash barrier. As with the other data segmentation, there was noticeable overlap in the data points with no clear influence on vertical position.

**Figure 11:** Data from previous graph (**Figure 10**) broken down by a) Age, b) Environment, c) Side and d) Vertical Position of Crash Barrier. For clarity, the error bars were removed.

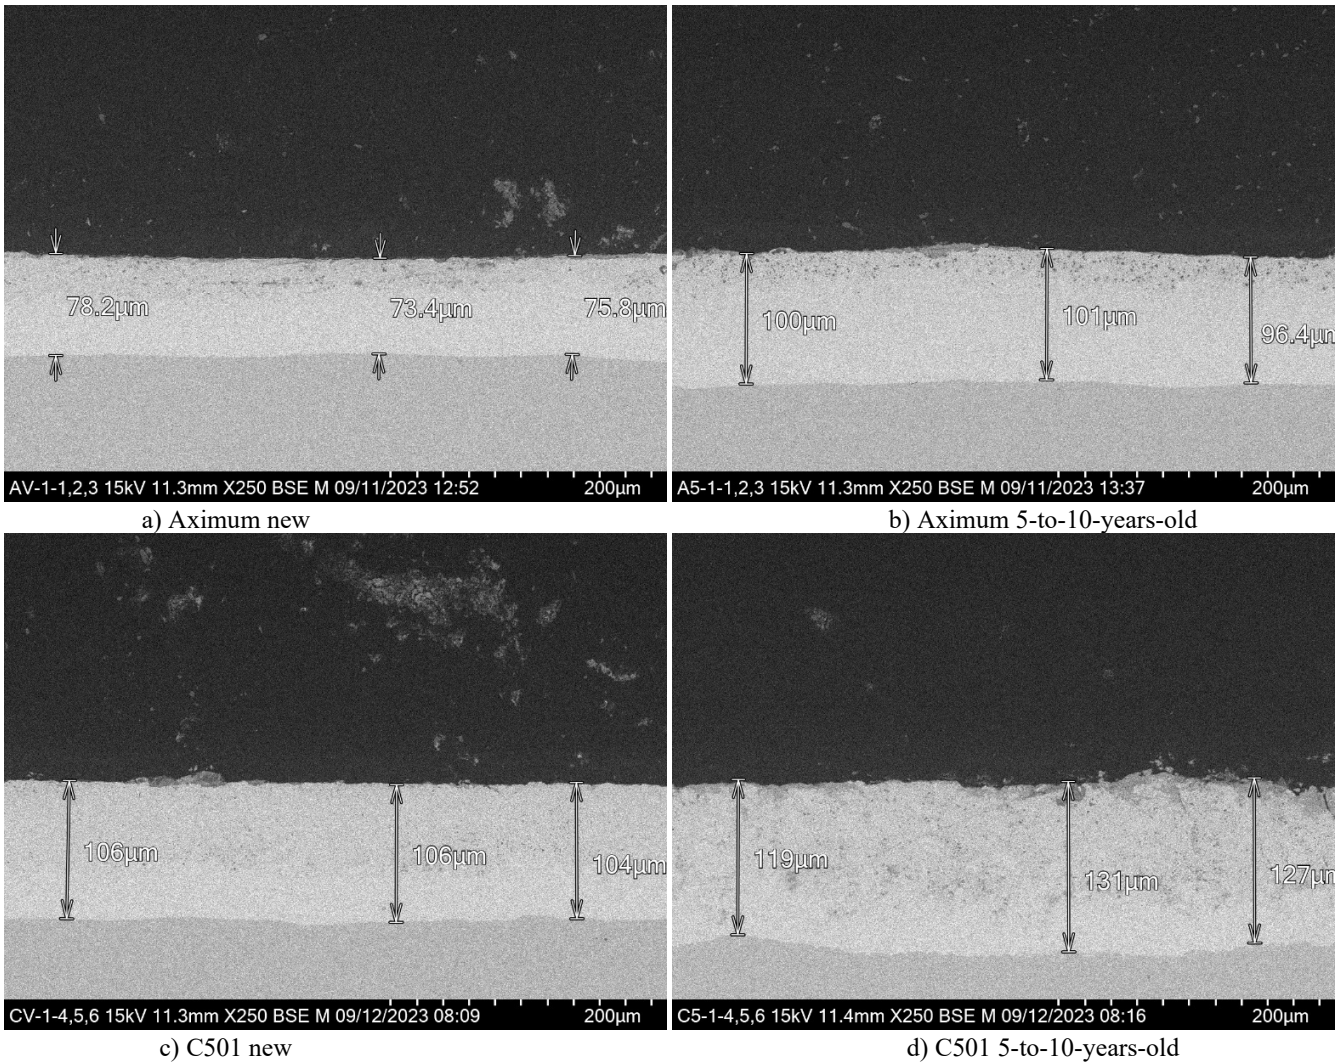
New and 5-year old crash barriers manufactured by Aximum and C501 were provided by Lagan to act as reference benchmark and also for developing the testing methodology. A total of x4 unique crash barriers were examined. It was noted that the newer crash barriers had a thinner zinc coating compared to the barriers that were 5-to-10 years old (see **Section 3.1 to 3.4**).

Figure 12: Reference crash barriers from Aximum, (a) new and (b) 5-to-10 years old, and C501, (c) new and (d) 5-to-10 years old.

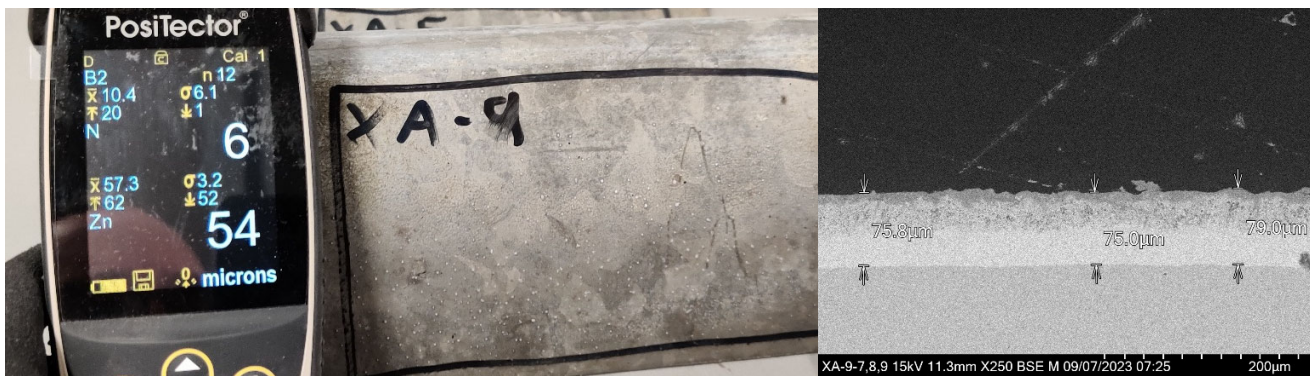
It was interesting to note the difference in appearance between the Exterior / Front (**Figure 18**) and Interior / Back (**Figure 19**) of the section taken from the N55. The exterior surface was noticeable worn after cleaning. However, there was still a significant zinc layer on the barrier (see **Figure 18 (right)**).

**Figure 18:** Photograph of front area of N55-LK-RN80 (XA-9) (left) and correspond SEM image (right). Galvanised zinc coating has been measured at 12 points using the Positector and 9 points via SEM.

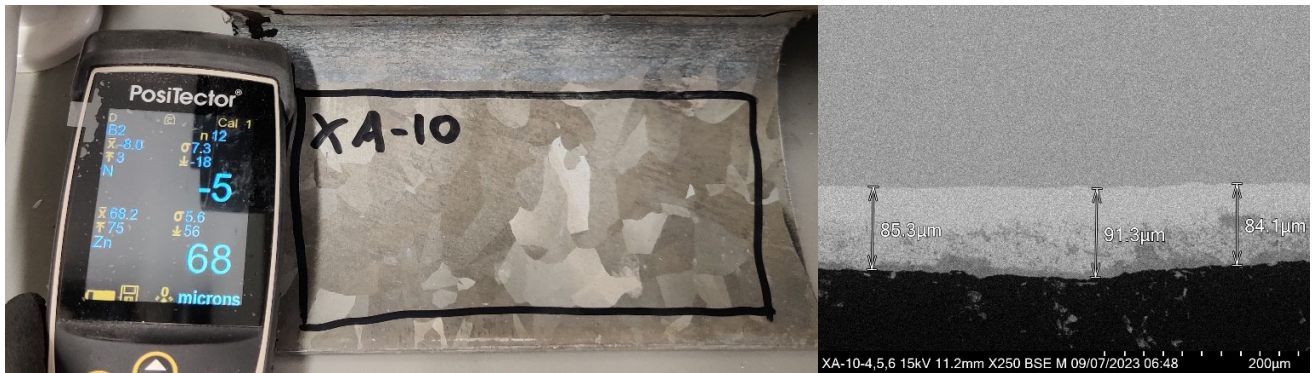
**Figure 19:** Photograph of front area of N55-LK-RN80 (XA-10) (left) and correspond SEM image (right). Galvanised zinc coating has been measured at 12 points using the Positector and 9 points via SEM.

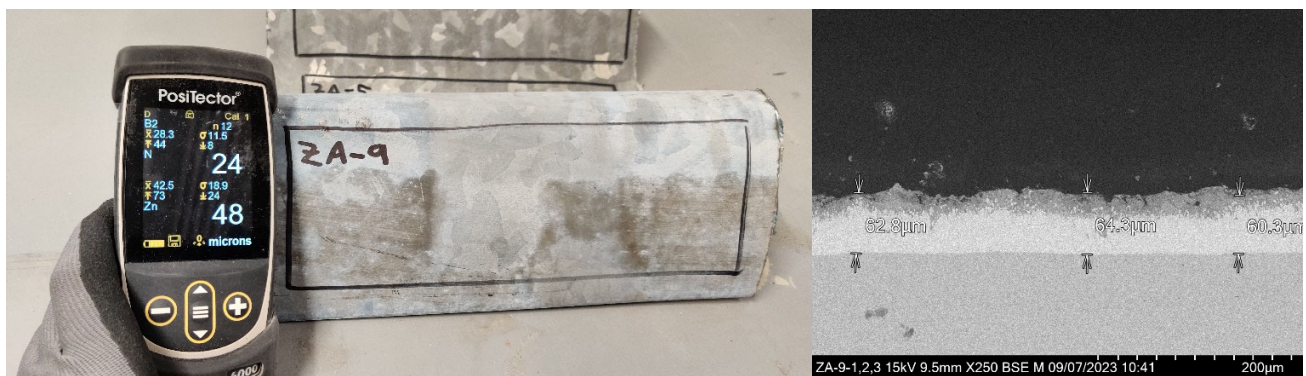
The crash barrier taken from the N59 also exhibited signs of corrosion on the underlying surface (see Figure 22 (left)). Despite this, the thickness of the zinc coating was over 60um as measure via SEM (see Figure 22 (right)). Figure 23 (left and right) showed that the interior surface of the crash barrier had a zinc thickness of approximately 95um.

Figure 22: Photograph of front area of N59-KM-RN078 (ZA-9) (left) and correspond SEM image (right). Galvanised zinc coating has been measured at three points.

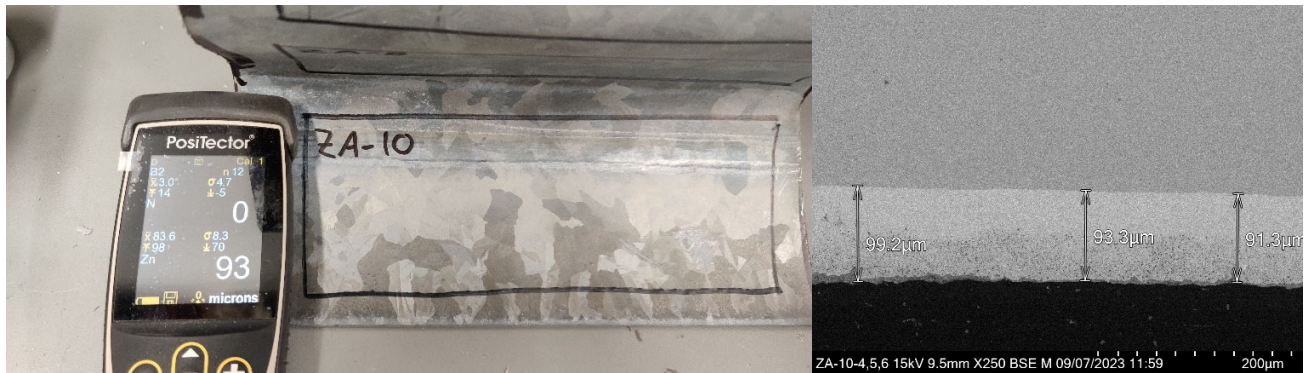
Figure 23: Photograph of front area of N59-KM-RN078 (ZA-10) (left) and correspond SEM image (right). Galvanised zinc coating has been measured at three points.
