ROAD SAFETY AUDIT FEEDBACK and the CLOSEOUT PROCESS

Lucy Curtis
Road Safety Engineer
Kerry National Road Design Office

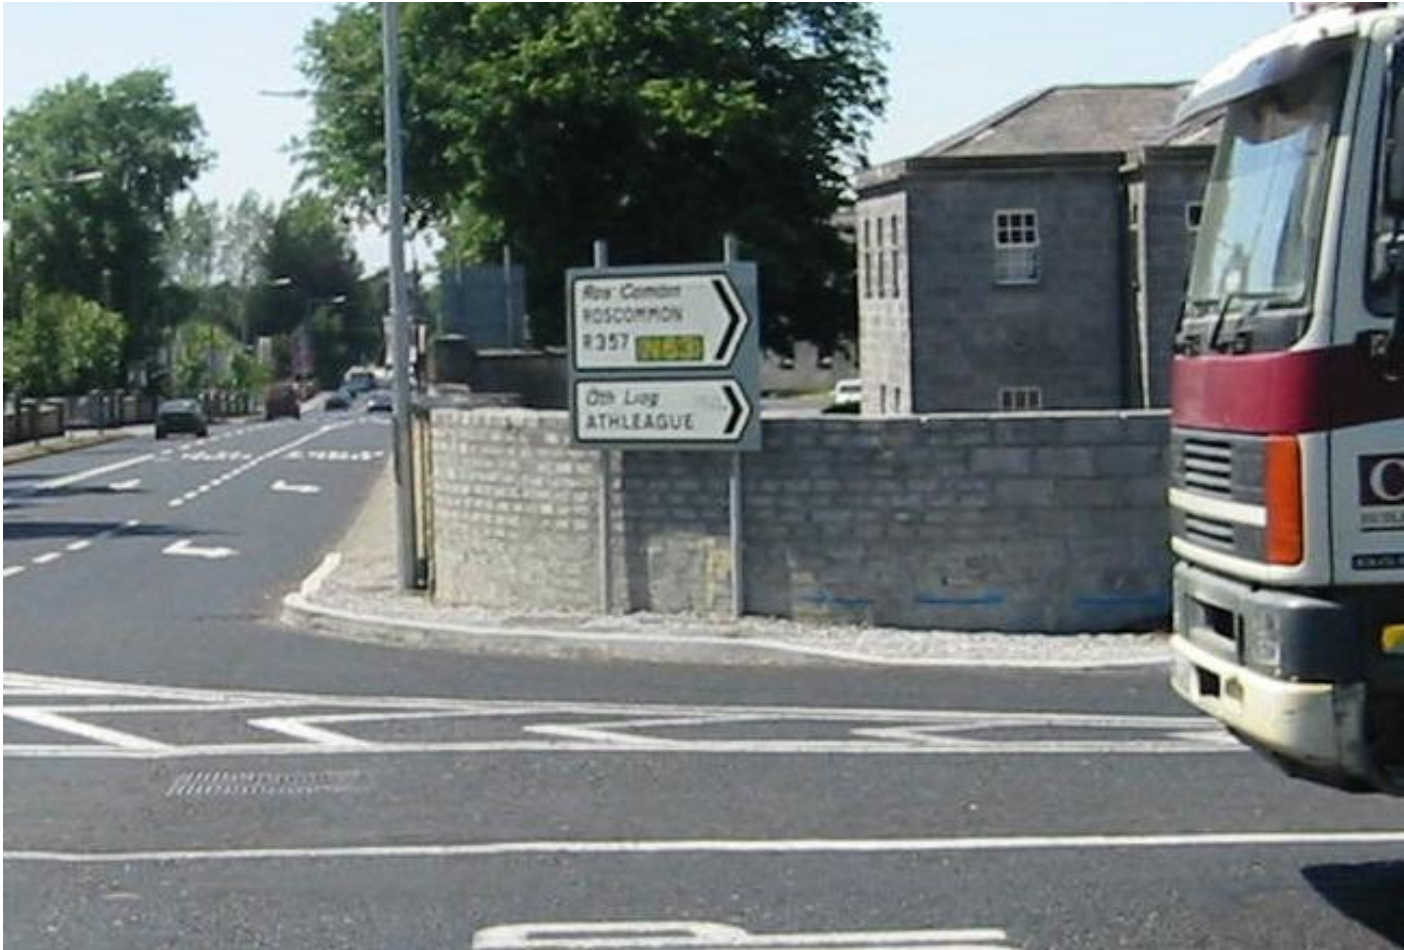
Sight distance for pedestrians crossing minor road

- **Problem:** Pedestrians walking along footpath on main road will need to cross minor road, and the sight distance at this crossing point is poor
- **Recommendation:** Improve visibility by removing or lowering the wall

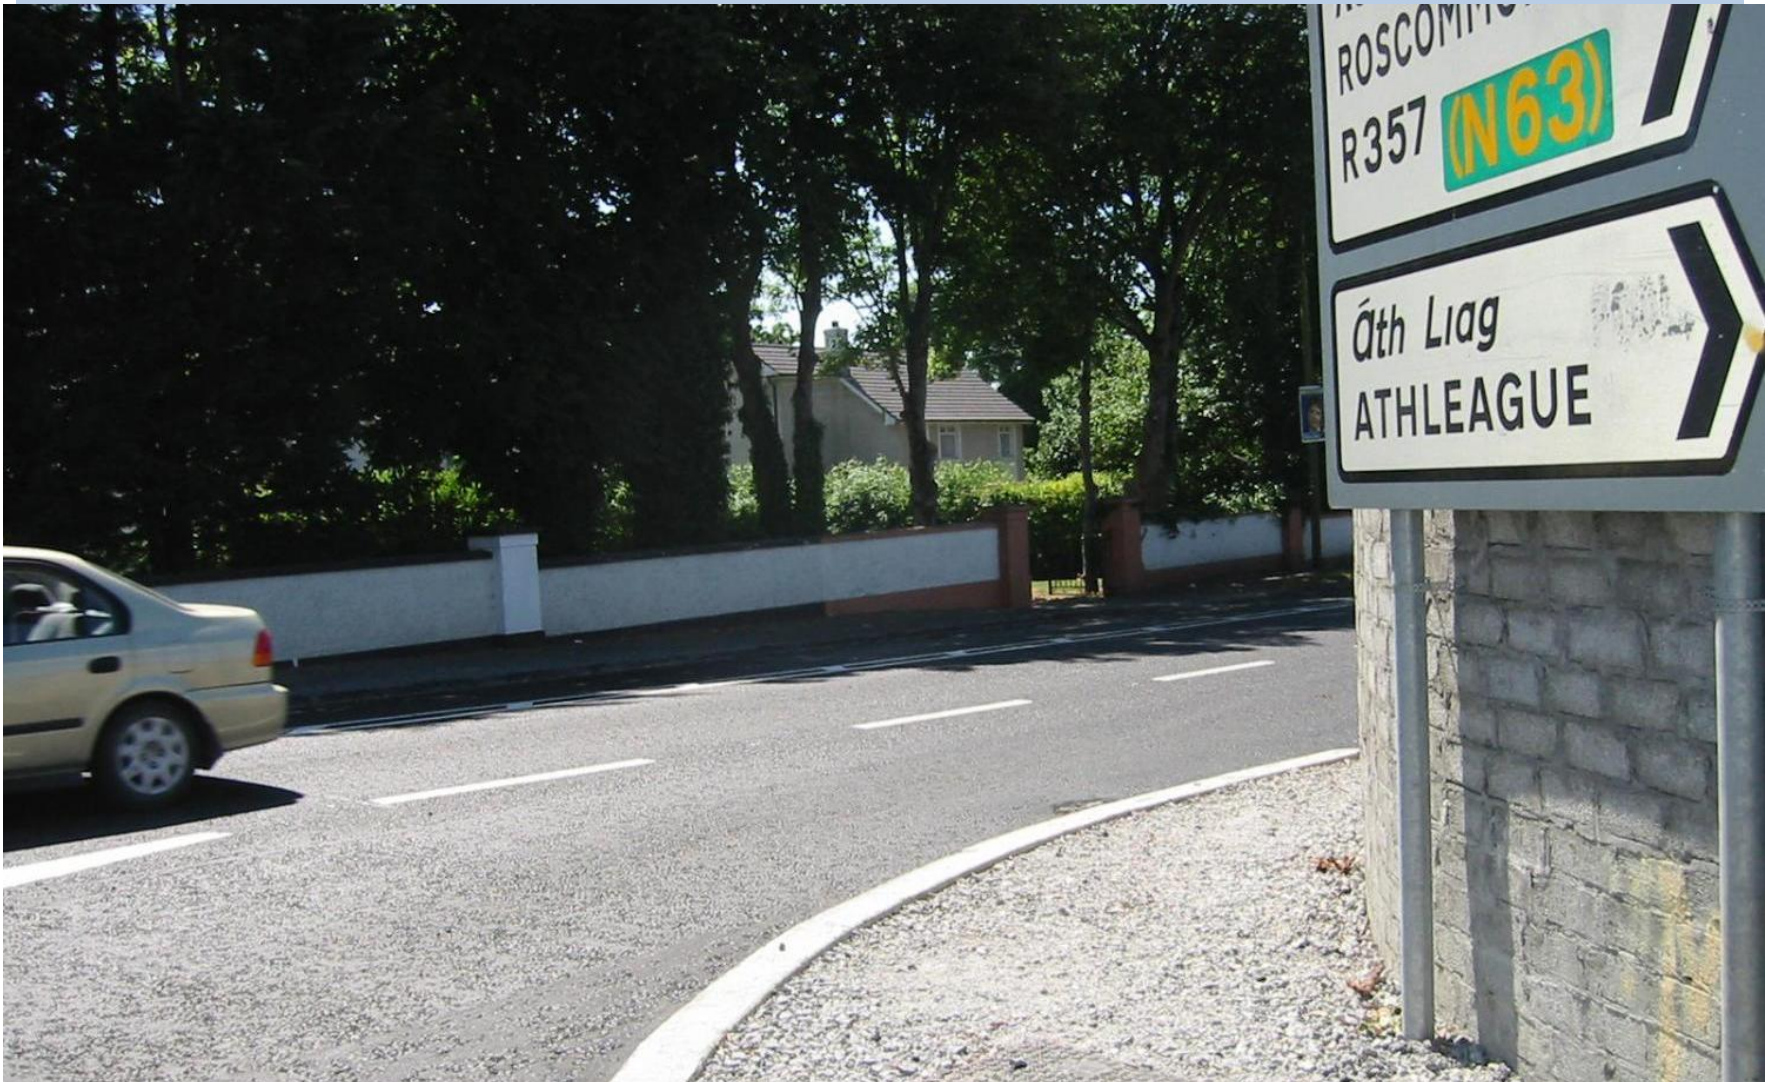
The pedestrians' view

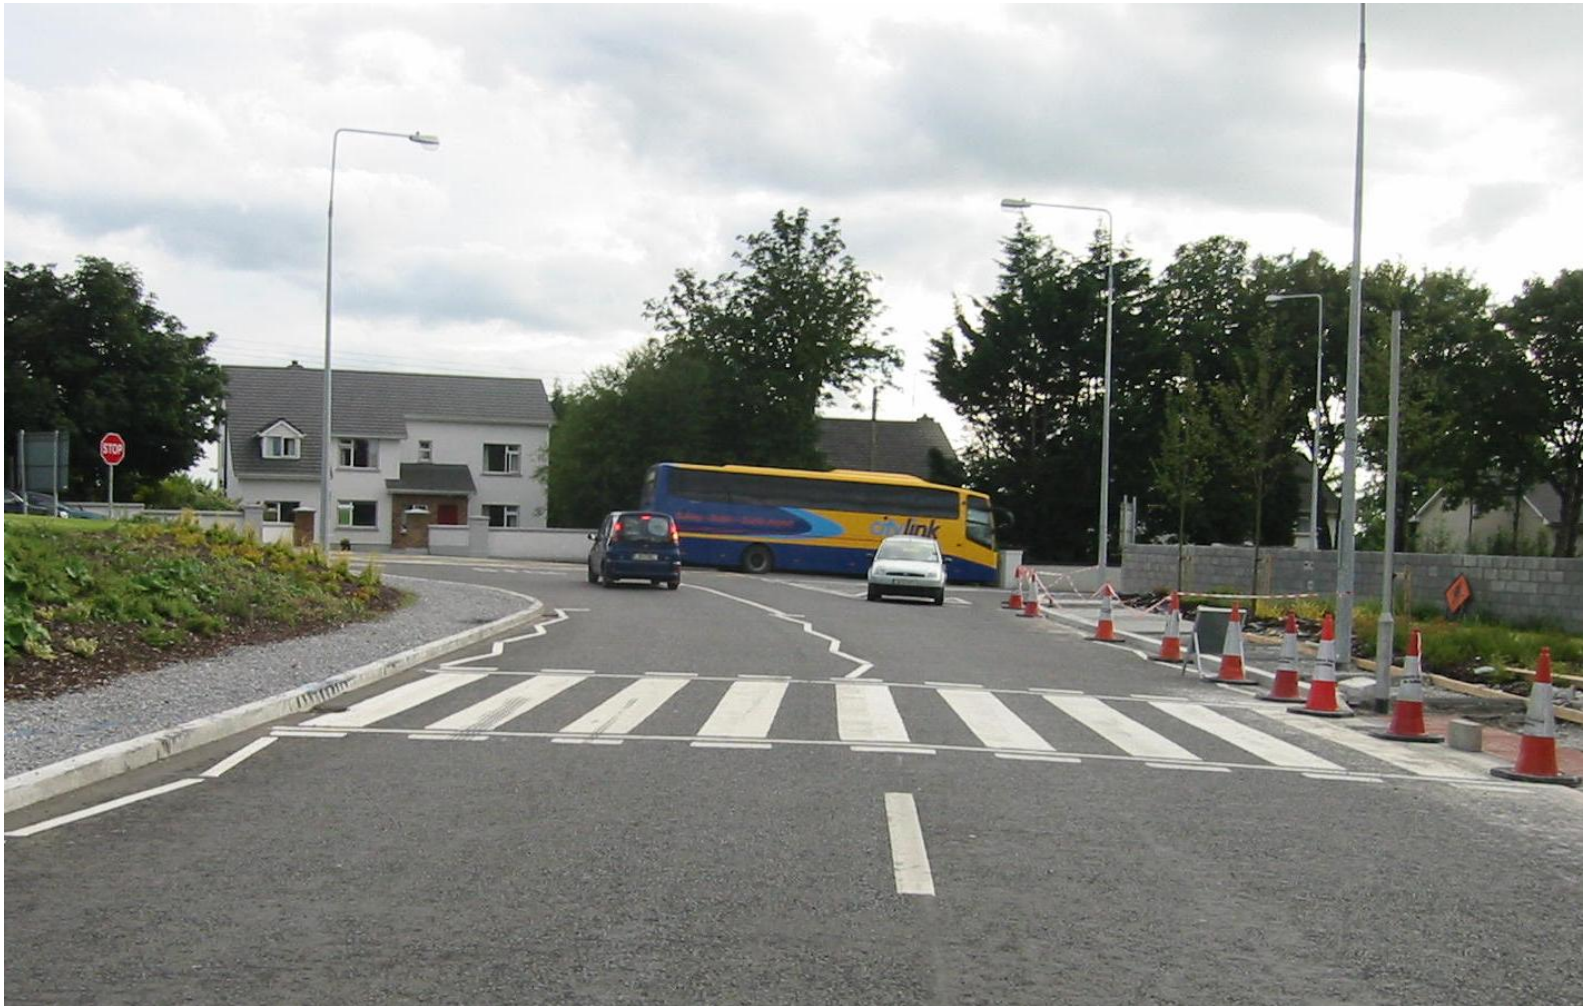
Designer's solution

- Yes, it's a problem
- No I don't want to demolish the wall
- The problem can be solved by moving the pedestrian crossing point 30m down the side road, where there is sufficient visibility

- **NO**, this will not solve the problem, as pedestrians will be reluctant to walk the extra 30m and will still be likely to attempt to cross at the junction mouth, where visibility is poor
- **YES**, that will solve it.

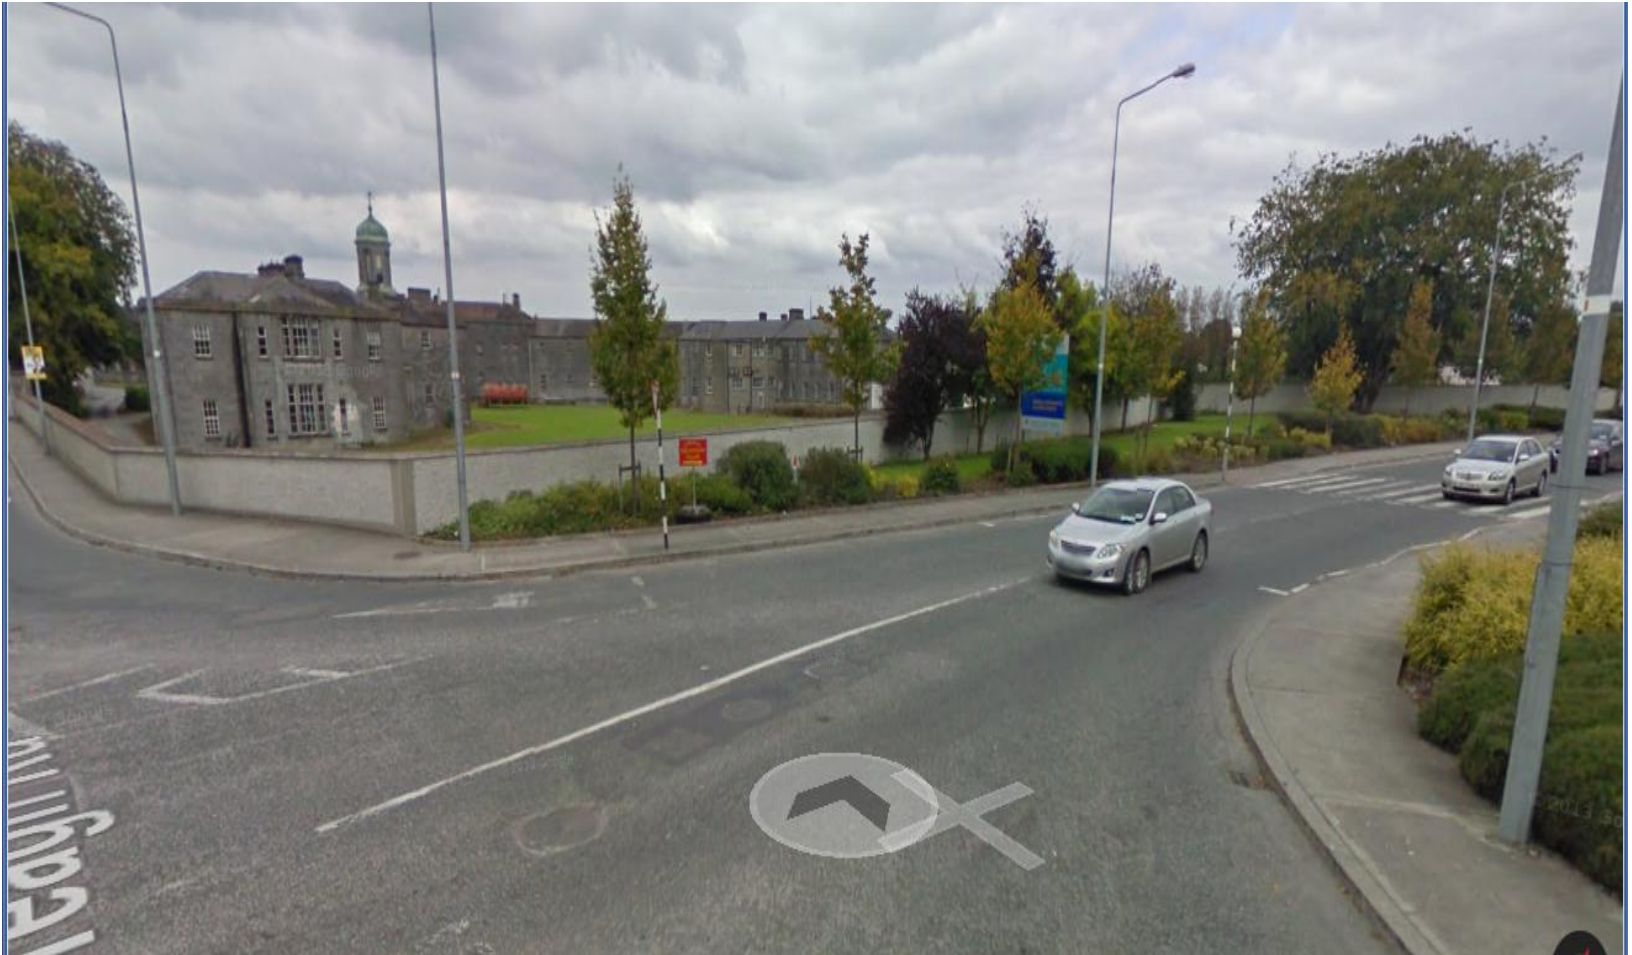
The wall..... after much consultation
