**Subject:** RE: Re. GC-N60-002.00 (Castlereagh Bridge) [Reactive Maintenance]

# Re. GC-N60-002.00 (Castlereagh Bridge) [Reactive Maintenance]

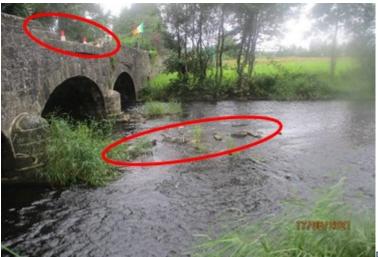
Following vehicular impact, the section of north parapet wall over the central span has been partly demolished from approximately 100mm above adjoining carriageway level with resultant masonry debris largely lying in the watercourse below. The top course of impacted masonry together with the coping are largely missing and the lower course of impacted masonry has been dislodged with sections displaced laterally inwards by up to 150mm and generally overhanging the spandrel wall below. The length of damaged wall excluding copings measures 6500mm in length, 525mm high, 450mm thick. The 210mm high coping to the section of parapet wall over the central span appears to have been constructed (prior to impact) of concrete faced random rubble stone extending over a length of 10,500mm. The copings to the remainder of parapet wall either side of this section of parapet wall are masonry block copings. The length of damaged mostly missing concrete faced random rubble stone coping measures 7750mm in length, 450mm thick. The damaged wall has been constructed with square cut stone masonry facings approximately 150mm thick each face and infilled with random rubble and some concrete. Some minor vehicle crash debris was also noted adjacent to the impacted wall.

Plate 1. Area of damage and material

which has fallen into the river (highlighted in red).

• Remove 5m<sup>2</sup> of masonry debris resulting from impact from watercourse below and re-utilise non-defective stone masonry facings salvaged from watercourse to rebuild the damaged

- section of north parapet wall or if not possible, new locally sourced stone masonry to match existing wall, and lime mortars.
- Rebuild damaged section of north parapet wall over central span of the bridge and to tie in and
  match existing wall construction. Reinstate copings to parapet with stone blocks to tie in and
  match existing parapet construction. The length of reinstatement of wall copings measures
  10,500mm in length. The extent of damage that warrants masonry repairs measures 2.75m3
  including reinstatement of copings
- Remove plastic/glass from verge adjacent to impacted parapet wall (1m2)

The damaged wall is to be deconstructed to stable material, and then fully reconstructed using hand tools to tie in with the existing wall utilising the existing non-defective stone masonry facings salvaged from watercourse below, or if not possible, new locally sourced stone masonry to match existing wall, and lime mortars. The mortar will be mixed away from the watercourse. All damaged masonry sections not suitable for re-use and other debris resulting from the damage to be disposed off-site. Edge protection will be erected on the outer side of the parapet for health and safety. This will also prevent material dropping into the watercourse below.

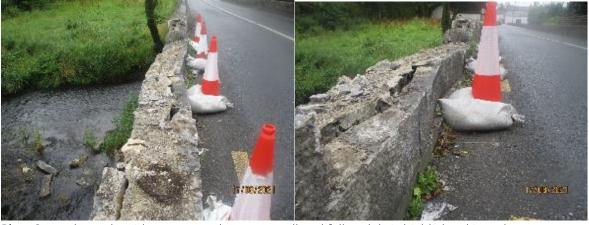
Plate 2. Castlereagh Bridge. Damaged parapet wall and fallen debris highlighted in red.
