## 5.0 VISUAL AND LANDSCAPE IMPACTS

### 5.1 ASSESSMENT METHODOLOGY

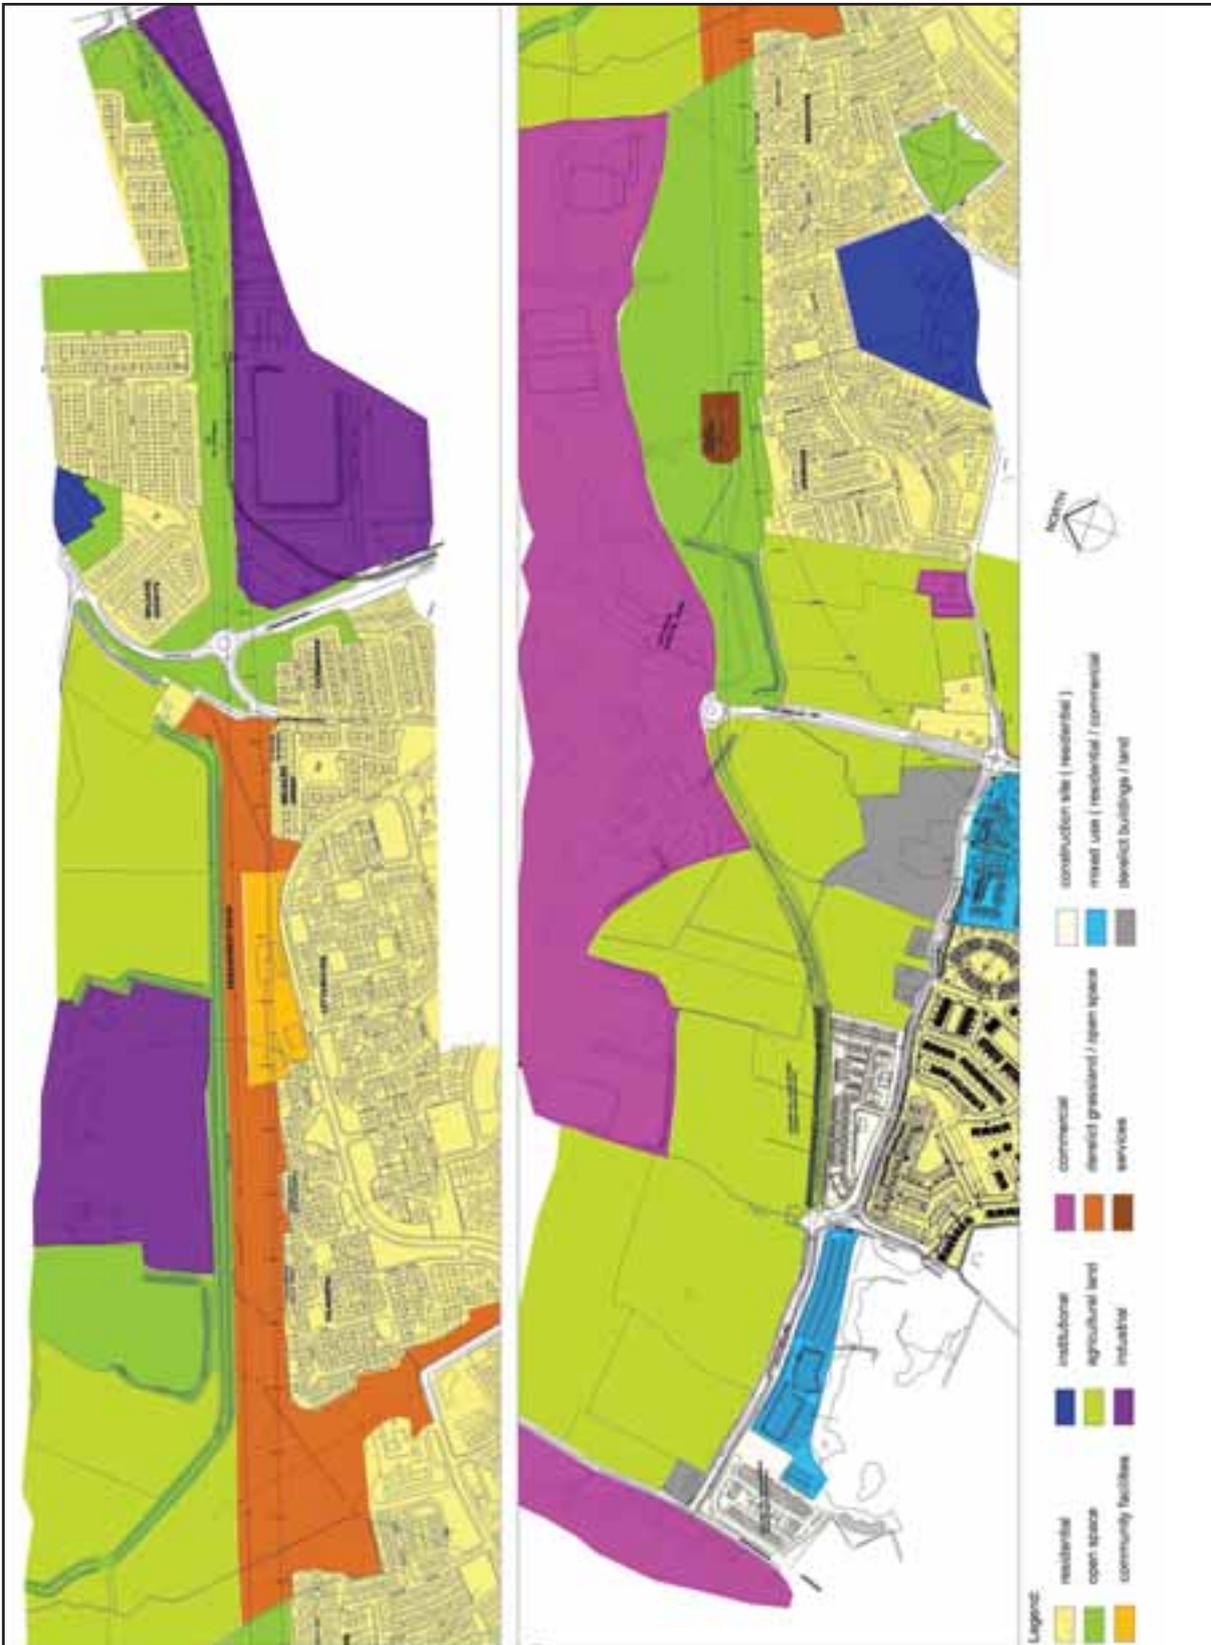
Figure 5.1: Land Use Map

Figure 5.1 illustrates existing land use patterns on and immediately adjacent to the proposed route corridor. The route corridor consists primarily of derelict backlands, some agricultural lands, and lands which are undeveloped but likely to be developed as part of the ongoing urbanisation of the area.

To the east of Cookstown road the route corridor is bounded to the north by Belgard Heights housing estate and to the south by the Cookstown Industrial Estate. To the west of Cookstown Road the route corridor is bounded to the north by Belgard quarry and to the south by the housing developments of Cairnwood, Belgard Green, Fettercairn and Kilmartin (Section A).

At Fortunestown the site traverses areas of derelict backlands, agricultural land, and development sites, some related to the existing Citywest business campus, until finally aligning itself with Fortunestown Lane at the new Citywest Shopping Centre (Section B).

Along the final part of the proposed route (Section C), lands to the north of Fortunestown Lane are largely undeveloped, with the Citywest business campus as a backdrop. To the south of Fortunestown Lane the land is rapidly developing as a series of mixed uses – retail, residential and recreational open space.

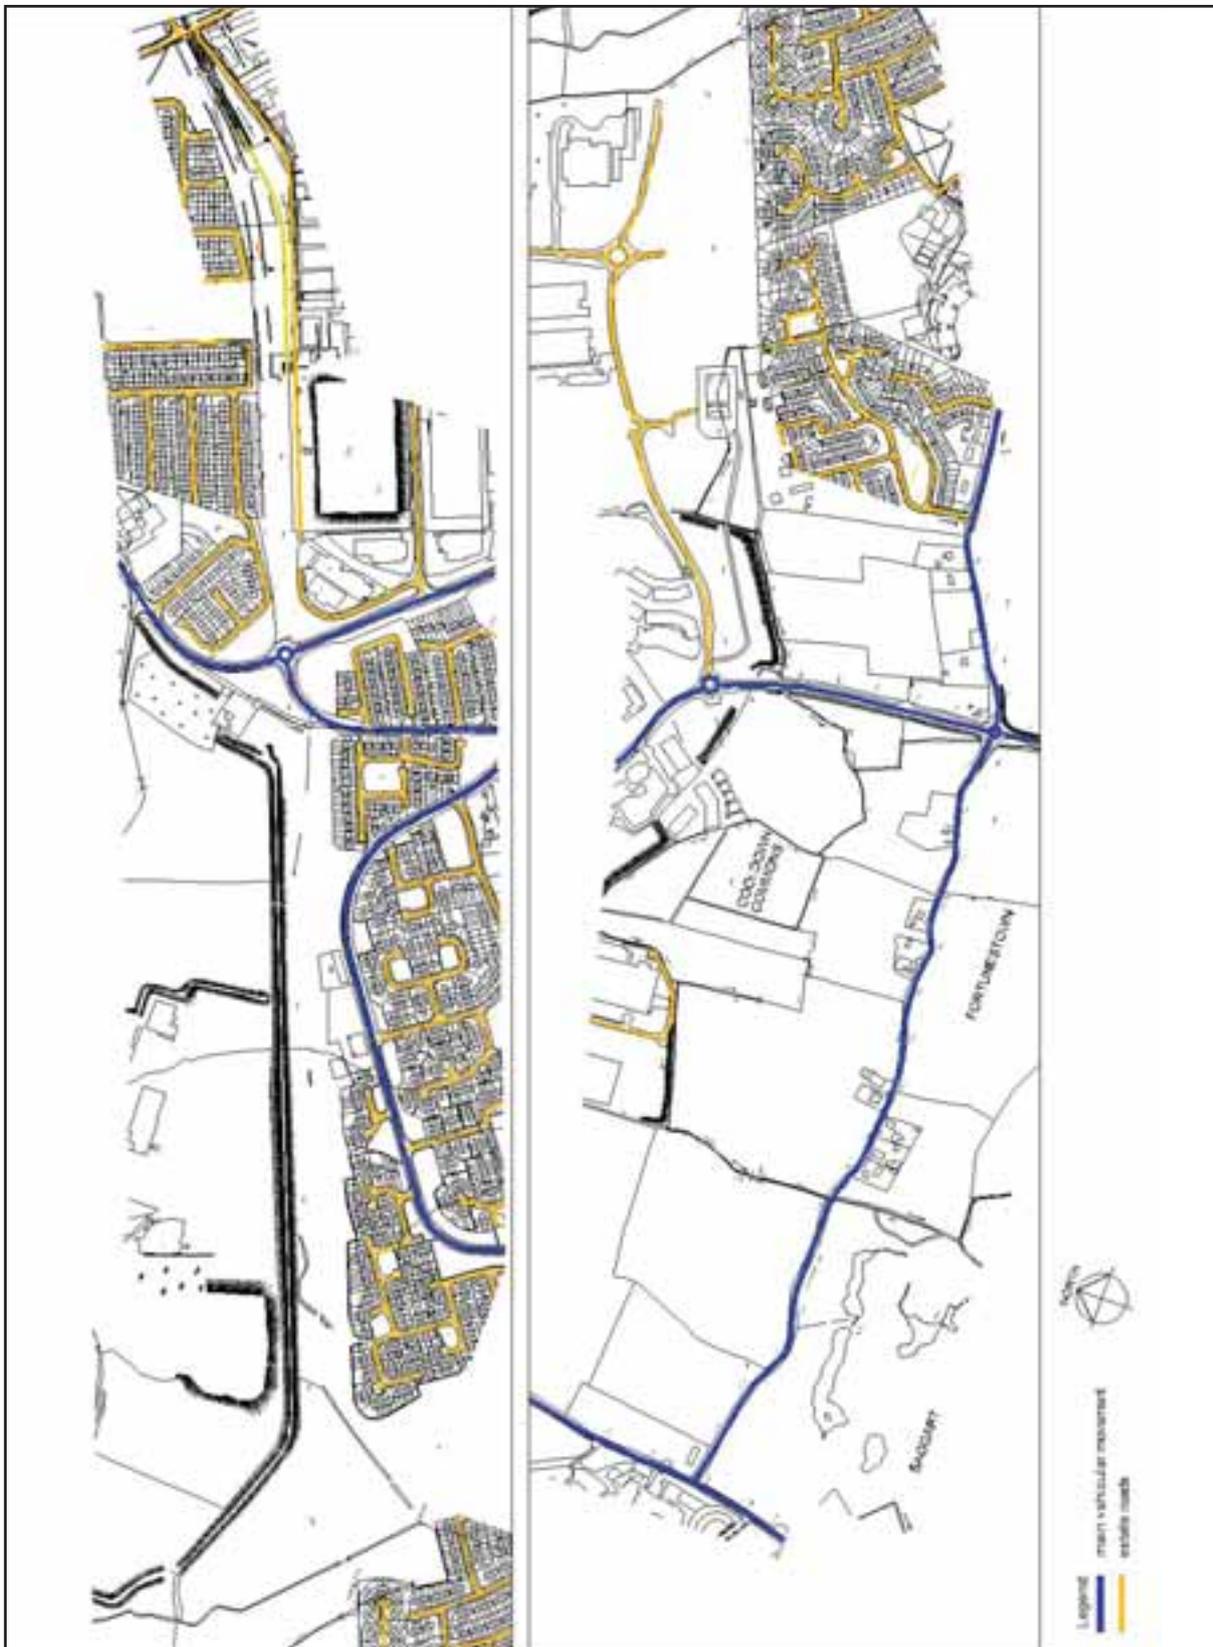
Figure 5.2: Circulation

Figure 5.2 defines the main circulation patterns within the area at present.

The main vehicular circulation in the area is along Fortunestown Lane/ Fortunestown Way/ Fettercairn Road connecting Saggart to Tallaght from east to west, Citywest Road (N82) linking the Blessington Road (N81) to the Naas Road (N7) from north to south, Saggart Road, also on a north-south axis at the extreme western end, and the Cookstown Road which traverses the proposed route at its eastern end.

Within this structure of major distributor roads, there is a network of local access roads serving the various housing groups. Within each housing group a system of cul-de-sacs defines the residential structure in each case.

Pedestrian movement is generally directly associated with the road network, and normally takes the form of flanking footpaths. There are also some informal off-street pedestrian links through the various open spaces and backlands.

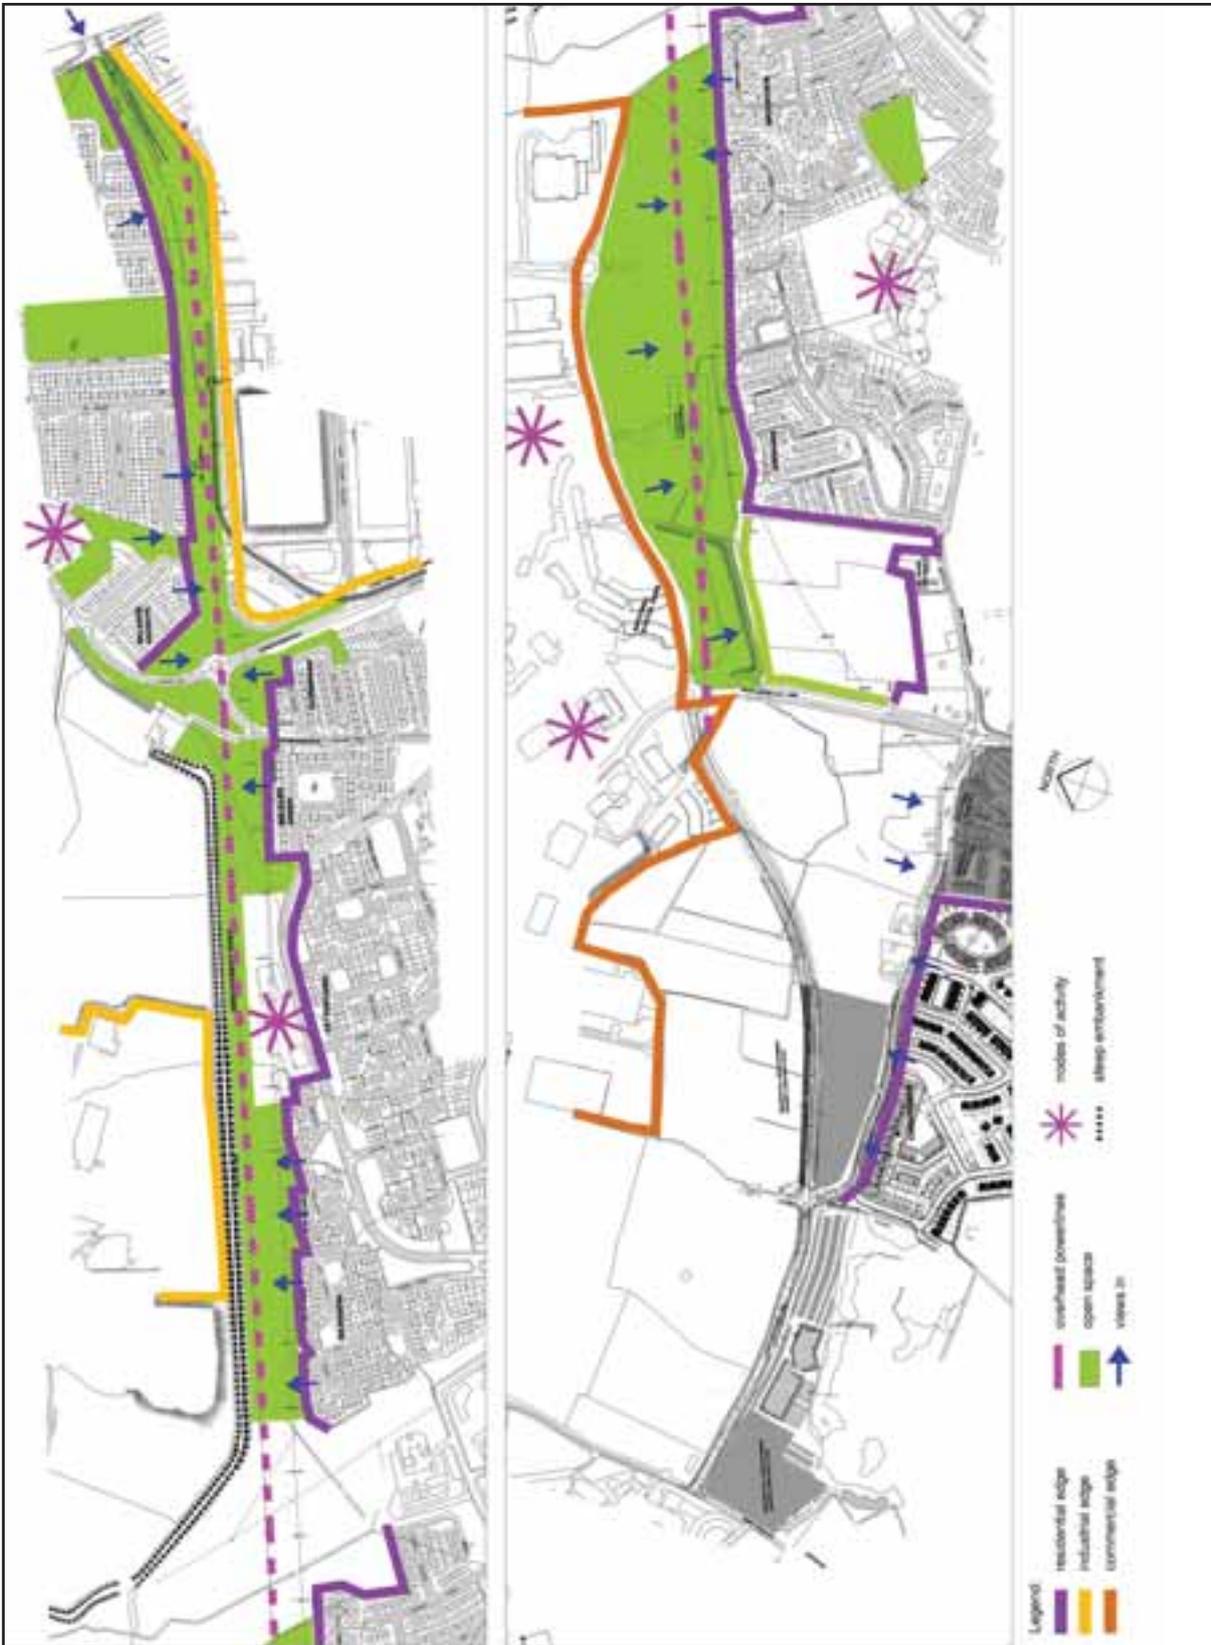
Figure 5.3: Visual Analysis

Figure 5.3 presents the visual analysis. In overall terms the proposed development site presents as a visually - degraded landscape, characterised by dumping, dereliction, vandalism etc., traversing a contiguous landscape of varying visual quality.

The large housing groups to the south of the corridor have a relatively low level of visual amenity, due to the lack of variation in house form and the absence of any significant amenity planting or developed open spaces. To the north of the proposed Luas Line A1 the twin foci of the Belgard quarry towards the eastern end, and the Citywest campus to the west provide a strong visual enclosure and a high - amenity "borrowed" landscape, respectively.

Towards the extreme western end of the site, the amenity level is heightened by the presence of the mature landscape associated with the Citywest Hotel and its associated golf courses.
